Expertise

Protocol number: 46301644
Order No. / Reference: 26562409
Inspection date: 29 Jun 2026

Model: Astra 1.5 D Start/Stop Sports Tourer Automatik Edition

VIN: W0VBD8EV9M8002455

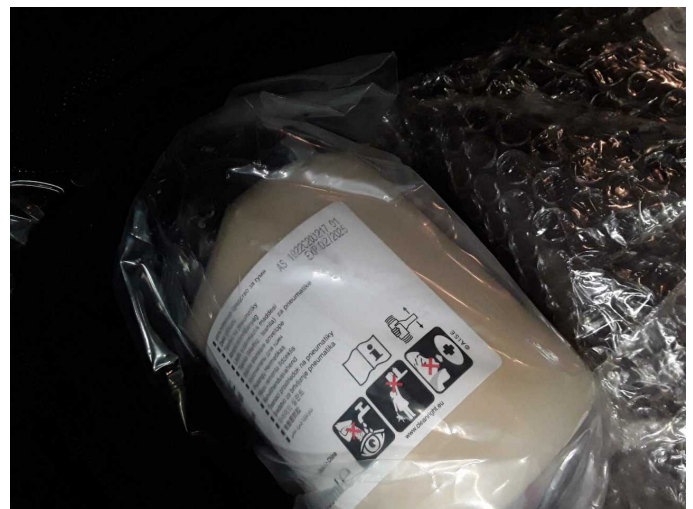
Damage 1: Equipment: Tirefit filler - Expired - Replace

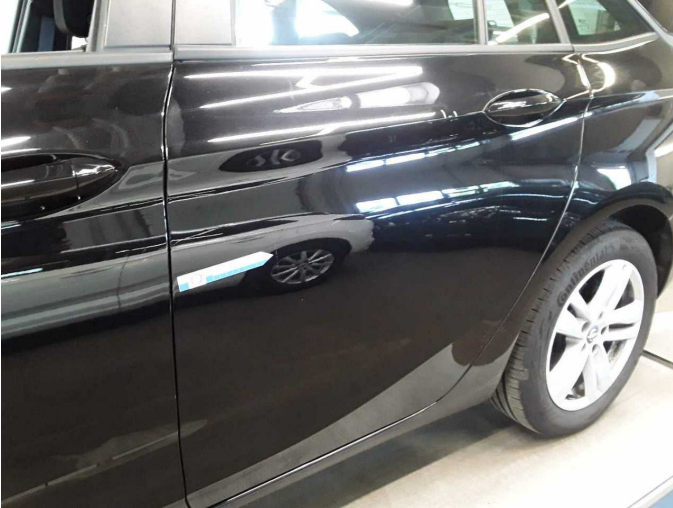
Damage 3: Door - rear left side: Door - Scratch(es) - Paint

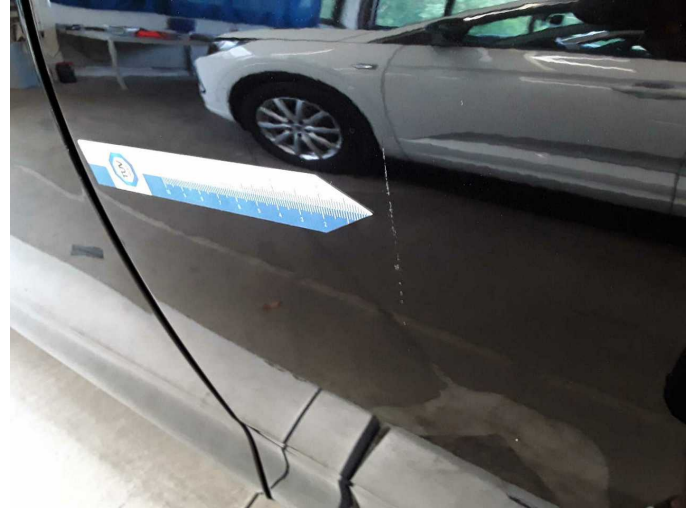
Damage 3: Door - rear left side: Door - Scratch(es) - Paint

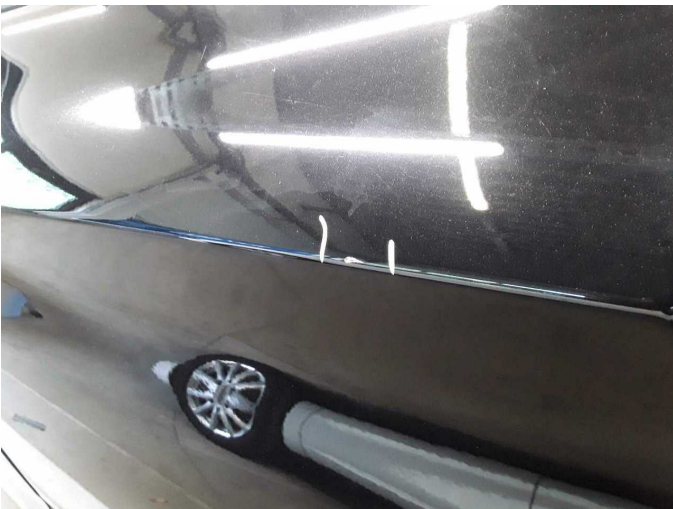
Damage 3: Door - rear left side: Door - Scratch(es) - Paint

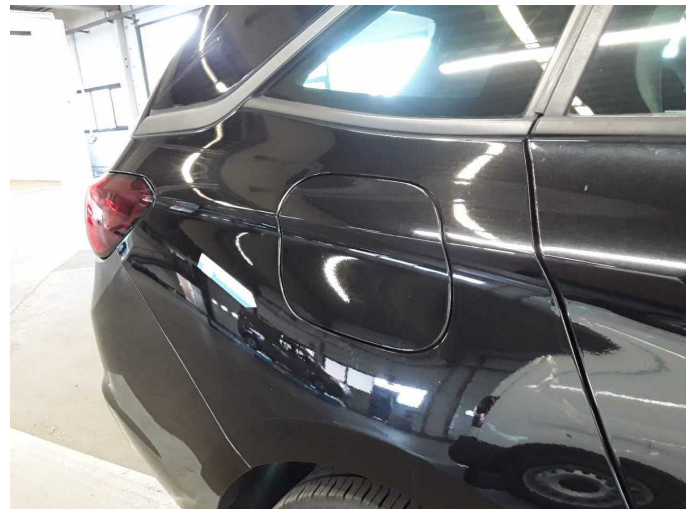
Damage 4: Side panel - rear right side: Side panel (Vogelkot eingebrannt) - Paint defect - Paint

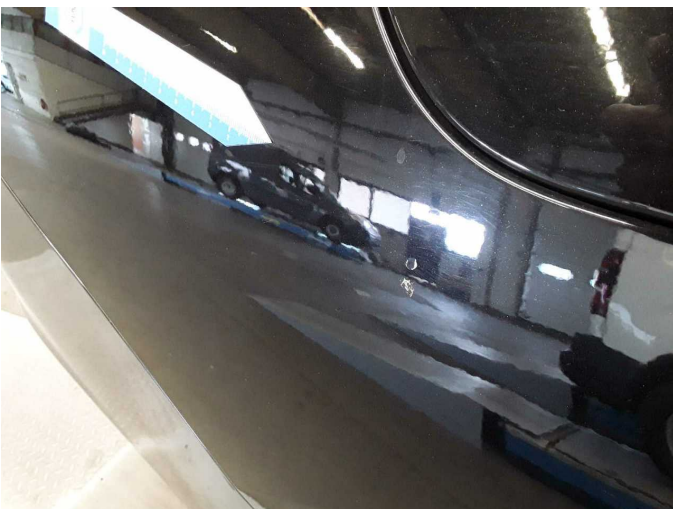
Damage 4: Side panel - rear right side: Side panel (Vogelkot eingebrannt) - Paint defect - Paint

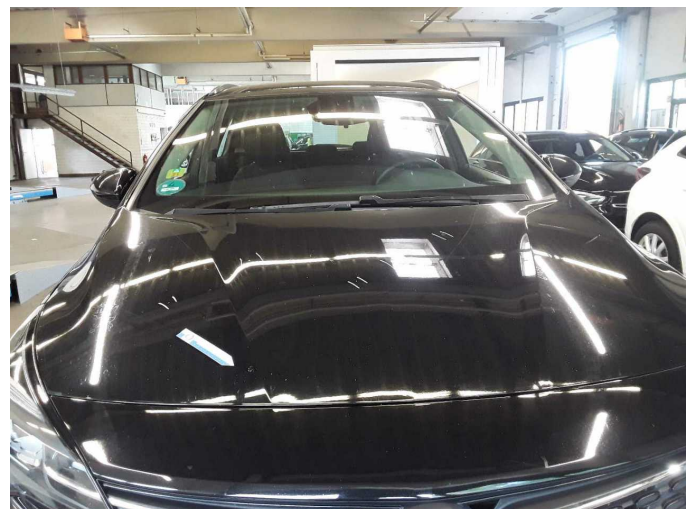
Damage 5: Bonnet: Bonnet (Vogelkot eingebrannt) - Paint defect - Paint

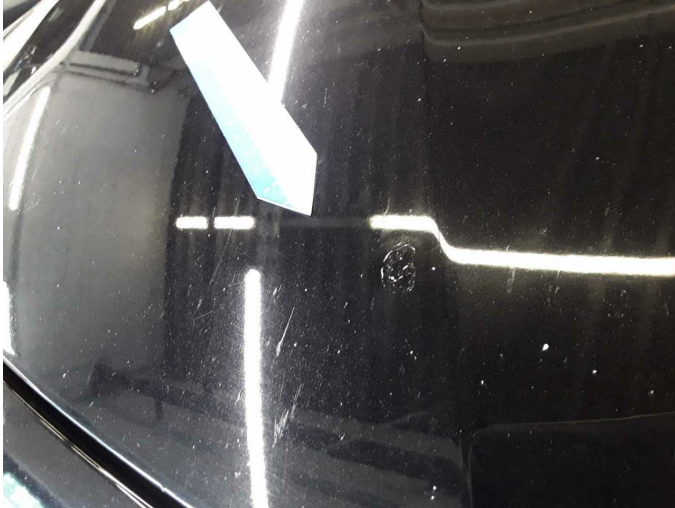
Damage 5: Bonnet: Bonnet (Vogelkot eingebrannt) - Paint defect - Paint

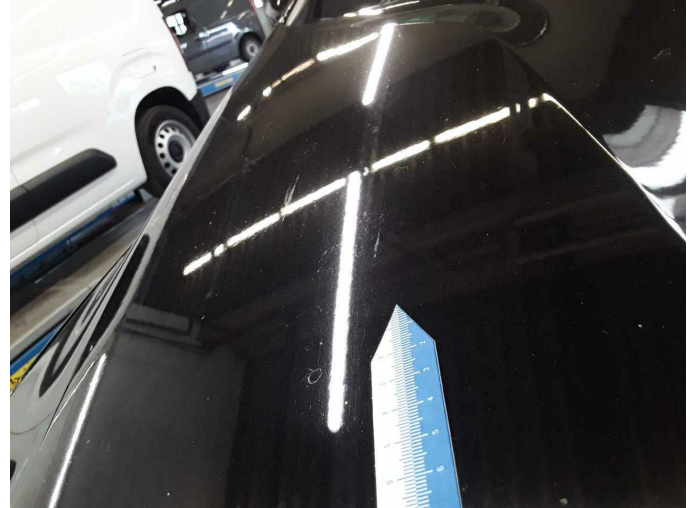
Damage 5: Bonnet: Bonnet (Vogelkot eingebrannt) - Paint defect - Paint

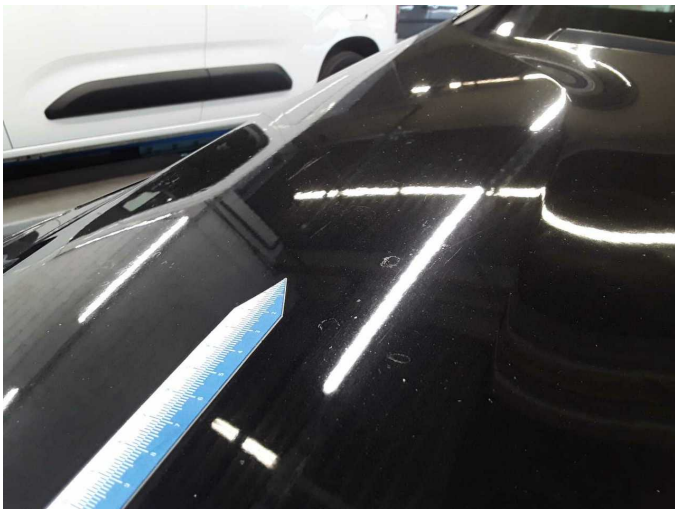
Damage 5: Bonnet: Bonnet (Vogelkot eingebrannt) - Paint defect - Paint

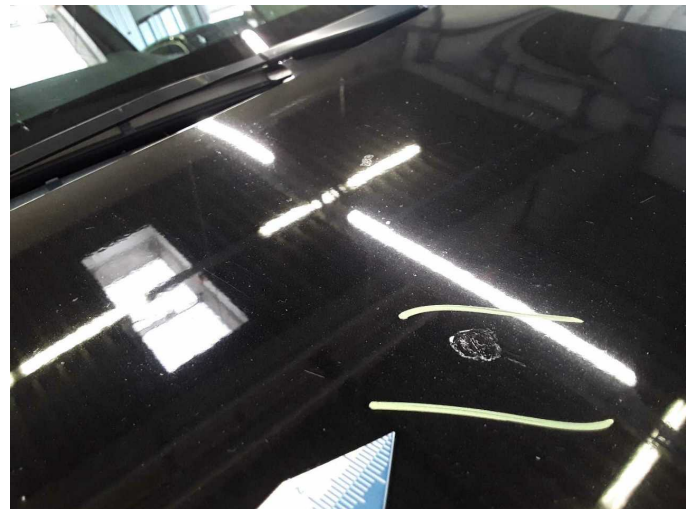
Damage 5: Bonnet: Bonnet (Vogelkot eingebrannt) - Paint defect - Paint

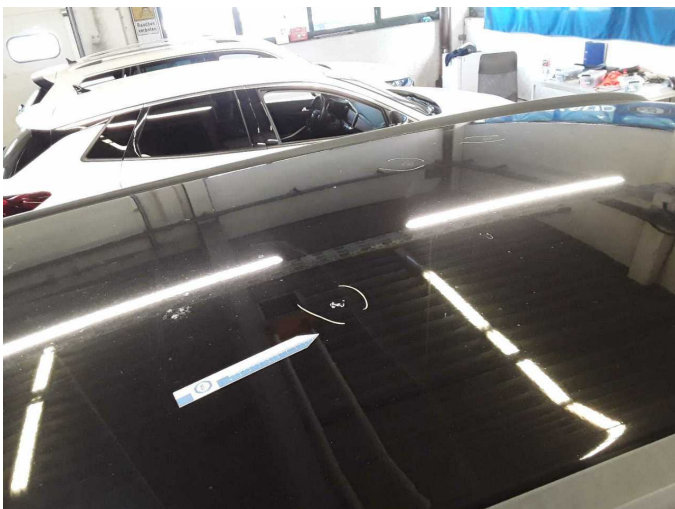
Damage 6: Roof: Roof (Vogelkot eingebrannt) - Paint defect - Paint

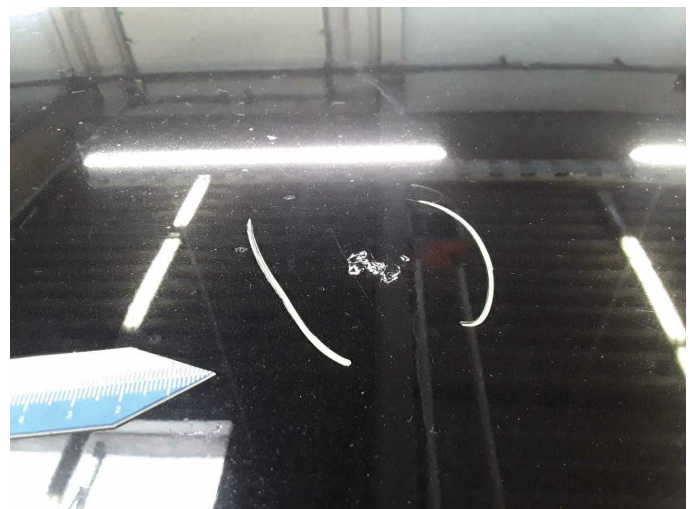
Damage 6: Roof: Roof (Vogelkot eingebrannt) - Paint defect - Paint

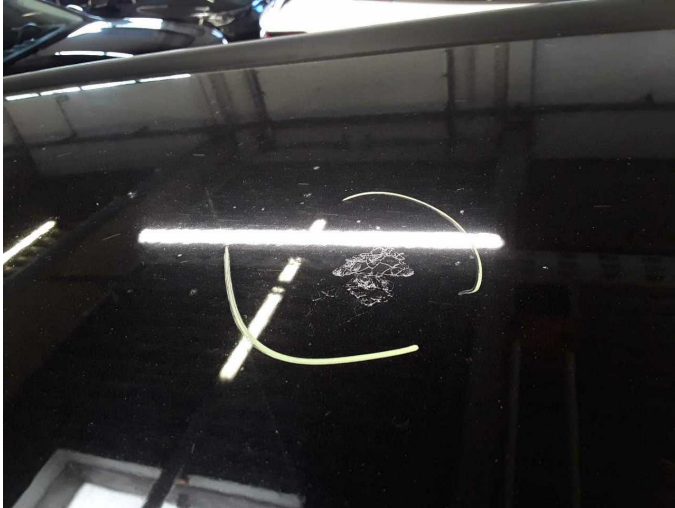
Damage 6: Roof: Roof (Vogelkot eingebrannt) - Paint defect - Paint

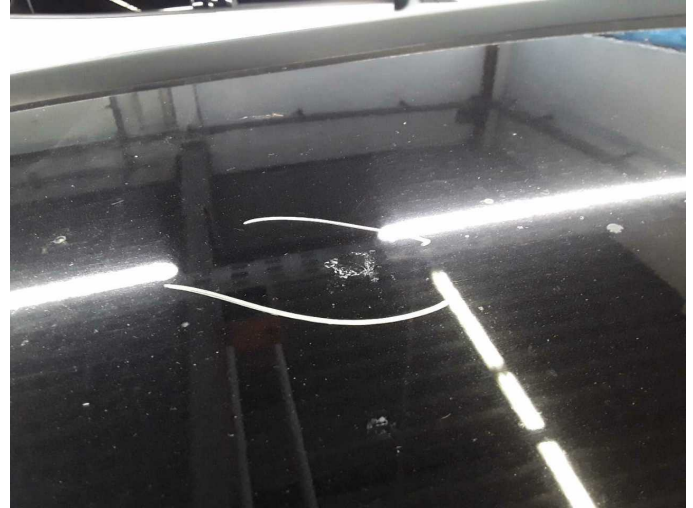
Damage 6: Roof: Roof (Vogelkot eingebrannt) - Paint defect - Paint

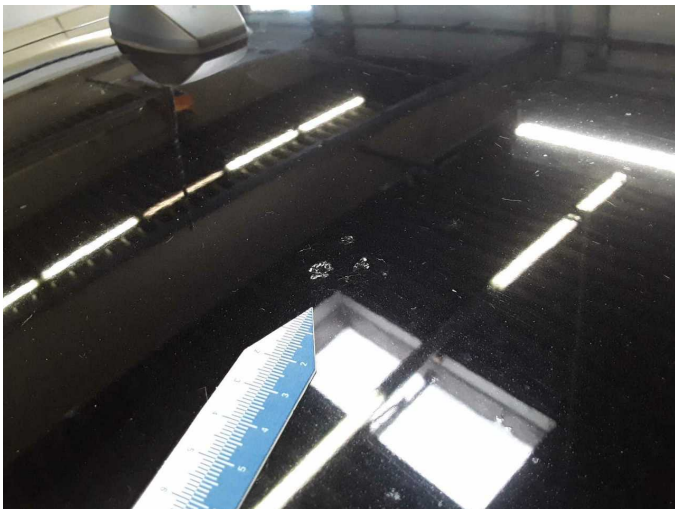
Damage 6: Roof: Roof (Vogelkot eingebrannt) - Paint defect - Paint

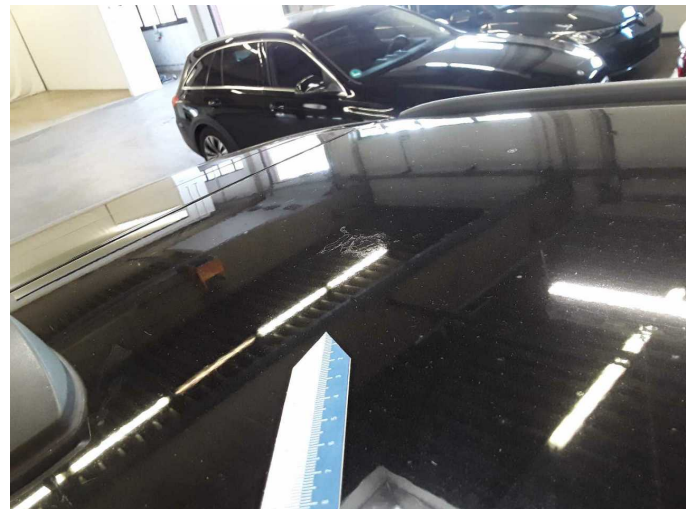
Damage 6: Roof: Roof (Vogelkot eingebrannt) - Paint defect - Paint

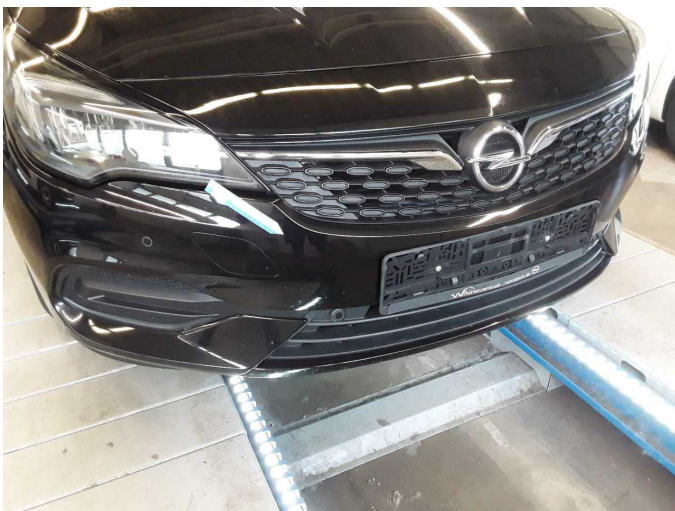
Wear and tear 1: Front bumper: Front bumper - Stone chips - No deduction

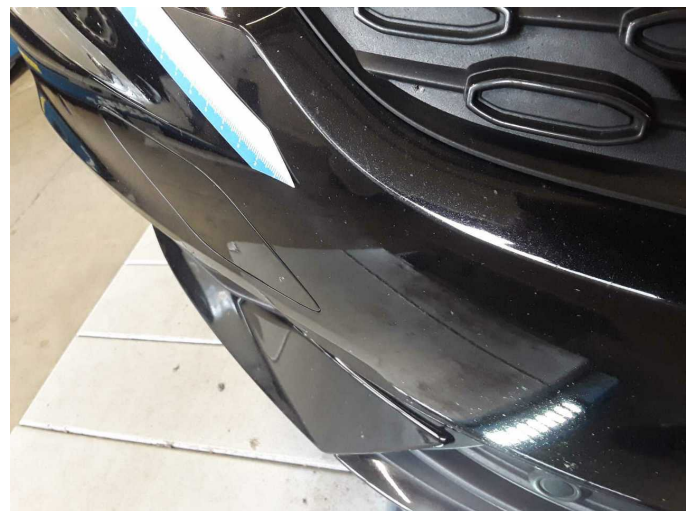
Wear and tear 1: Front bumper: Front bumper - Stone chips - No deduction
