Expertise

Protocol number: 46192678
Order No. / Reference: 26151877
Inspection date: 22 May 2026

Model: Vito 116 CDI Tourer Extralang Aut. PRO

VIN: W1VVLGFZ3T4559141

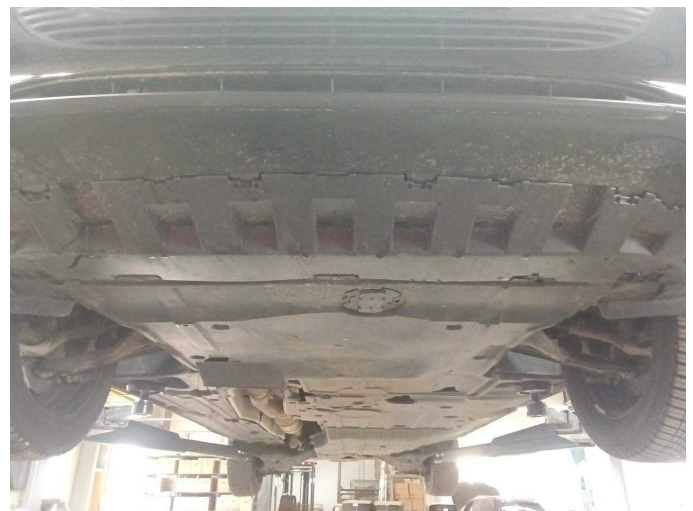
Damage 1: Body: Underbody panelling - Scratched - Replace

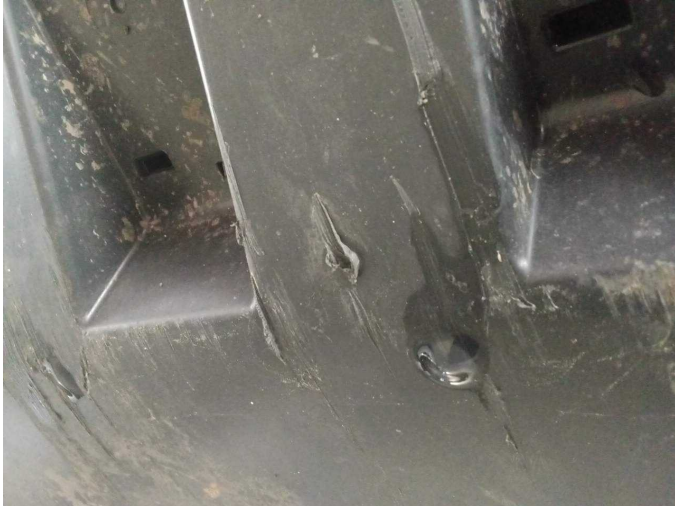
Damage 1: Body: Underbody panelling - Scratched - Replace

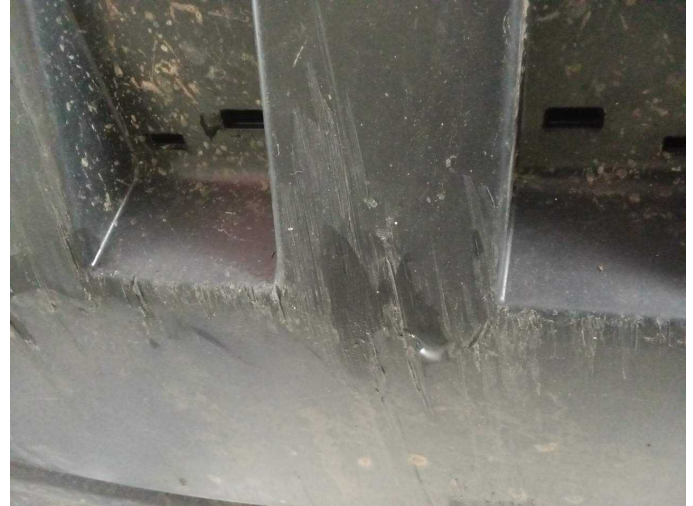
Damage 1: Body: Underbody panelling - Scratched - Replace

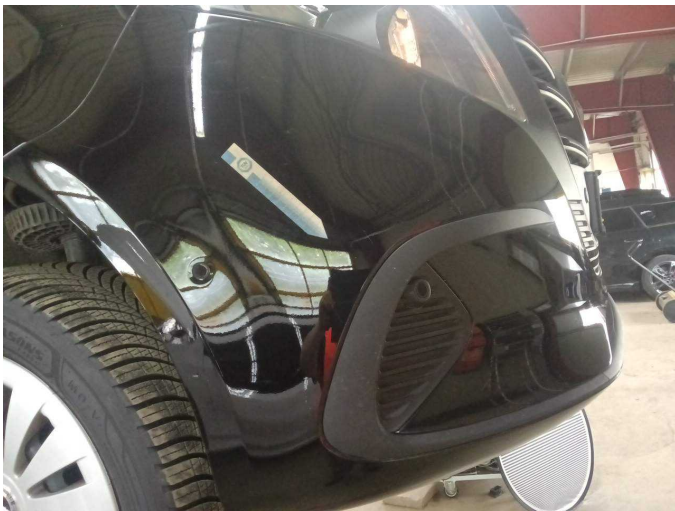
Damage 2: Front bumper: Front bumper - Scratch(es) - Smart repair

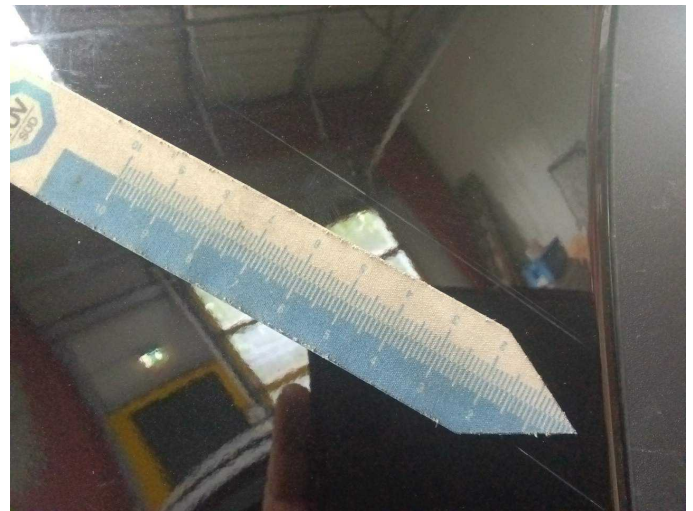
Damage 2: Front bumper: Front bumper - Scratch(es) - Smart repair

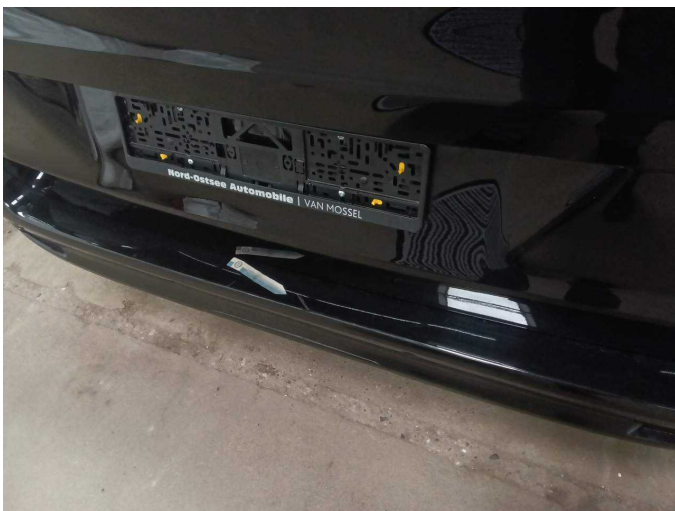
Damage 3: Rear bumper: Rear bumper - Scratch(es) - Paint

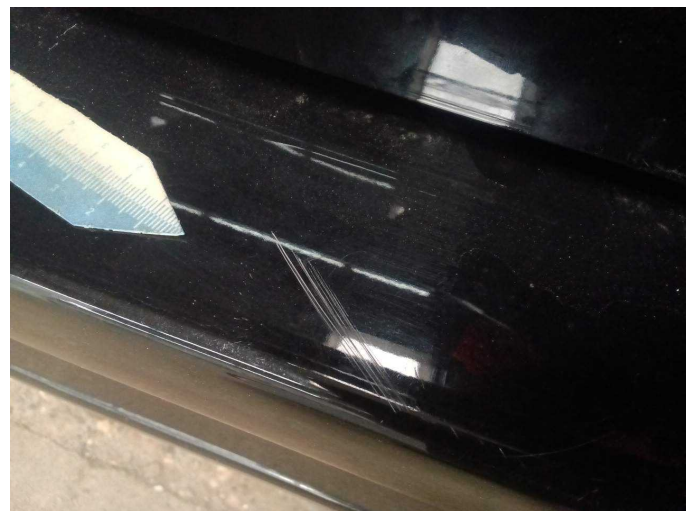
Damage 3: Rear bumper: Rear bumper - Scratch(es) - Paint

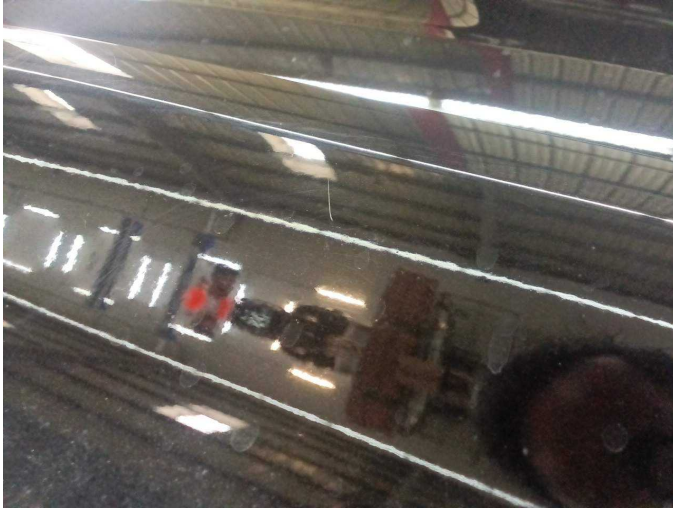
Damage 3: Rear bumper: Rear bumper - Scratch(es) - Paint

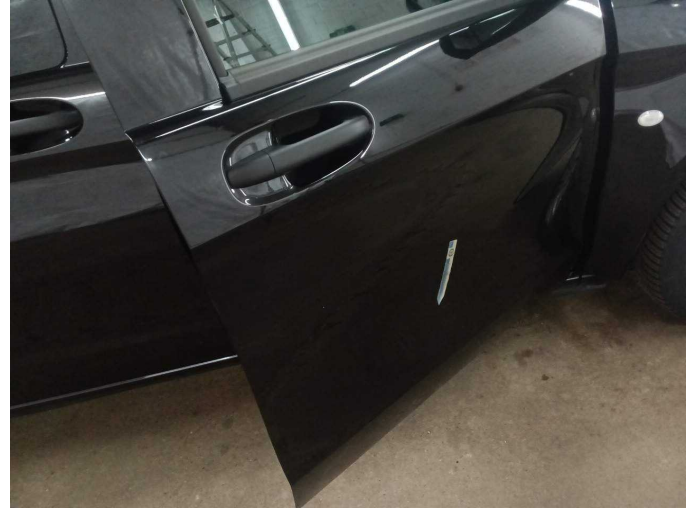
Damage 4: Door - front right side: Door - Dent / paintcoat damage - Repair and paint

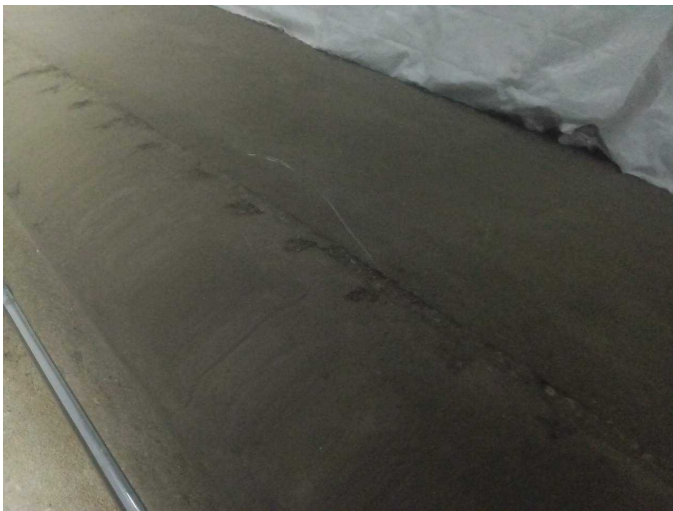
Damage 4: Door - front right side: Door - Dent / paintcoat damage - Repair and paint

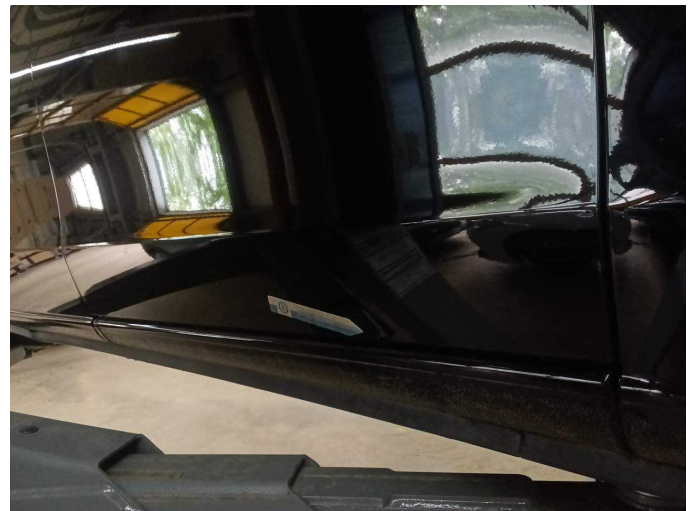
Damage 4: Door - front right side: Door - Dent / paintcoat damage - Repair and paint

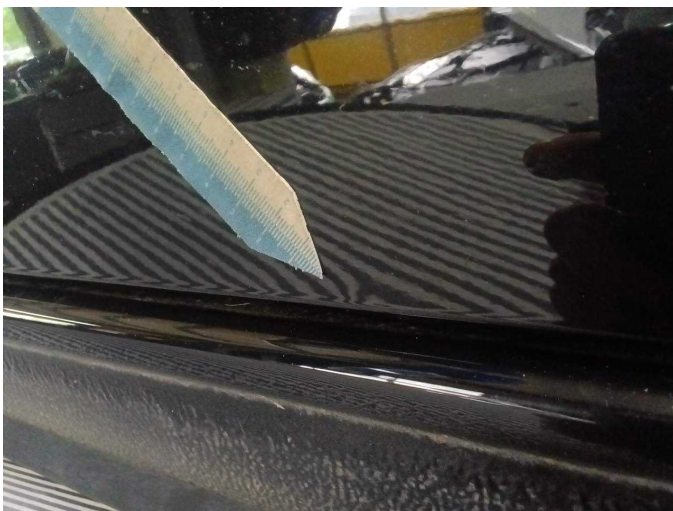
Damage 4: Door - front right side: Door - Dent / paintcoat damage - Repair and paint

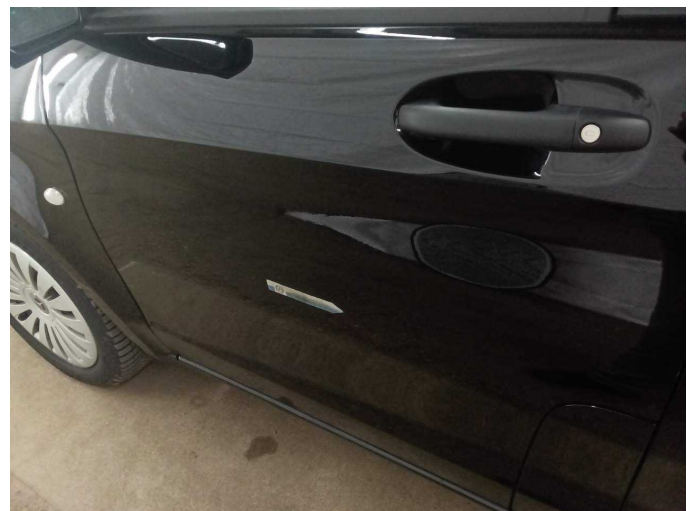
Wear and tear 8: Door - front left side: Door - dent(s) - No deduction

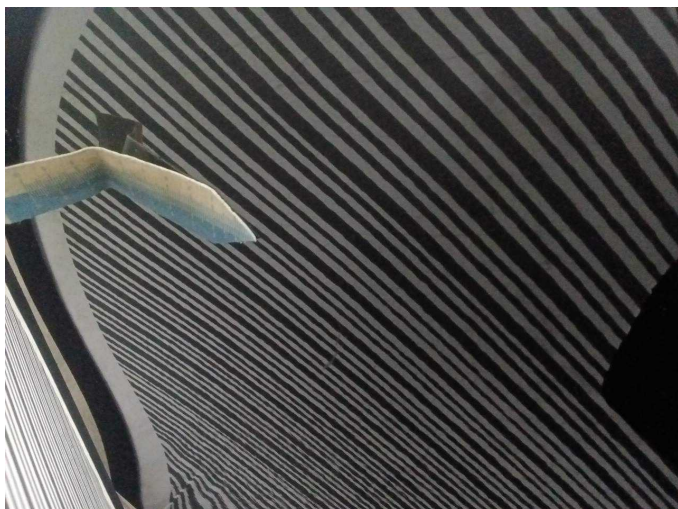
Wear and tear 8: Door - front left side: Door - dent(s) - No deduction

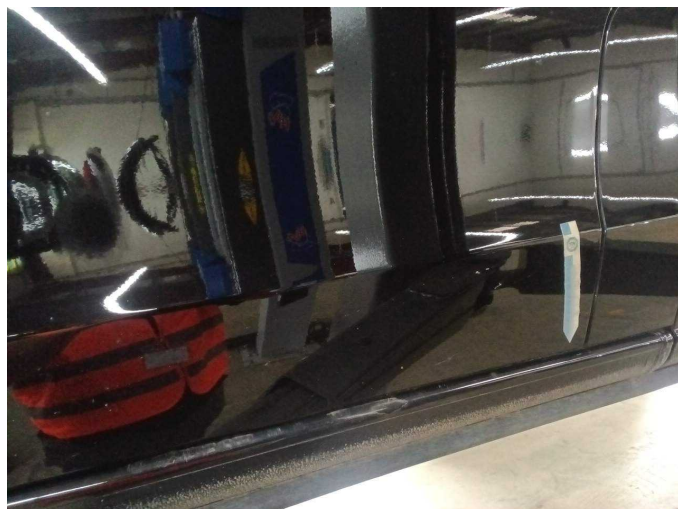
Wear and tear 8: Door - front left side: Door - dent(s) - No deduction

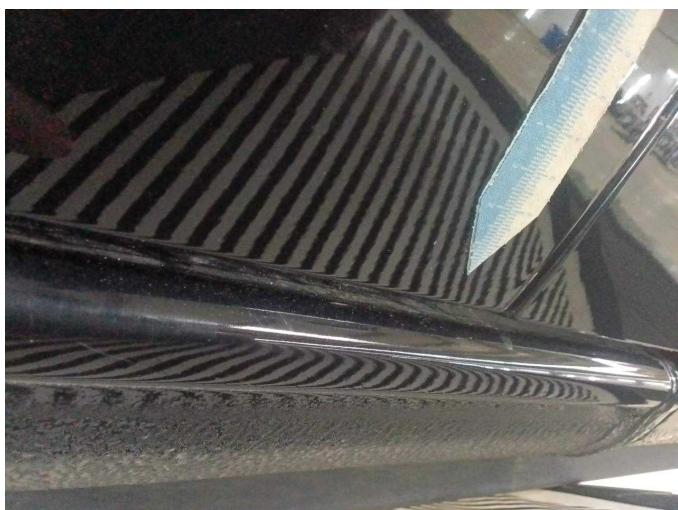
Wear and tear 8: Door - front left side: Door - dent(s) - No deduction
