Expertise

Protocol number: 46030993
Order No. / Reference: 26534703
Inspection date: 18 Jun 2026

Manufacturer: Ford

Model: Transit Connect 210 L2 S&S Trend

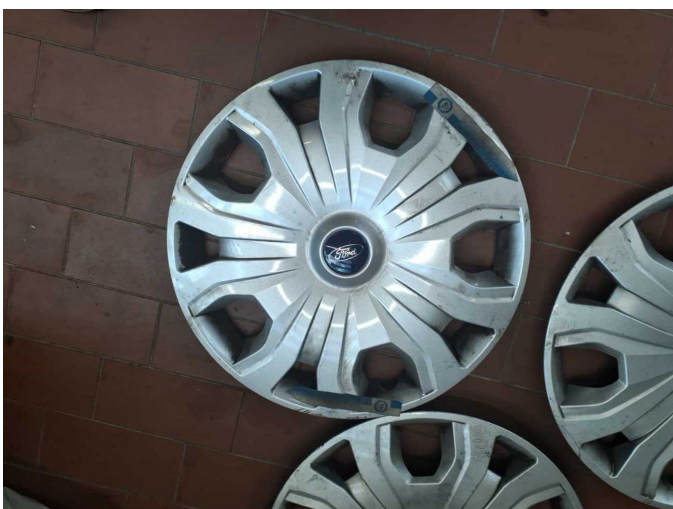
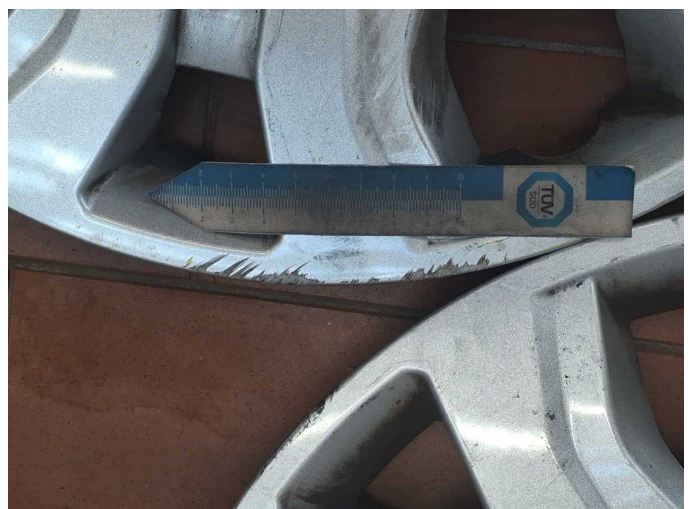
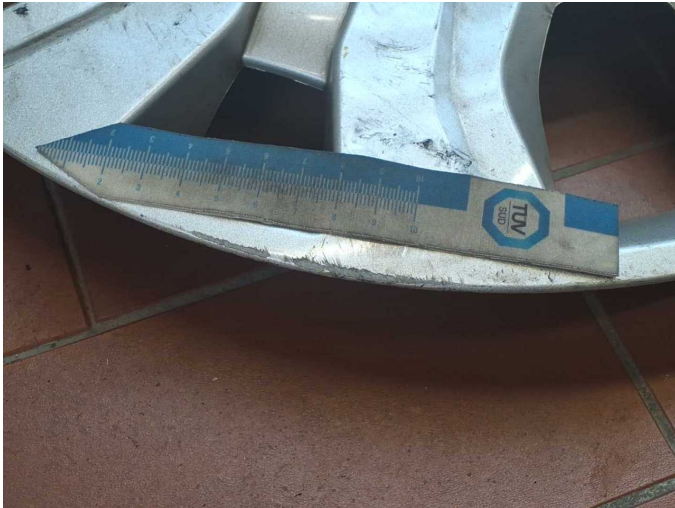
Damage 1: 2nd wheel set: 1 wheel cover - Scratched - Replace

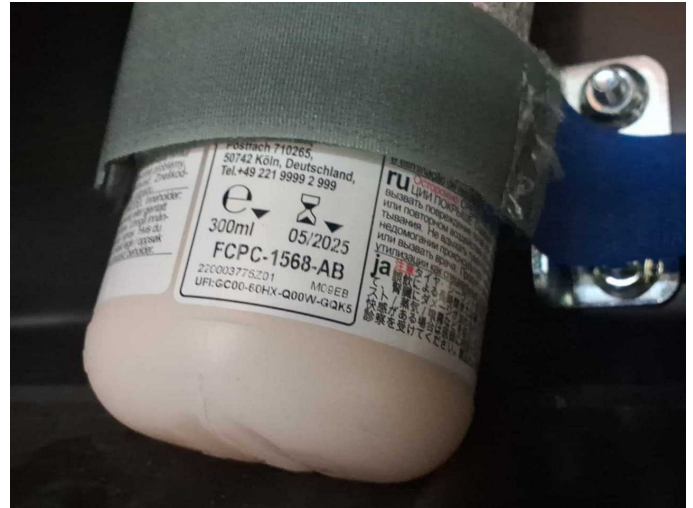
Damage 2: Equipment: Tirefit filler - Expired - Replace

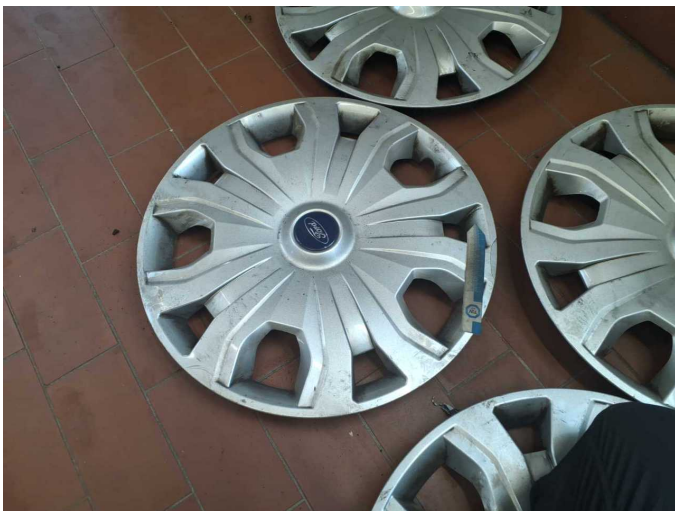
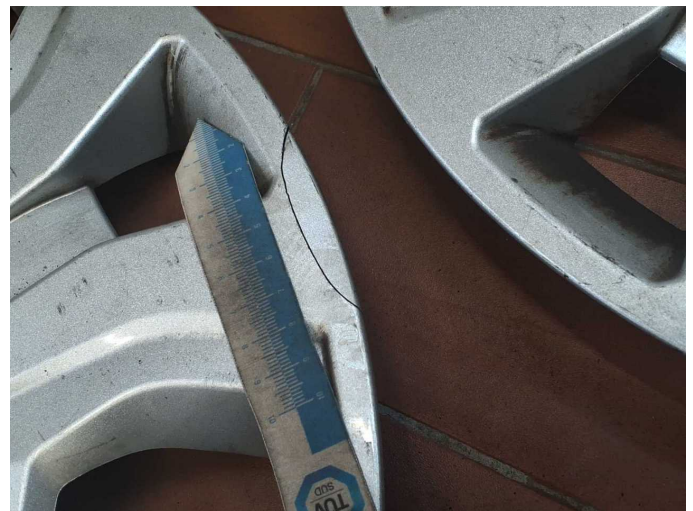
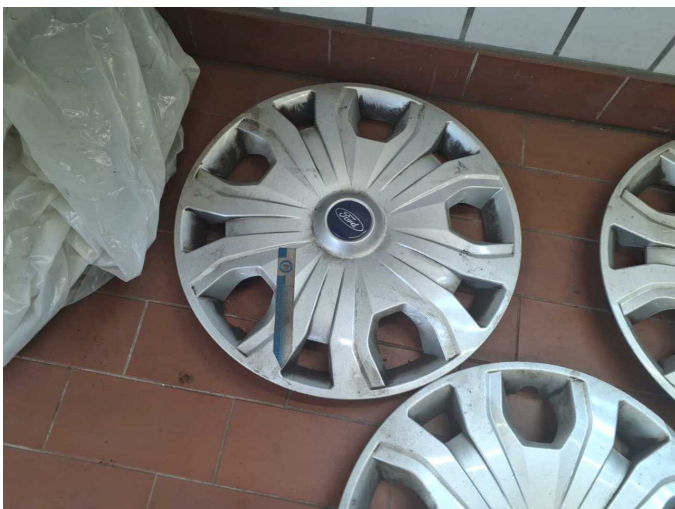
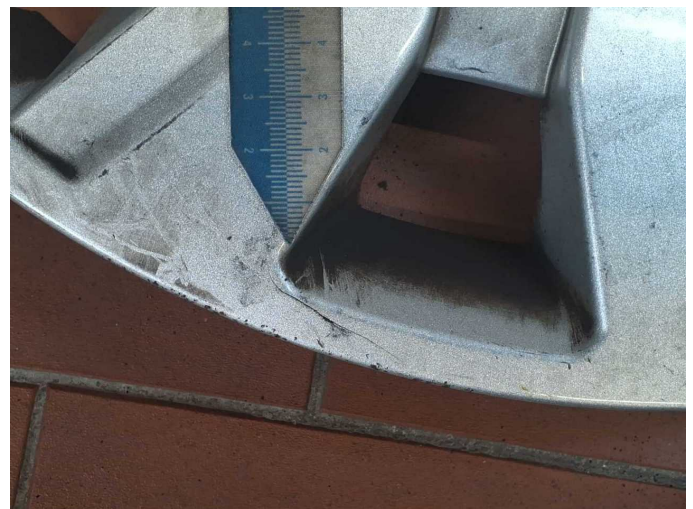
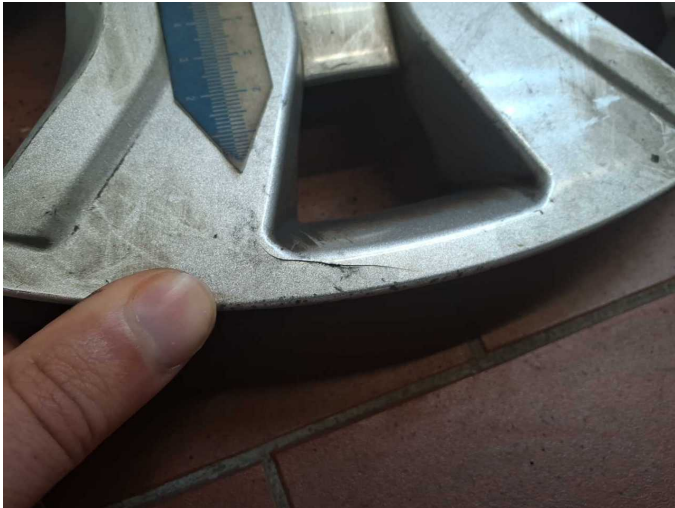
Damage 3: 2nd wheel set: 2 wheel covers - Broken / torn - Replace

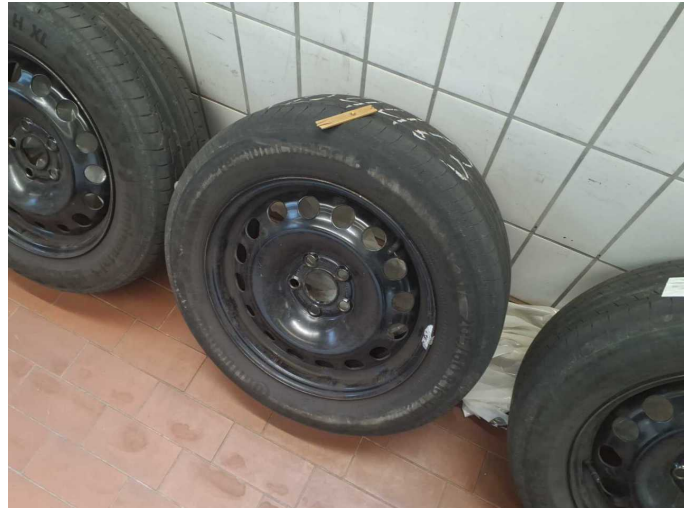
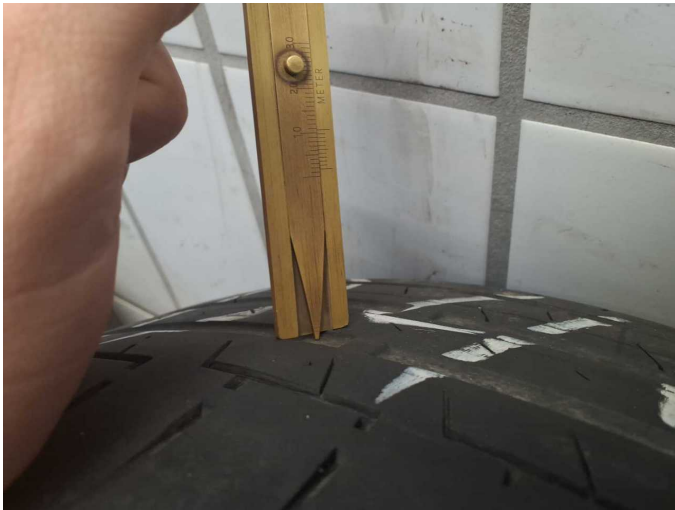
Damage 4: 2nd wheel set: 1 tyre - Worn - Replace

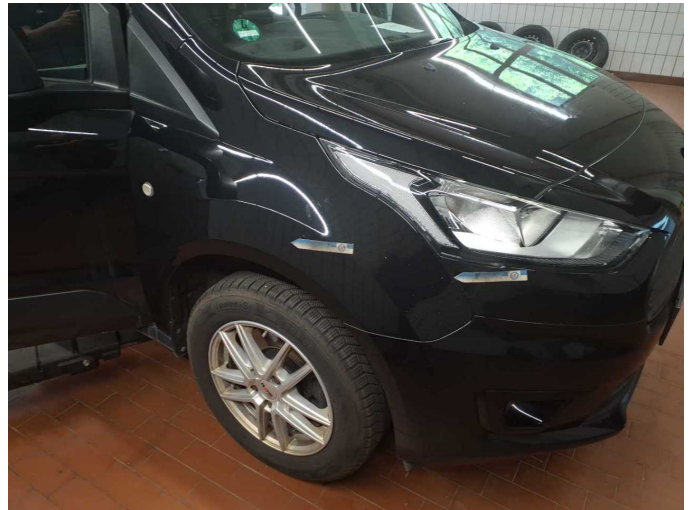
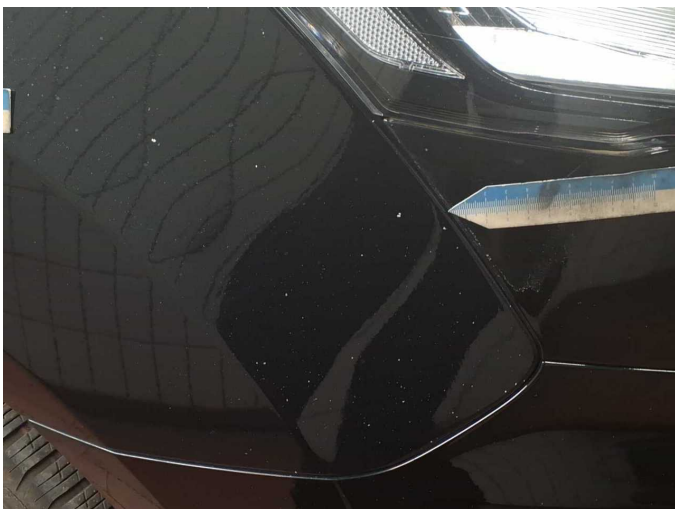
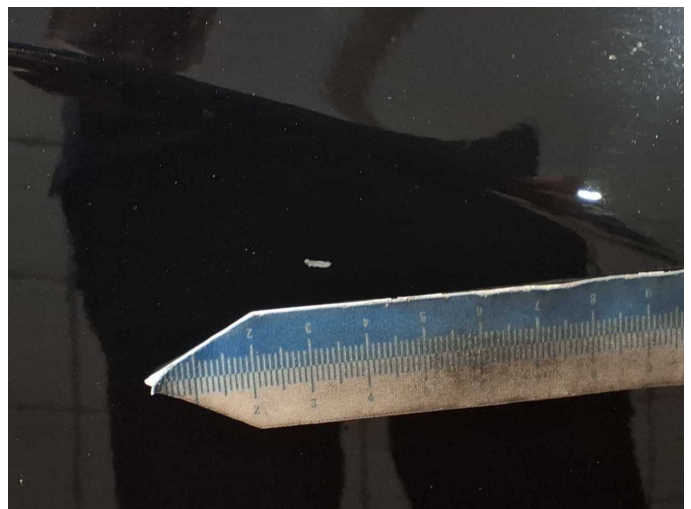
Damage 5: Mudguard - right side: Mudguard - right side (+ Steinschläge)
- Scratch(es) - Paint

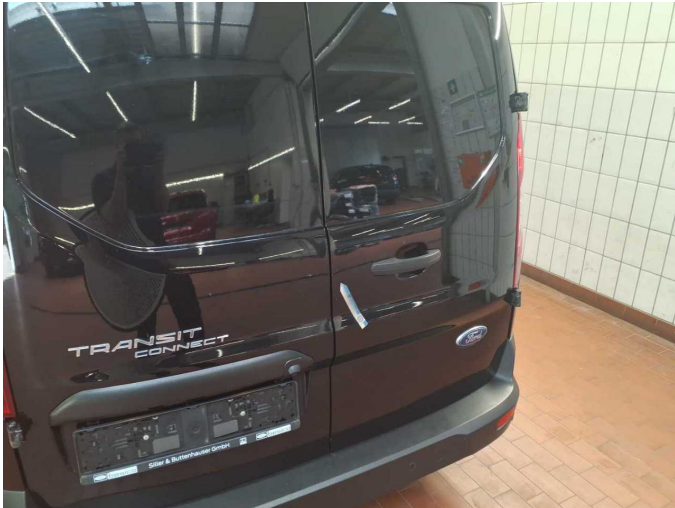
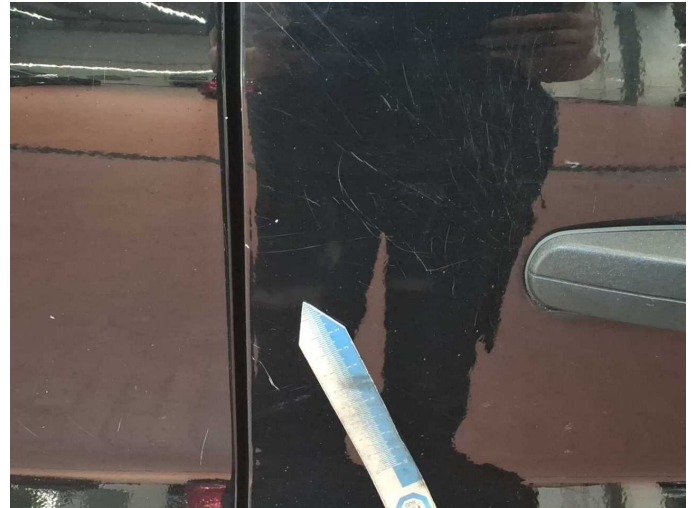
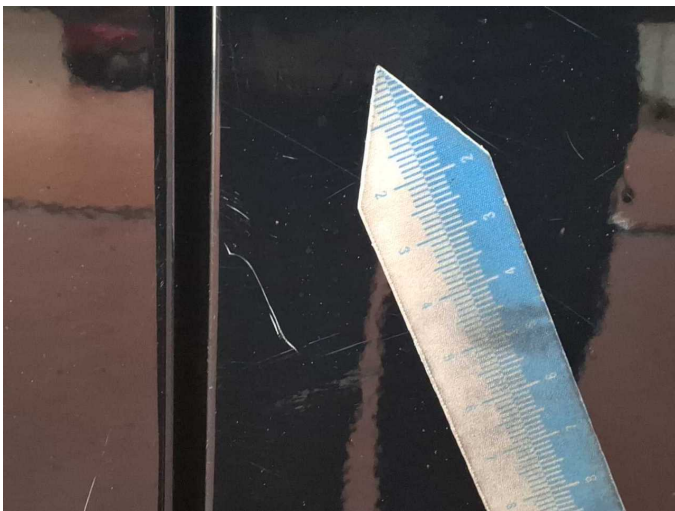
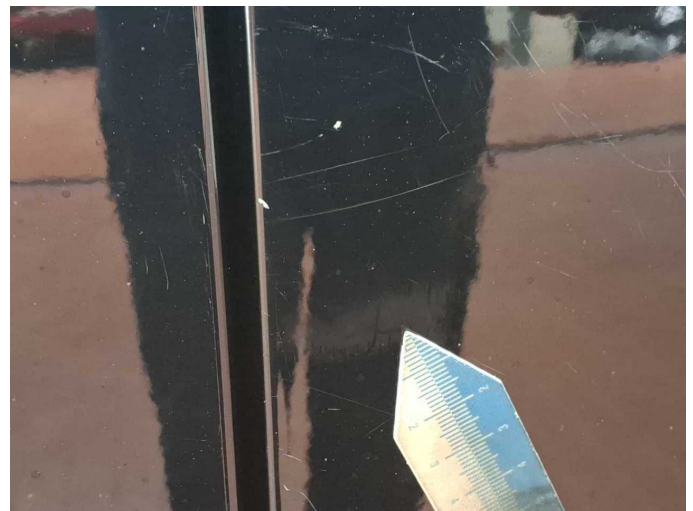
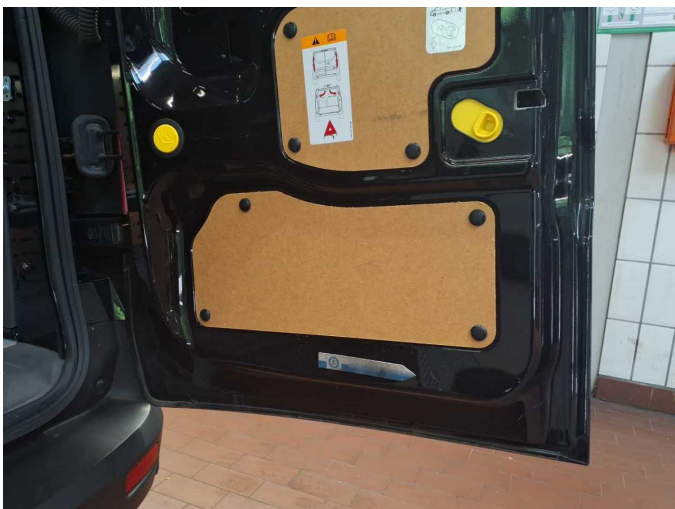
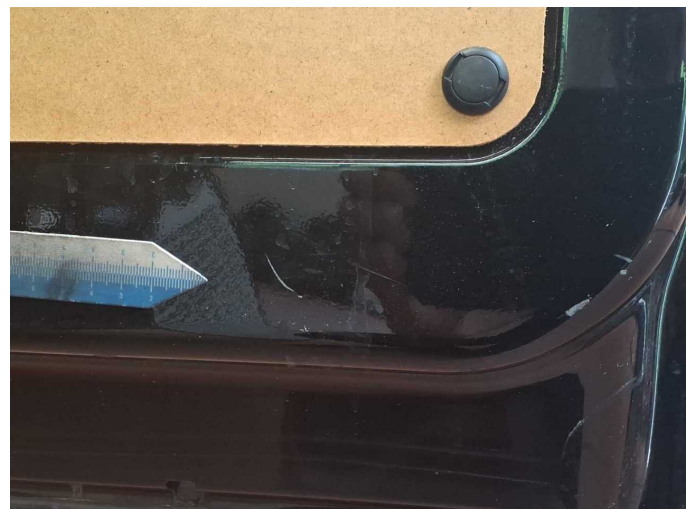
Damage 6: Boot lid / rear door: Rear door - right side - Scratch(es) - Paint

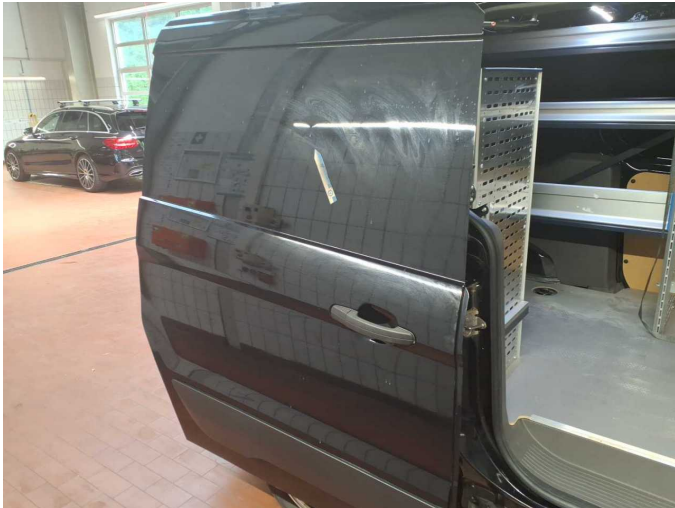
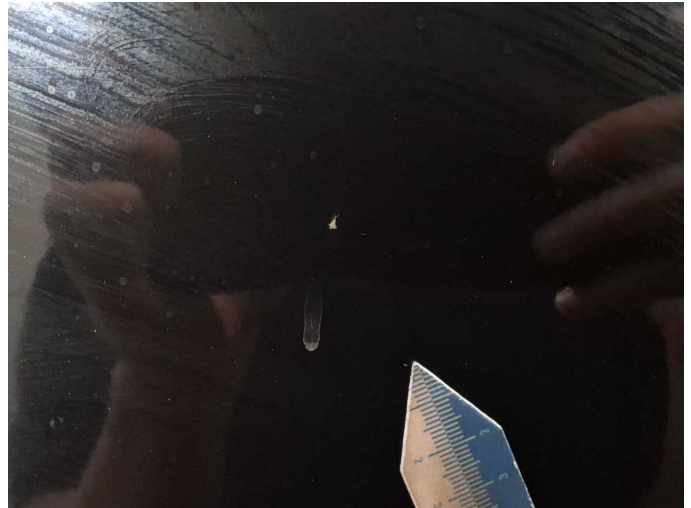
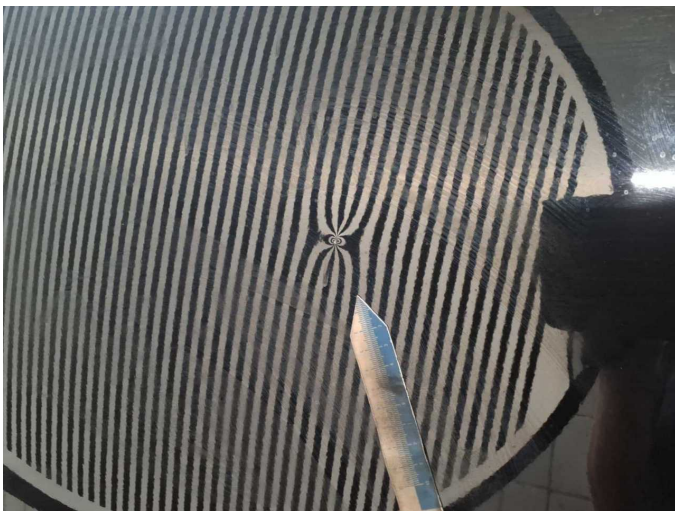
Damage 7: Sliding door, right: Sliding door (Beule) - Dent / paintcoat damage - Repair and paint

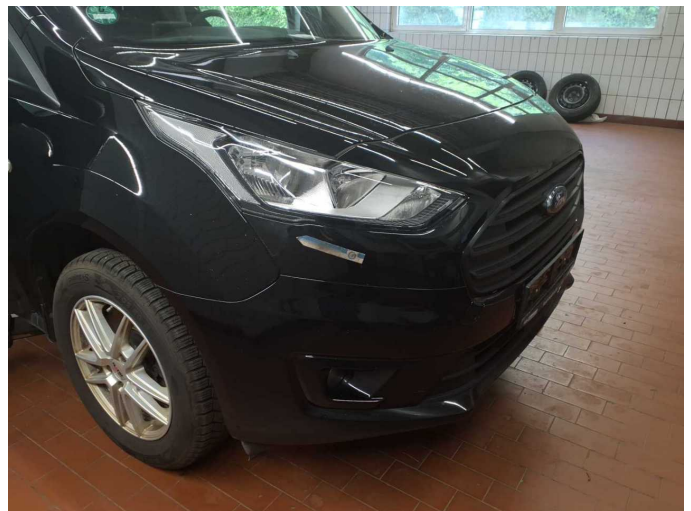
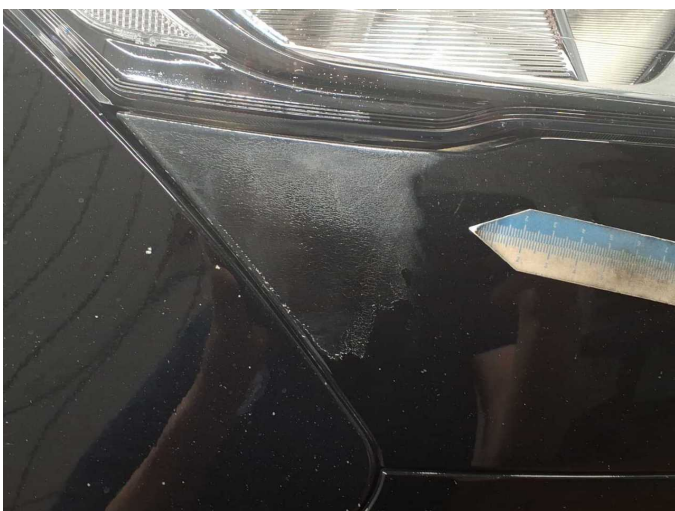
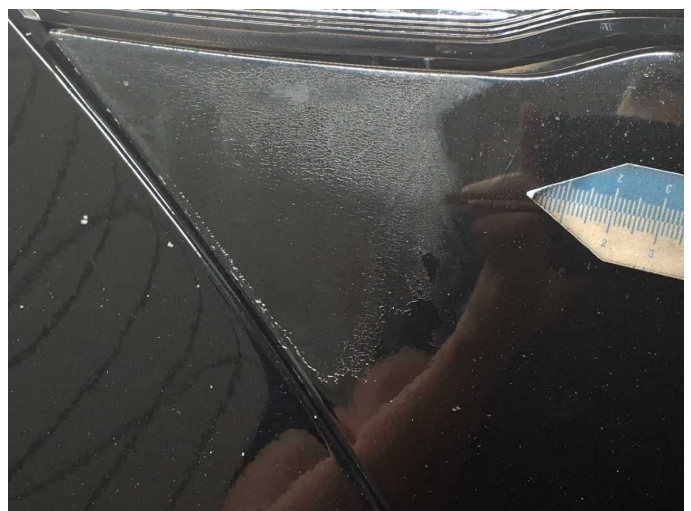
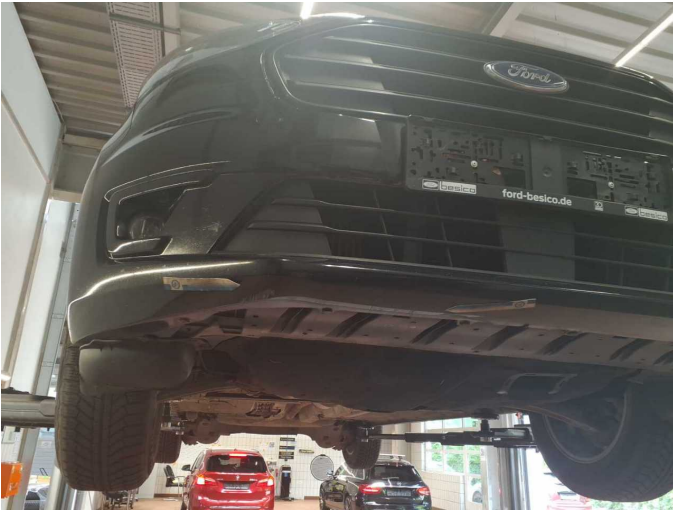
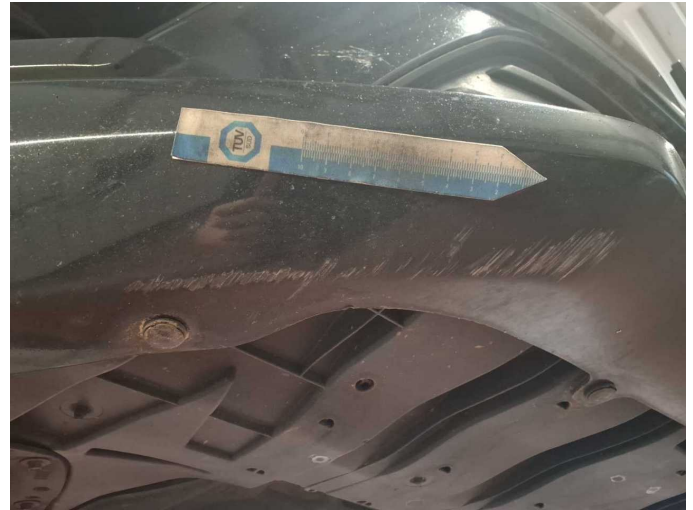
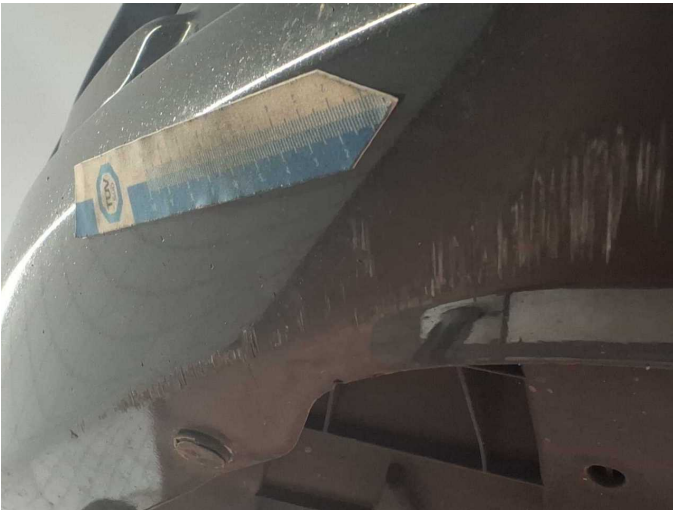
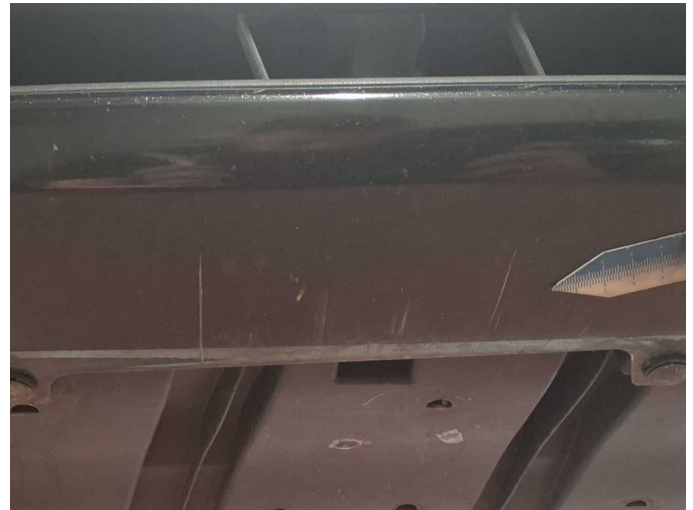
Damage 8: Front bumper: Front bumper (Oben Lack löst sich + Unten verschürft) - Scratched - Paint

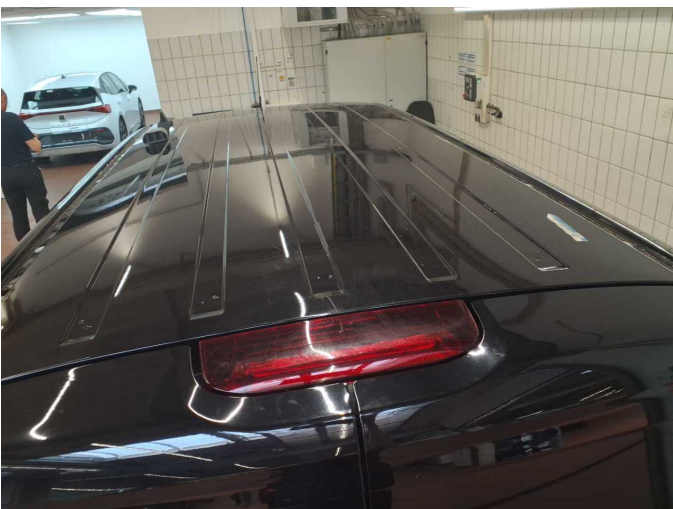
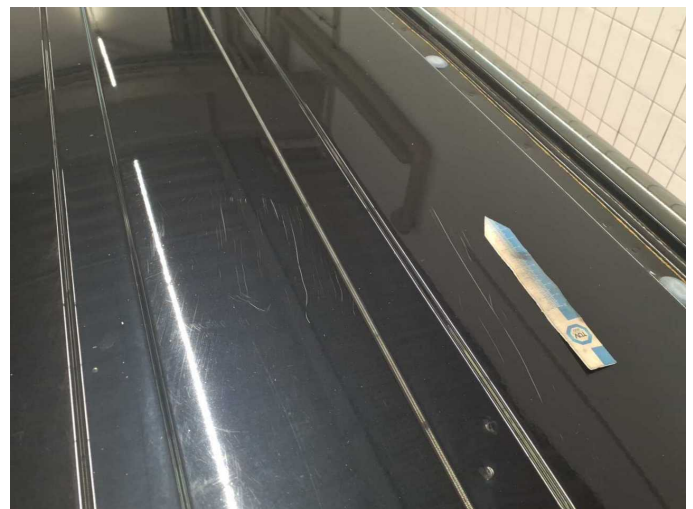
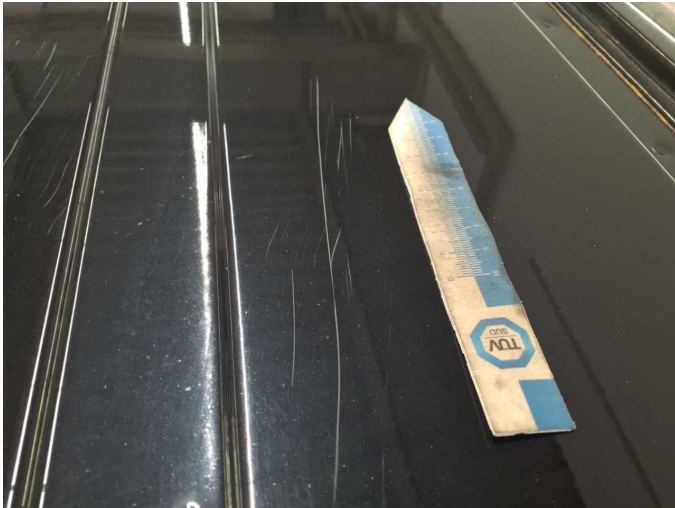
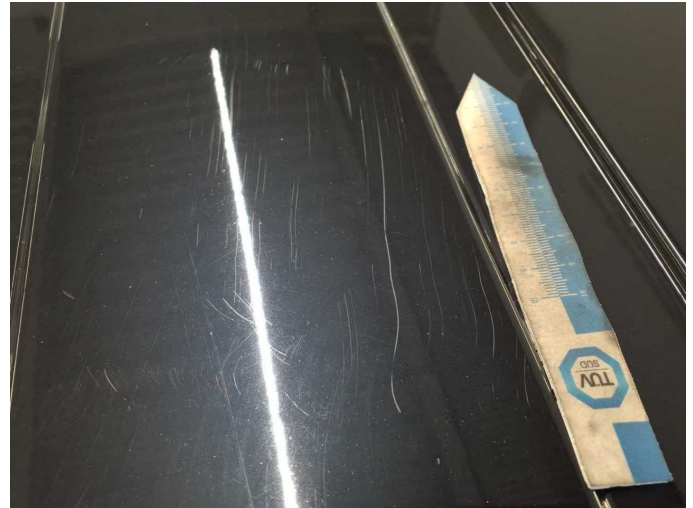
Damage 9: Roof: Roof - Dent / paintcoat damage - Repair and paint

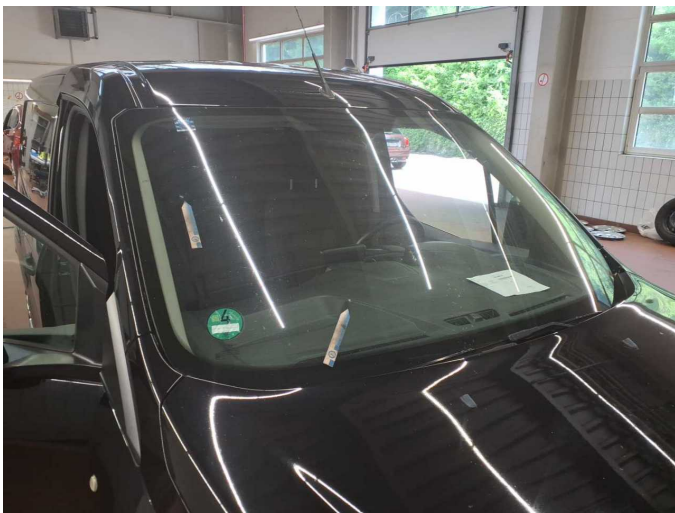
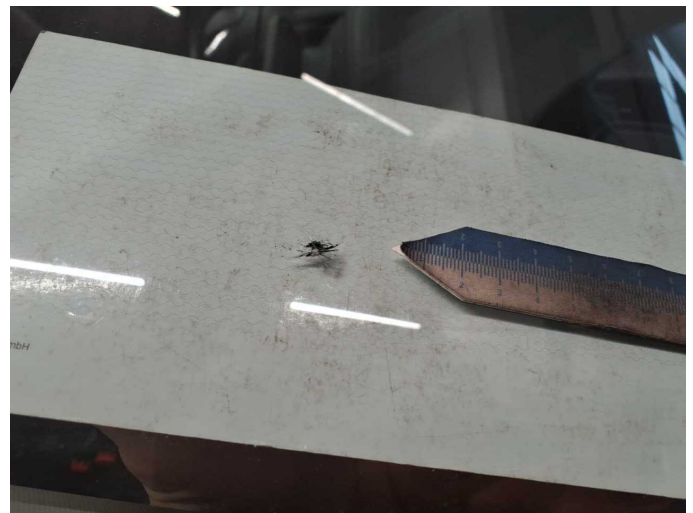
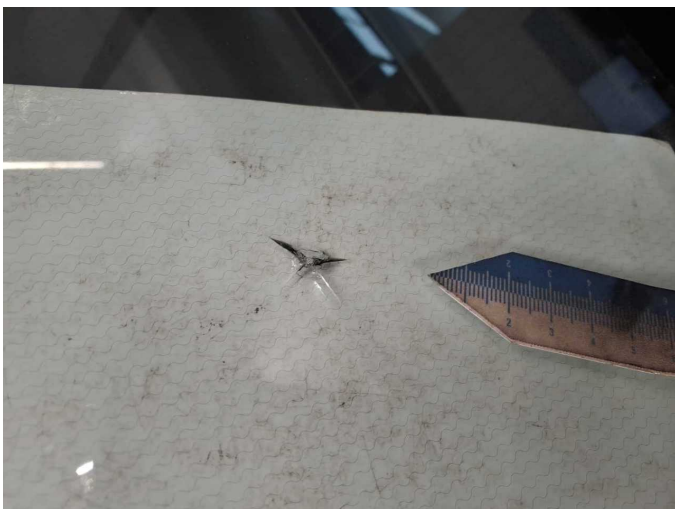
Damage 10: Vehicle glazing: Windscreen (Mit Rissbildung;) - Stone chips - repair according to calculation

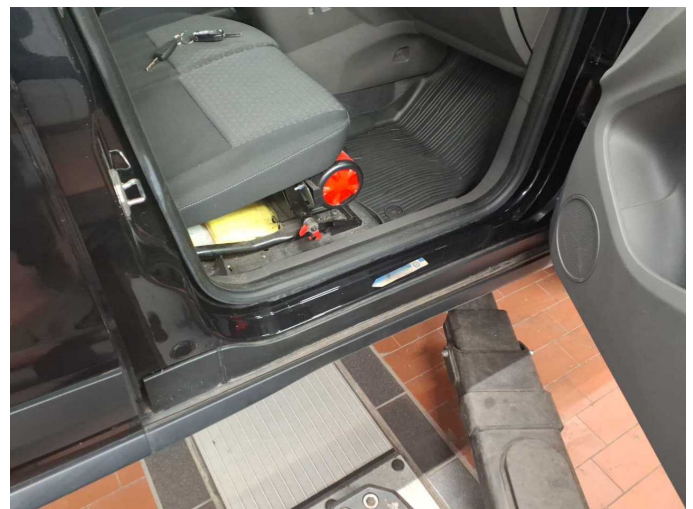
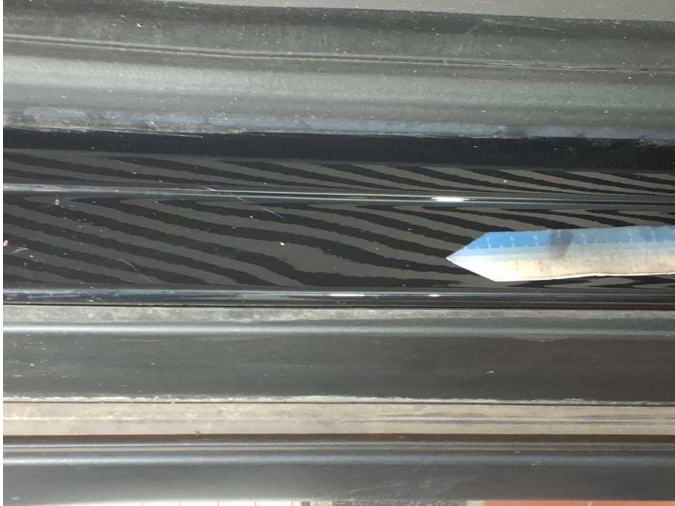
Wear and tear 7: Sill - right side: Sill - dent(s) - No deduction

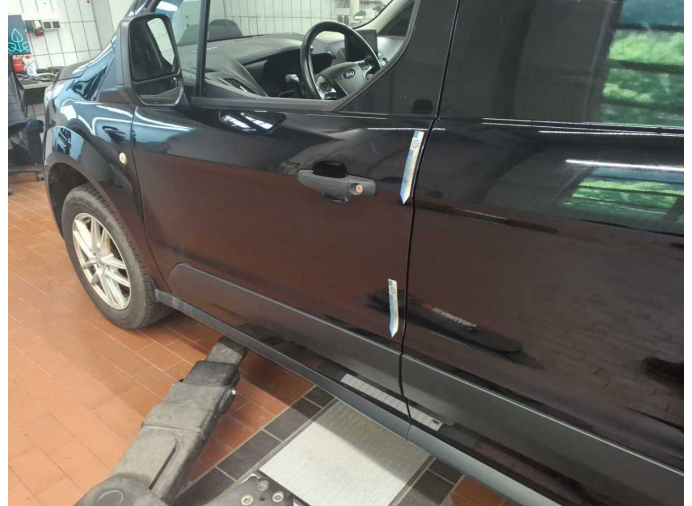
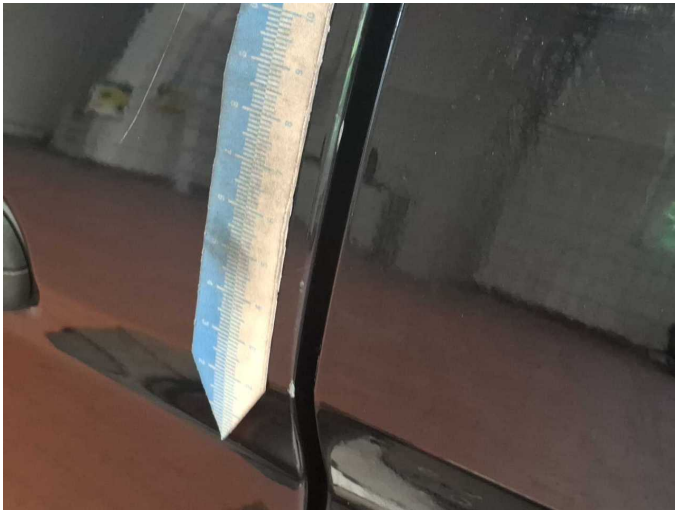
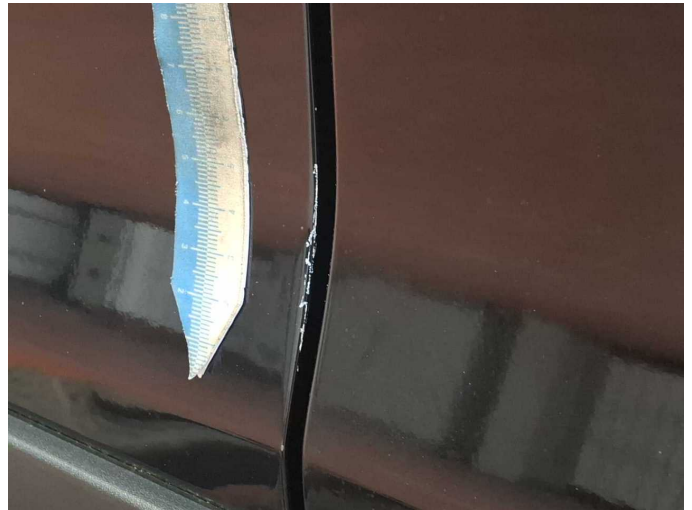
Wear and tear 8: Door - front left side: Door edge - Scratch(es) - Smart repair
