Expertise

Protocol number: 45568656
Order No. / Reference: 26352062
Inspection date: 15 May 2026

Model: Focus Turnier 2.0 EcoBlue Start-Stopp-System Aut.
COOL&CONNECT

VIN: WF0PXXGCHPLK11806

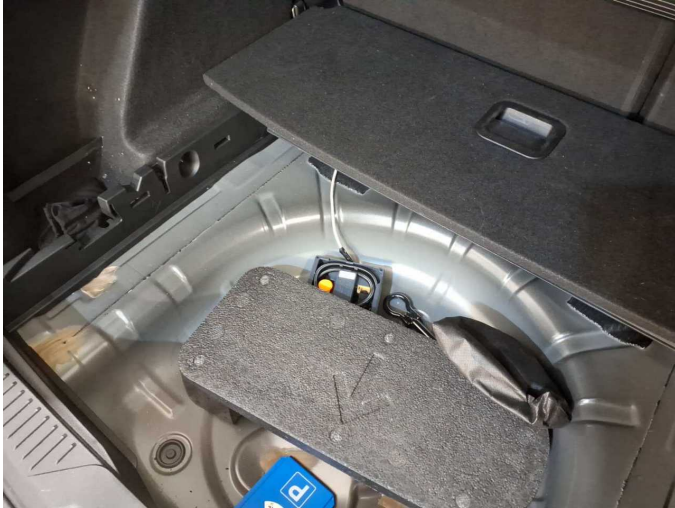
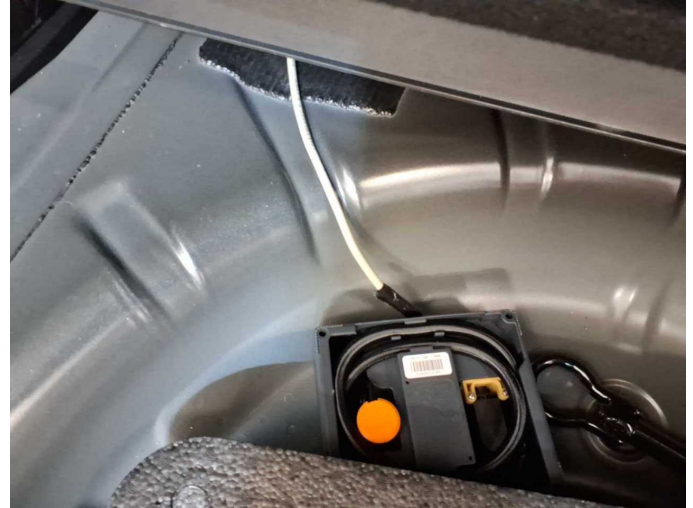
Damage 3: Electrical system: Cable strand (Kabelanschluss in) - Specify findings - Remove

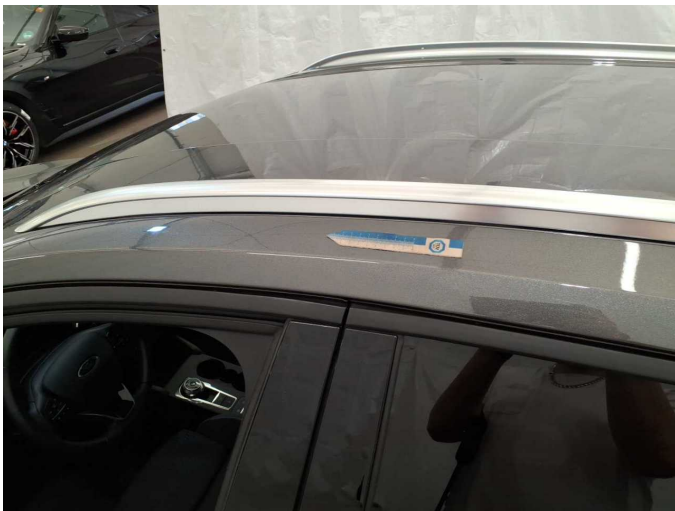
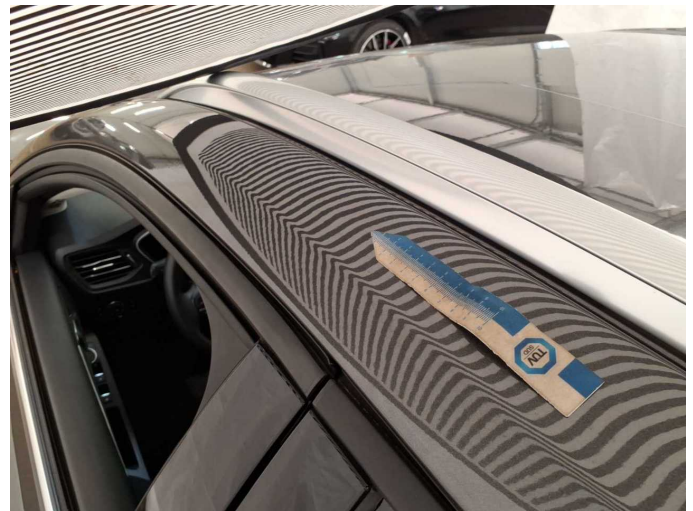
Damage 4: Roof: Roof rail - left side - dent(s) - Smooth repair work

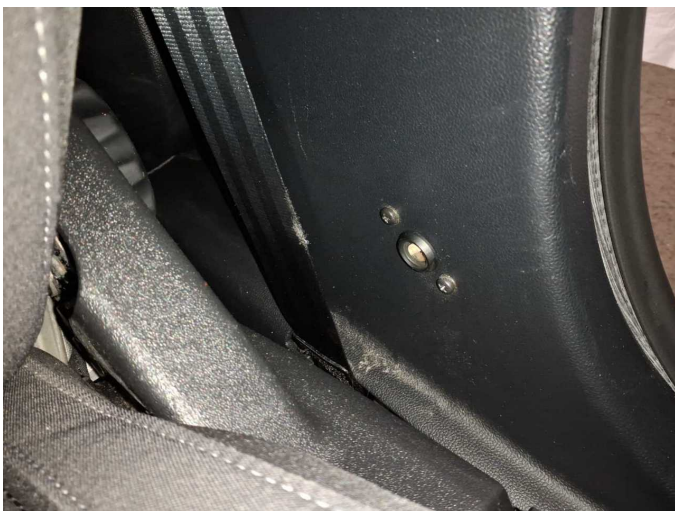
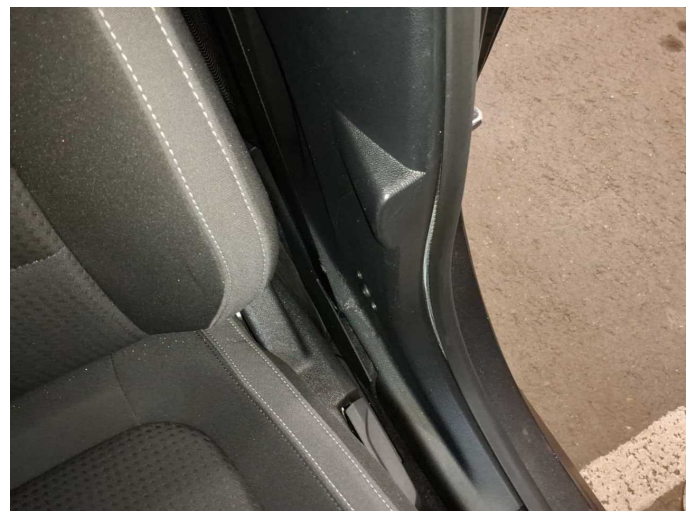
Damage 5: Trim / covers: B-pillar - trim - interior, left side (Fehlbohrung) - Damaged - Replace

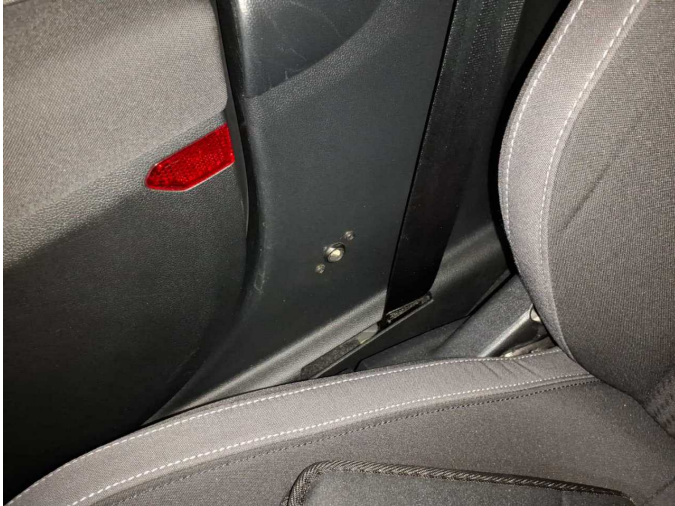
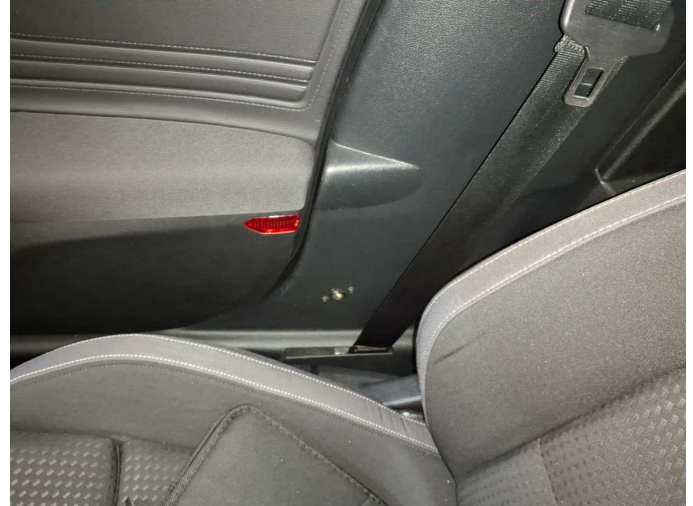
Damage 6: Trim / covers: B-pillar - trim - interior, right side (Fehlbohrung)
- Damaged - Replace

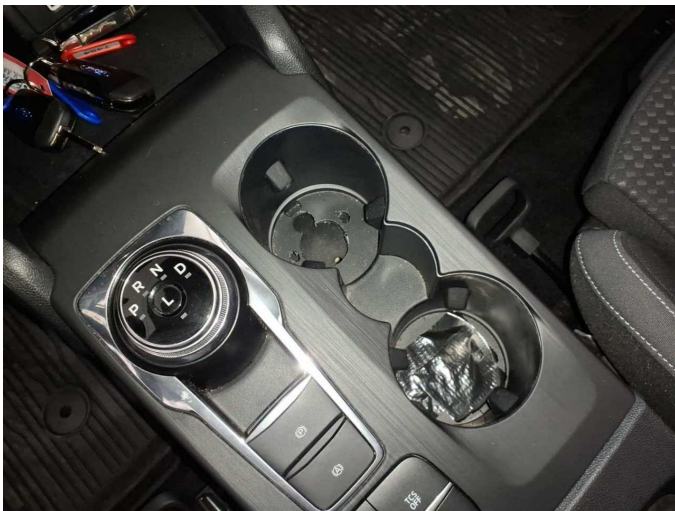
Damage 7: Instrument panel: Centre console - front (Fehlbohrung) -
Damaged - Replace

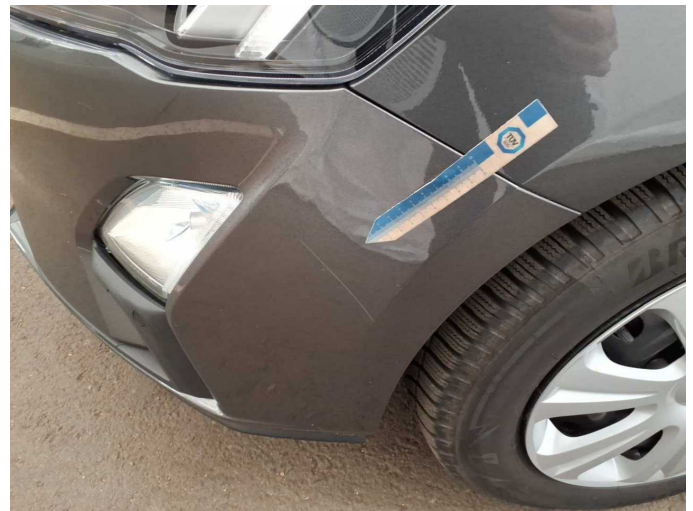
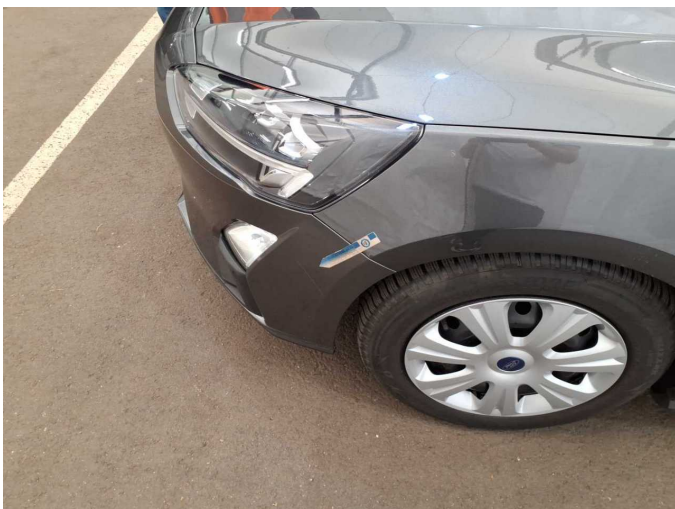
Damage 8: Front bumper: Front bumper - Scratch(es) - Paint

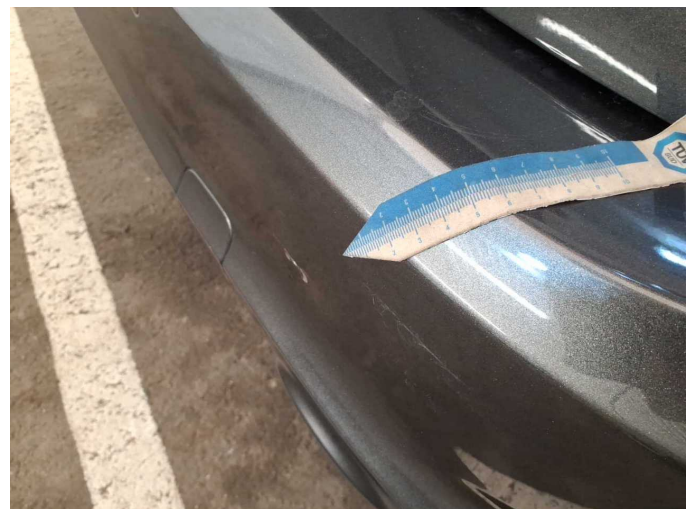
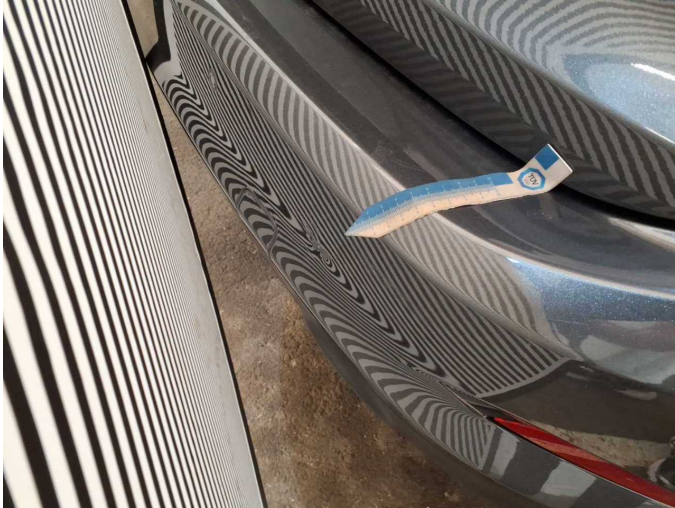
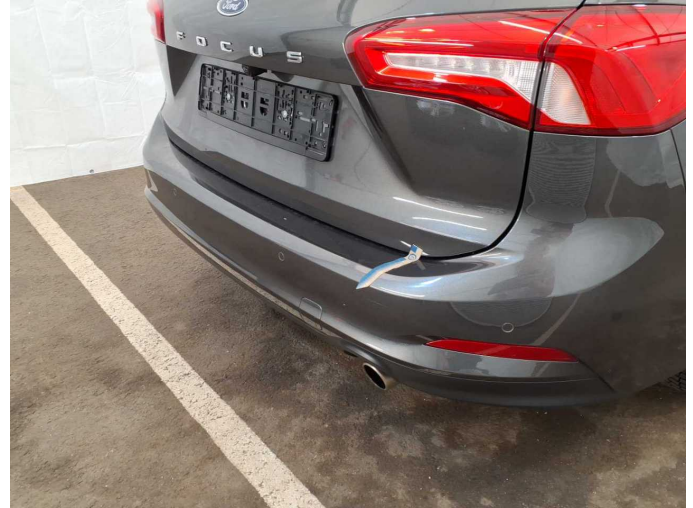
Damage 9: Rear bumper: Rear bumper - Dent / paintcoat damage -
Repair and paint

Damage 9: Rear bumper: Rear bumper - Dent / paintcoat damage - Repair and paint

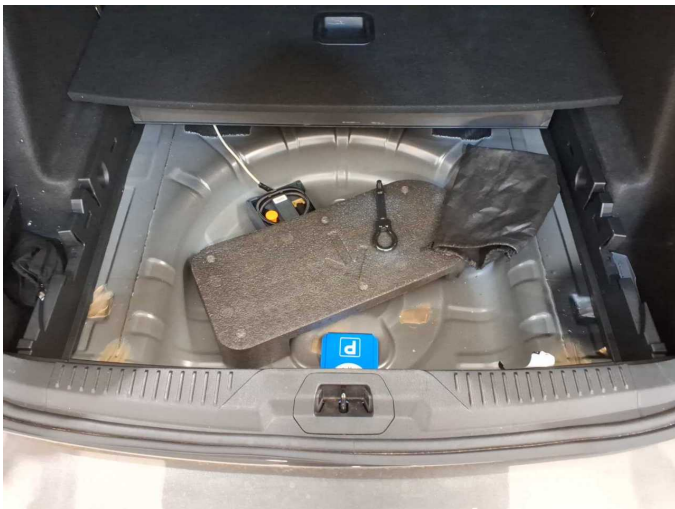
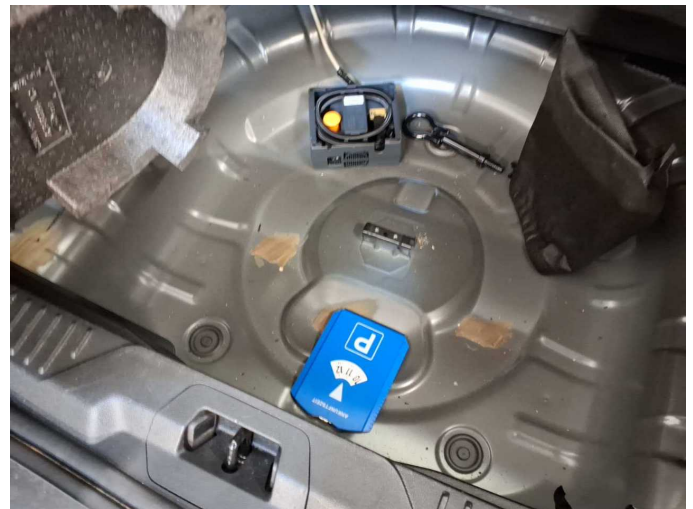
Missing part 1: Equipment: Tirefit filler - Missing - Replace
