Expertise

Protocol number: 46272384
Order No. / Reference: 26584267
Inspection date: 30 Jun 2026

Model: Fabia Combi 1.0 TSI Ambition

VIN: TMBJR6NJ5MZ025766

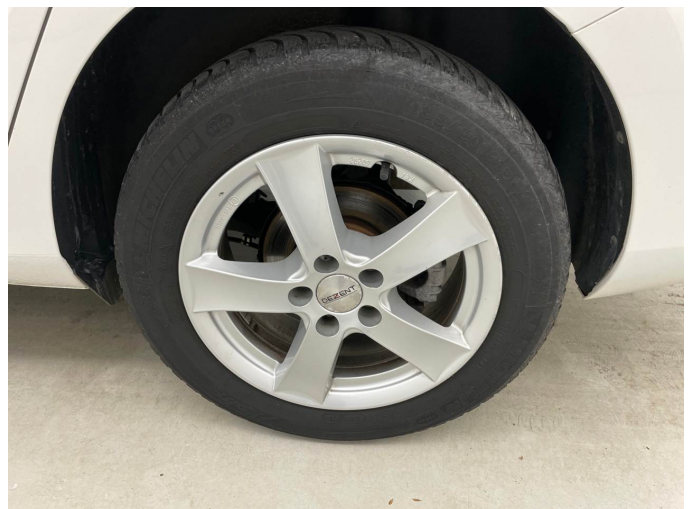
Figure 12: Mounted tyres

- Die Zulässigkeit des Radsatzes konnte nicht nachgewiesen werden.
- Leichtmetallfelgen sind in der Regel höher wertig als Stahlfelgen, daher werden die Stahlfelgen nicht berechnet.

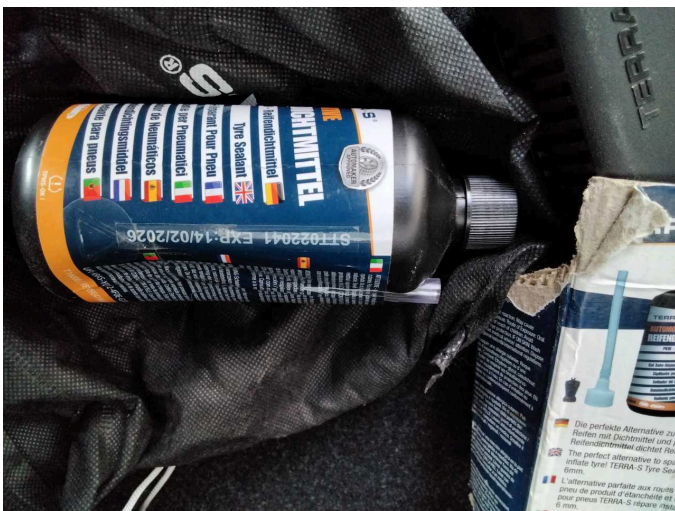
Damage 2: Equipment: Tirefit filler - Expired - Replace

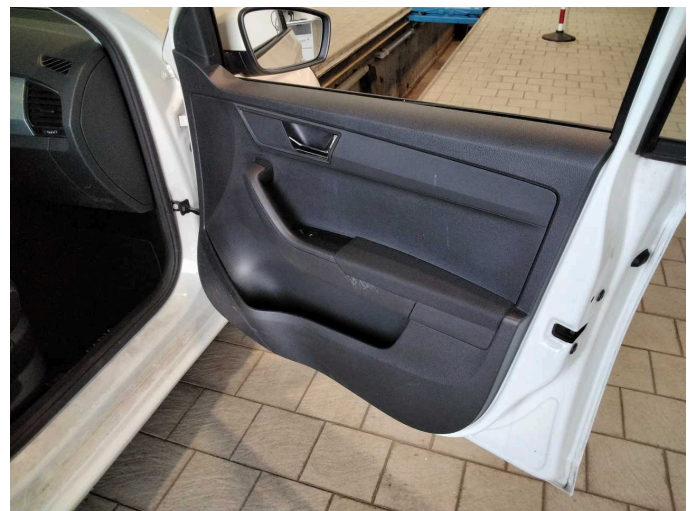
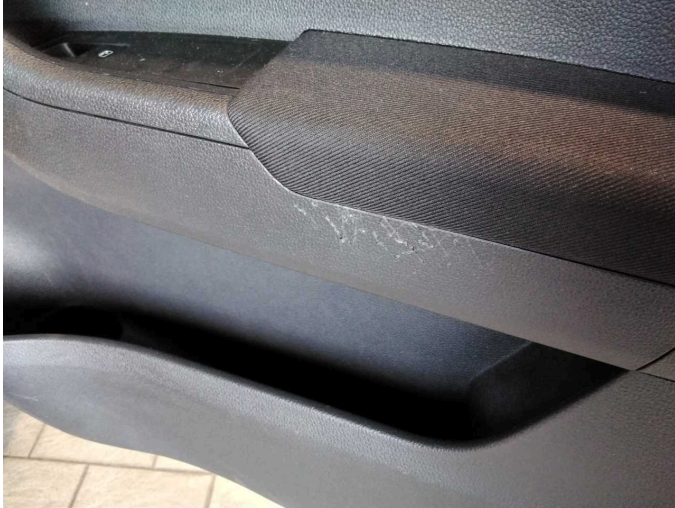
Damage 3: Trim / covers: Door trim - front right side - Scratch(es) - Loss in value

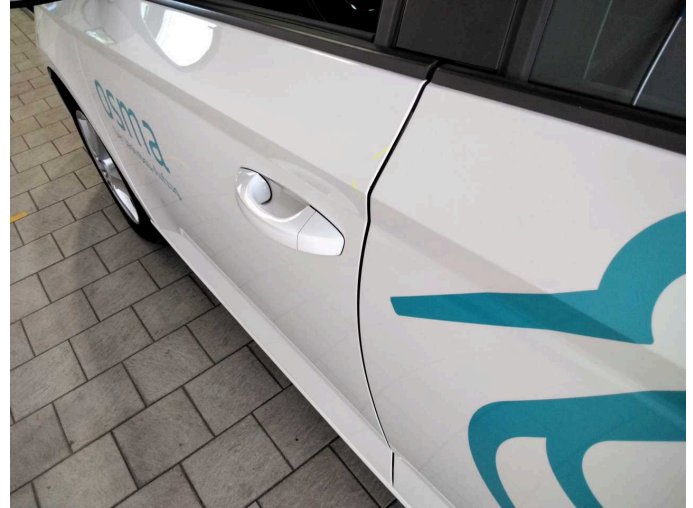
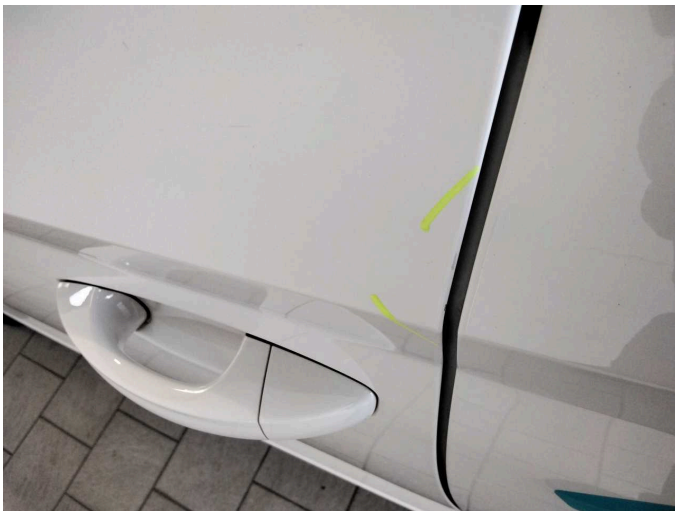
Damage 4: Door - front left side: Door edge - Scratch(es) - Smart repair

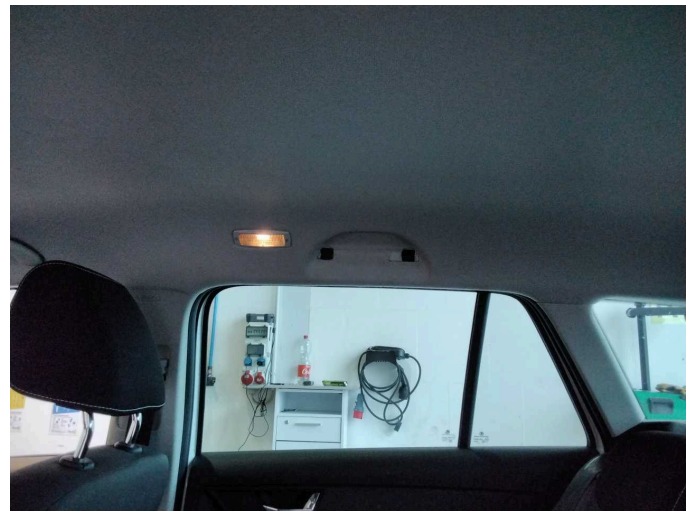
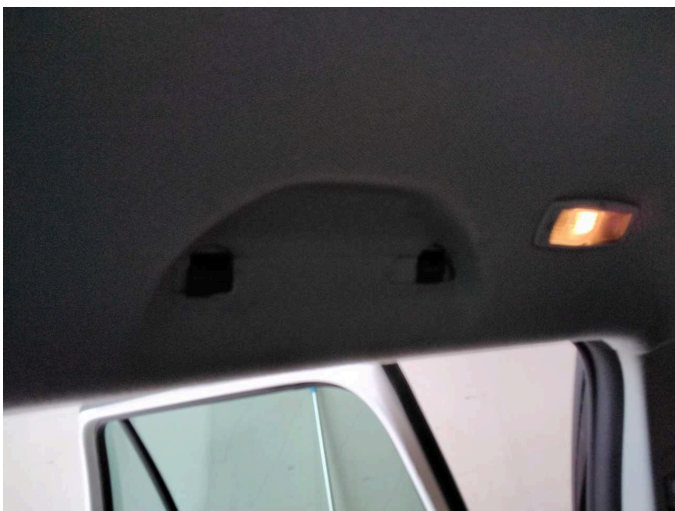
Damage 5: Trim / covers: Roof lining (Griffe hinten) - Missing - Replace

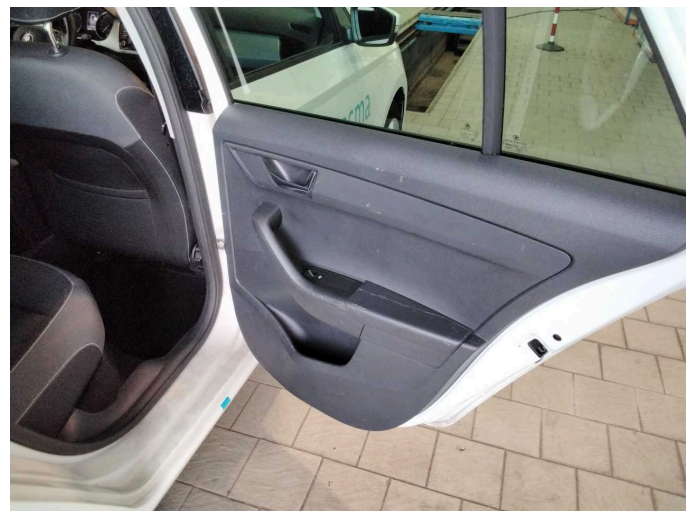
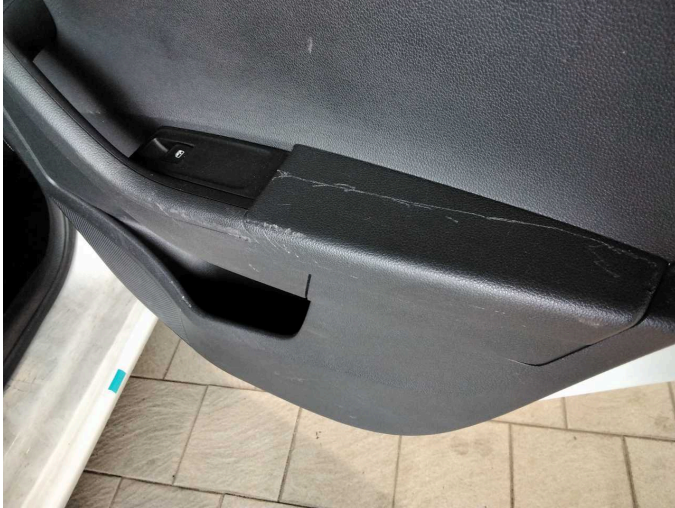
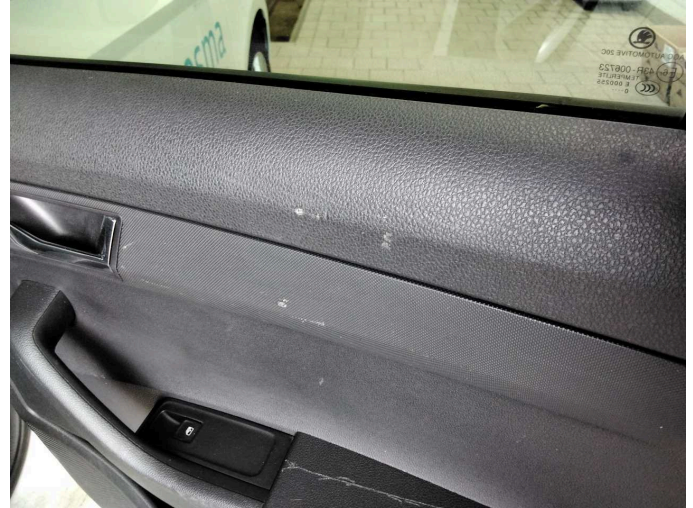
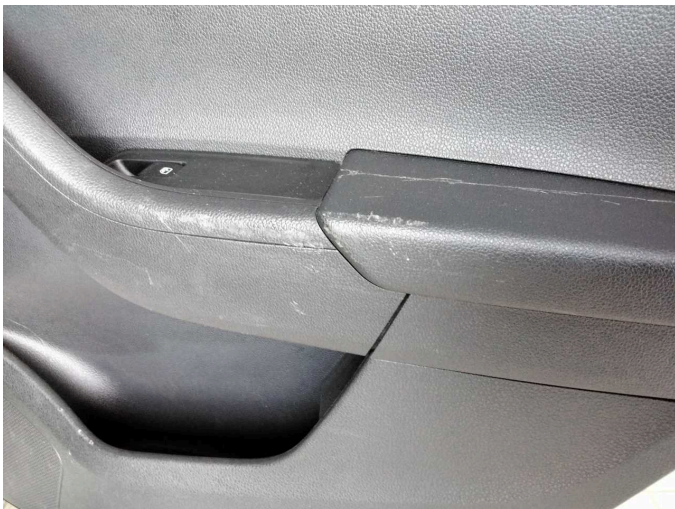
Damage 6: Trim / covers: Door trim - rear right side - Scratch(es) - Loss in value

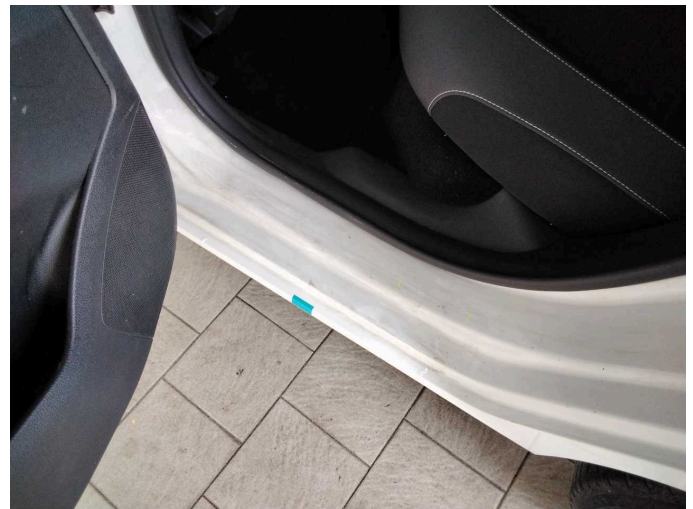
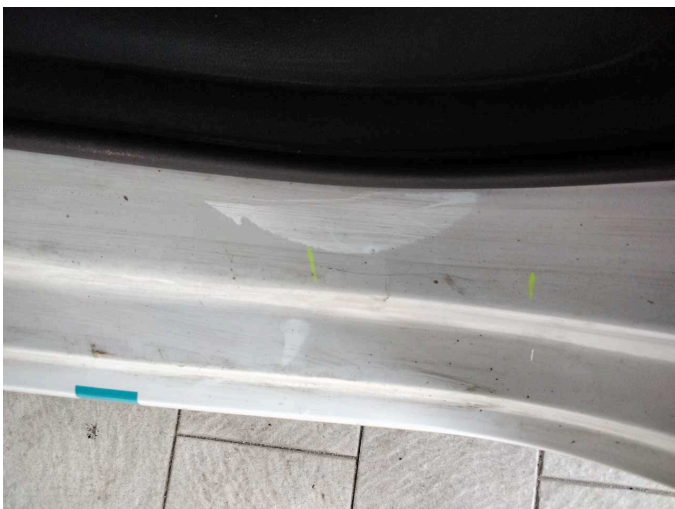
Damage 7: Side panel - rear left side: Sill - Scratch(es) - Smart repair

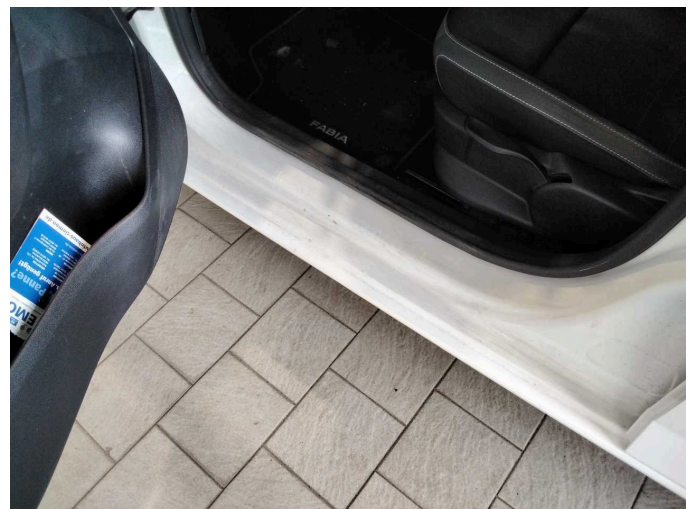
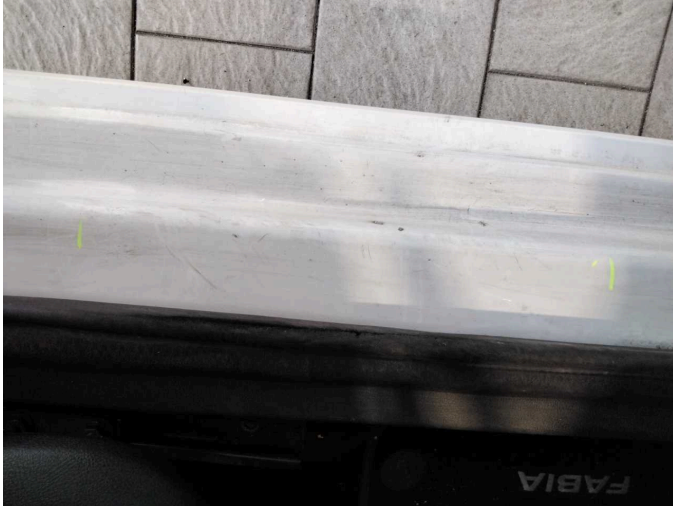
Damage 8: Sill - left side: Sill - Scratch(es) - Smart repair

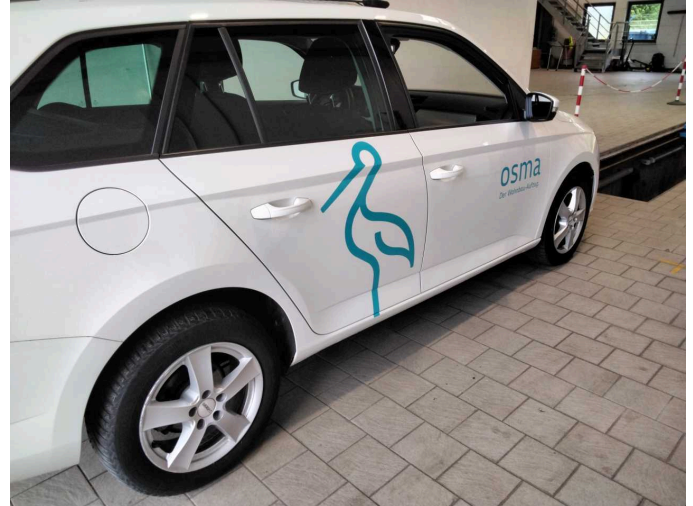
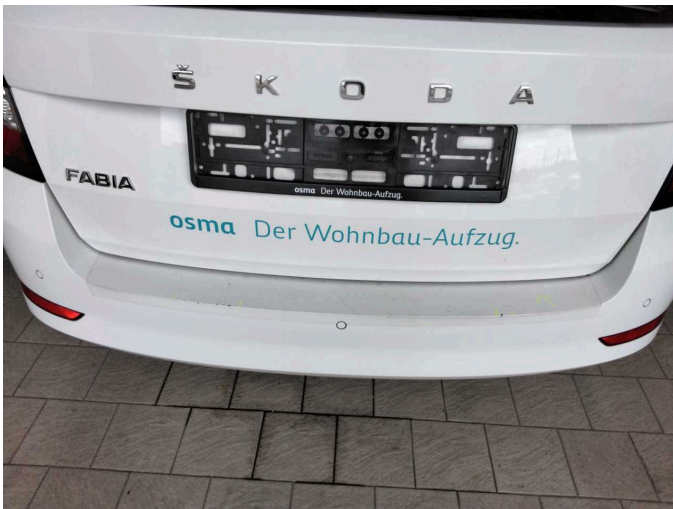
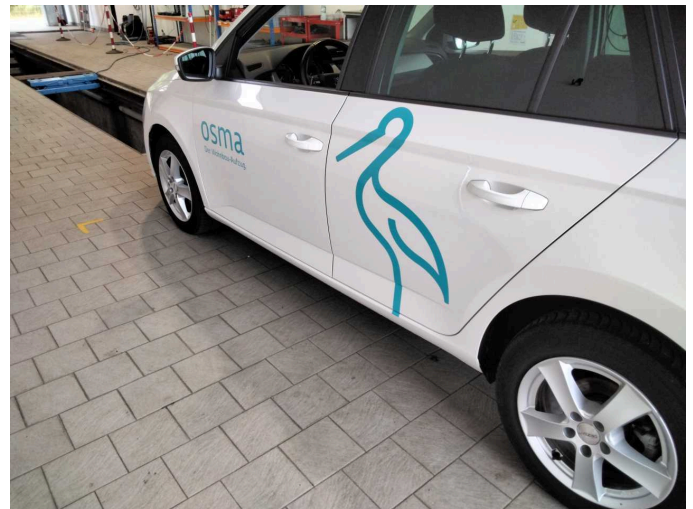
Damage 9: Body: Body - Glued / labelled - De-glue / neutralise

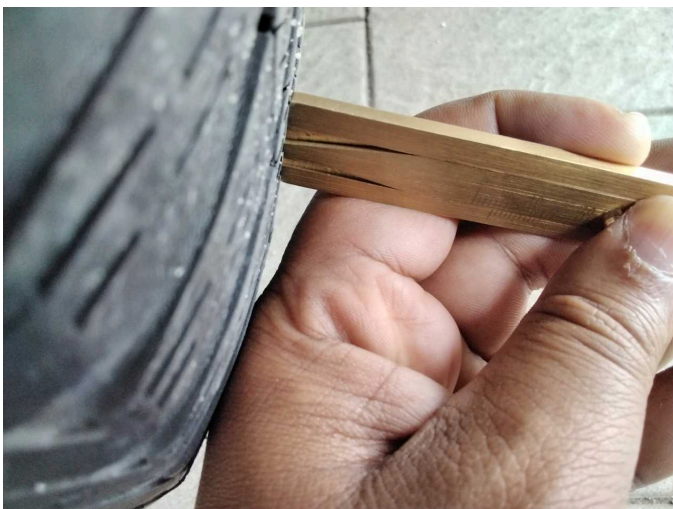
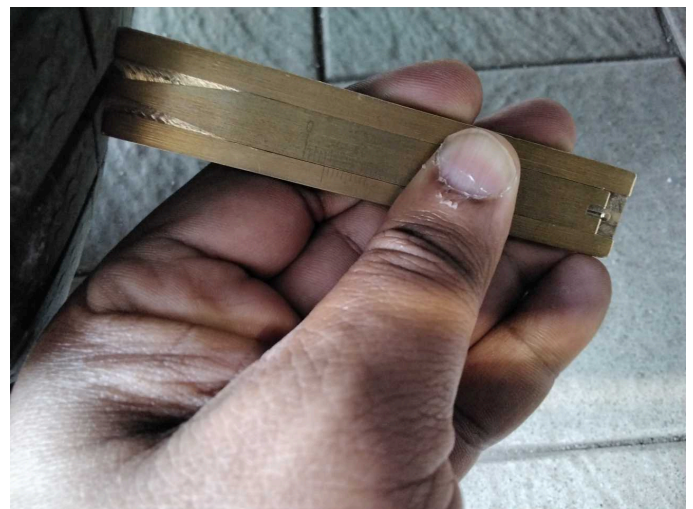
Damage 10: Wheel / tyres: Tyre - right (4mm) - does not meet manufacturer specifications - Replace

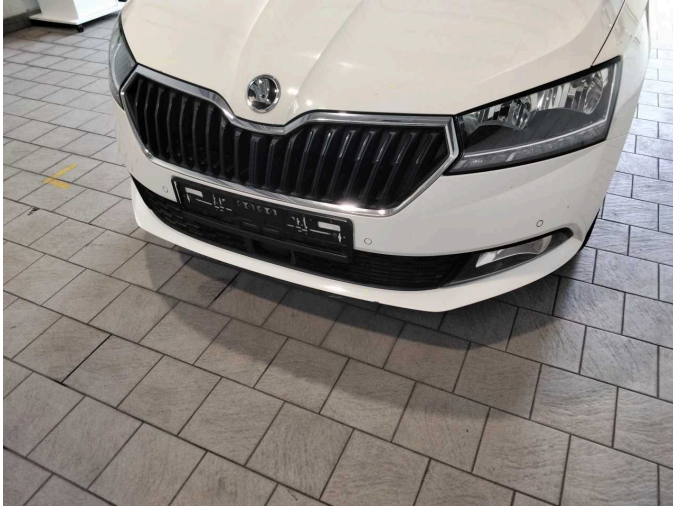
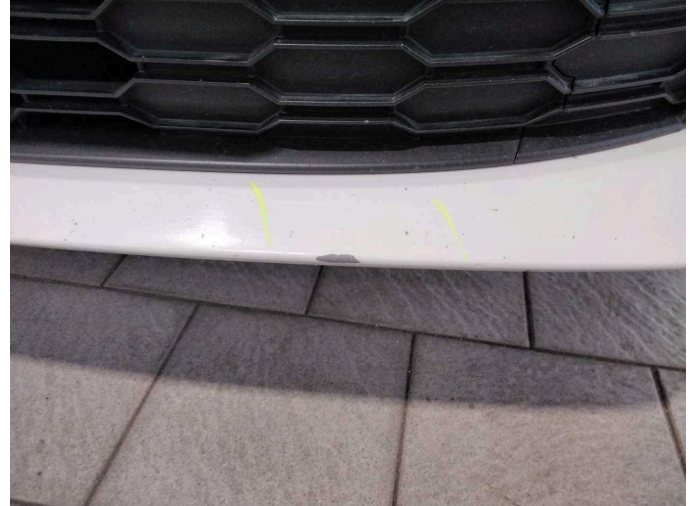
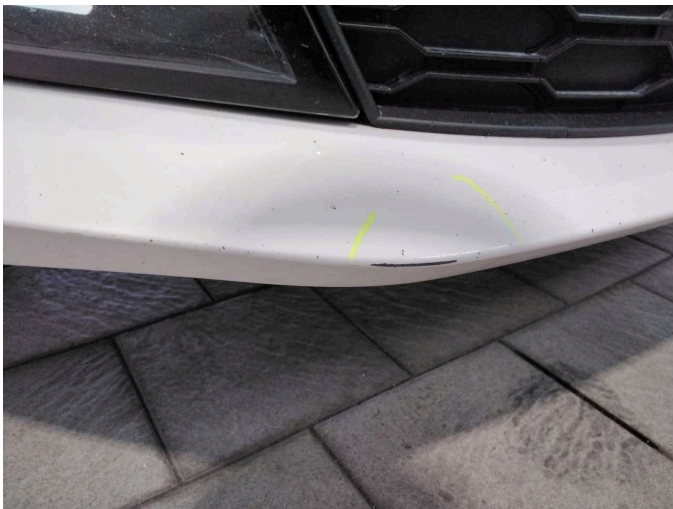
Damage 11: Front bumper: Front bumper - Scratch(es) - Paint

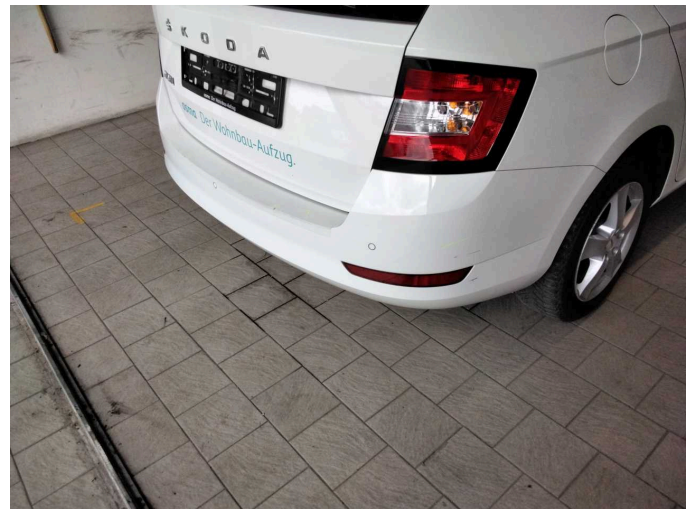
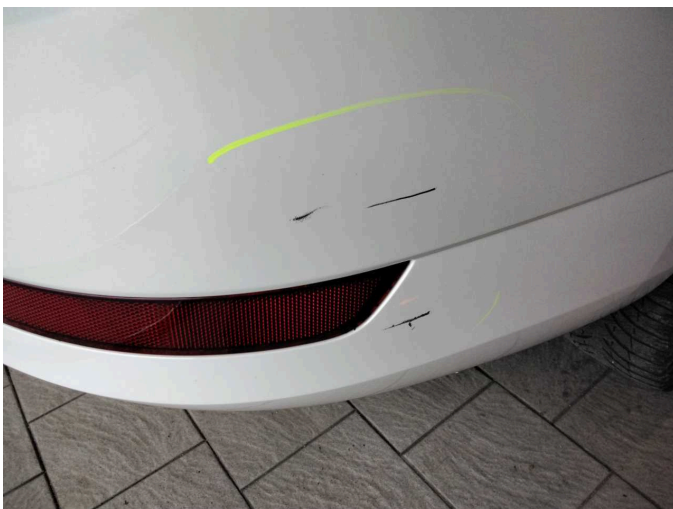
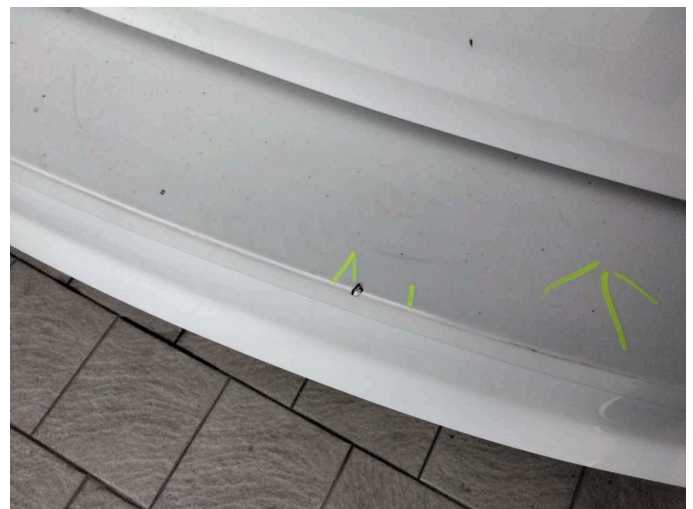
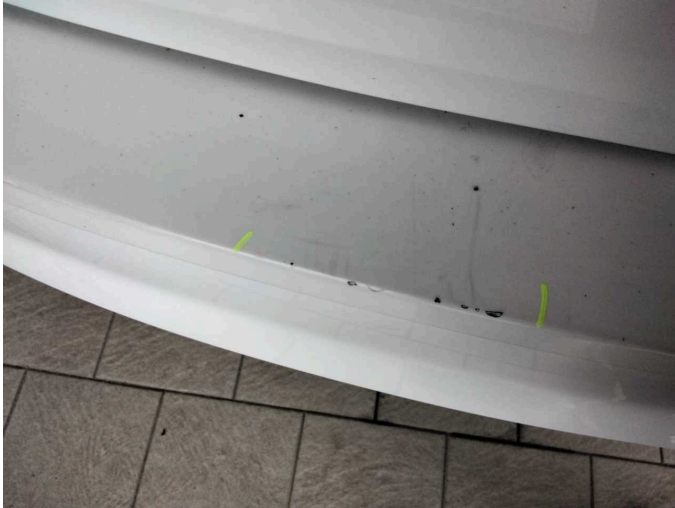
Damage 12: Rear bumper: Rear bumper - Scratch(es) - Paint

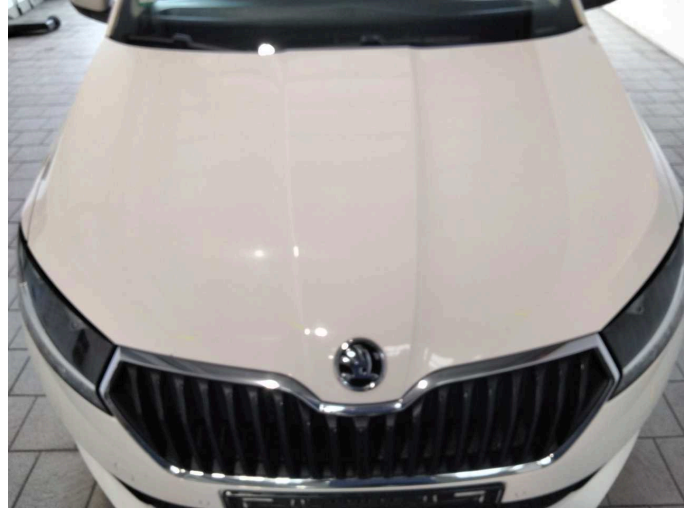
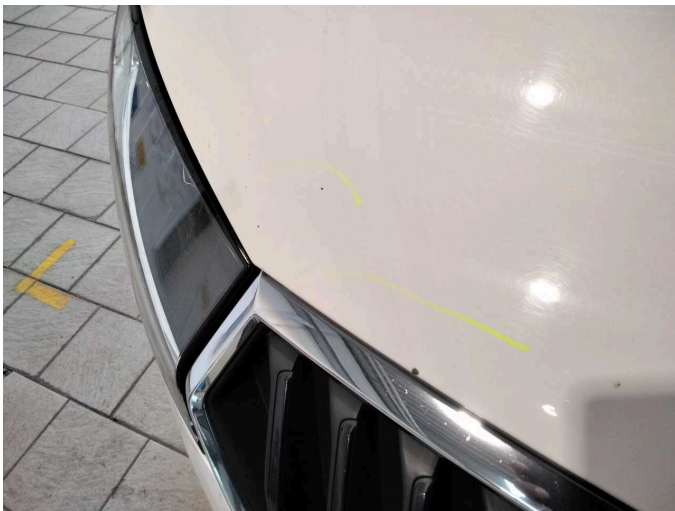
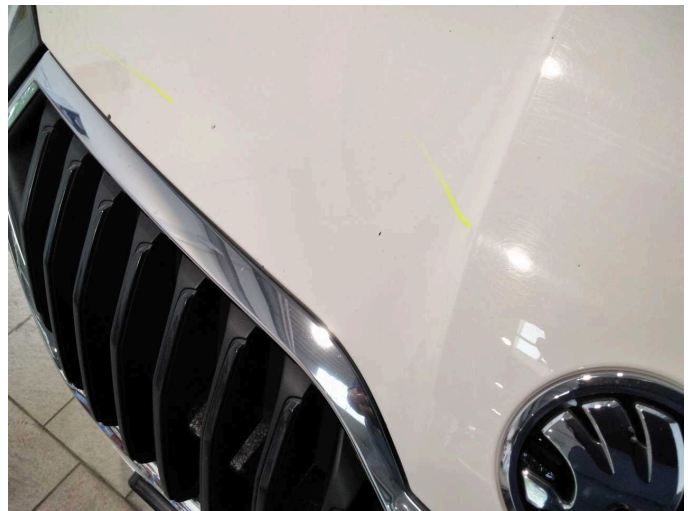
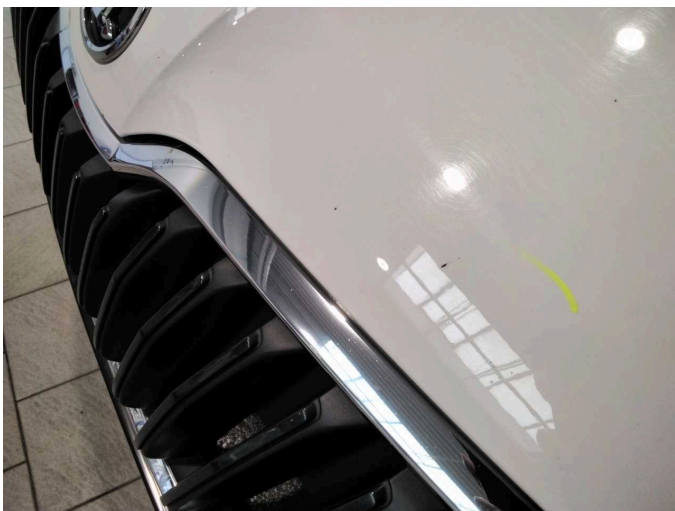
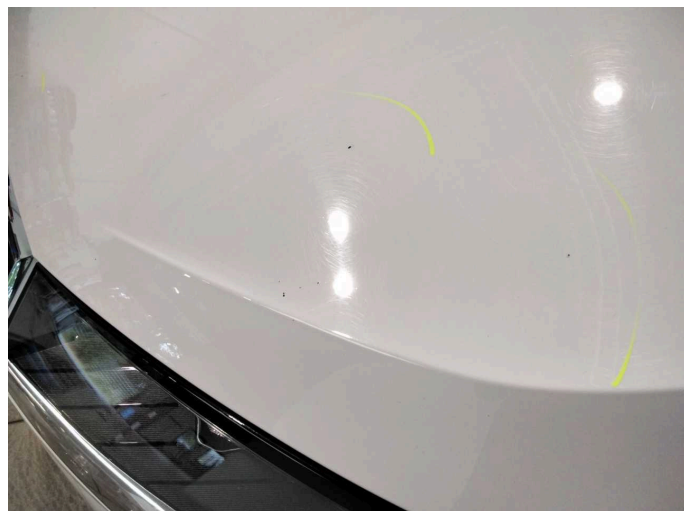
Damage 13: Bonnet: Bonnet - Stone chips - Paint

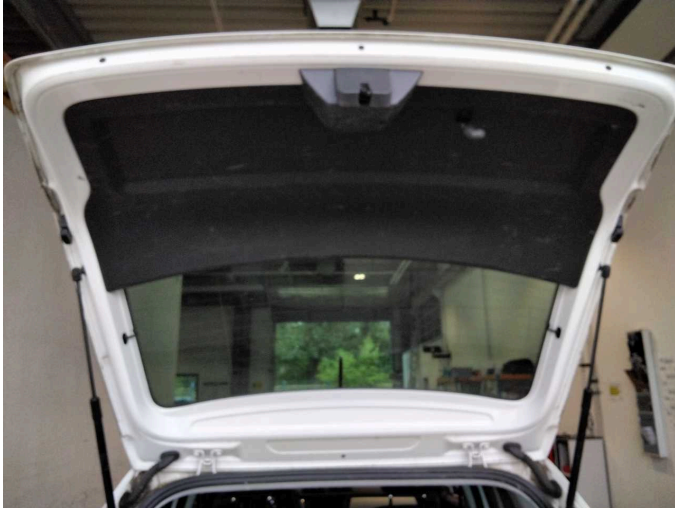
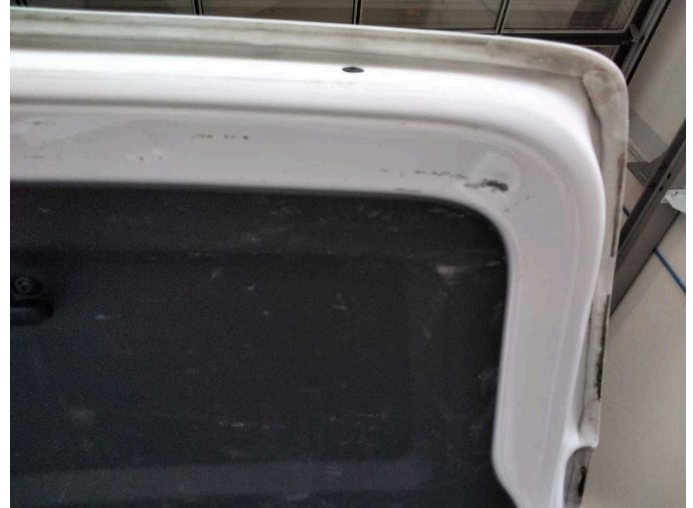
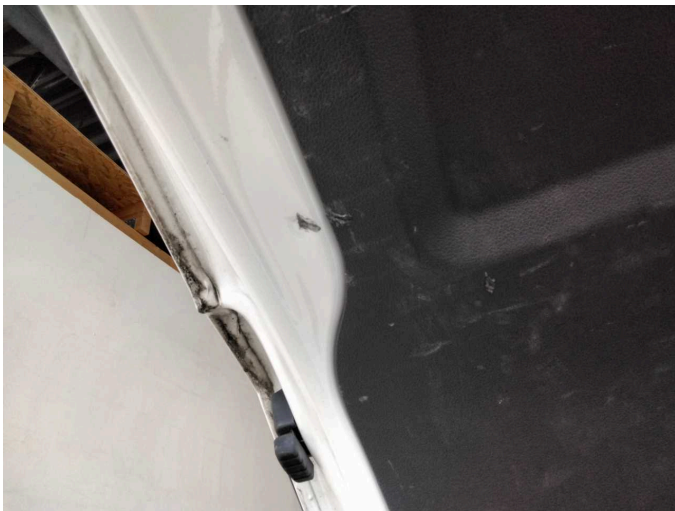
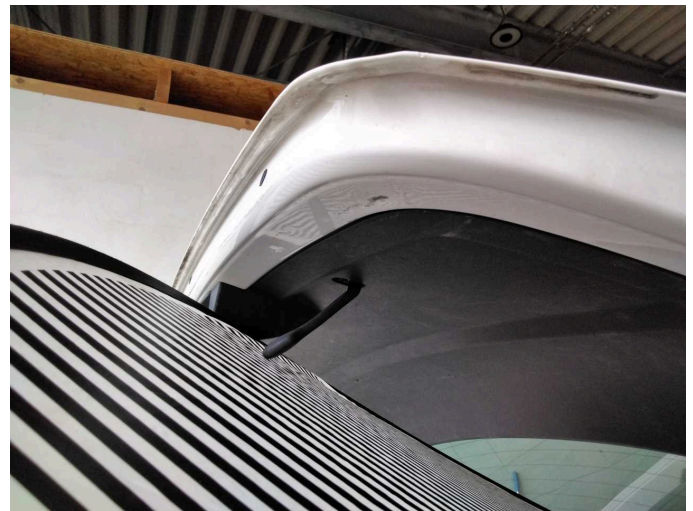
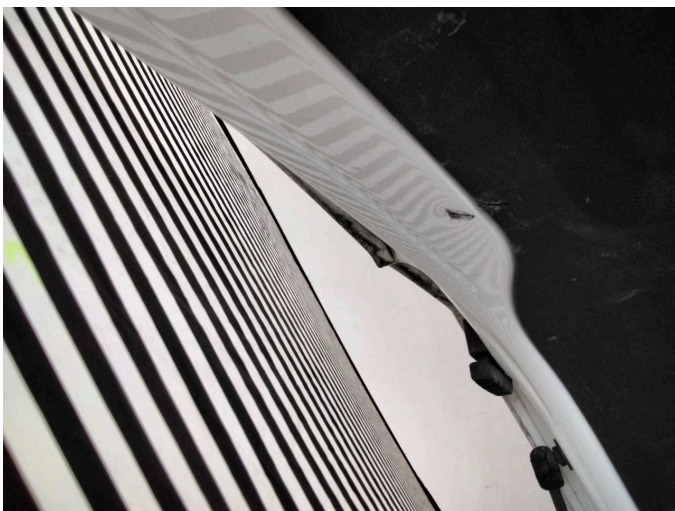
Damage 14: Boot lid / rear door: Boot lid (Innen) - Dent / paintcoat damage - Repair and paint

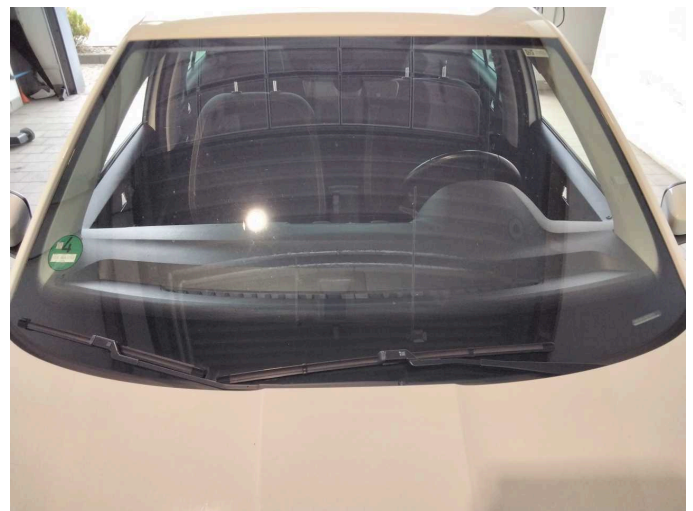
Wear and tear 1: Vehicle glazing: Windscreen - Stone chips - No deduction

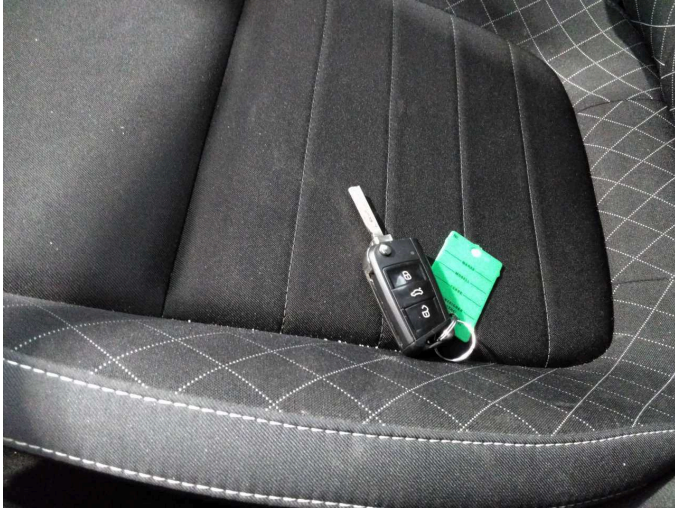
Missing part 1: Equipment: Vehicle key - Missing - Replace
