Expertise

Protocol number: 46820596  
Order No. / Reference: 26805526  
Inspection date: 31 Jul 2026

Manufacturer: Seat

Model: Ateca 2.0 TDI Style

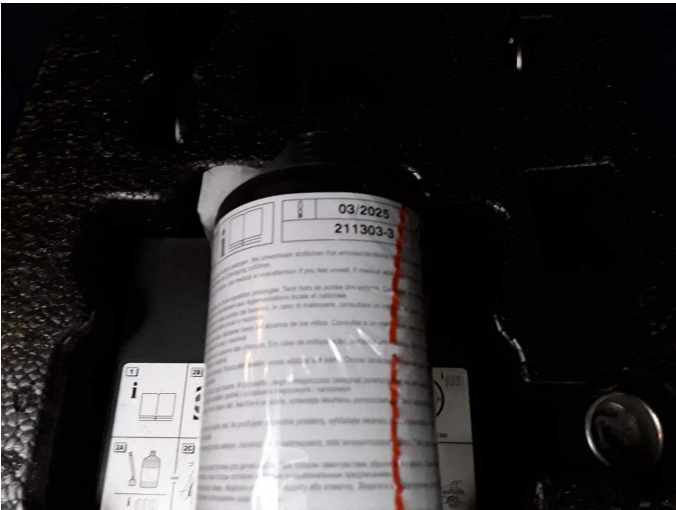
| No. | Component group | Description |
|---|---|---|
| 1 | Equipment | Tirefit filler - Expired - Replace |

Damage 1: Equipment: Tirefit filler - Expired - Replace

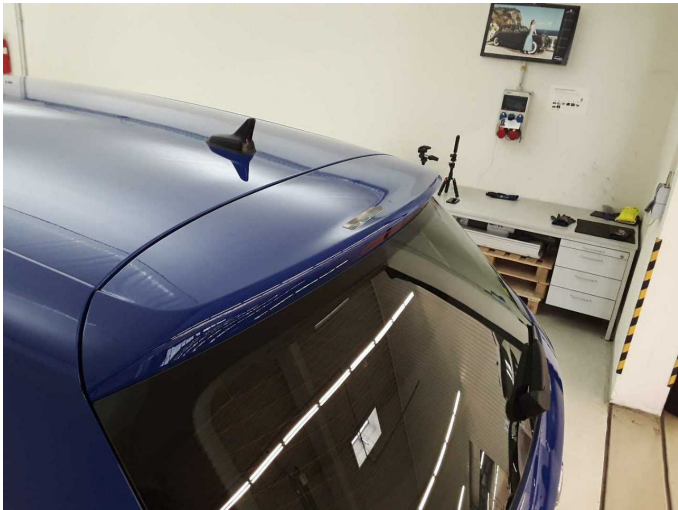
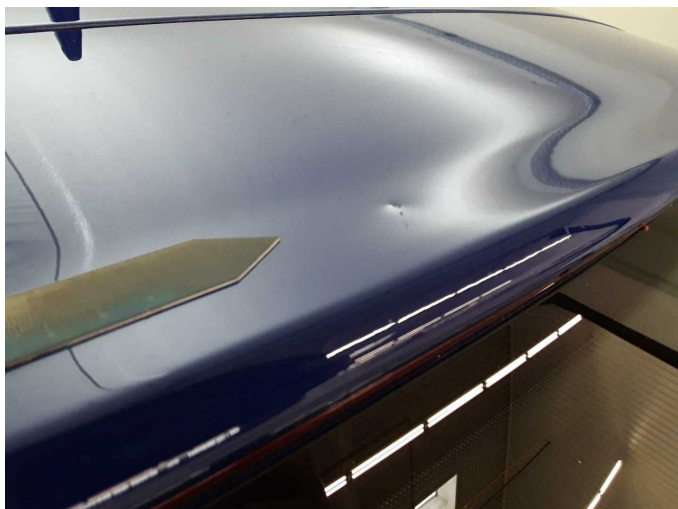
| No. | Component group | Description |
|---|---|---|
| 2 | Boot lid / rear door | Boot lid glazed - Dent / paintcoat damage - Smart repair |

Damage 2: Boot lid / rear door: Boot lid glazed - Dent / paintcoat damage - Smart repair

**Damage 2:** Boot lid / rear door: Boot lid glazed - Dent / paintcoat damage - Smart repair

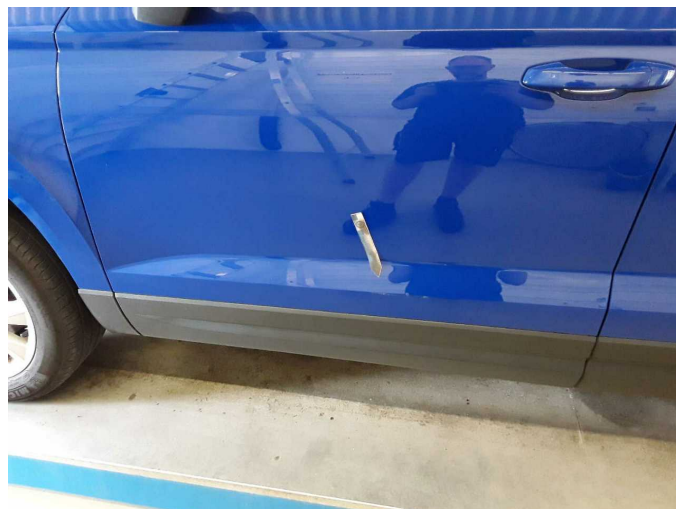
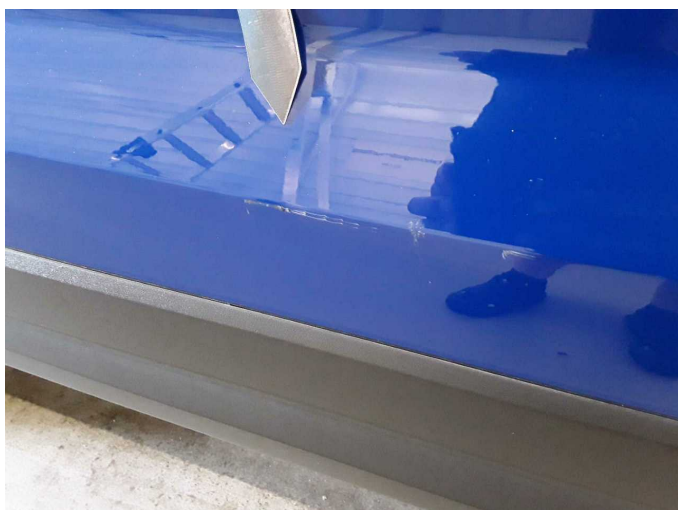
| No. | Component group | Description |
|---|---|---|
| 3 | Door - front left side | Door - Scratch(es) - Smart repair |

**Damage 3:** Door - front left side: Door - Scratch(es) - Smart repair

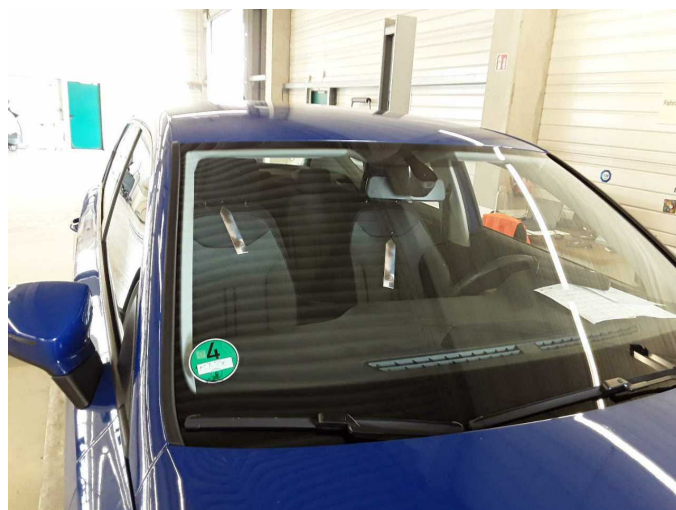
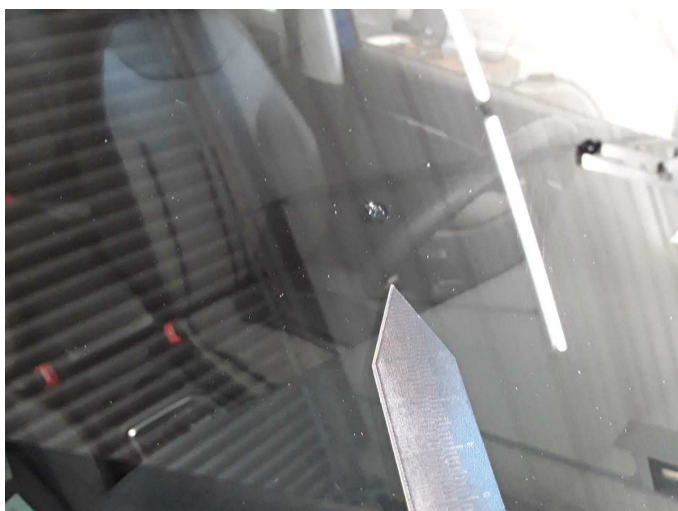
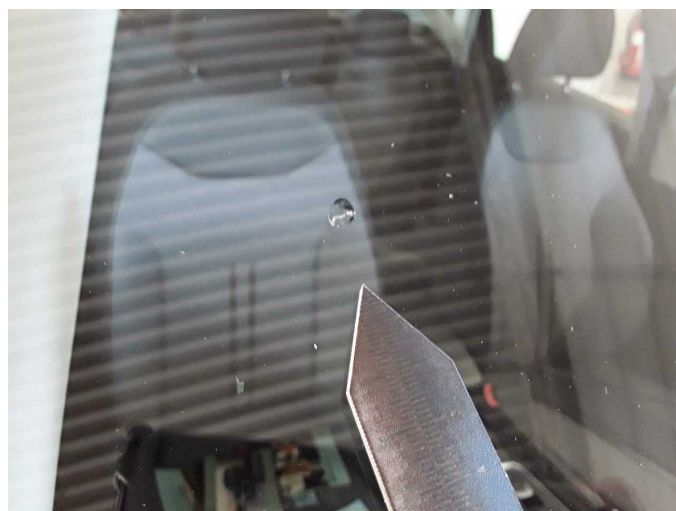
| No. | Component group | Description |
|---|---|---|
| 4 | Vehicle glazing | Windscreen with rain sensor - Stone chips - Replace |

**Damage 4:** Vehicle glazing: Windscreen with rain sensor - Stone chips - Replace

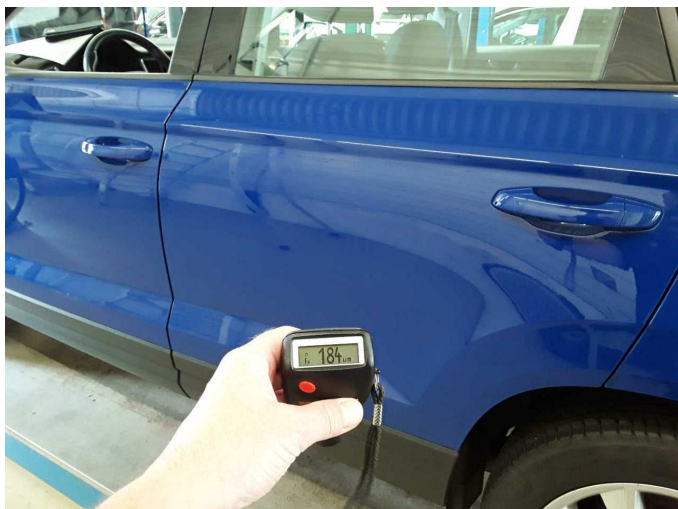
| No. | Repainting |
|---|---|
| 1 | Door - rear left side, Professionally carried out |

| Door - rear left side | 184 µm |

**Door - rear left side: 184 µm**
