Expertise

Protocol number: 46723043  
Order No. / Reference: 26663408  
Inspection date: 22 Jul 2026

| Manufacturer: Opel | Model: Astra 1.5 D Start/Stop Sports Tourer Automatik Edition |
| VIN: W0VBD8EVXN8042951 | |

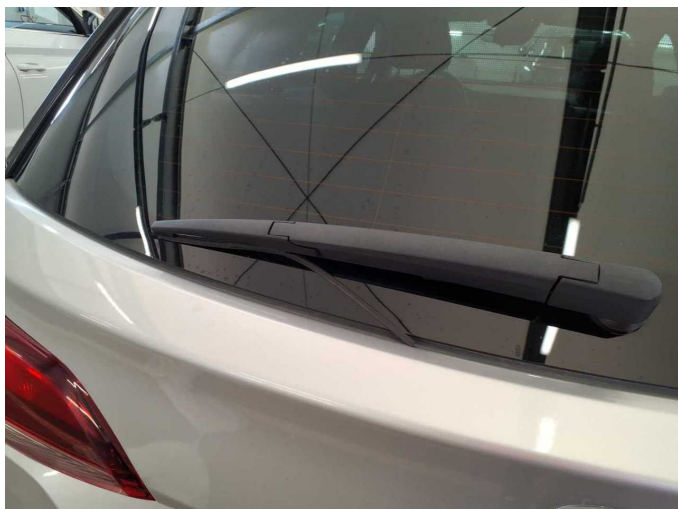
| No. | Component group | Description |
|---|---|---|
| 1 | Screen cleaning | Wiper blades - rear - Damaged - Replace |

**Damage 1:** Screen cleaning: Wiper blades - rear - Damaged - Replace

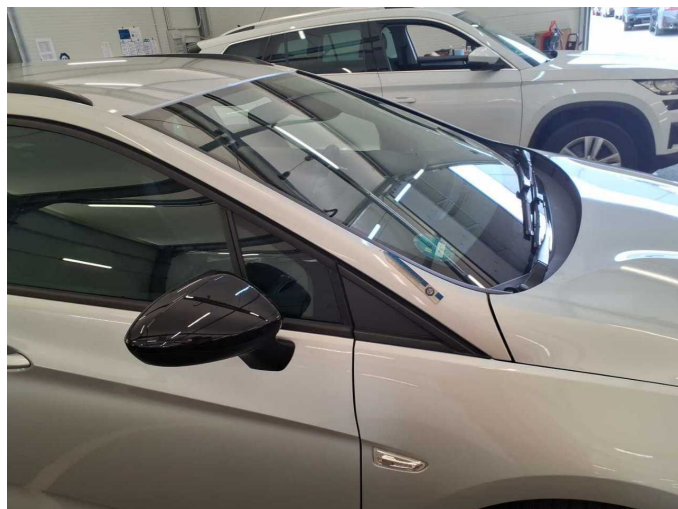
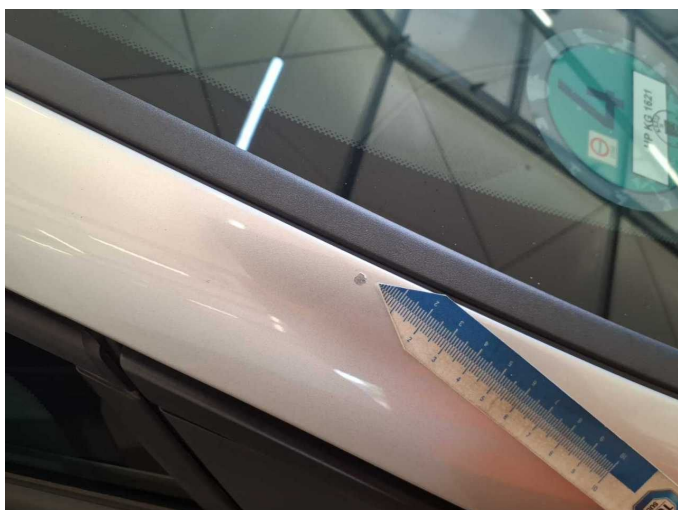
| No. | Component group | Description |
|---|---|---|
| 2 | Roof | Roof rail - right side - Stone chips - Smart repair |

**Damage 2:** Roof: Roof rail - right side - Stone chips - Smart repair

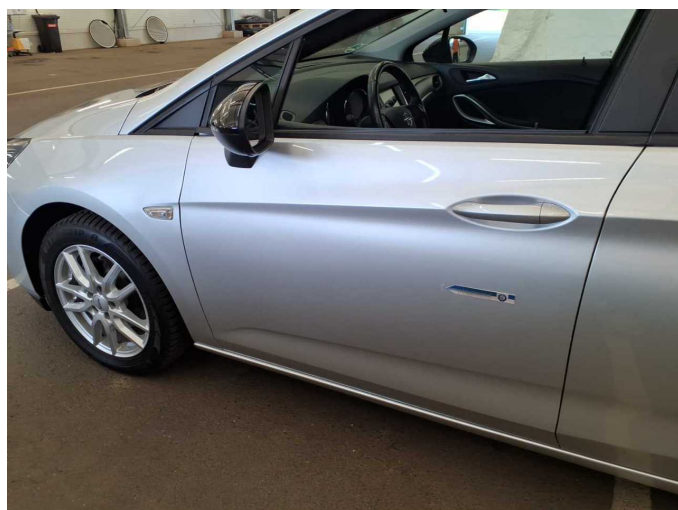
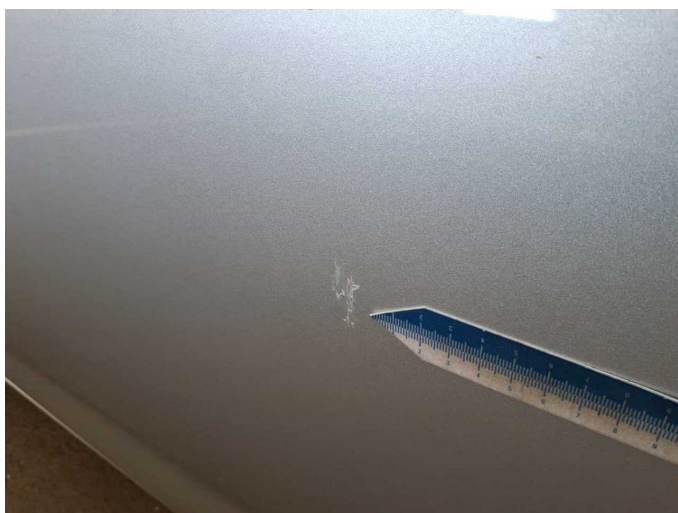
| No. | Component group | Description |
|---|---|---|
| 3 | Door - front left side | Door - Scratch(es) - Paint |

**Damage 3:** Door - front left side: Door - Scratch(es) - Paint

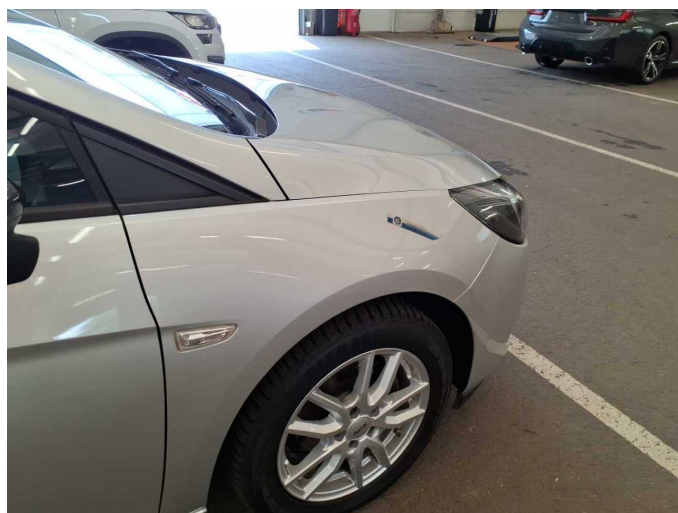
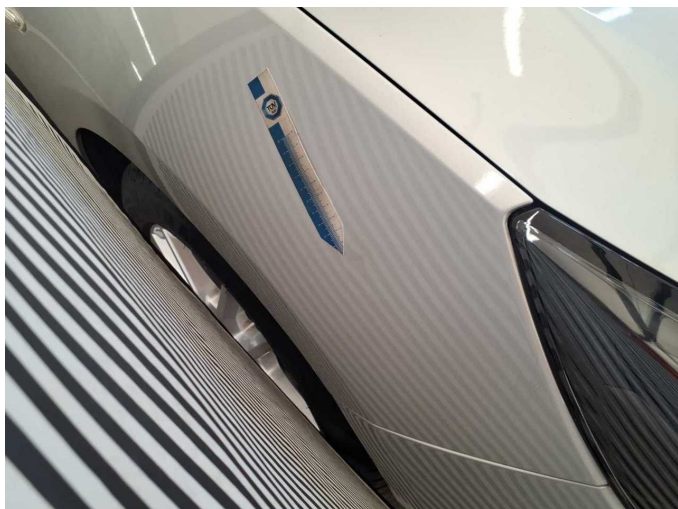
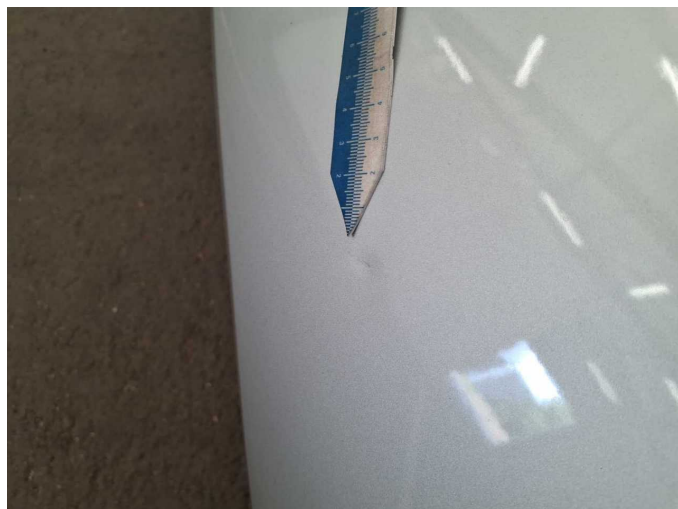
| No. | Component group | Description |
|---|---|---|
| 4 | Mudguard - right side | Mudguard - right side - Dent / paintcoat damage - Repair and paint |

**Damage 4:** Mudguard - right side: Mudguard - right side - Dent / paintcoat damage - Repair and paint

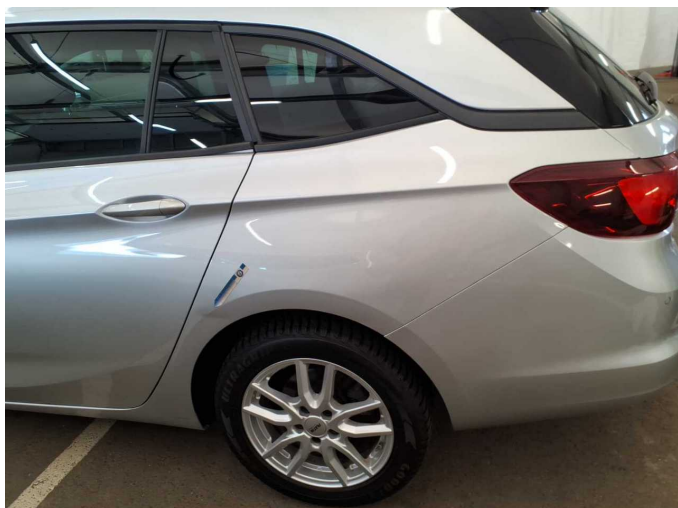
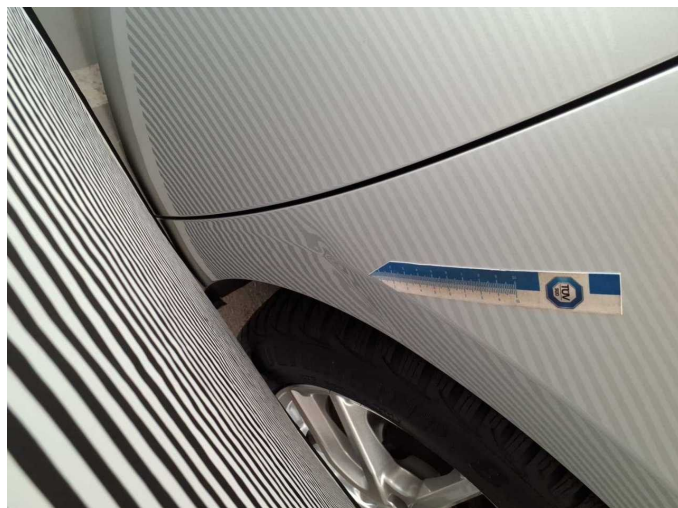
| No. | Component group | Description |
|---|---|---|
| 5 | Side panel - rear left side | Side panel - Deformed - Repair and paint |

**Damage 5:** Side panel - rear left side: Side panel - Deformed - Repair and paint
