Expertise

Protocol number: 46610897  
Order No. / Reference: 26777014  
Inspection date: 17 Jul 2026

Model: Kodiaq 2.0 TDI DSG Ambition

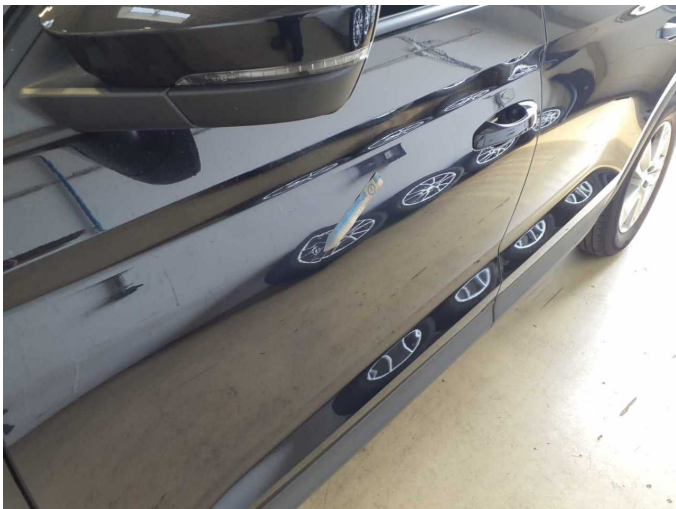
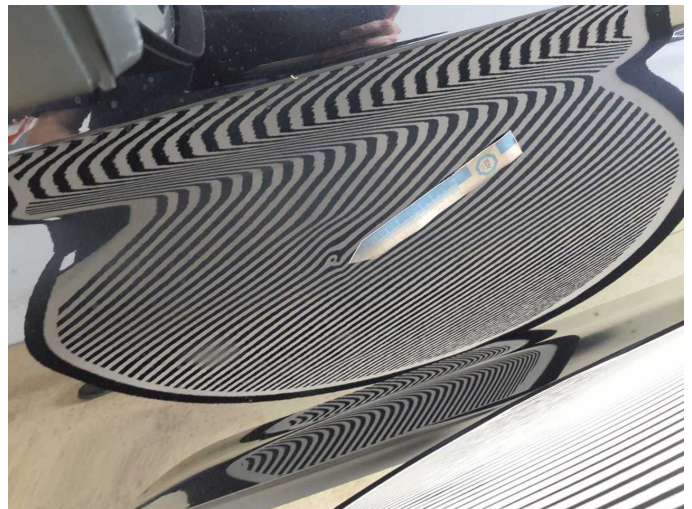
| No. | Component group | Description |
|---|---|---|
| 1 | Door - front left side | Door - dent(s) - Smooth repair work |

**Damage 1:** Door - front left side: Door - dent(s) - Smooth repair work

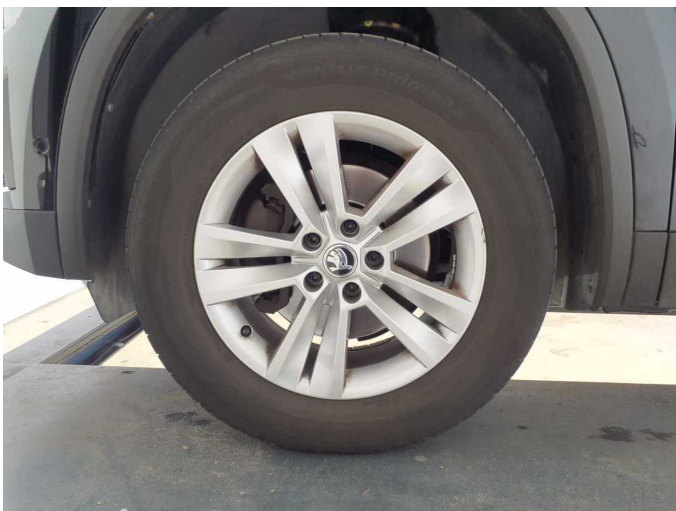
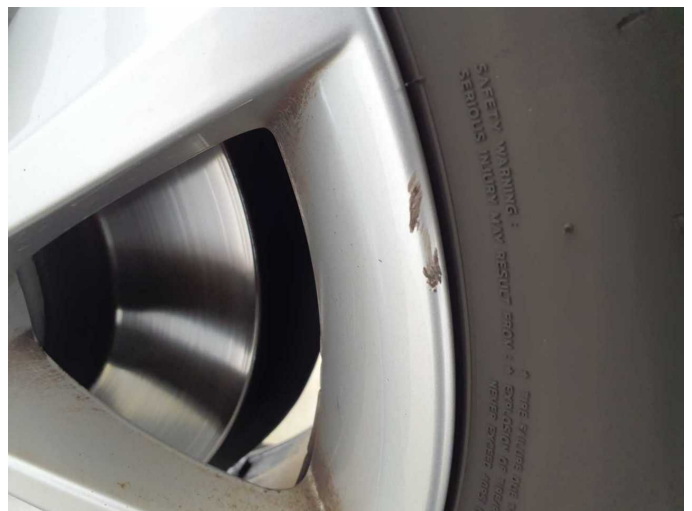
| No. | Component group | Description |
|---|---|---|
| 2 | Wheel / tyres | Alloy rim - front left side - Scratch(es) - Loss in value |

**Damage 2:** Wheel / tyres: Alloy rim - front left side - Scratch(es) - Loss in value

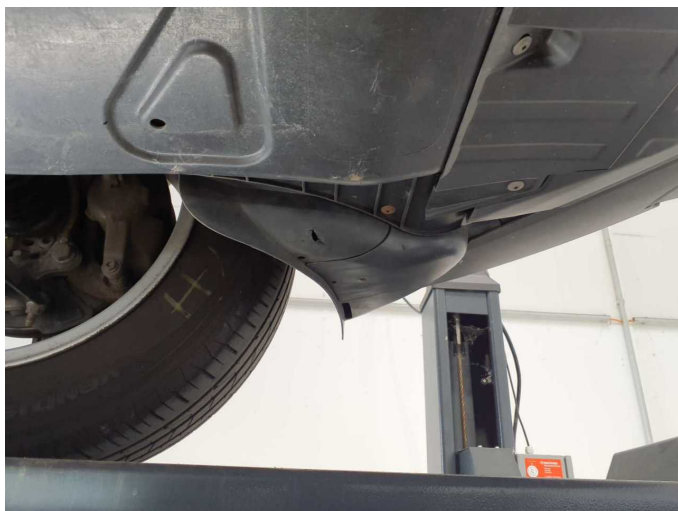
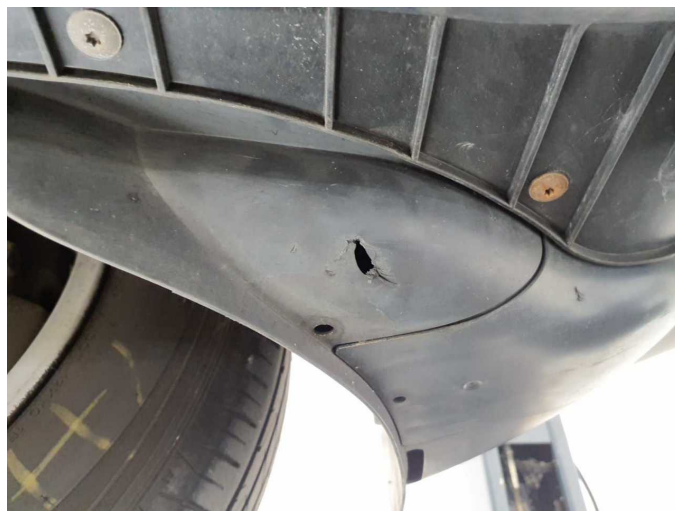
| No. | Component group | Description |
|---|---|---|
| 3 | Body | Wheel well - front left side - Broken / torn - Replace |

**Damage 3:** Body: Wheel well - front left side - Broken / torn - Replace

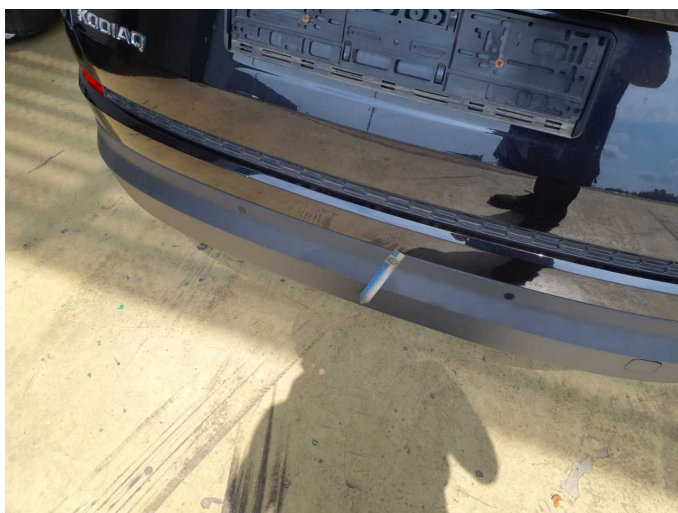
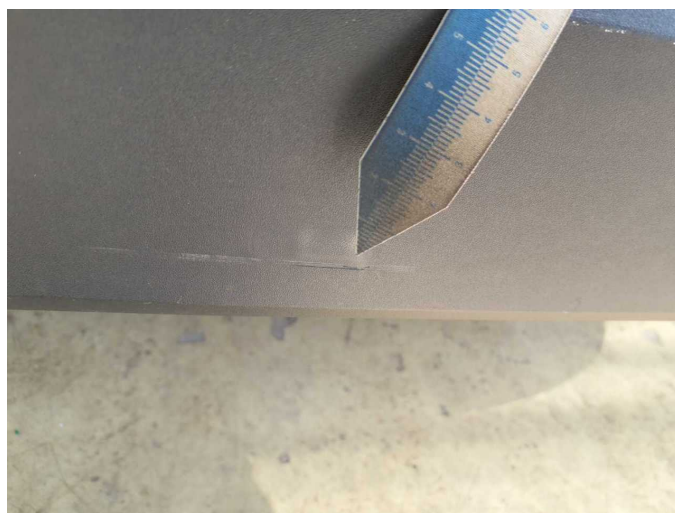
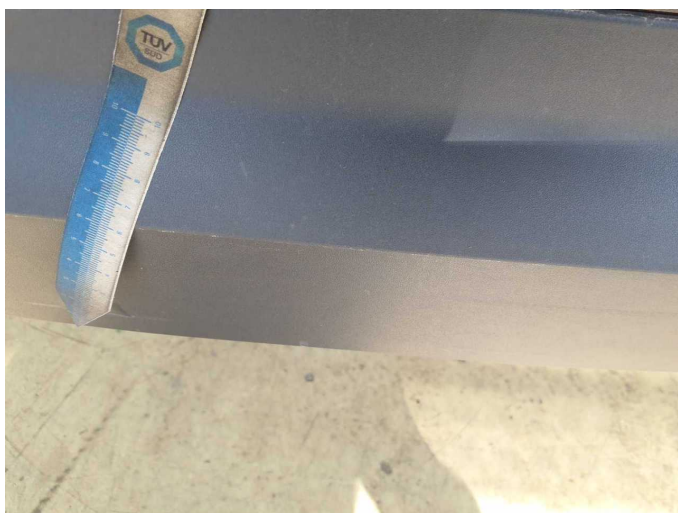
| No. | Component group | Description |
|---|---|---|
| 4 | Rear bumper | Spoiler - Scratch(es) - Replace |

**Damage 4:** Rear bumper: Spoiler - Scratch(es) - Replace

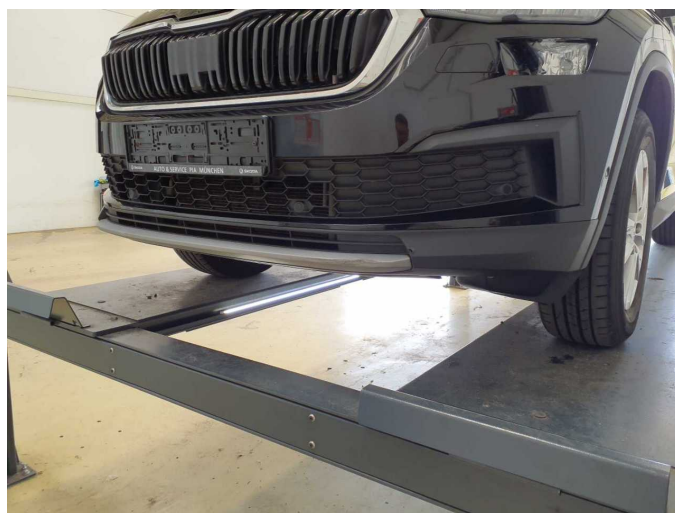
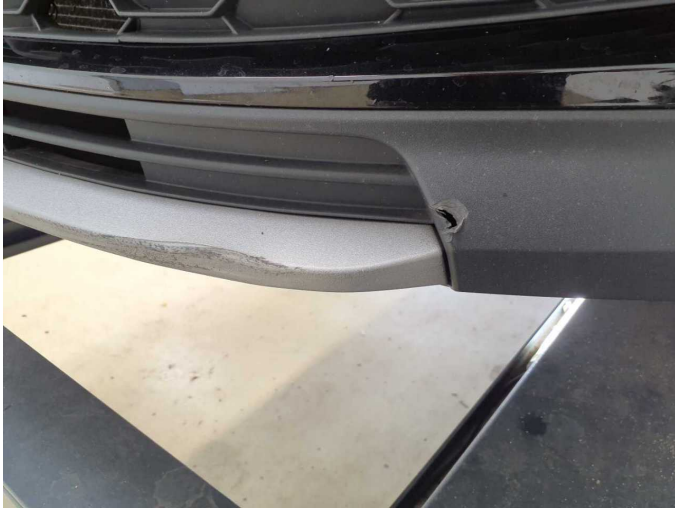
| No. | Component group | Description |
|---|---|---|
| 5 | Front bumper | Spoiler - Broken / torn - Replace |

**Damage 5:** Front bumper: Spoiler - Broken / torn - Replace

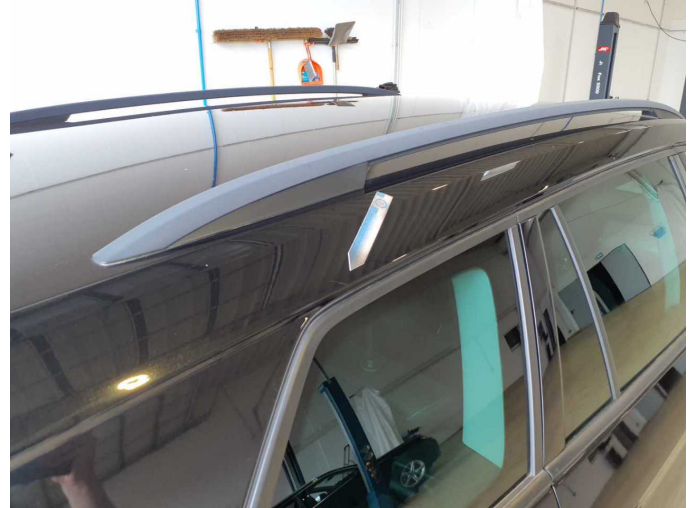
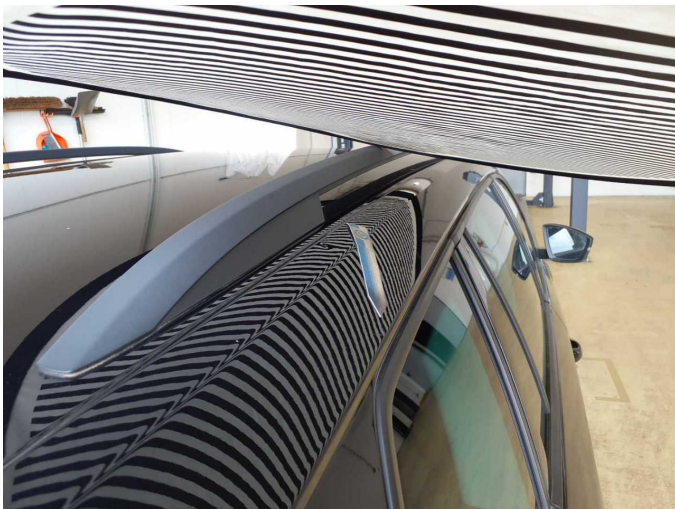
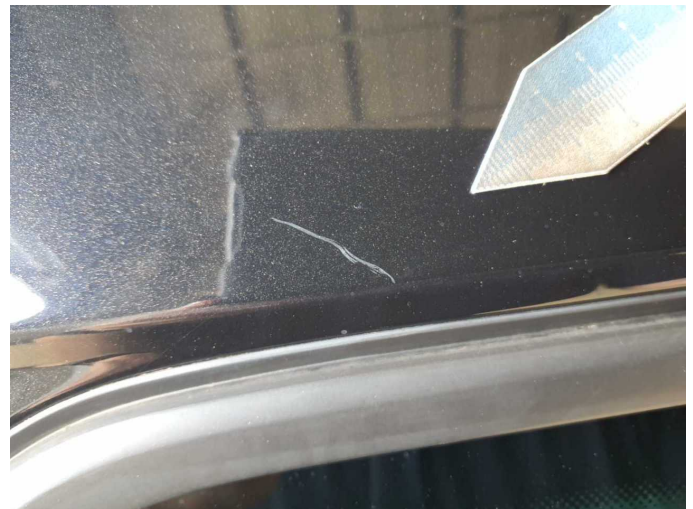
| No. | Component group | Description |
|---|---|---|
| 6 | Roof | Roof rail - right side - Dent / paintcoat damage - Repair and paint |

**Damage 6:** Roof: Roof rail - right side - Dent / paintcoat damage - Repair and paint

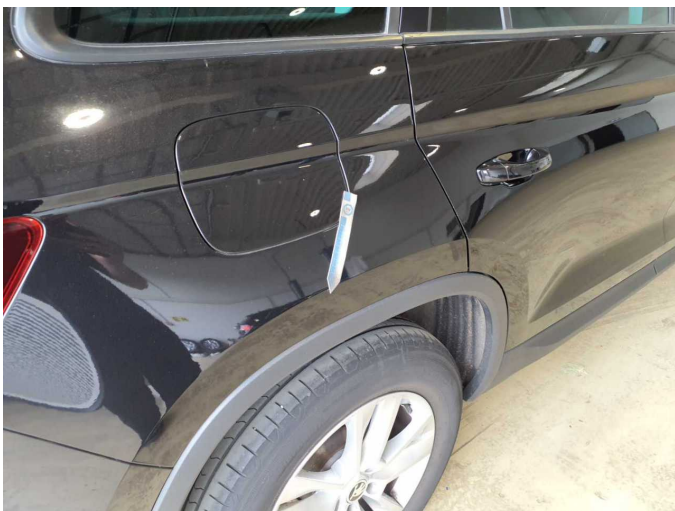
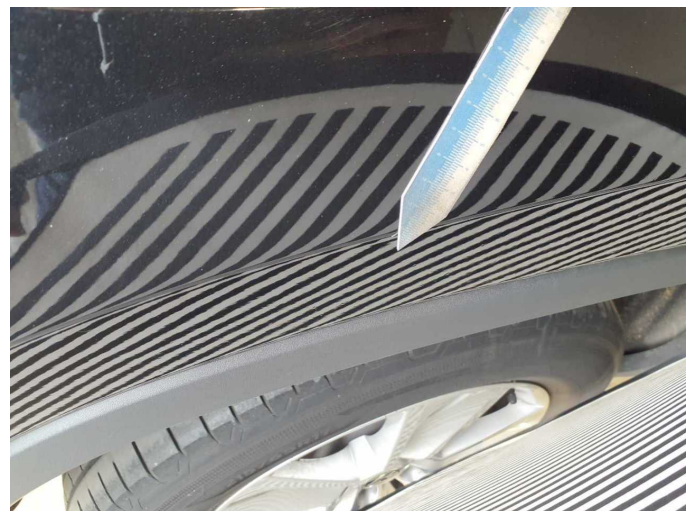
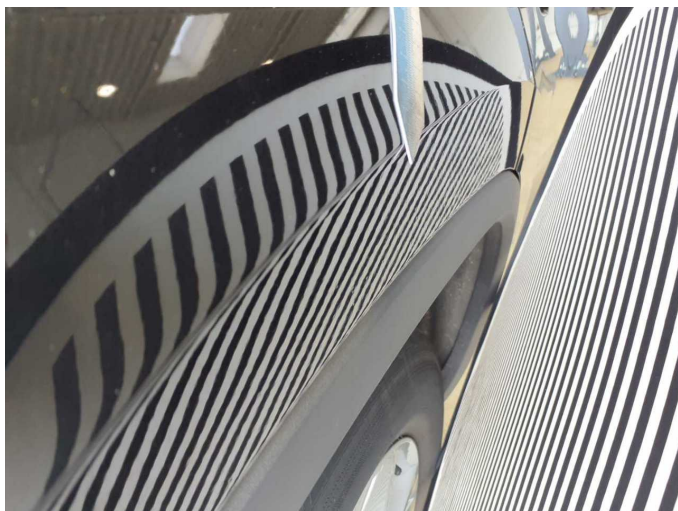
| No. | Component group | Description |
|---|---|---|
| 7 | Side panel - rear right side | Side panel (Einschlüsse) - Unprofessionally repaired - Repair and paint |

**Damage 7:** Side panel - rear right side: Side panel (Einschlüsse) - Unprofessionally repaired - Repair and paint

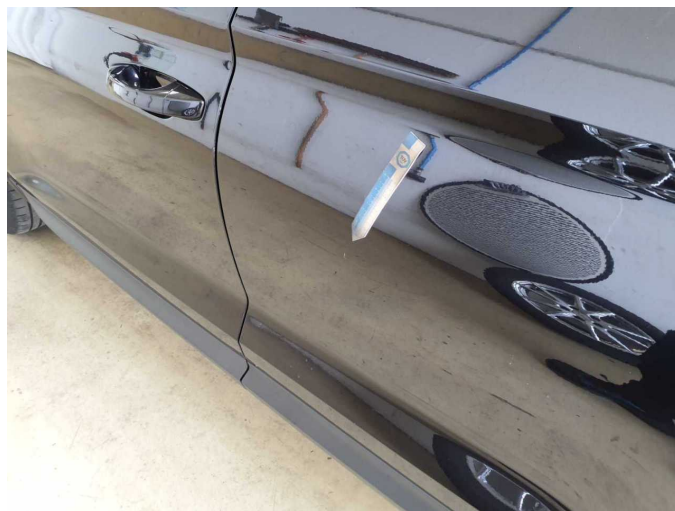
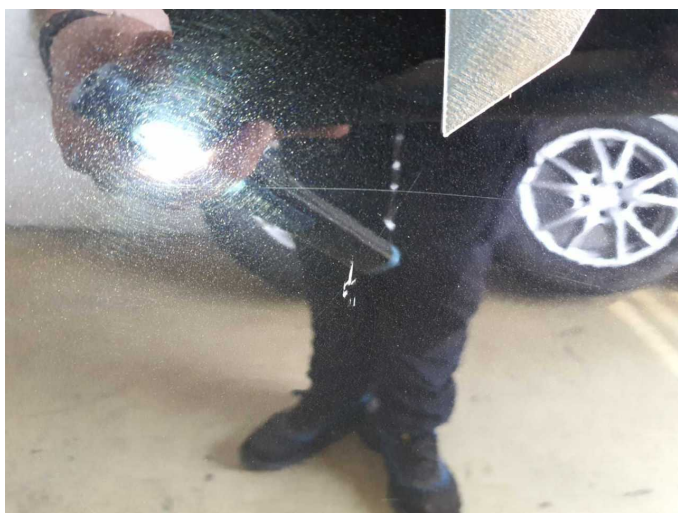
| No. | Component group | Description |
|---|---|---|
| 8 | Door - rear left side | Door - Scratch(es) - Paint |

**Damage 8:** Door - rear left side: Door - Scratch(es) - Paint

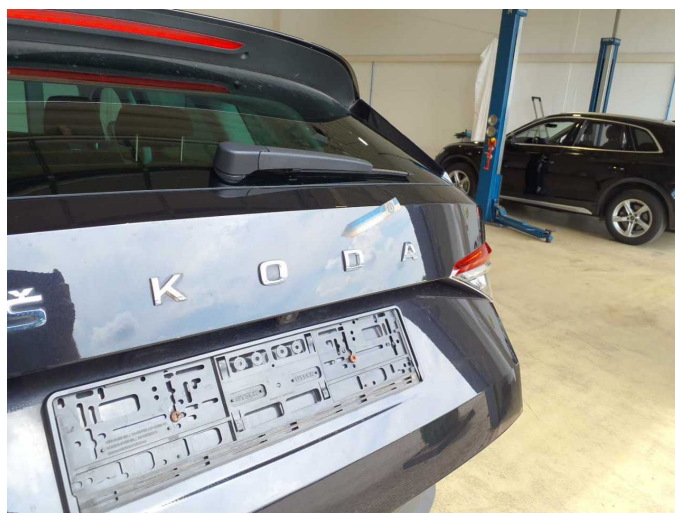
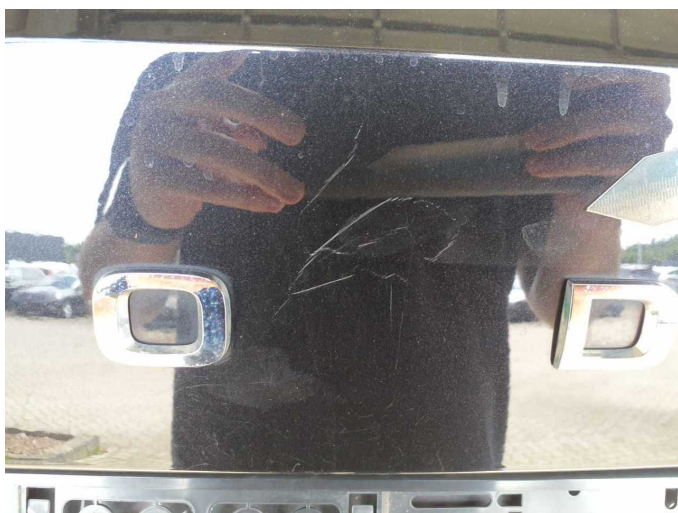
| No. | Component group | Description |
|---|---|---|
| 9 | Boot lid / rear door | Boot lid - Scratch(es) - Paint |

**Damage 9:** Boot lid / rear door: Boot lid - Scratch(es) - Paint

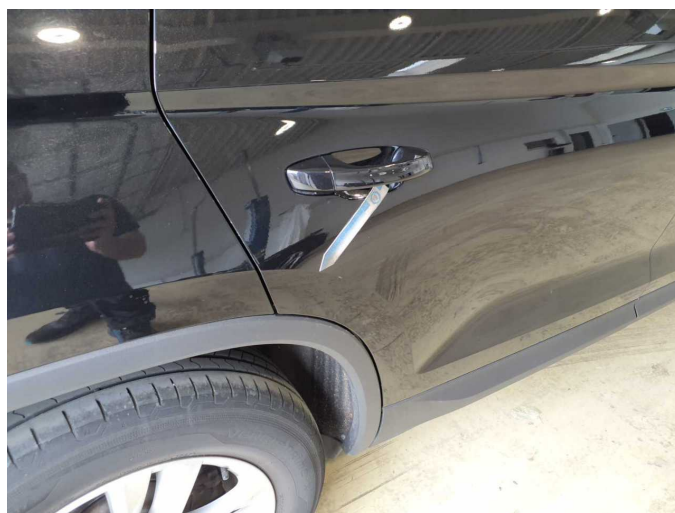
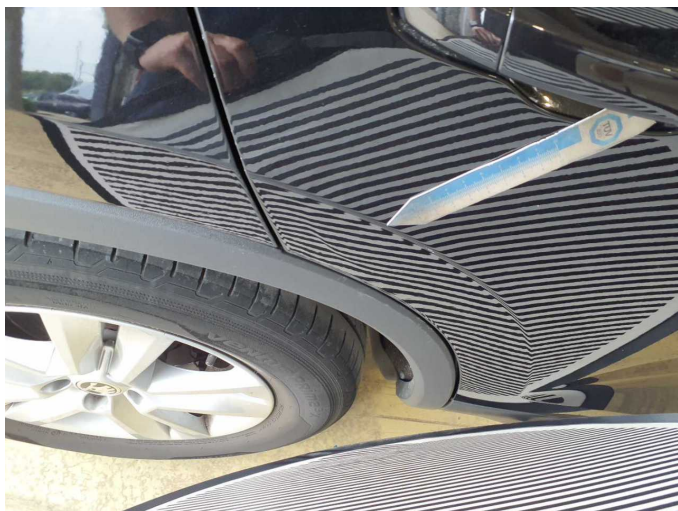
| No. | Component group | Description |
|---|---|---|
| 10 | Door - rear right side | Door (Wellig) - Unprofessionally repaired - Repair and paint |

**Damage 10:** Door - rear right side: Door (Wellig) - Unprofessionally repaired - Repair and paint

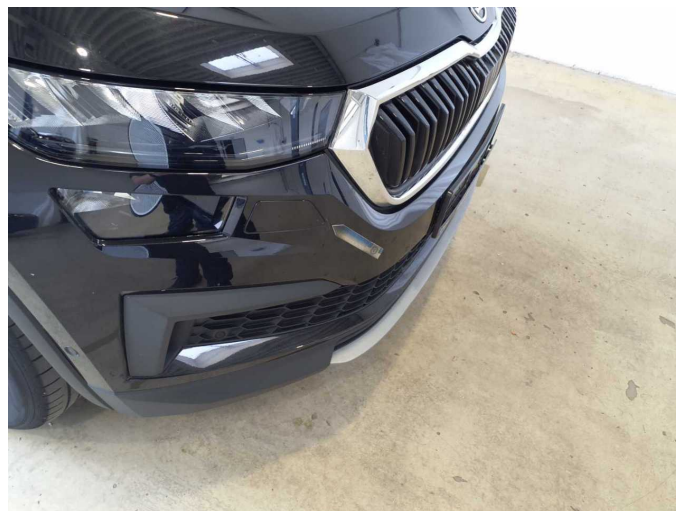
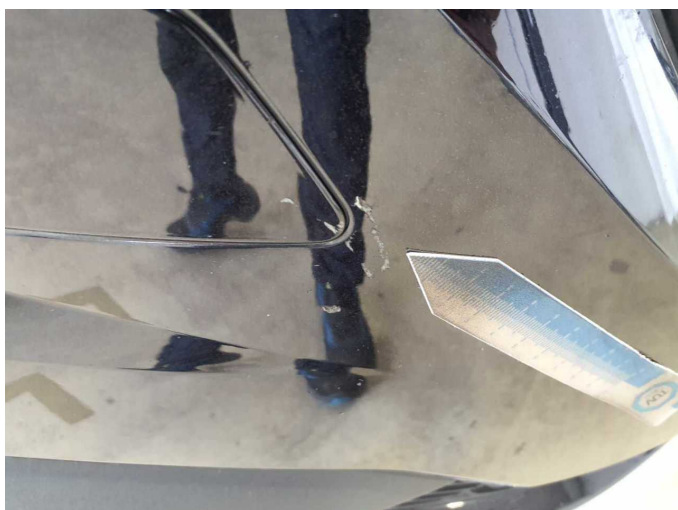
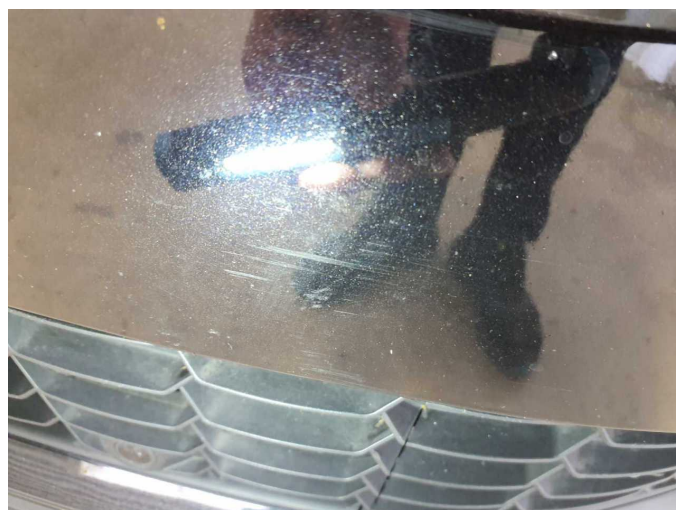
| No. | Component group | Description |
|---|---|---|
| 11 | Front bumper | Front bumper - Scratch(es) - Paint |

**Damage 11:** Front bumper: Front bumper - Scratch(es) - Paint

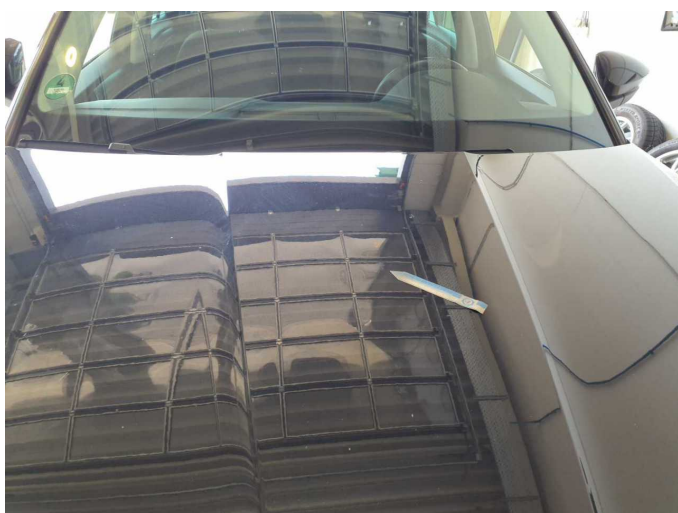
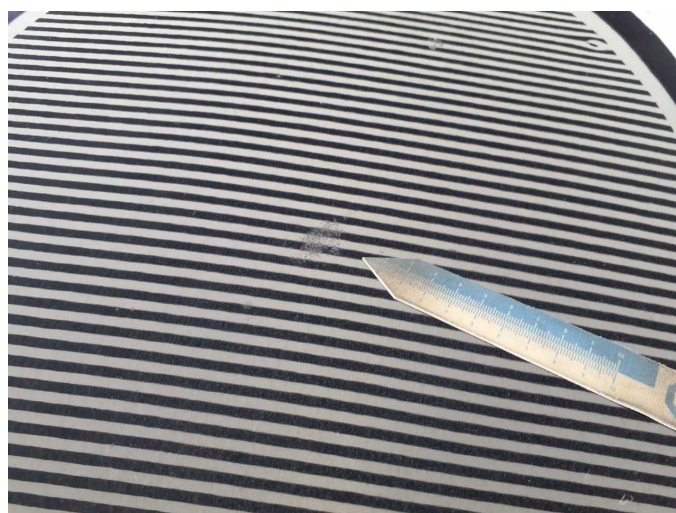
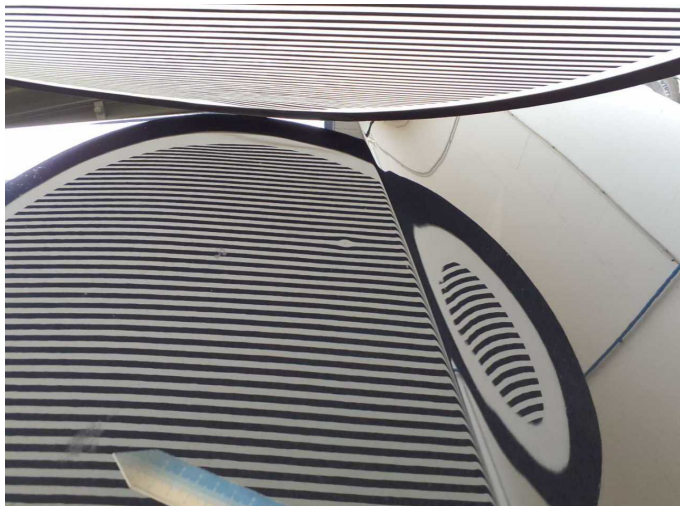
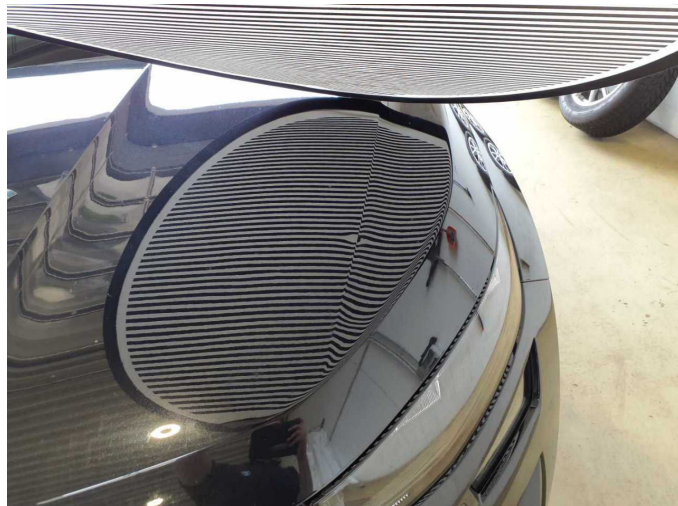
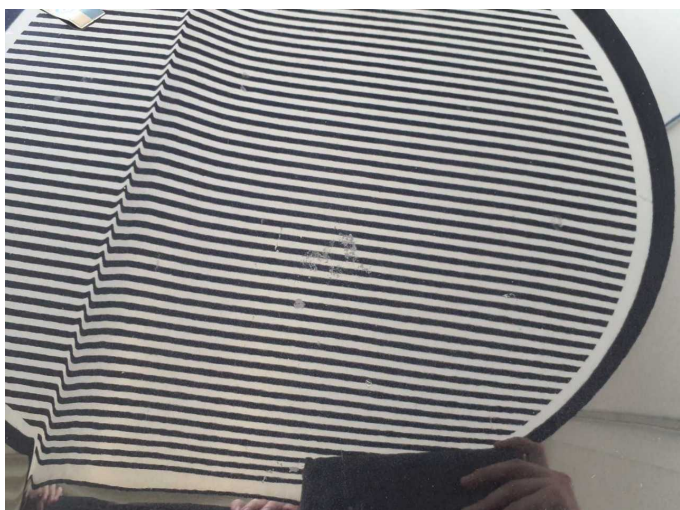
| No. | Component group | Description |
|---|---|---|
| 12 | Bonnet | Bonnet (Anätzung) - Paint defect - Repair and paint |

**Damage 12:** Bonnet: Bonnet (Anätzung) - Paint defect - Repair and paint

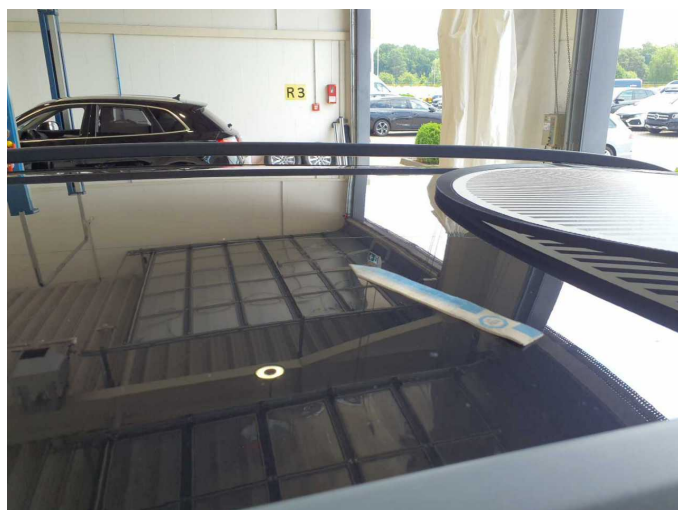
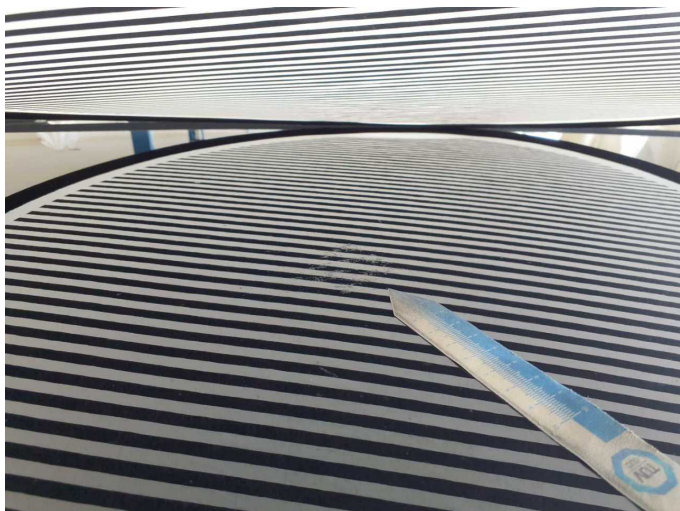
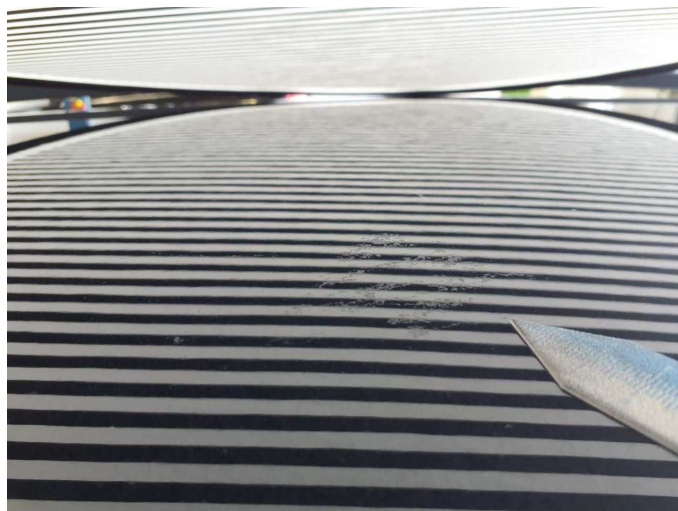
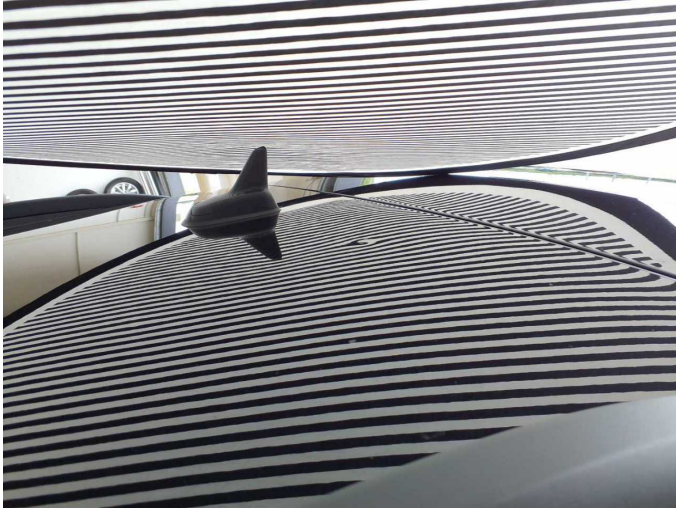
| No. | Component group | Description |
|---|---|---|
| 13 | Roof | Roof - Paint defect - Repair and paint |

**Damage 13:** Roof: Roof - Paint defect - Repair and paint

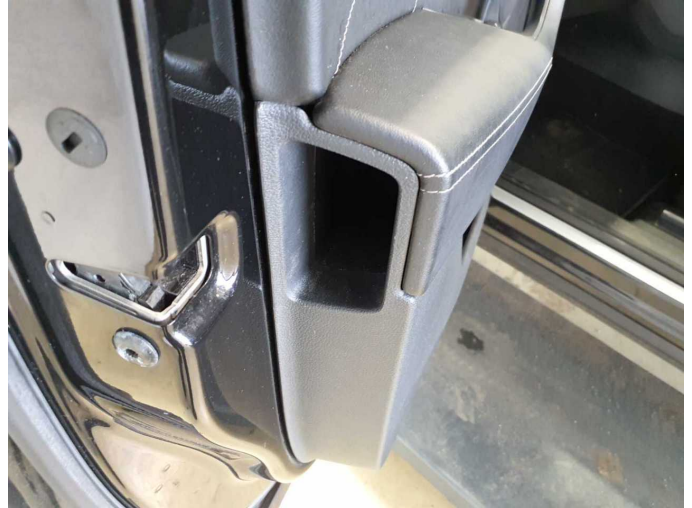
| Description |
|---|
| Equipment - Umbrella |

**Missing part 1:** Equipment: Umbrella - Missing - Replace

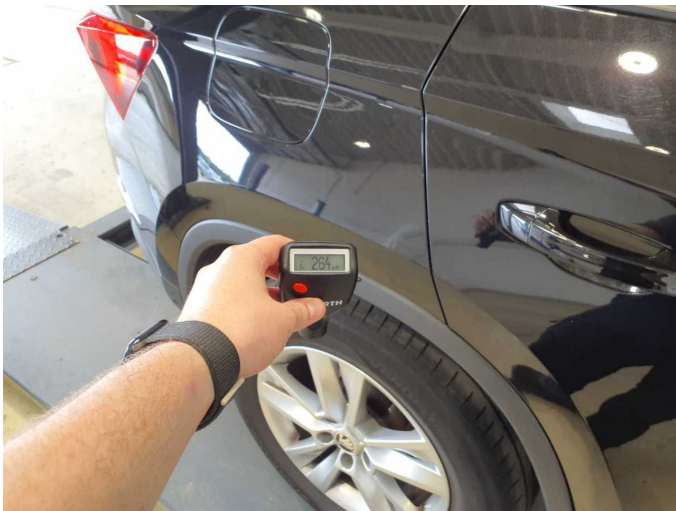
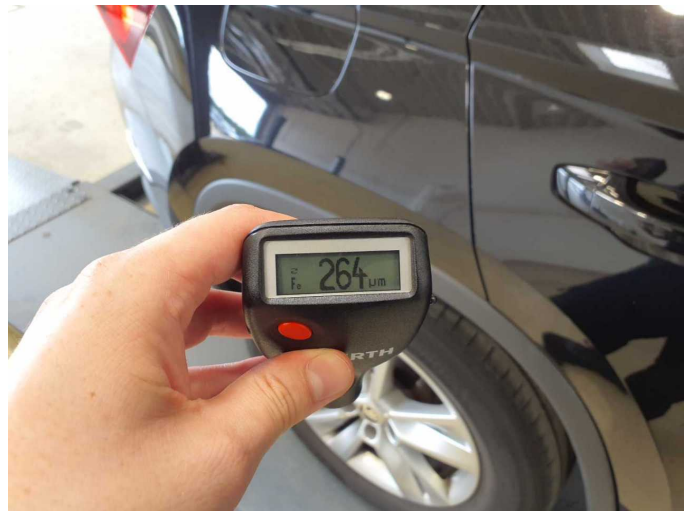
| No. | Repainting |
|---|---|
| 1 | Side panel - rear right side, Unprofessionally carried out, Invoice of repair done Non-existent |

| Side panel - rear right side | 264 µm | Door - rear right side | 173 µm |

**Repainting 1:** Side panel - rear right side

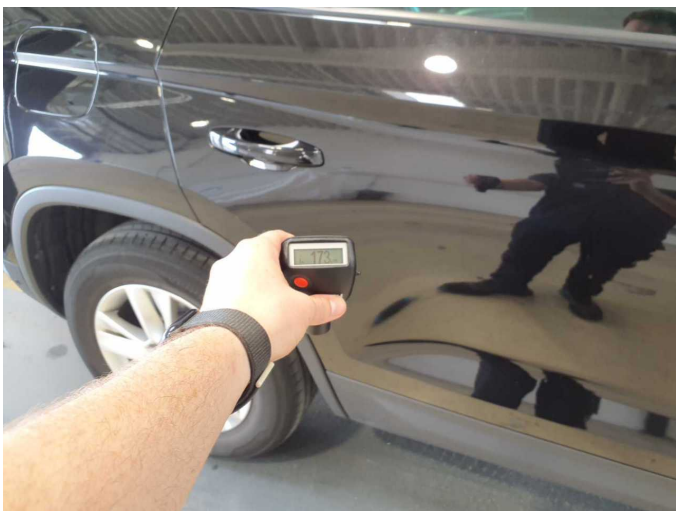
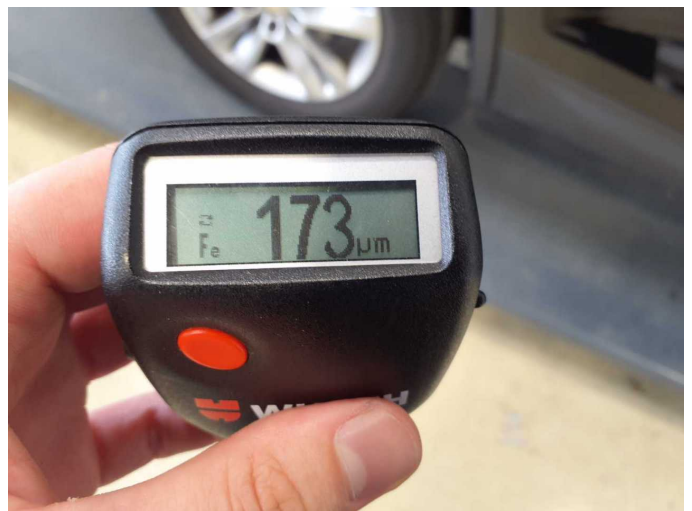
| No. | Repainting |
|---|---|
| 2 | Door - rear right side, Unprofessionally carried out, Invoice of repair done Non-existent |

**Repainting 2:** Door - rear right side
