## 2-FWF-888

2-FWF-888 · Cross 1.8 Hybrid Safety Pack DYNAMIC 1.8 140PS AT / · 28 July 2026 · Zaventem (BE)

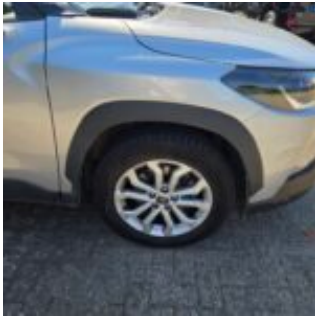
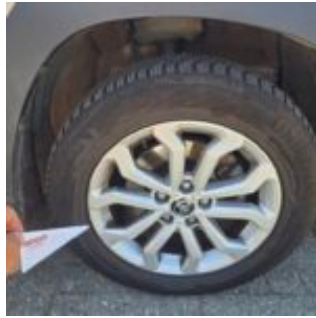
| Damage Part | Damage Type | Repair Type | Acceptable |
|---|---|---|---|
| Alloy – Right Front | Damaged | Rim repair | No |

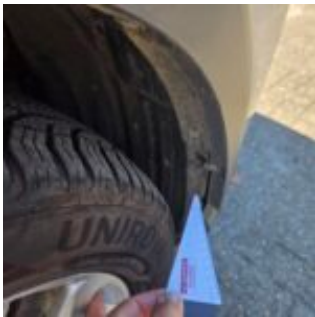
| Damage Part | Damage Type | Notes | Repair Type | Acceptable |
|---|---|---|---|---|
| Other | Dislocated / Loose | Wielkuipbescherming | Repair | No |

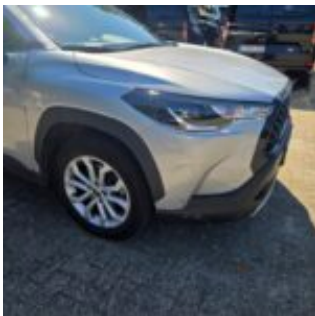
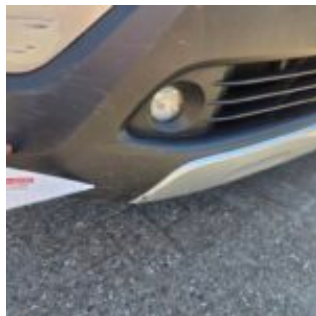
| Damage Part | Damage Type | Repair Type | Acceptable |
|---|---|---|---|
| spoiler FB | Scratch(es) | Spotrepair | No |

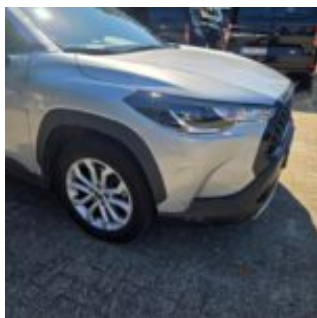
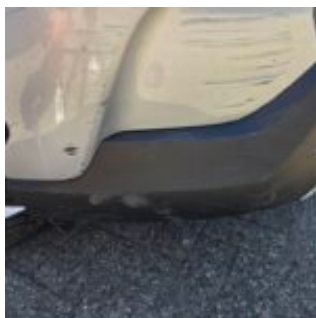
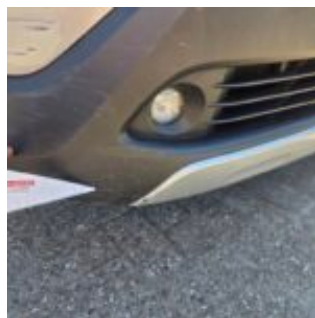
| Damage Part | Damage Type | Notes | Repair Type | Acceptable |
|---|---|---|---|---|
| Bumper - Front | Scratch(es) | Midden gedeelte | Plastic Repair | No |

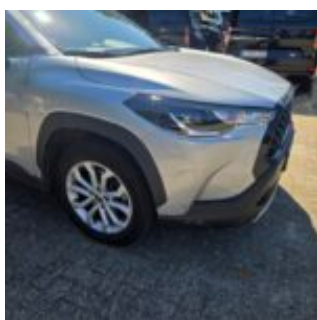
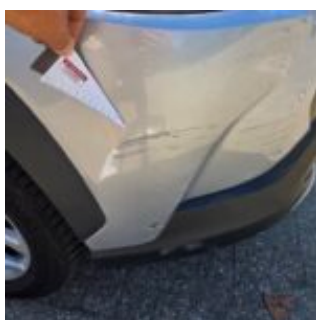
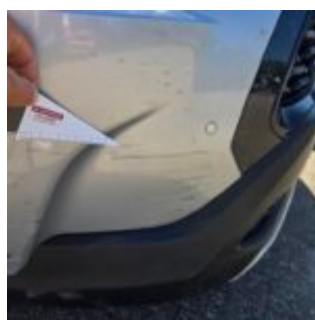
| Damage Part | Damage Type | Repair Type | Acceptable |
|---|---|---|---|
| Bumper - Front | Scratch(es) | Spray | No |

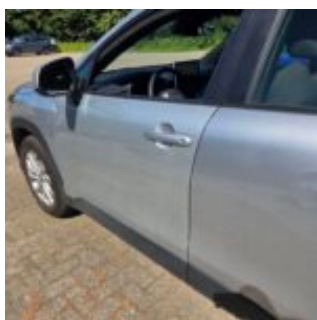
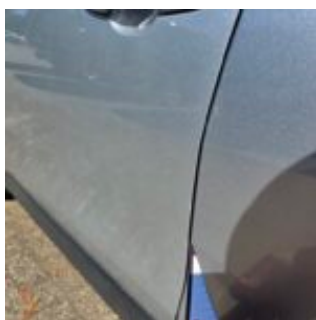
| Damage Part | Damage Type | Repair Type | Acceptable |
|---|---|---|---|
| Frontdoor - Left | Previous Repair | Spray | No |

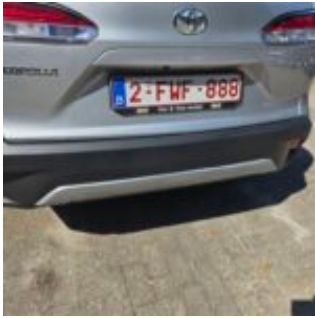
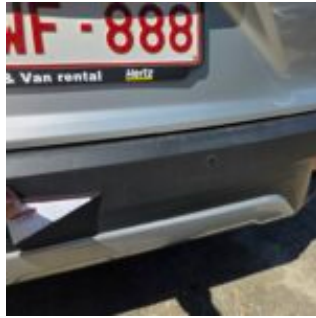
| Damage Part | Damage Type | Notes | Repair Type | Acceptable |
|---|---|---|---|---|
| Bumper - Rear | Small scratch(es) | Middenstuk | Acceptable | Yes |
