# smart #3

## Vehicle information

| Model: | #3 | VIN: | HESCA2C48RS266829 |

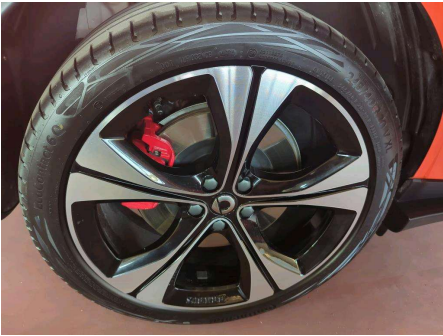
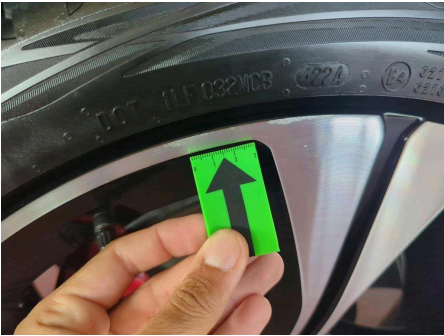
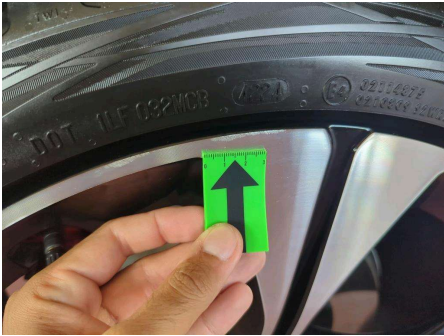
Alloy rim RR polished  
Scratch(es)  
Repair and paint (complete)  
Right

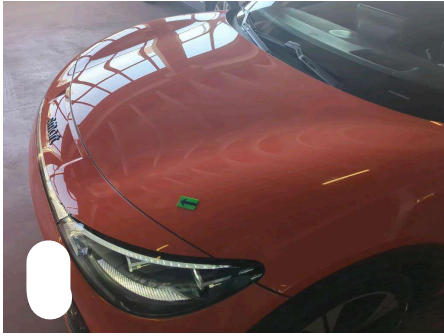
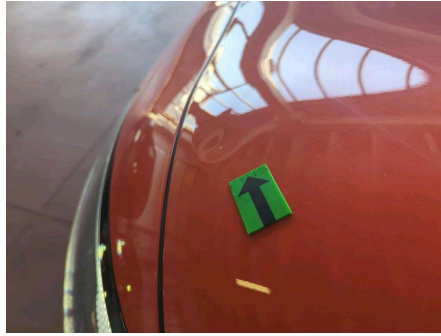
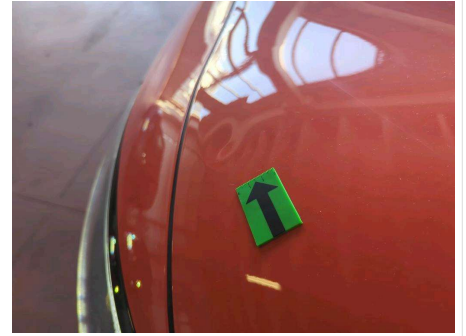
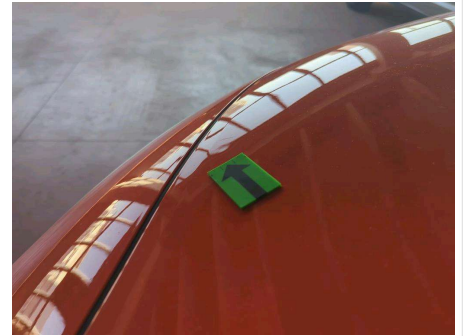
### Bonnet

Dent(s)

Front

Repair and paint (complete)

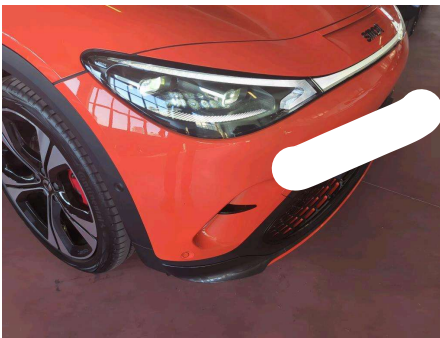
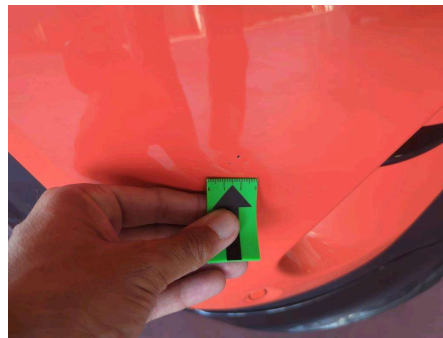
### Bumper F

Scratch(es)

Front

Spot repair

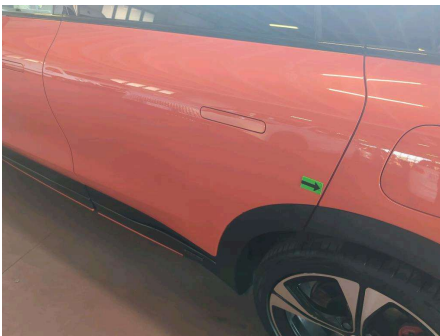
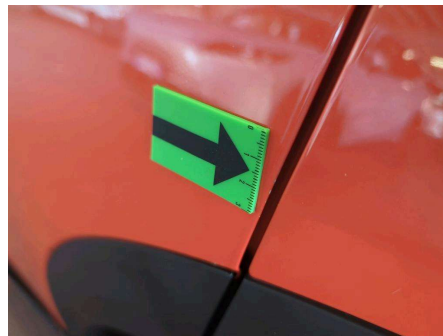
### Door RL

Scratch(es)

Left

Spot repair

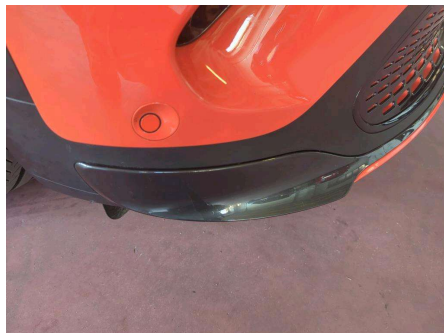
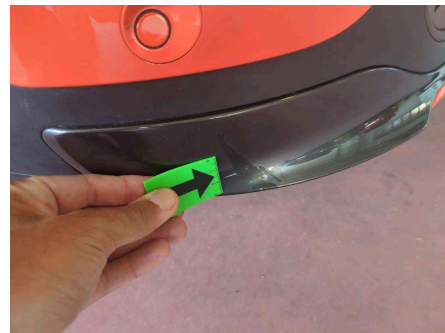
### Spoiler FR

Scratch(es)

Front

Repair and paint (complete)

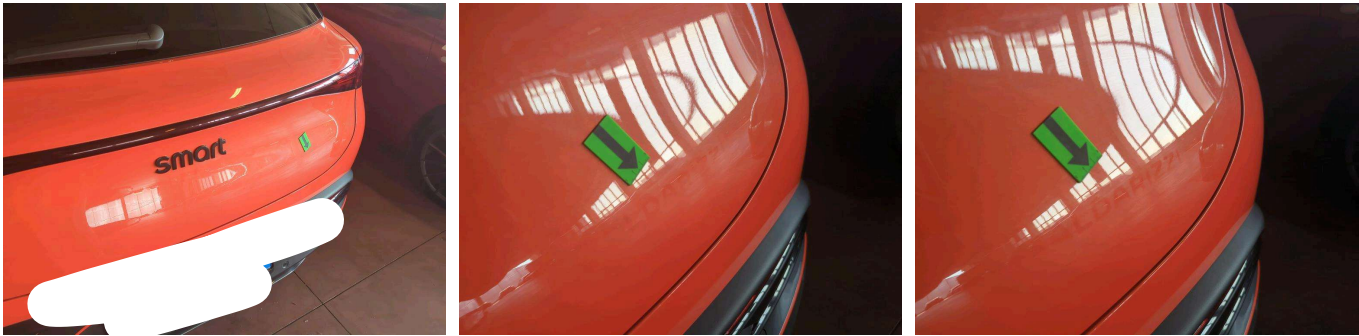
Tailgate / Boot

Chemical polution  
Polish  
Rear

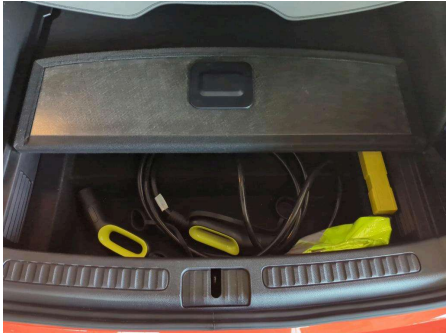
Tyre repair kit

Missing  
Replace  
Rear
