Expertise

Protocol number: 45546987
Order No. / Reference: 26368388
Inspection date: 19 May 2026

Manufacturer: Opel

Model: Astra 1.5 D Automatik Business Elegance

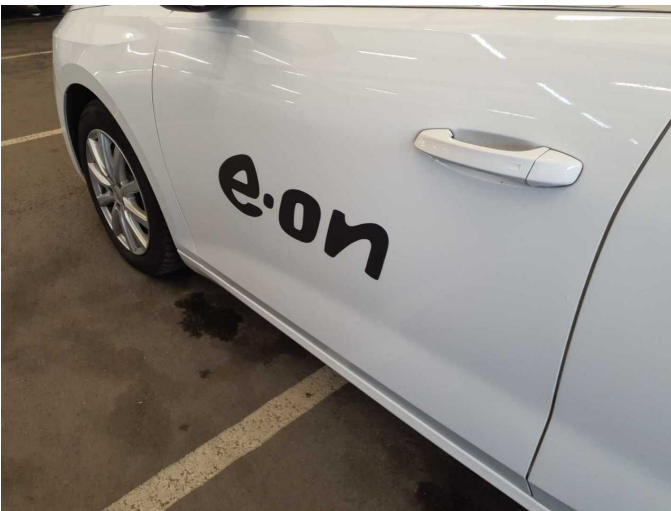
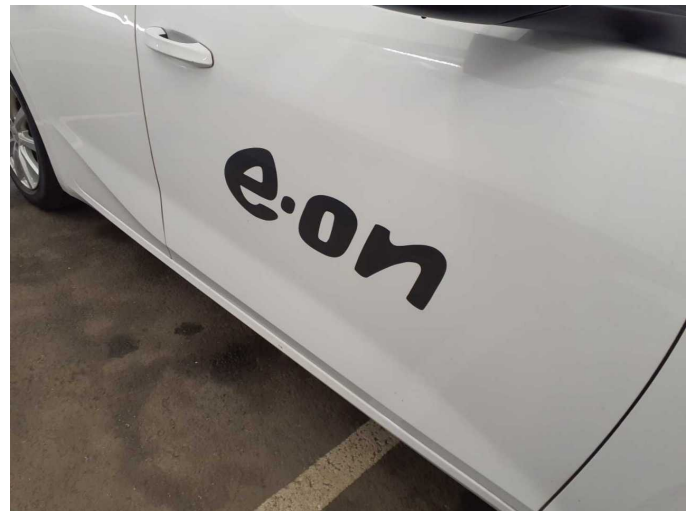
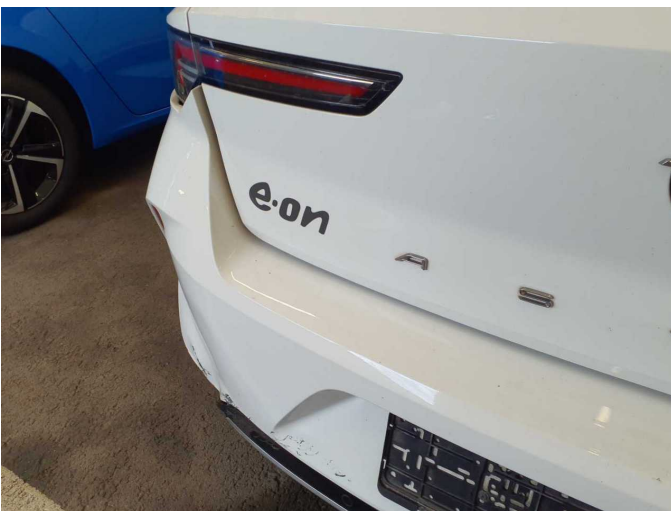
No.	Component group	Description
1	Misc.	Main inspection - No evidence - No deduction
2	Body	Body - Glued / labelled - De-glue / neutralise
3	Interior	Interior (Sitze vorne stark verschmutzt, Mehraufwand möglich) - Soiled - Clean
4	Bonnet	Insulation lining - Damage caused by marten / rodent - Replace
5	2nd wheel set	1 alloy rim - Scratched - Loss in value
6	2nd wheel set	1 alloy rim - Scratched - Loss in value

Damage 2: Body: Body - Glued / labelled - De-glue / neutralise

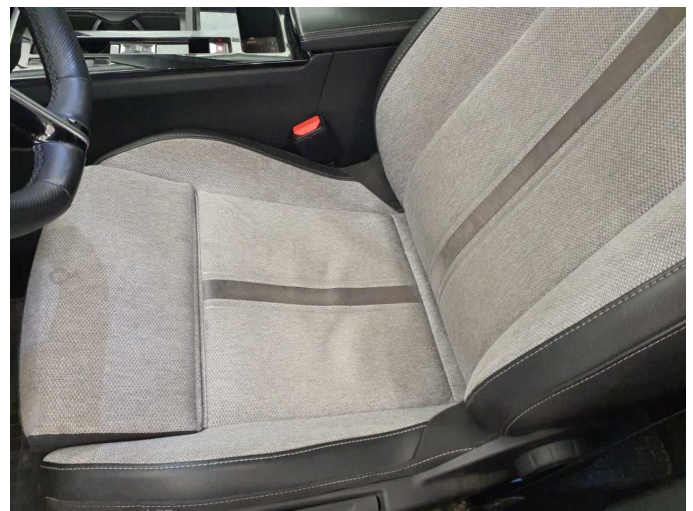
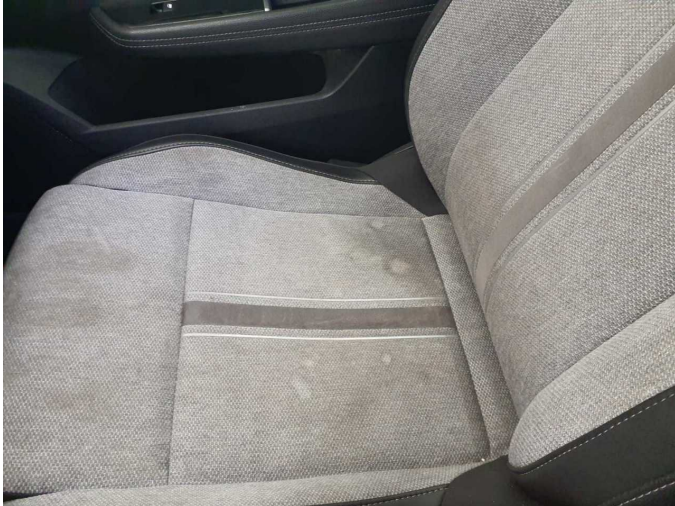
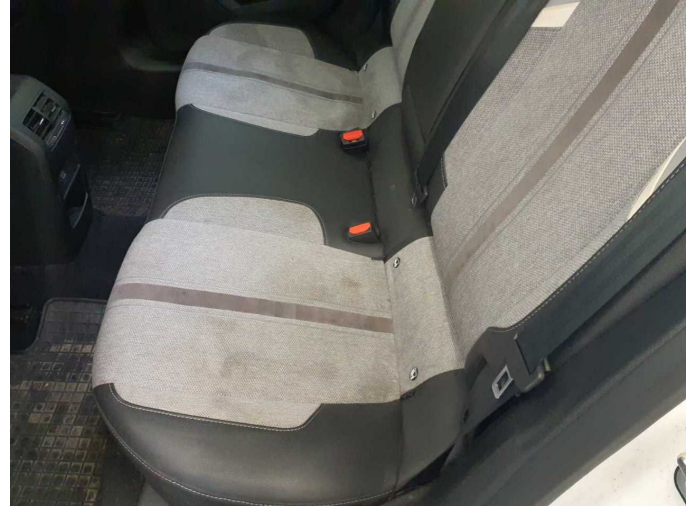
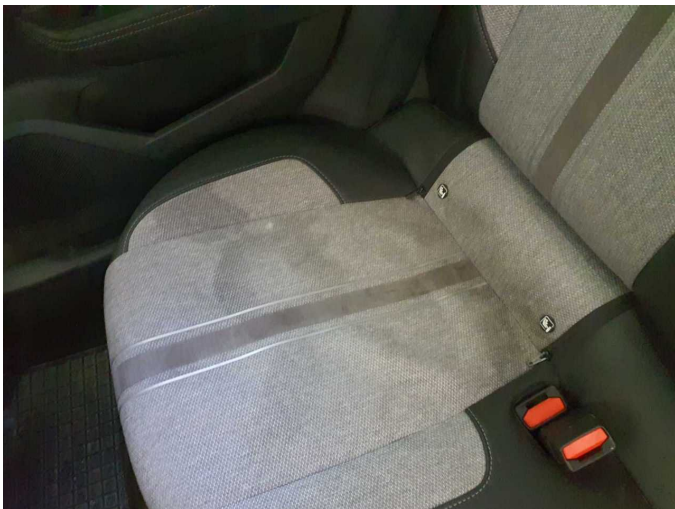
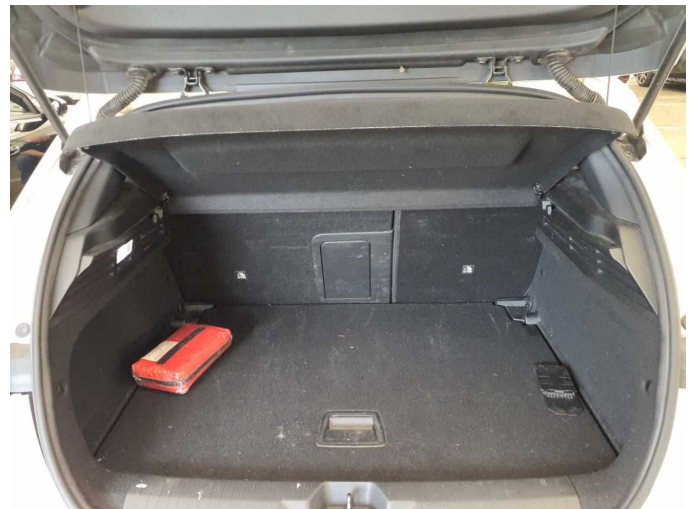
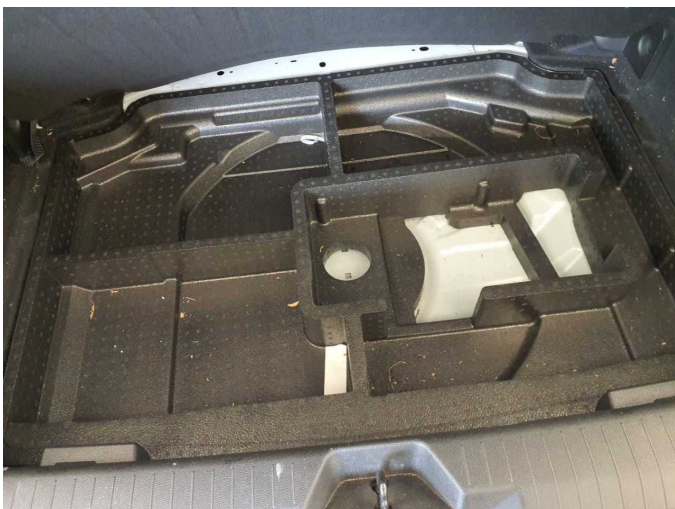
Damage 3: Interior: Interior (Sitze vorne stark verschmutzt, Mehraufwand möglich) - Soiled - Clean

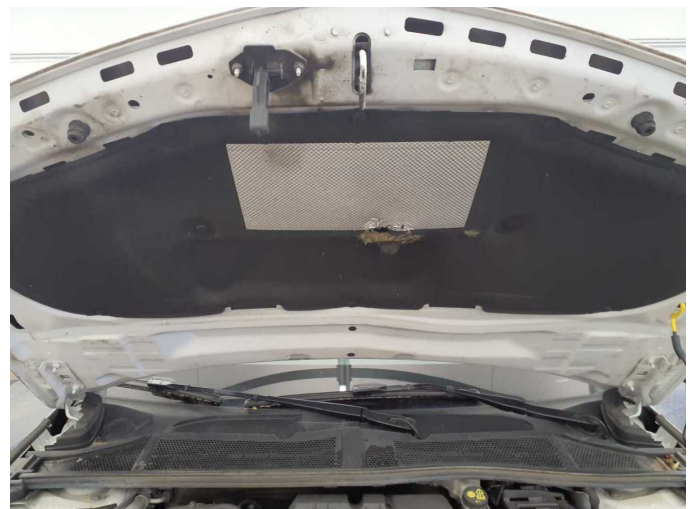
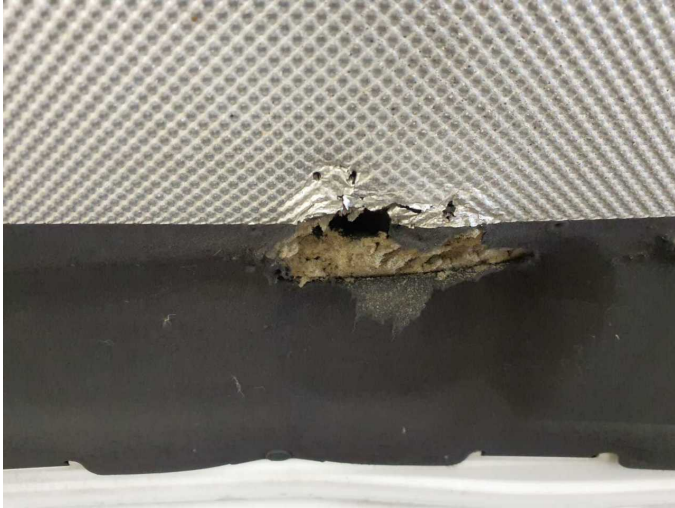
Damage 4: Bonnet: Insulation lining - Damage caused by marten / rodent - Replace

Damage 4: Bonnet: Insulation lining - Damage caused by marten / rodent
- Replace

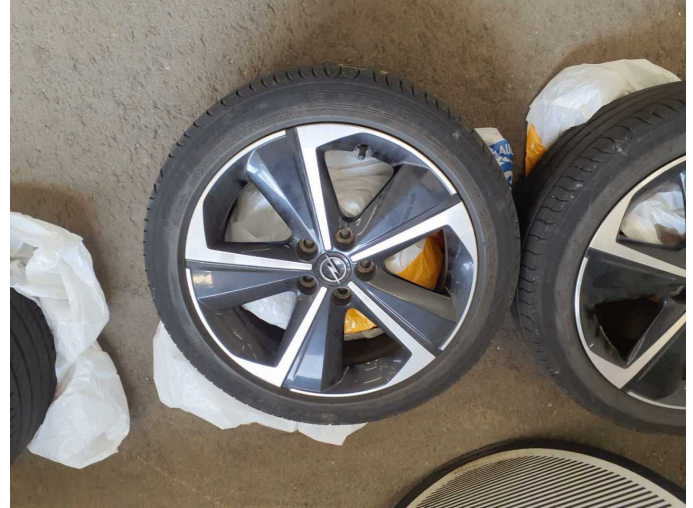
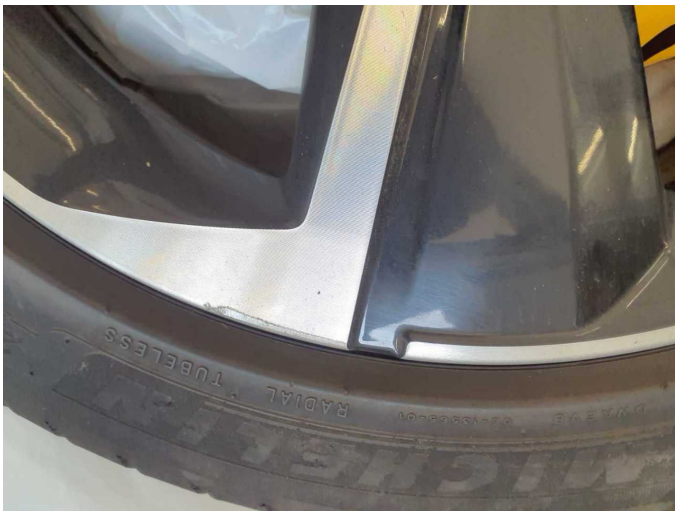
Damage 5: 2nd wheel set: 1 alloy rim - Scratched - Loss in value

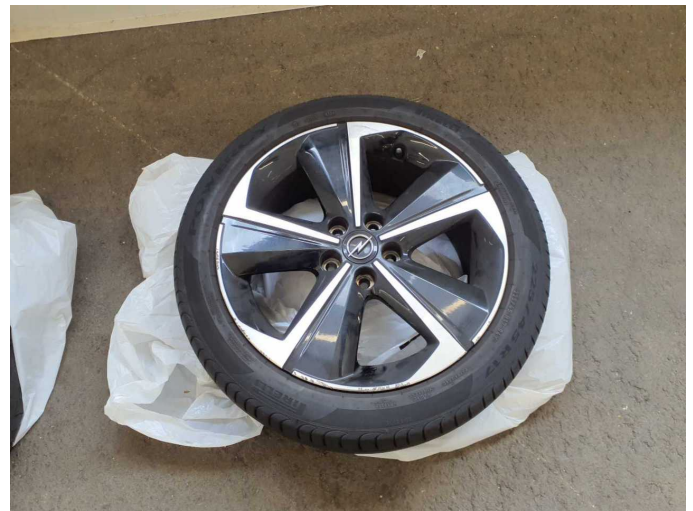
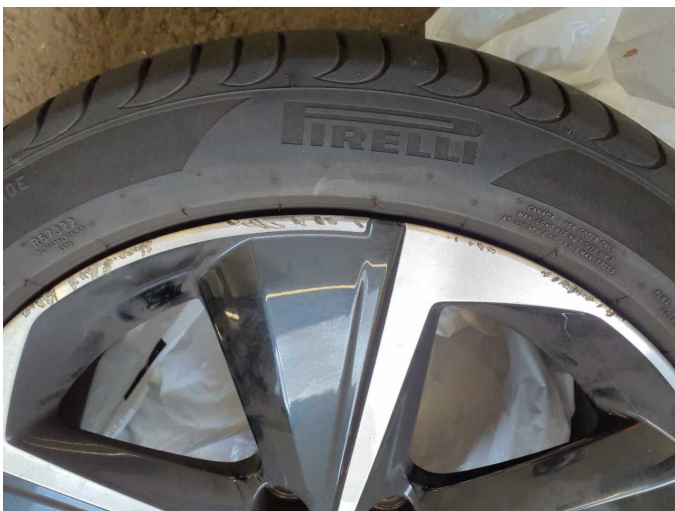
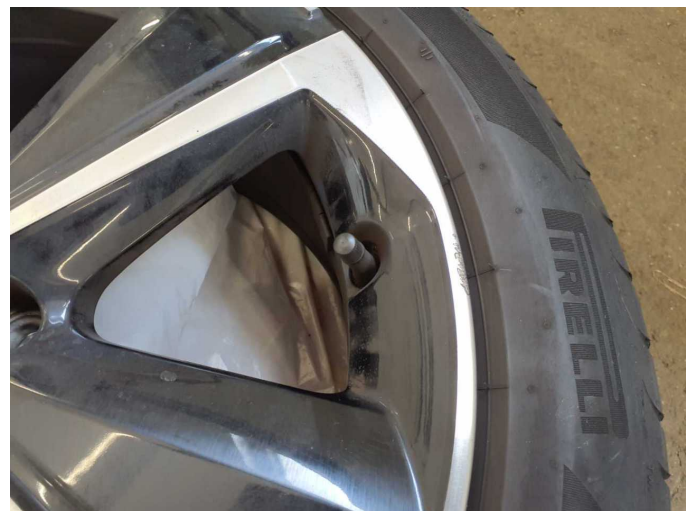
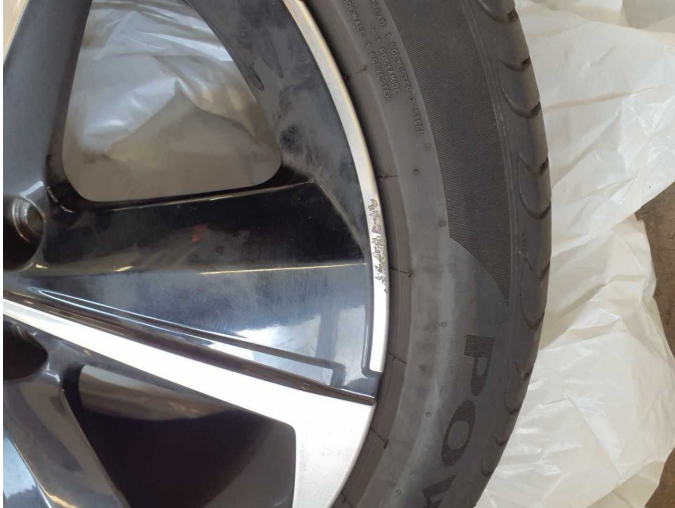
Damage 6: 2nd wheel set: 1 alloy rim - Scratched - Loss in value

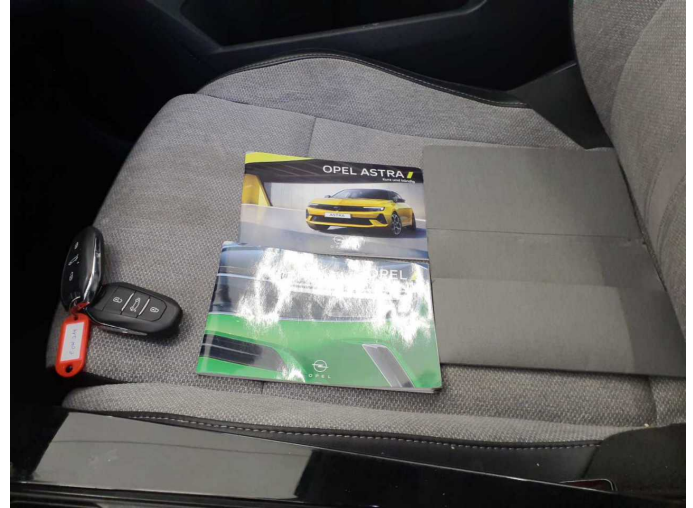
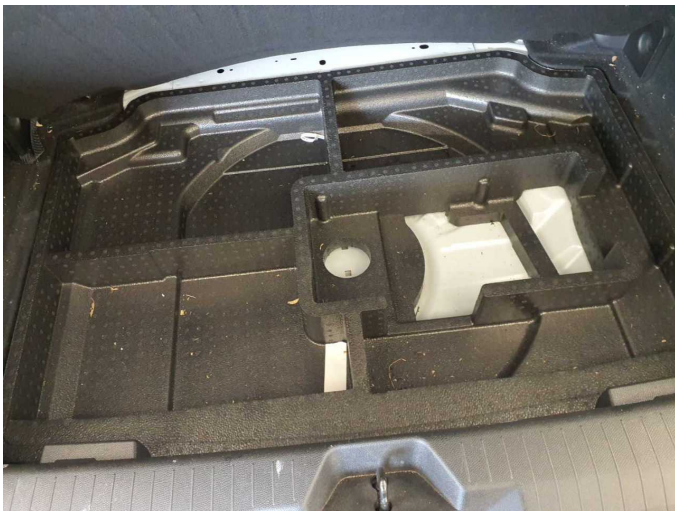
Missing part 1: Rear of vehicle: Key trailer hitch (2x) - Missing - Replace

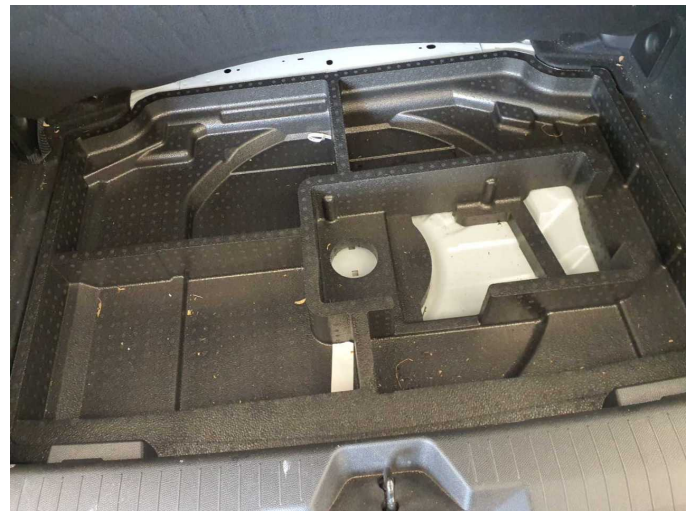
Missing part 2: Equipment: Tirefit complete - Missing - Replace

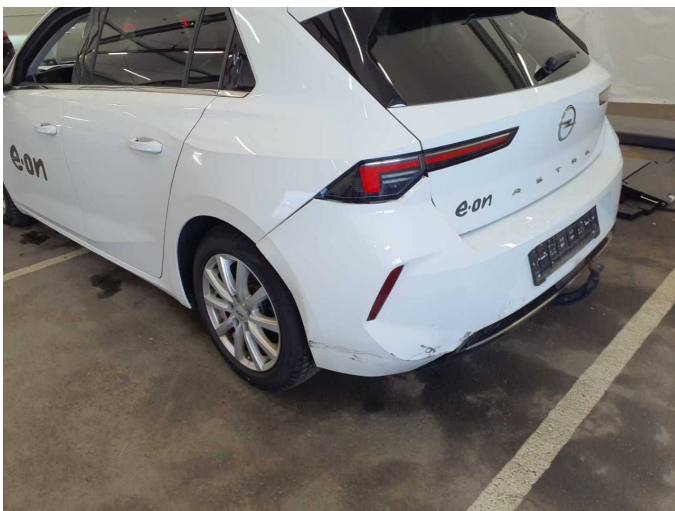
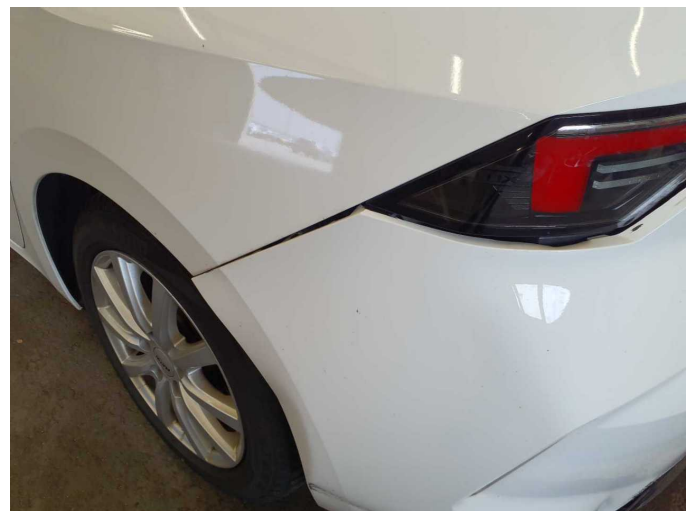
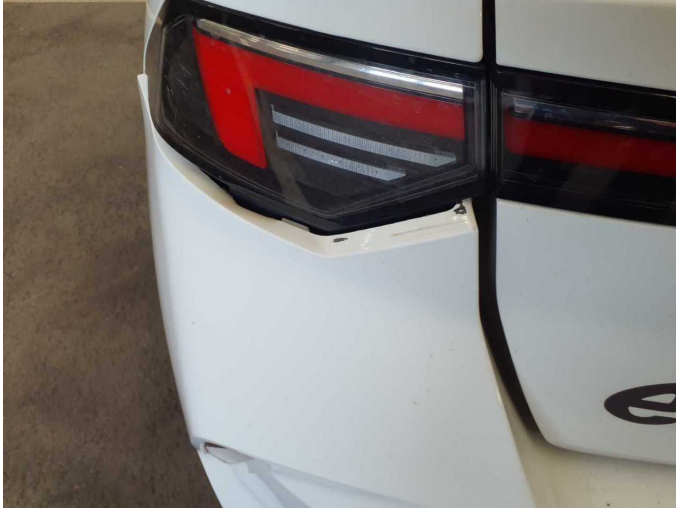
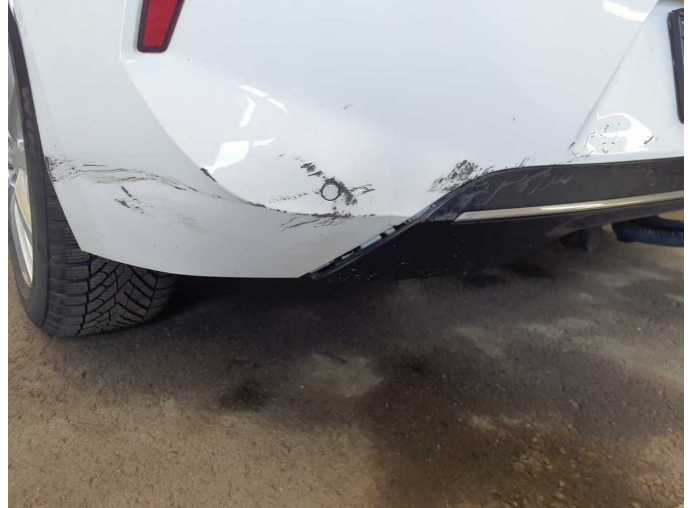
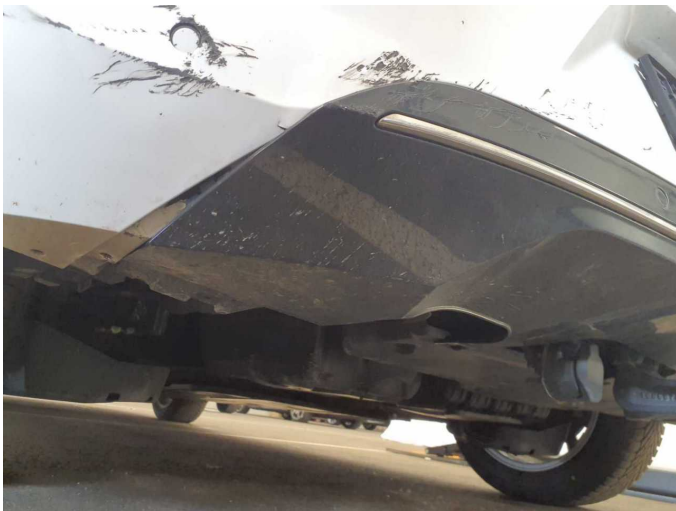
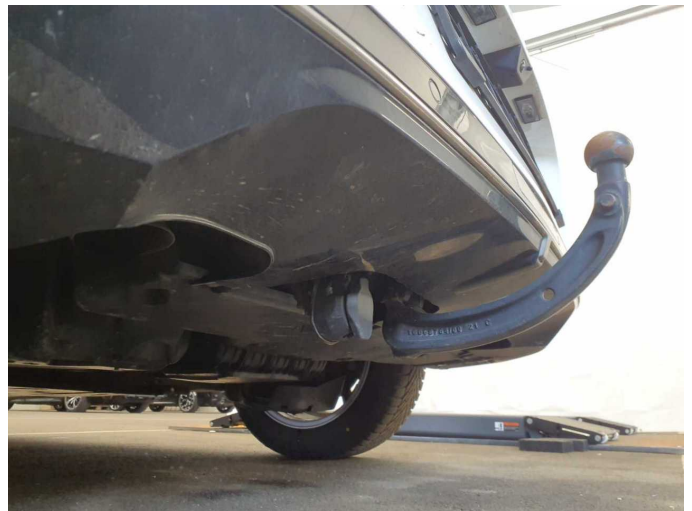
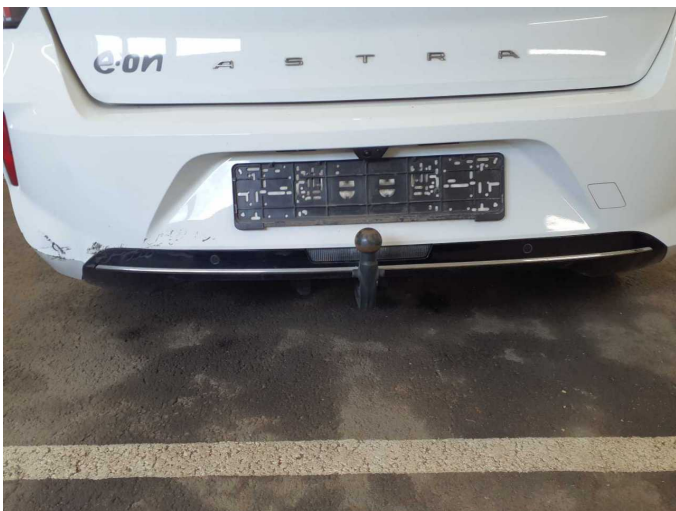
No.	Previous damage	Extent of damage (Net)
1	Rear, Provided by user / customer, from 13 Nov 2023	1.116,57 €

Accident 1: Rear

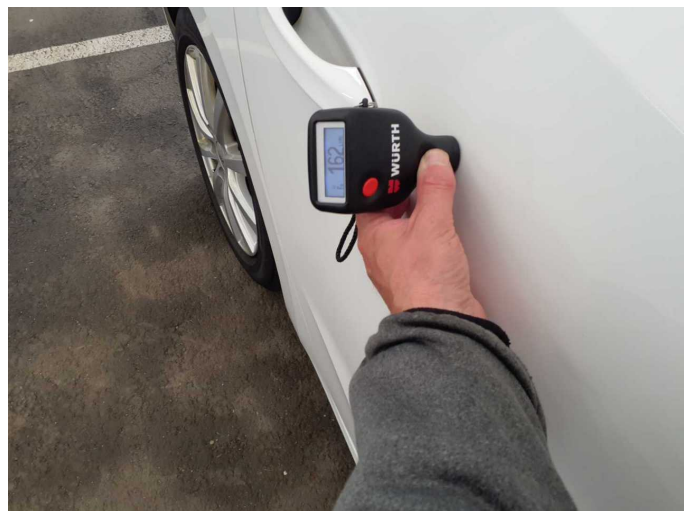
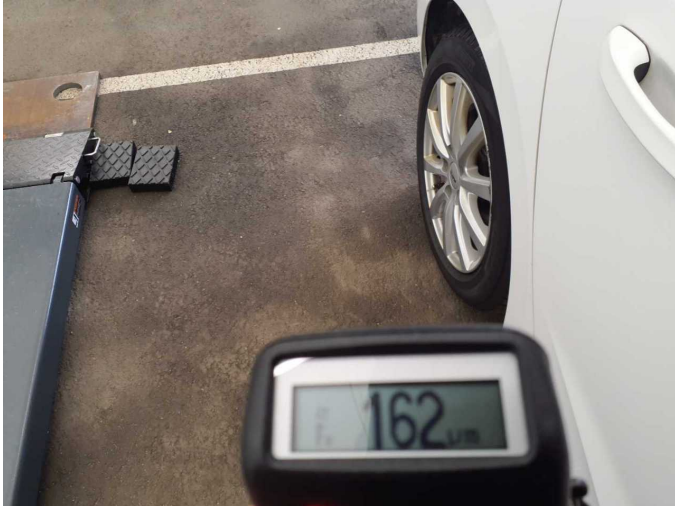
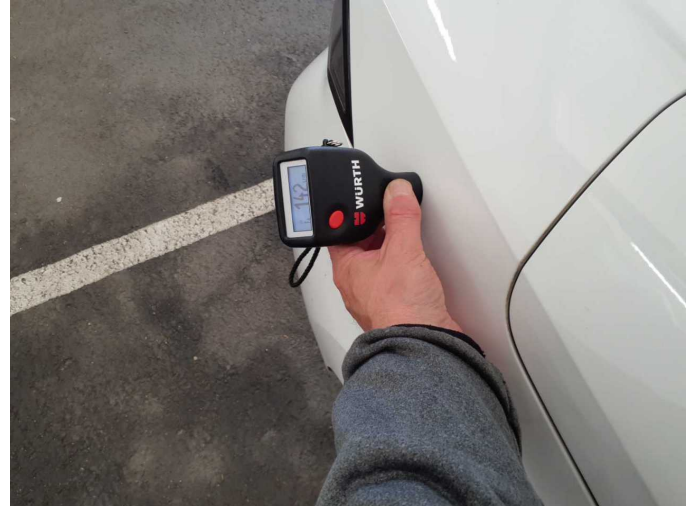
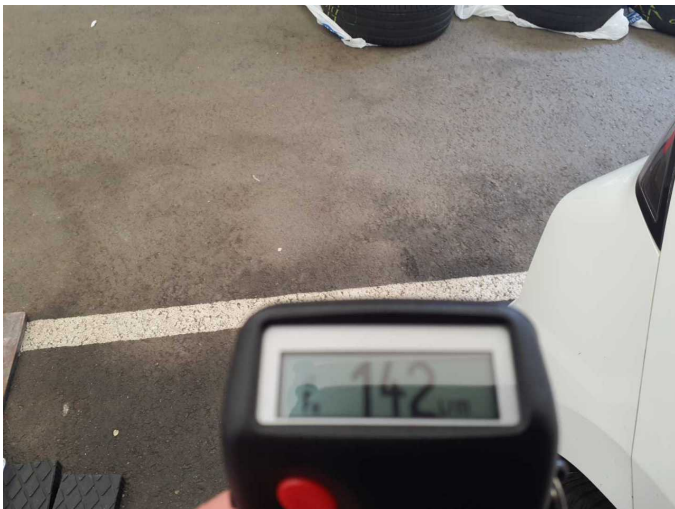
Side panel - rear right side	142 µm	Door - rear right side	162 µm
------------------------------	--------	------------------------	--------

Repainting 1: Side panel - rear right side, Door - rear right side
