Expertise

Protocol number: 46709457  
Order No. / Reference: 26725739  
Inspection date: 24 Jul 2026

Manufacturer: Ford

Model: Tourneo Connect 2.0 EcoBlue TITANIUM

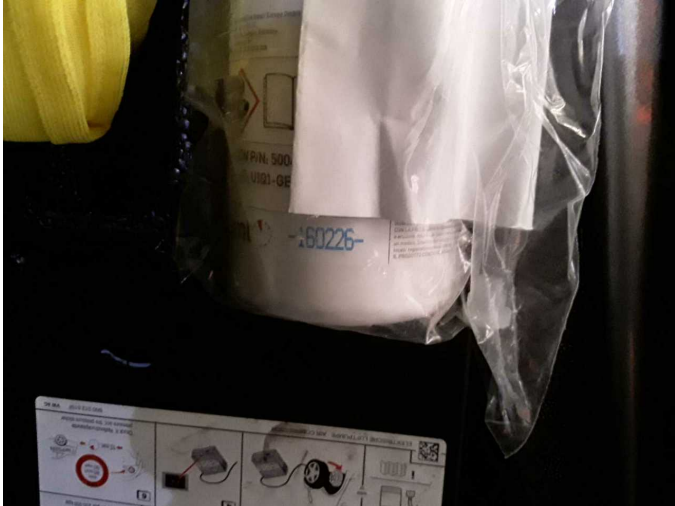
**Damage 1:** Equipment: Tirefit filler - Expired - Replace

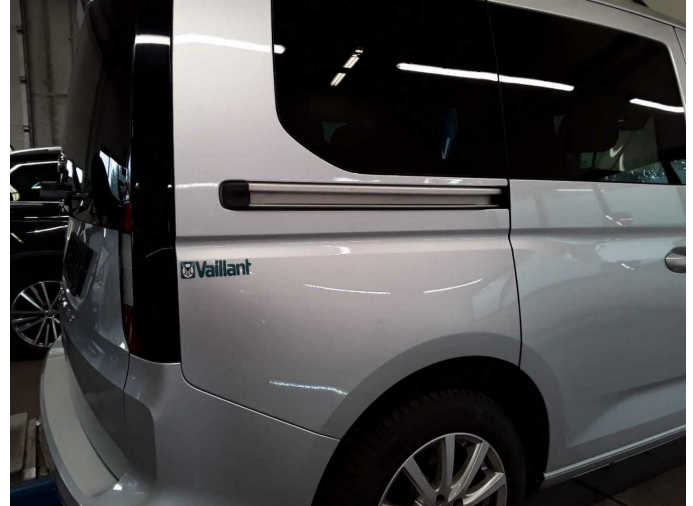
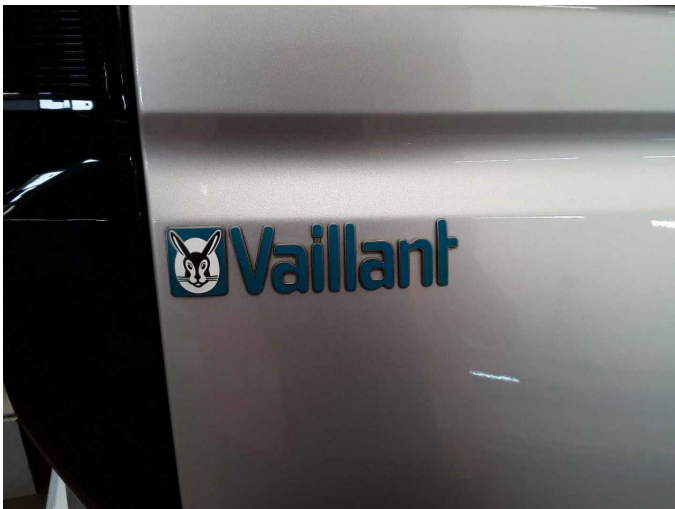
**Damage 2:** Side panel - rear right side: Side panel - Glued / labelled - De-glue / neutralise

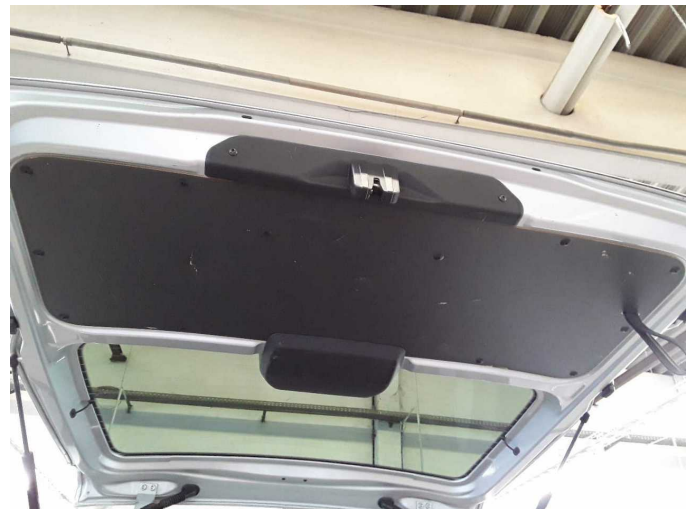
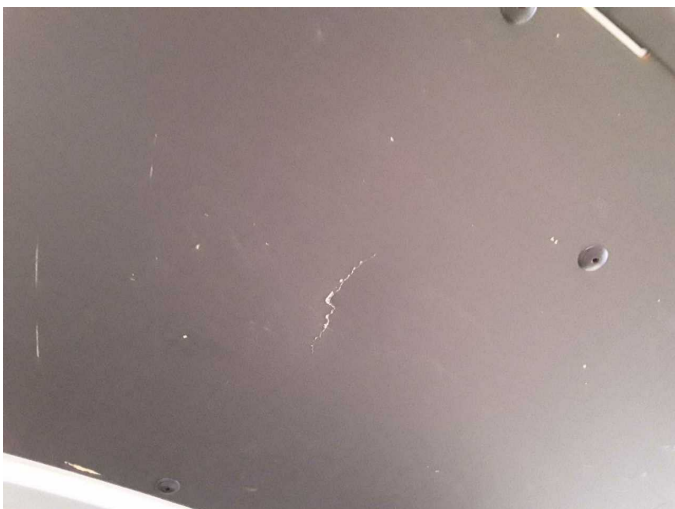
**Damage 3:** Trim / covers: Boot lid - interior trim - Broken / torn - Replace

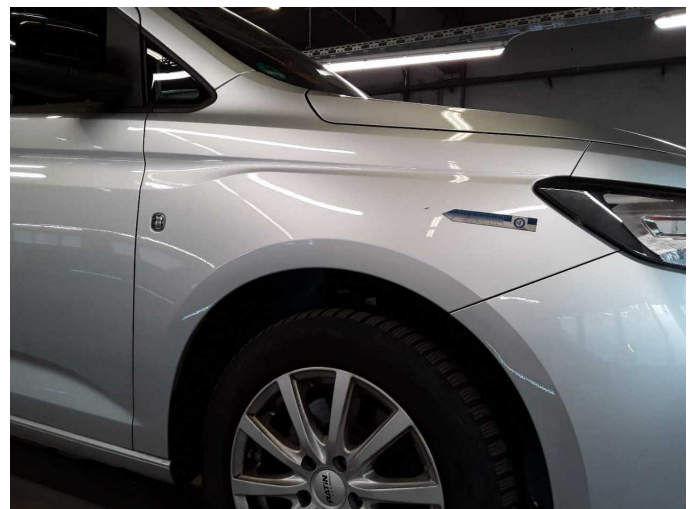
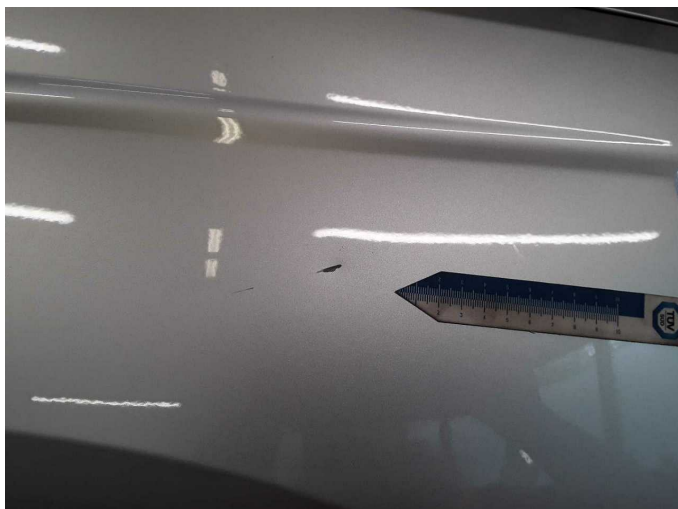
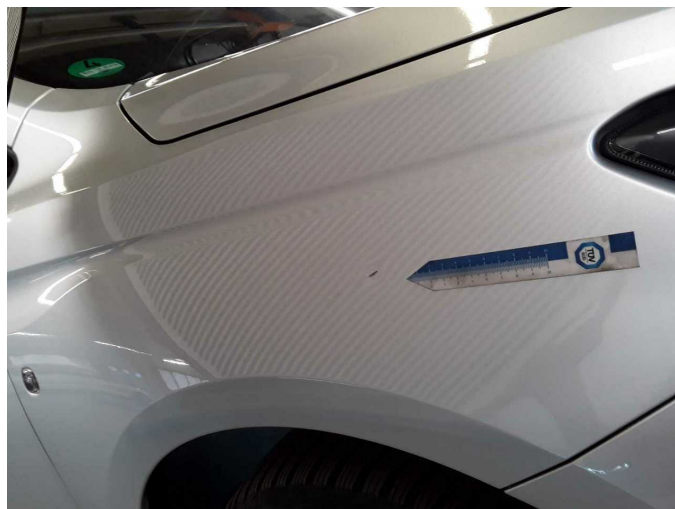
**Damage 4:** Mudguard - right side: Mudguard - right side - Dent / paintcoat damage - Smart repair

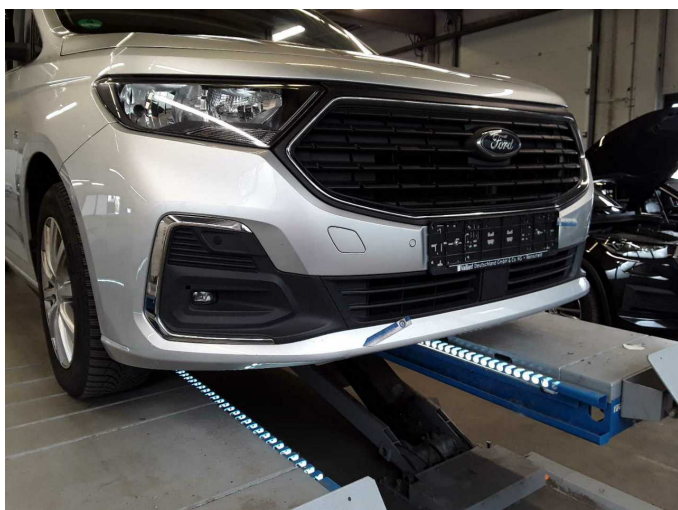
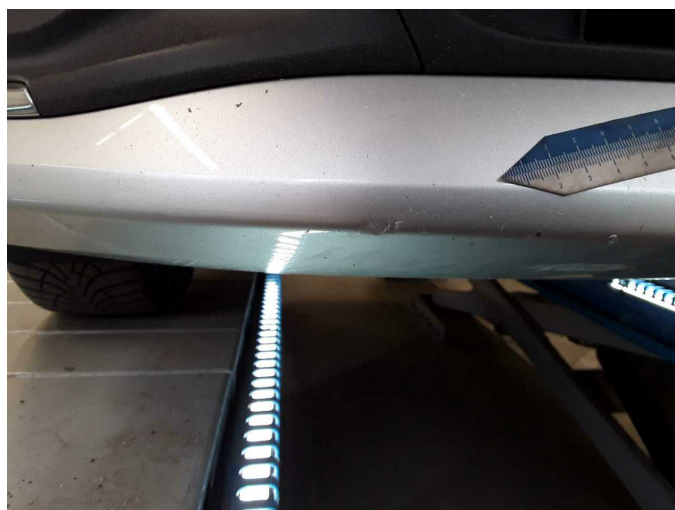
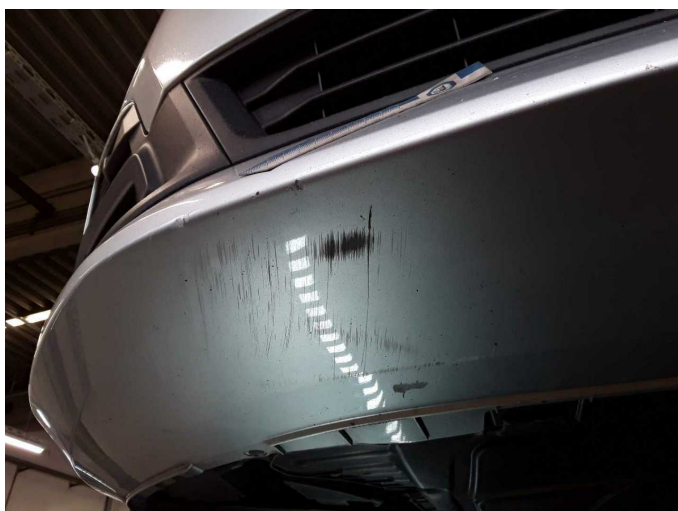
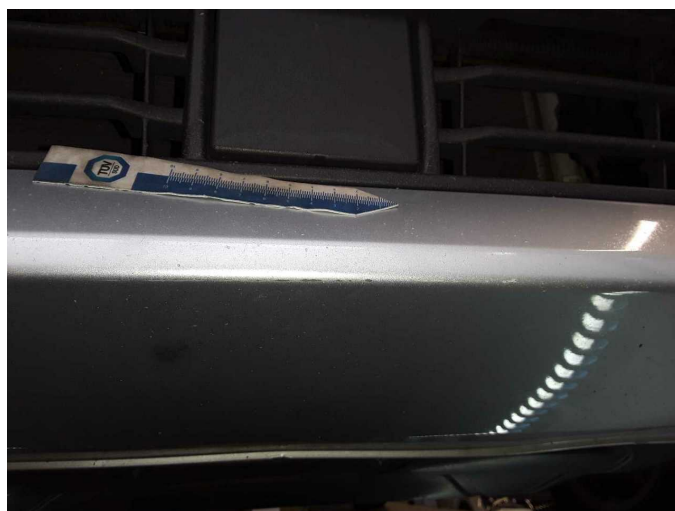
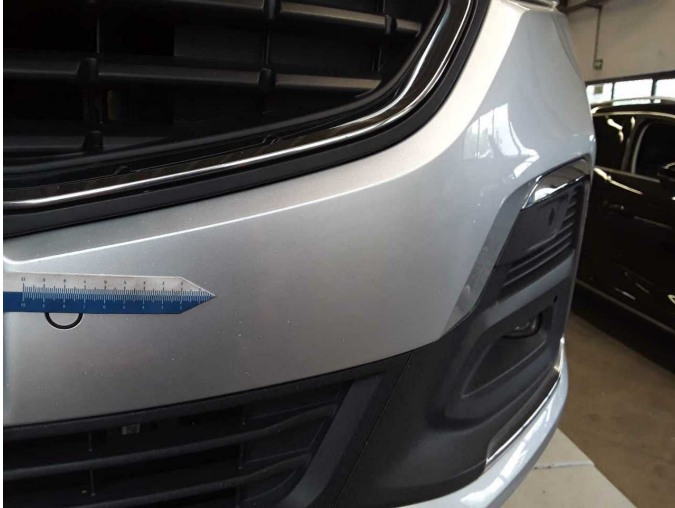
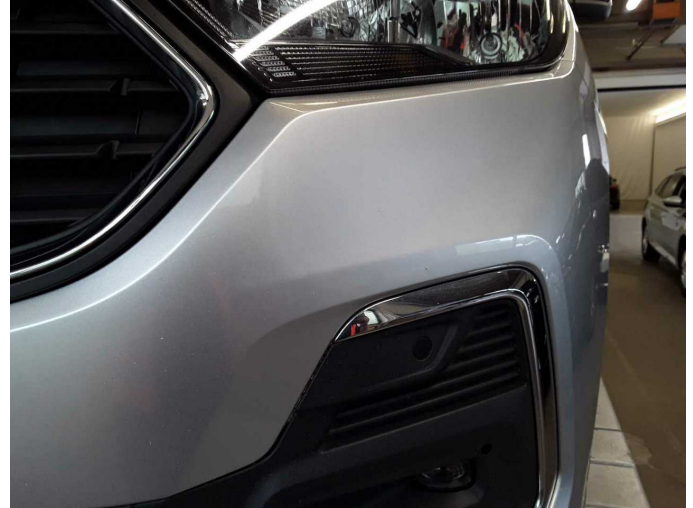
**Damage 5:** Front bumper: Front bumper - Scratched - Paint

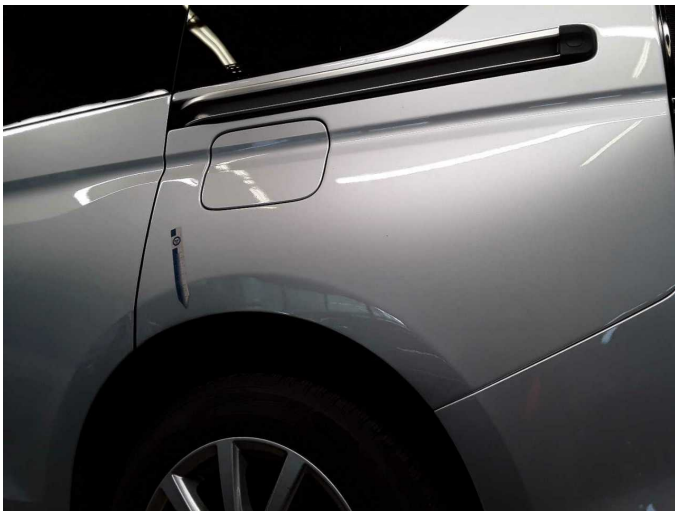
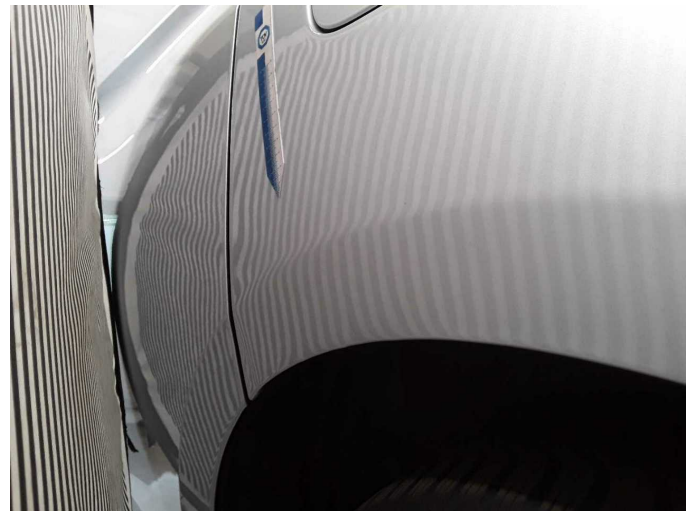
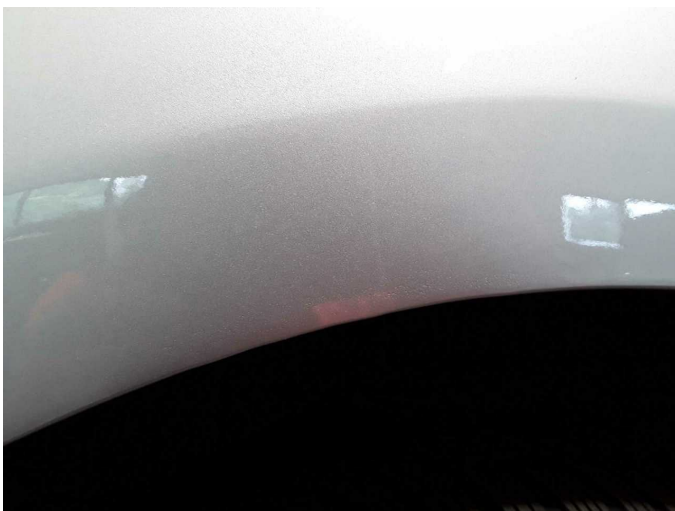
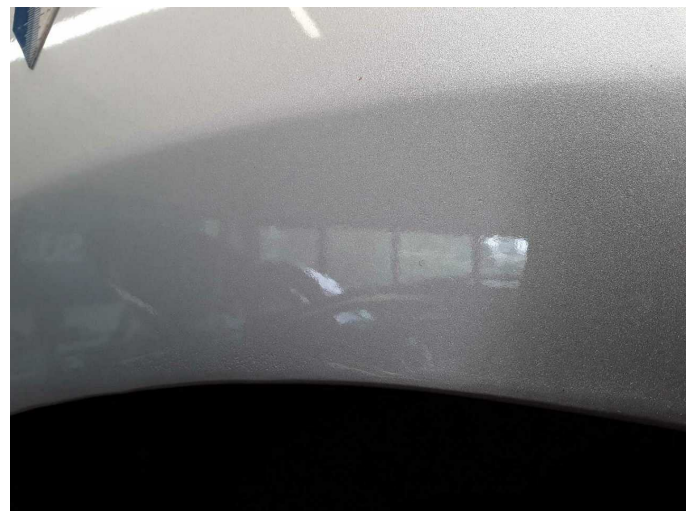
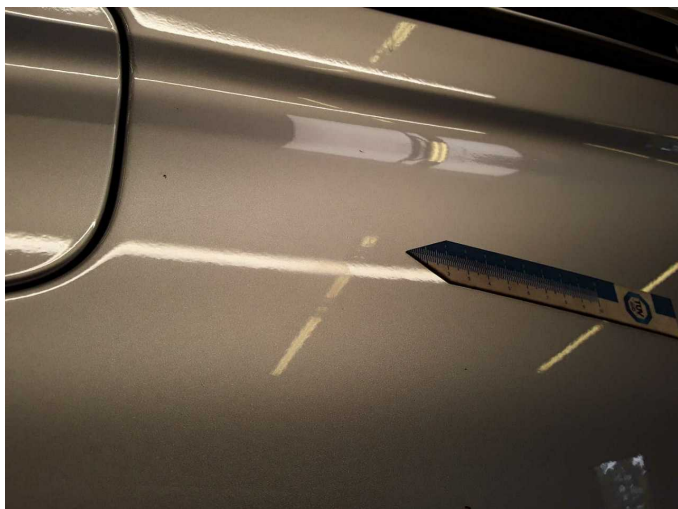
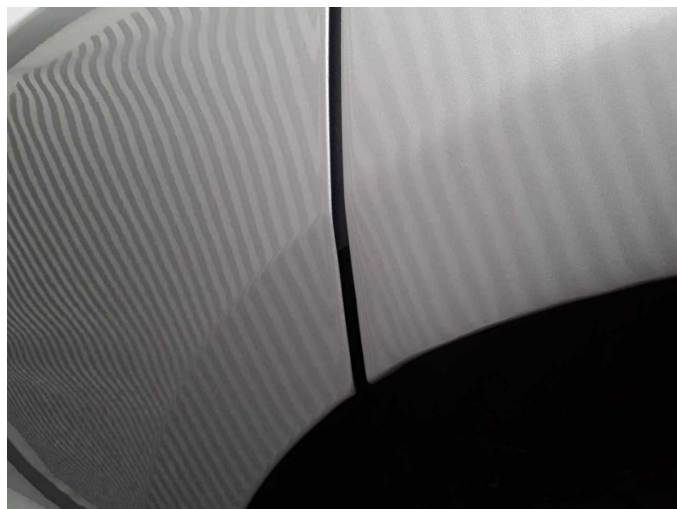
| Boot lid / rear door | 197 µm | Side panel - rear left side | 722 µm |

**Damage 6:** Side panel - rear left side: Side panel (Schleifspuren, wellig) - Unprofessionally repaired - Repair and paint

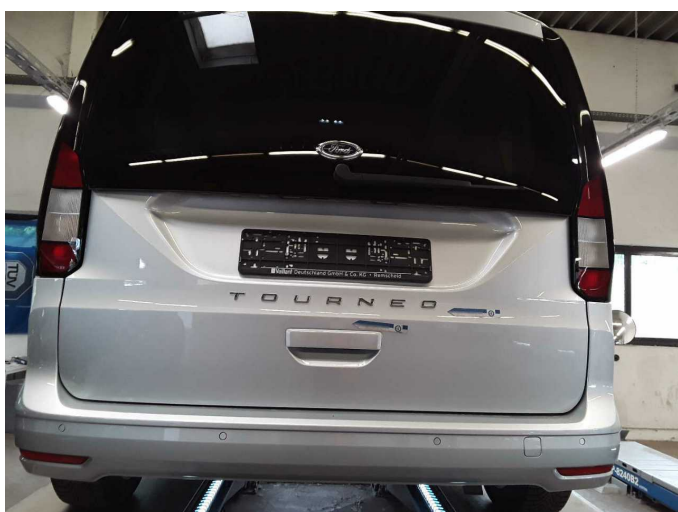
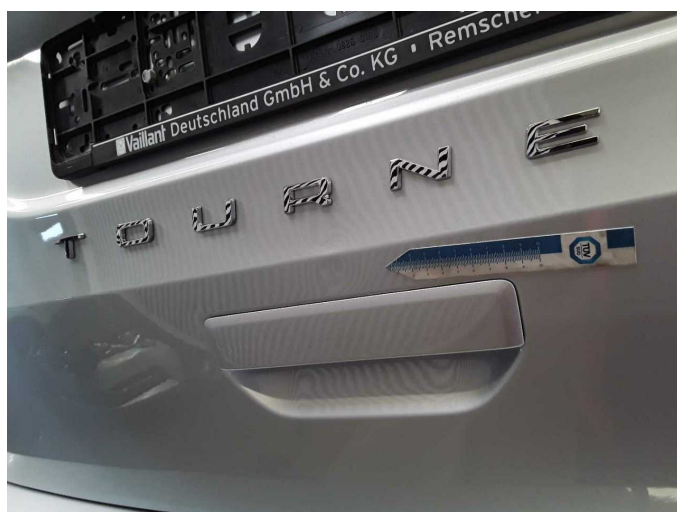
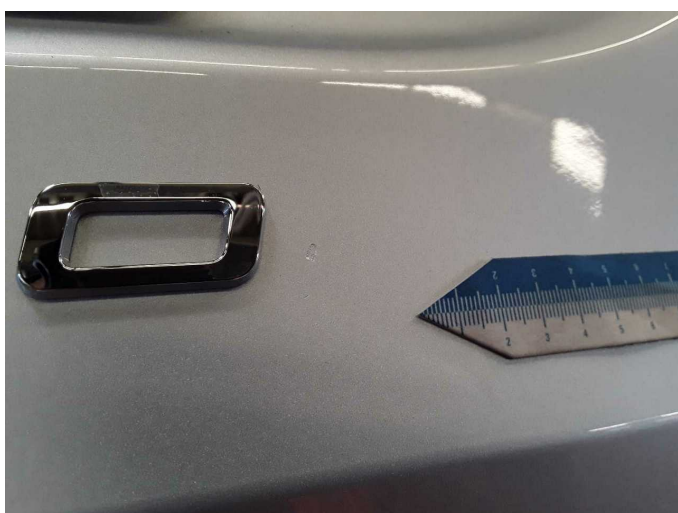
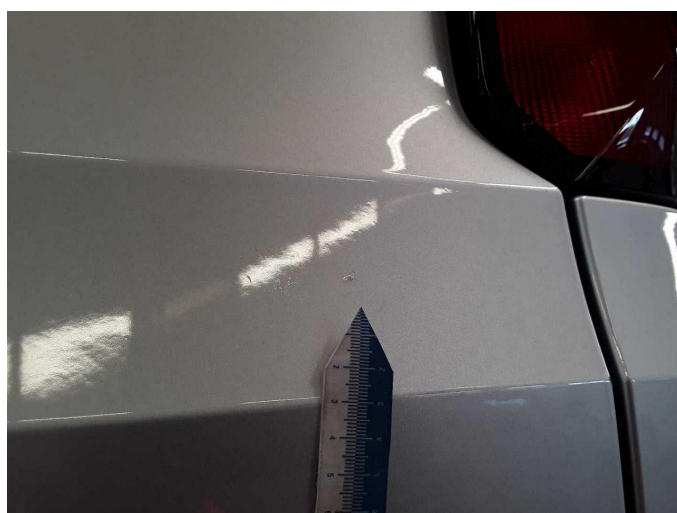
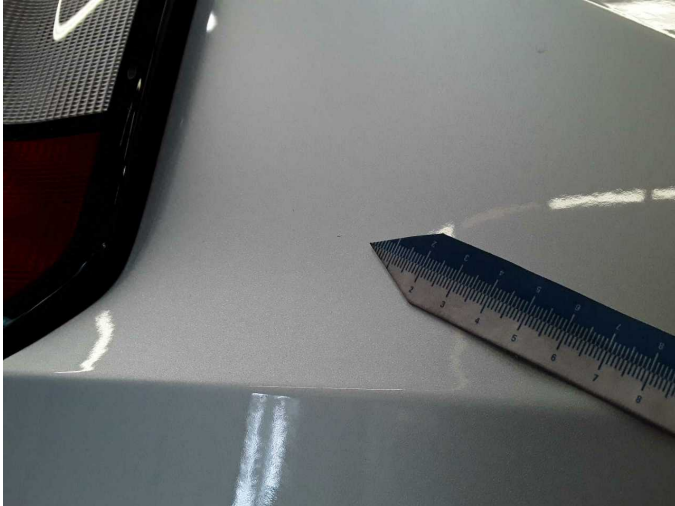
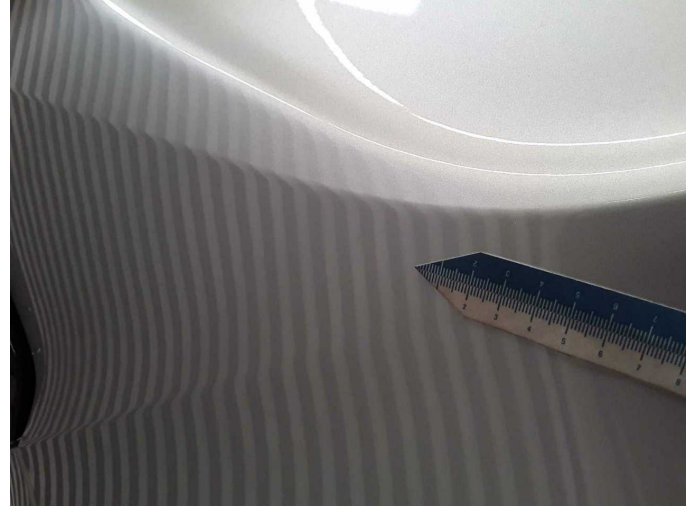
**Damage 7:** Boot lid / rear door: Boot lid - Dent / paintcoat damage - Repair and paint

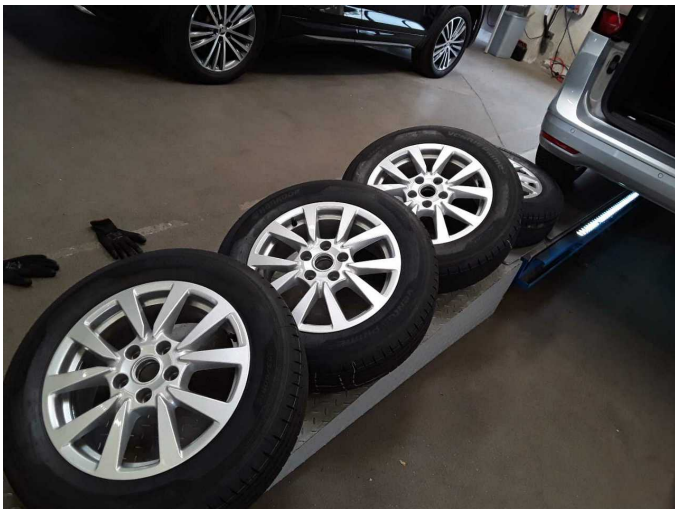
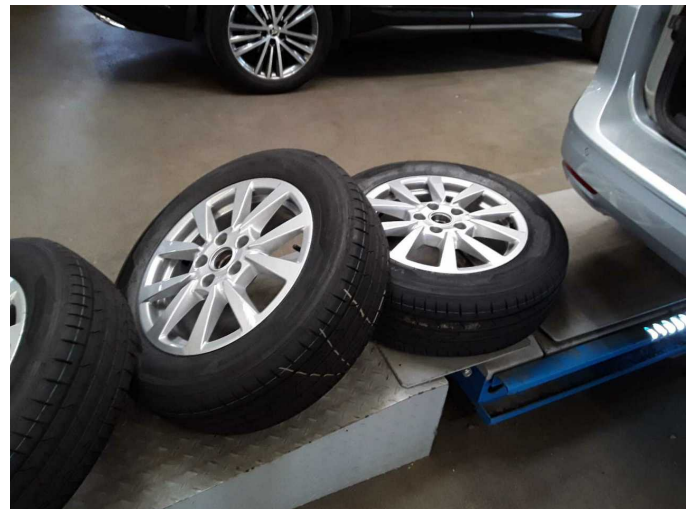
**Missing part 1:** 2nd wheel set: Wheel cover set - complete - Missing - Replace

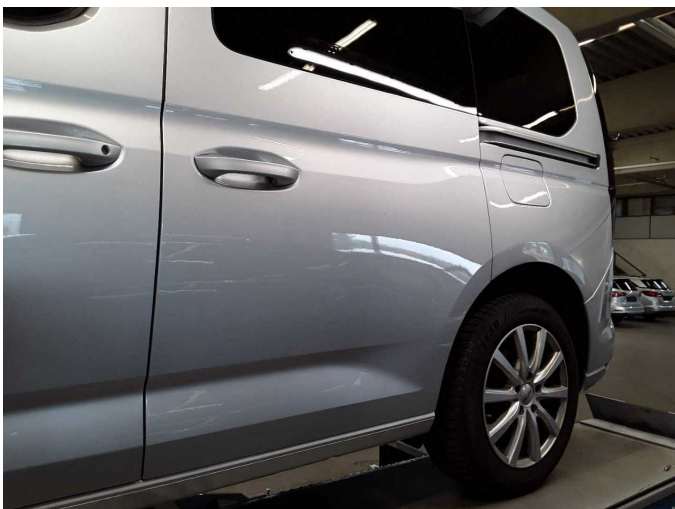
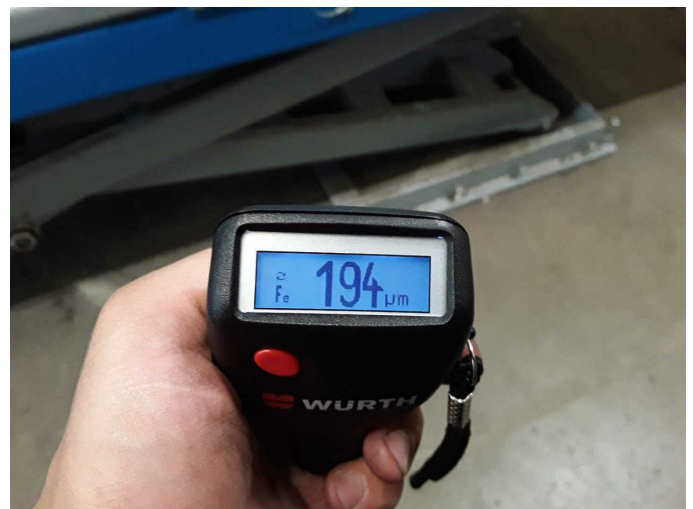
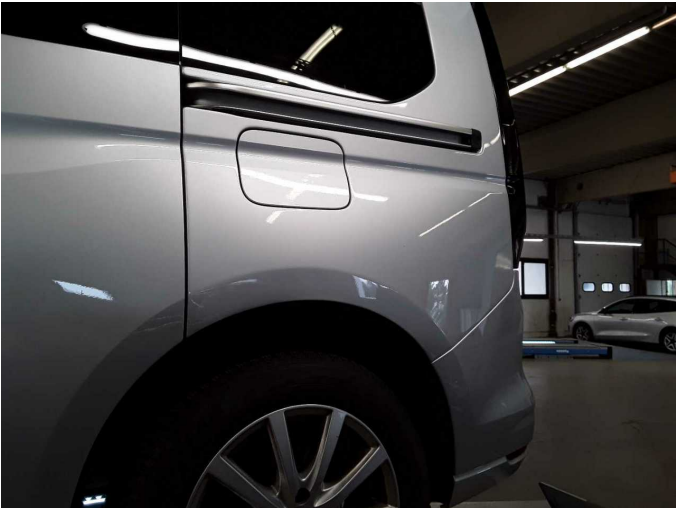
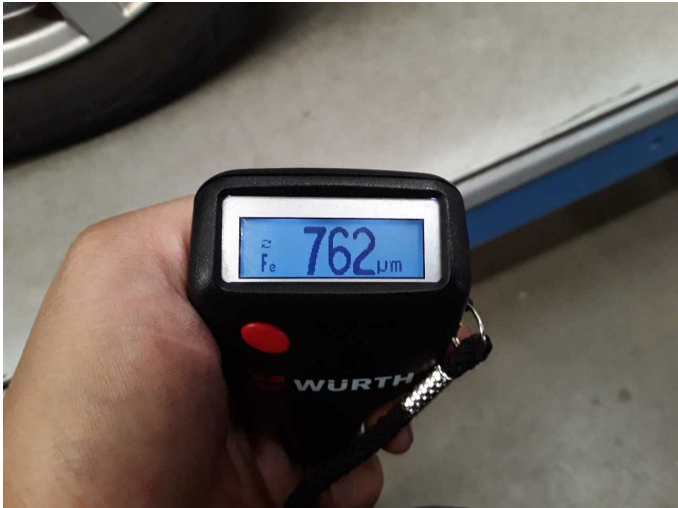
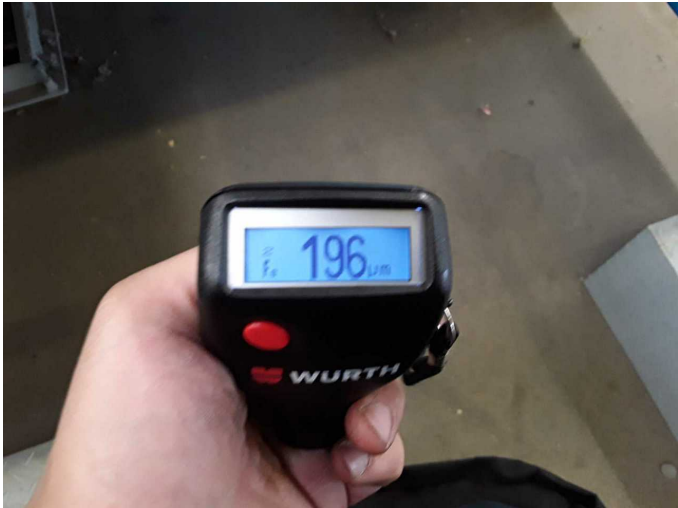
**Repainting 1:** Boot lid / rear door, Side panel - rear left side, Door - rear left side
