Expertise

Protocol number: 46385288  
Order No. / Reference: 26512547  
Inspection date: 2 Jul 2026

Manufacturer: Skoda  
VIN: TMBJC7NY9NF019119

Model: Enyaq iV 80

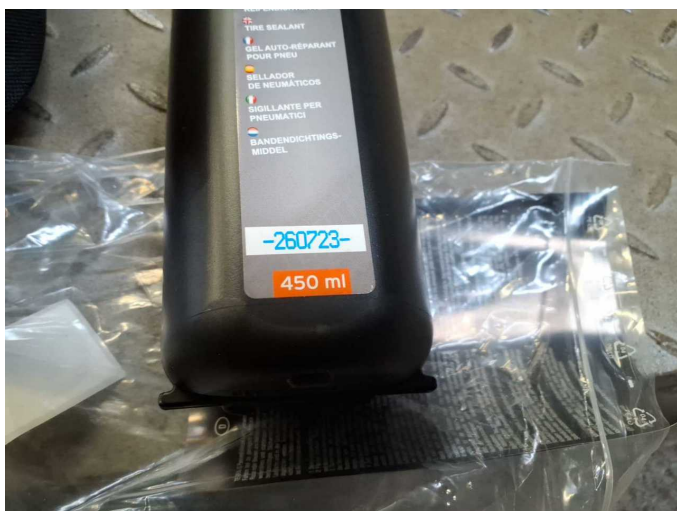
| No. | Component group | Description |
|---|---|---|
| 1 | Equipment | Tirefit filler - Expired - Replace |

Damage 1: Equipment: Tirefit filler - Expired - Replace

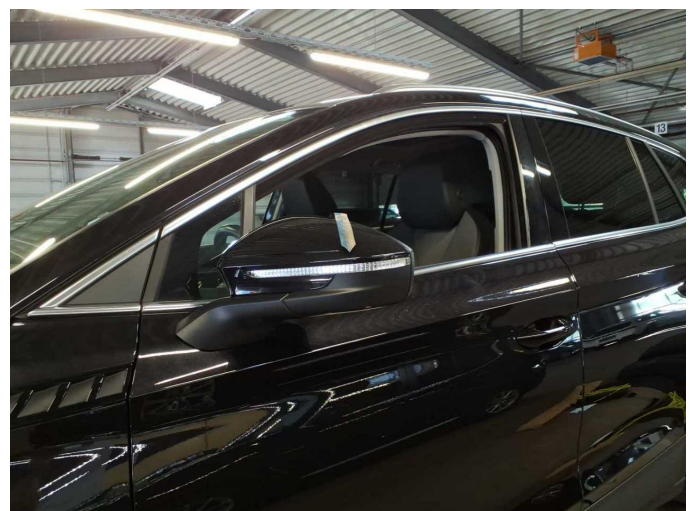
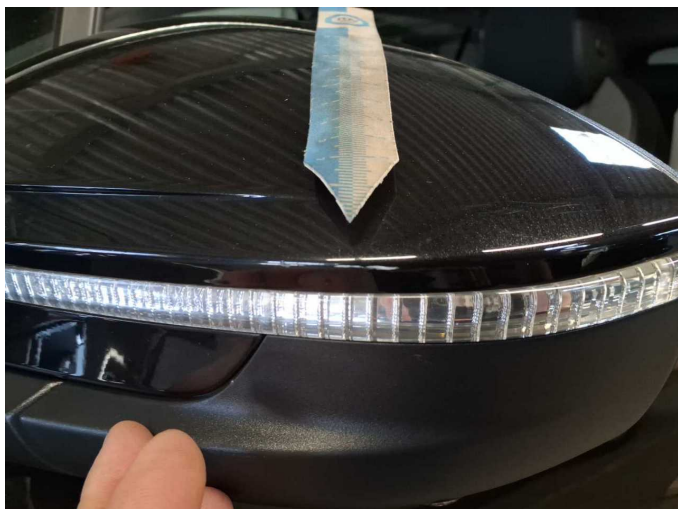
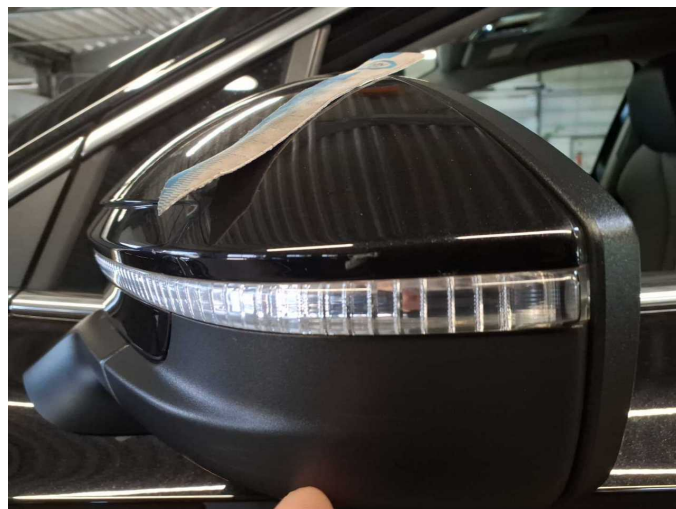
| No. | Component group | Description |
|---|---|---|
| 2 | Wing mirror - left side | Cap - Scratch(es) - Smart repair |

Damage 2: Wing mirror - left side: Cap - Scratch(es) - Smart repair

**Damage 2:** Wing mirror - left side: Cap - Scratch(es) - Smart repair

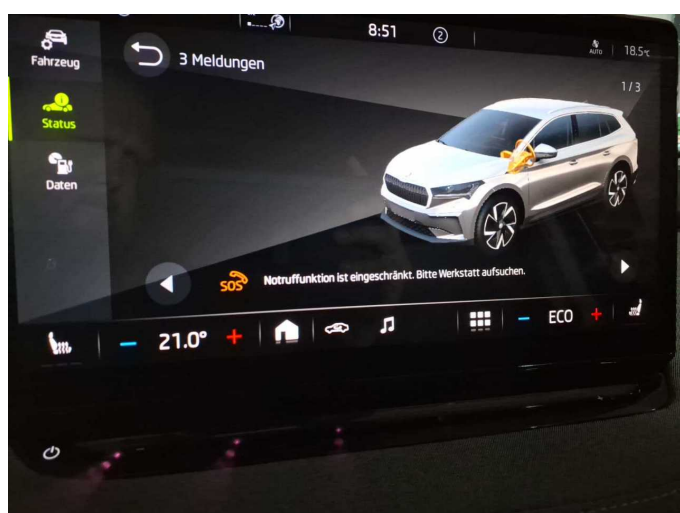
| No. | Component group | Description |
|---|---|---|
| 3 | Electronic systems | Electronic systems (SOS) - Non-operational - Perform diagnosis |

**Damage 3:** Electronic systems: Electronic systems (SOS) - Non-operational - Perform diagnosis

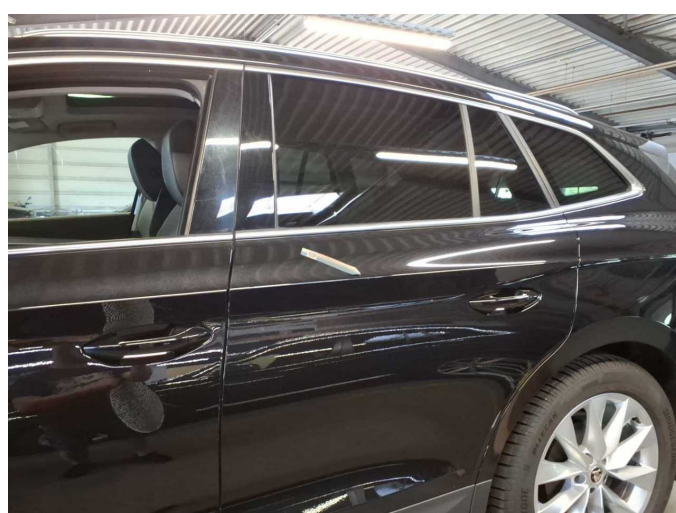
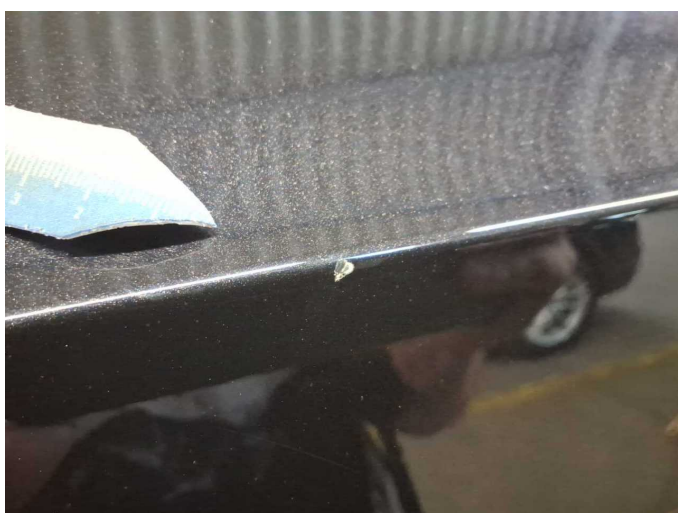
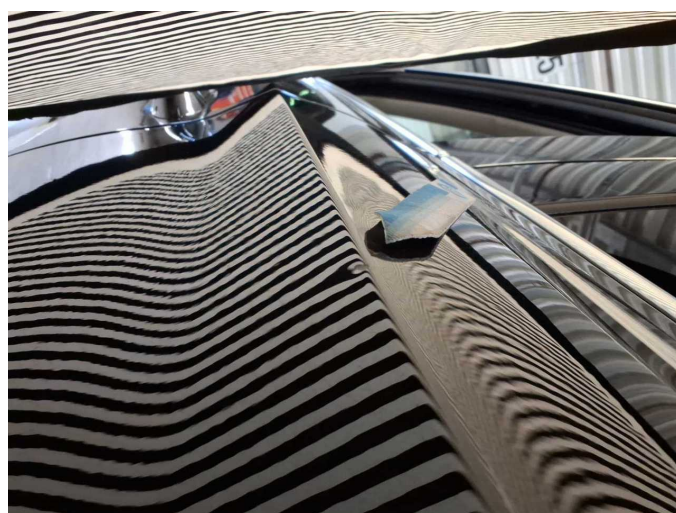
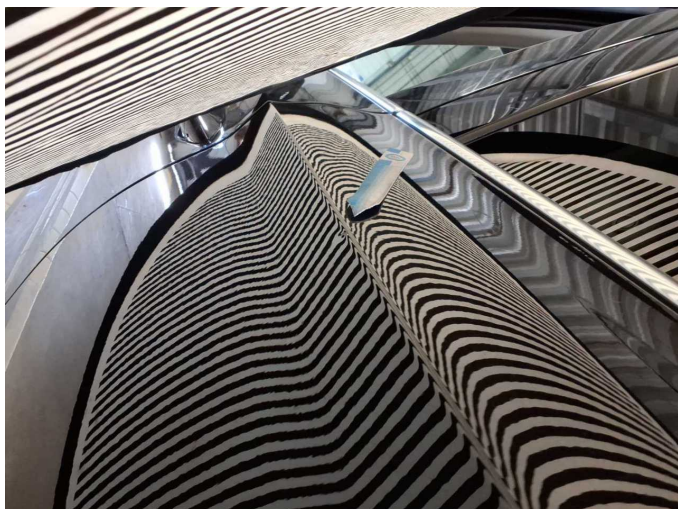
| No. | Component group | Description |
|---|---|---|
| 4 | Door - rear left side | Door - Dent / paintcoat damage - Smart repair |

**Damage 4:** Door - rear left side: Door - Dent / paintcoat damage - Smart repair

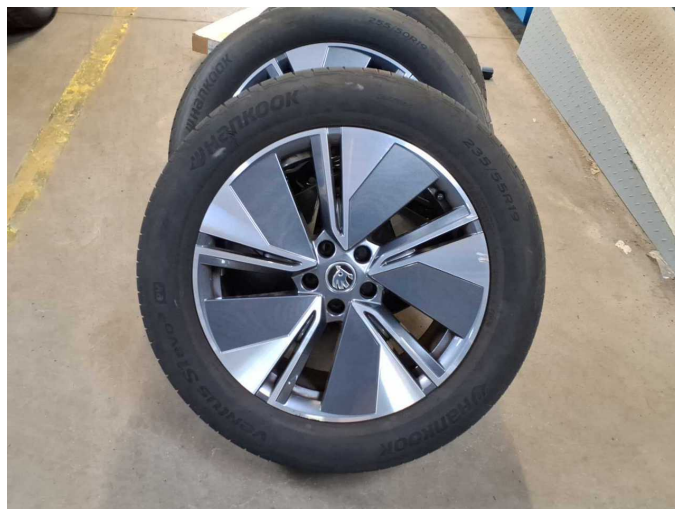
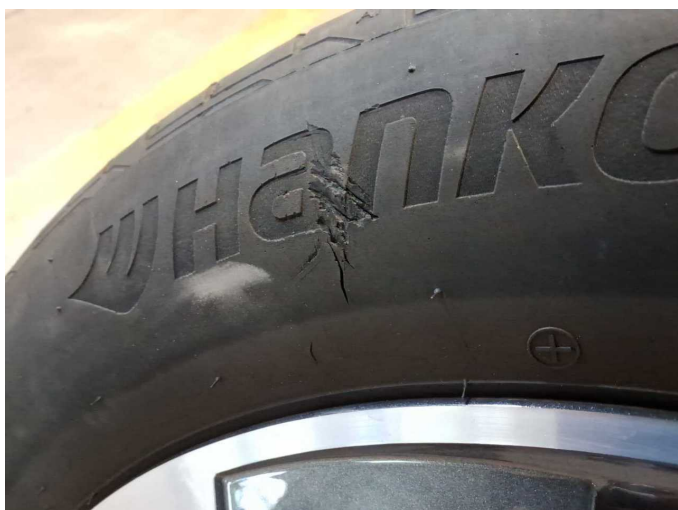
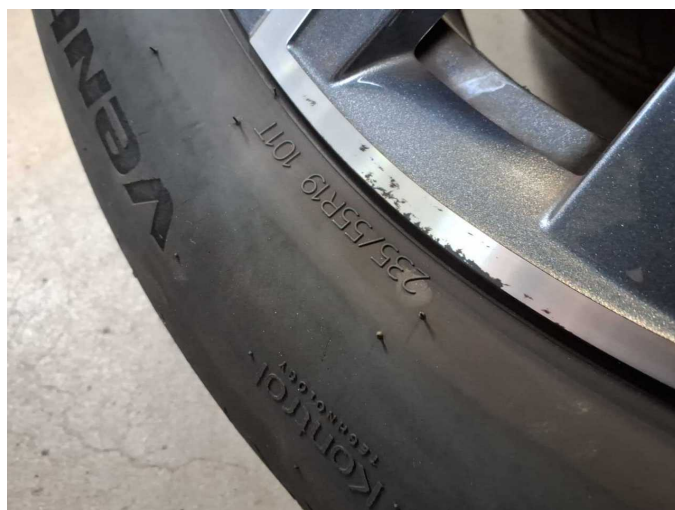
| No. | Component group | Description |
|---|---|---|
| 5 | 2nd wheel set | 1 tyre (Flanke) - Damaged - Replace |

**Damage 5:** 2nd wheel set: 1 tyre (Flanke) - Damaged - Replace

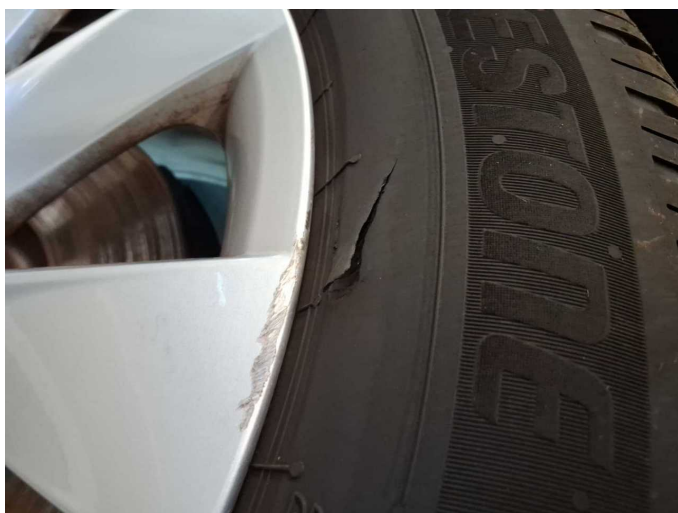
| No. | Component group | Description |
|---|---|---|
| 6 | Wheel / tyres | Tyre - front right side (nicht fahrbereit,) - Damaged - Replace |

**Damage 6:** Wheel / tyres: Tyre - front right side (nicht fahrbereit.) - Damaged - Replace

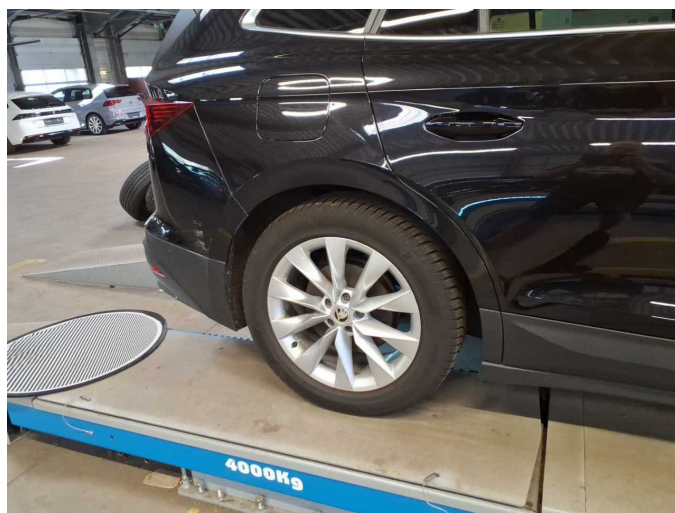
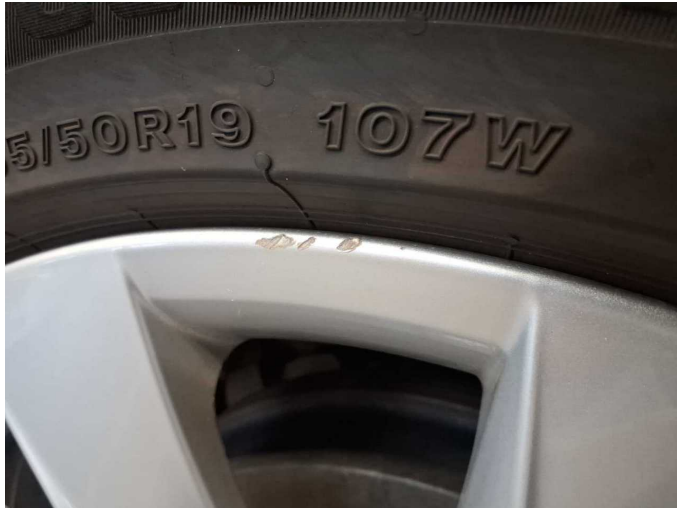
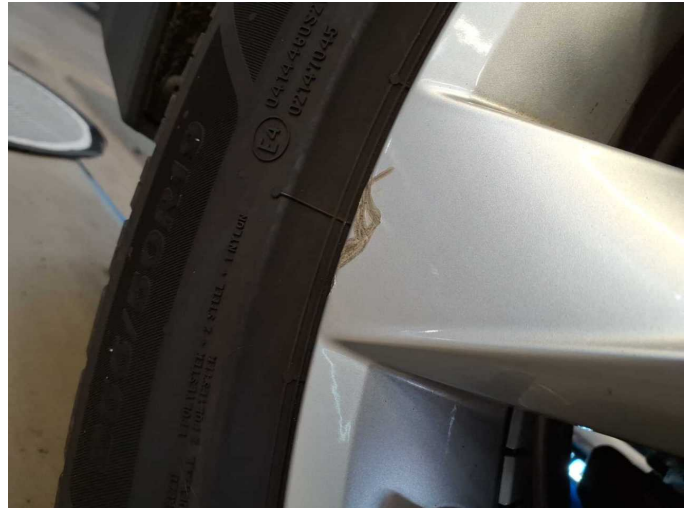
| No. | Component group | Description |
|---|---|---|
| 8 | Wheel / tyres | Alloy rim - rear right side - Scratch(es) - Loss in value |

**Damage 8:** Wheel / tyres: Alloy rim - rear right side - Scratch(es) - Loss in value

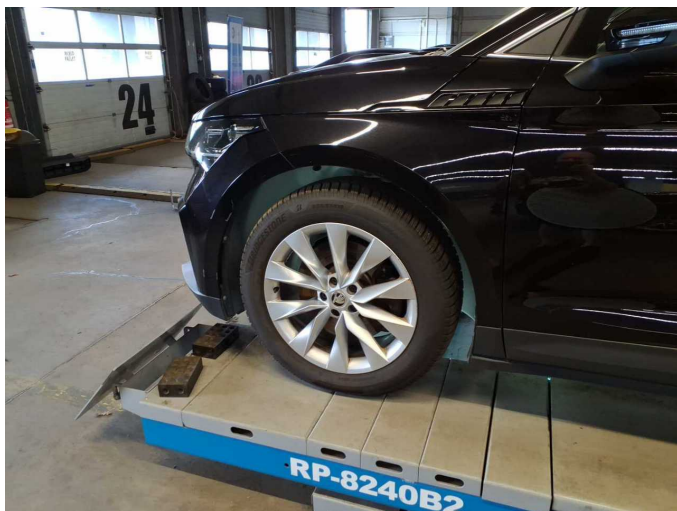
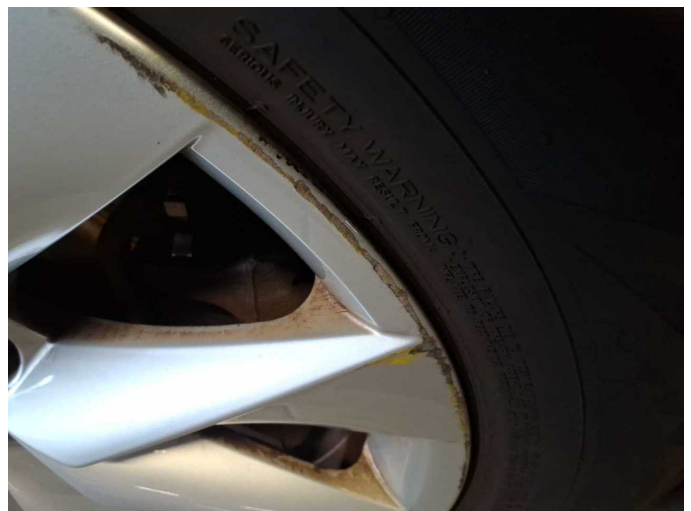
| No. | Component group | Description |
|---|---|---|
| 9 | Wheel / tyres | Alloy rim - front left side - Scratch(es) - Loss in value |

**Damage 9:** Wheel / tyres: Alloy rim - front left side - Scratch(es) - Loss in value

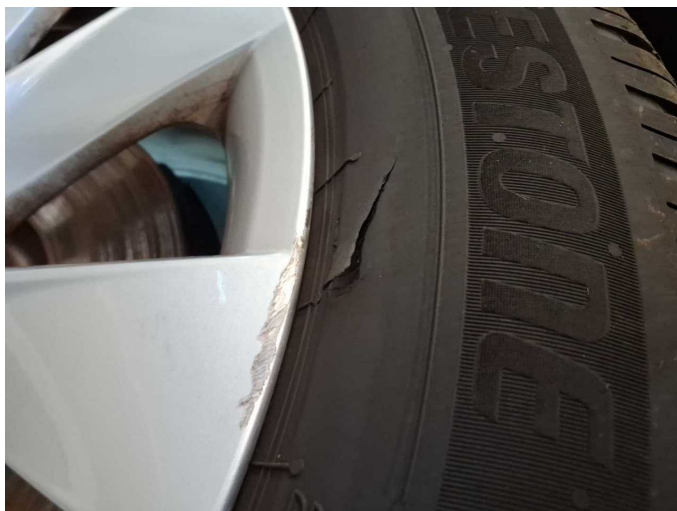
| No. | Component group | Description |
|---|---|---|
| 10 | Wheel / tyres | Alloy rim - front right side - Scratched - Loss in value |

**Damage 10:** Wheel / tyres: Alloy rim - front right side - Scratched - Loss in value

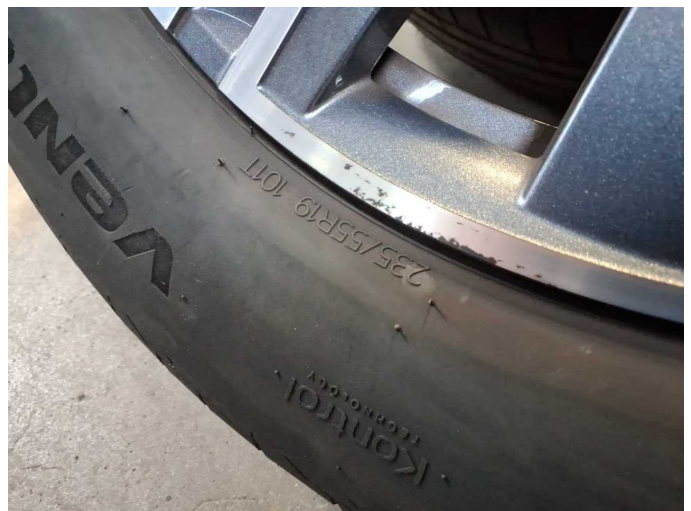
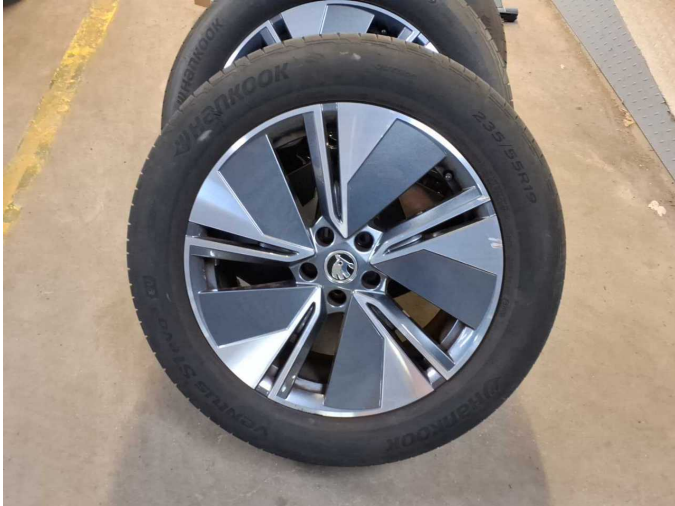
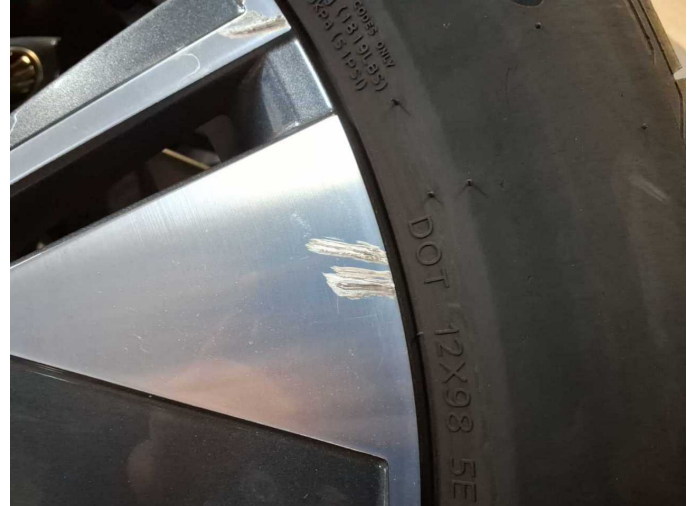
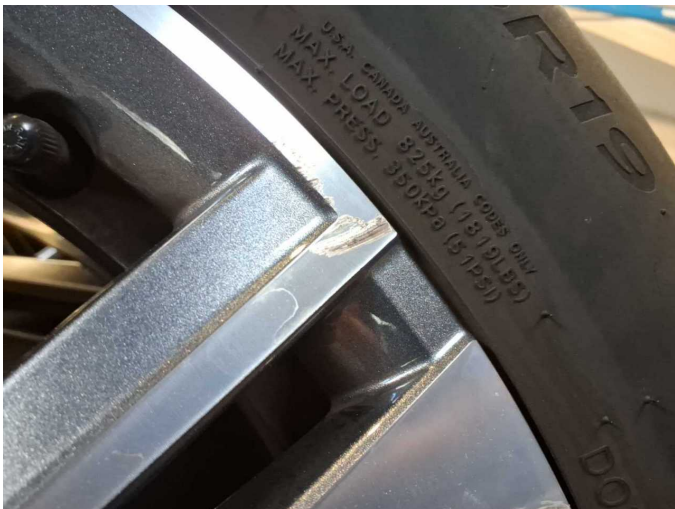
| No. | Component group | Description |
|---|---|---|
| 11 | 2nd wheel set | 1 alloy rim - Scratch(es) - Loss in value |

**Damage 11:** 2nd wheel set: 1 alloy rim - Scratch(es) - Loss in value

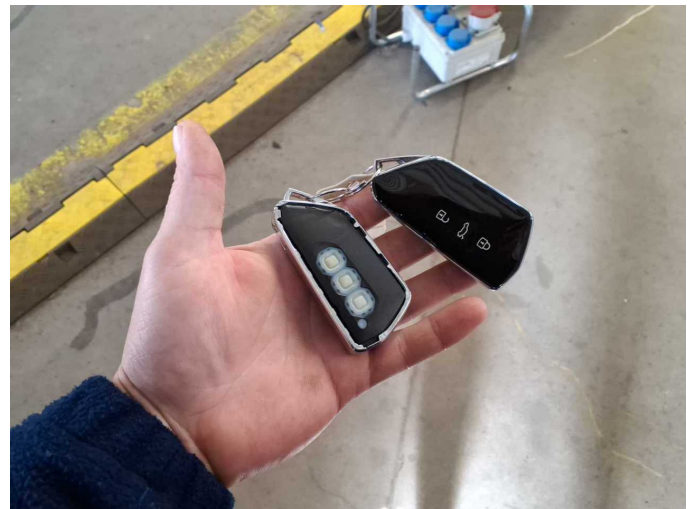
| No. | Component group | Description |
|---|---|---|
| 12 | Equipment | Vehicle key with remote control - Damaged - Replace |

**Damage 12:** Equipment: Vehicle key with remote control - Damaged - Replace

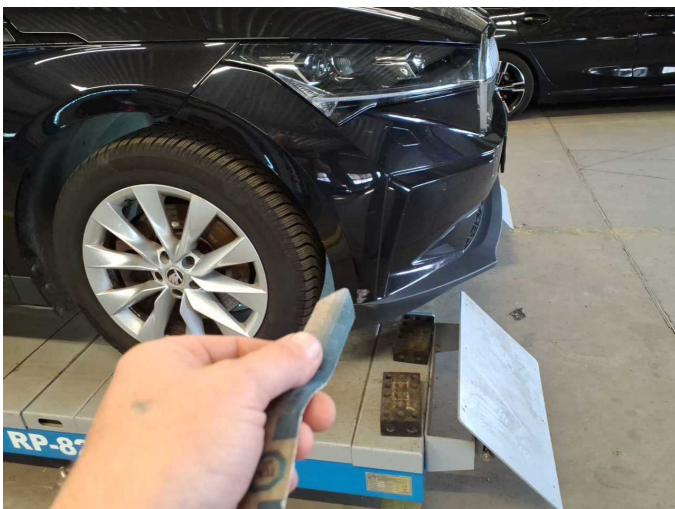
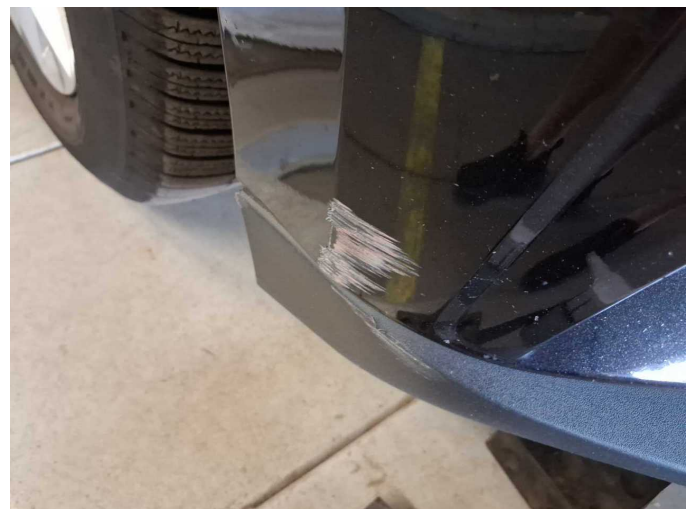
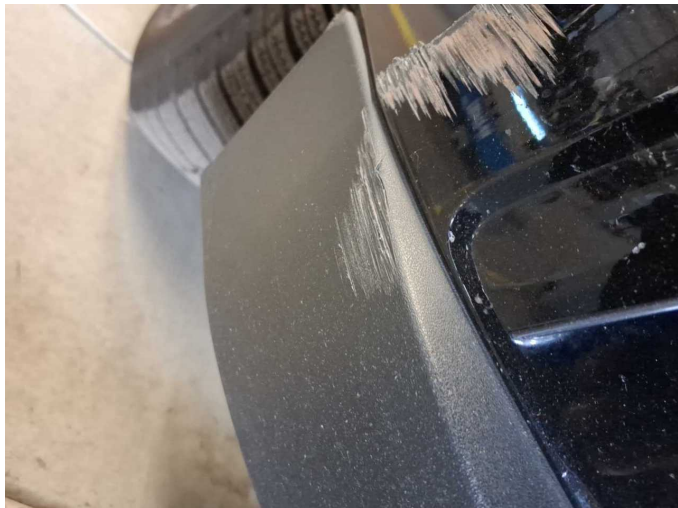
| No. | Component group | Description |
|---|---|---|
| 13 | Front bumper | Spoiler - Scratched - Replace |

**Damage 13:** Front bumper: Spoiler - Scratched - Replace

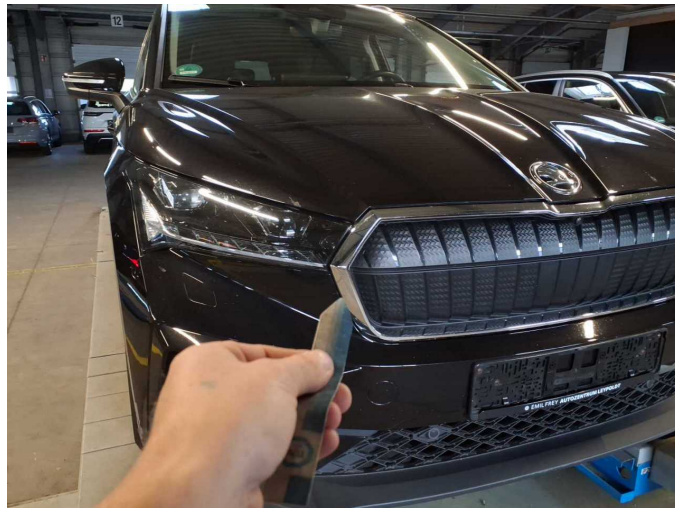
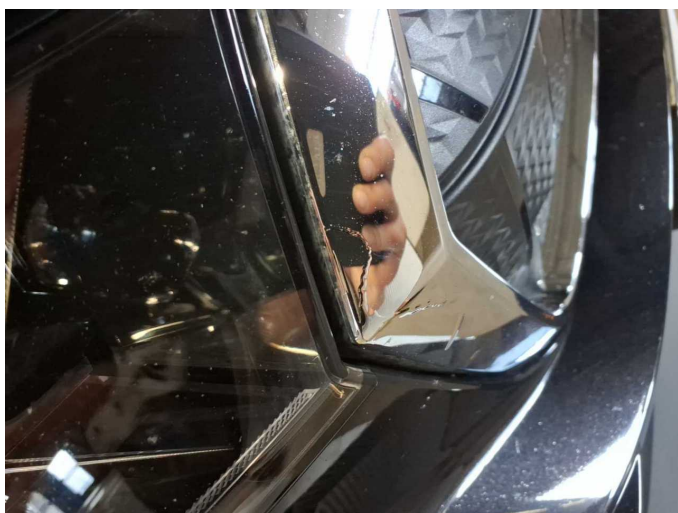
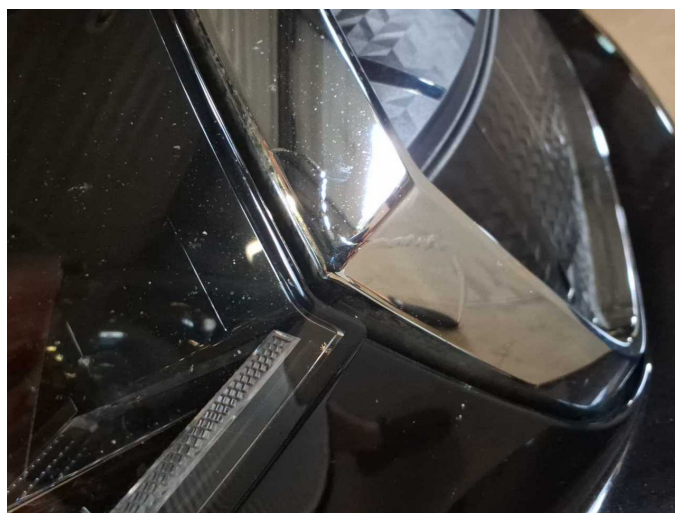
| No. | Component group | Description |
|---|---|---|
| 14 | Bonnet | Radiator grille (Rahmen) - Paint defect - Replace |

**Damage 14:** Bonnet: Radiator grille (Rahmen) - Paint defect - Replace

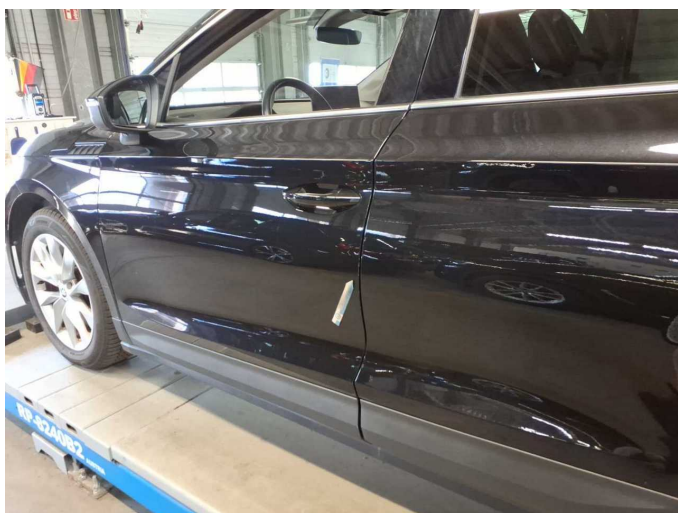
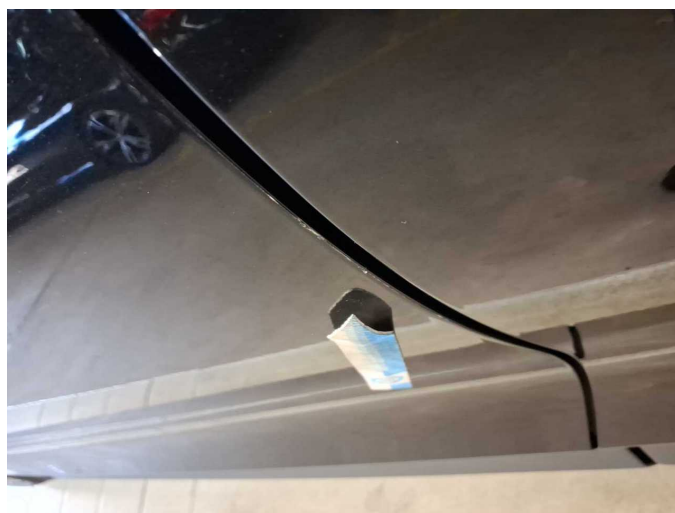
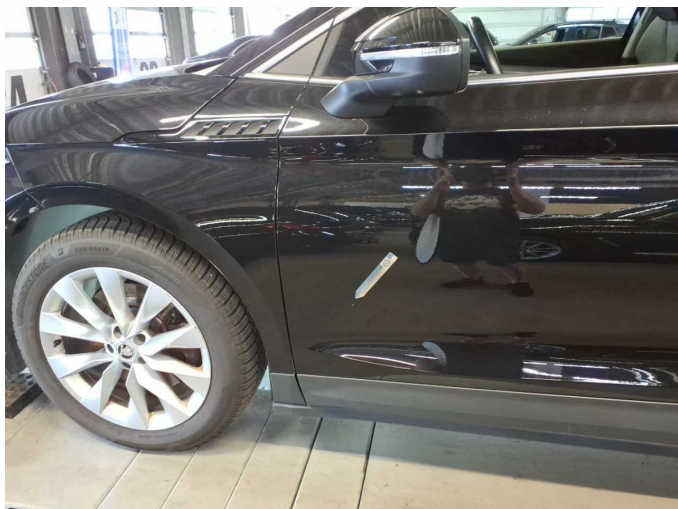
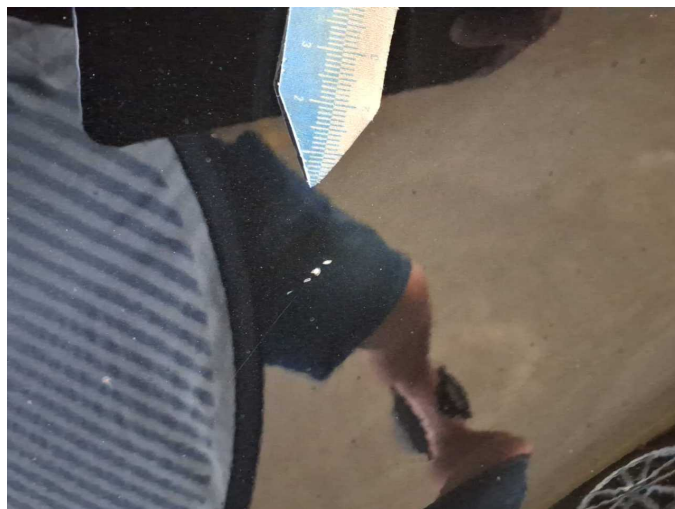
| No. | Component group | Description |
|---|---|---|
| 15 | Door - front left side | Door - Scratch(es) - Paint |

**Damage 15:** Door - front left side: Door - Scratch(es) - Paint

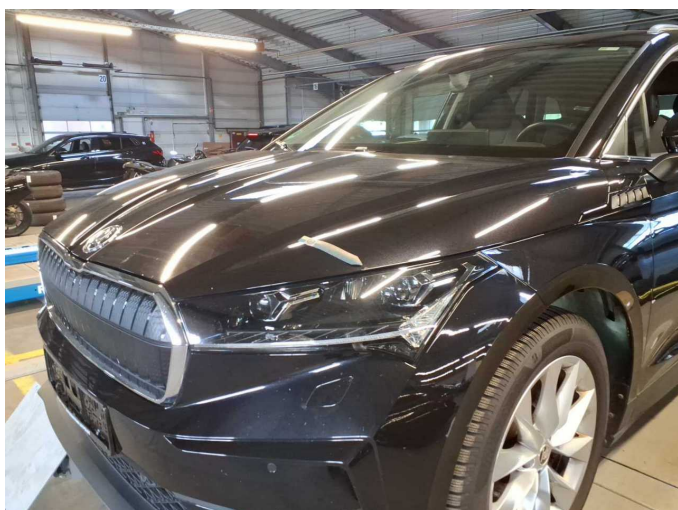
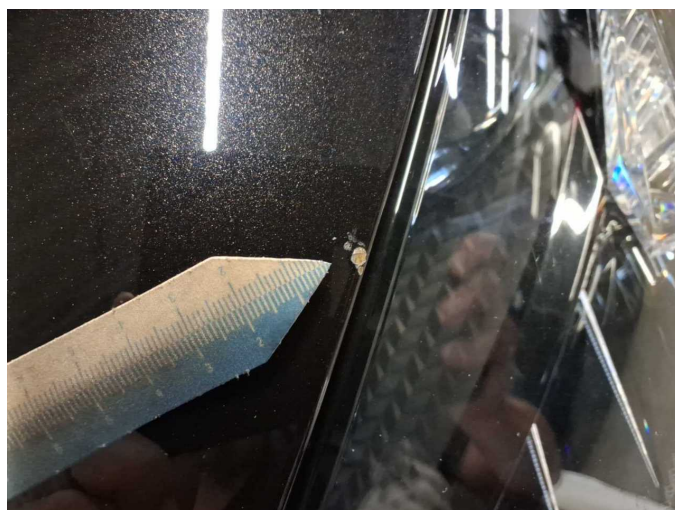
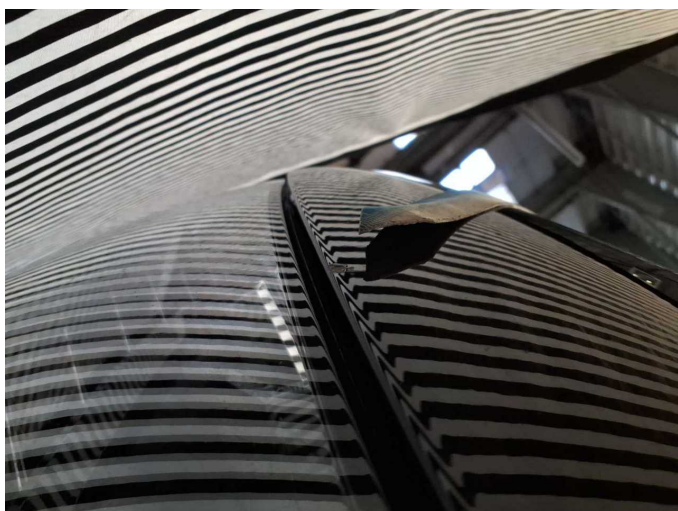
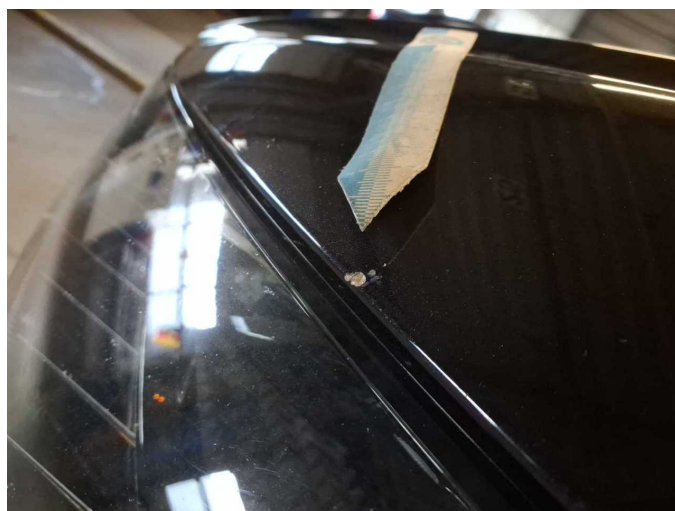
| No. | Component group | Description |
|---|---|---|
| 16 | Bonnet | Bonnet (Rostbildung) - Stone chips - Repair and paint |

**Damage 16:** Bonnet: Bonnet (Rostbildung) - Stone chips - Repair and paint

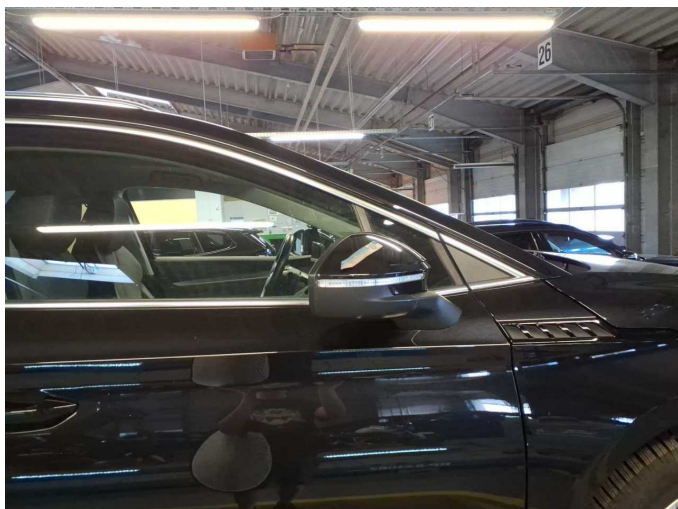
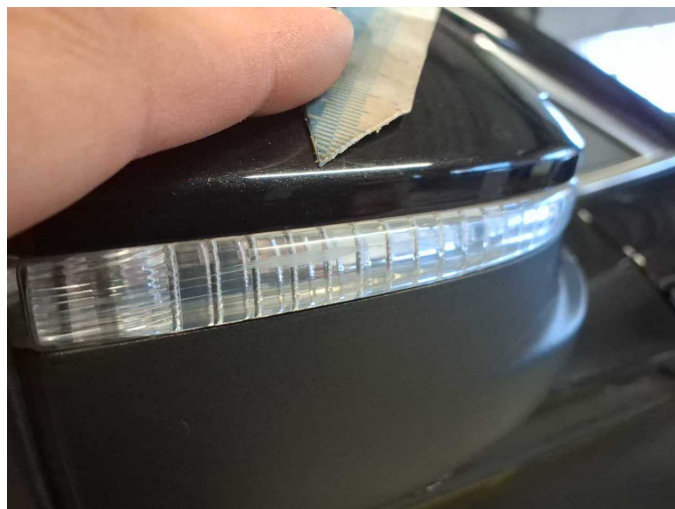
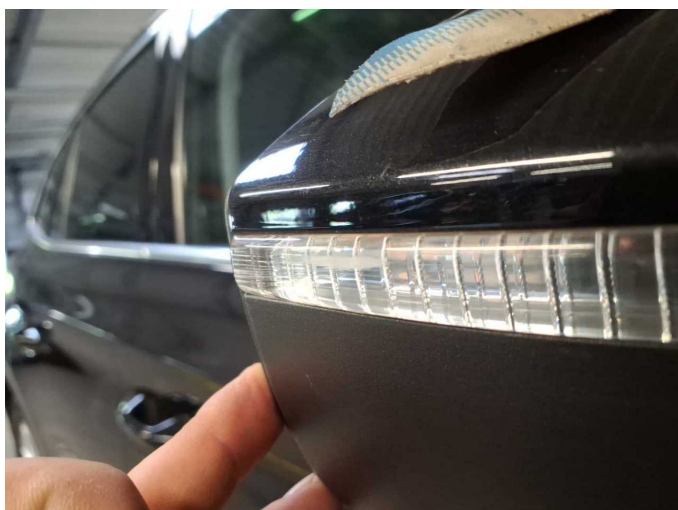
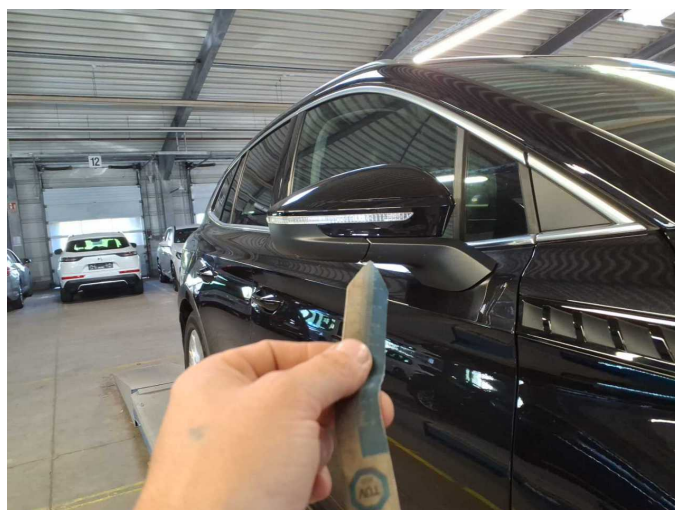
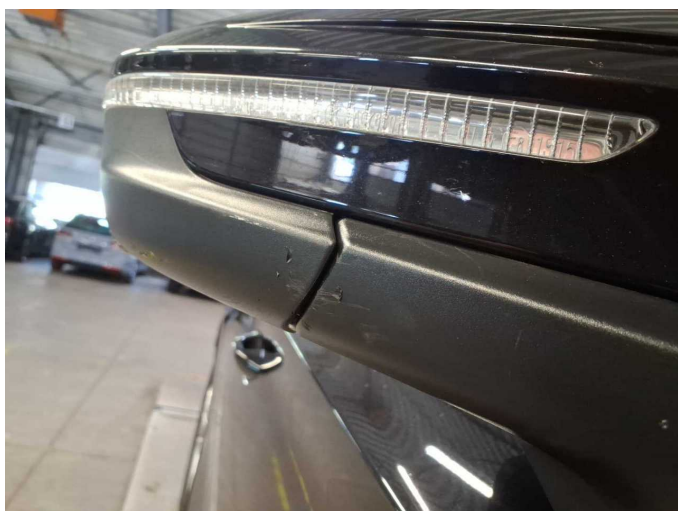
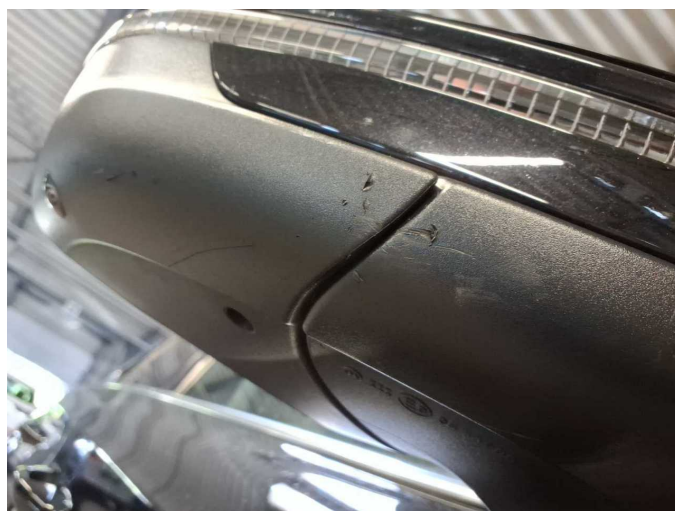
| No. | Component group | Description |
|---|---|---|
| 17 | Wing mirror - right side | Wing mirror - Damaged - repair according to calculation |

**Damage 17:** Wing mirror - right side: Wing mirror - Damaged - repair according to calculation

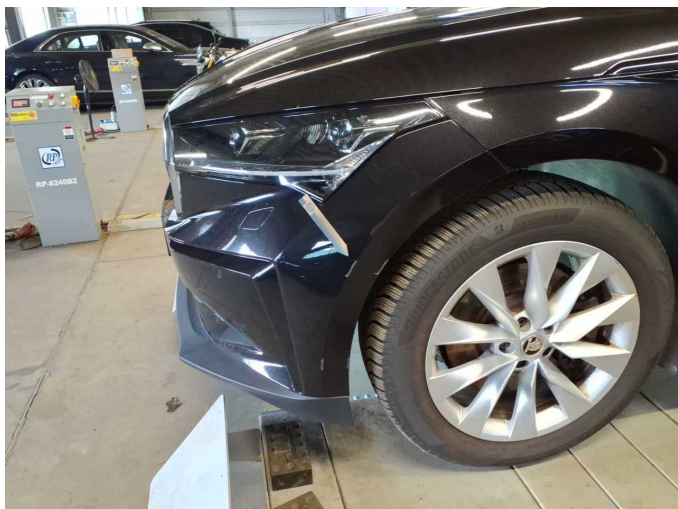
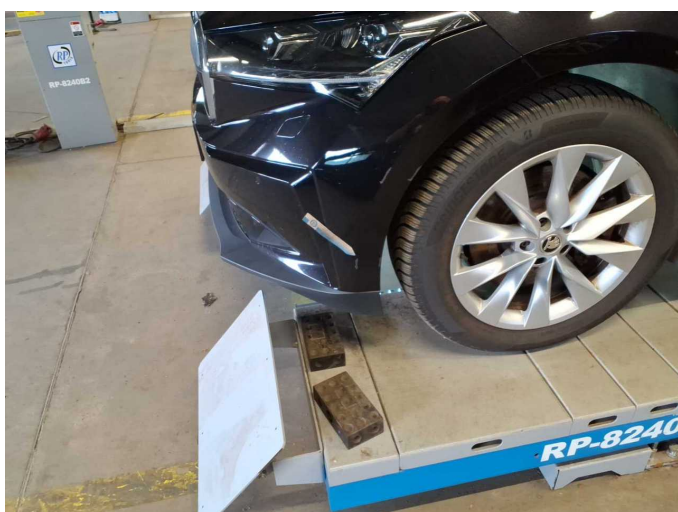
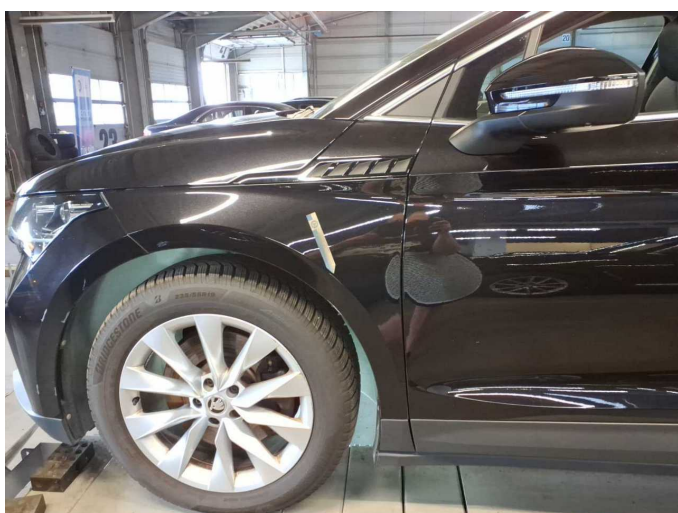
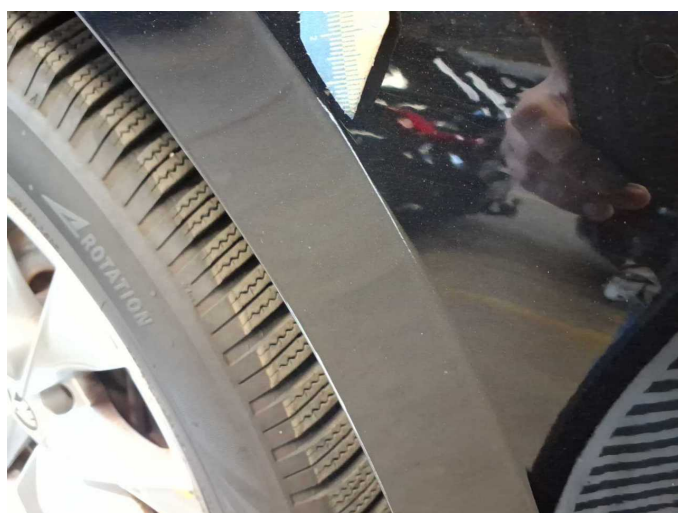
| No. | Accident |
|---|---|
| 1 | Front, Side - left |

**Accident 1: Front, Side - left**

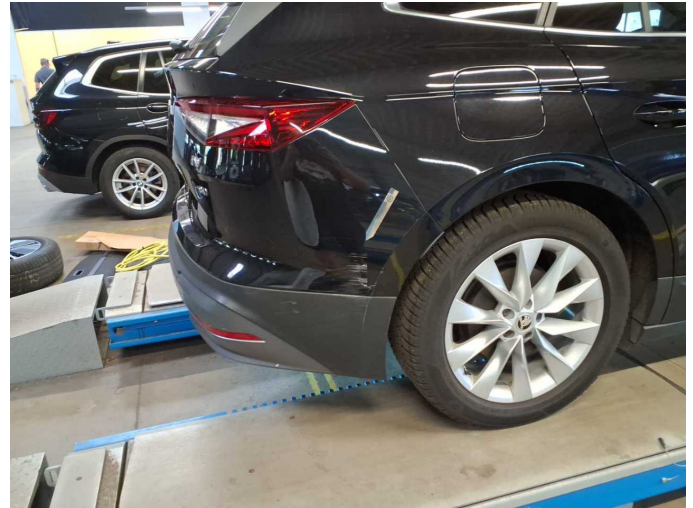
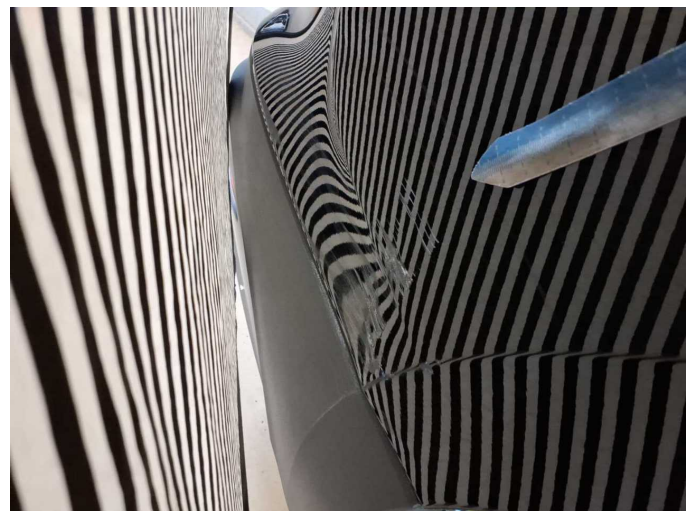
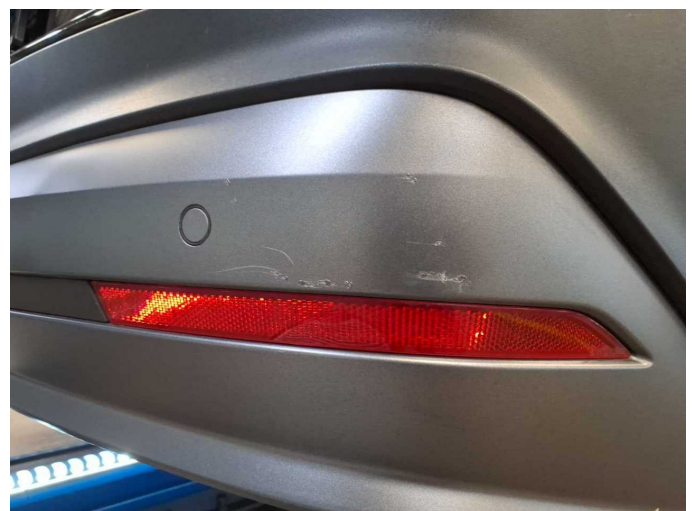
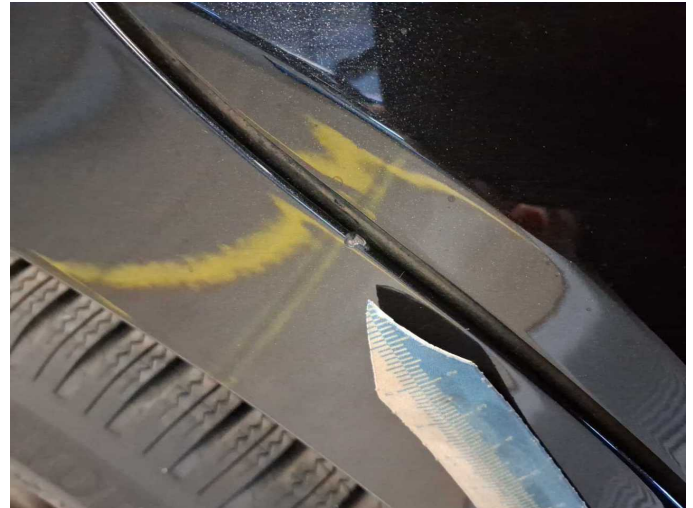
| No. | Accident |
|---|---|
| 2 | Rear, Side right |

**Accident 2:** Rear, Side right
