Expertise

Protocol number: 45470703
Order No. / Reference: 26296220
Inspection date: 6 May 2026

Model: Tiguan 2.0 TDI SCR DSG Elegance

VIN: WVGZZZ5NZMW062891

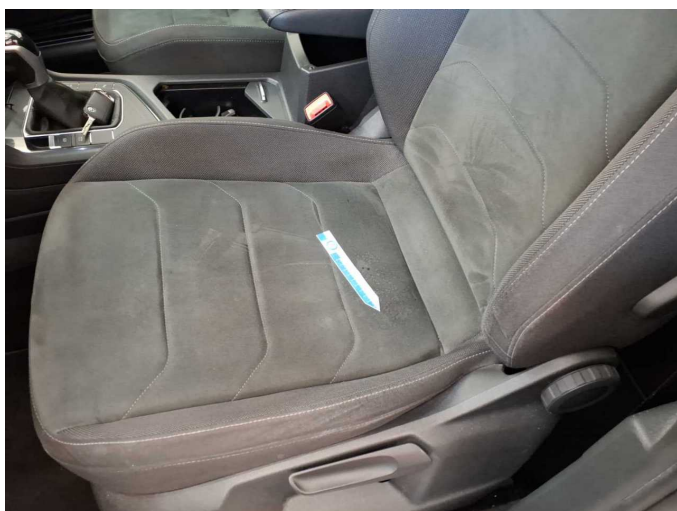
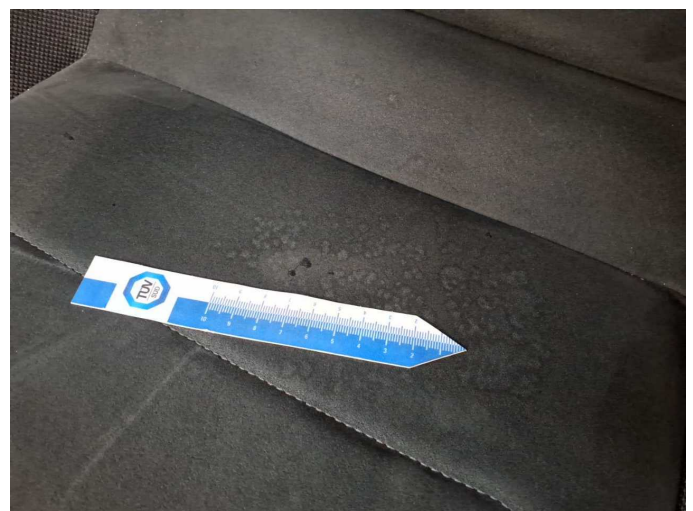
Damage 1: Seat - front: Seat cover - left side - Soiled - Clean

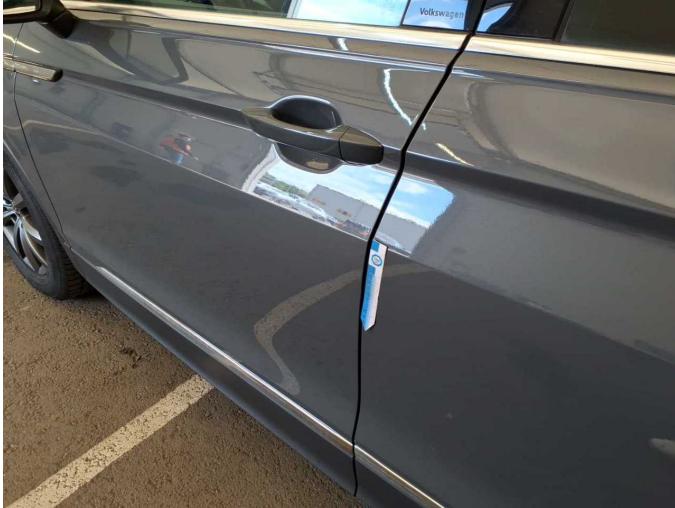
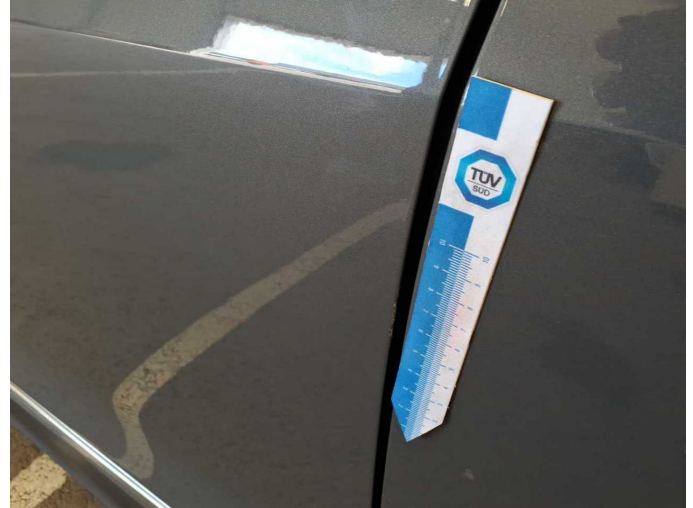
Damage 2: Door - front left side: Door - Scratch(es) - Smart repair

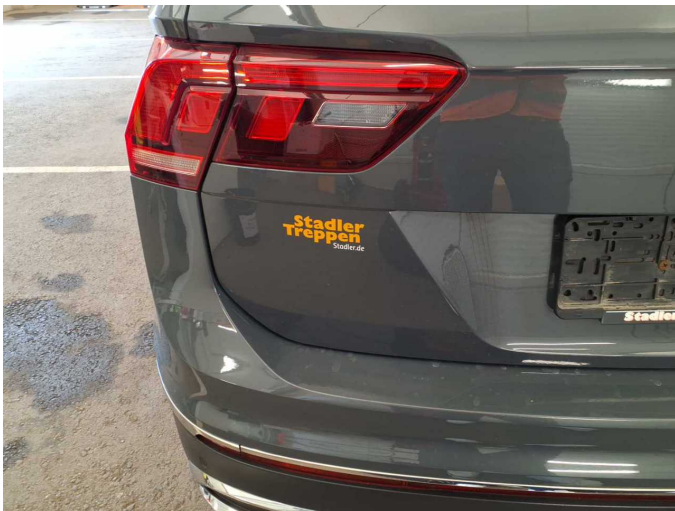
Damage 3: Boot lid / rear door: Boot lid - Glued / labelled - De-glu / neutralise

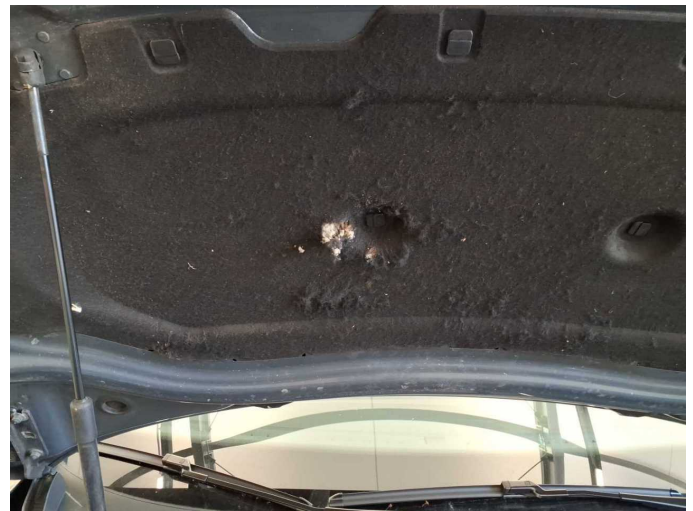
Damage 4: Bonnet: Insulation lining - Damage caused by marten / rodent - Replace

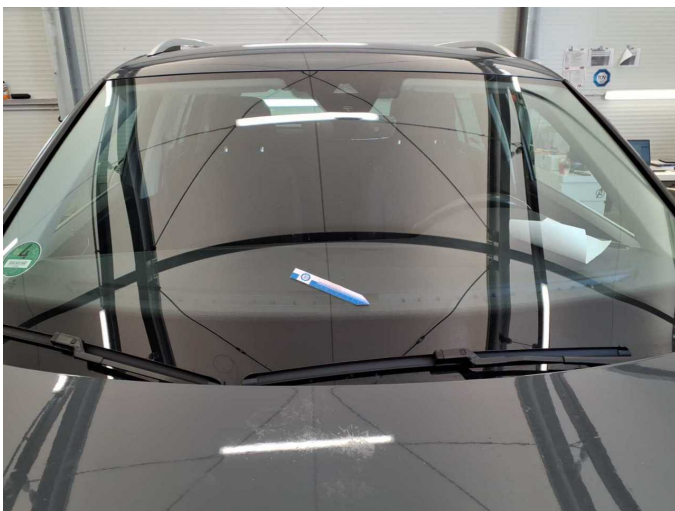
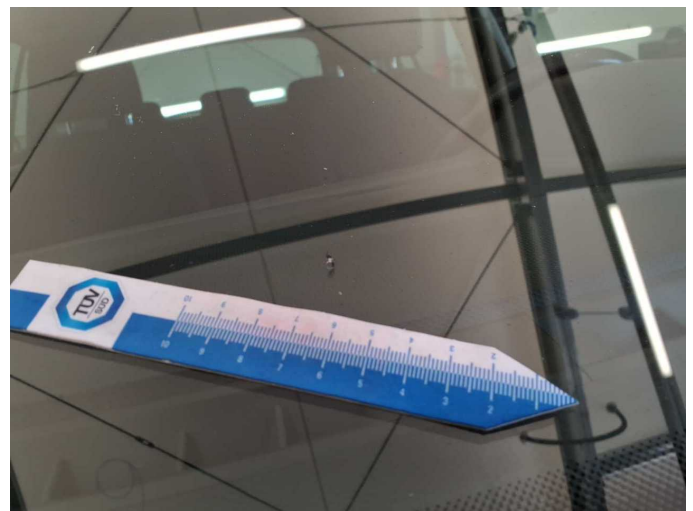
Damage 5: Vehicle glazing: Windscreen - Stone chips - Smart repair

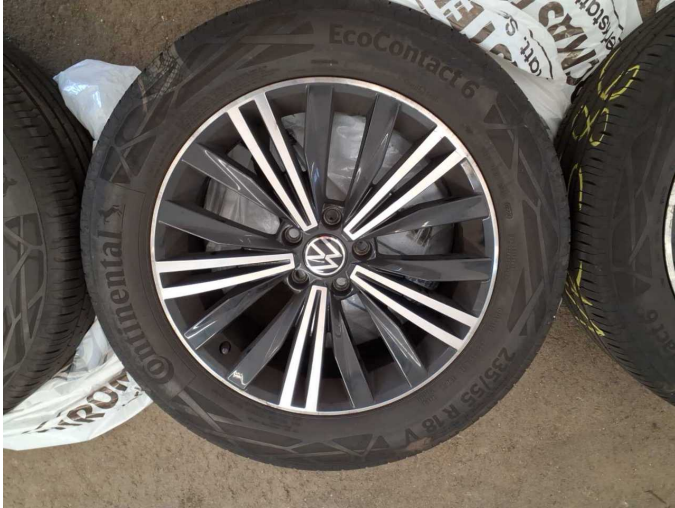
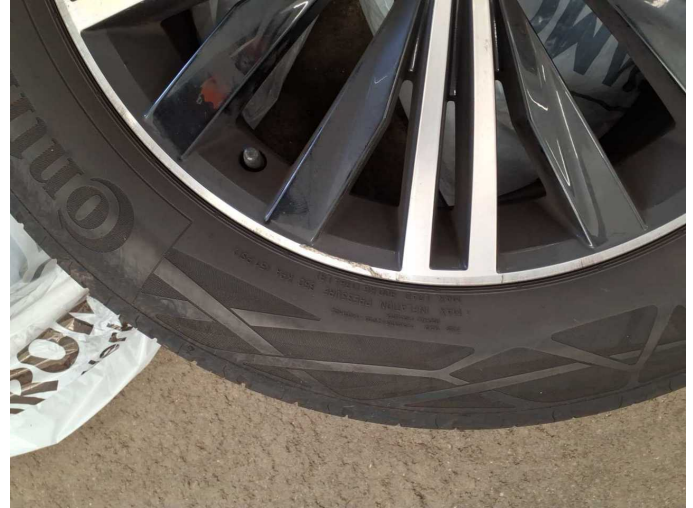
Damage 6: 2nd wheel set: 1 alloy rim - Scratched - Loss in value

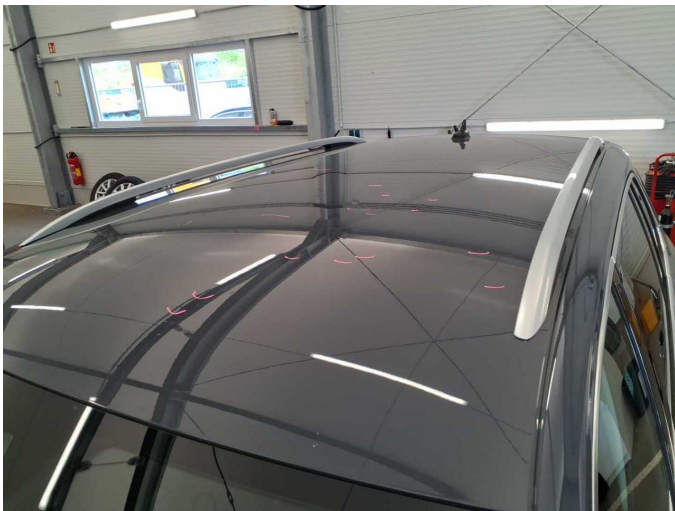
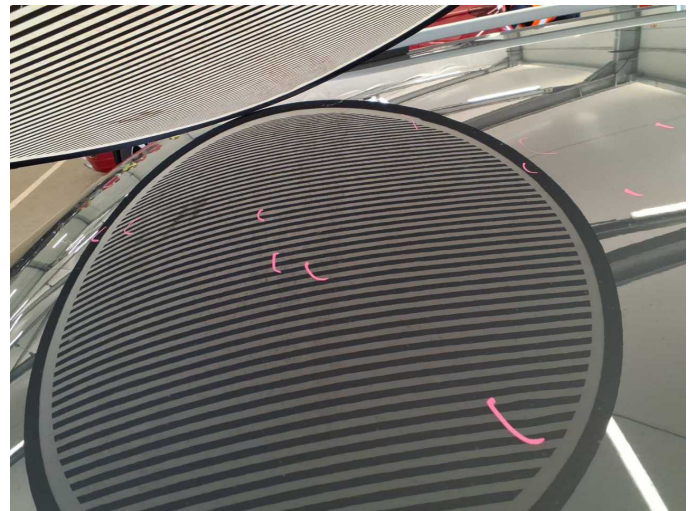
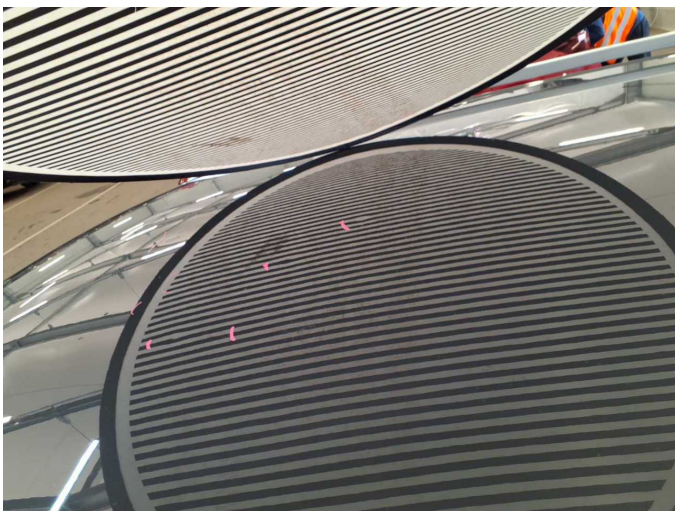
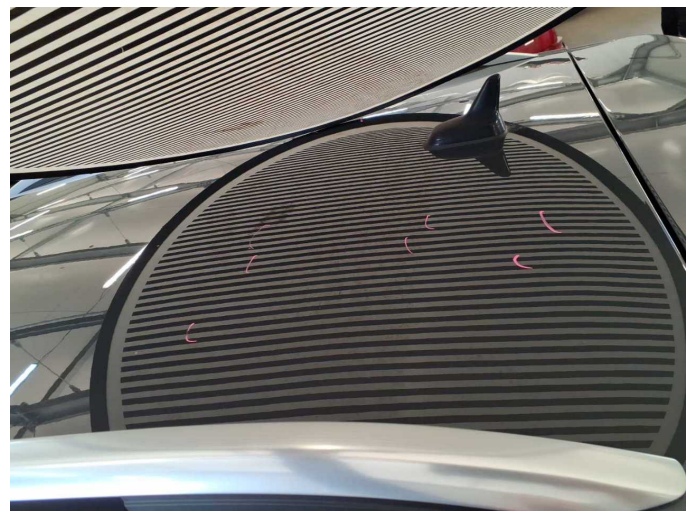
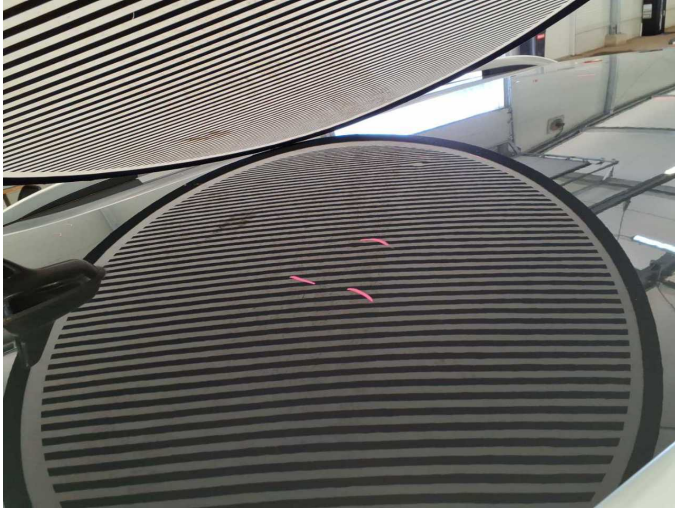
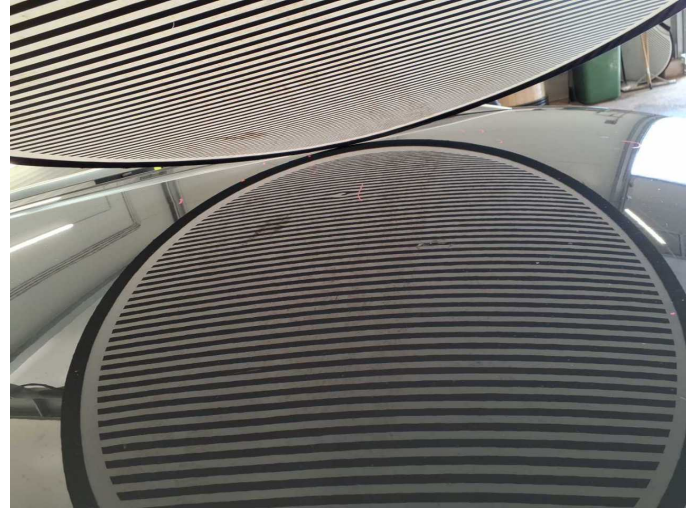
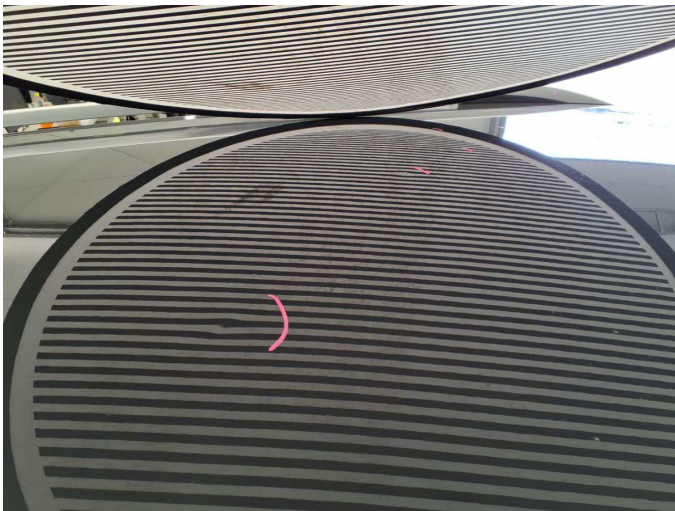
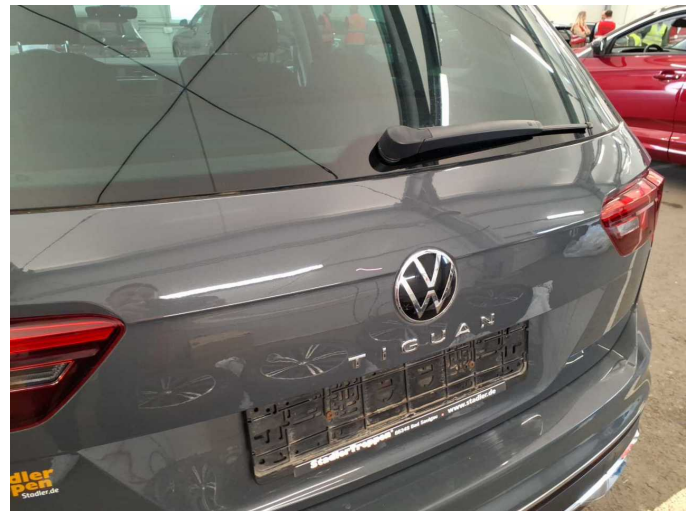
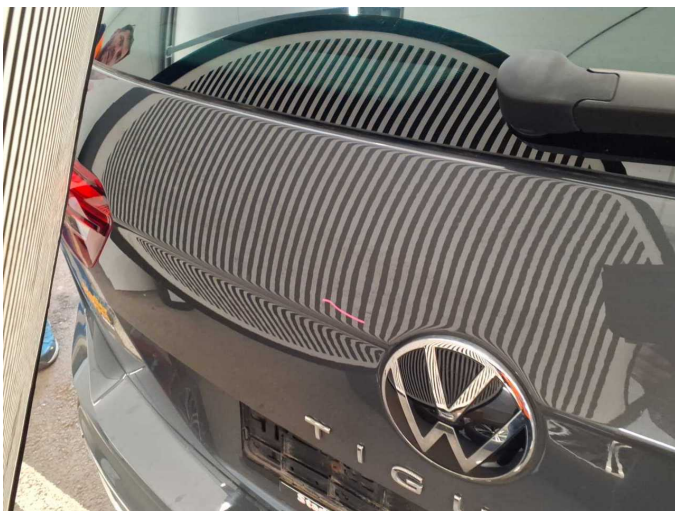
Damage 7: Body: Body - Damage by hail - Smooth repair work

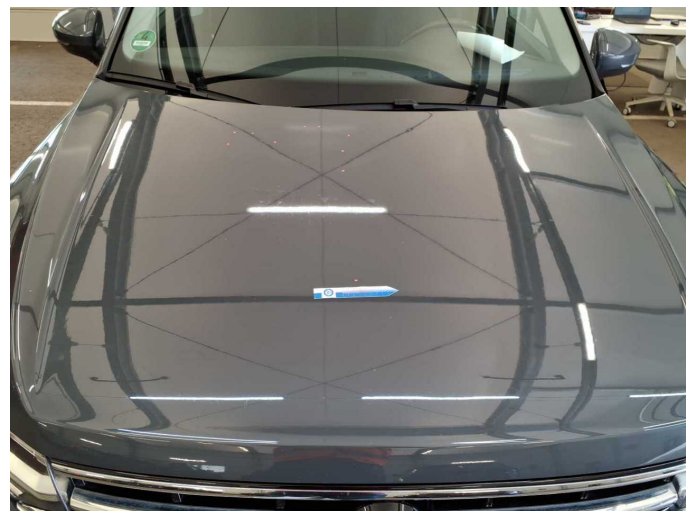
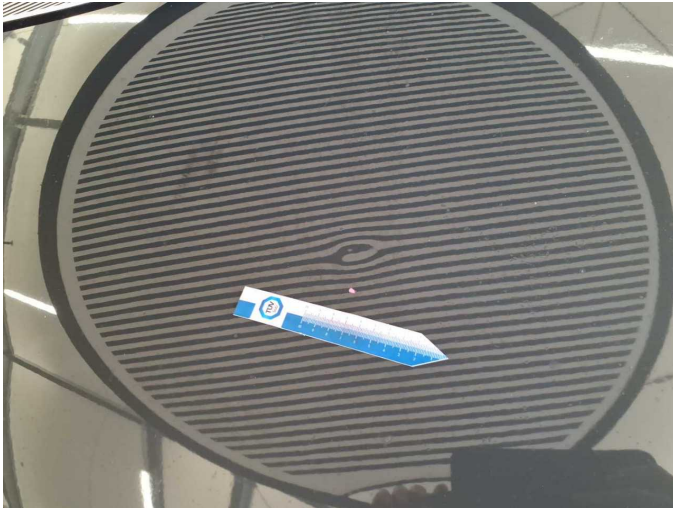
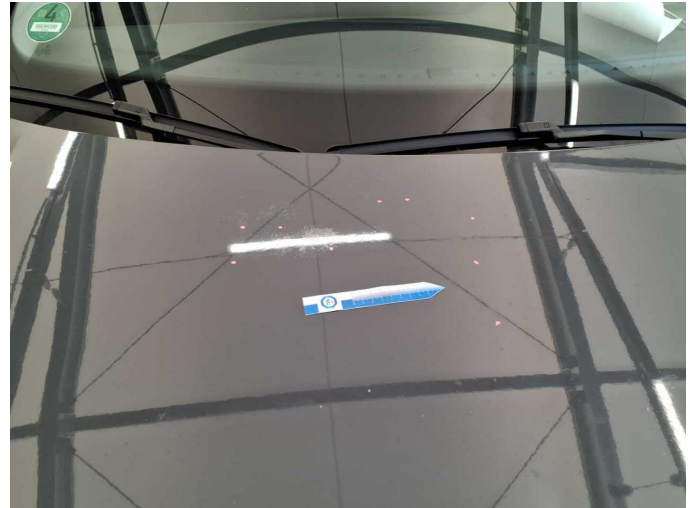
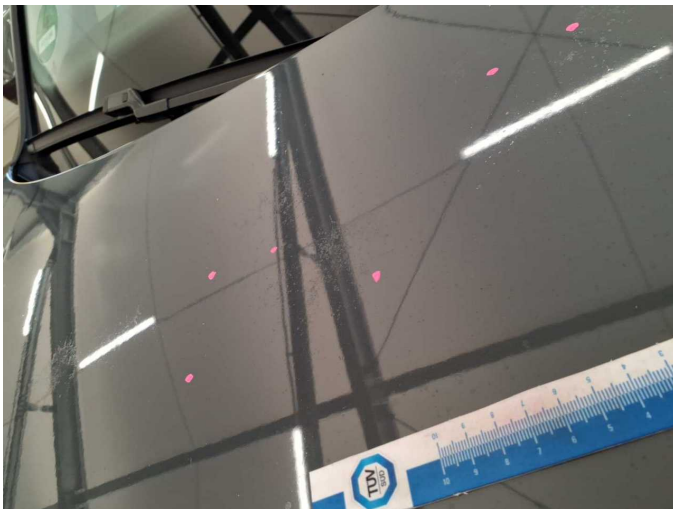
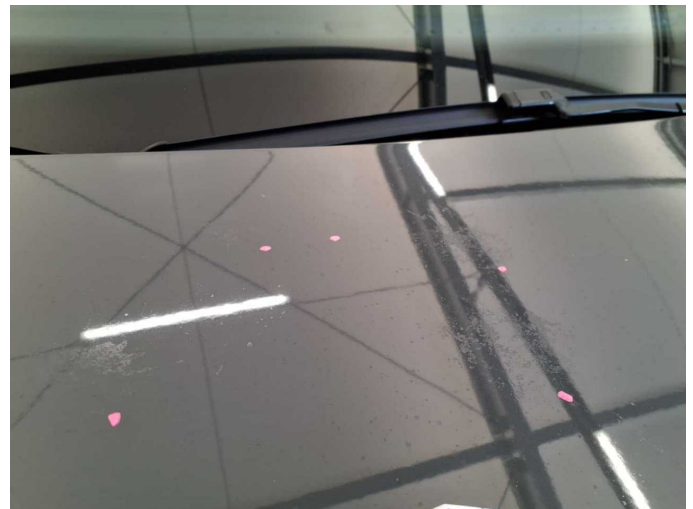
Damage 8: Bonnet: Bonnet (Delle+ Verätzungen) - Dent / paintcoat damage - Repair and paint

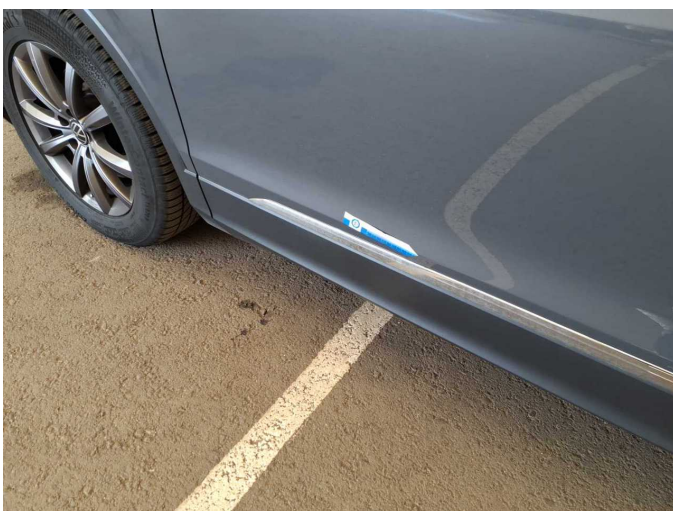
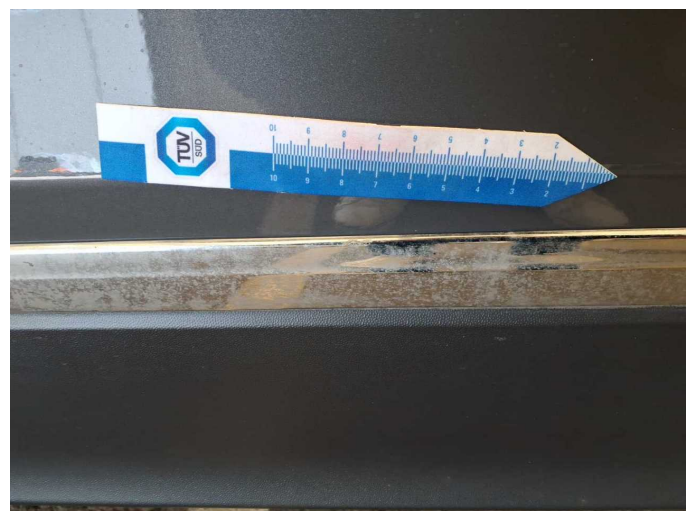
No.	Component group	Description
1	Door - front left side	Brightware - lower - Scratch(es) - No deduction

Wear and tear 1: Door - front left side: Brightware - lower - Scratch(es) - No deduction

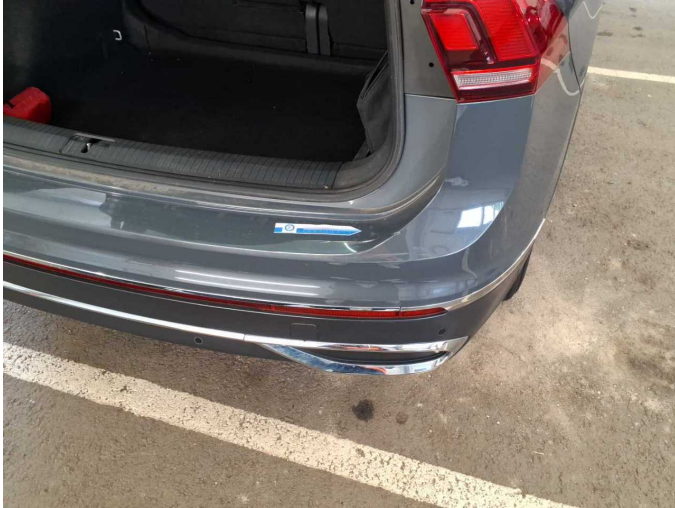
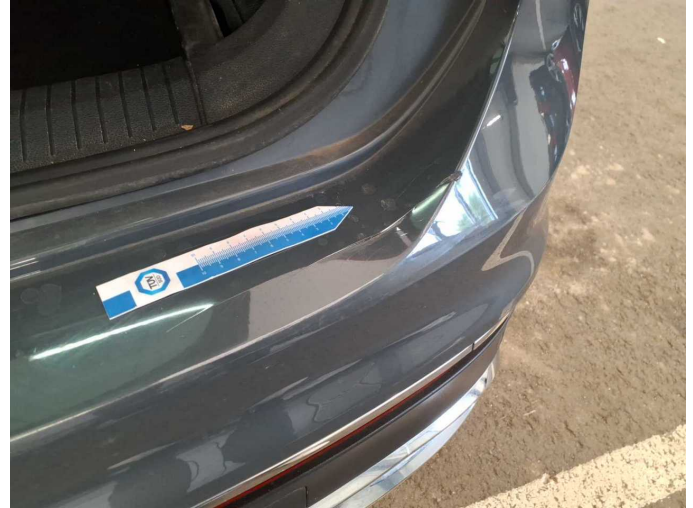
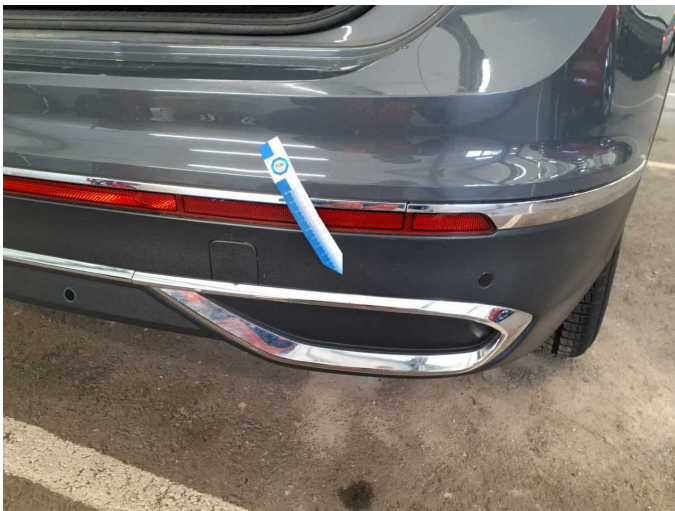
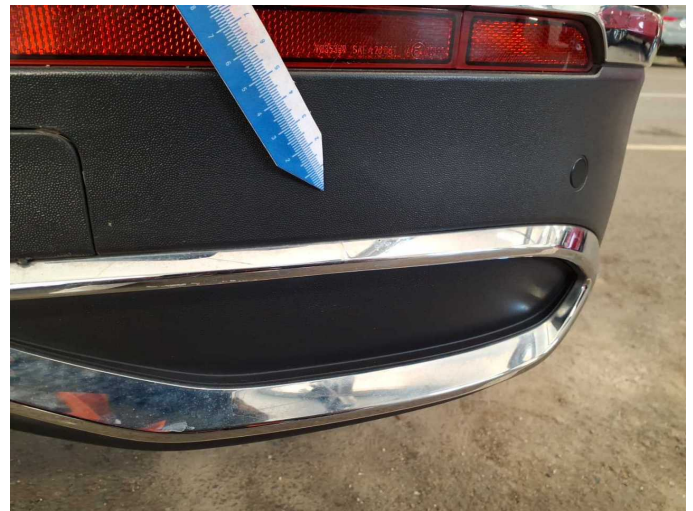
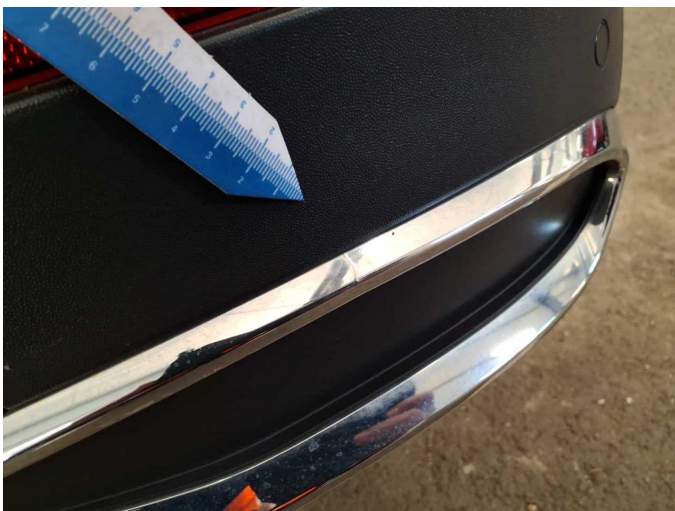
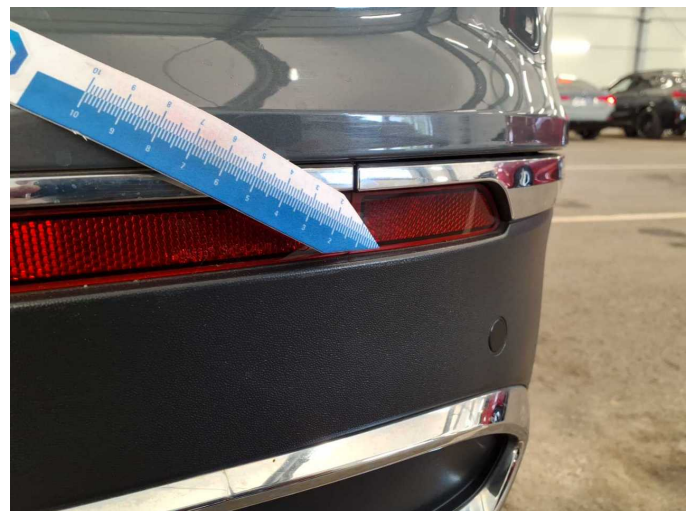
Accident 1: Rear

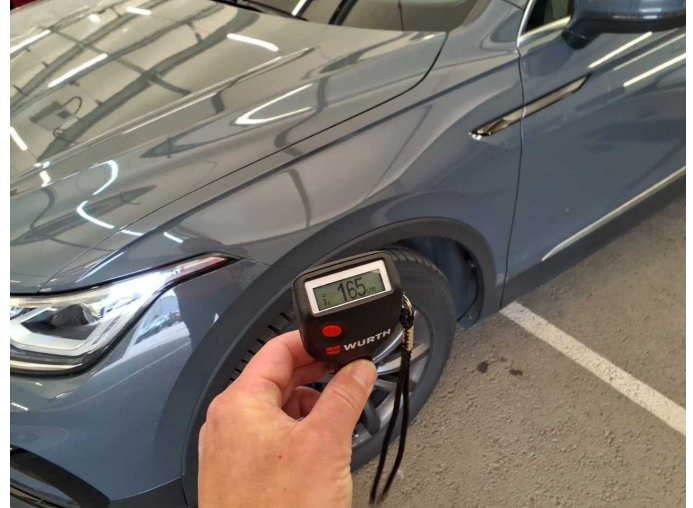
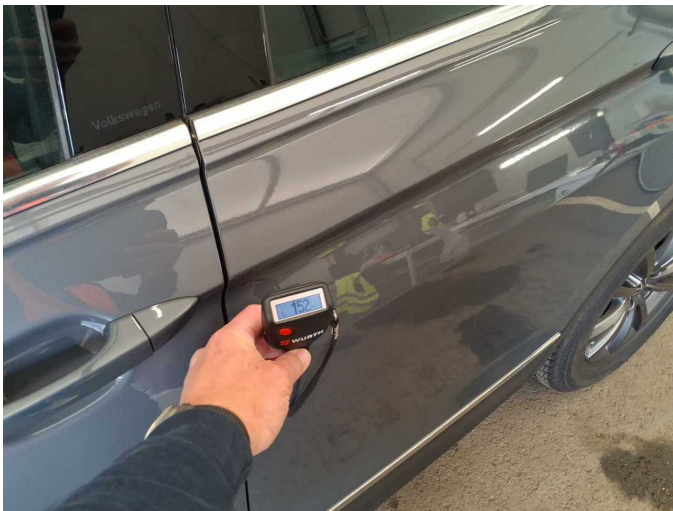
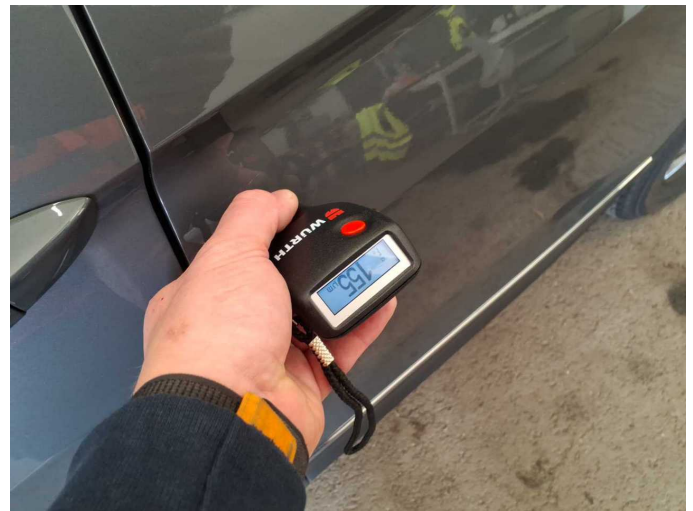
No.	Repainting
1	Door - rear left side, Door - front left side

Mudguard - left side	165 µm	Door - rear left side	155 µm
----------------------	--------	-----------------------	--------

Repainting 1: Door - rear left side, Door - front left side
