## Expertise

Protocol number: 45498450  
Order No. / Reference: 26287792  
Inspection date: 13 May 2026

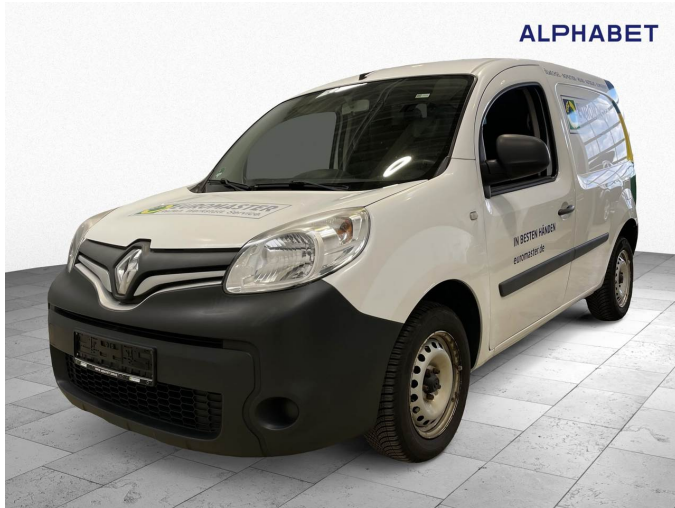
Figure 1: Diagonal front (left)

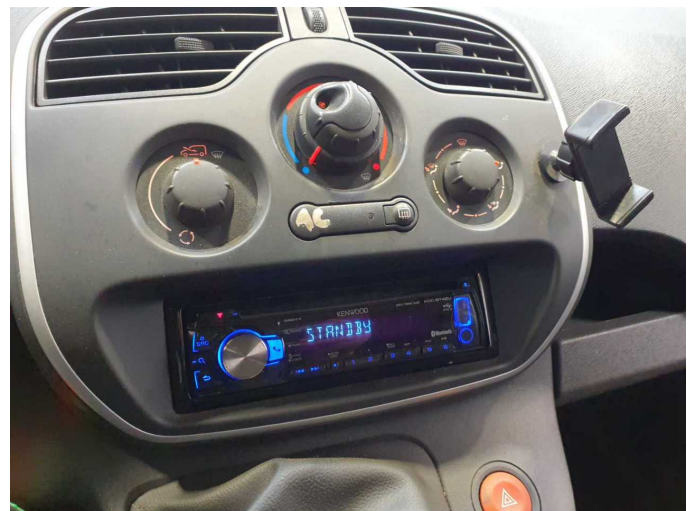
Damage 1: Multimedia system: Radio (nachgerüstet) - Differs from the original configuration - No deduction

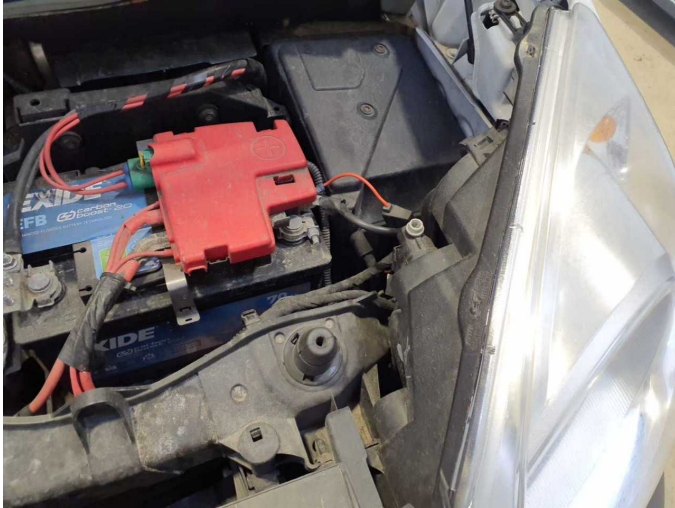
**Damage 1:** Multimedia system: Radio (nachgerüstet) - Differs from the original configuration - No deduction

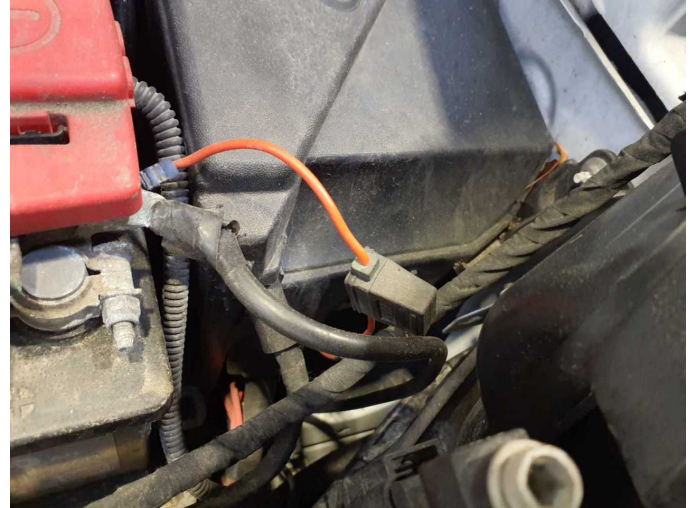
**Damage 1:** Multimedia system: Radio (nachgerüstet) - Differs from the original configuration - No deduction

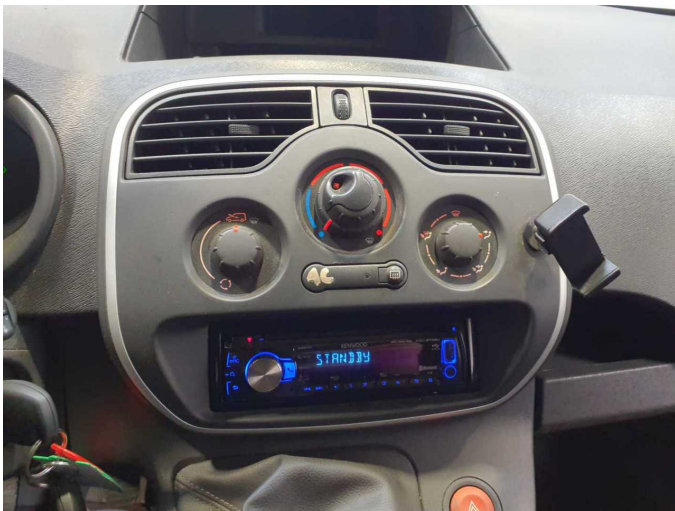
**Damage 2:** Trim / covers: Trim / covers - Differs from the original configuration - No deduction

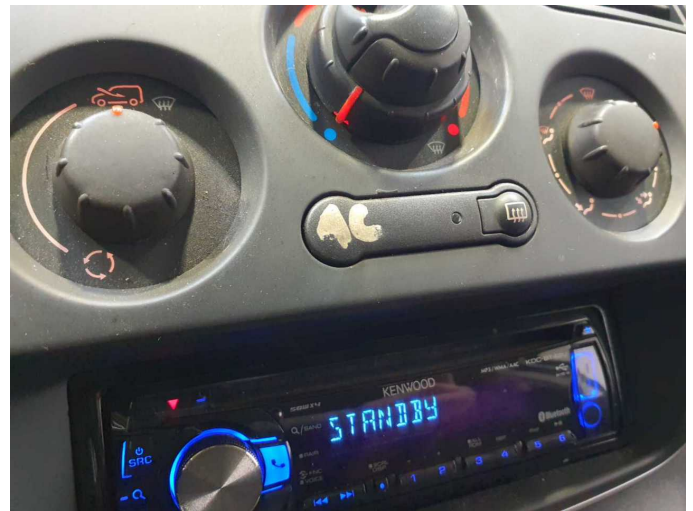
**Damage 2:** Trim / covers: Trim / covers - Differs from the original configuration - No deduction

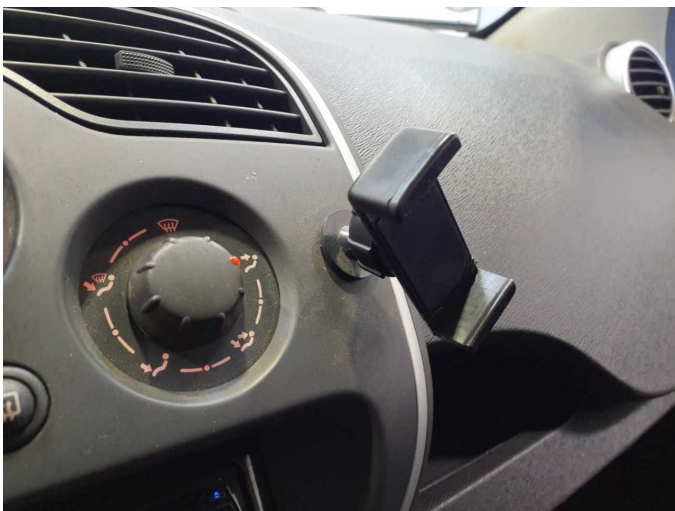
**Damage 2:** Trim / covers: Trim / covers - Differs from the original configuration - No deduction

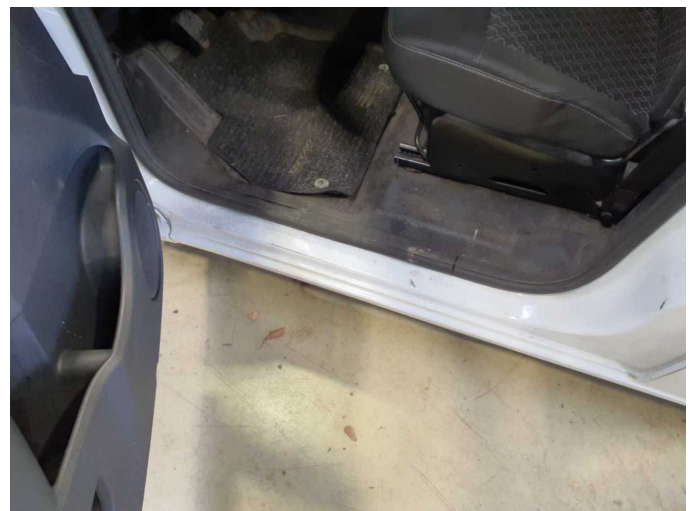
**Damage 3:** Sill - left side: Sill - Scratch(es) - Smart repair

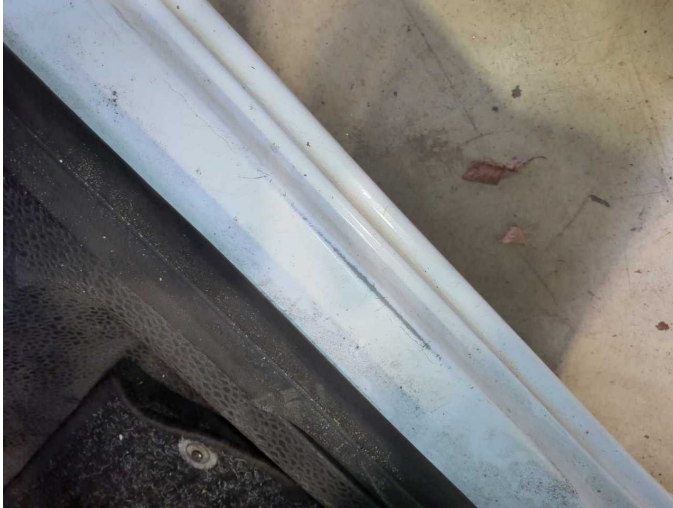
**Damage 3:** Sill - left side: Sill - Scratch(es) - Smart repair

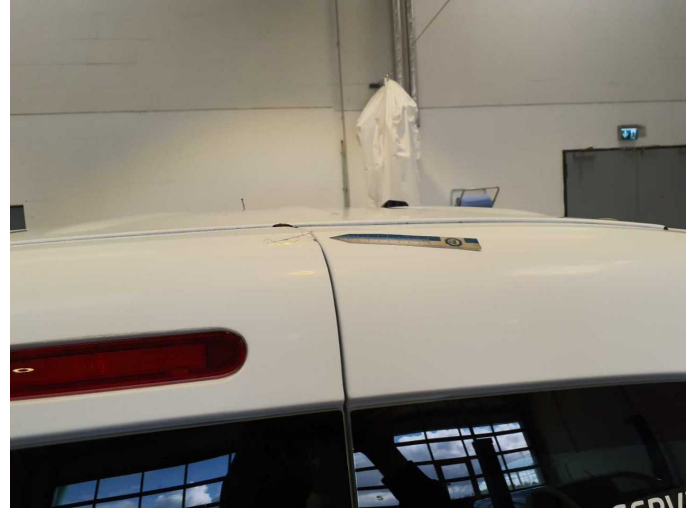
**Damage 4:** Boot lid / rear door: Rear door - right side - Dent / paintcoat damage - Smart repair

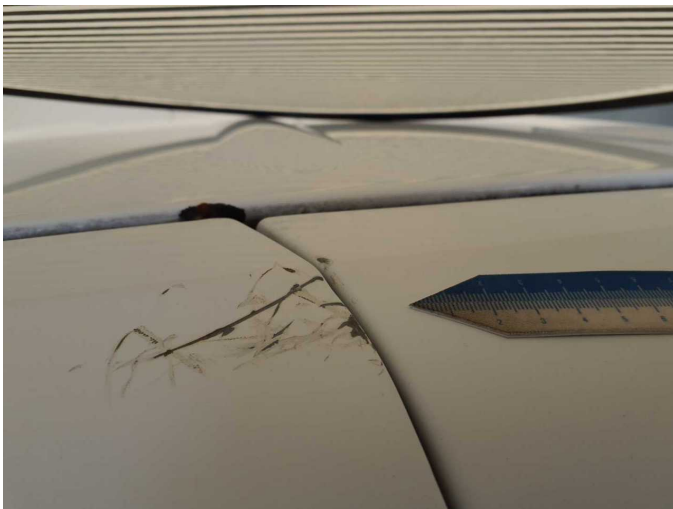
**Damage 4:** Boot lid / rear door: Rear door - right side - Dent / paintcoat damage - Smart repair

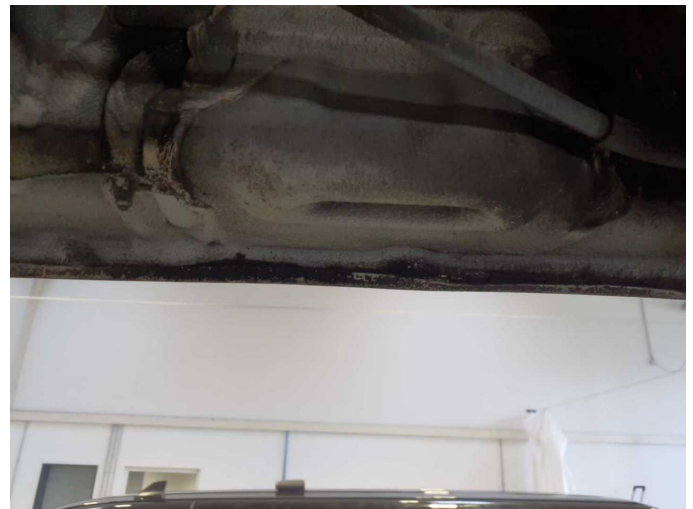
**Damage 5:** Sill - right side: Sill - dent(s) - Smart repair

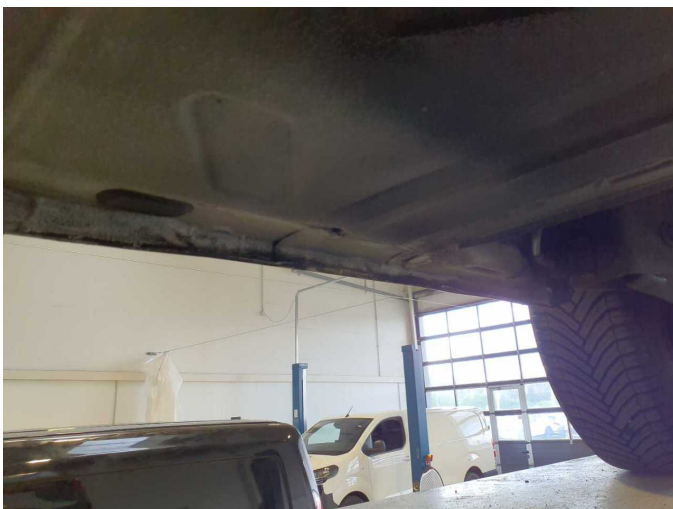
**Damage 5:** Sill - right side: Sill - dent(s) - Smart repair

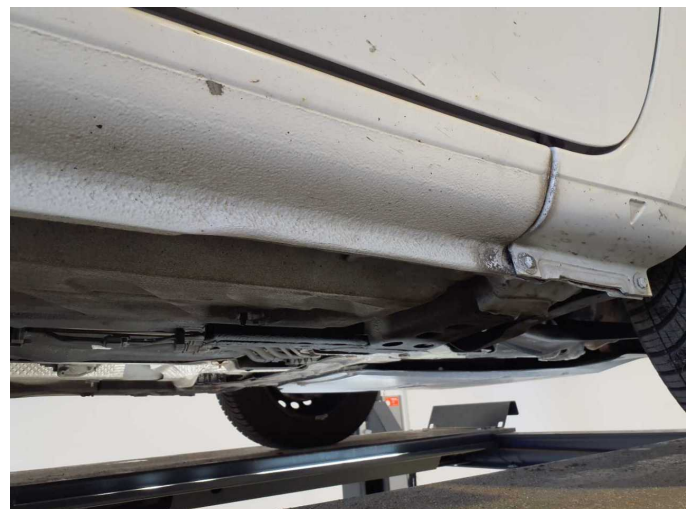
**Damage 5:** Sill - right side: Sill - dent(s) - Smart repair

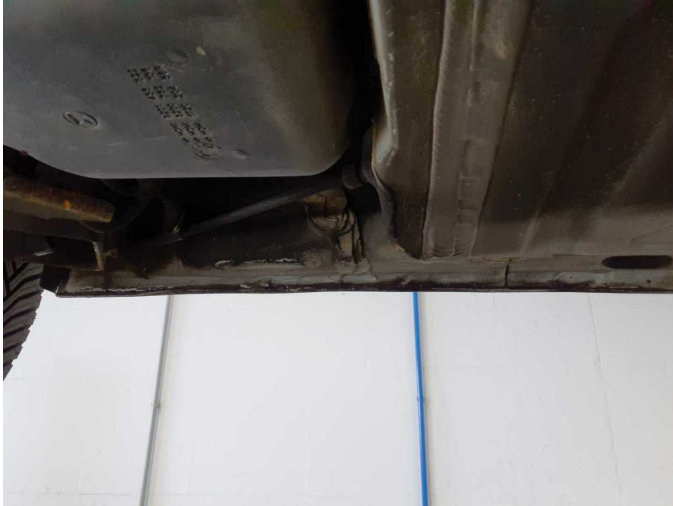
**Damage 6:** Sill - left side: Sill - dent(s) - Smart repair

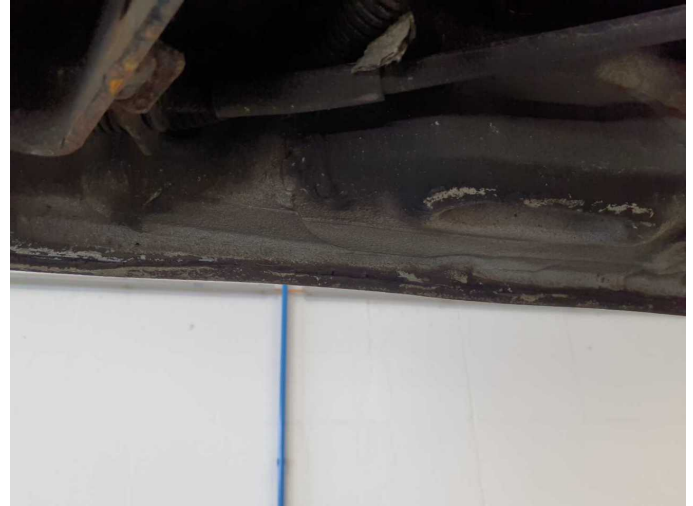
**Damage 6:** Sill - left side: Sill - dent(s) - Smart repair

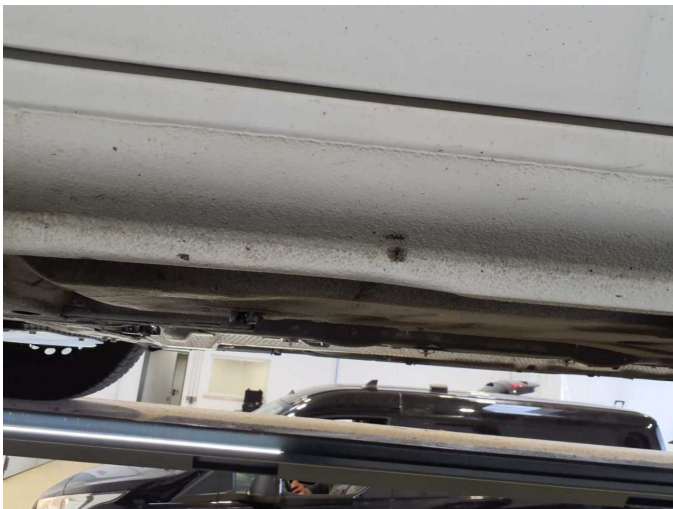
**Damage 6:** Sill - left side: Sill - dent(s) - Smart repair

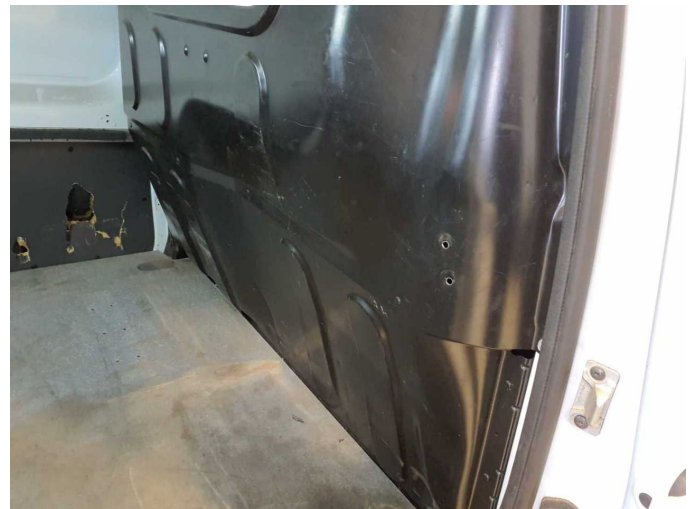
**Damage 7:** Body: Partition wall - Holes - Loss in value

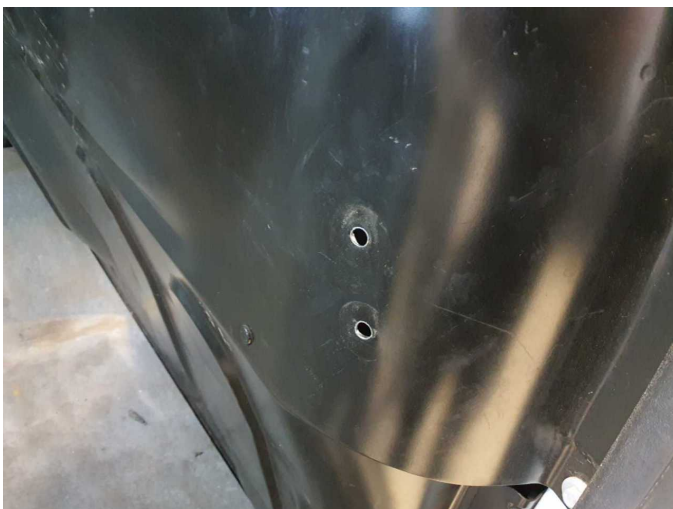
**Damage 7:** Body: Partition wall - Holes - Loss in value

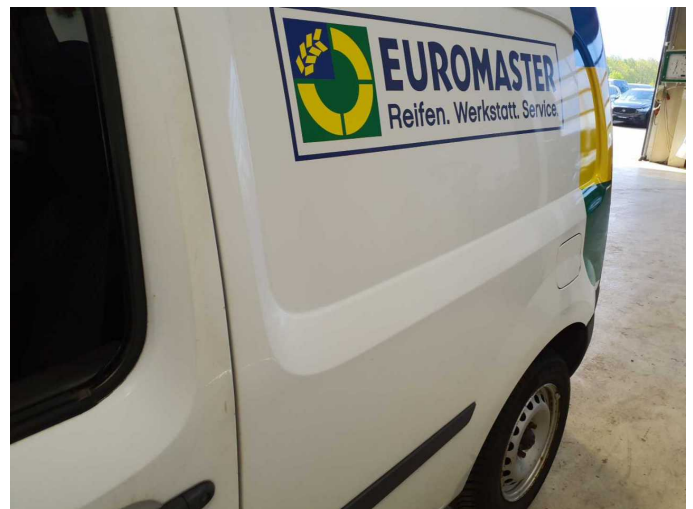
**Damage 8:** Body: Body (Matt) - Paint defect - Conditioning

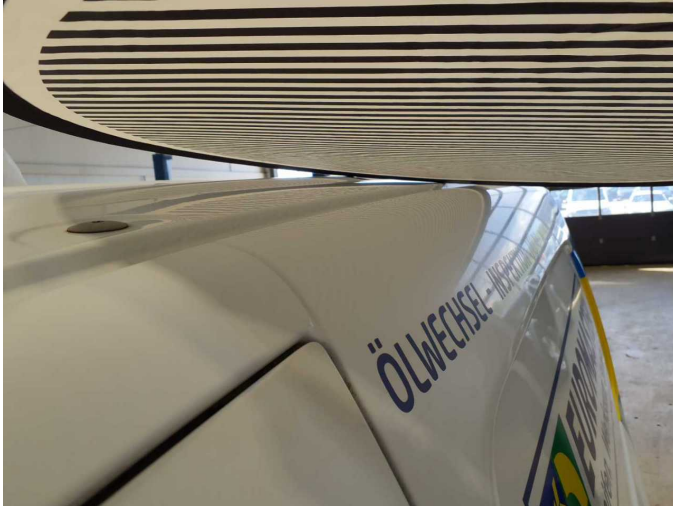
**Damage 8:** Body: Body (Matt) - Paint defect - Conditioning

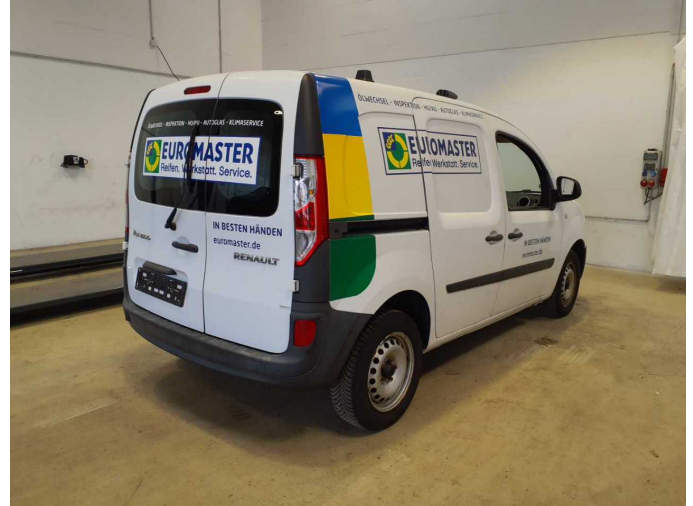
**Damage 9:** Body: Body - Glued / labelled - De-glue / neutralise

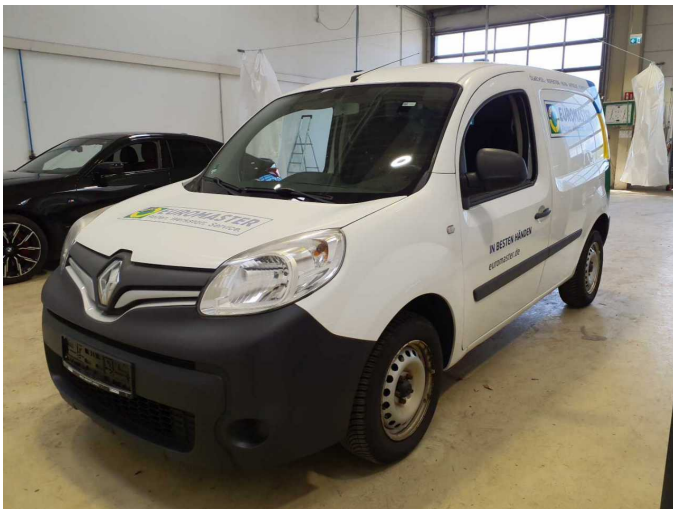
**Damage 9:** Body: Body - Glued / labelled - De-glue / neutralise

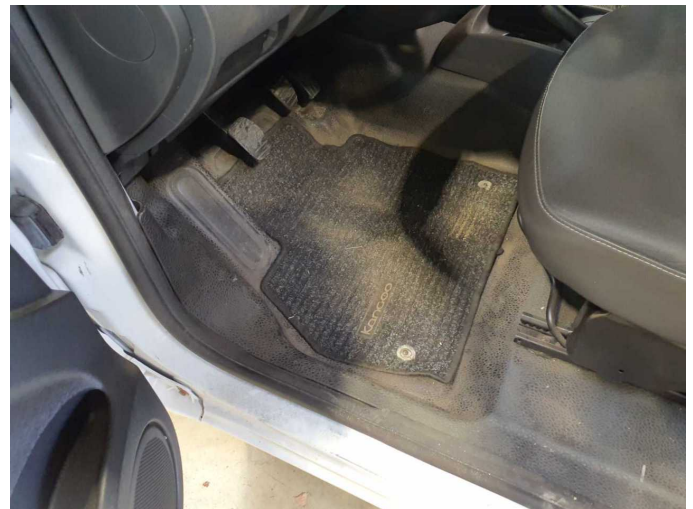
**Damage 10:** Interior: Interior (Fußmatten verschraubt, Pedalgummi Kupplung verschlissen) - Damaged - Replace

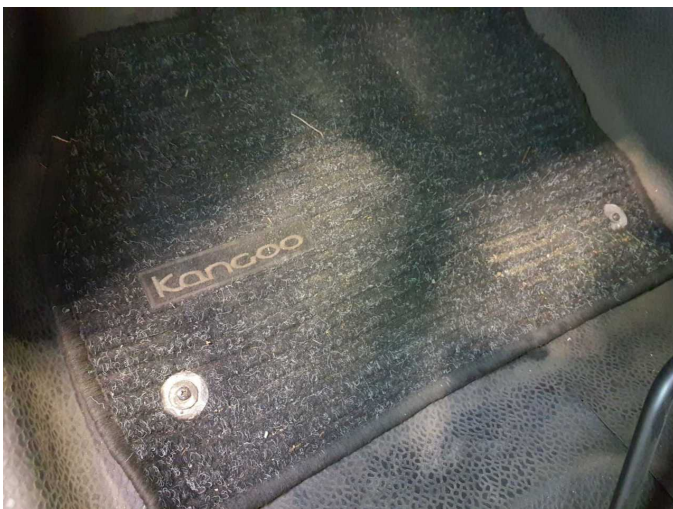
**Damage 10:** Interior: Interior (Fußmatten verschraubt, Pedalgummi Kupplung verschlissen) - Damaged - Replace

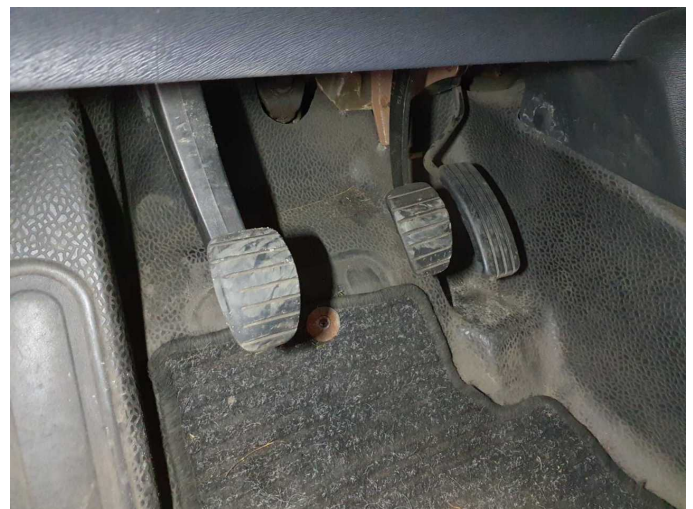
**Damage 10:** Interior: Interior (Fußmatten verschraubt, Pedalgummi Kupplung verschlissen) - Damaged - Replace

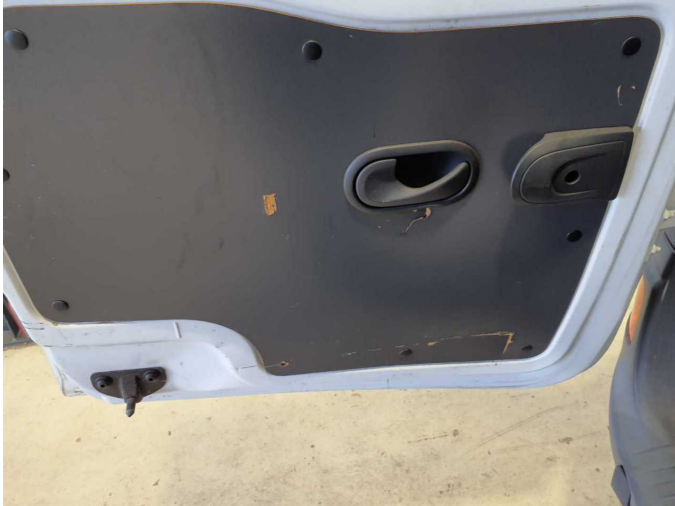
**Damage 11:** Trim / covers: Boot lining (Mehrere) - Broken / torn - Replace

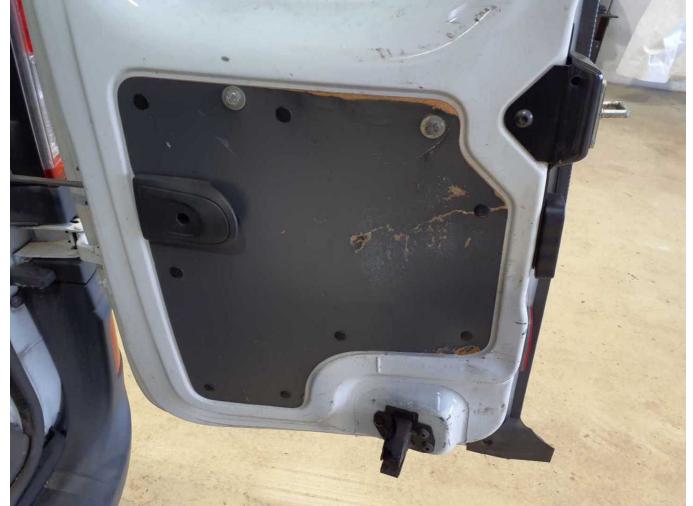
**Damage 11:** Trim / covers: Boot lining (Mehrere) - Broken / torn - Replace

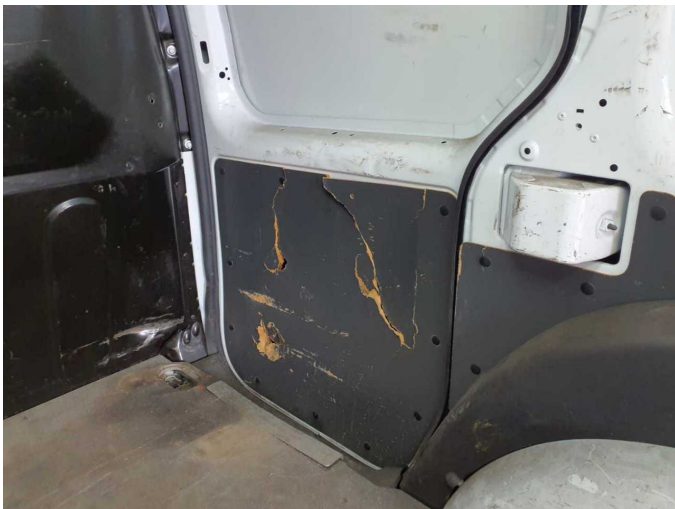
**Damage 11:** Trim / covers: Boot lining (Mehrere) - Broken / torn - Replace

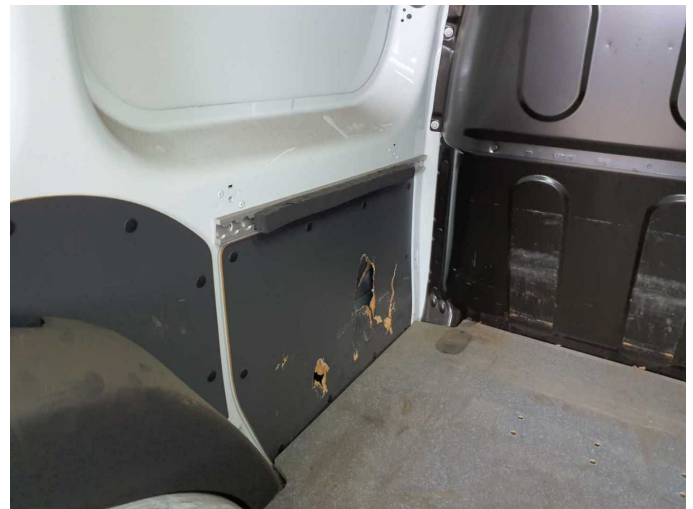
**Damage 11:** Trim / covers: Boot lining (Mehrere) - Broken / torn - Replace

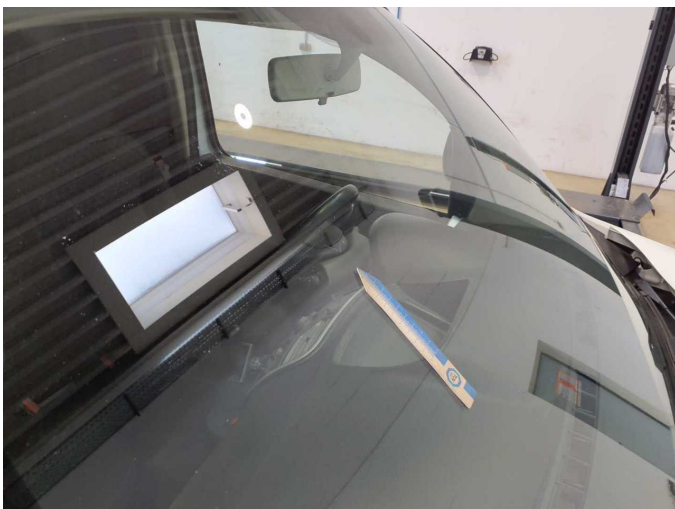
**Damage 12:** Vehicle glazing: Windscreen - Scratch(es) - Replace

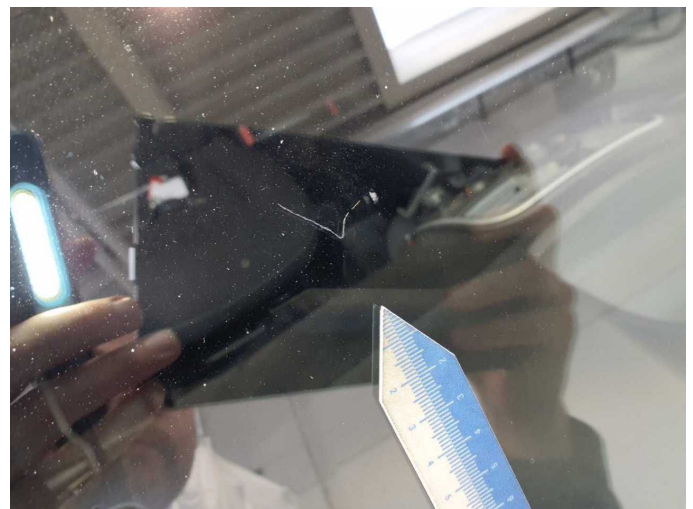
**Damage 12:** Vehicle glazing: Windscreen - Scratch(es) - Replace

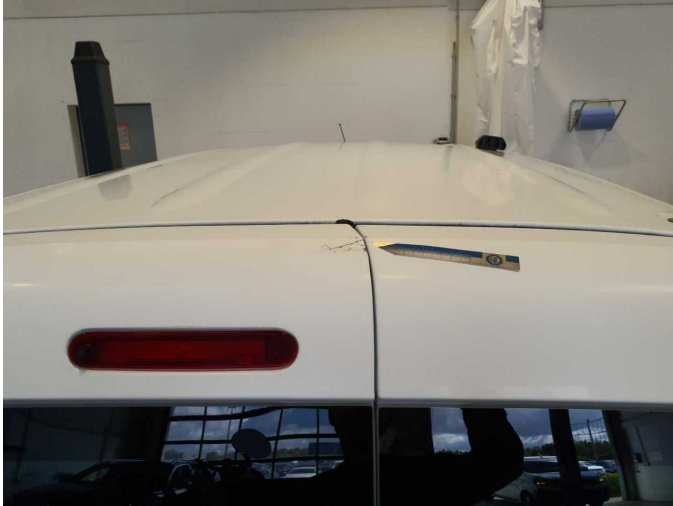
**Damage 13:** Boot lid / rear door: Rear door - left side - Dent / paintcoat damage - Repair and paint

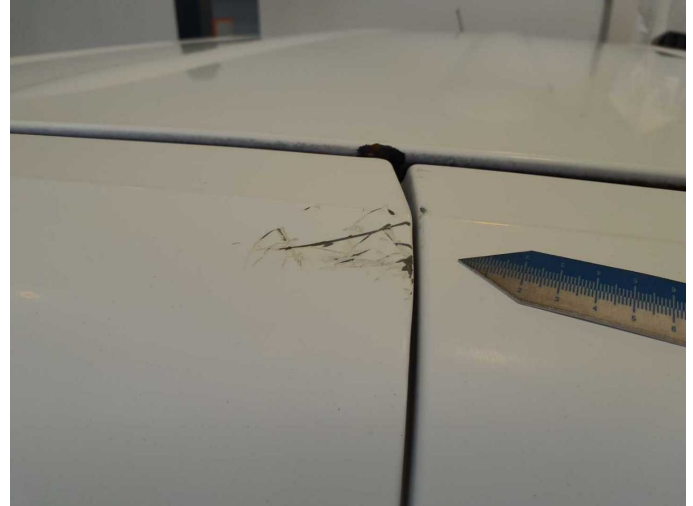
**Damage 13:** Boot lid / rear door: Rear door - left side - Dent / paintcoat damage - Repair and paint

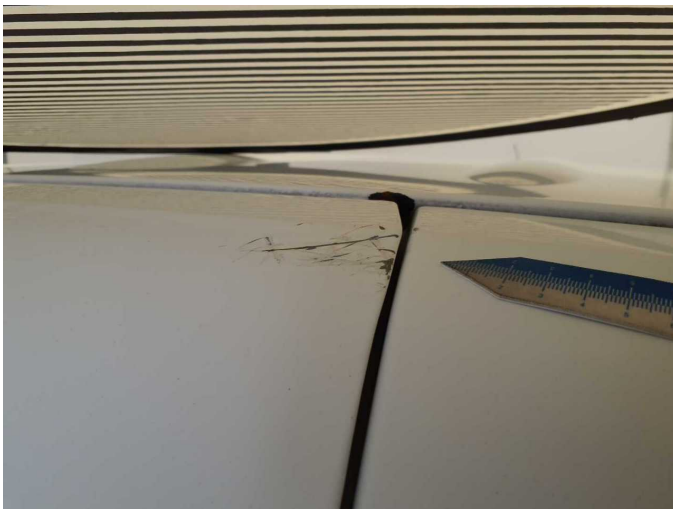
**Damage 13:** Boot lid / rear door: Rear door - left side - Dent / paintcoat damage - Repair and paint

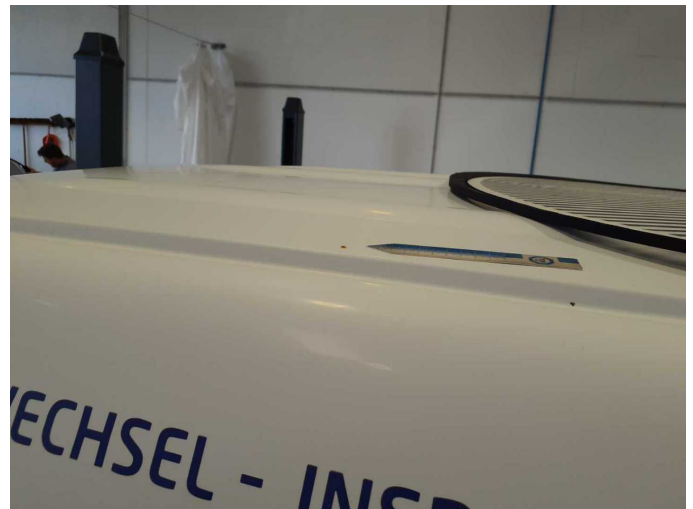
**Damage 14:** Roof: Roof - Corrosion - Repair and paint

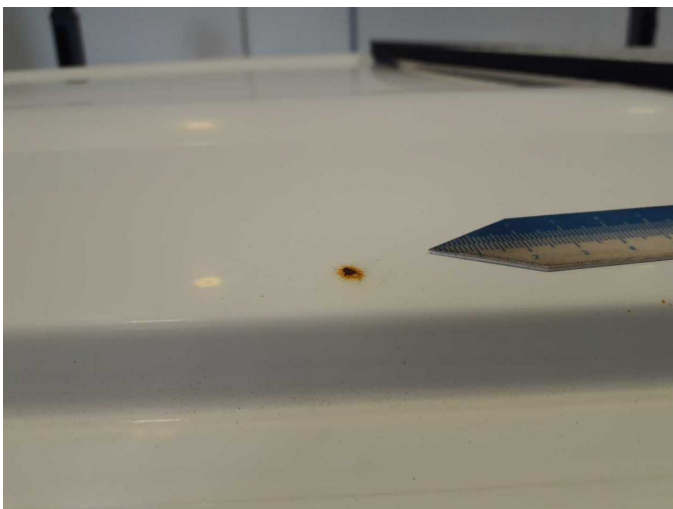
**Damage 14:** Roof: Roof - Corrosion - Repair and paint

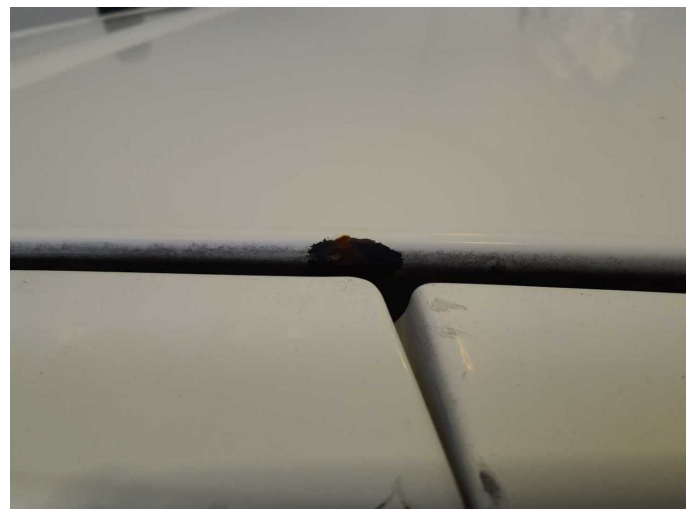
**Damage 14:** Roof: Roof - Corrosion - Repair and paint

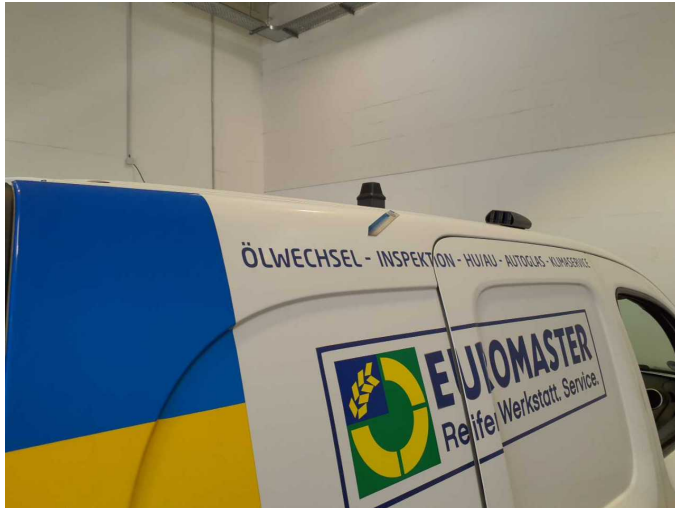
**Wear and tear 6:** Side panel - rear right side: Side panel - dent(s) - No deduction

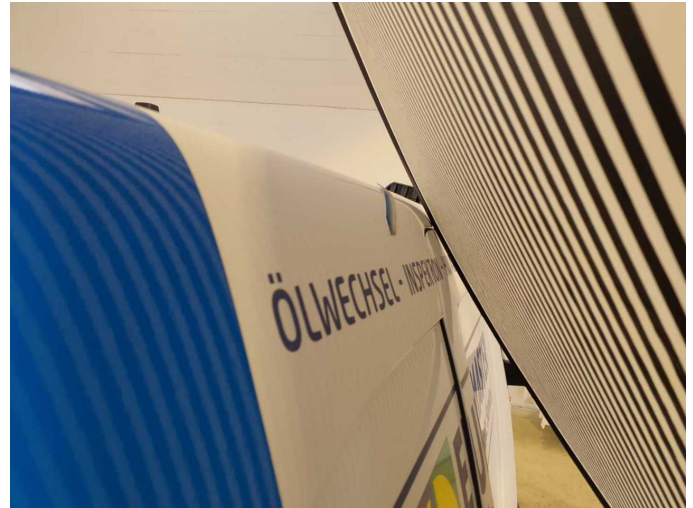
**Wear and tear 6:** Side panel - rear right side: Side panel - dent(s) - No deduction

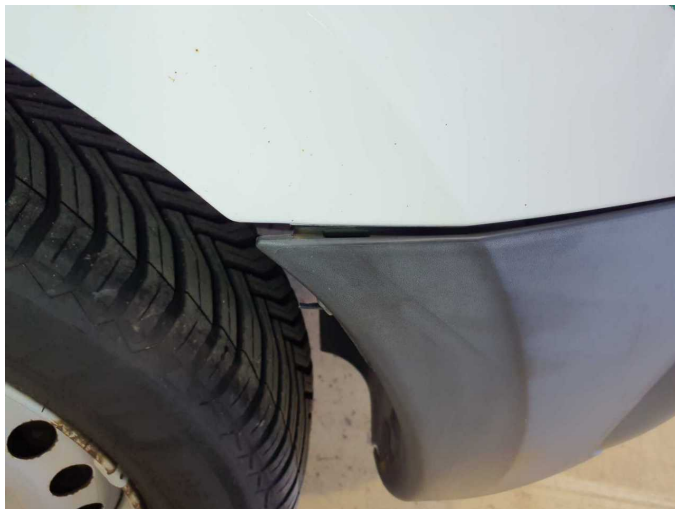
**Wear and tear 7:** Rear bumper: Rear bumper (unpainted) - Malposition - Repair

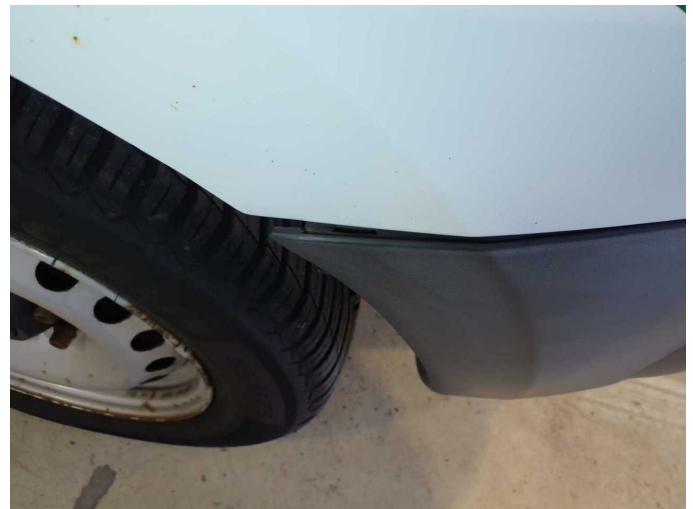
**Wear and tear 7:** Rear bumper: Rear bumper (unpainted) - Malposition - Repair
