Expertise

Protocol number: 45969494
Order No. / Reference: 26531168
Inspection date: 16 Jun 2026

Manufacturer: CUPRA

Model: Born 150kW/58kWh

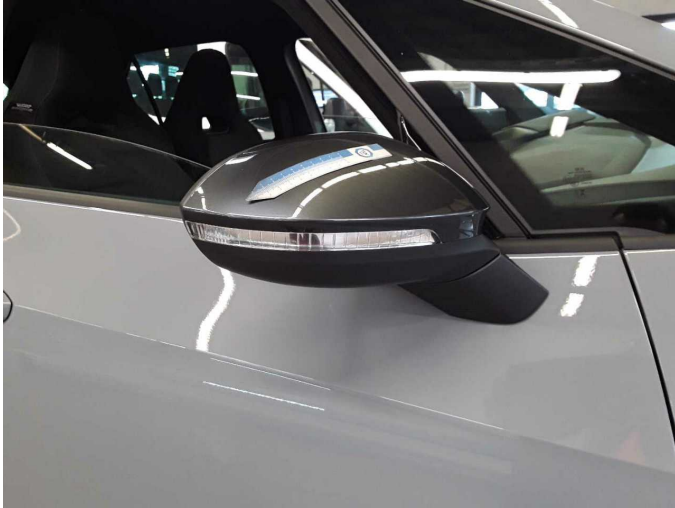
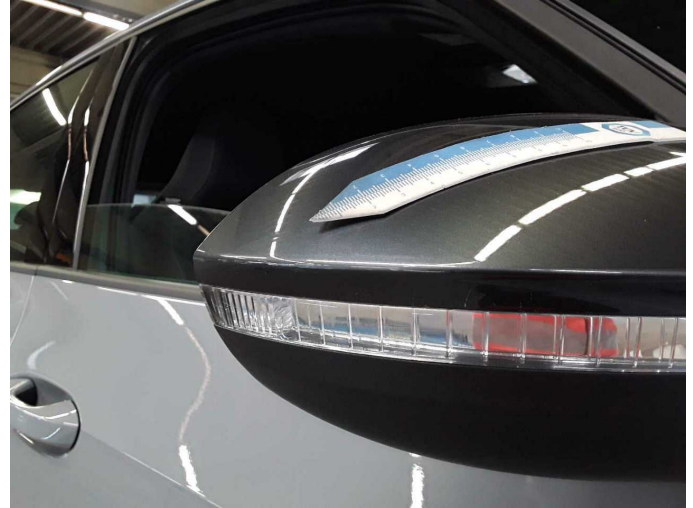
Damage 1: Wing mirror - right side: Cap - Scratch(es) - Smart repair

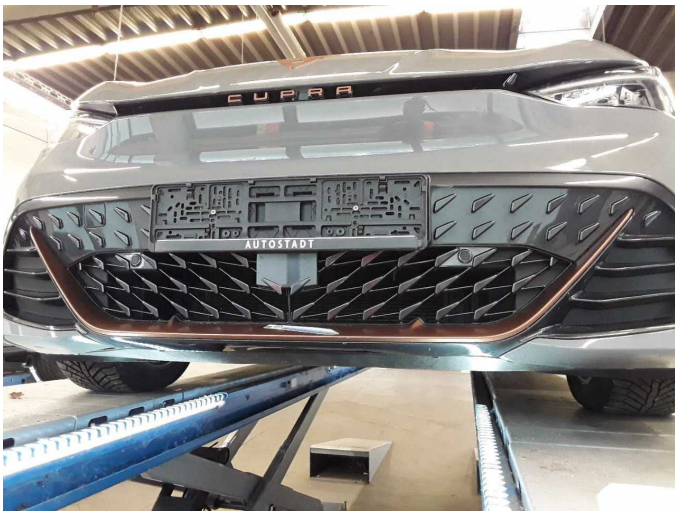
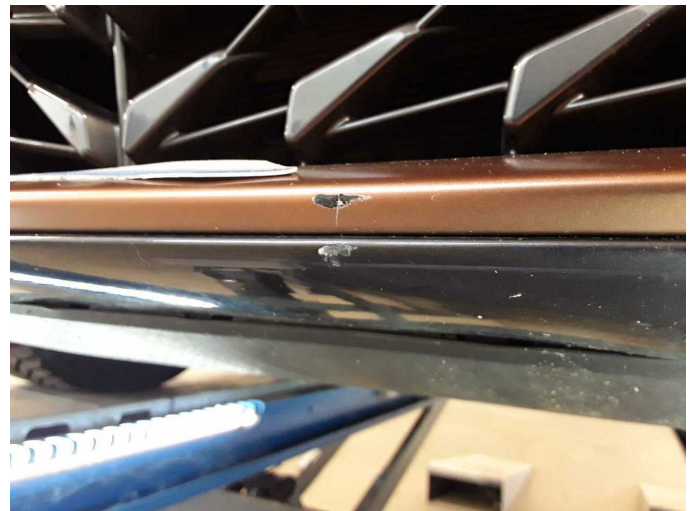
Damage 2: Front bumper: Spoiler - Scratch(es) - Smart repair

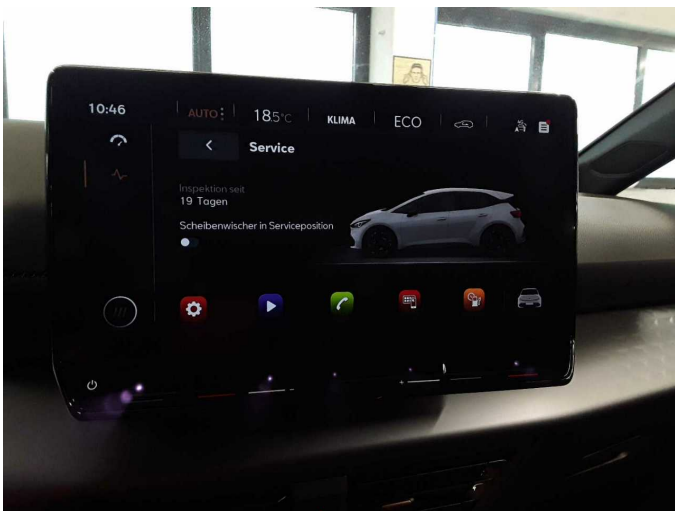
Damage 3: Misc.: Inspection / maintenance - Due - Perform

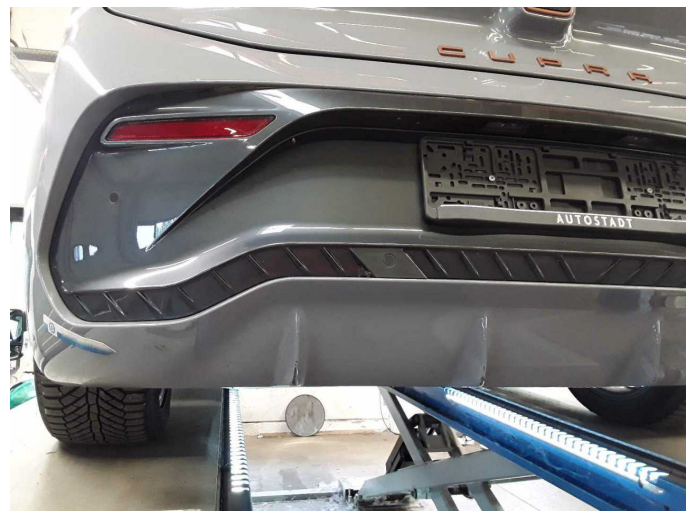
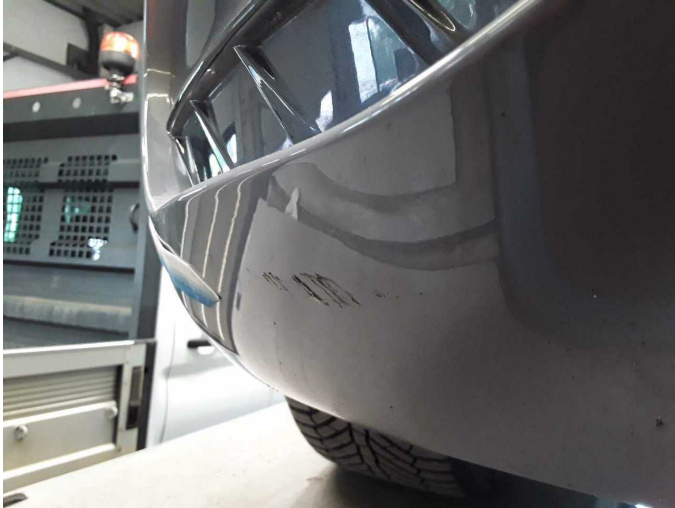
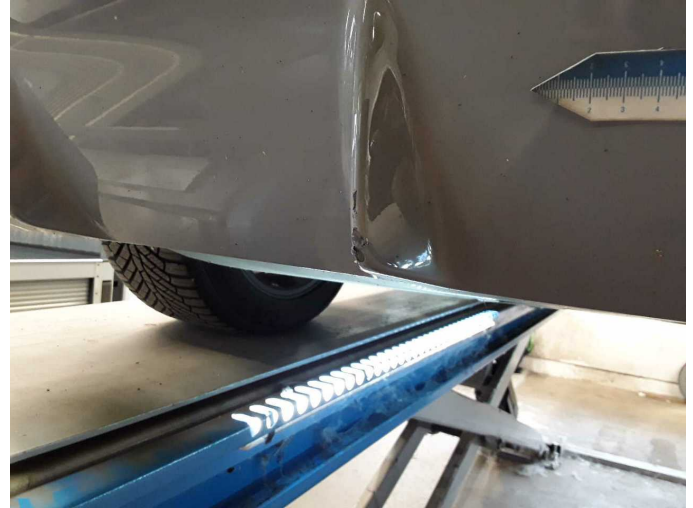
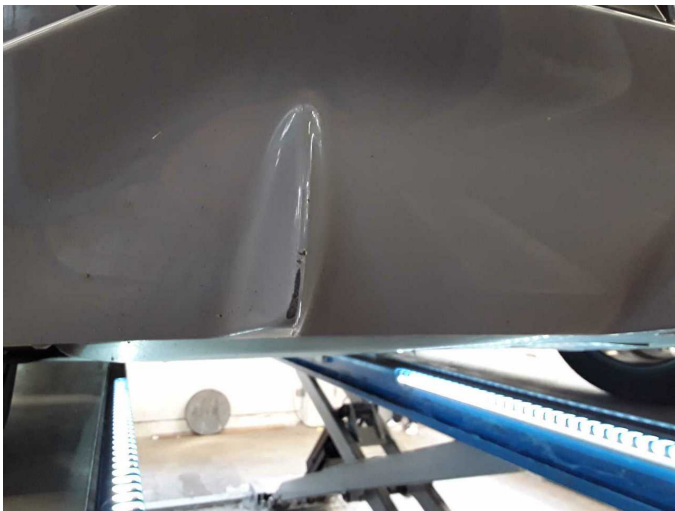
Damage 4: Rear bumper: Rear bumper - Scratch(es) - Paint

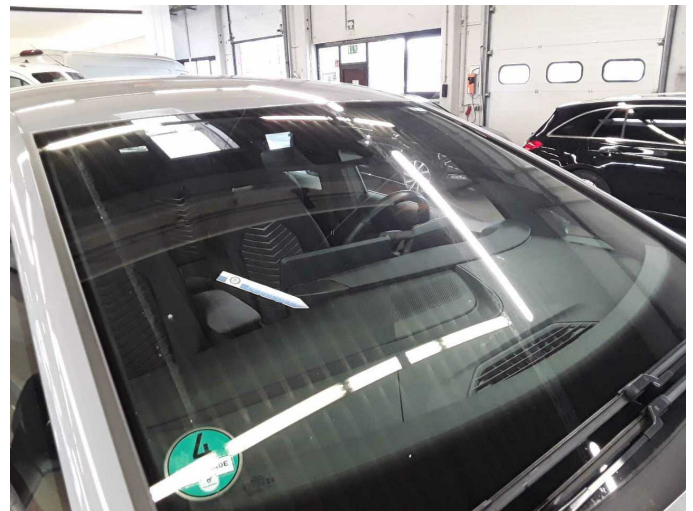
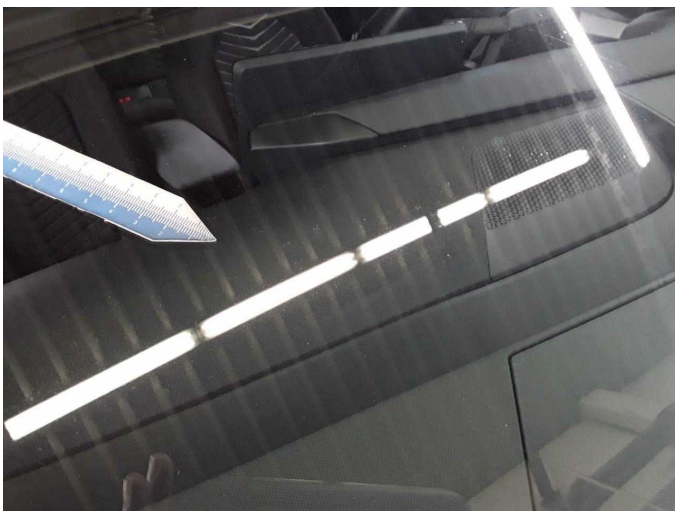
Wear and tear 1: Vehicle glazing: Windscreen - Stone chips - No deduction
