Expertise

Protocol number: 46401289  
Order No. / Reference: 26597064  
Inspection date: 8 Jul 2026

Manufacturer: Opel

Model: Astra 1.5 D Start/Stop Sports Tourer Business Edition

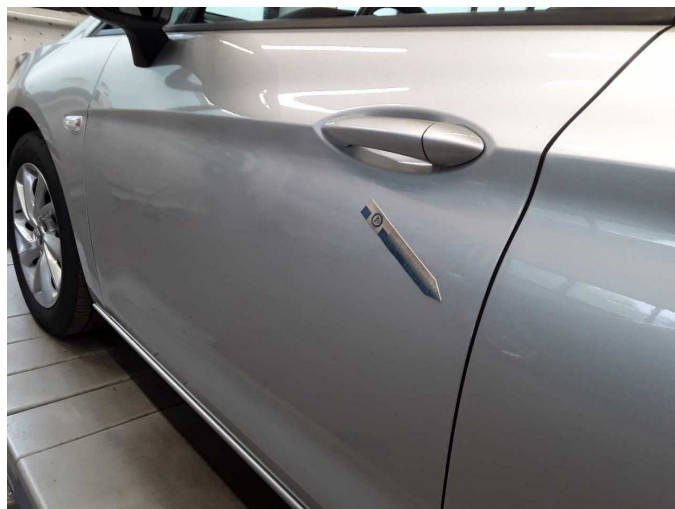
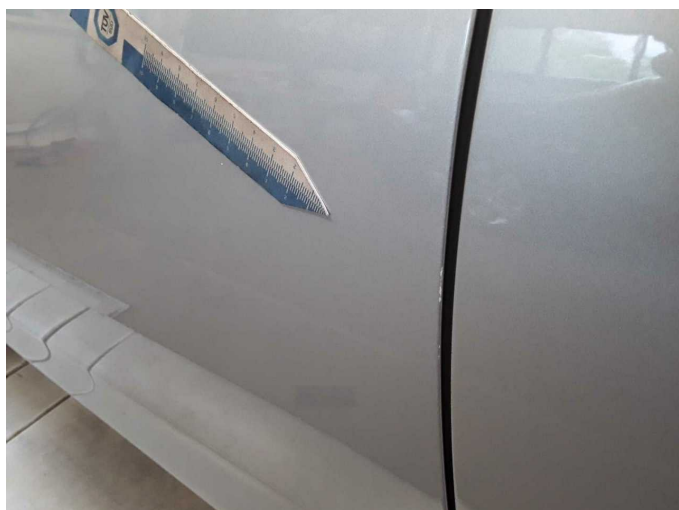
| No. | Component group | Description |
|---|---|---|
| 1 | Door - front left side | Door - Scratch(es) - Smart repair |

**Damage 1:** Door - front left side: Door - Scratch(es) - Smart repair

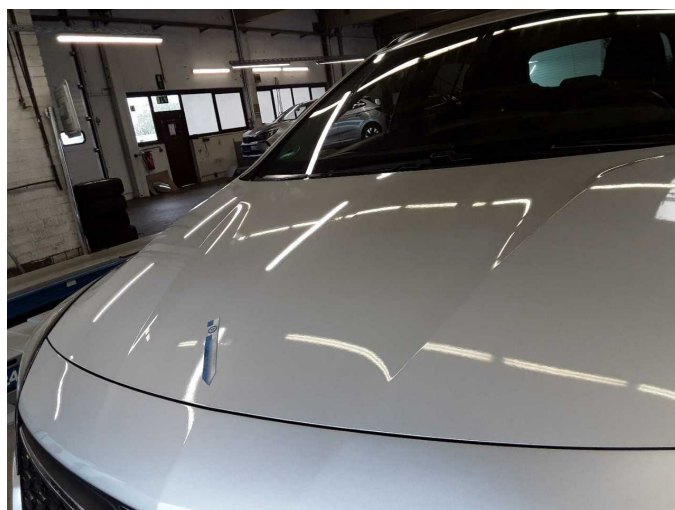
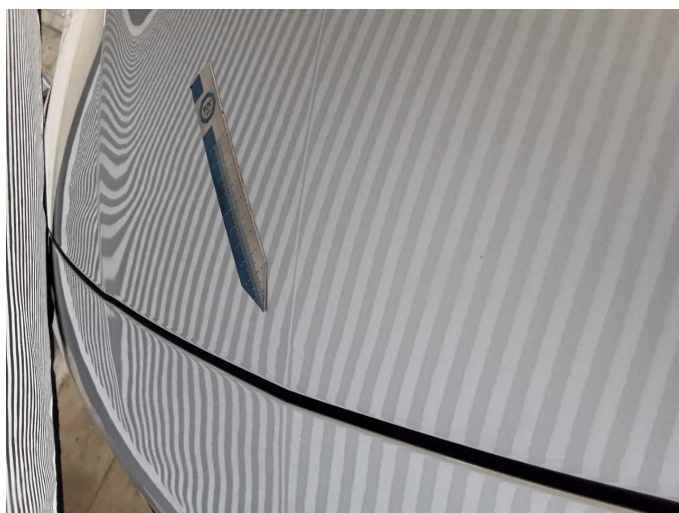
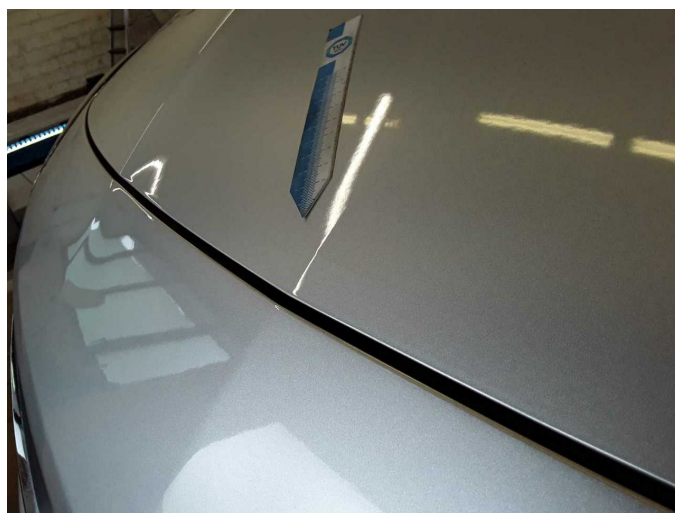
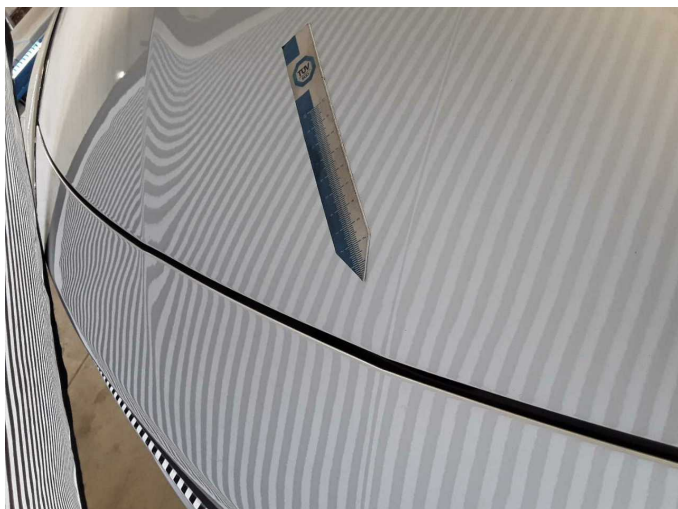
| No. | Component group | Description |
|---|---|---|
| 2 | Bonnet | Bonnet - dent(s) - Smooth repair work |

**Damage 2:** Bonnet: Bonnet - dent(s) - Smooth repair work

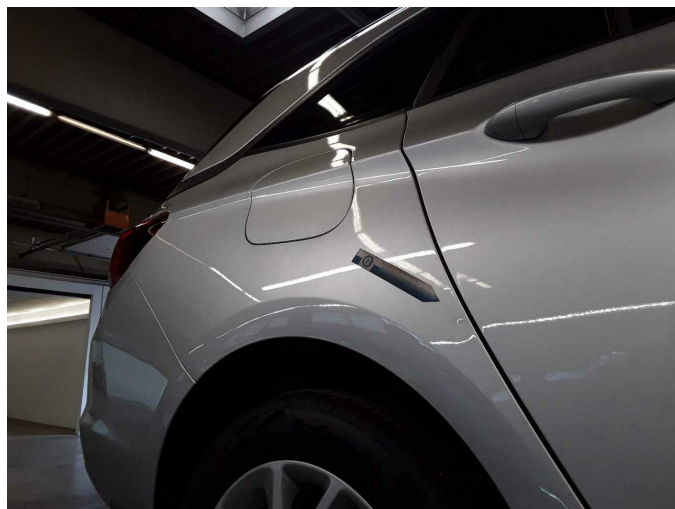
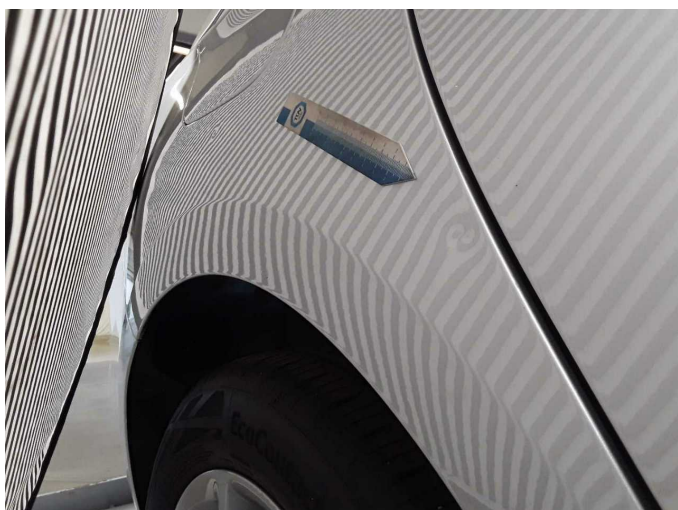
| No. | Component group | Description |
|---|---|---|
| 3 | Side panel - rear right side | Side panel - dent(s) - Smooth repair work |

**Damage 3:** Side panel - rear right side: Side panel - dent(s) - Smooth repair work

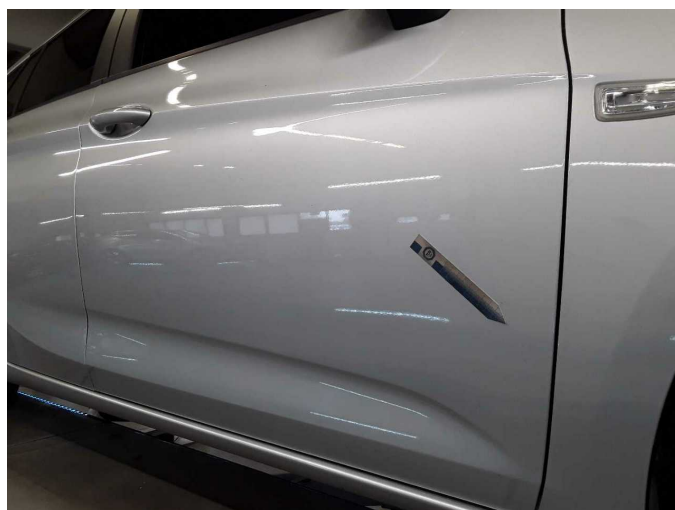
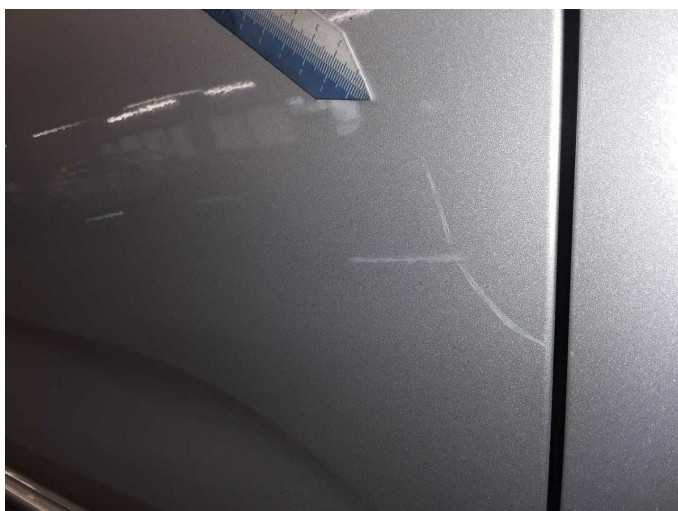
| No. | Component group | Description |
|---|---|---|
| 4 | Door - front right side | Door (Mehrkosten möglich) - Scratch(es) - Conditioning |

**Damage 4:** Door - front right side: Door (Mehrkosten möglich) - Scratch(es) - Conditioning

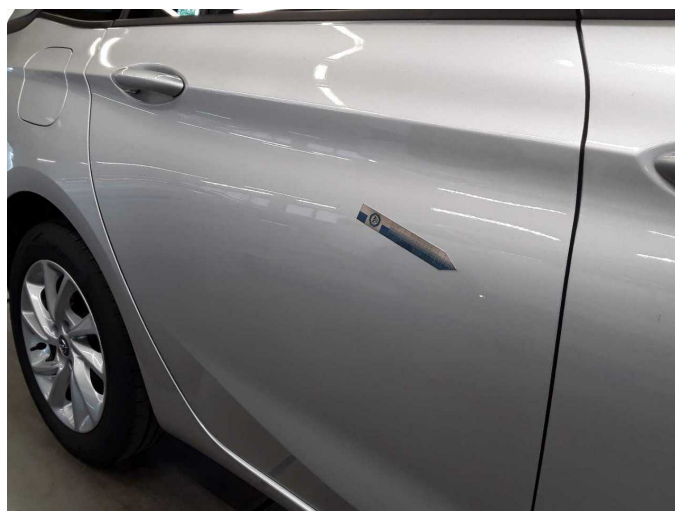
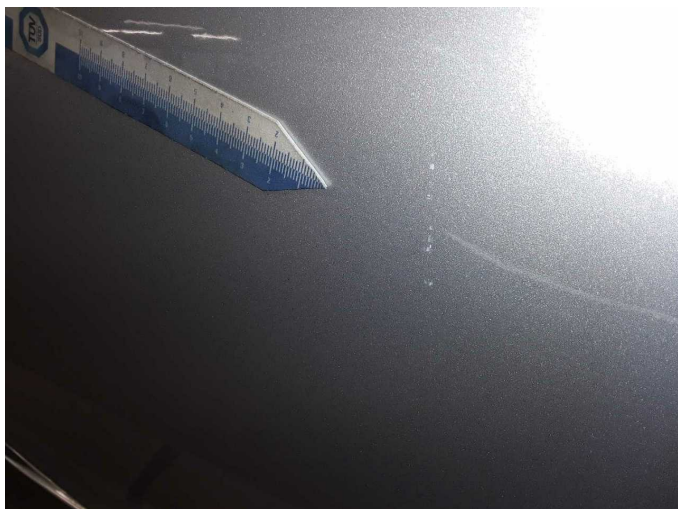
| No. | Component group | Description |
|---|---|---|
| 5 | Door - rear right side | Door (Mehrkosten möglich) - Scratch(es) - Conditioning |

**Damage 5:** Door - rear right side: Door (Mehrkosten möglich) - Scratch(es) - Conditioning

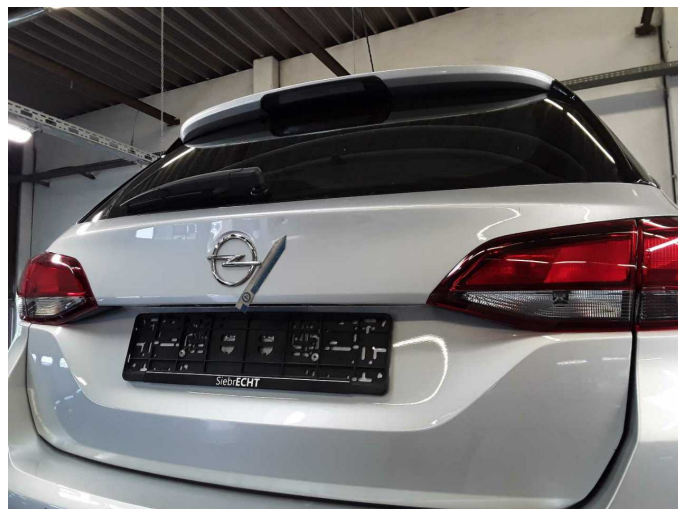
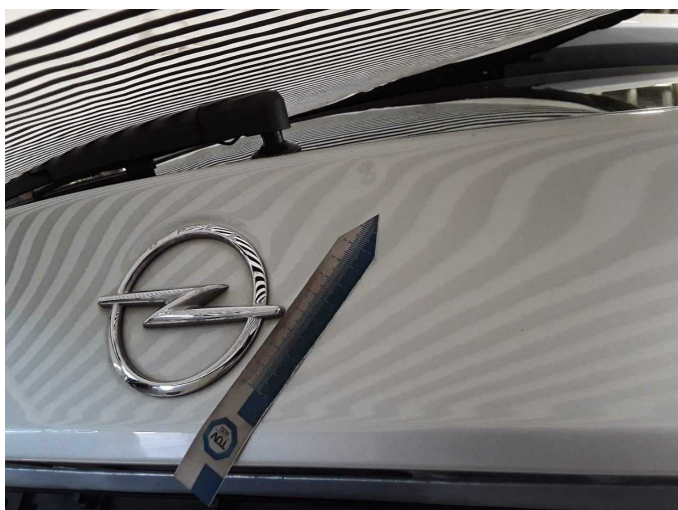
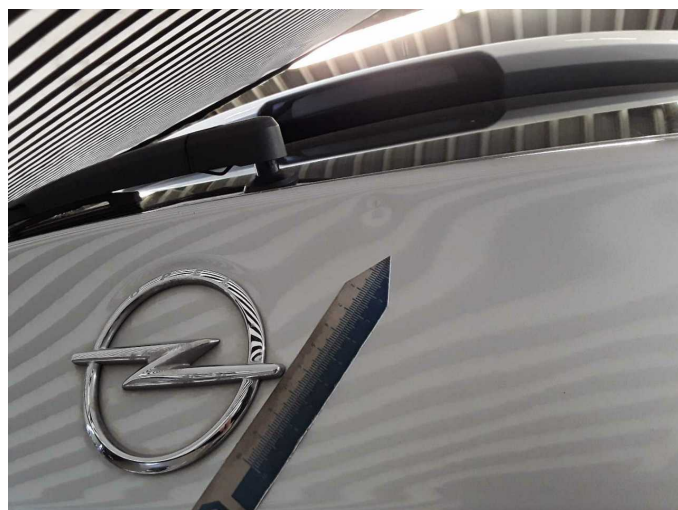
| No. | Component group | Description |
|---|---|---|
| 6 | Boot lid / rear door | Boot lid - Dent / paintcoat damage - Smart repair |

**Damage 6:** Boot lid / rear door: Boot lid - Dent / paintcoat damage - Smart repair
