Expertise

Protocol number: 46313528
Order No. / Reference: 26520813
Inspection date: 2 Jul 2026

Model: Insignia Sports Tourer 2.0 Diesel Business

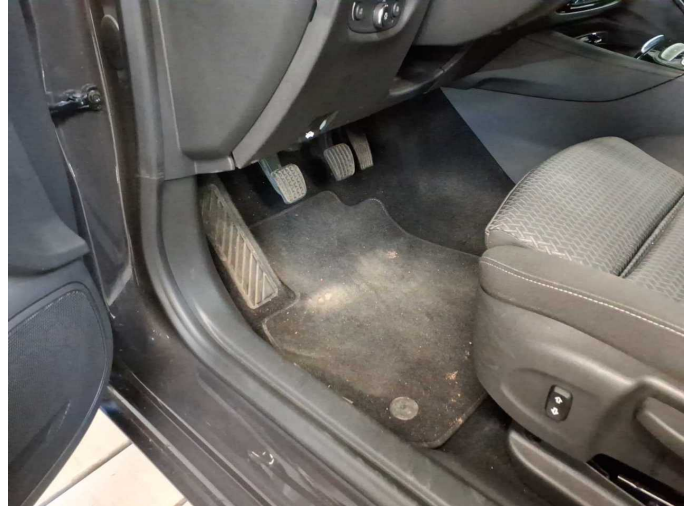
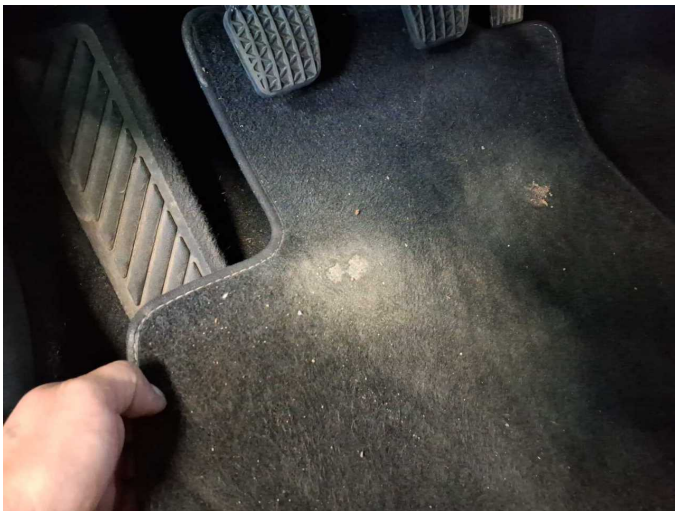
Damage 2: Trim / covers: Floor mats - Broken / torn - Replace

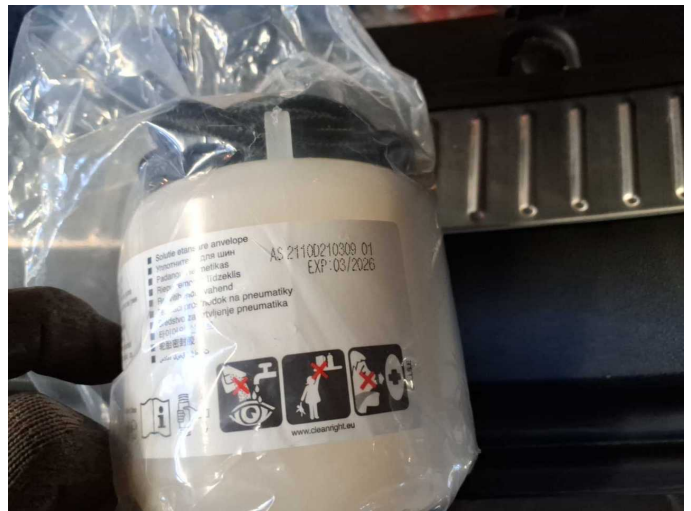
Damage 3: Equipment: Tirefit filler - Expired - Replace

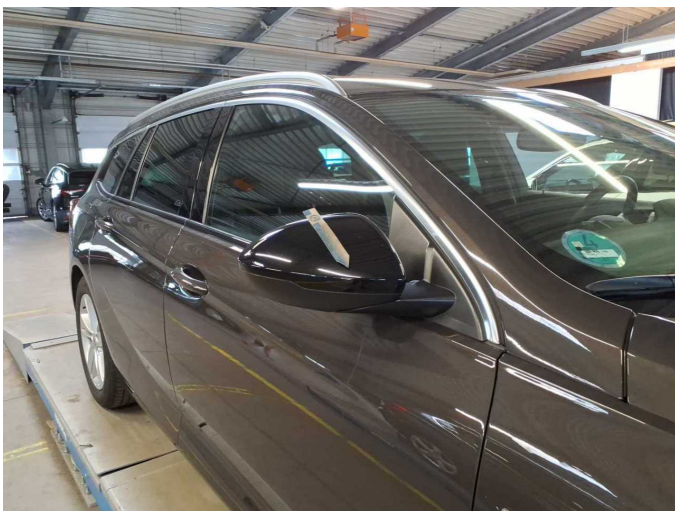
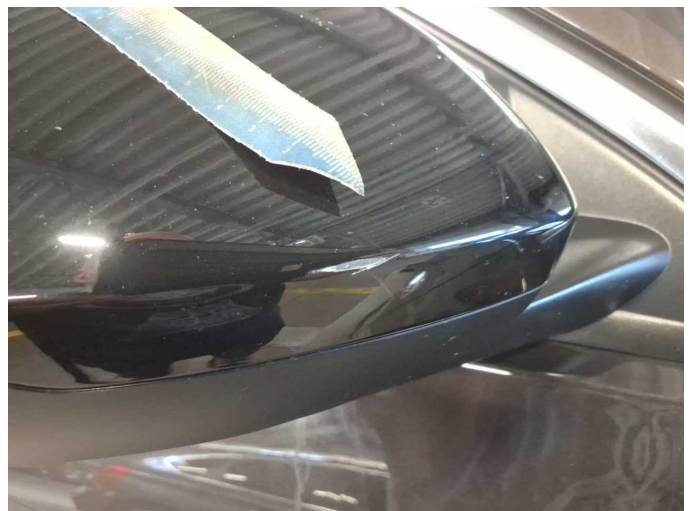
Damage 4: Wing mirror - right side: Cap - Scratch(es) - Smart repair

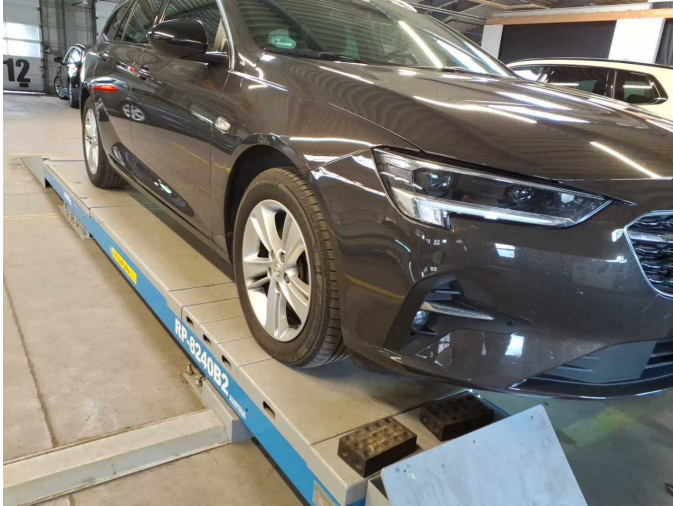
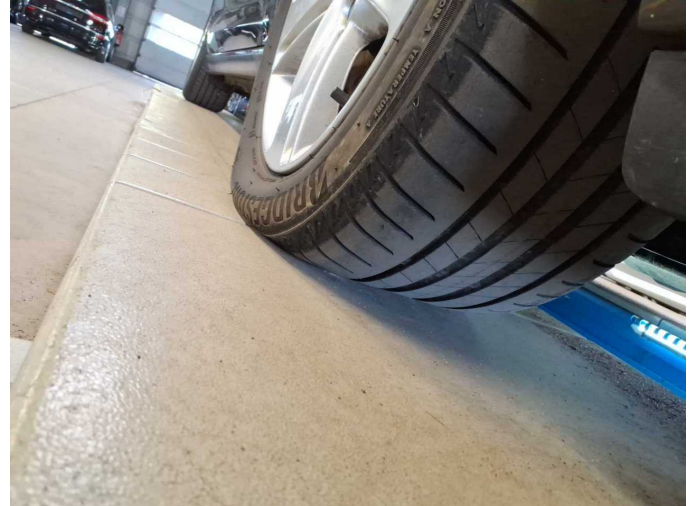
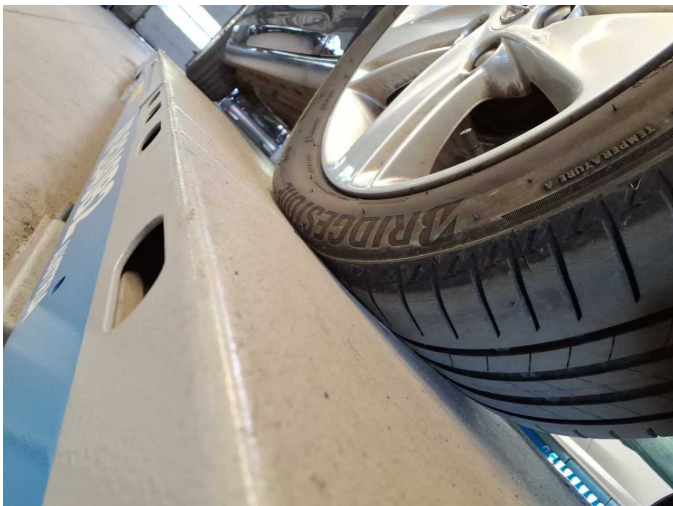
Damage 5: Wheel / tyres: Tyre - front right side (platt - Folgekosten möglich) - Empty - Perform diagnosis

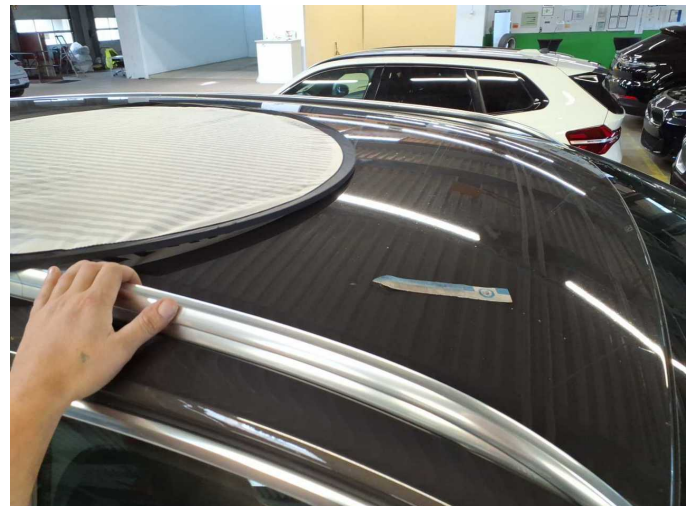
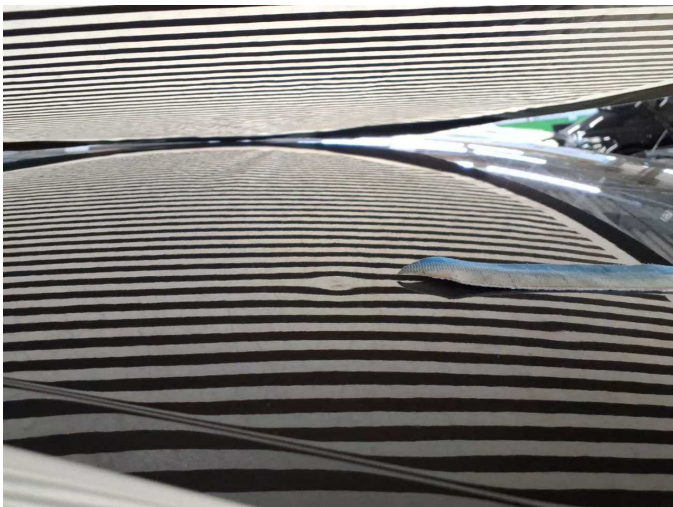
Damage 6: Roof: Roof - dent(s) - Smooth repair work

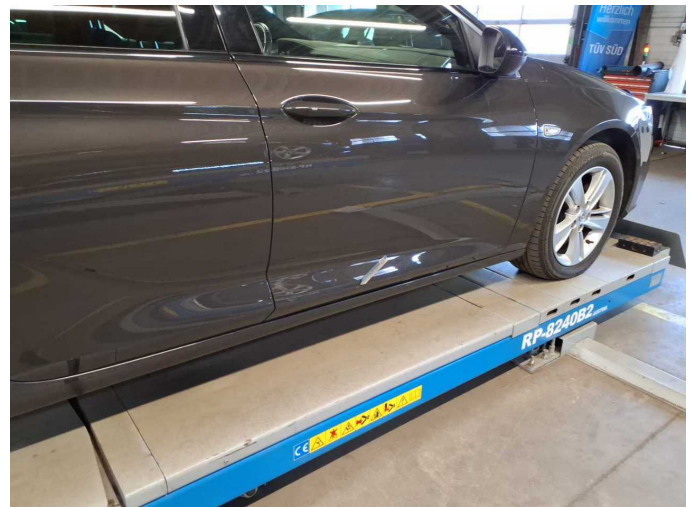
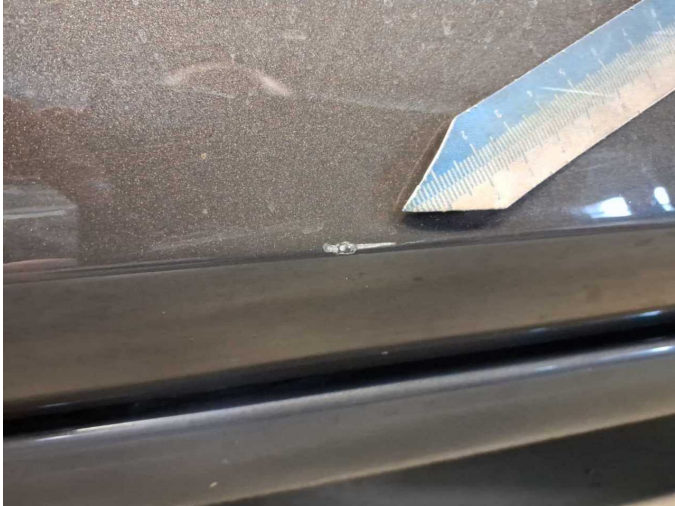
Damage 7: Door - front right side: Door - Scratch(es) - Smart repair

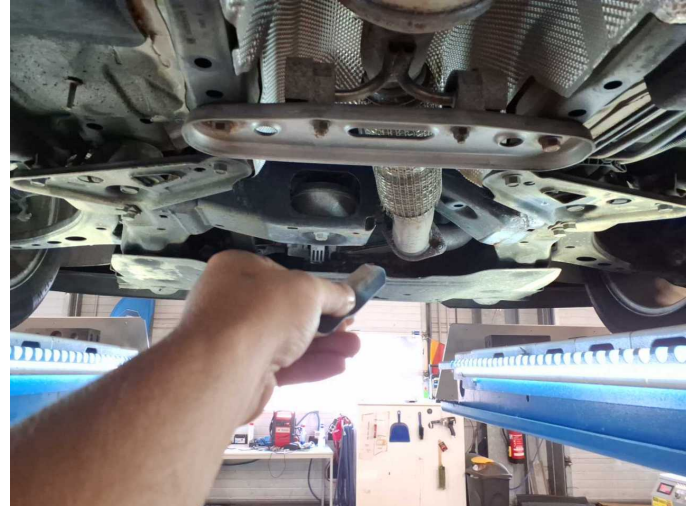
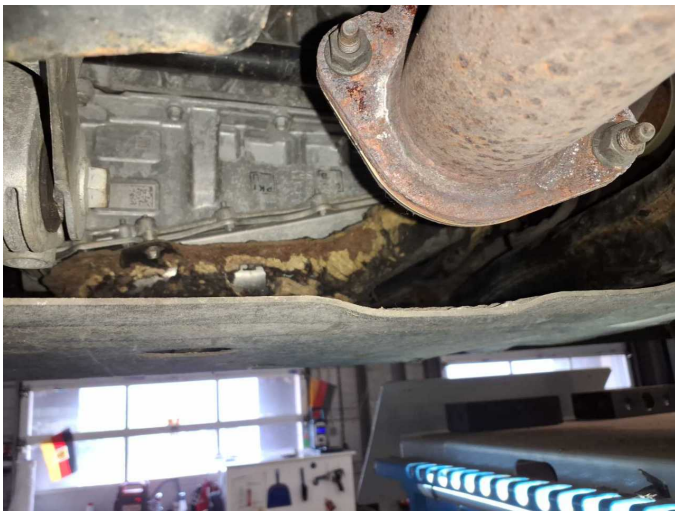
Damage 8: Engine: Engine oil sump (Dämmung - Mehrkosten möglich) - Damage caused by marten / rodent - Replace

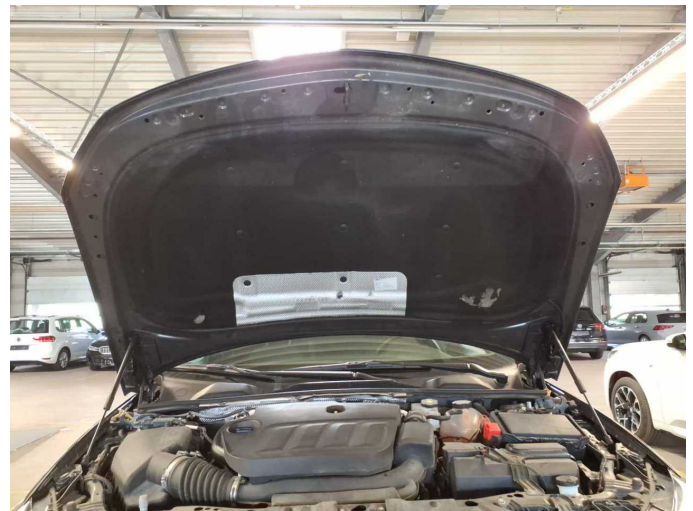
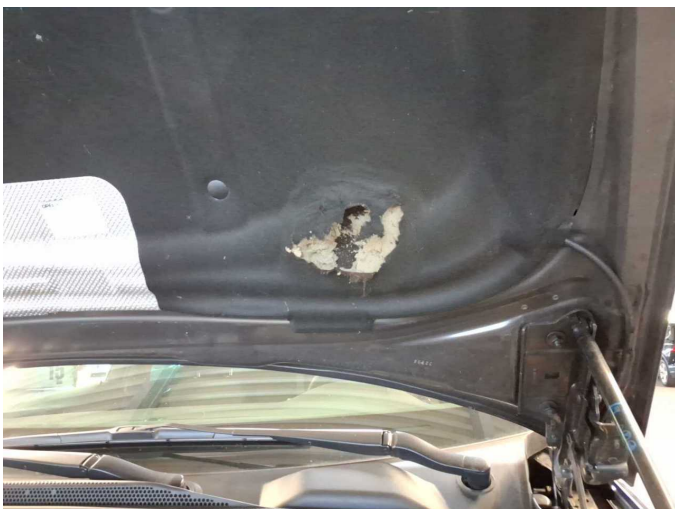
Damage 9: Bonnet: Insulation lining - Damage caused by marten / rodent - Replace

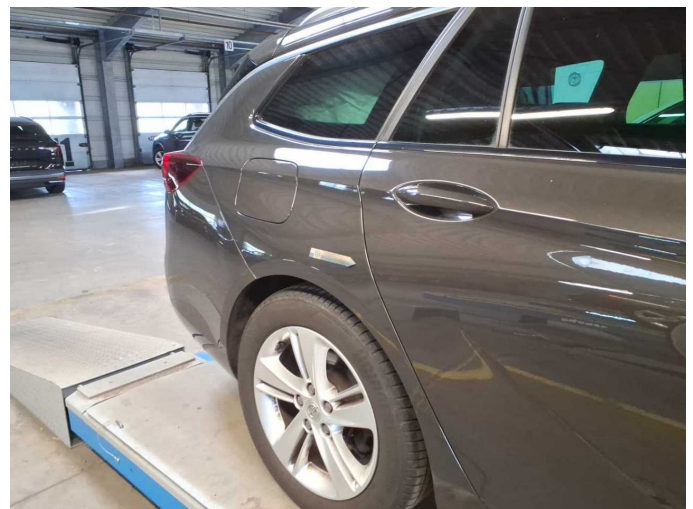
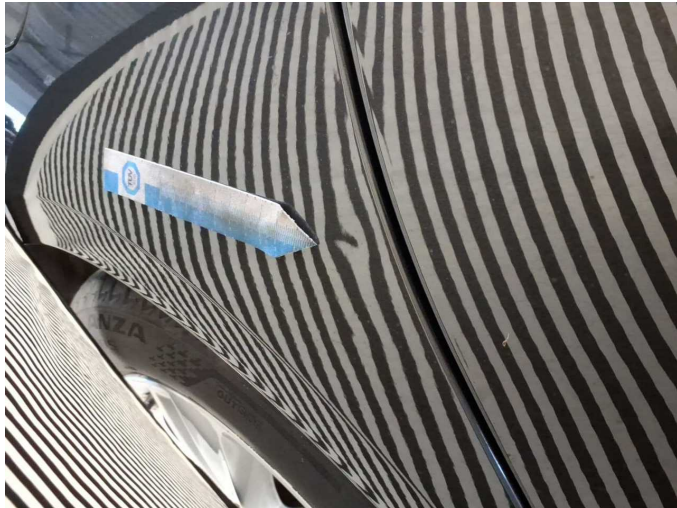
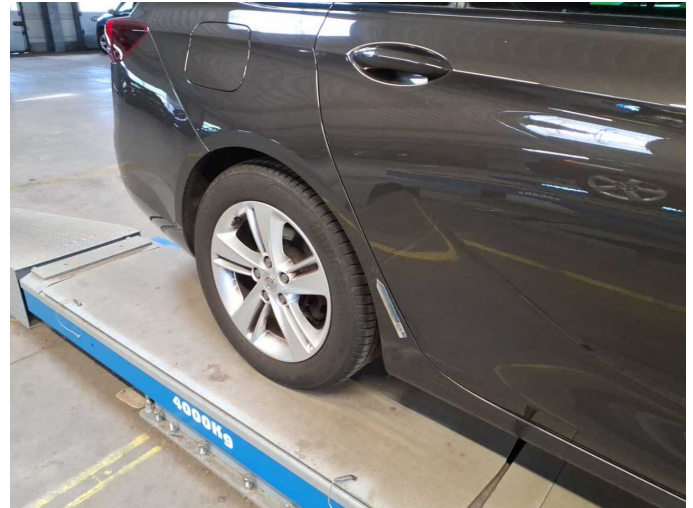
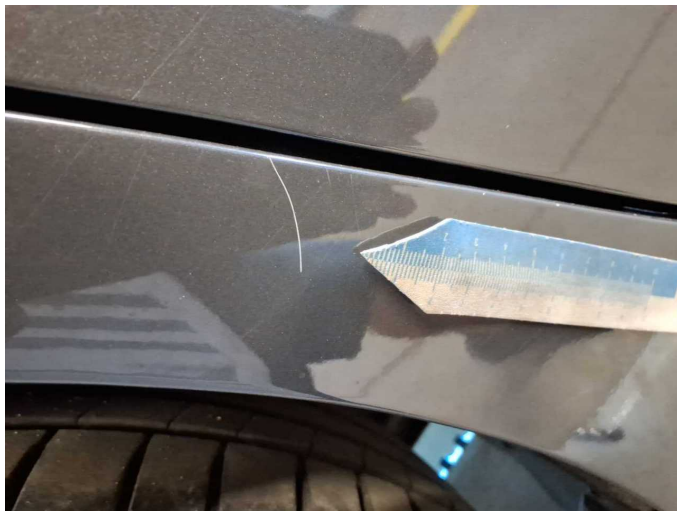
Damage 10: Side panel - rear right side: Side panel - Dent / paintcoat damage - Repair and paint

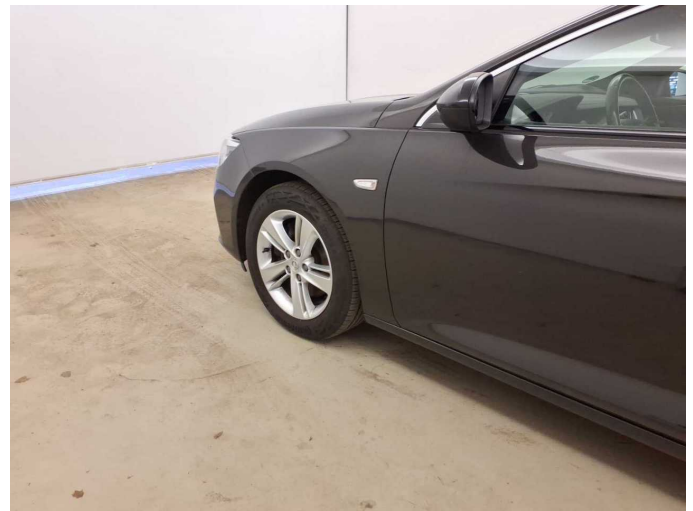
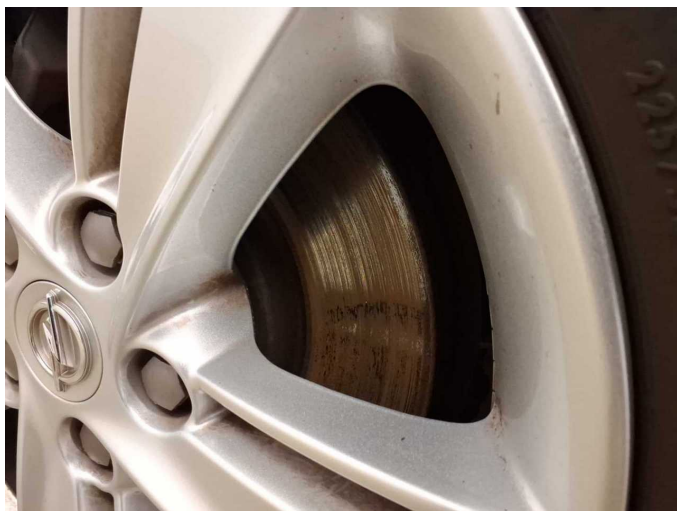
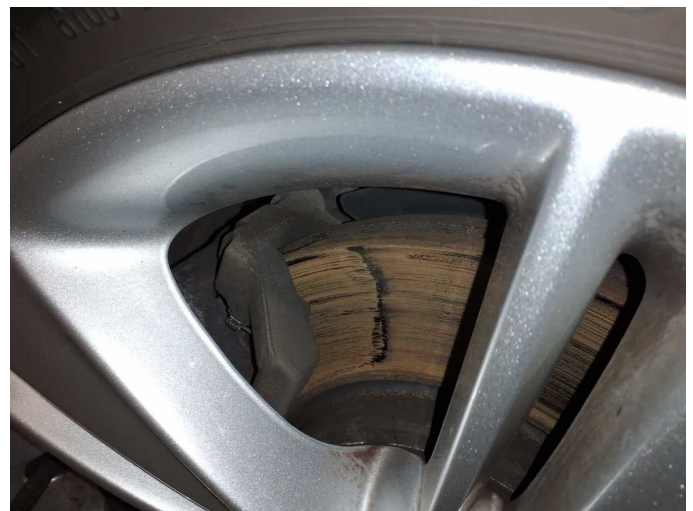
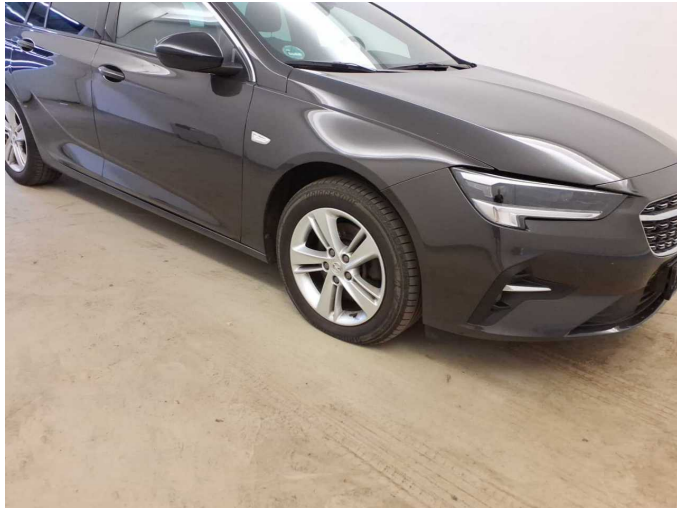
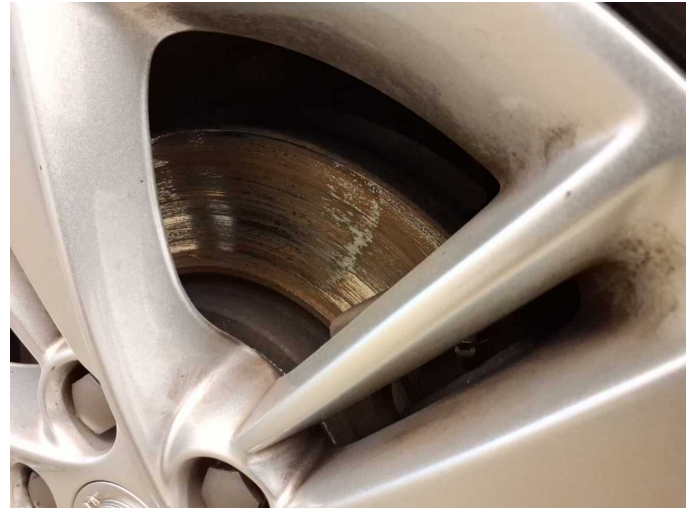
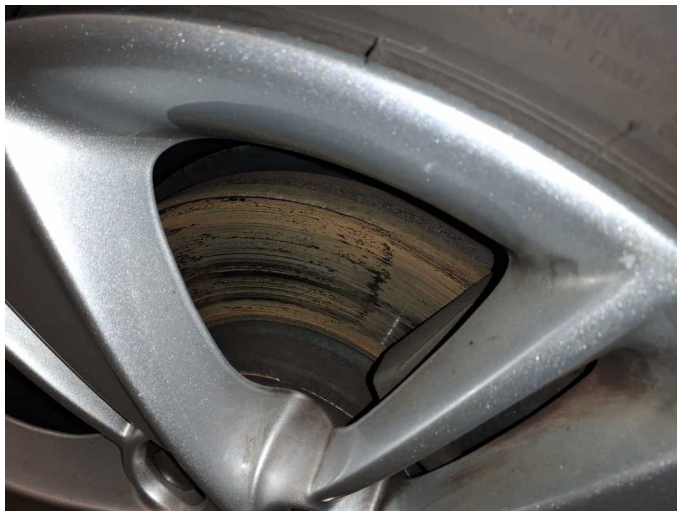
Damage 11: Braking system: Brake discs - front (Tragbild mangelhaft) - Corrosion - Replace

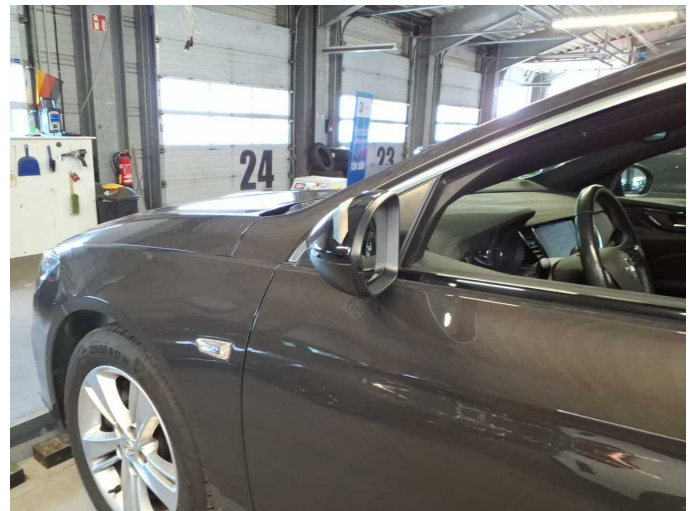
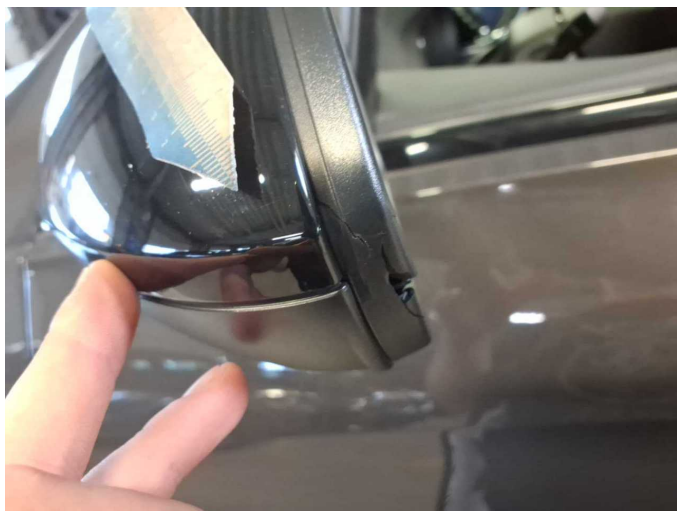
Damage 12: Wing mirror - left side: Mirror housing (Rahmen) - Broken / torn - Replace

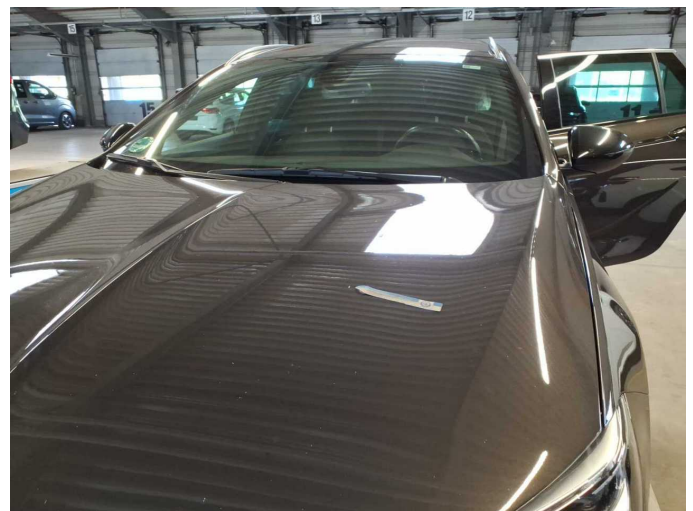
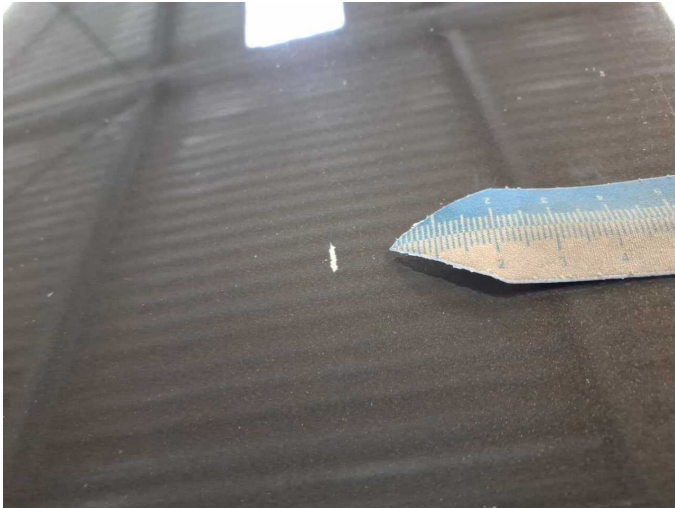
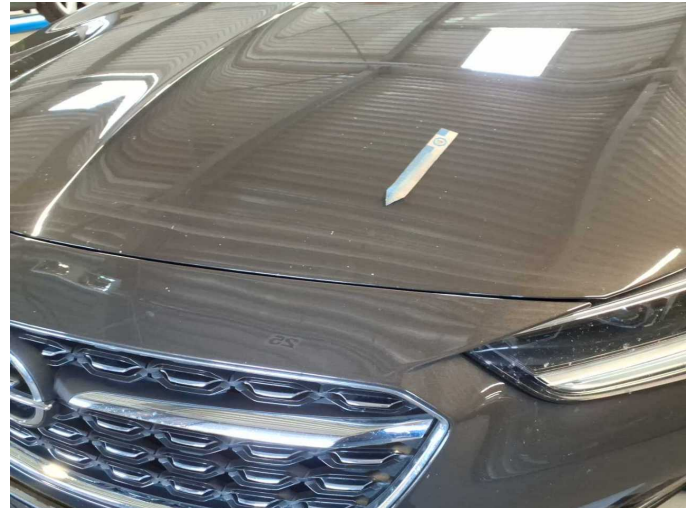
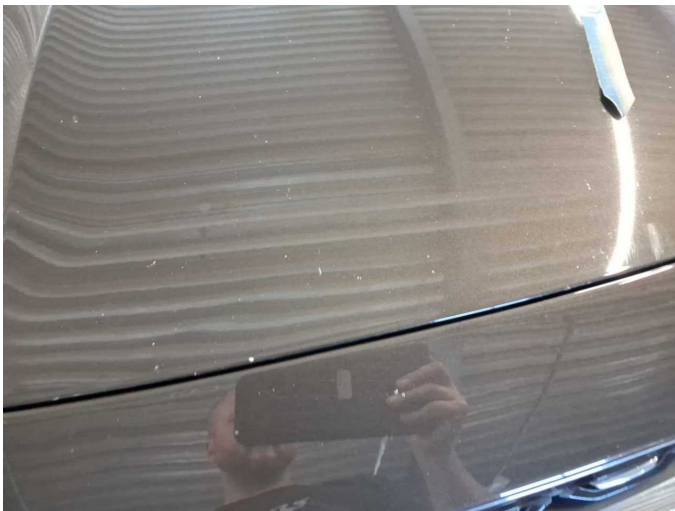
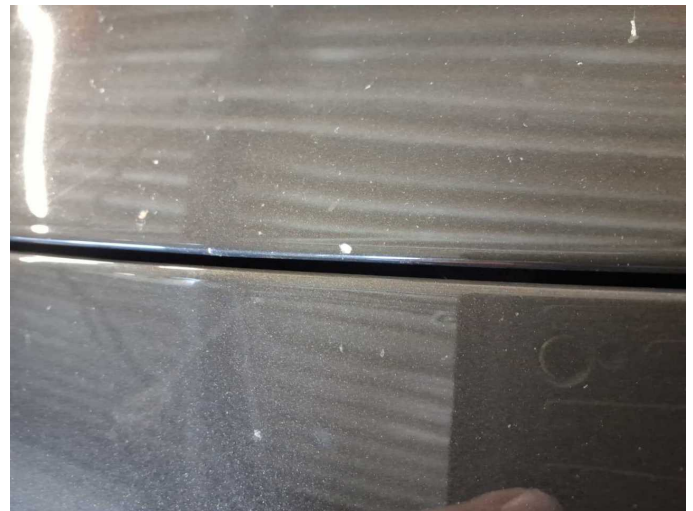
Damage 13: Bonnet: Bonnet - Stone chips - Paint

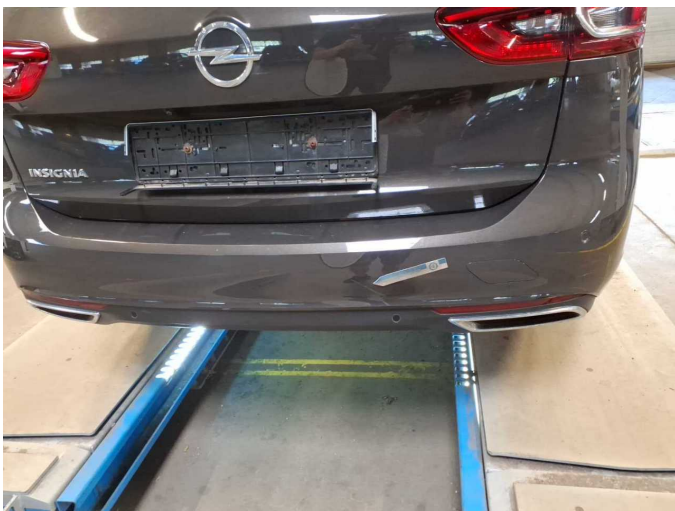
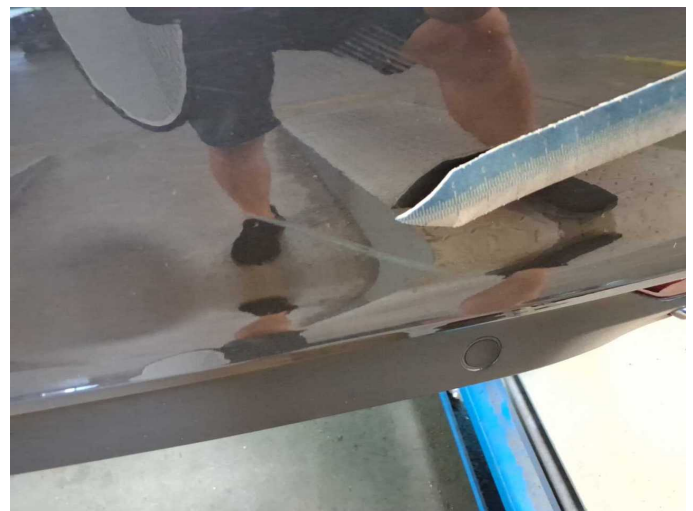
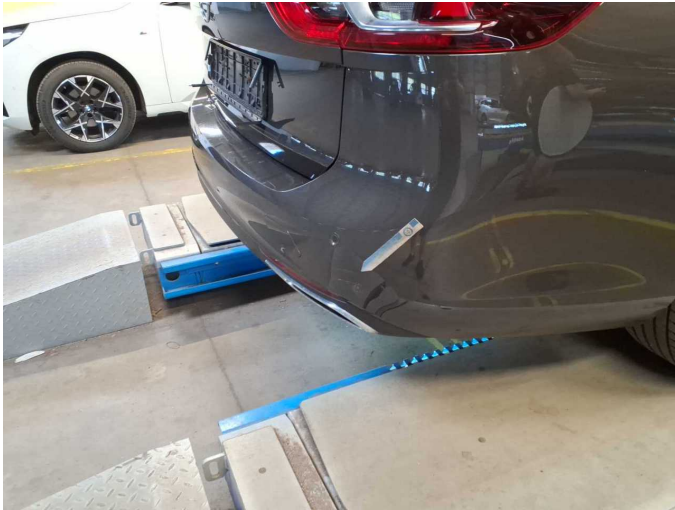
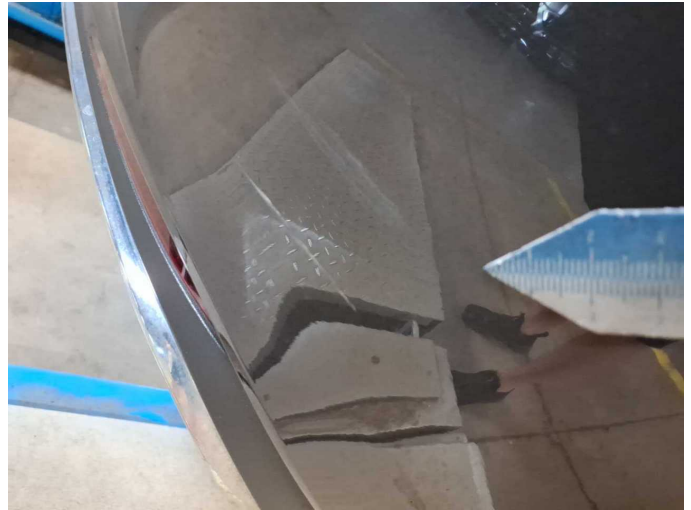
Wear and tear 2: Rear bumper: Rear bumper - Abrasion - No deduction

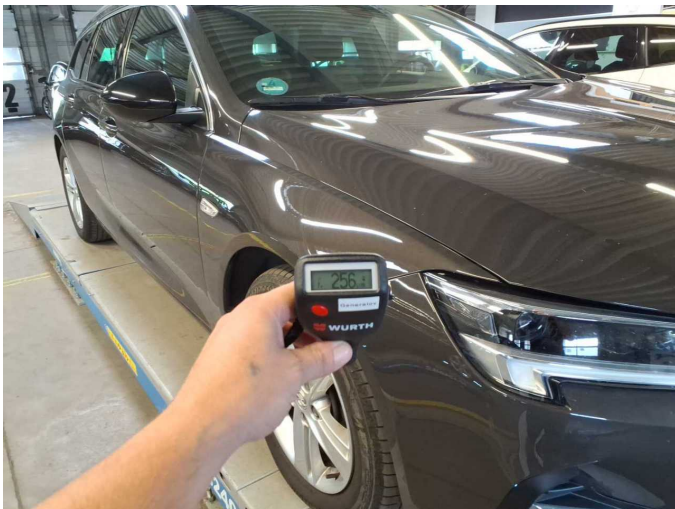
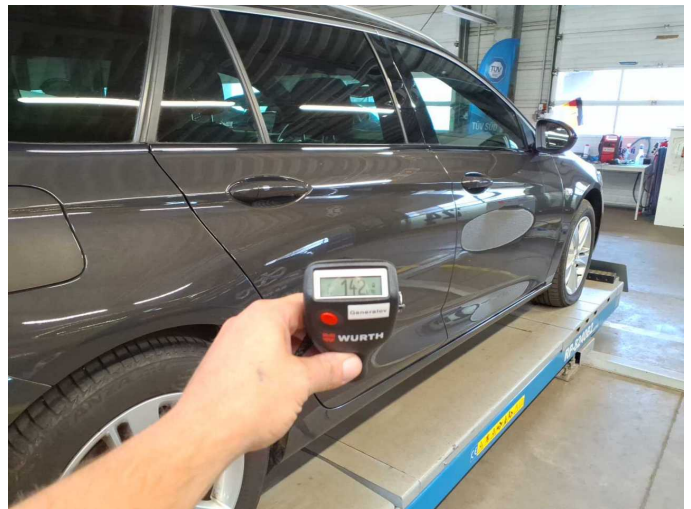
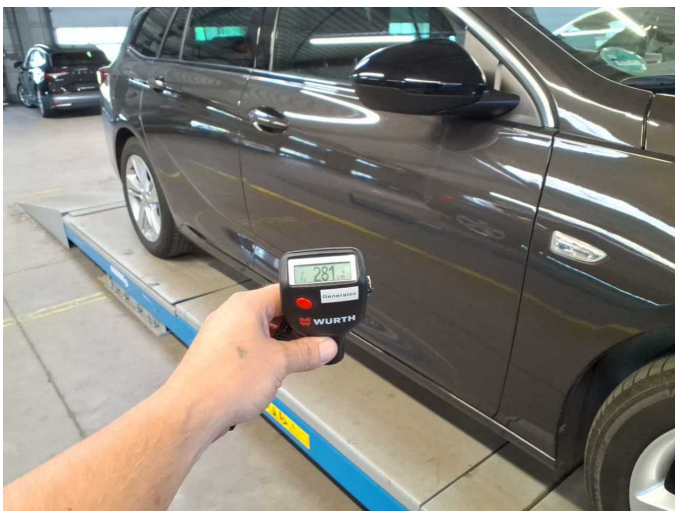
Mudguard - right side	256 µm	Door - rear right side	142 µm
Door - front right side	281 µm

Repainting 1: Mudguard - right side, Door - rear right side, Door - front right side
