## Expertise

Protocol number: 46242168  
Order No. / Reference: 26509281  
Inspection date: 26 Jun 2026

Manufacturer: Opel

Model: Astra 1.6 D Start/Stop Sports Tourer Business

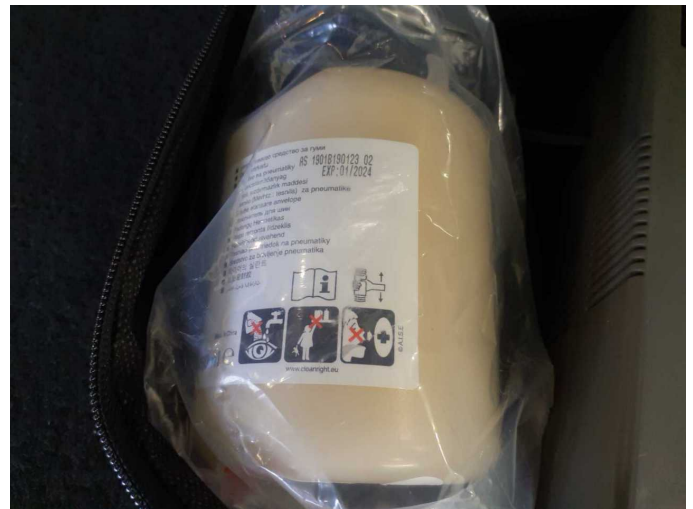
Damage 1: Equipment: Tirefit filler - Expired - Replace

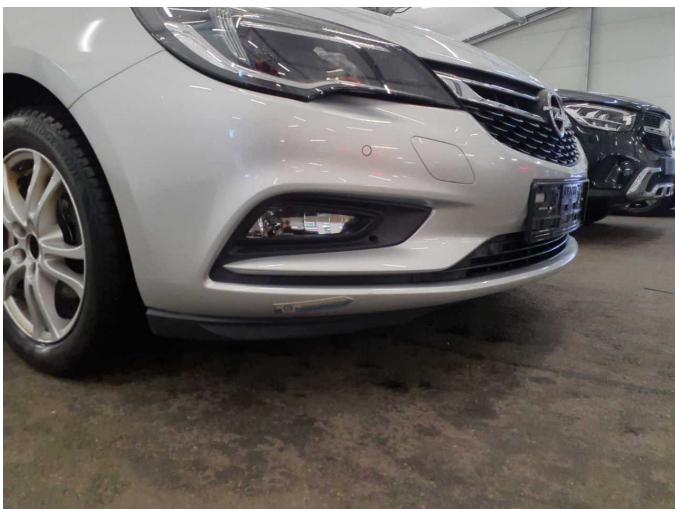
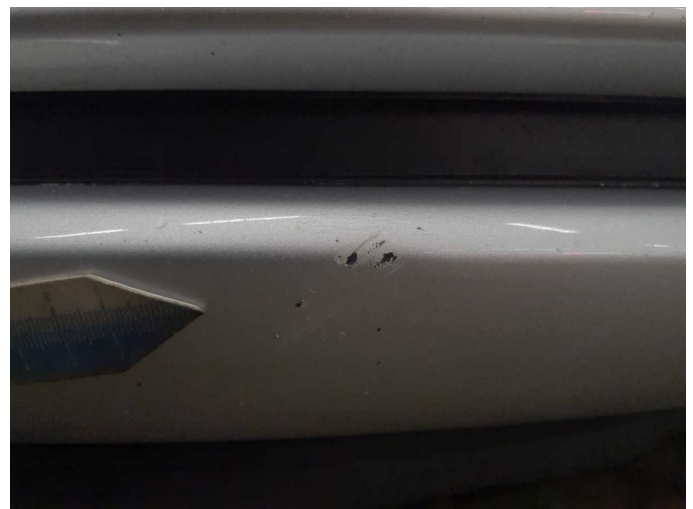
Damage 2: Front bumper: Front bumper - Scratch(es) - Smart repair

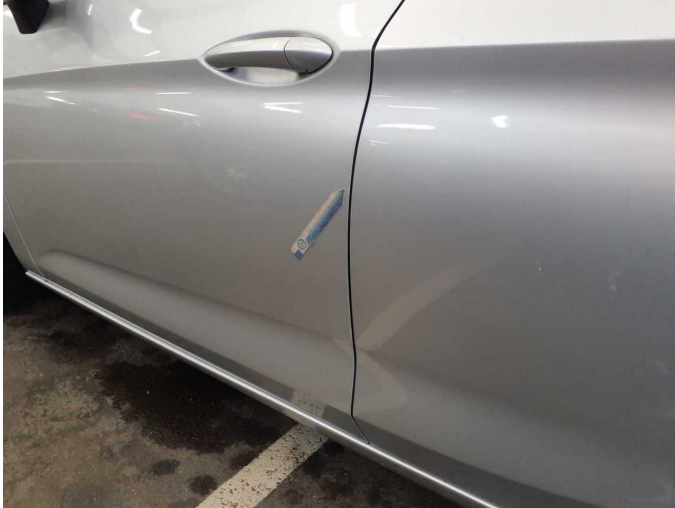
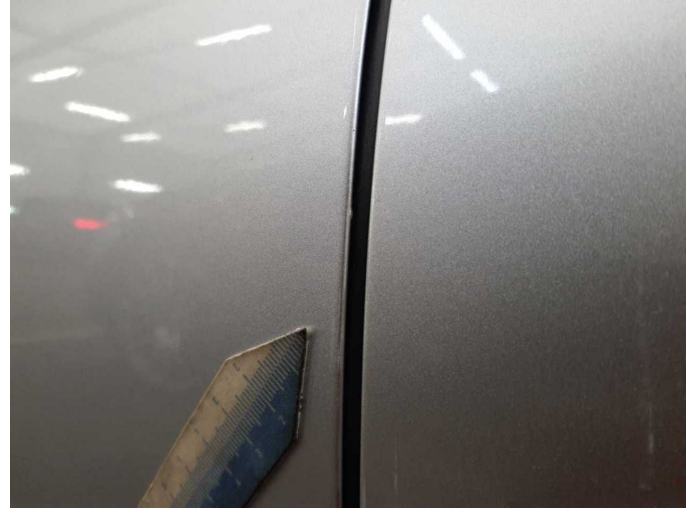
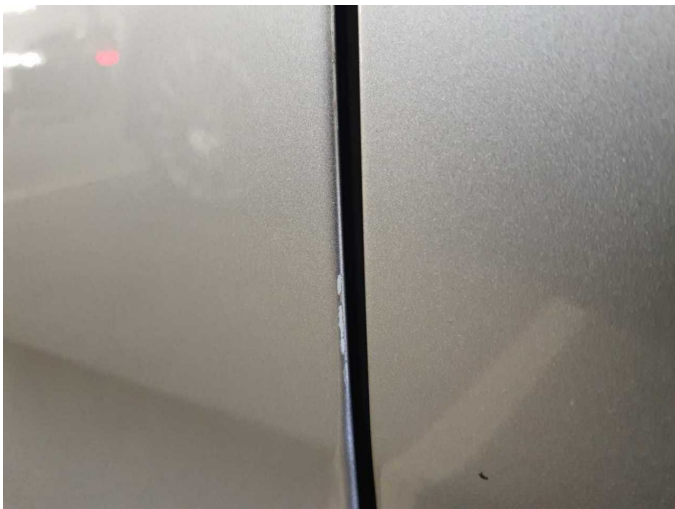
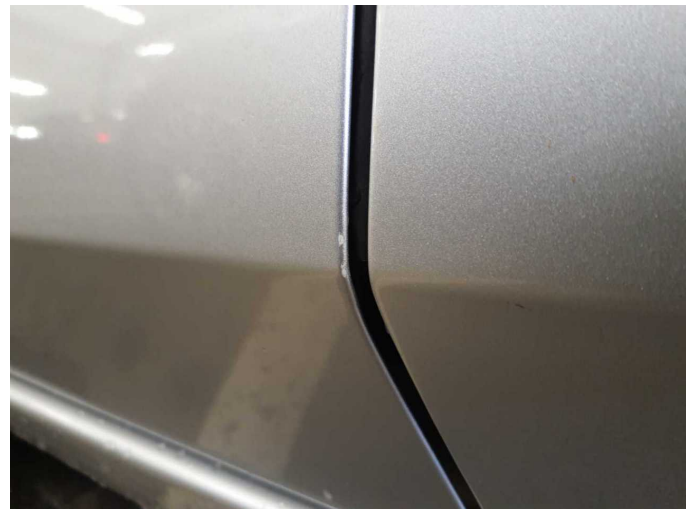
**Damage 3:** Door - front left side: Door edge - Scratch(es) - Smart repair

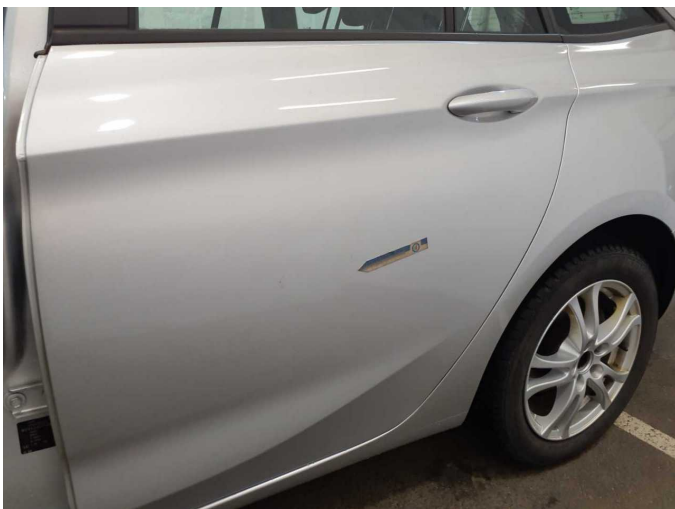
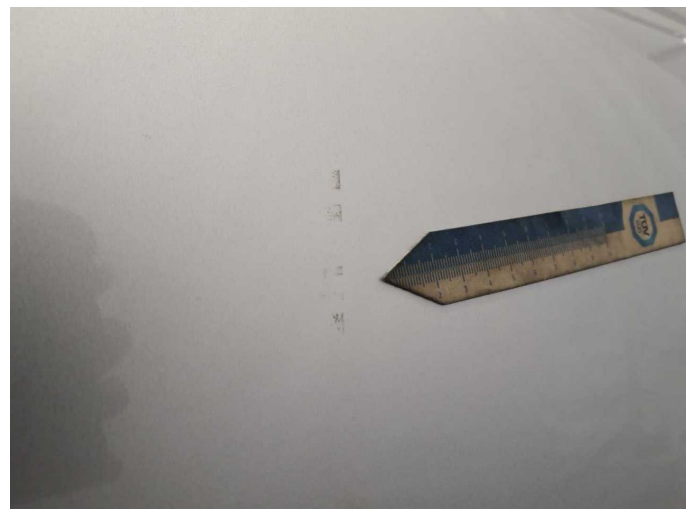
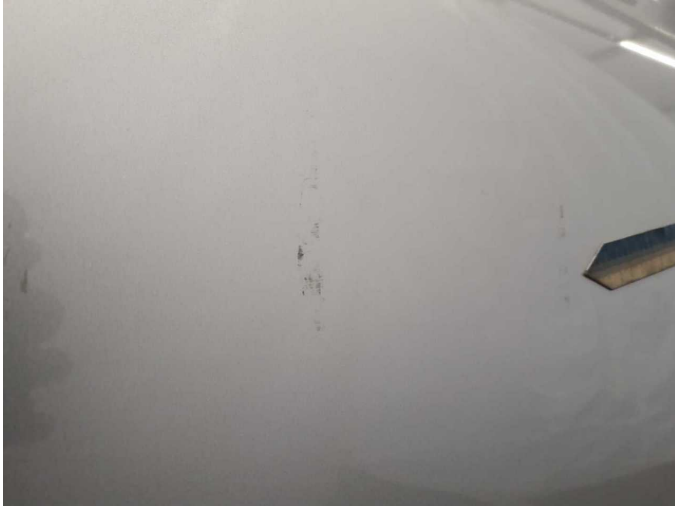
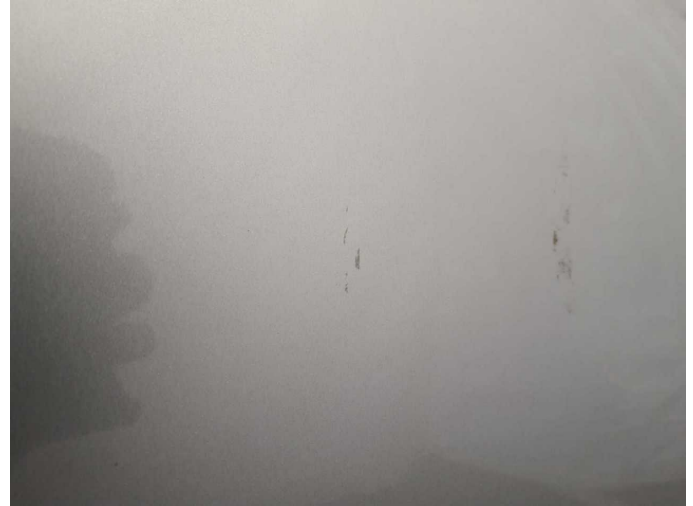
**Damage 4:** Door - rear left side: Door - Scratch(es) - Smart repair

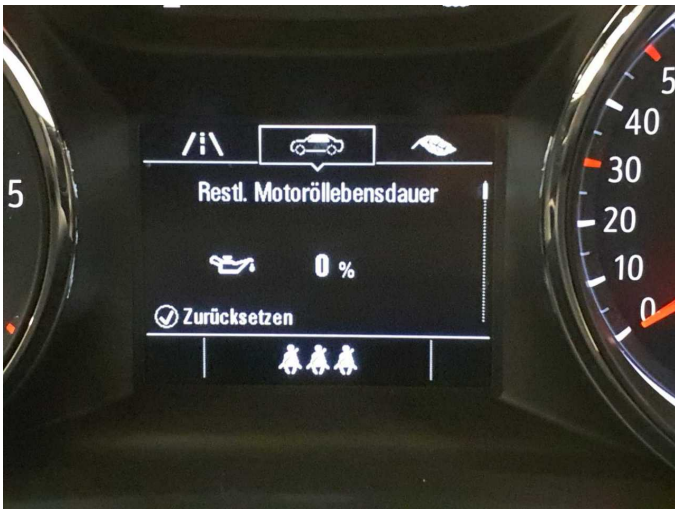
**Damage 5:** Misc.: Inspection / maintenance - Due - Perform

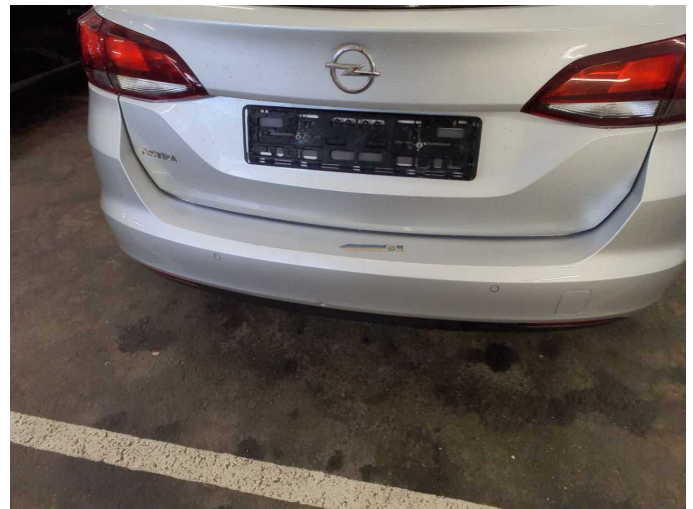
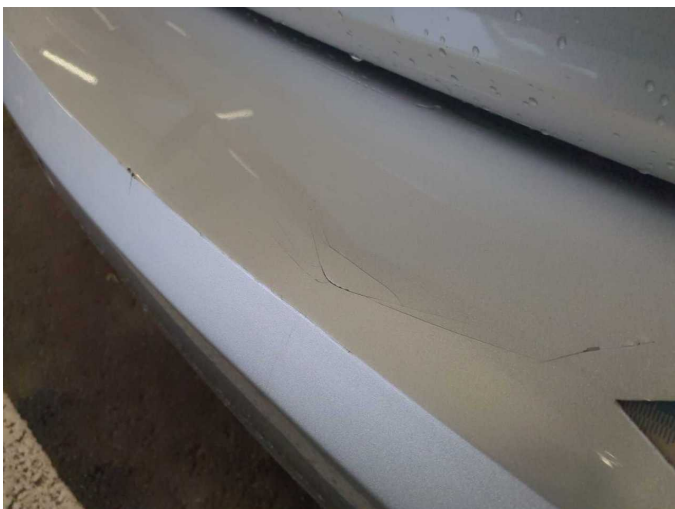
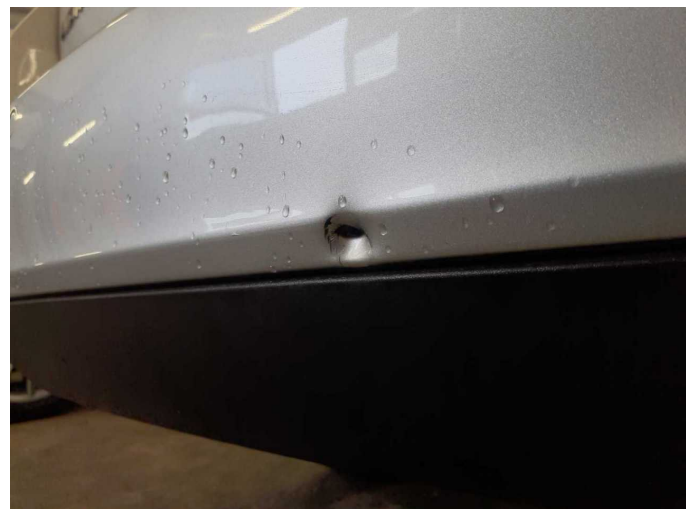
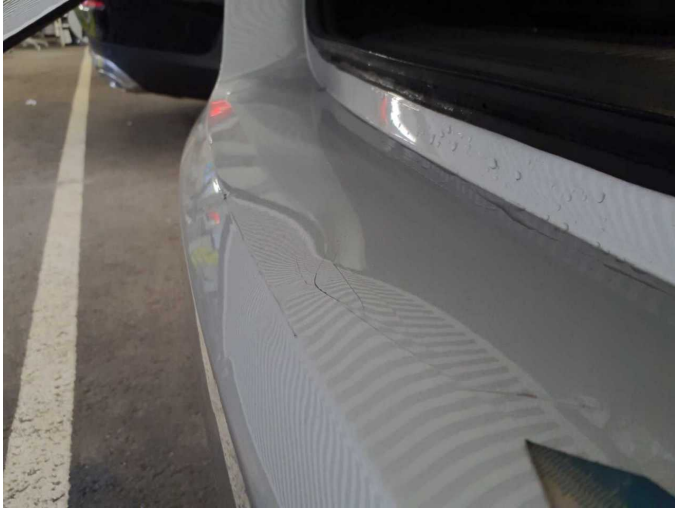
**Damage 6:** Rear bumper: Rear bumper - Deformed - Replace

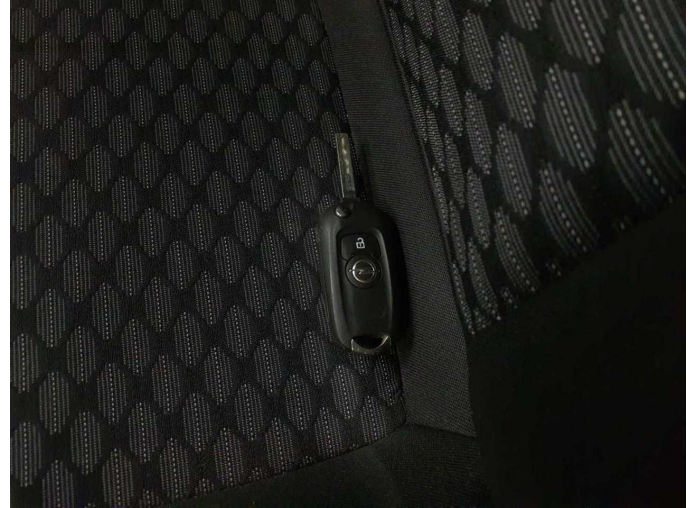
**Missing part 2:** Equipment: Vehicle key - Missing - Replace
