Expertise

Protocol number: 47211654  
Order No. / Reference: 26841787  
Inspection date: 19 Aug 2026

Manufacturer: Kia

Model: Ceed SW 1.6 GDI DCT OPF Plug-in-Hybrid Spirit

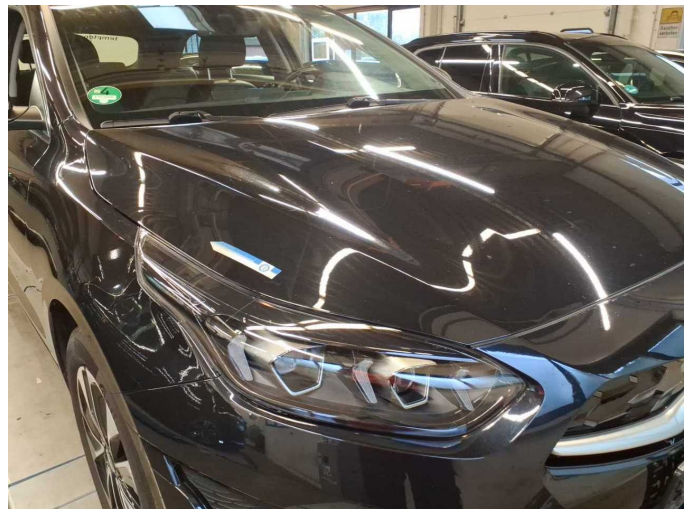
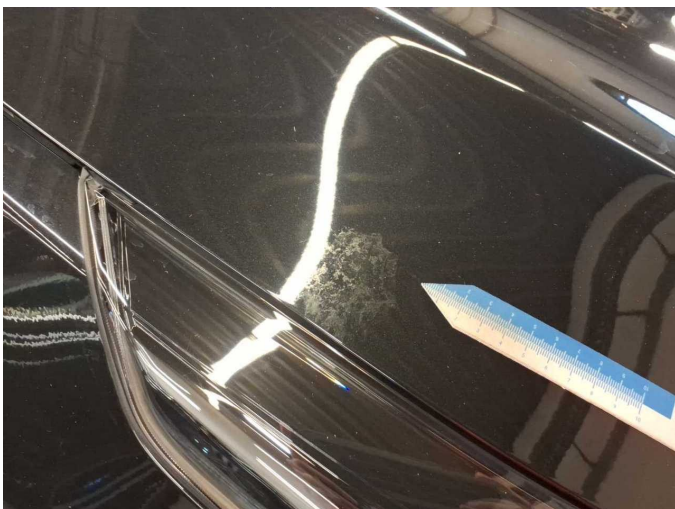
| No. | Component group | Description |
|---|---|---|
| 1 | Bonnet | Bonnet (Vogelkotverätzung eingebrannt) - Paint defect - Cover / polish |

**Damage 1:** Bonnet: Bonnet (Vogelkotverätzung eingebrannt) - Paint defect - Cover / polish

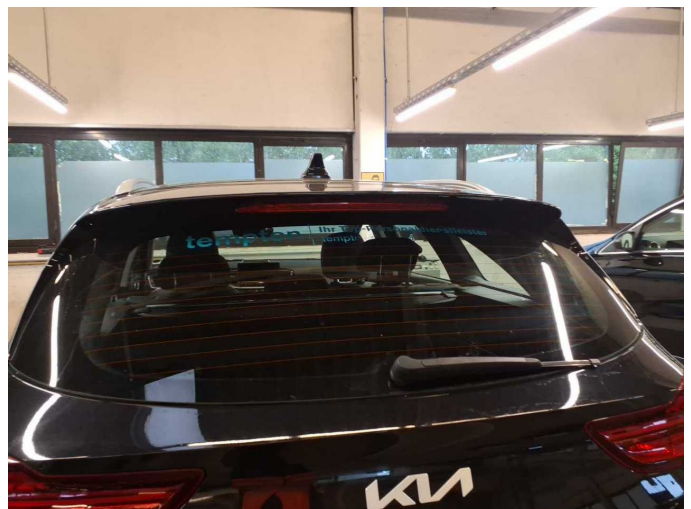
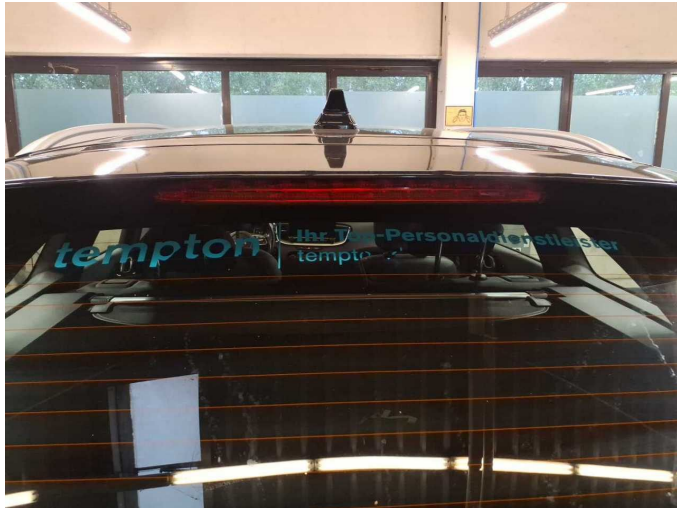
| No. | Component group | Description |
|---|---|---|
| 2 | Vehicle glazing | Rear window - Glued / labelled - De-glue / neutralise |

**Damage 2:** Vehicle glazing: Rear window - Glued / labelled - De-glue / neutralise

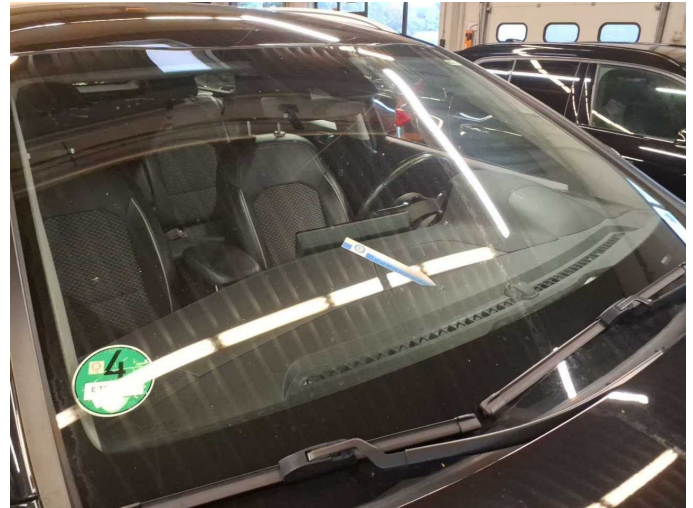
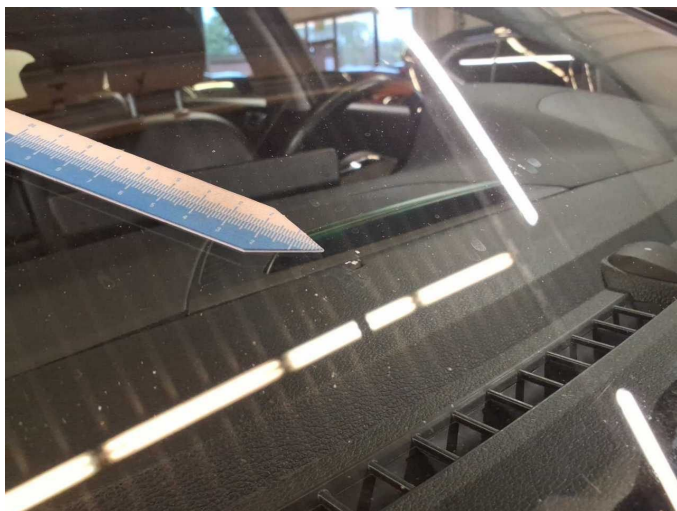
| No. | Component group | Description |
|---|---|---|
| 3 | Vehicle glazing | Windscreen - Stone chips - Smart repair |

**Damage 3:** Vehicle glazing: Windscreen - Stone chips - Smart repair

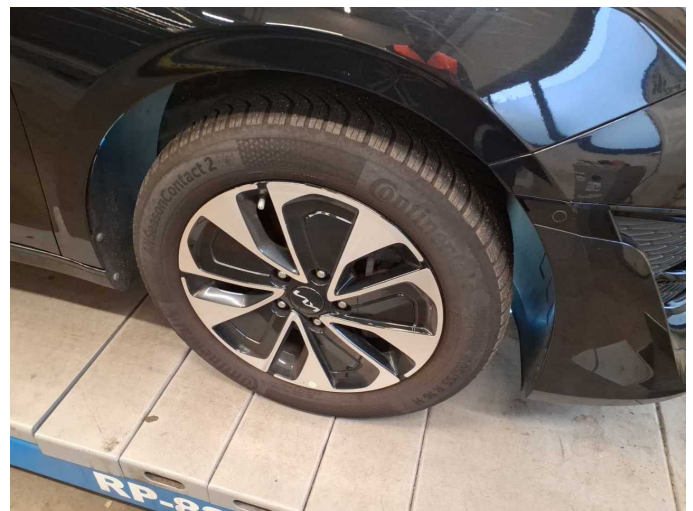
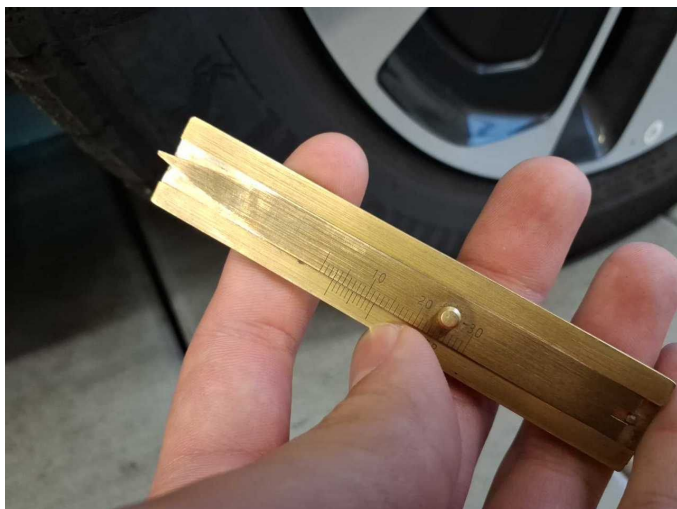
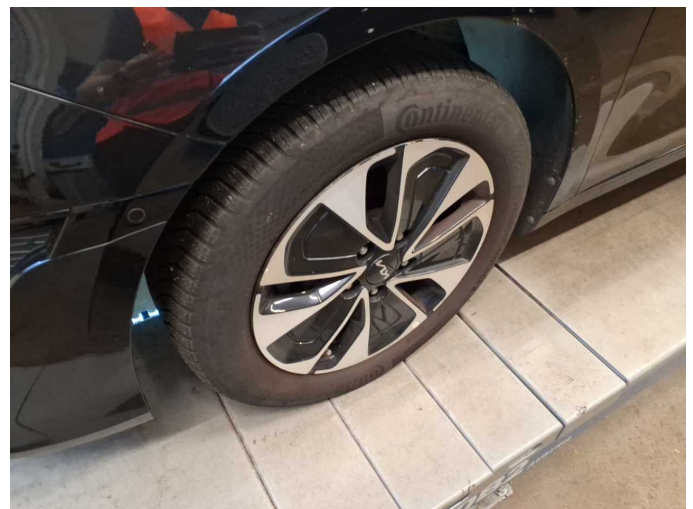
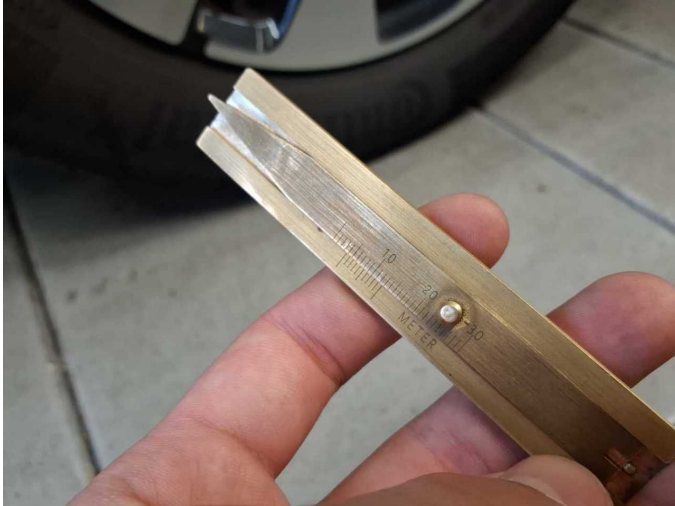
| No. | Component group | Description |
|---|---|---|
| 4 | Wheel / tyres | Tyre - front - Does not meet the leasing specifications - Replace |

**Damage 4:** Wheel / tyres: Tyre - front - Does not meet the leasing specifications - Replace

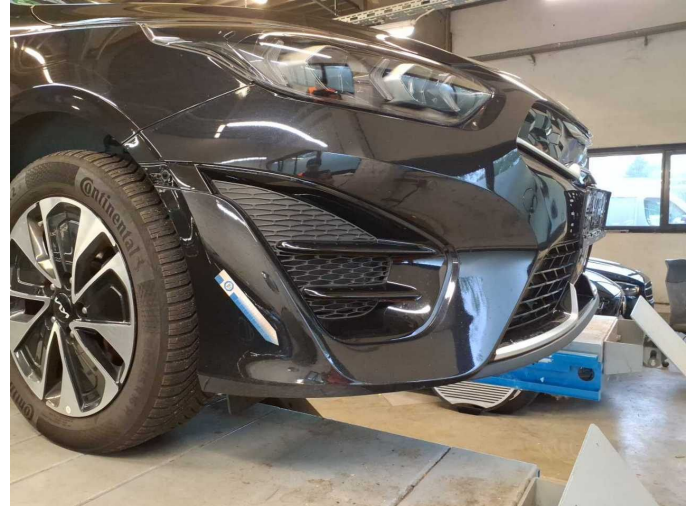
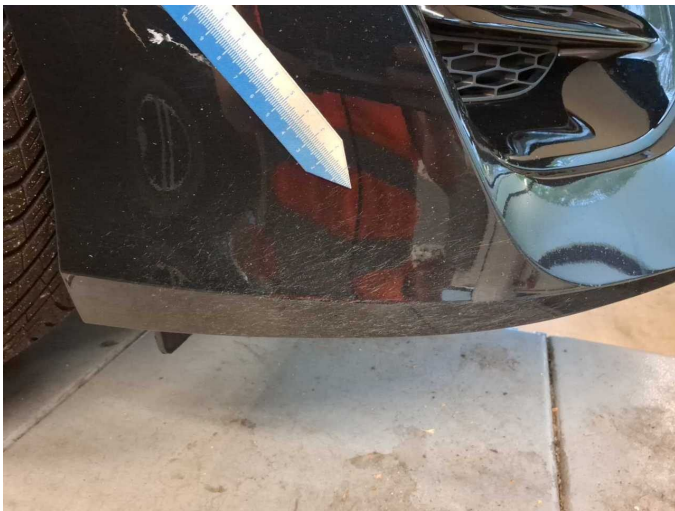
| No. | Component group | Description |
|---|---|---|
| 5 | Front bumper | Front bumper - Scratched - Paint |

**Damage 5:** Front bumper: Front bumper - Scratched - Paint

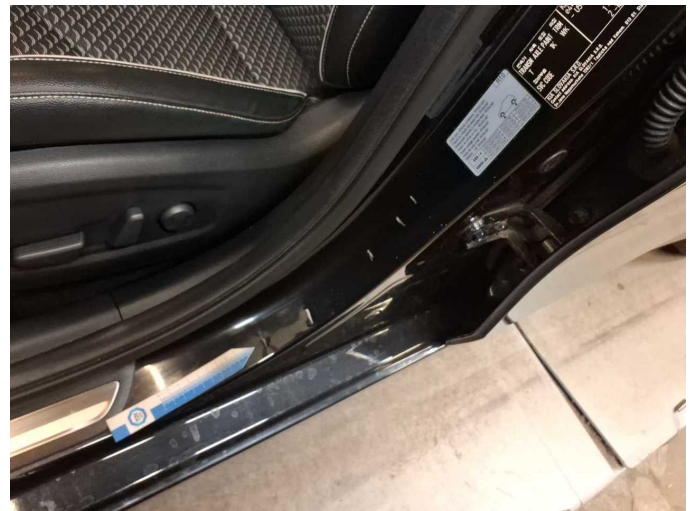
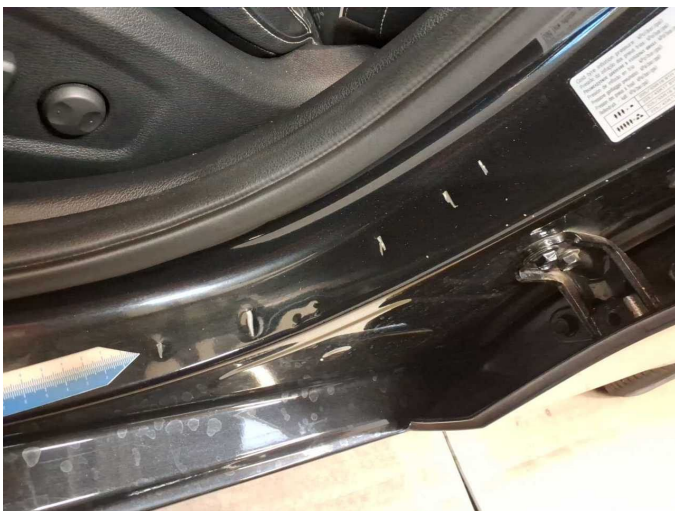
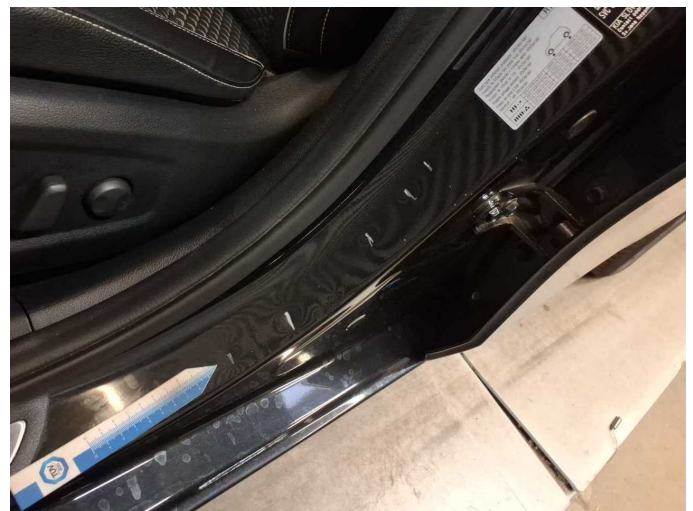
| No. | Component group | Description |
|---|---|---|
| 6 | Sill - left side | Sill - Dent / paintcoat damage - Repair and paint |

**Damage 6:** Sill - left side: Sill - Dent / paintcoat damage - Repair and paint

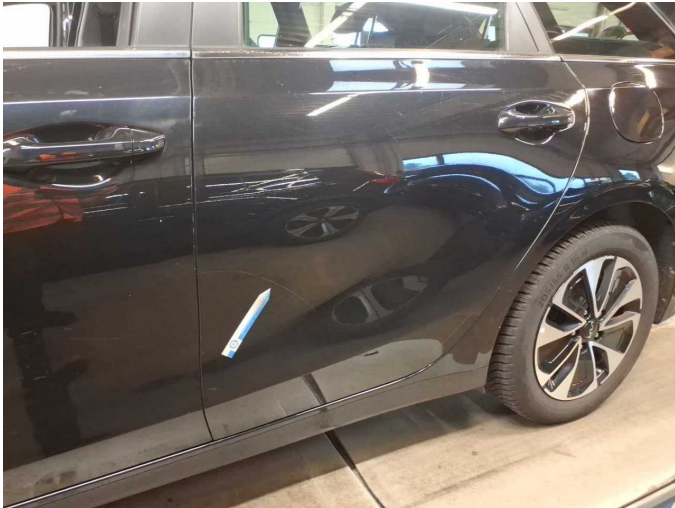
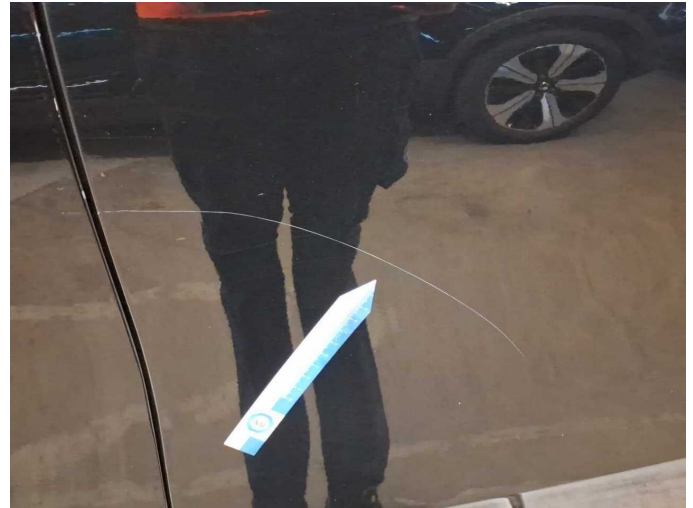
| No. | Component group | Description |
|---|---|---|
| 7 | Door - rear left side | Door - Scratch(es) - Paint |

**Damage 7:** Door - rear left side: Door - Scratch(es) - Paint

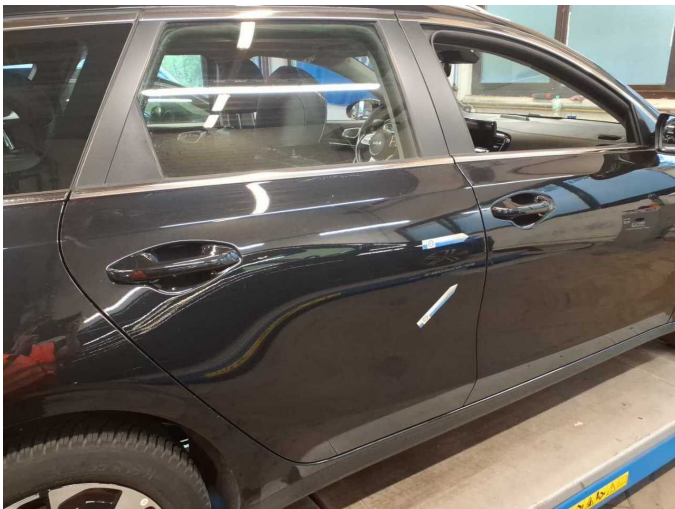
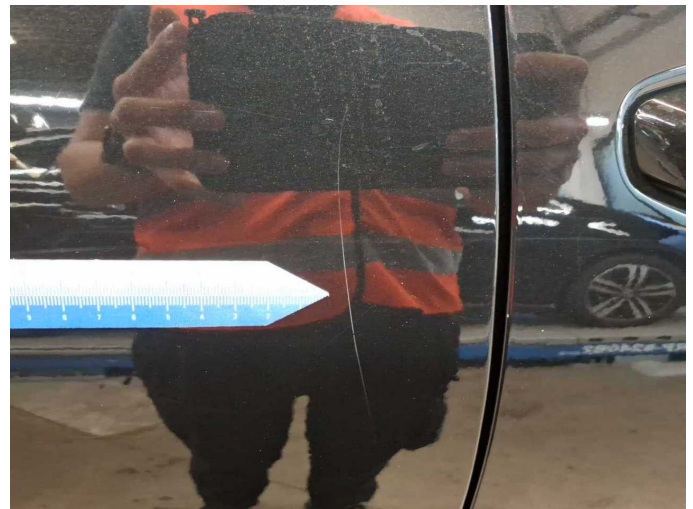
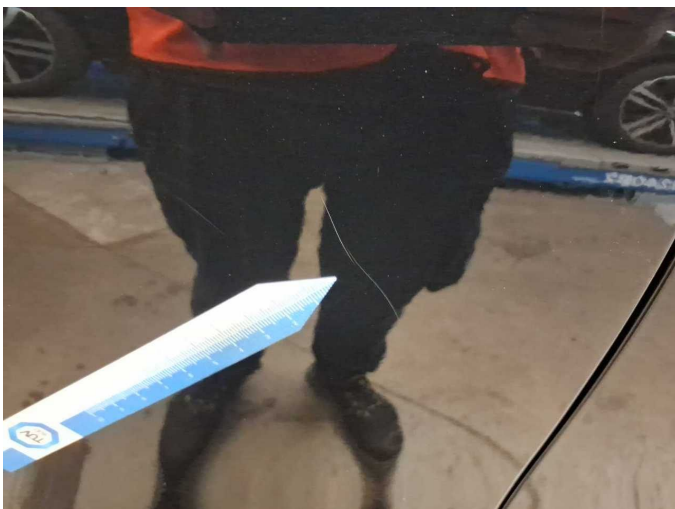
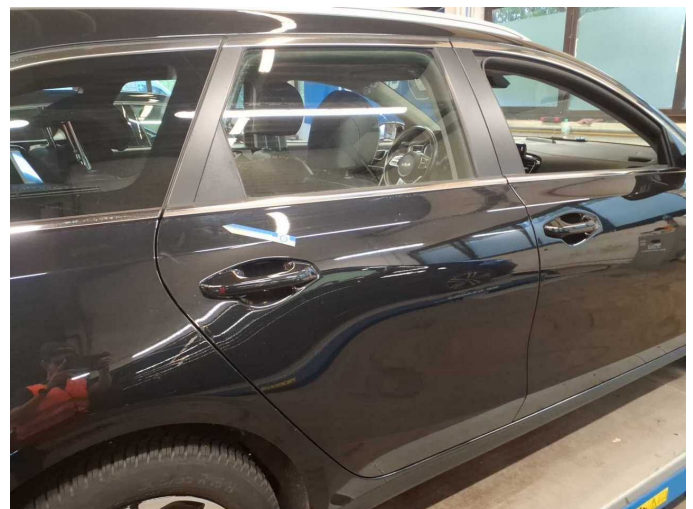
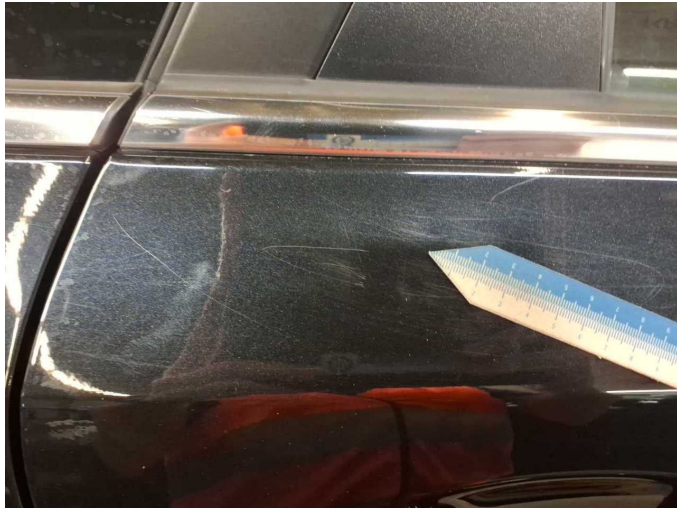
| No. | Component group | Description |
|---|---|---|
| 8 | Door - rear right side | Door - Scratch(es) - Paint |

**Damage 8:** Door - rear right side: Door - Scratch(es) - Paint

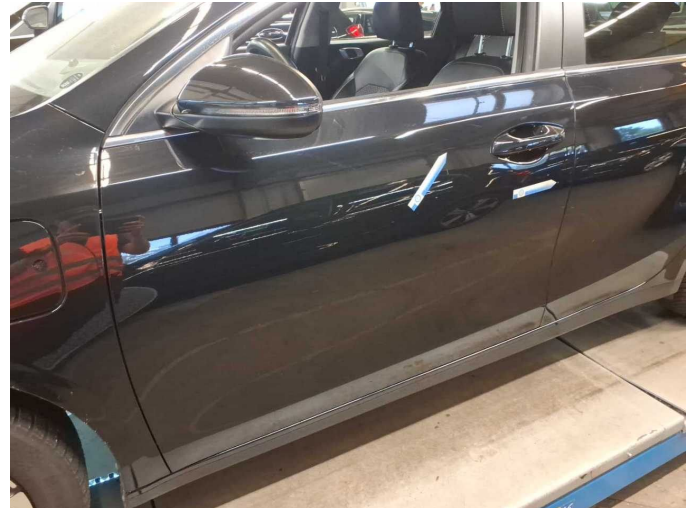
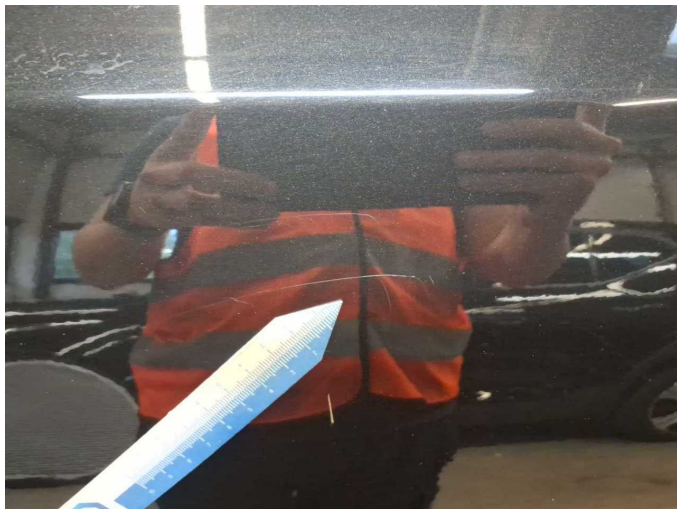
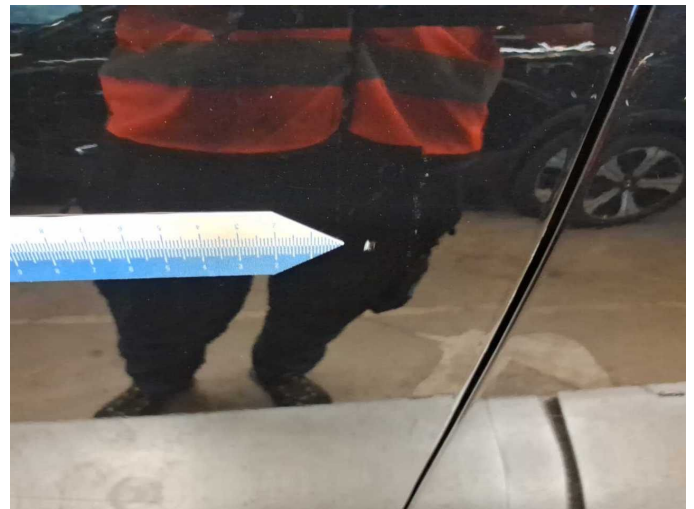
| No. | Component group | Description |
|---|---|---|
| 9 | Door - front left side | Door - Scratch(es) - Paint |

**Damage 9:** Door - front left side: Door - Scratch(es) - Paint

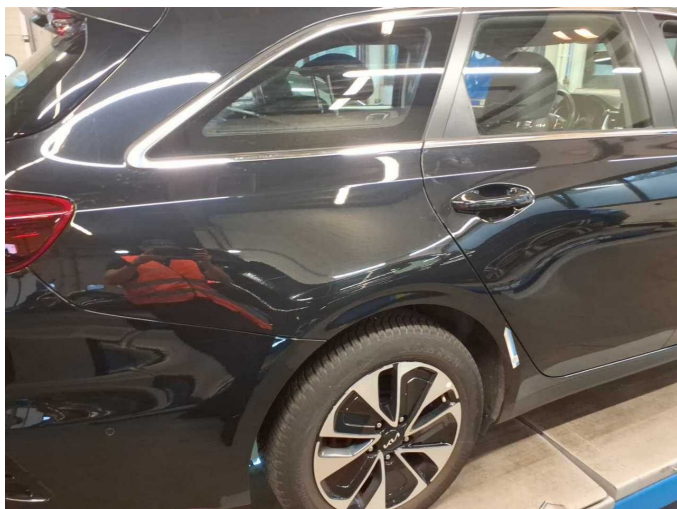
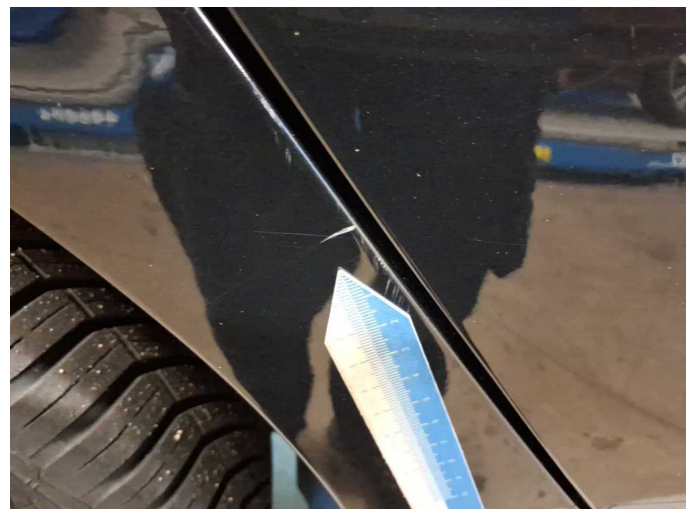
| No. | Component group | Description |
|---|---|---|
| 3 | Side panel - rear right side | Side panel - Scratch(es) - No deduction |

**Wear and tear 3:** Side panel - rear right side: Side panel - Scratch(es) -  
No deduction

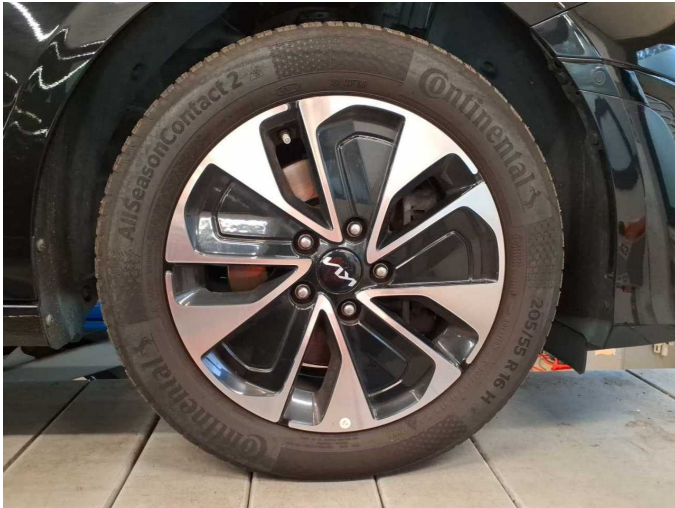
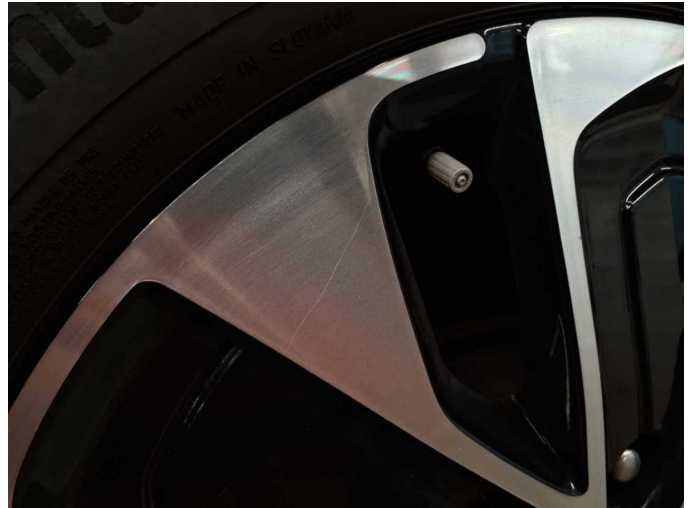
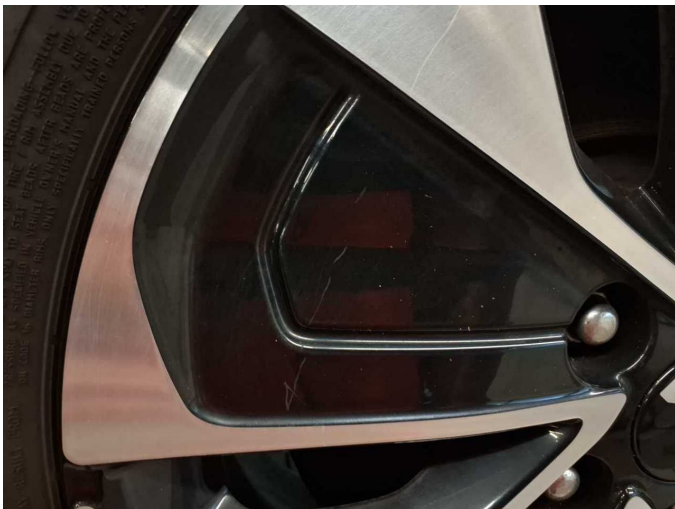
| No. | Component group | Description |
|---|---|---|
| 4 | Wheel / tyres | Alloy rim - front right side - Scratch(es) - No deduction |

**Wear and tear 4:** Wheel / tyres: Alloy rim - front right side - Scratch(es) - No deduction

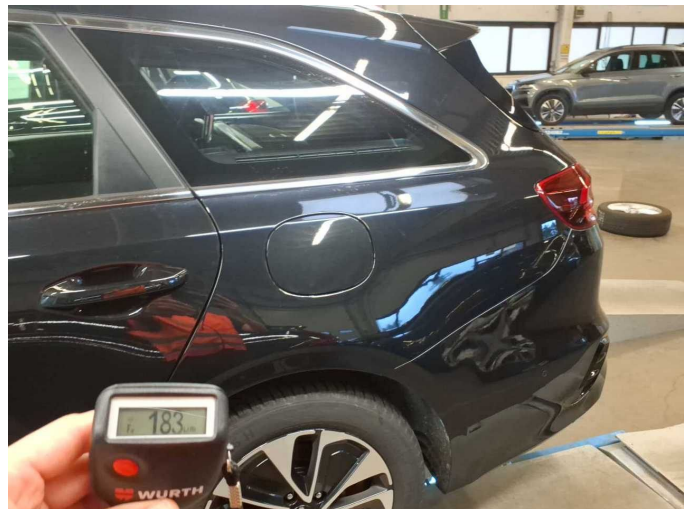
| No. | Repainting |
|---|---|
| 1 | Side panel - rear left side, Professionally carried out, Invoice of repair done Non-existent |

**Repainting 1:** Side panel - rear left side
