Expertise

Protocol number: 46179752  
Order No. / Reference: 26553528  
Inspection date: 26 Jun 2026

Manufacturer: Ford

Model: Kuga 2.0 EcoBlue Aut. 4x4 COOL&CONNECT

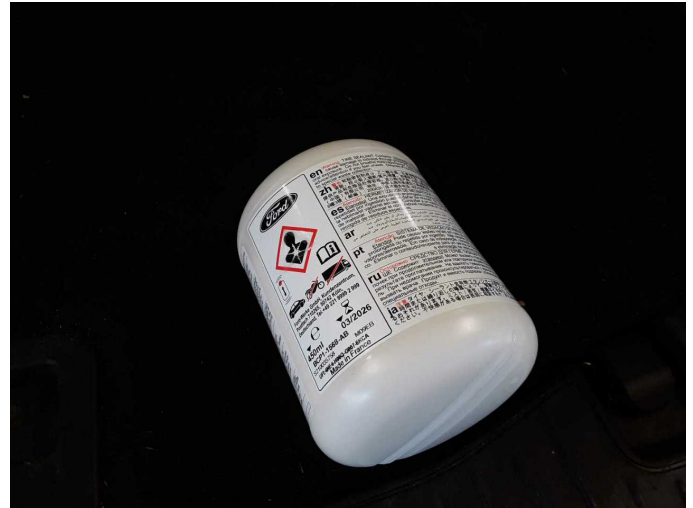
| No. | Component group | Description |
|---|---|---|
| 1 | Equipment | Tirefit filler - Expired - Replace |

**Damage 1:** Equipment: Tirefit filler - Expired - Replace

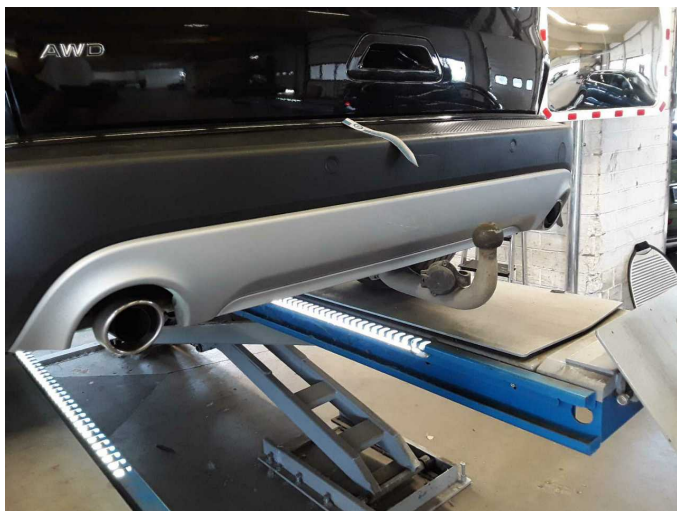
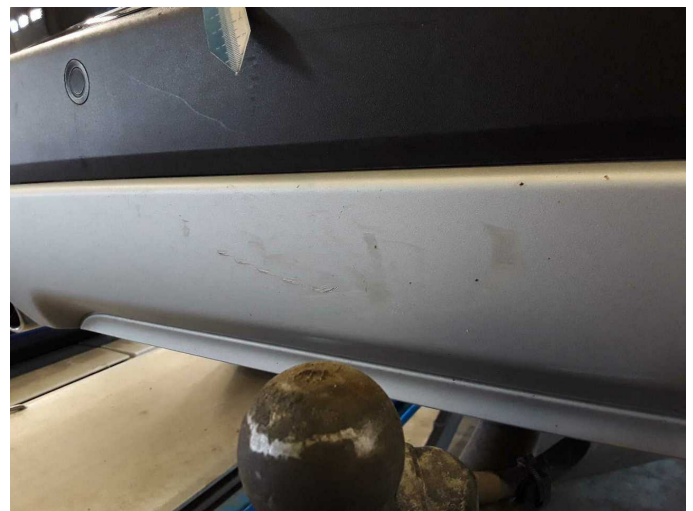
| No. | Component group | Description |
|---|---|---|
| 2 | Rear bumper | Spoiler - Scratched - Loss in value |

**Damage 2:** Rear bumper: Spoiler - Scratched - Loss in value

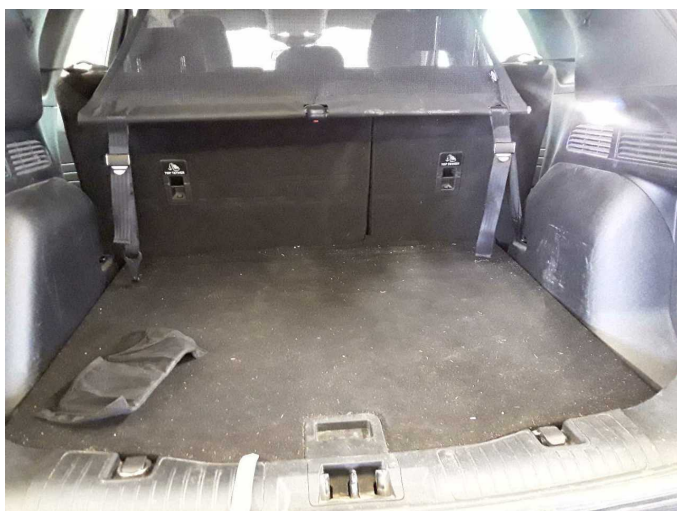
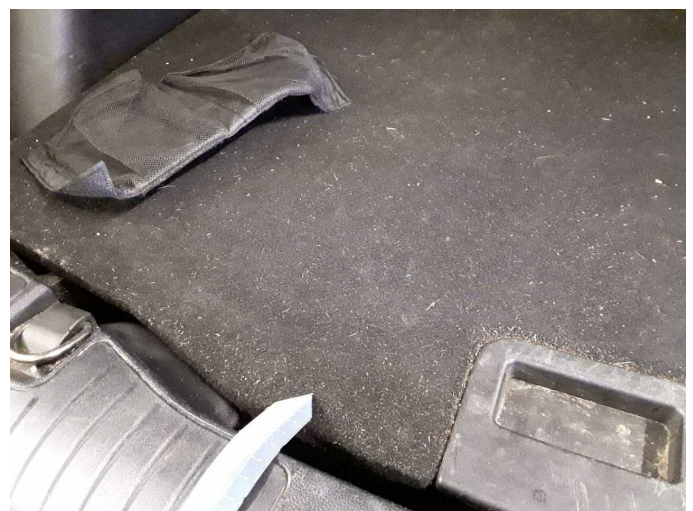
| No. | Component group | Description |
|---|---|---|
| 3 | Interior | Interior (Hundehaare) - Soiled - Conditioning |

**Damage 3:** Interior: Interior (Hundehaare) - Soiled - Conditioning

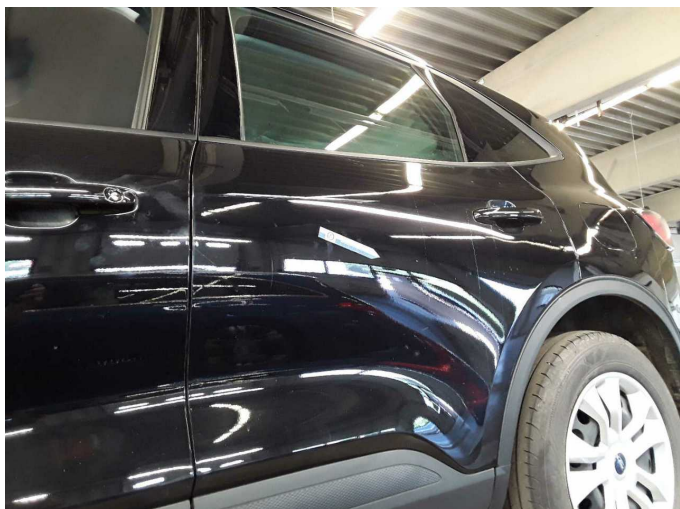
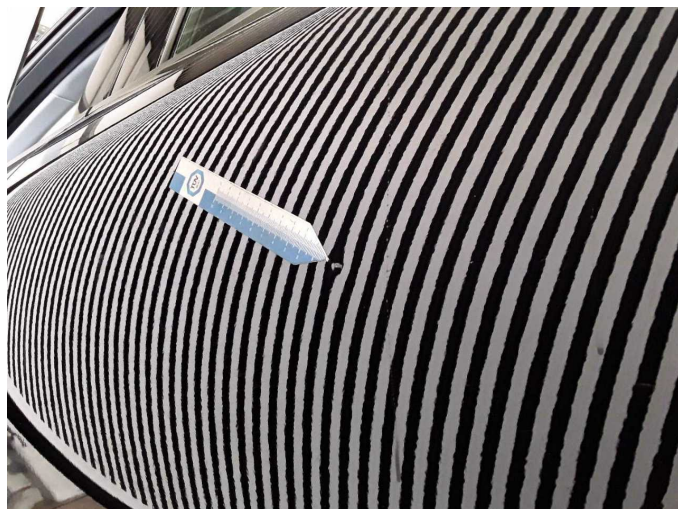
| No. | Component group | Description |
|---|---|---|
| 4 | Door - rear left side | Door - Dent / paintcoat damage - Repair and paint |

**Damage 4:** Door - rear left side: Door - Dent / paintcoat damage - Repair and paint

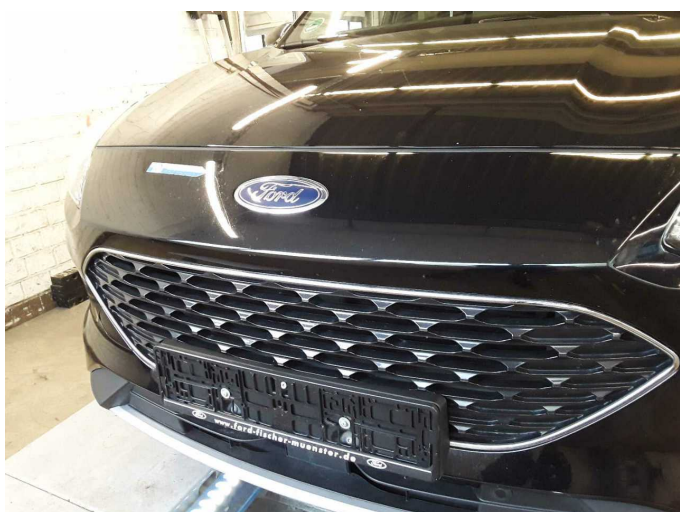
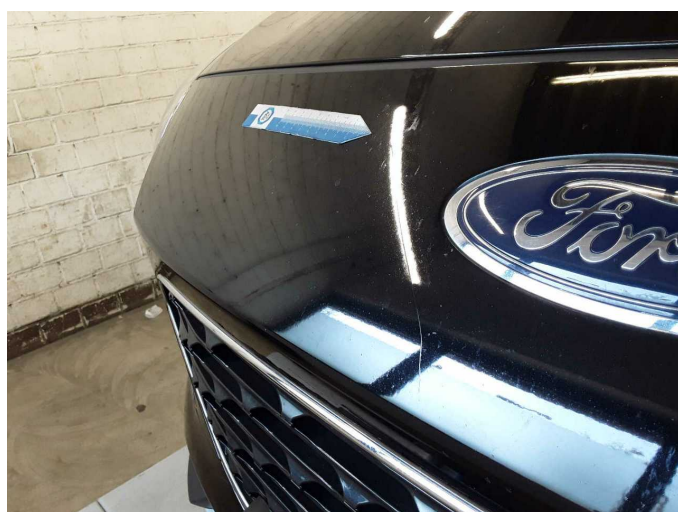
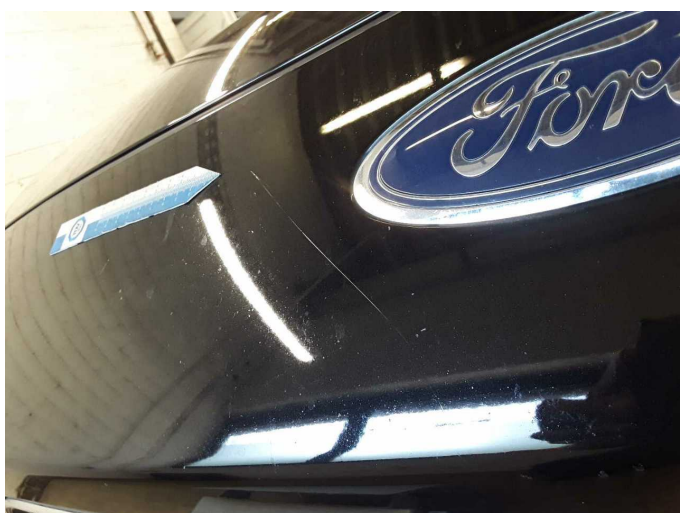
| No. | Component group | Description |
|---|---|---|
| 5 | Front bumper | Front bumper - Scratch(es) - Paint |

**Damage 5:** Front bumper: Front bumper - Scratch(es) - Paint

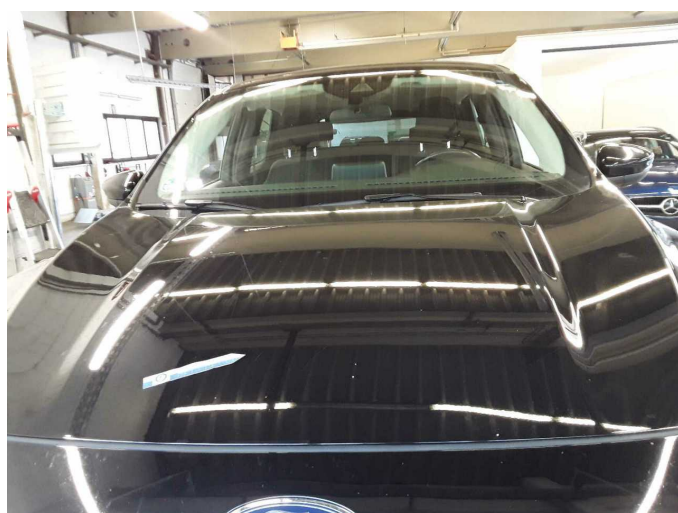
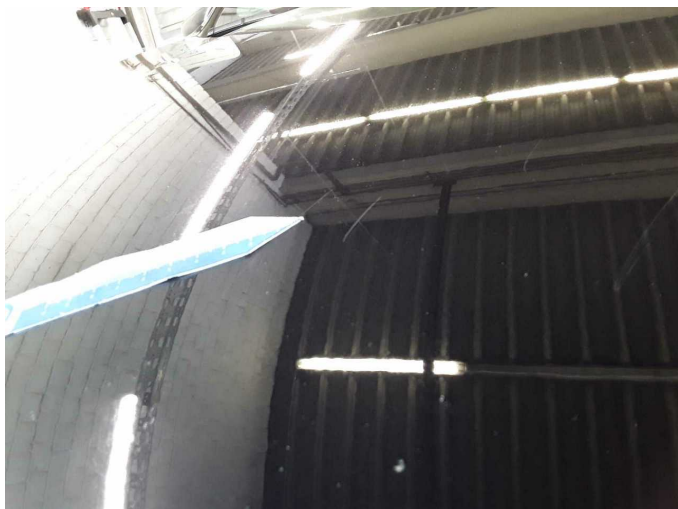
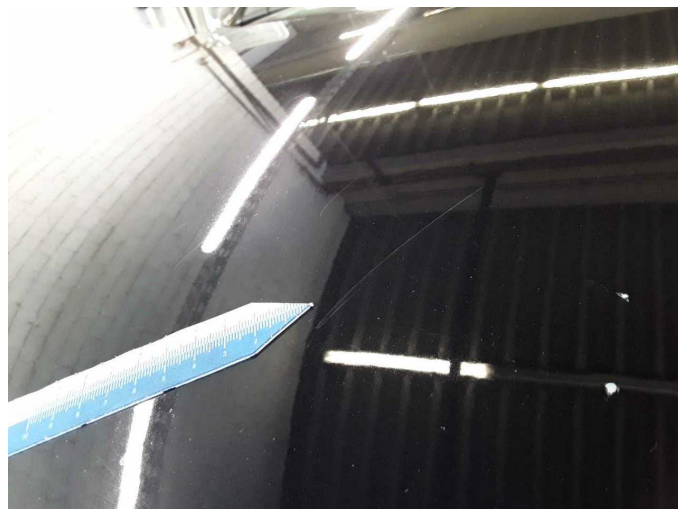
| No. | Component group | Description |
|---|---|---|
| 6 | Bonnet | Bonnet - Scratch(es) - Paint |

**Damage 6:** Bonnet: Bonnet - Scratch(es) - Paint

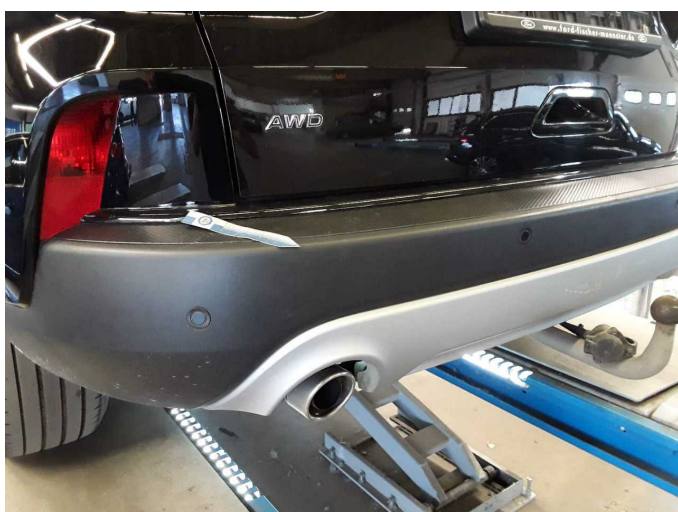
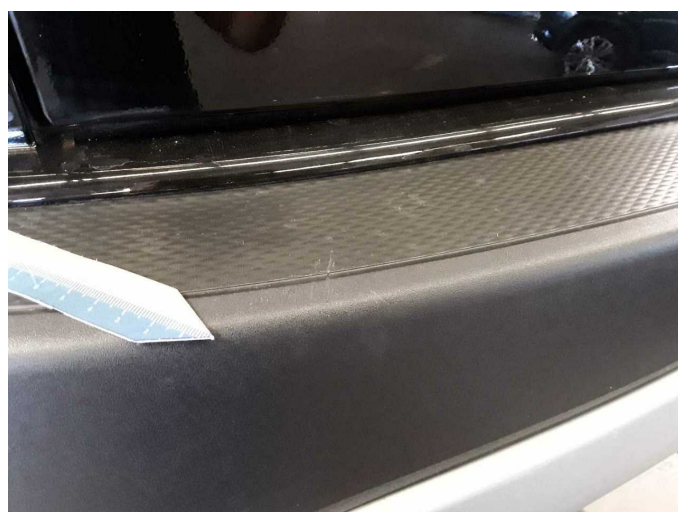
| No. | Component group | Description |
|---|---|---|
| 1 | Rear bumper | Rear bumper (unpainted) - Scratch(es) - No deduction |

**Wear and tear 1:** Rear bumper: Rear bumper (unpainted) - Scratch(es) - No deduction

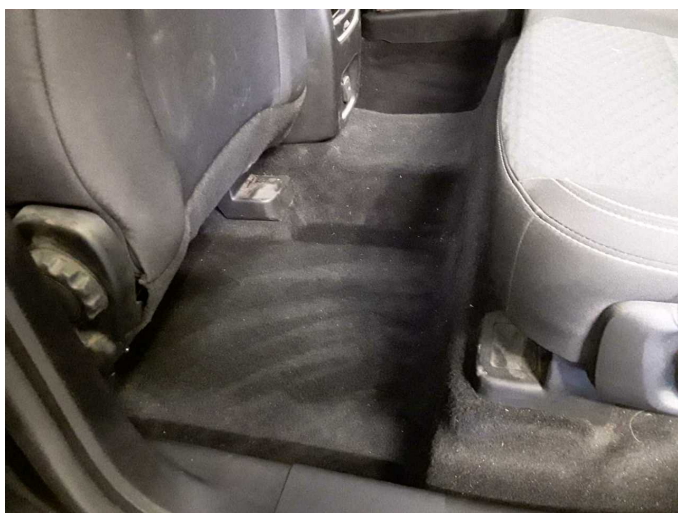
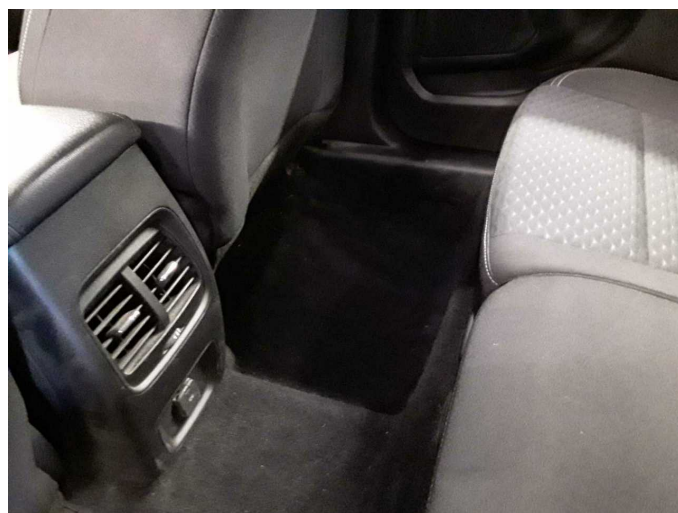
Trim / covers - Floor mats

**Missing part 1:** Trim / covers: Floor mats - Missing - Replace
