## Expertise

Protocol number: 46206592  
Order No. / Reference: 26589064  
Inspection date: 29 Jun 2026

Manufacturer: MAN

Model: TGE 3.140 4X2F SB

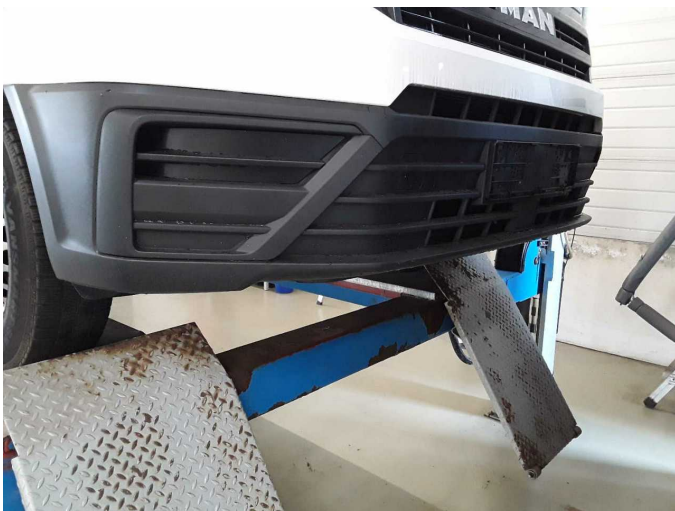
**Damage 1:** Front bumper: Front bumper (Unterteil) - Scratched - Smart repair

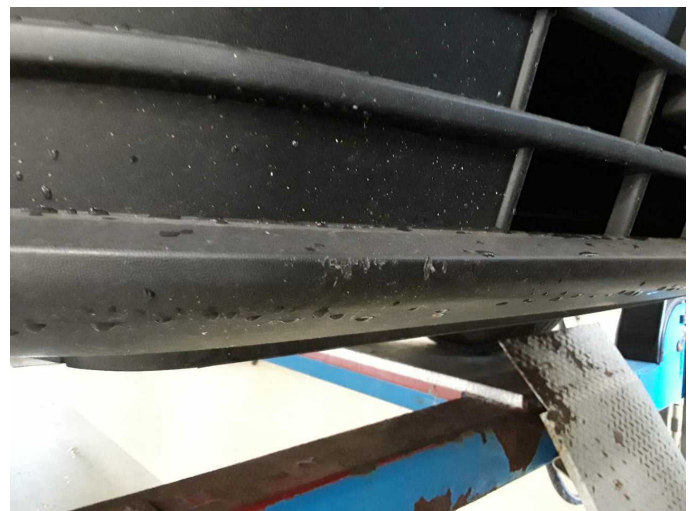
**Damage 1:** Front bumper: Front bumper (Unterteil) - Scratched - Smart repair

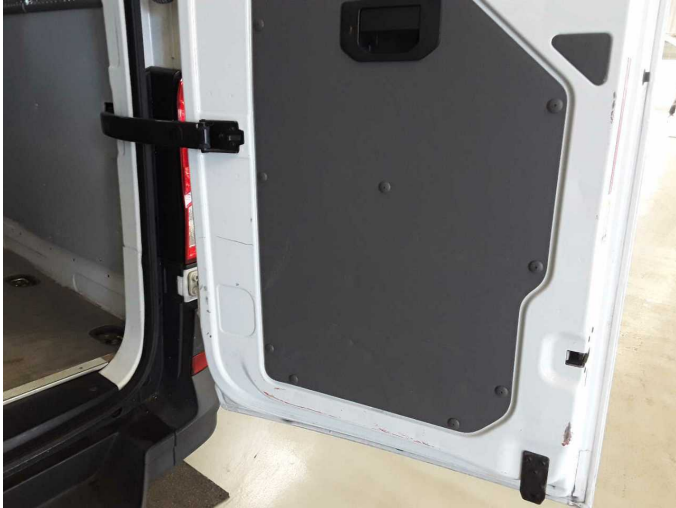
**Damage 2:** Boot lid / rear door: Trim washable - lower (rechts) - Broken / torn - Replace

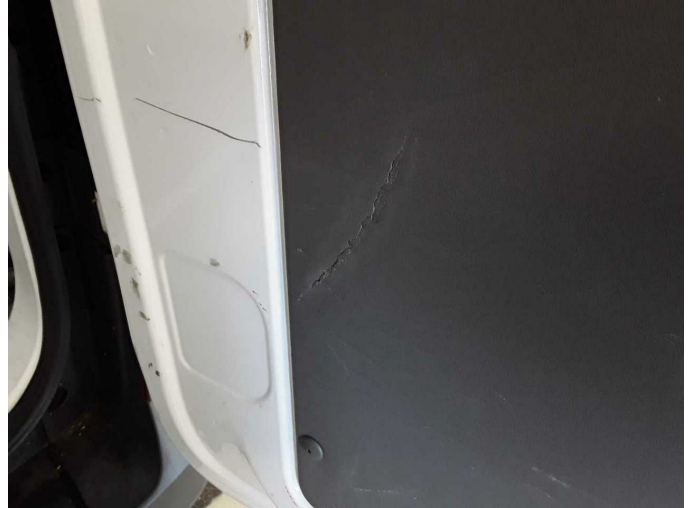
**Damage 2:** Boot lid / rear door: Trim washable - lower (rechts) - Broken / torn - Replace

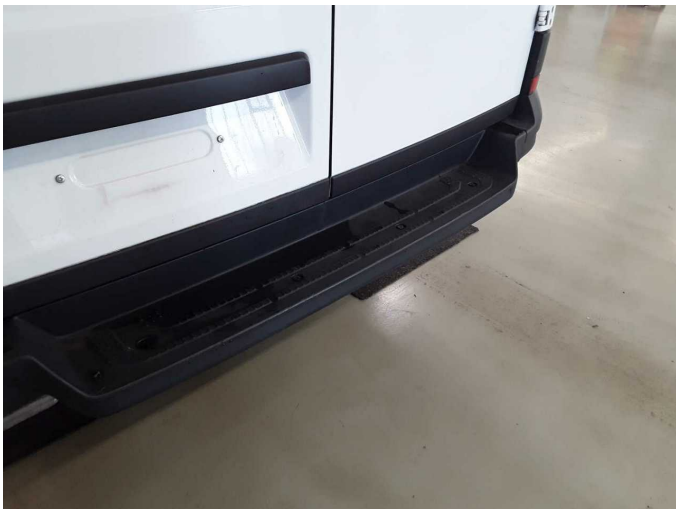
**Damage 3:** Rear bumper: Rear bumper - dent(s) - Loss in value

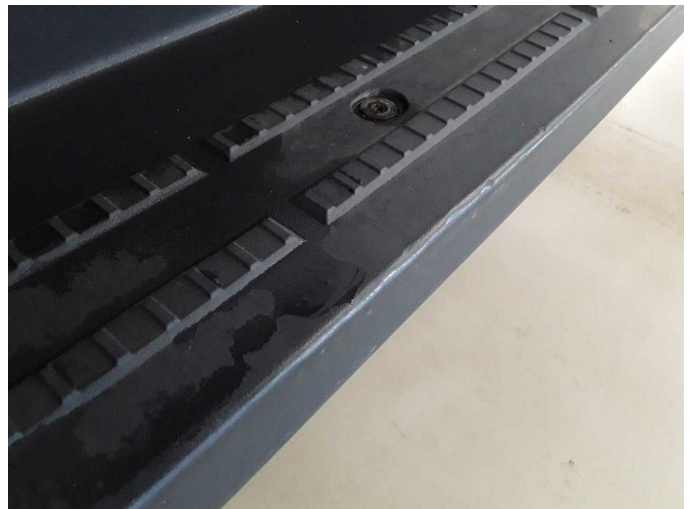
**Damage 3:** Rear bumper: Rear bumper - dent(s) - Loss in value

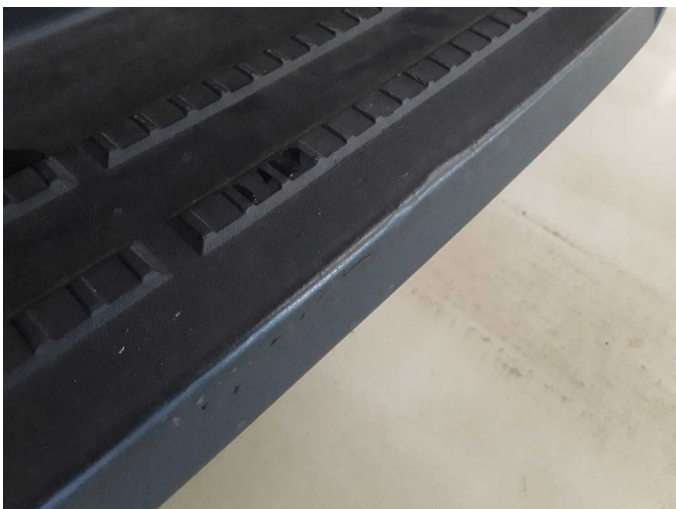
**Damage 3:** Rear bumper: Rear bumper - dent(s) - Loss in value
