Expertise

Protocol number: 46166343
Order No. / Reference: 26501253
Inspection date: 25 Jun 2026

Manufacturer: Volvo

Model: XC60 T6 AWD Recharge Plus Bright

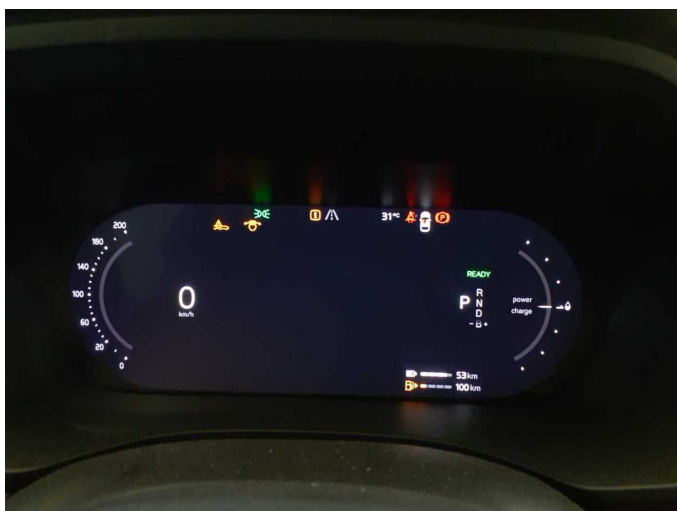
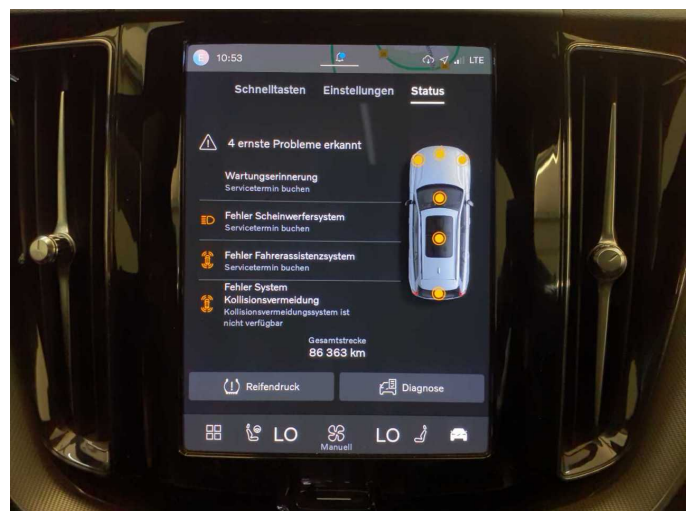
Damage 1: Instrument panel: Indicator light (Scheinwerfersystem) - Specify findings - Perform diagnosis

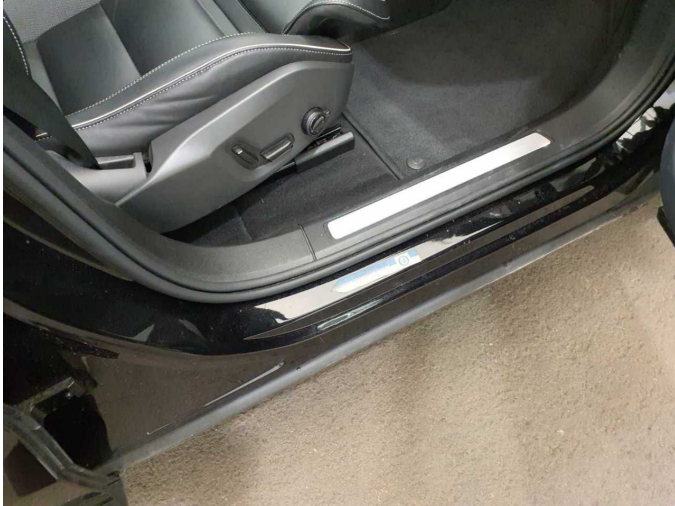
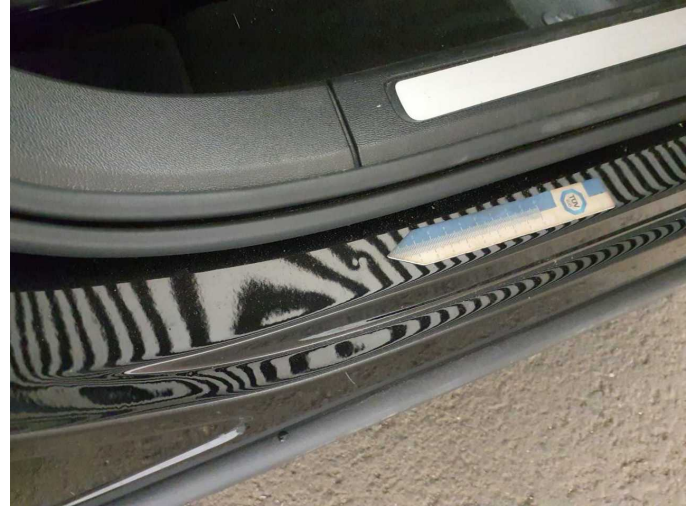
Damage 2: Sill - right side: Sill - dent(s) - Smooth repair work

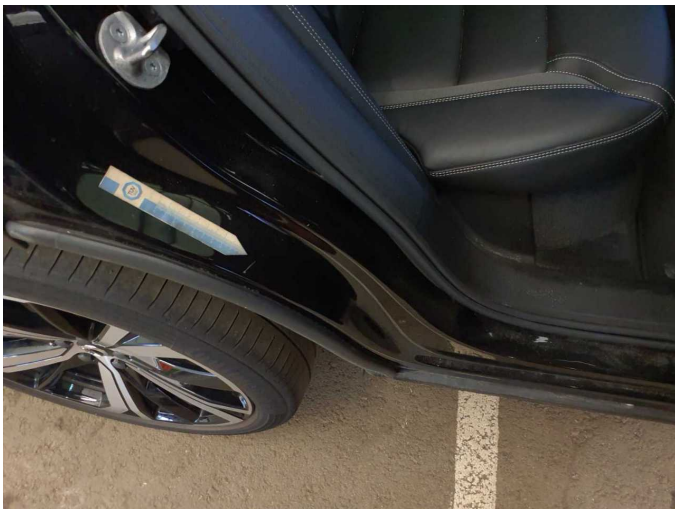
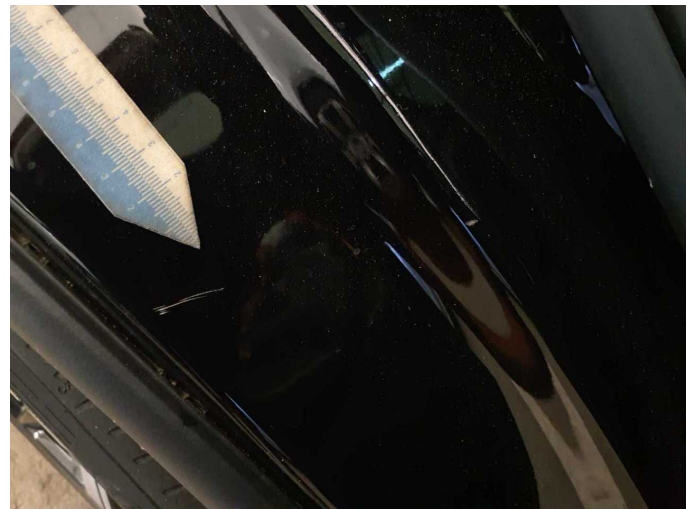
Damage 3: Side panel - rear right side: Sill - Scratch(es) - Smart repair

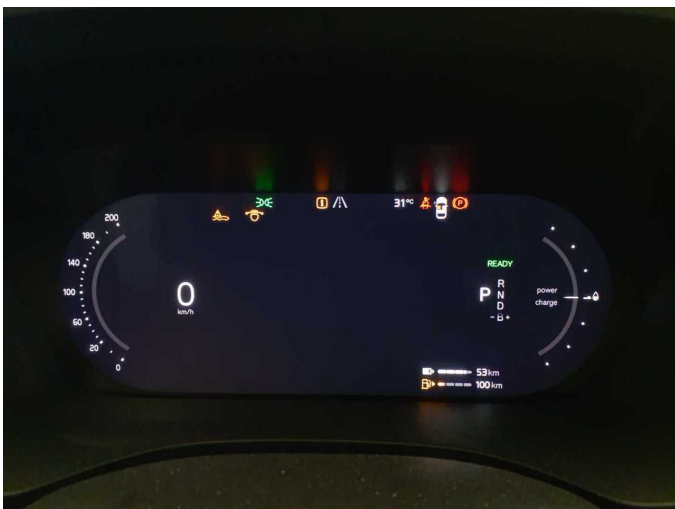
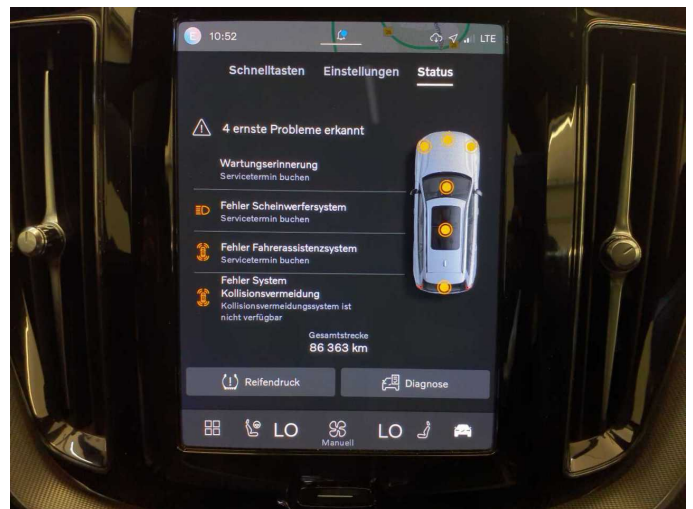
Damage 4: Instrument panel: Indicator light (Fahrerassistenzsystem) - Specify findings - Perform diagnosis

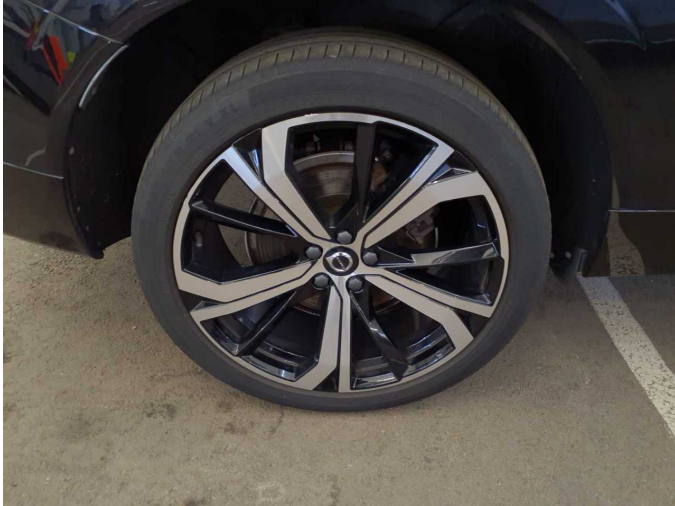
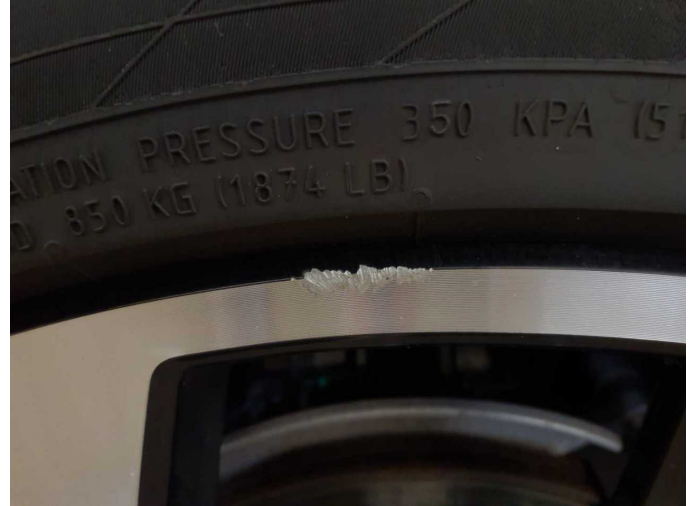
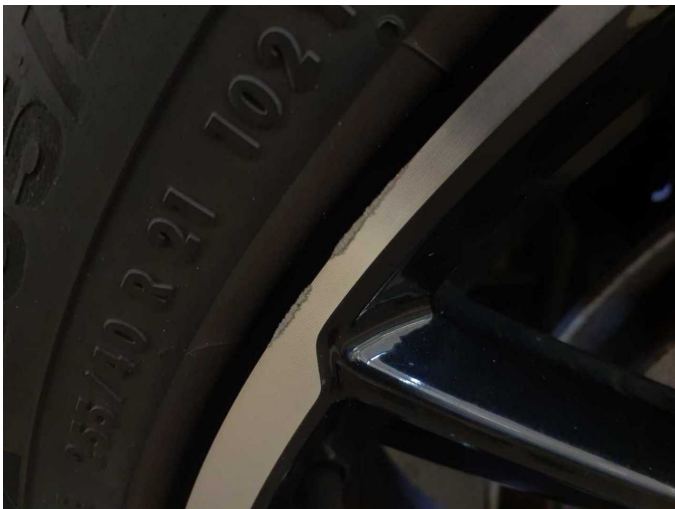
Damage 5: Wheel / tyres: Alloy rim - rear right side - Scratch(es) - Loss in value

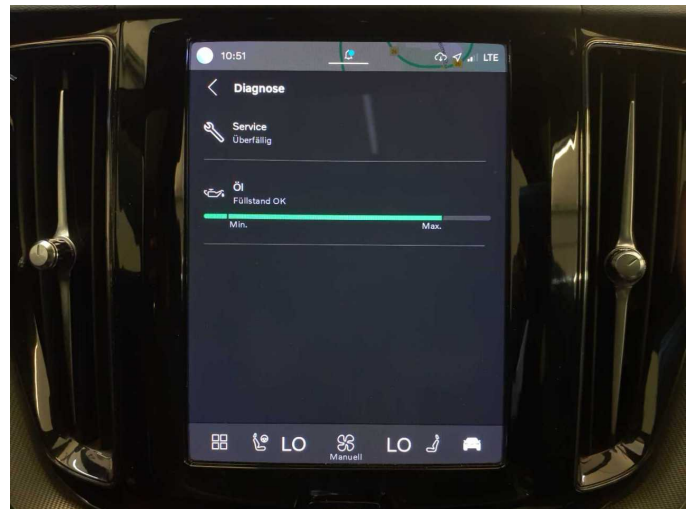
Damage 6: Misc.: Inspection / maintenance - Due - Perform

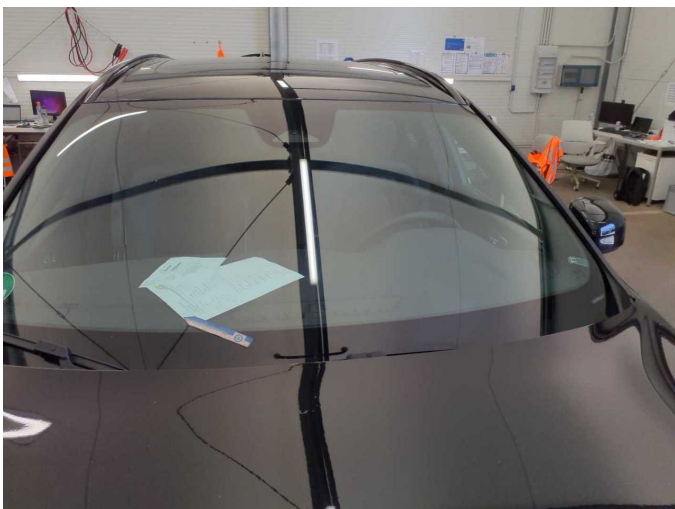
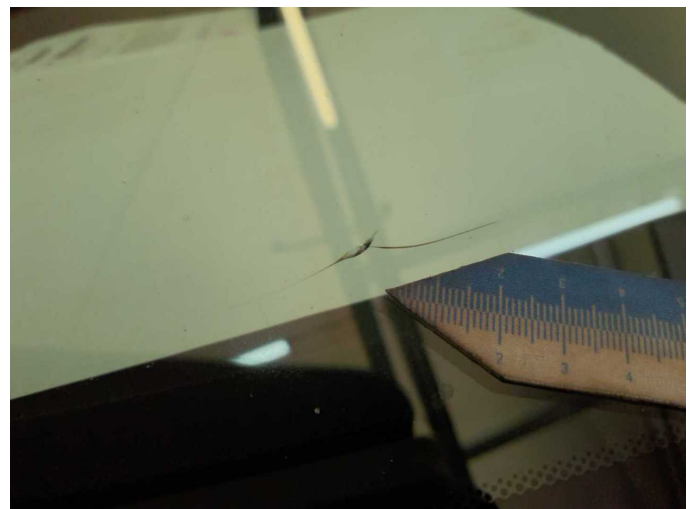
Damage 7: Vehicle glazing: Windscreen with lane departure assistant - Broken / torn - Replace
