Expertise

Protocol number: 46338681
Order No. / Reference: 26185451
Inspection date: 30 Jun 2026

Model: Vito 116 CDI Lang HA Aut. PRO

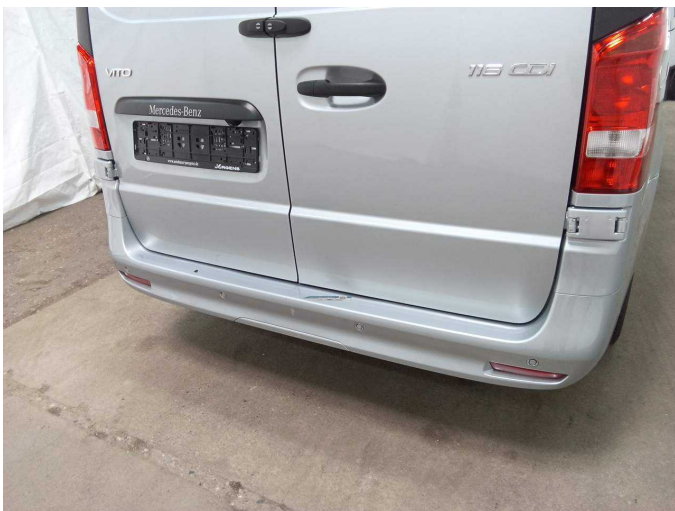
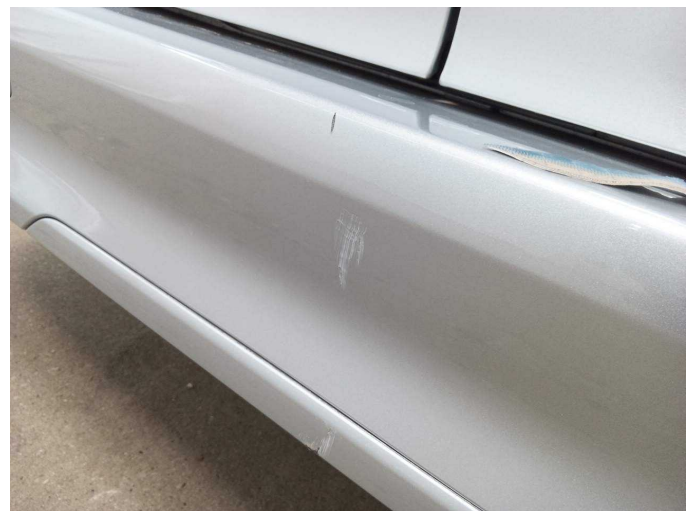
No.	Component group	Description
1	Rear bumper	Rear bumper - Scratch(es) - Paint

Damage 1: Rear bumper: Rear bumper - Scratch(es) - Paint
