Expertise

Protocol number: 46184538
Order No. / Reference: 26606884
Inspection date: 25 Jun 2026

Manufacturer: Ford

Model: Transit Custom 280 L1H1 LKW VA Trend

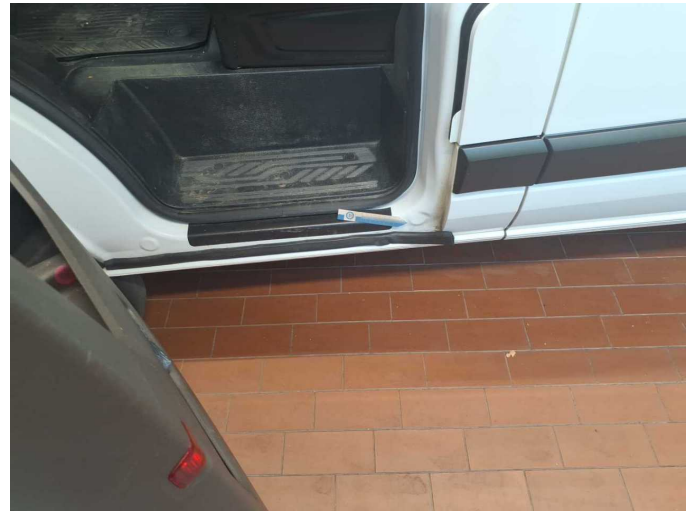
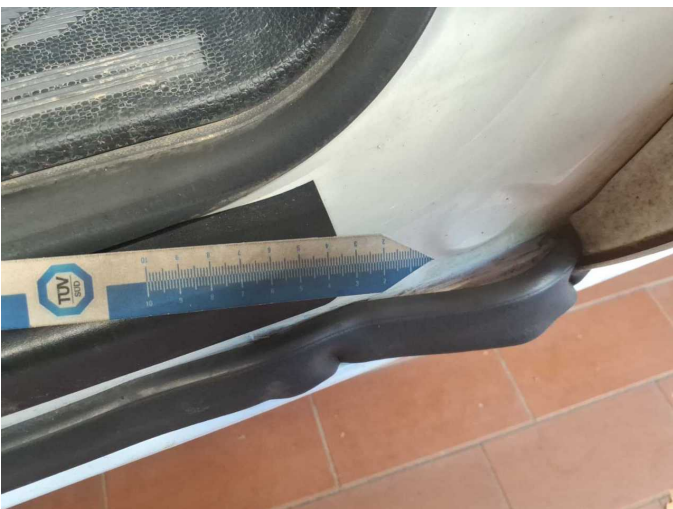
Damage 1: Door - front left side: Door seal - Loose - Un- / install

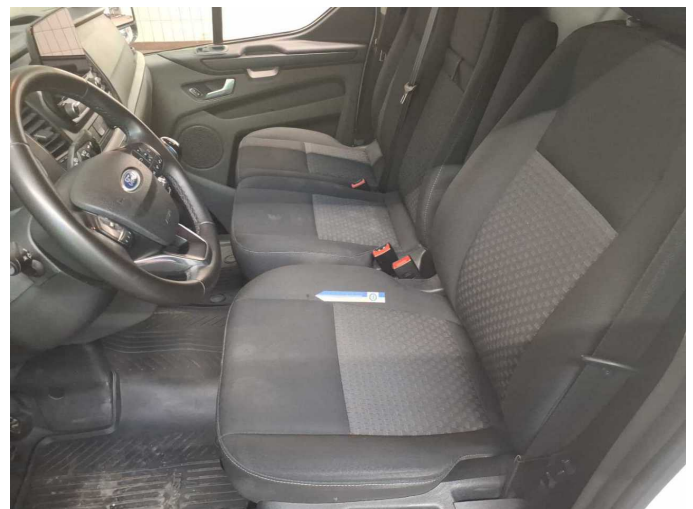
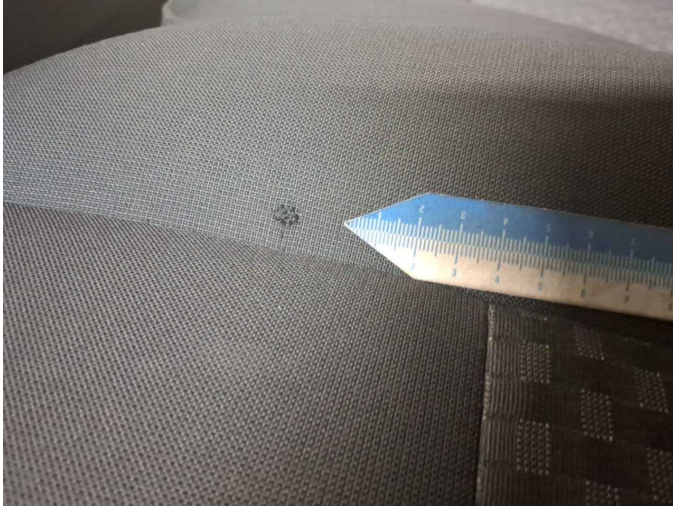
Damage 2: Seat - front: Seat cover - left side - Holes - Smart repair

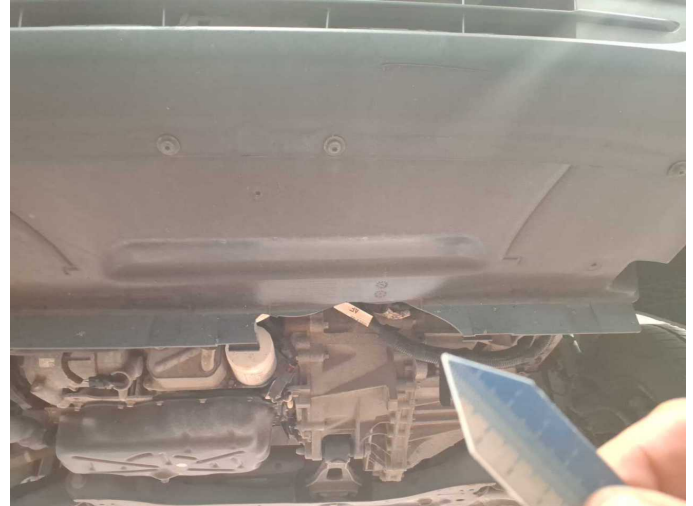
Damage 3: Engine: Engine cowling lower front - Broken / torn - Replace

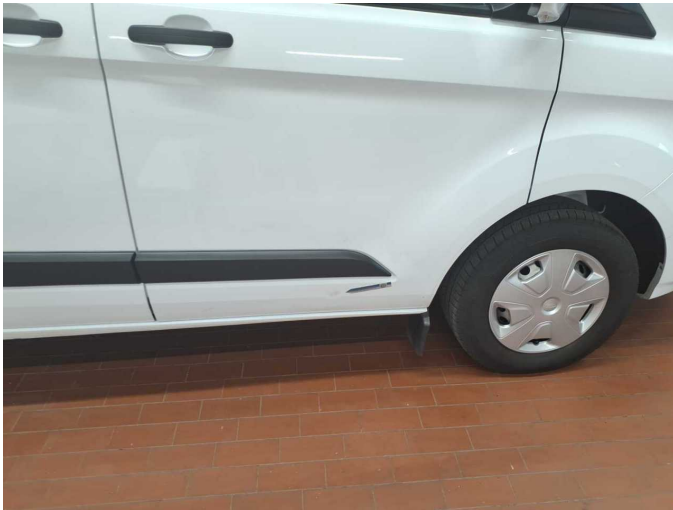
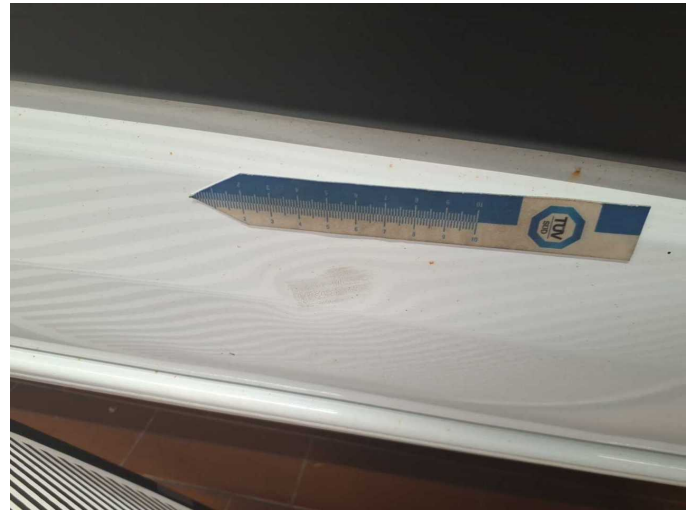
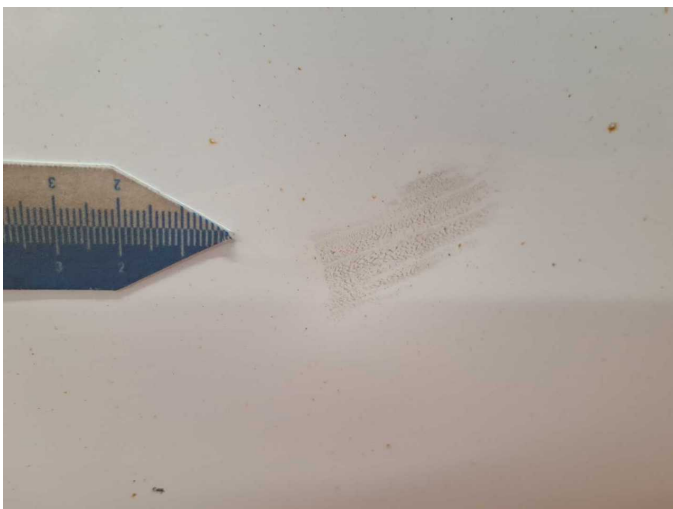
Damage 4: Door - front right side: Door - Dent / paintcoat damage - Smart repair

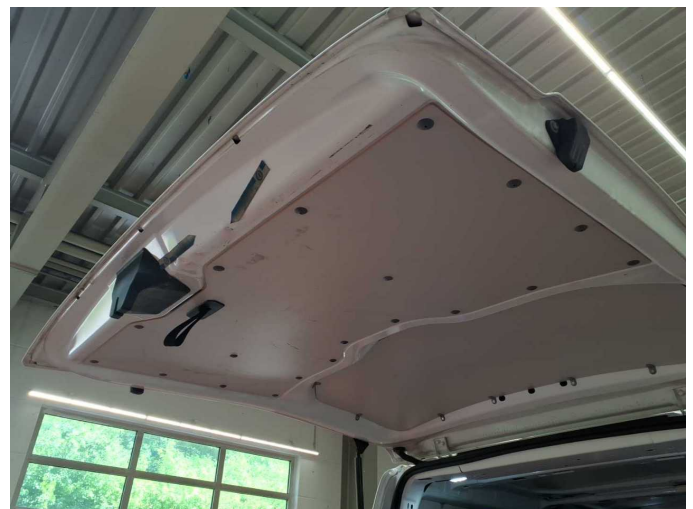
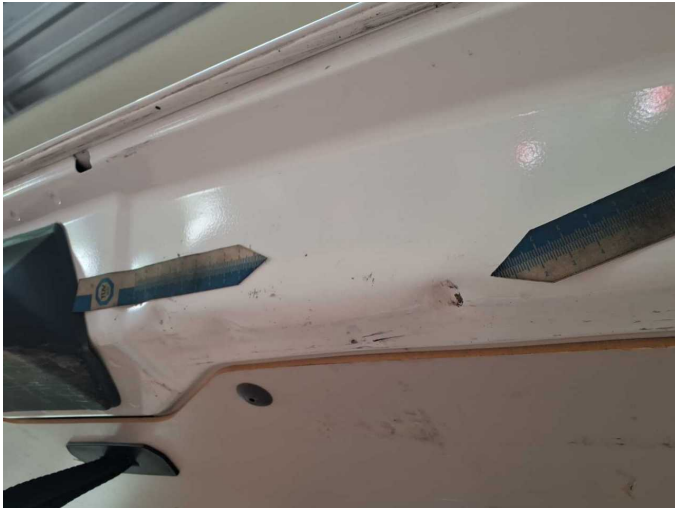
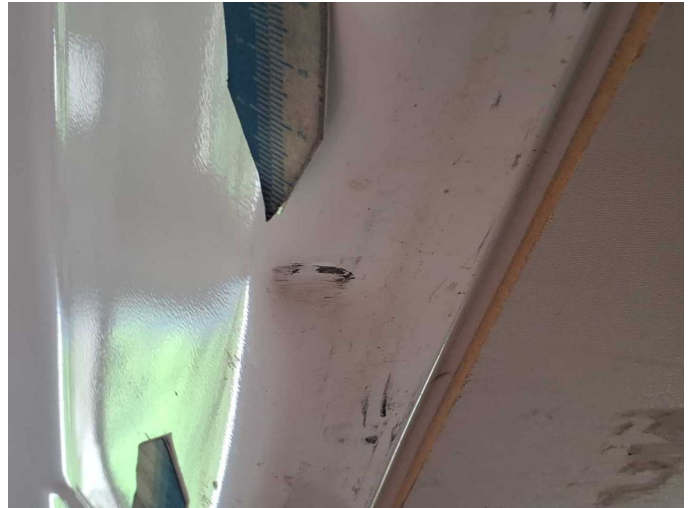
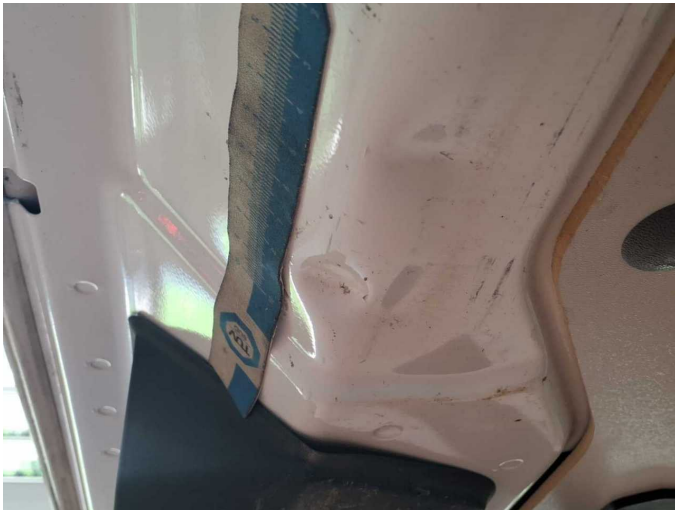
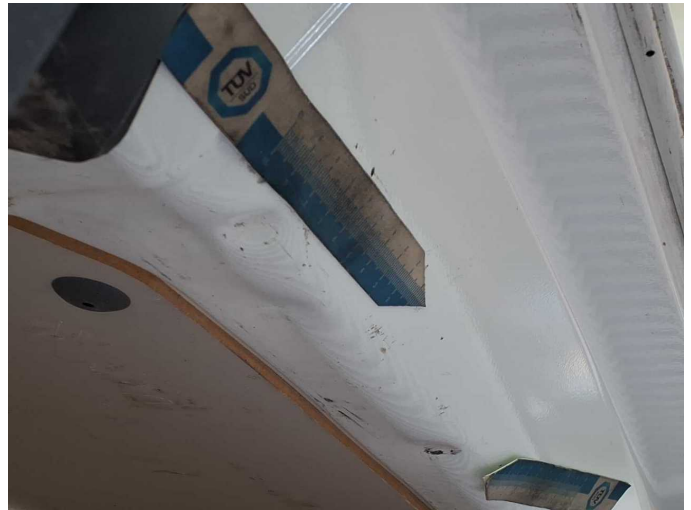
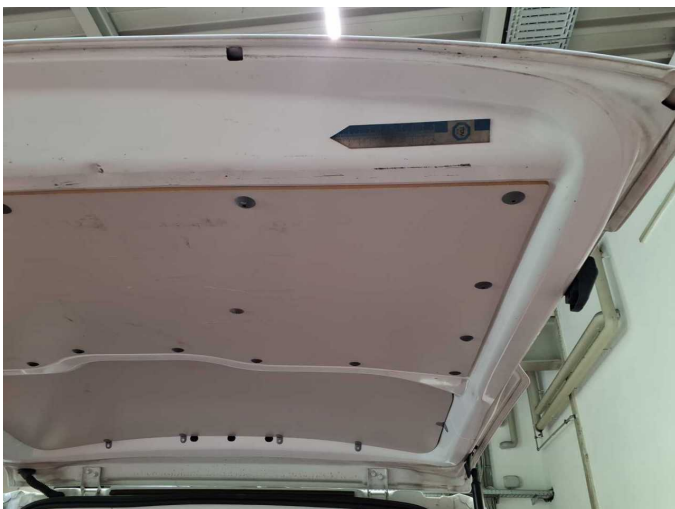
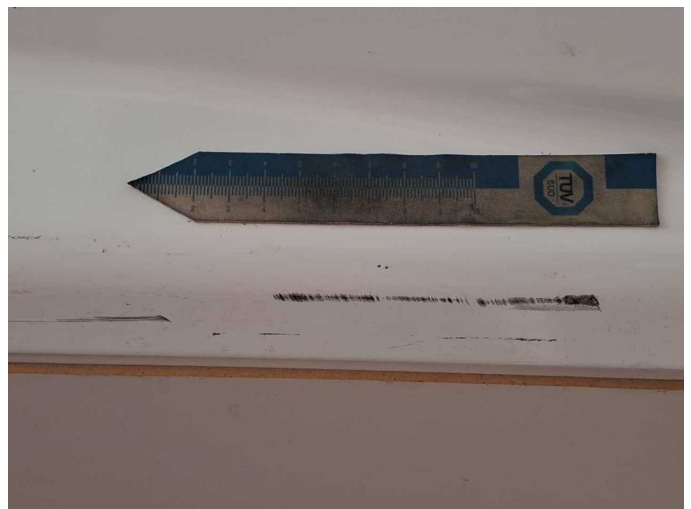
Damage 5: Boot lid / rear door: Boot lid - Dent / paintcoat damage - Loss in value

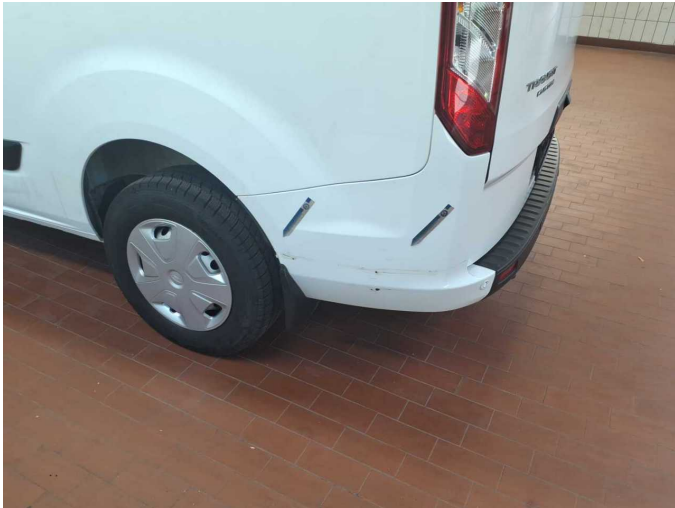
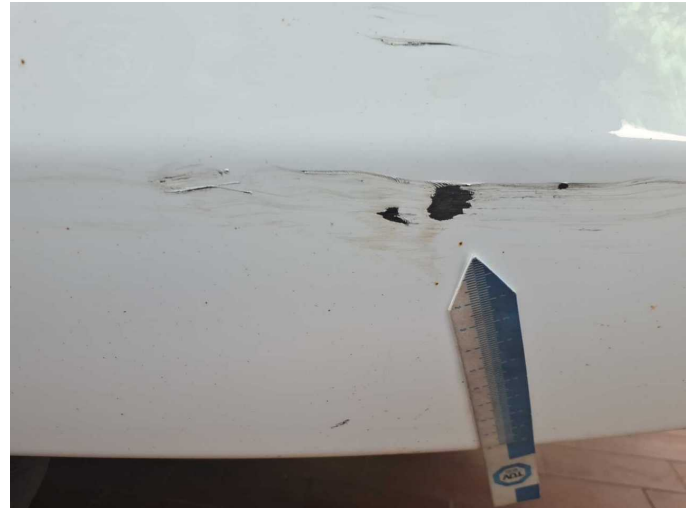
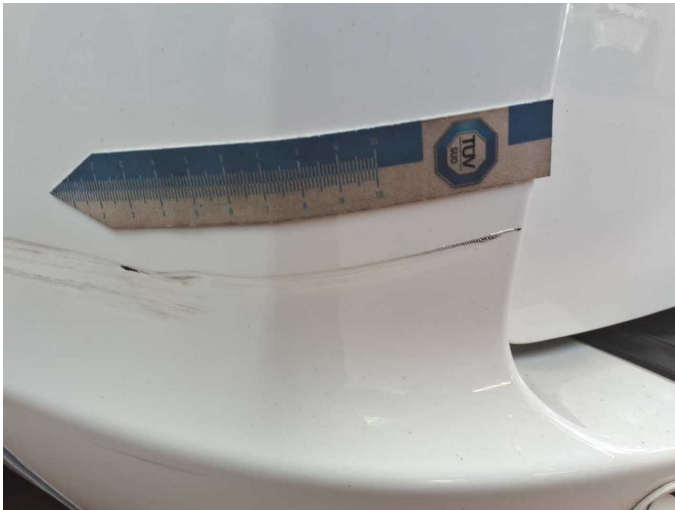
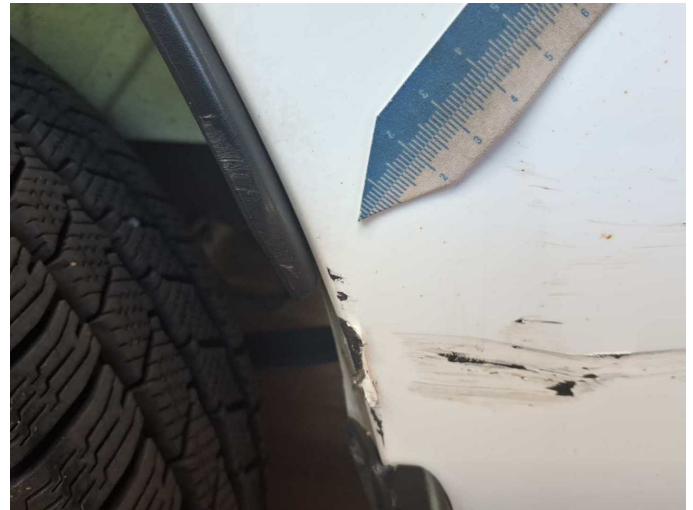
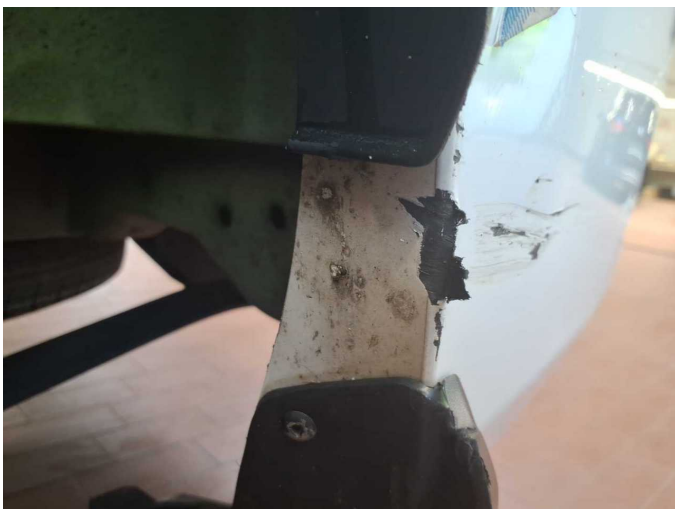
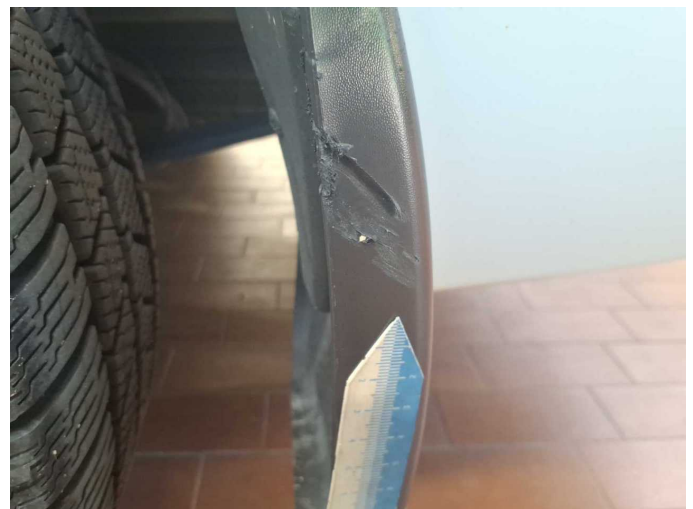
Damage 6: Rear bumper: Bumper - rear left side (+ Schmutzfänger verschürft erneuern) - Scratched - Repair and paint

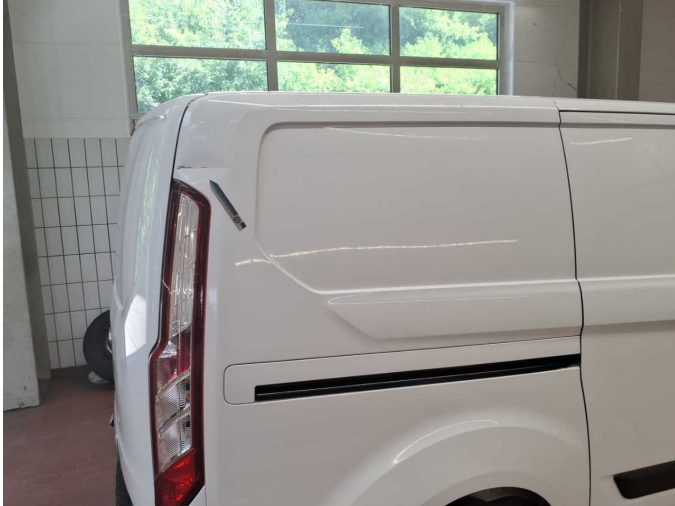
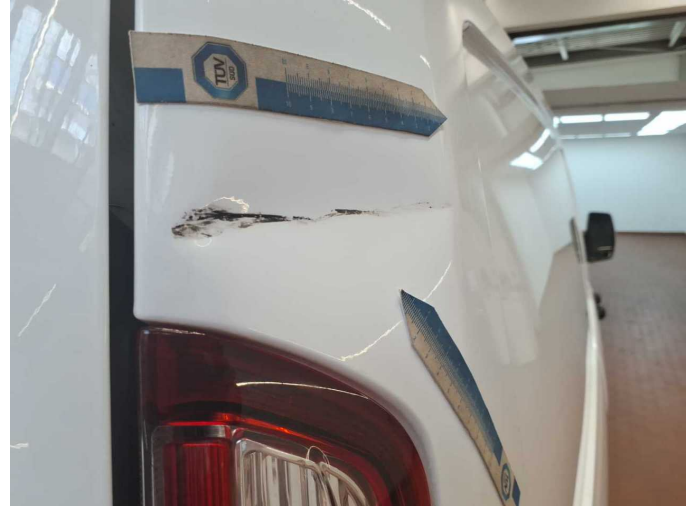
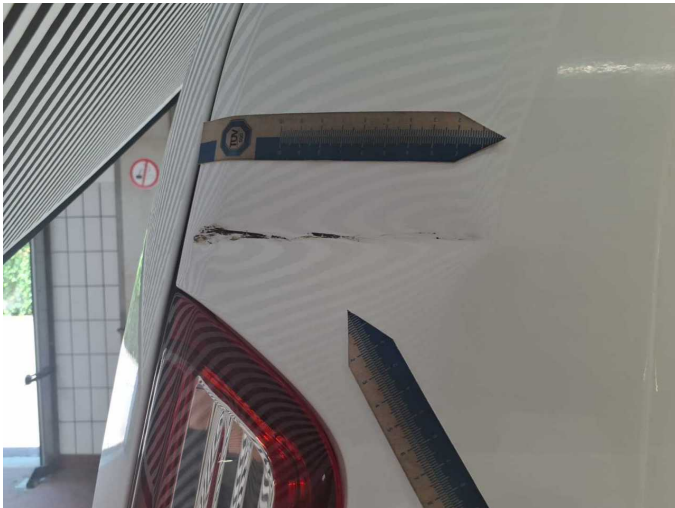
Damage 7: Body: D-pillar - right side - Dent / paintcoat damage - Repair and paint

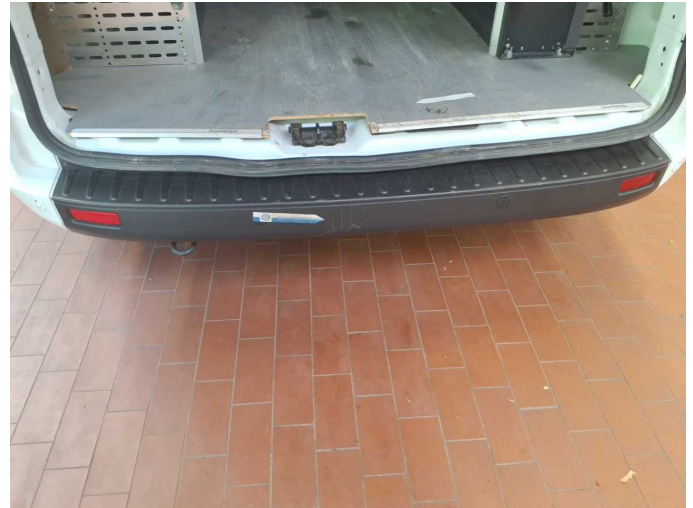
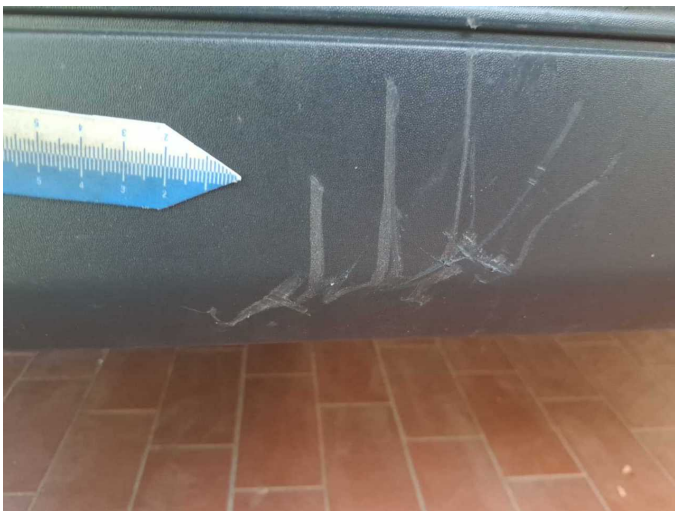
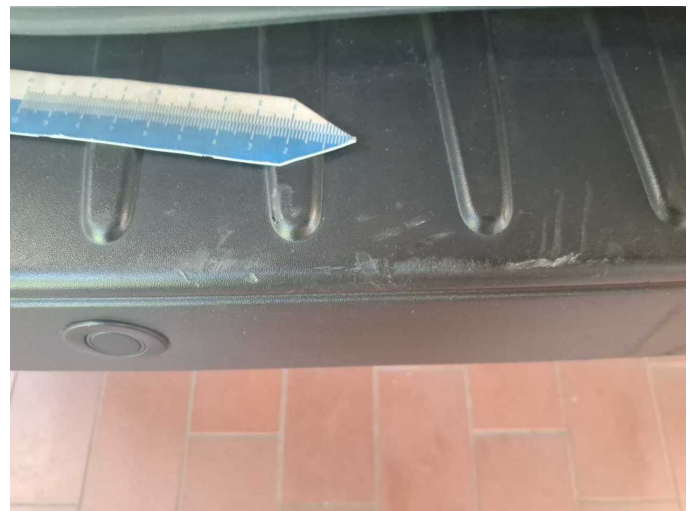
Wear and tear 7: Rear bumper: Bumper - rear centre (Verlade- / Einstiegsbereich) - Scratch(es) - No deduction

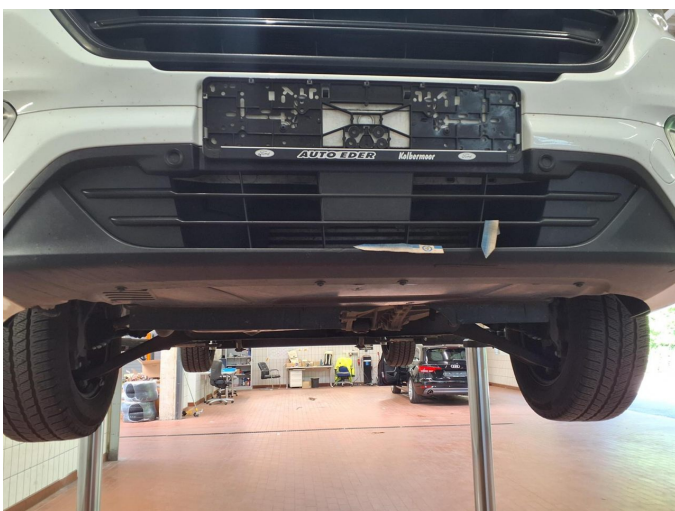
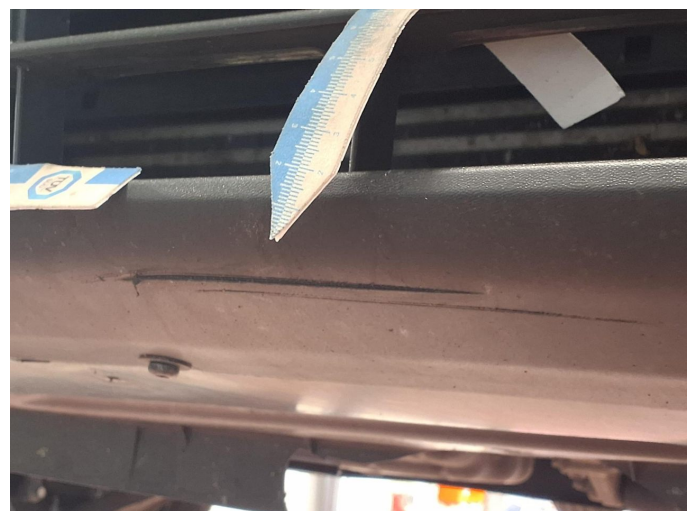
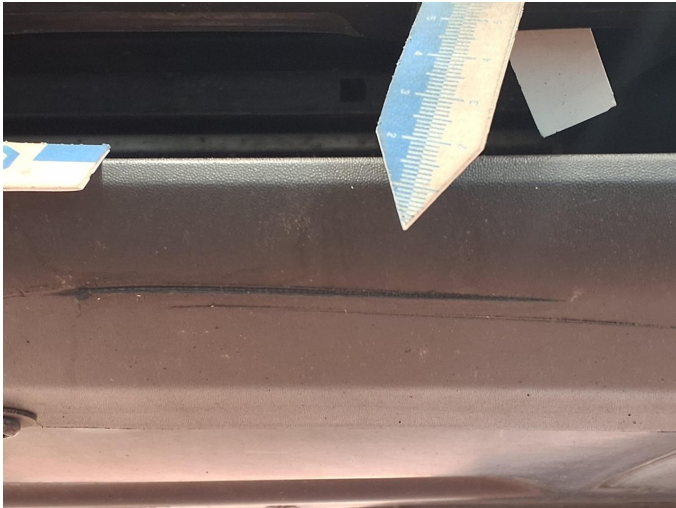
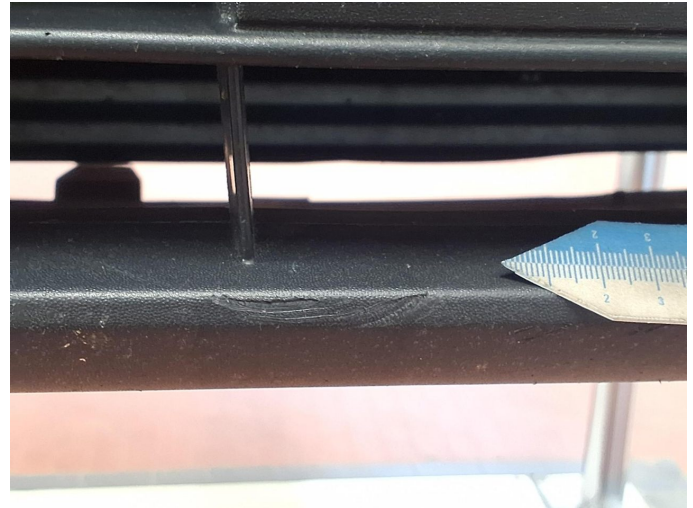
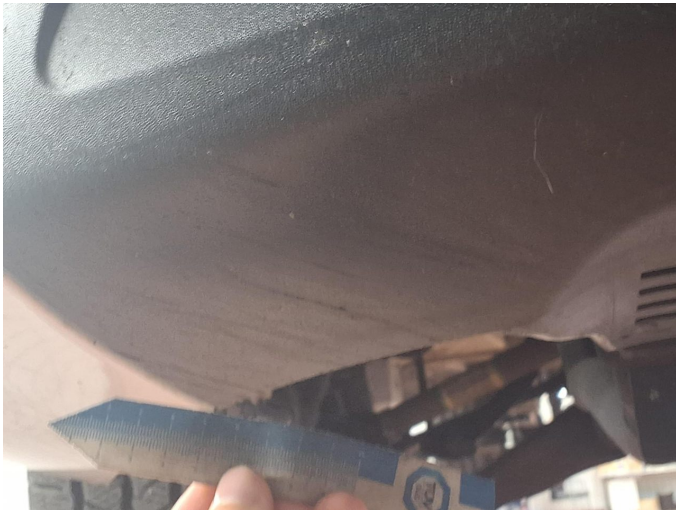
Wear and tear 8: Front bumper: Spoiler - Scratched - No deduction
