Expertise

Protocol number: 46147712  
Order No. / Reference: 26591553  
Inspection date: 24 Jun 2026

Manufacturer: Volkswagen

Model: Tiguan 2.0 TDI SCR DSG Life

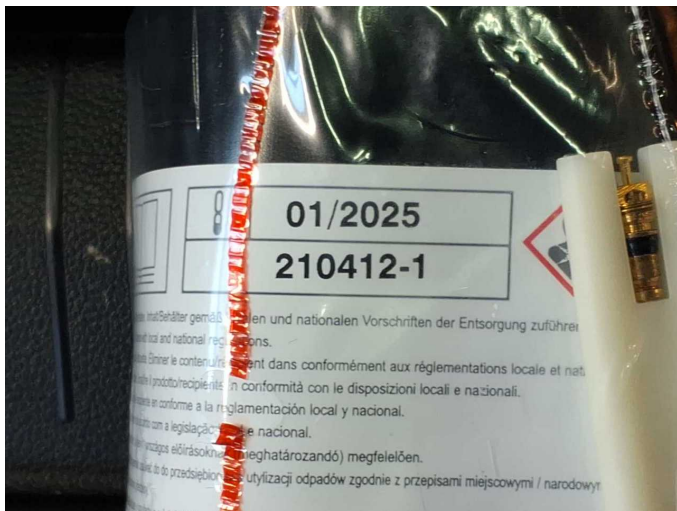
| No. | Component group | Description |
|---|---|---|
| 1 | Equipment | Tirefit filler - Expired - Replace |

Damage 1: Equipment: Tirefit filler - Expired - Replace

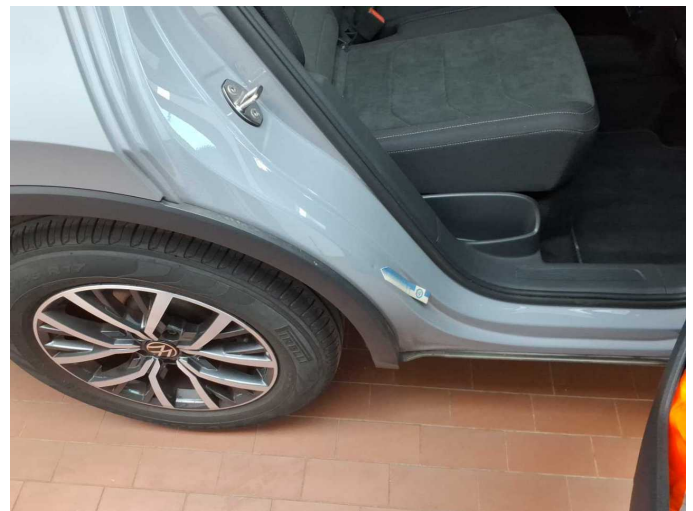
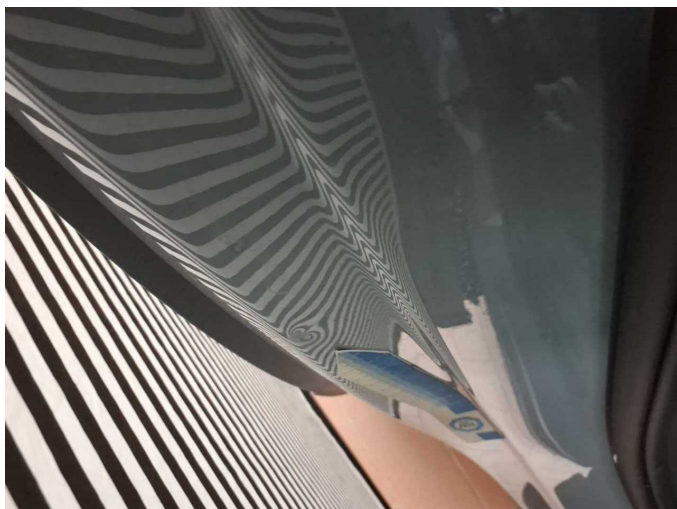
| No. | Component group | Description |
|---|---|---|
| 2 | Side panel - rear right side | Sill - dent(s) - Smart repair |

Damage 2: Side panel - rear right side: Sill - dent(s) - Smart repair

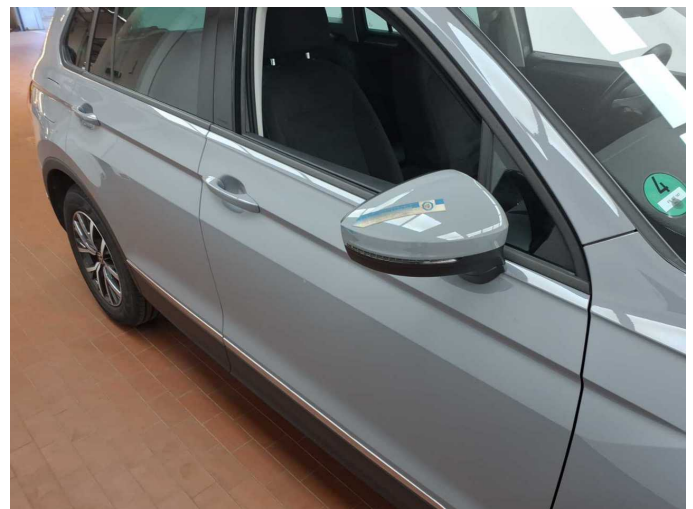
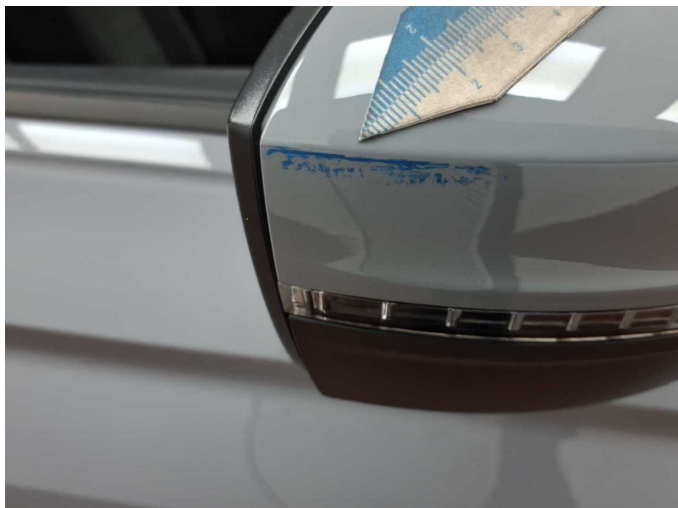
| No. | Component group | Description |
|---|---|---|
| 3 | Wing mirror - right side | Cap - Scratched - Paint |

Damage 3: Wing mirror - right side: Cap - Scratched - Paint

**Damage 3:** Wing mirror - right side: Cap - Scratched - Paint

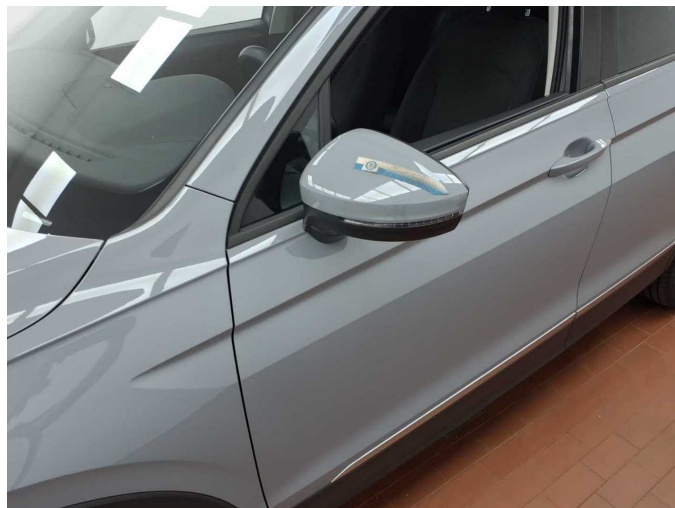
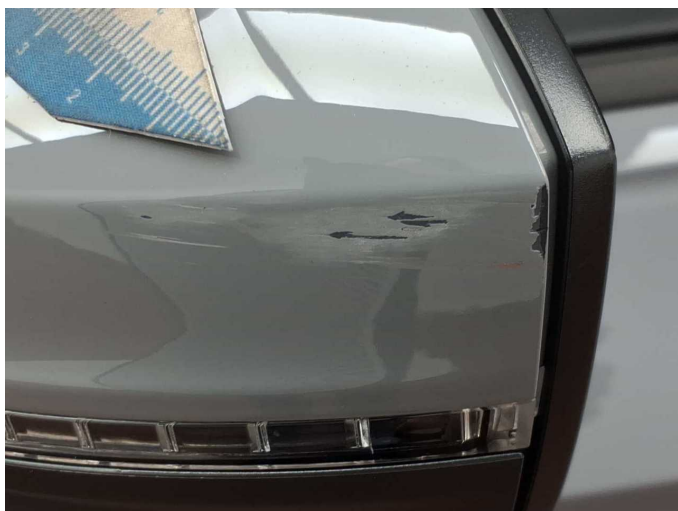
| No. | Component group | Description |
|---|---|---|
| 4 | Wing mirror - left side | Cap - Scratched - Paint |

**Damage 4:** Wing mirror - left side: Cap - Scratched - Paint

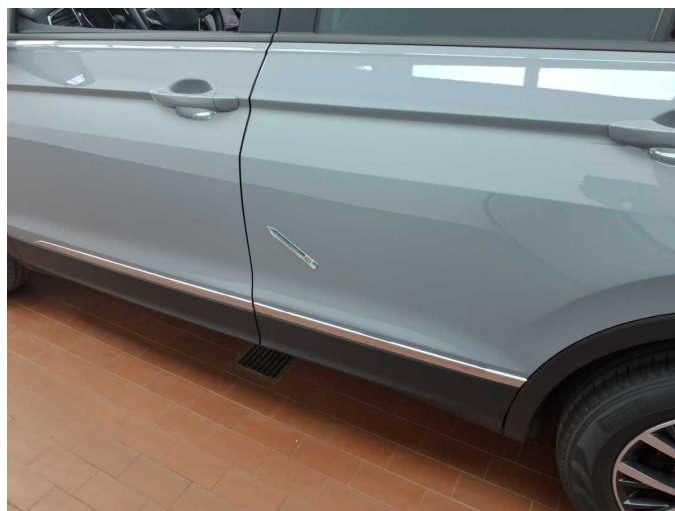
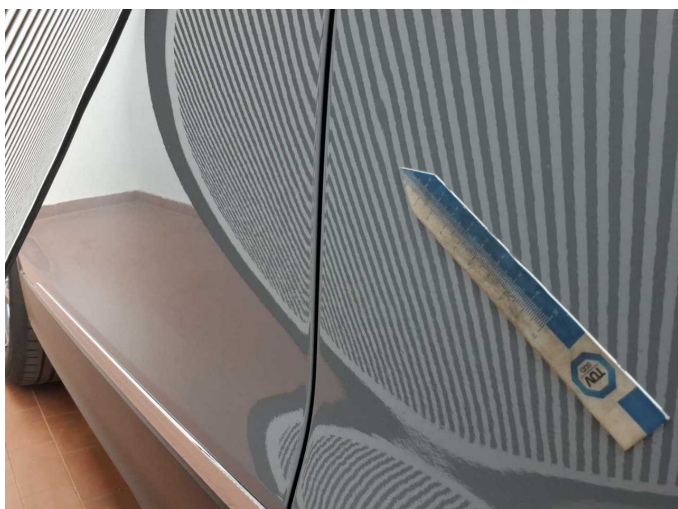
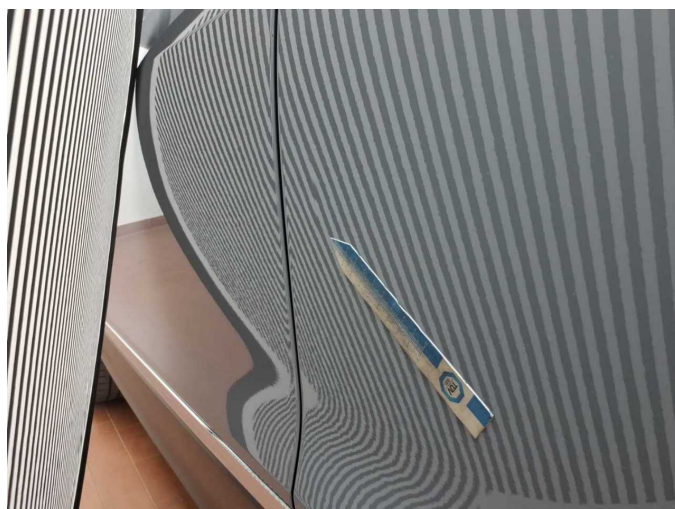
| No. | Component group | Description |
|---|---|---|
| 5 | Door - rear left side | Door - dent(s) - Smooth repair work |

**Damage 5:** Door - rear left side: Door - dent(s) - Smooth repair work

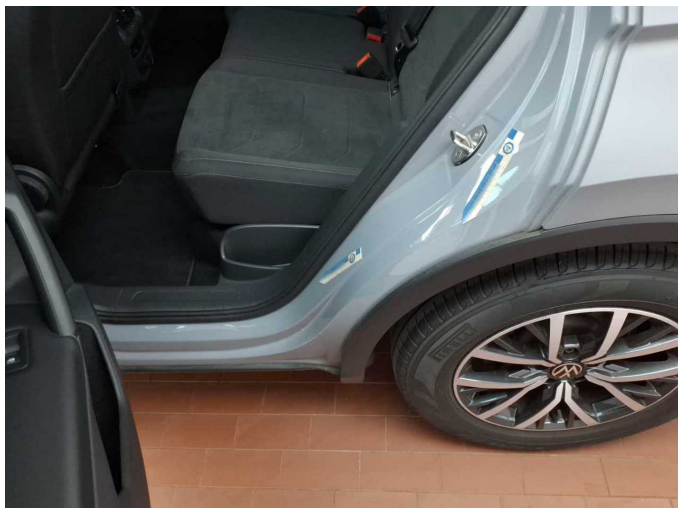
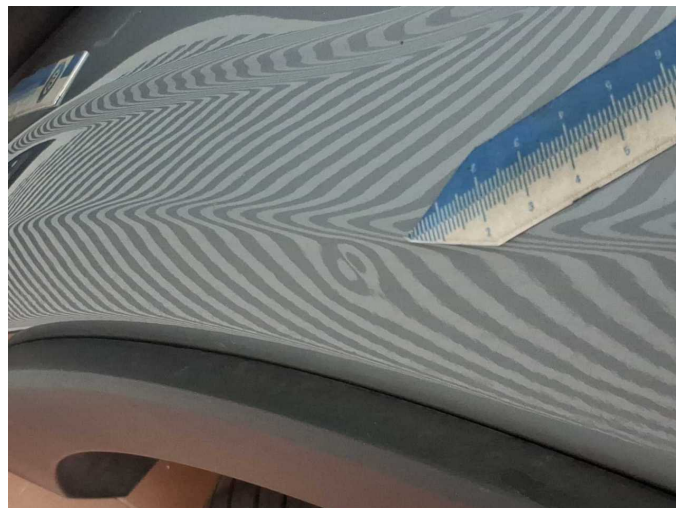
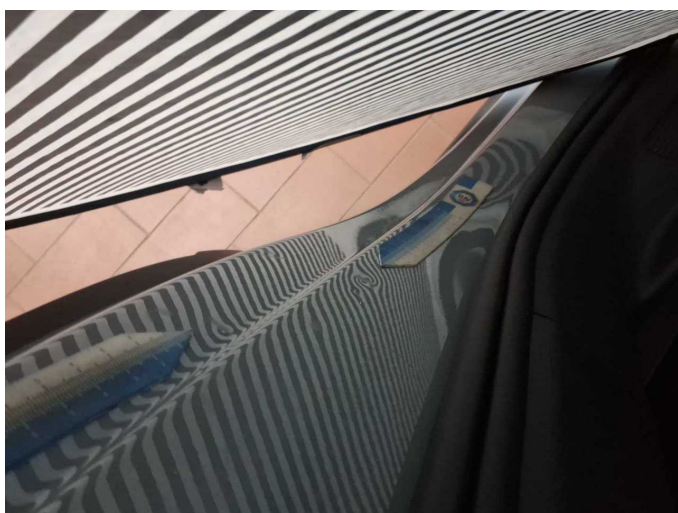
| No. | Component group | Description |
|---|---|---|
| 6 | Side panel - rear left side | Sill - dent(s) - Smooth repair work |

**Damage 6:** Side panel - rear left side: Sill - dent(s) - Smooth repair work

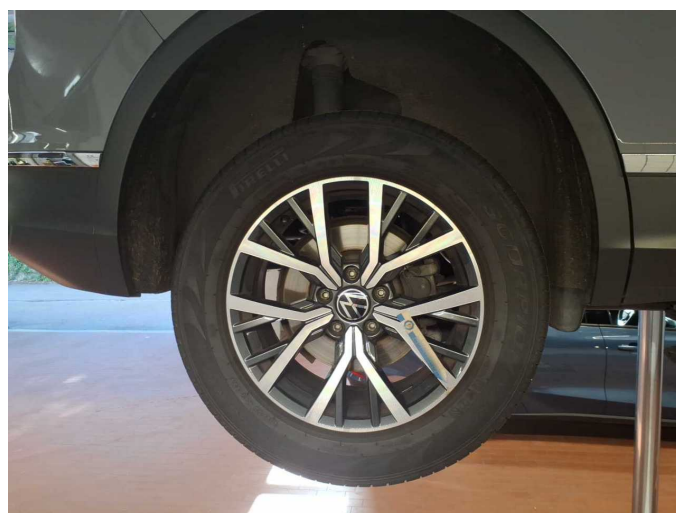
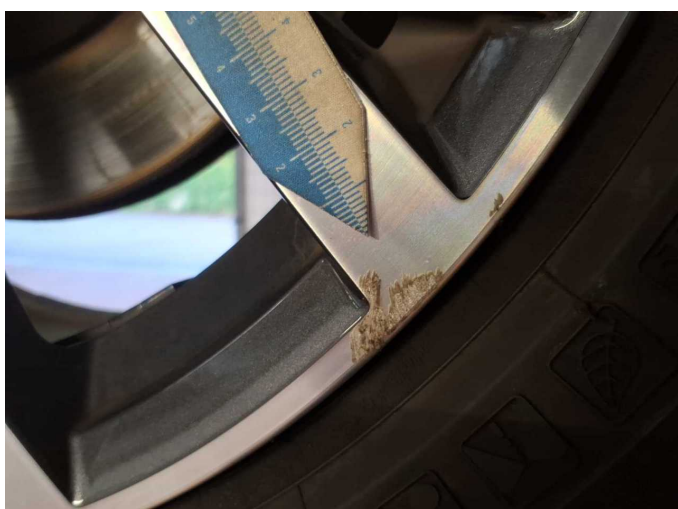
| No. | Component group | Description |
|---|---|---|
| 7 | Wheel / tyres | Alloy rim - rear right side - Scratched - Loss in value |

**Damage 7:** Wheel / tyres: Alloy rim - rear right side - Scratched - Loss in value

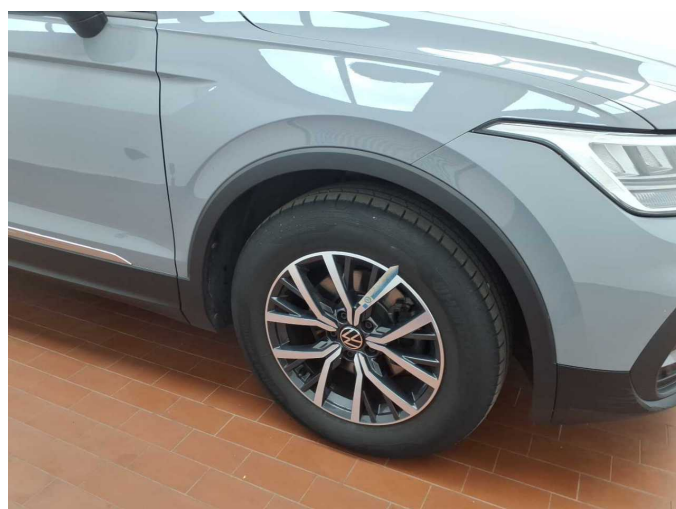
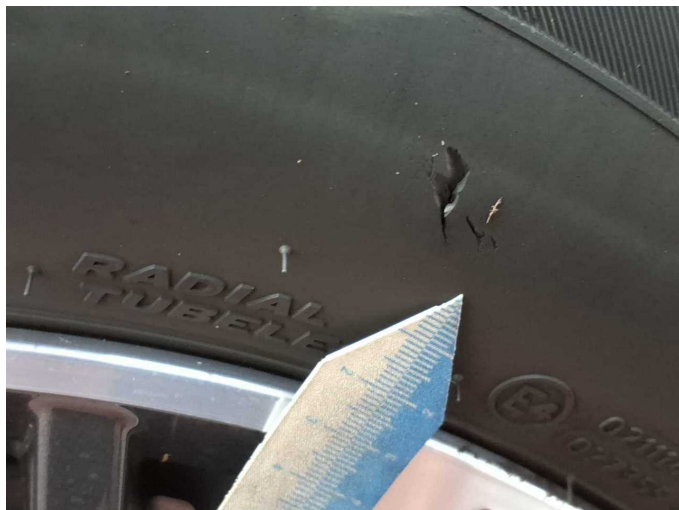
| No. | Component group | Description |
|---|---|---|
| 8 | Wheel / tyres | Tyre - front right side - Damaged - Replace |

**Damage 8:** Wheel / tyres: Tyre - front right side - Damaged - Replace

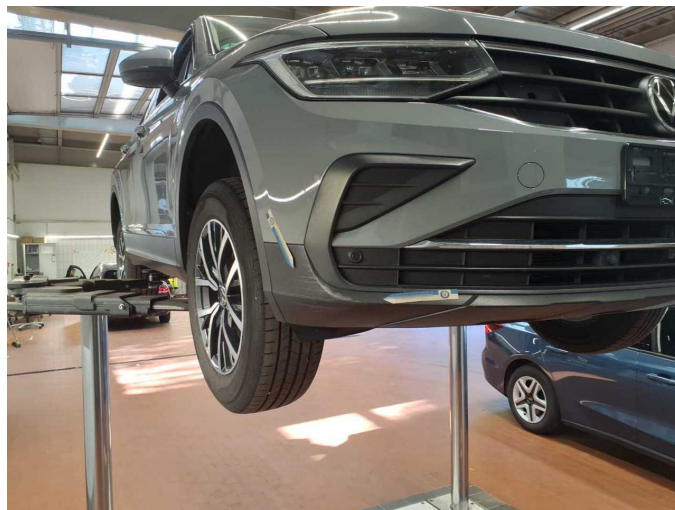
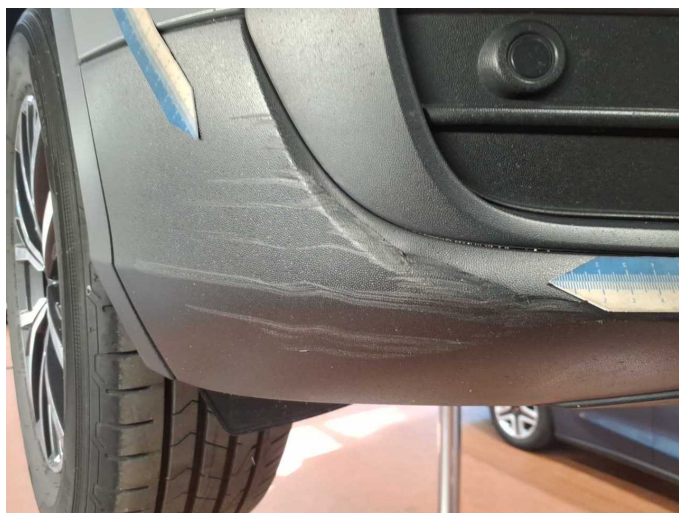
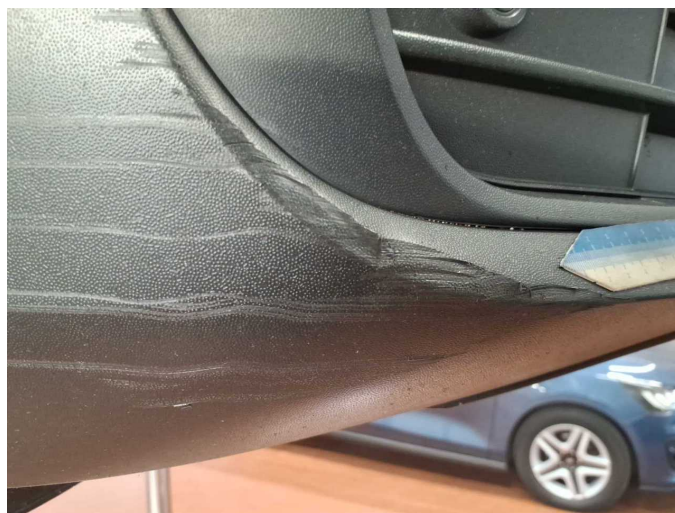
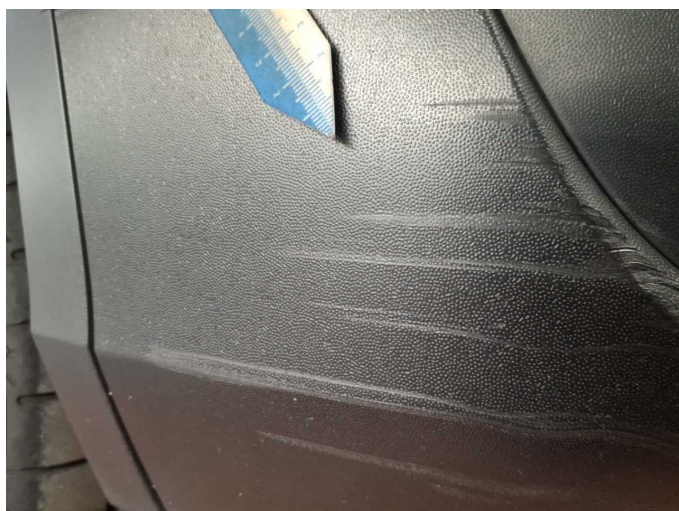
| No. | Component group | Description |
|---|---|---|
| 9 | Front bumper | Spoiler - Scratched - Replace |

**Damage 9:** Front bumper: Spoiler - Scratched - Replace

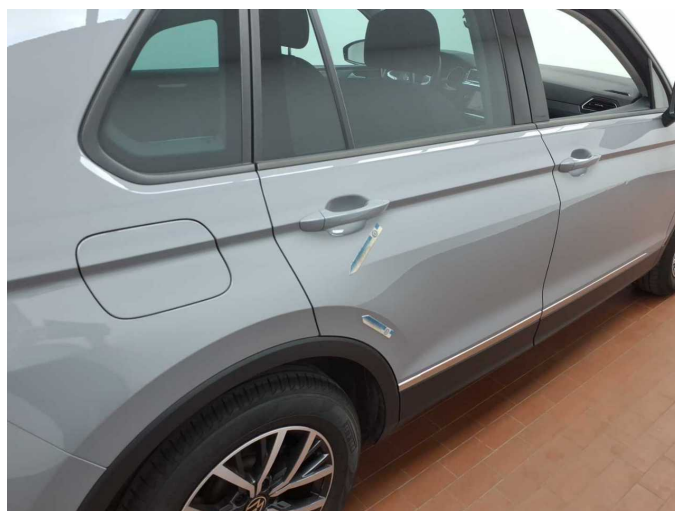
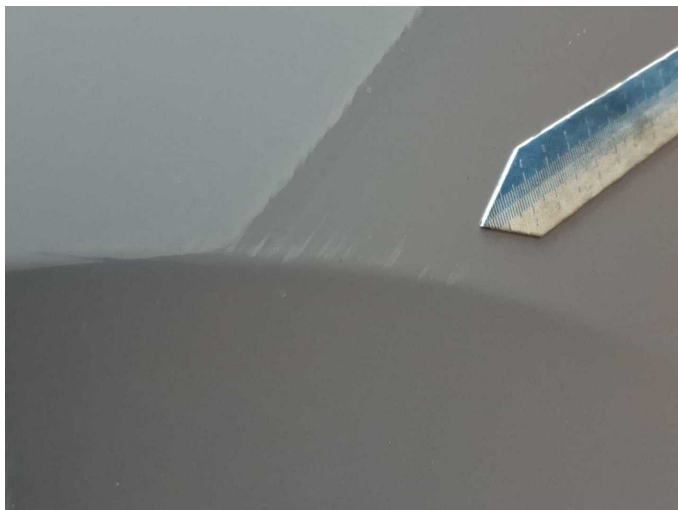
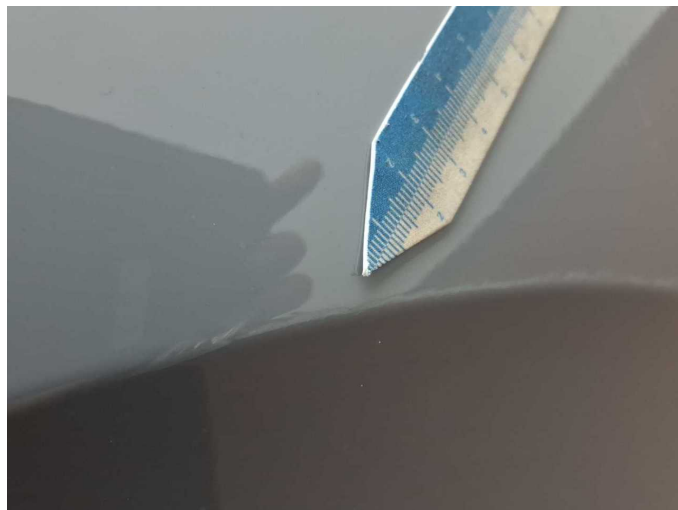
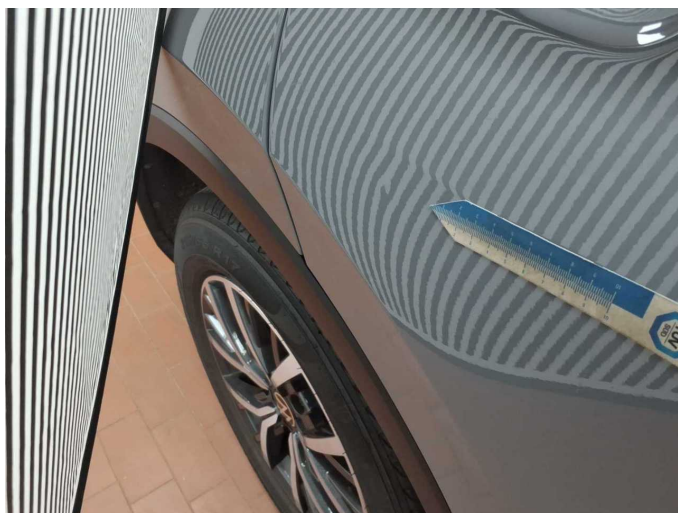
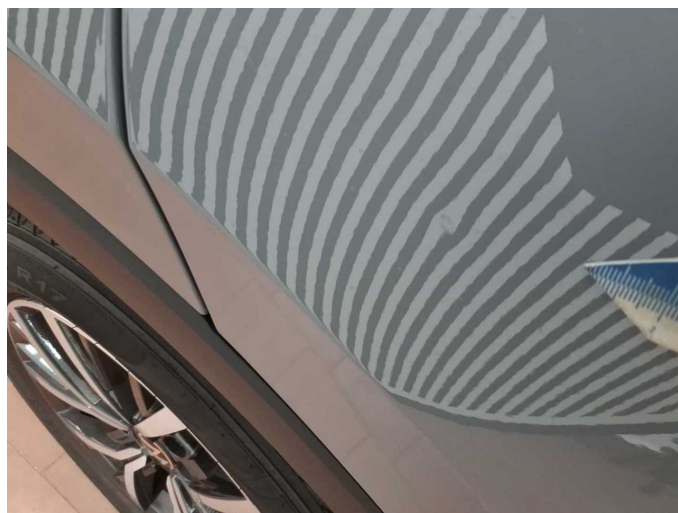
| No. | Component group | Description |
|---|---|---|
| 10 | Door - rear right side | Door - Scratched - Repair and paint |

**Damage 10:** Door - rear right side: Door - Scratched - Repair and paint

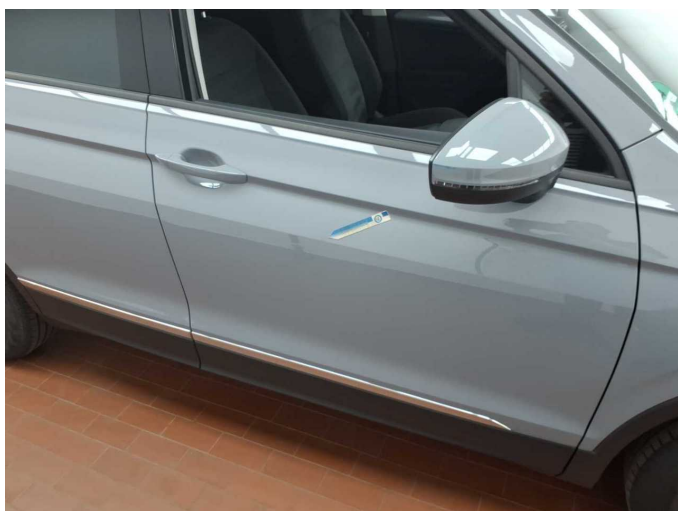
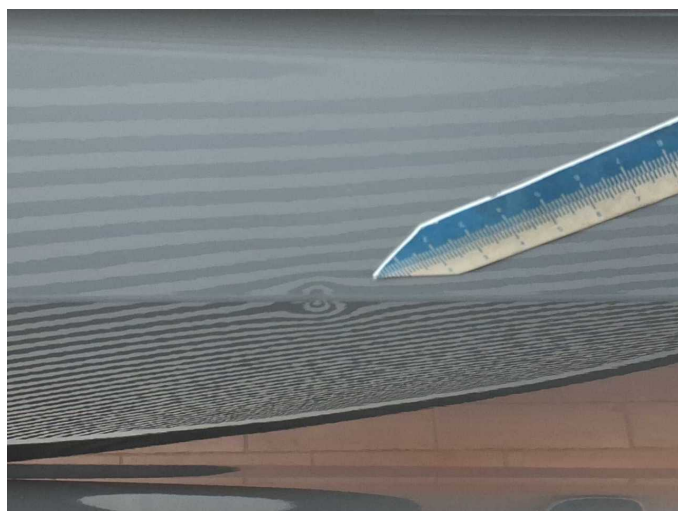
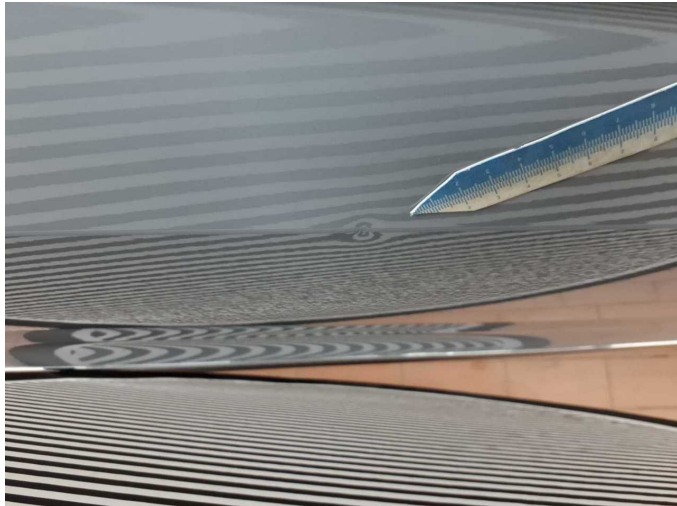
| No. | Component group | Description |
|---|---|---|
| 11 | Door - front right side | Door - Deformed - Repair and paint |

**Damage 11:** Door - front right side: Door - Deformed - Repair and paint

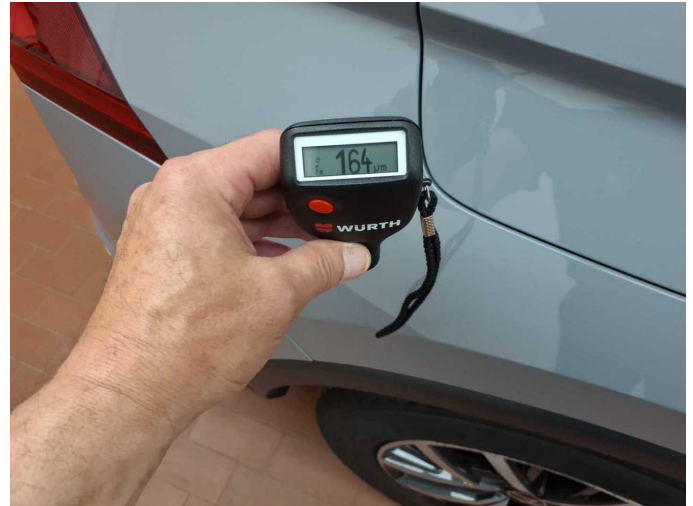
| No. | Repainting |
|---|---|
| 1 | Side panel - rear right side |

**Repainting 1:** Side panel - rear right side

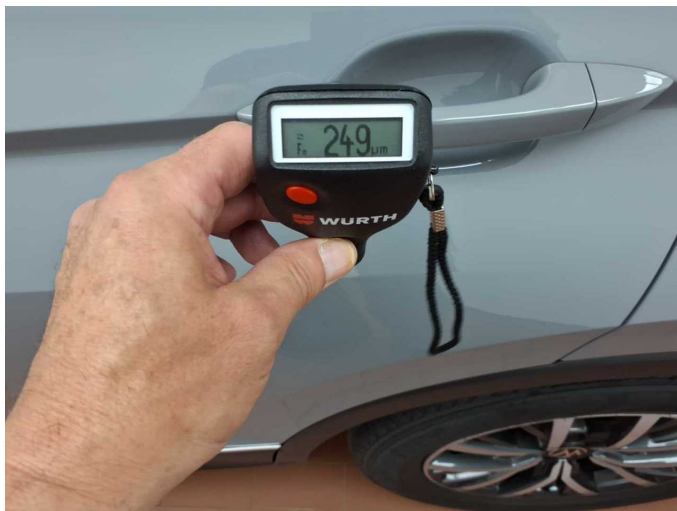
| No. | Repainting |
|---|---|
| 2 | Door - rear left side |

**Repainting 2:** Door - rear left side

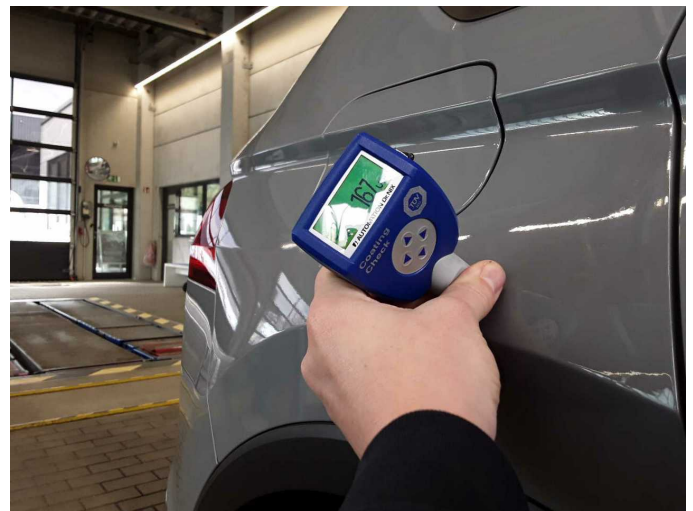
**Side panel - rear right side:** 164 µm
