» Overview

Order number: 1002340041
Order completed: 27.02.2026 13:34
Report number: 10133295
VIN: VSSZZZKJ5RR098974

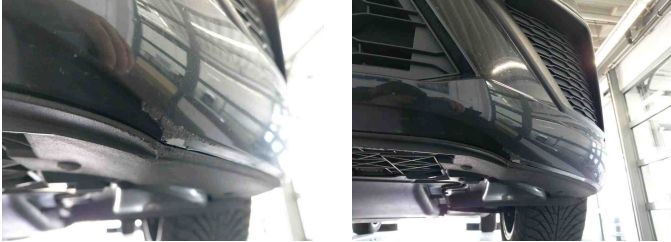
1 - Bumper F - Scratch(es) - Smart repair

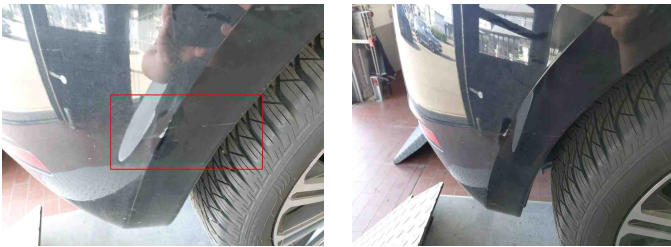
2 - Bumper R - Scratch(es) - Smart repair

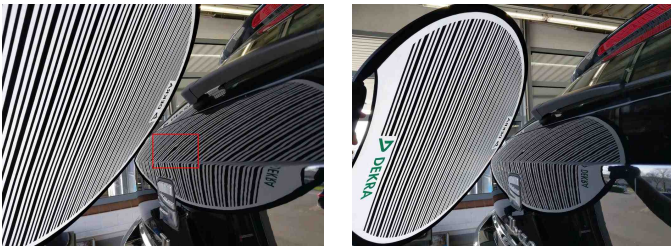
3 - Tailgate / Boot - Dent(s) - Paintless dent repair

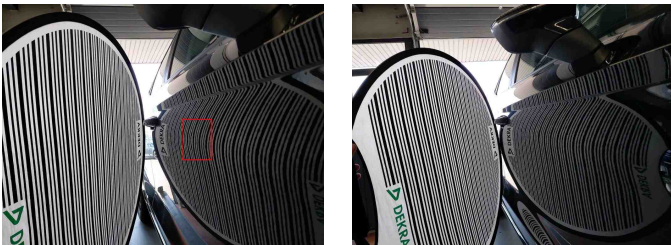
4 - Door FR - Dent(s) - Paintless dent repair

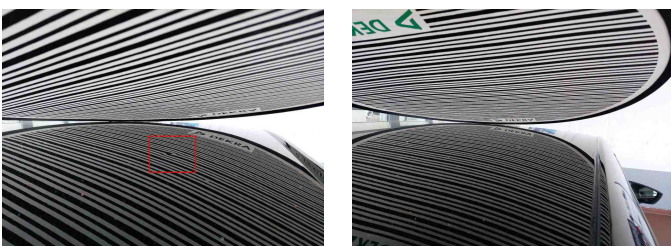
5 - Roof - Dent(s) - Paintless dent repair
