Expertise

Protocol number: 43183177  
Order number / reference: 25661187  
Inspection date: 2 Jan 2026

Manufacturer: Opel

Model: Combo Cargo XL 1.5 D EHZ Edition

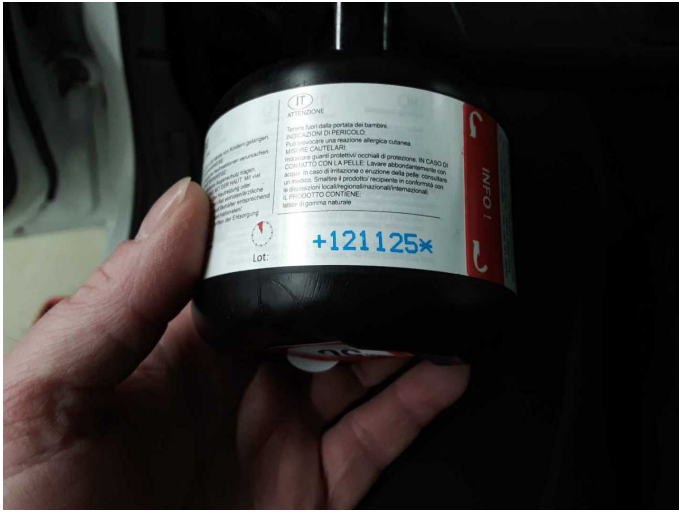
| No. | Component group | Description |
|---|---|---|
| 1 | Equipment | Tirefit filler - Expired - Replace |

Damage 1: Equipment: Tirefit filler - Expired - Replace

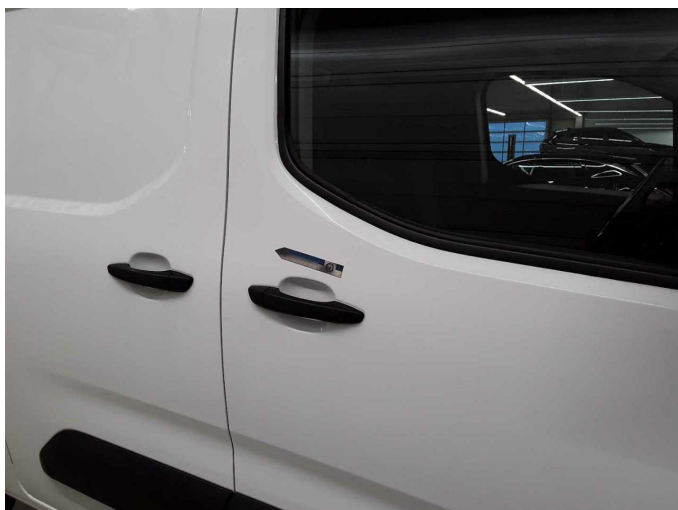
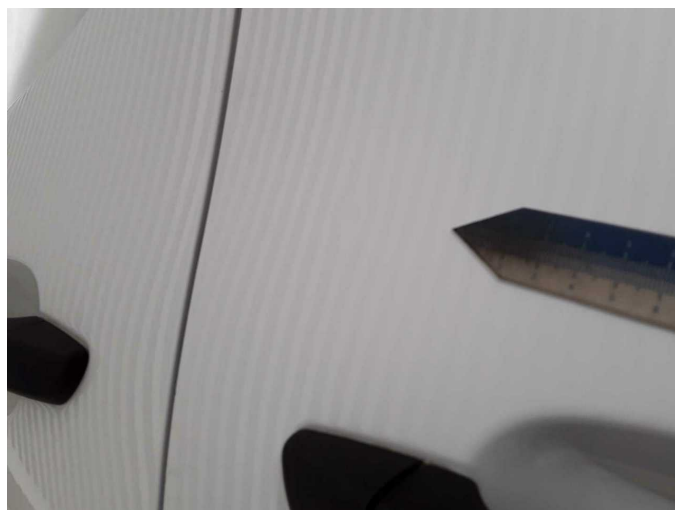
| No. | Component group | Description |
|---|---|---|
| 2 | Door - front right side | Door - dent(s) - Smart repair |

**Damage 2:** Door - front right side: Door - dent(s) - Smart repair

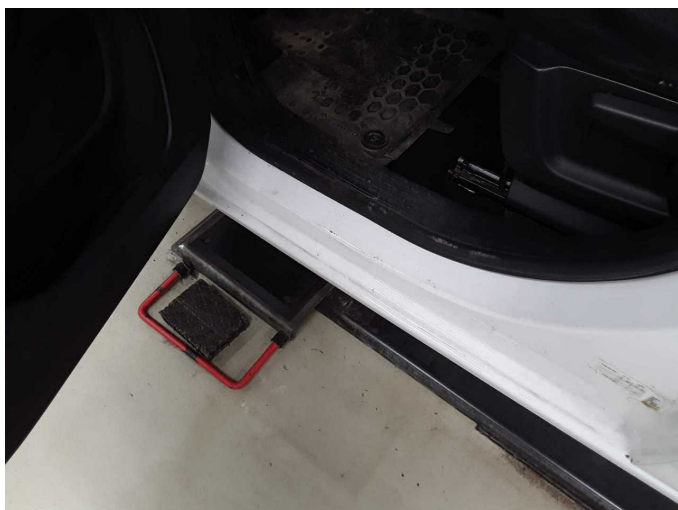
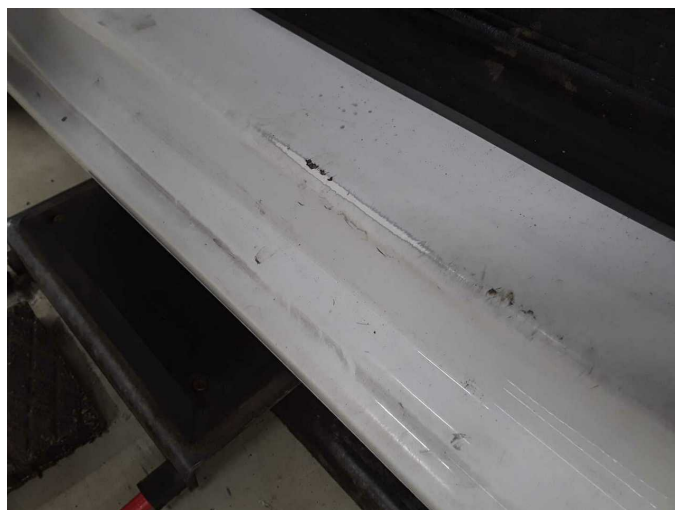
| No. | Component group | Description |
|---|---|---|
| 5 | Sill - left side | Sill - Scratched - Paint |

**Damage 5:** Sill - left side: Sill - Scratched - Paint

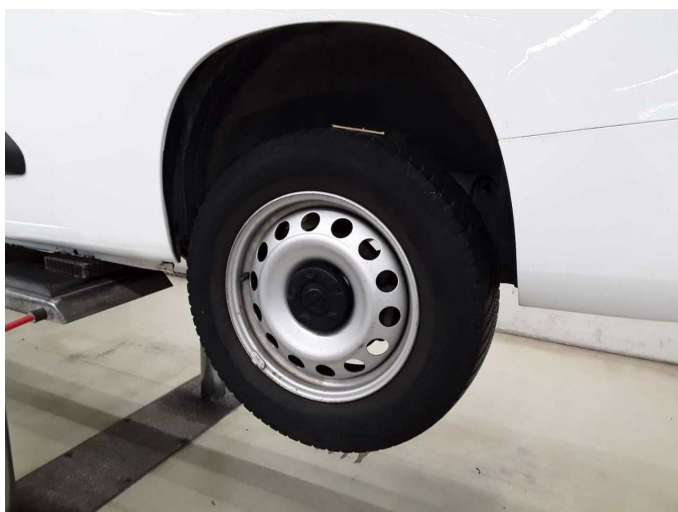
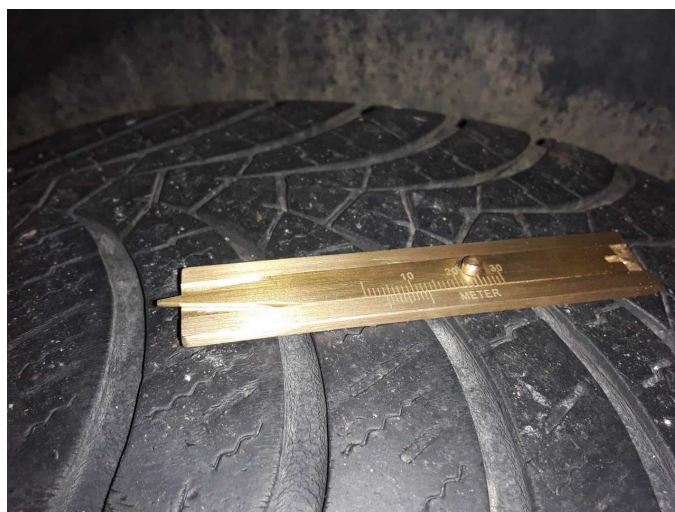
| No. | Component group | Description |
|---|---|---|
| 6 | Wheel / tyres | Tyre - rear left side (poros, rissig) - Does not meet the leasing specifications - Replace |

**Damage 6:** Wheel / tyres: Tyre - rear left side (poros, rissig) - Does not meet the leasing specifications - Replace

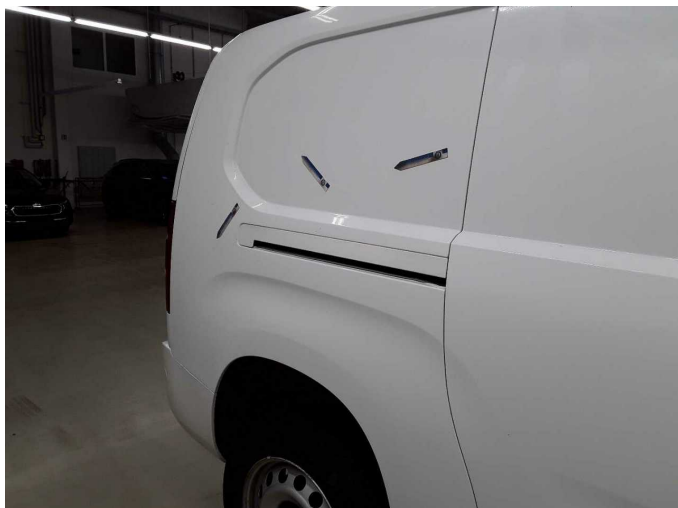
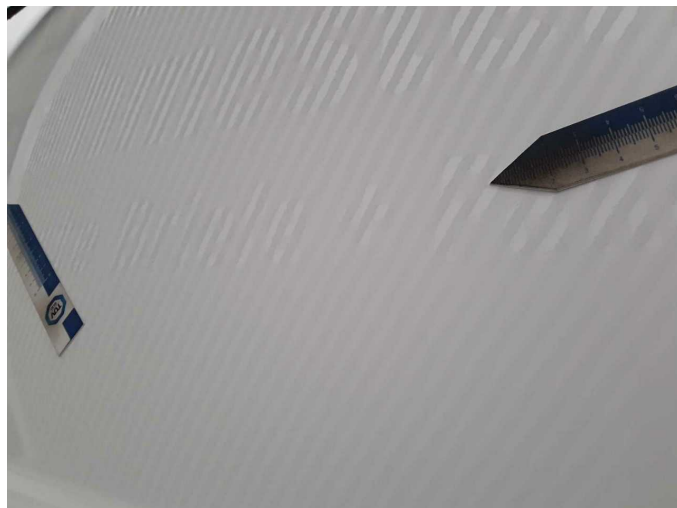
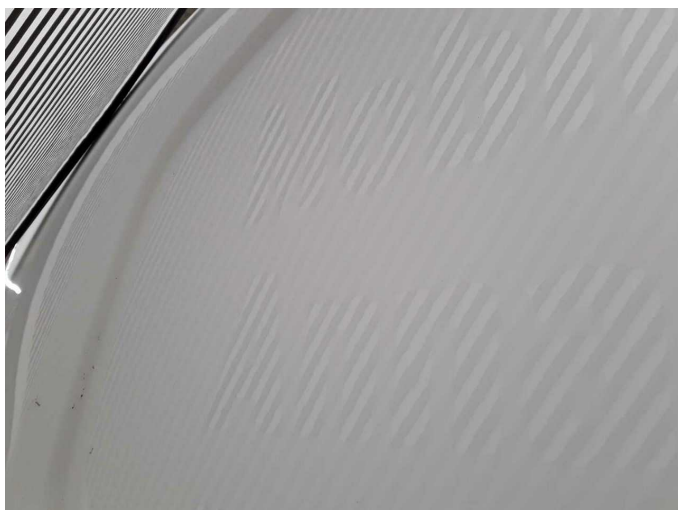
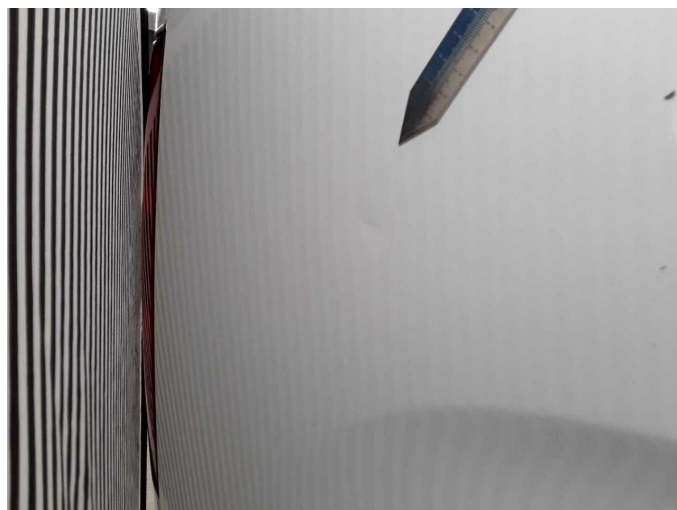
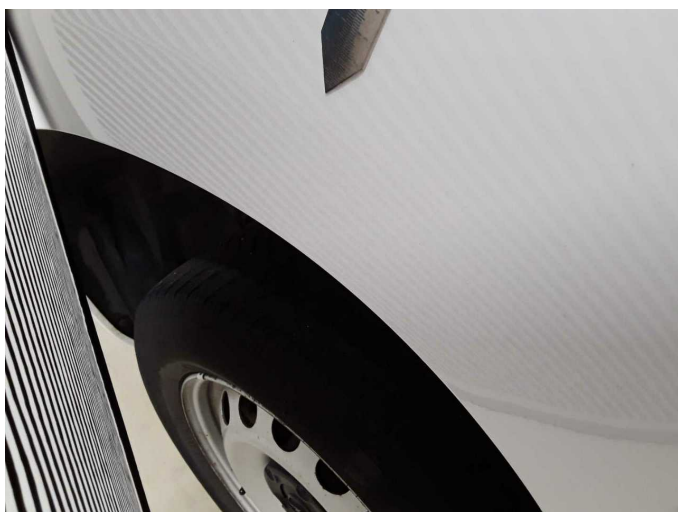
| No. | Component group | Description |
|---|---|---|
| 7 | Side panel - rear right side | Side panel - dent(s) - Smart repair |

**Damage 7:** Side panel - rear right side: Side panel - dent(s) - Smart repair

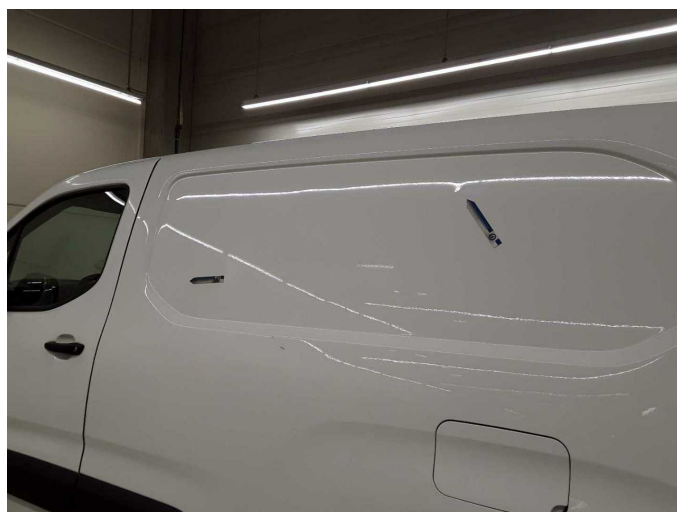
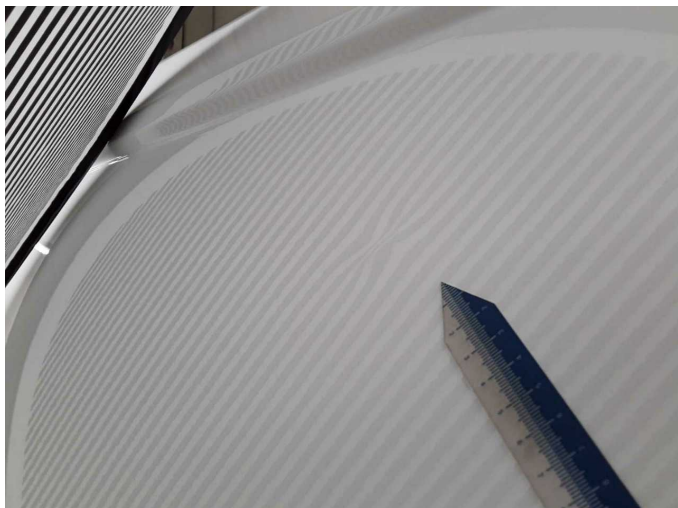
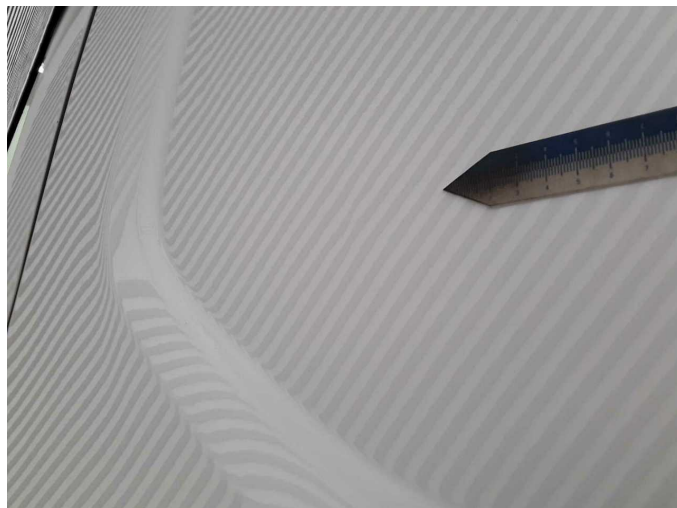
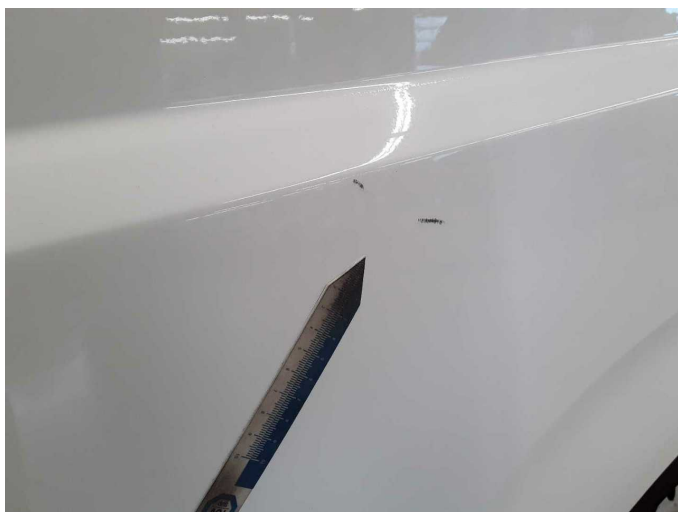
| No. | Component group | Description |
|---|---|---|
| 8 | Side panel - rear left side | Side panel - Dent / paintcoat damage - Smart repair |

**Damage 8:** Side panel - rear left side: Side panel - Dent / paintcoat damage - Smart repair

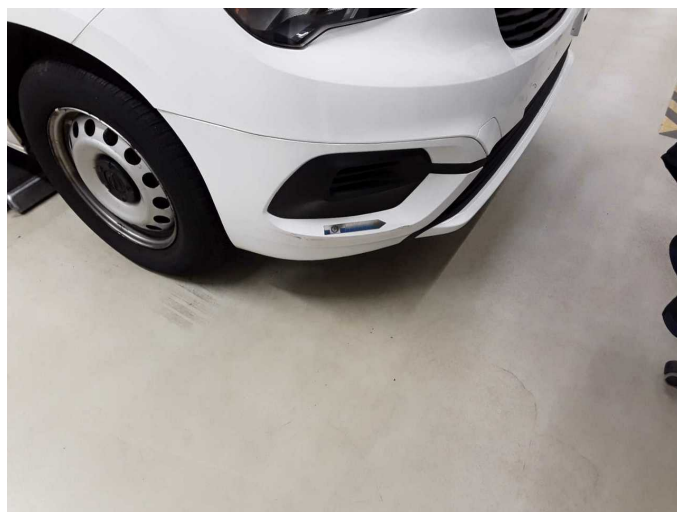
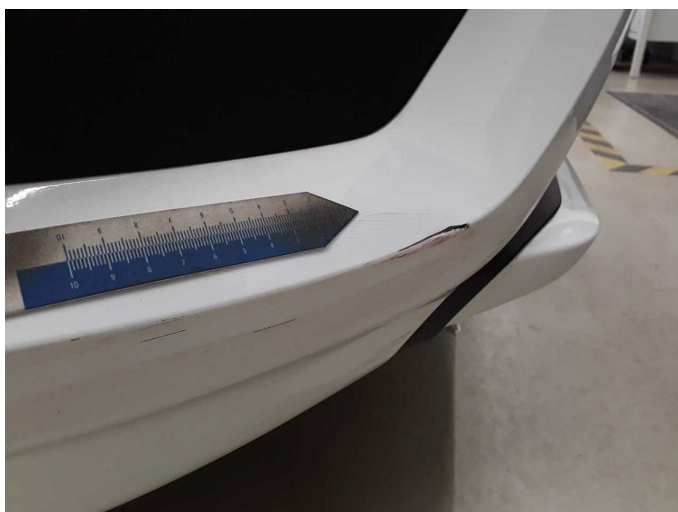
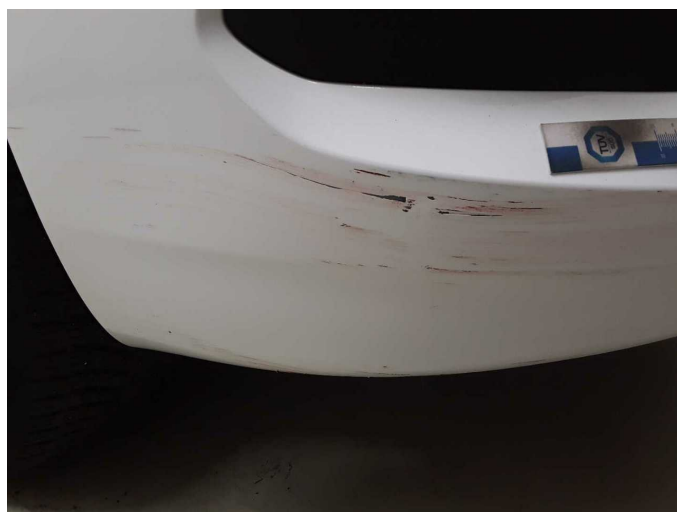
| No. | Component group | Description |
|---|---|---|
| 9 | Front bumper | Front bumper (Unterteil) - Deformed - Replace |

**Damage 9:** Front bumper: Front bumper (Unterteil) - Deformed - Replace

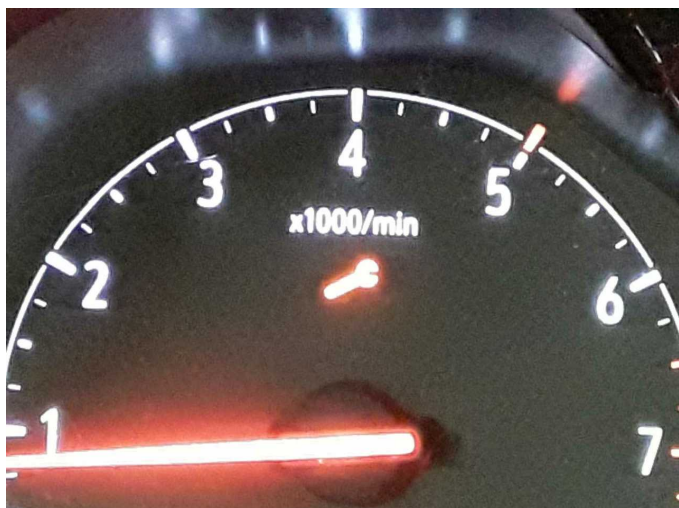
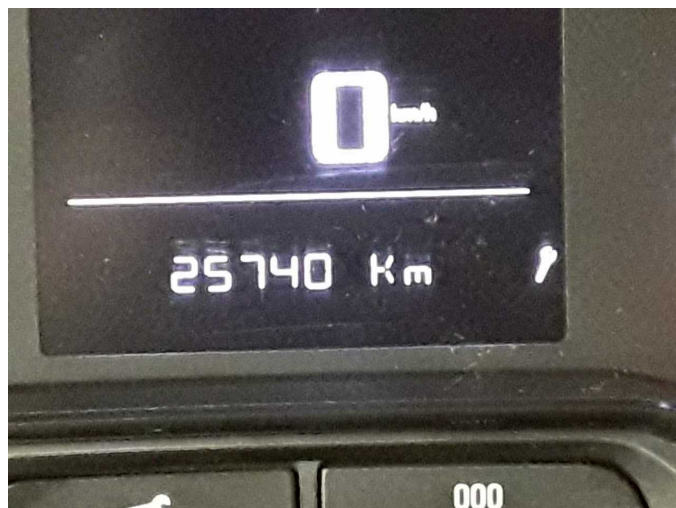
| No. | Component group | Description |
|---|---|---|
| 10 | Misc. | Inspection / maintenance - Due - Perform |

**Damage 10:** Misc.: Inspection / maintenance - Due - Perform

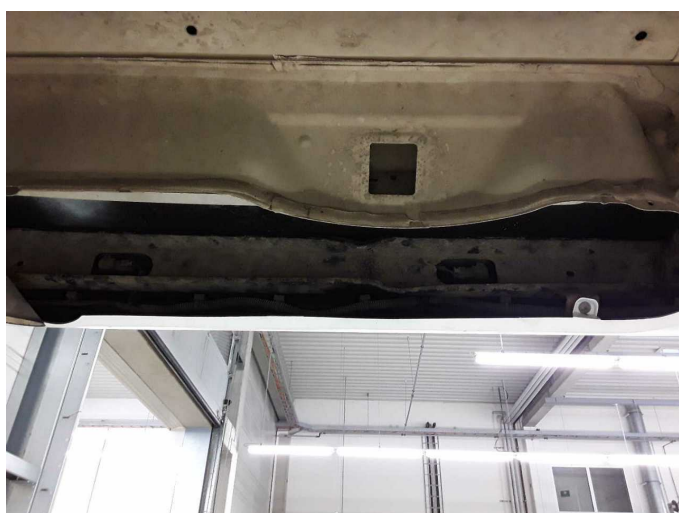
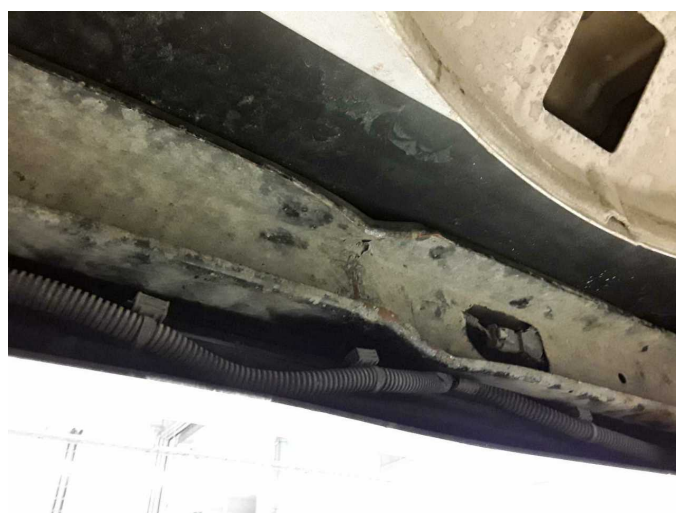
| No. | Component group | Description |
|---|---|---|
| 11 | Rear bumper | Support - Deformed - Replace |

**Damage 11:** Rear bumper: Support - Deformed - Replace

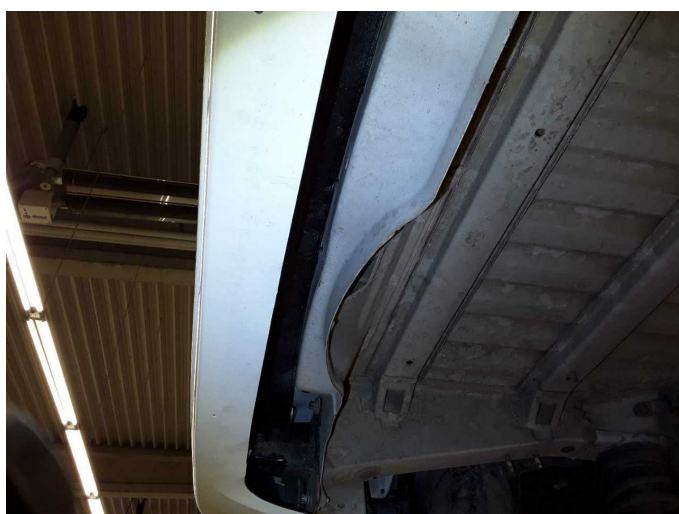
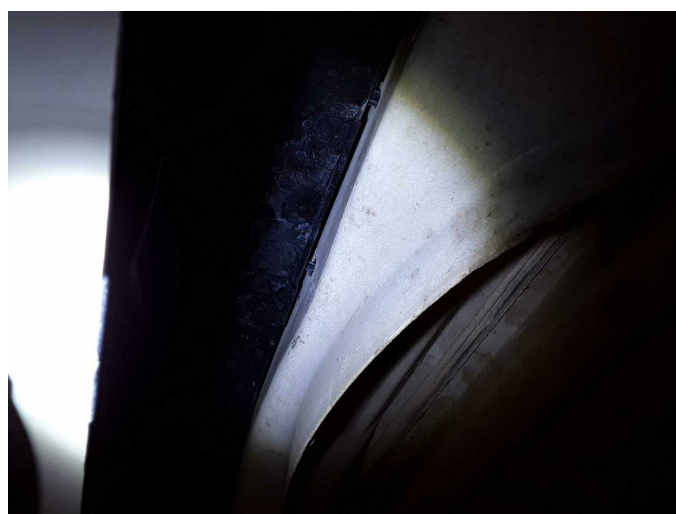
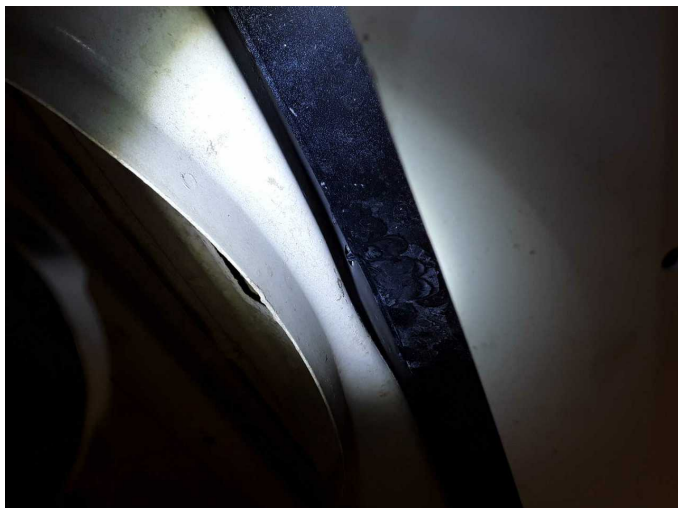
| No. | Component group | Description |
|---|---|---|
| 12 | Rear of vehicle | Rear panel - Deformed - Repair and paint |

**Damage 12:** Rear of vehicle: Rear panel - Deformed - Repair and paint

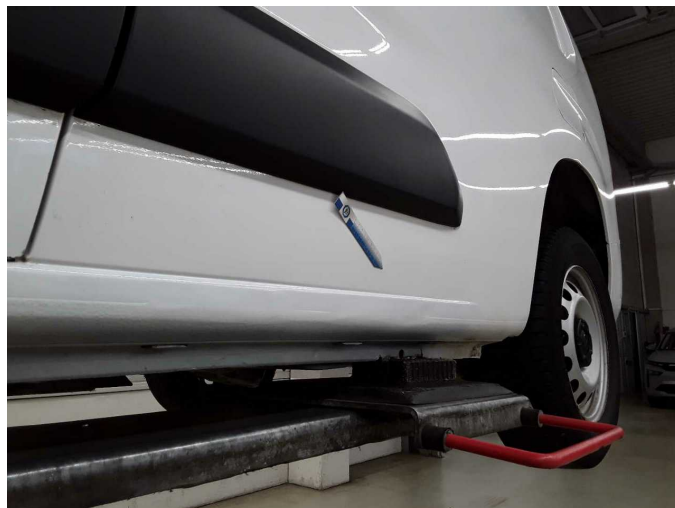
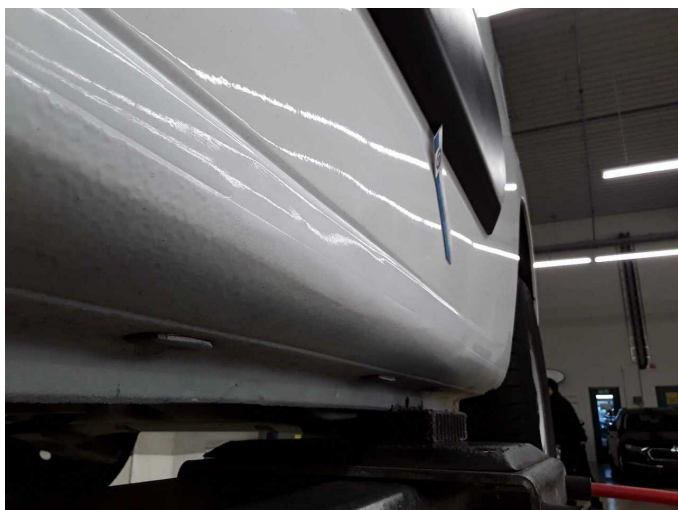
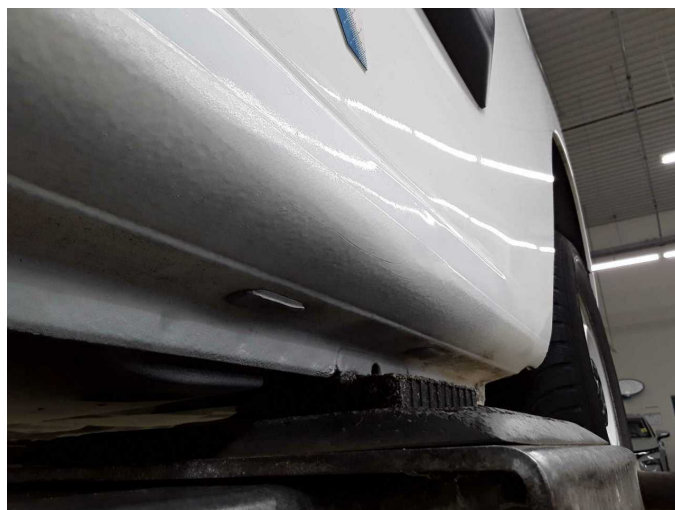
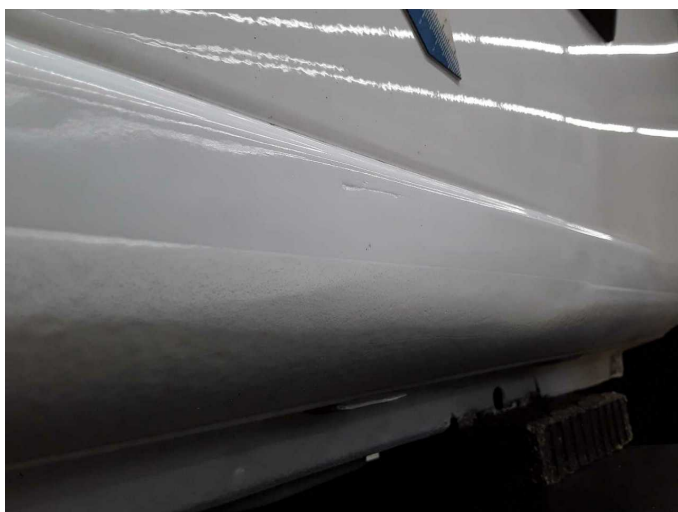
| No. | Component group | Description |
|---|---|---|
| 13 | Sill - left side | Sill - Unprofessionally repaired - Repair and paint |

| No. | Repainting |
|---|---|
| 2 | Sill - left side, Unprofessionally carried out |

**Damage 13:** Sill - left side: Sill - Unprofessionally repaired - Repair and paint

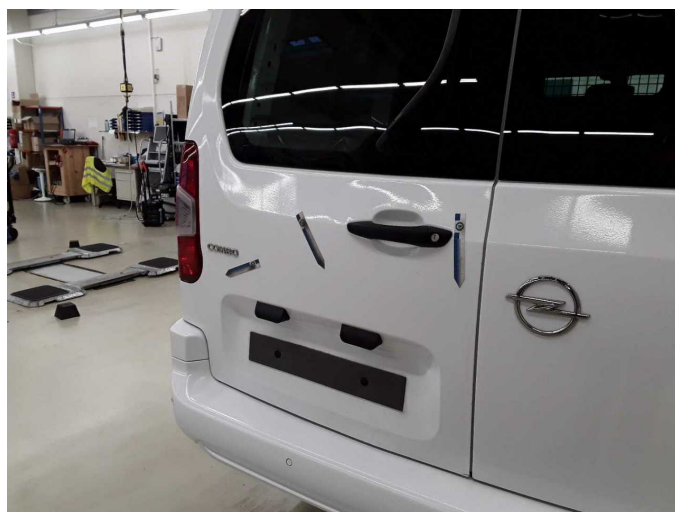
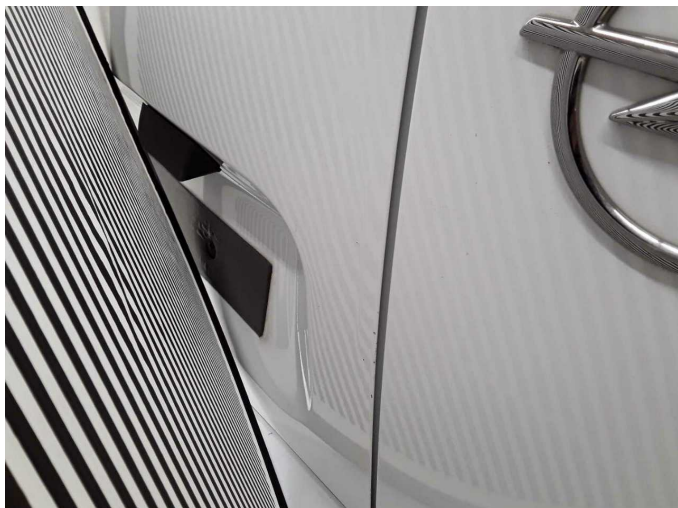
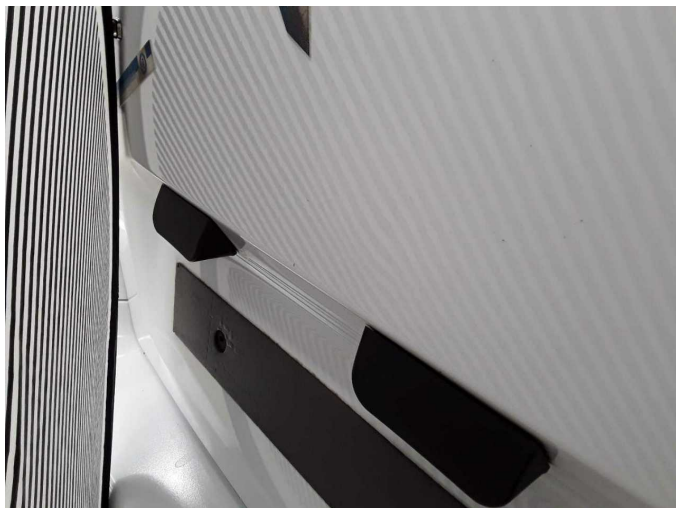
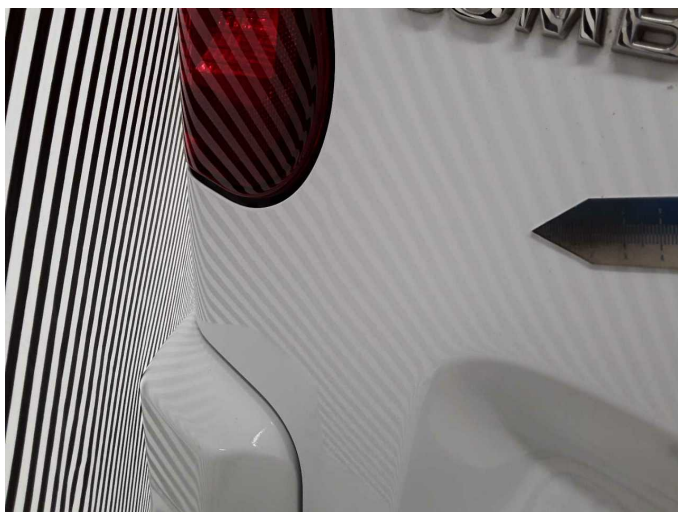
| No. | Component group | Description |
|---|---|---|
| 14 | Boot lid / rear door | Rear door glazed - left side - dent(s) - Repair and paint |

**Damage 14:** Boot lid / rear door: Rear door glazed - left side - dent(s) - Repair and paint

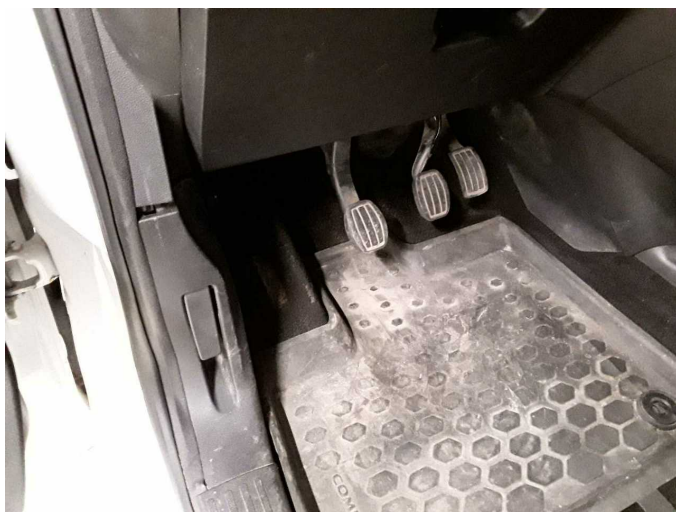
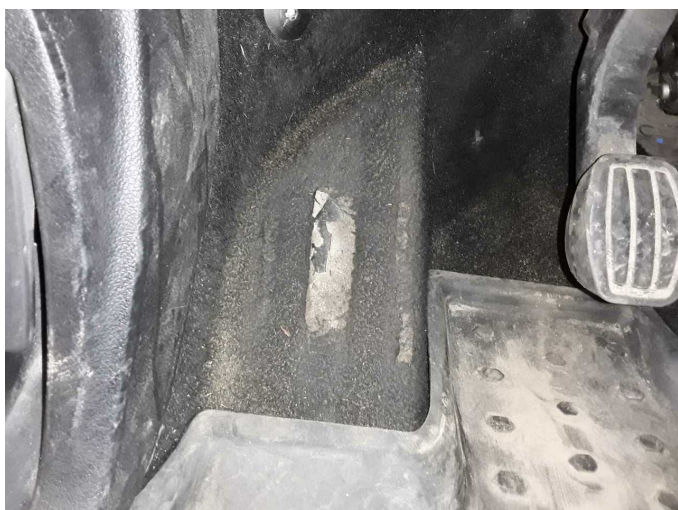
| No. | Component group | Description |
|---|---|---|
| 15 | Trim / covers | Floor covering - front left side - Broken / torn - Replace |

**Damage 15:** Trim / covers: Floor covering - front left side - Broken / torn - Replace

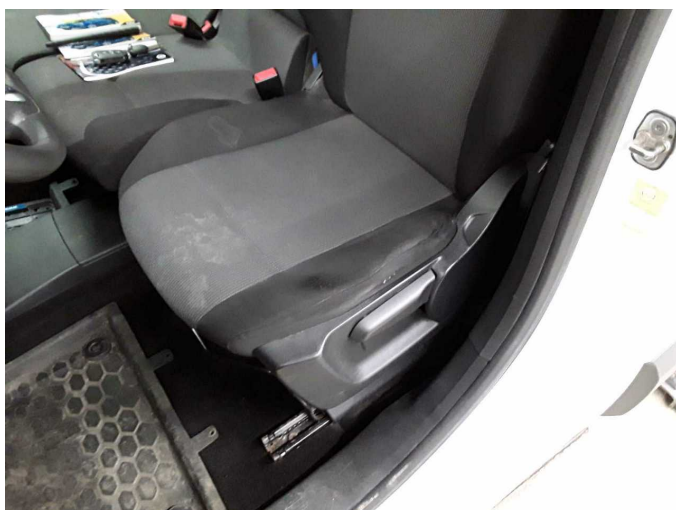
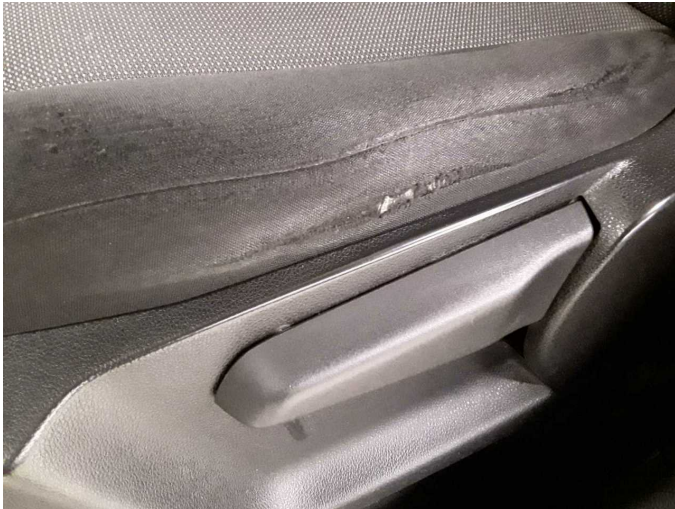
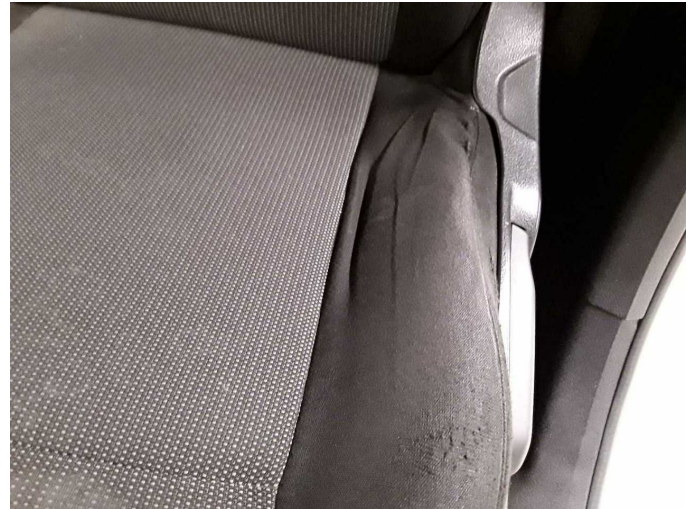
| No. | Component group | Description |
|---|---|---|
| 16 | Seat - front | Seat cover - left side (inkl. Polster) - Broken / torn - Replace |

**Damage 16:** Seat - front: Seat cover - left side (inkl. Polster) - Broken / torn - Replace

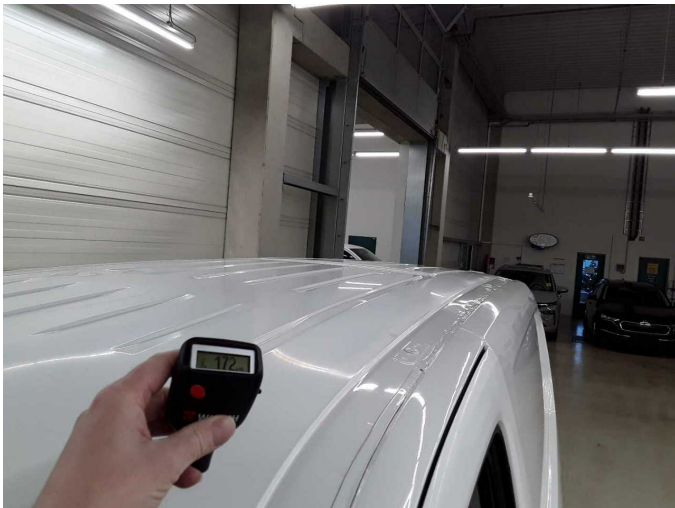
**Roof:** 172 µm

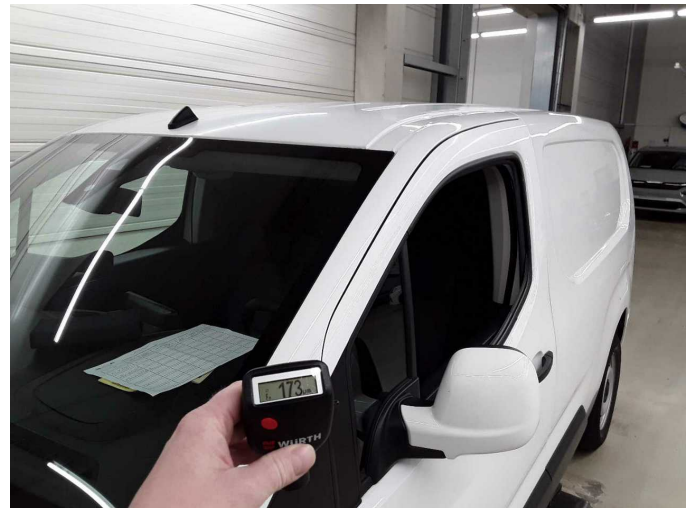
**Roof rail - left side:** 173 µm

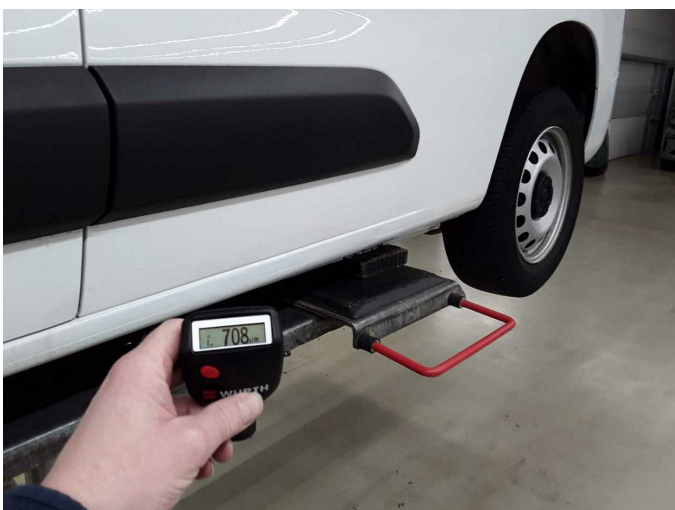
**Sill - left side:** 708 µm
