## Expertise

Protocol number: 46350496  
Order No. / Reference: 26194865  
Inspection date: 2 Jul 2026

Model: Vito 116 CDI Extralang HA PRO

VIN: W1VVLCEZ4T4555304

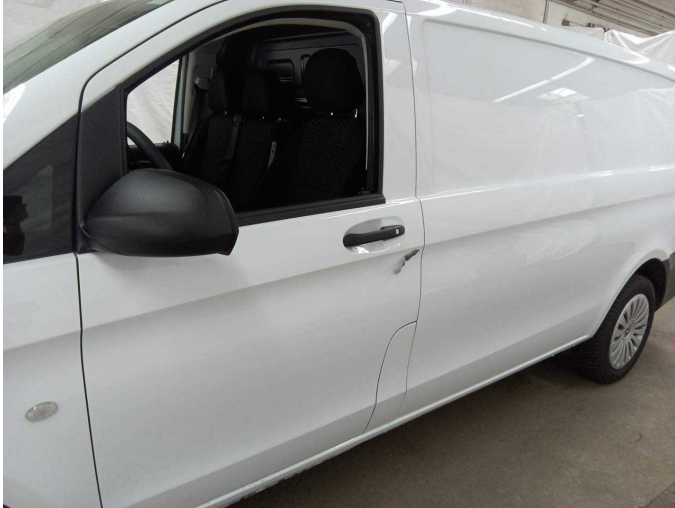
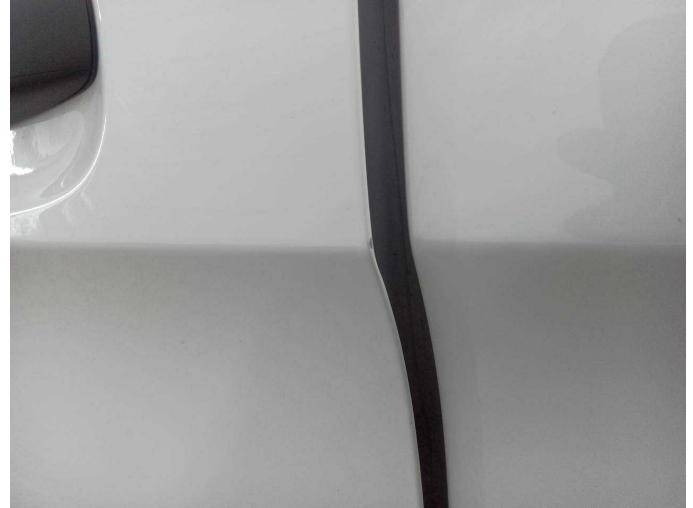
**Damage 1:** Door - front left side: Door edge - Scratch(es) - Smart repair

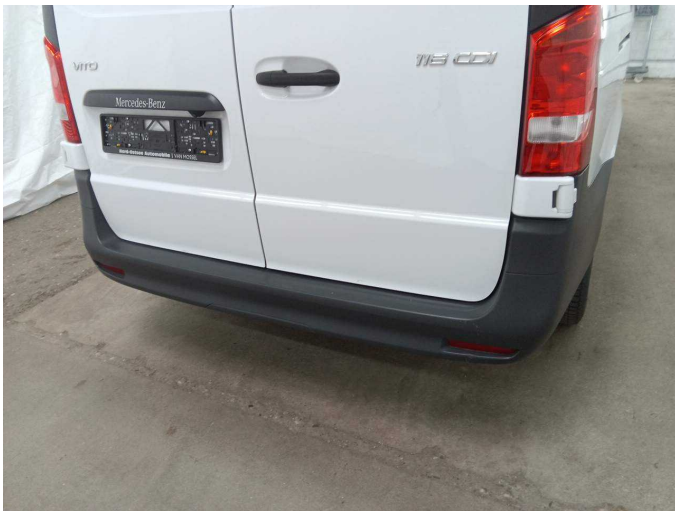
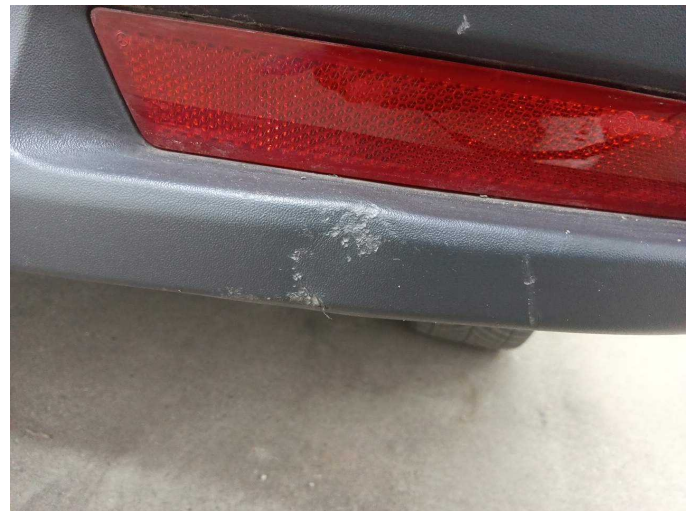
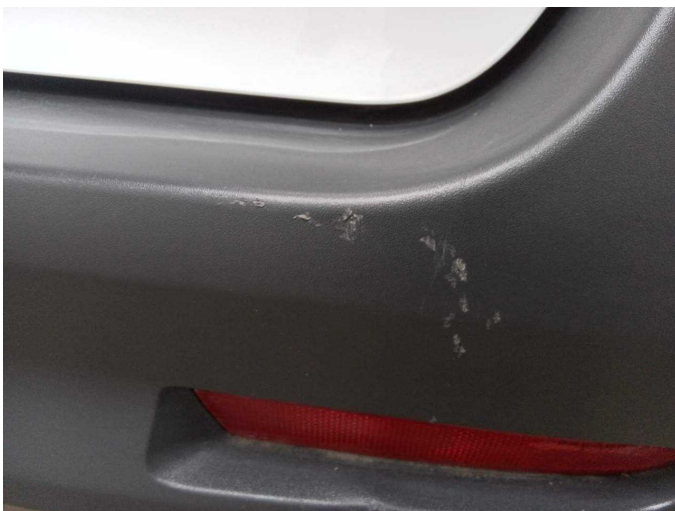
**Damage 2:** Rear bumper: Rear bumper - Scratch(es) - Replace

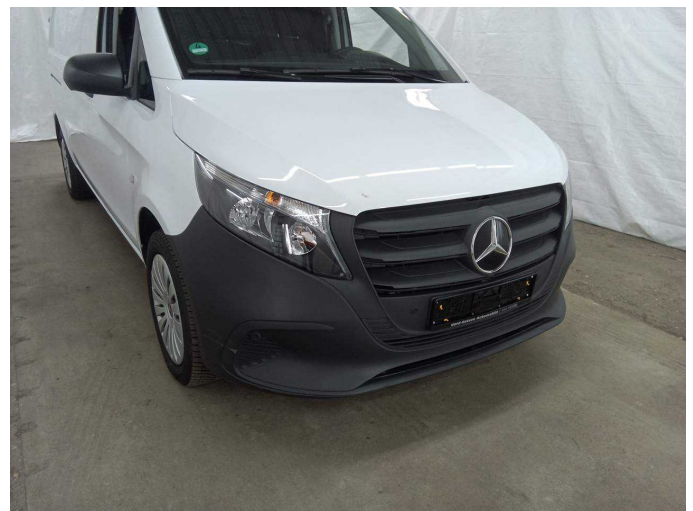
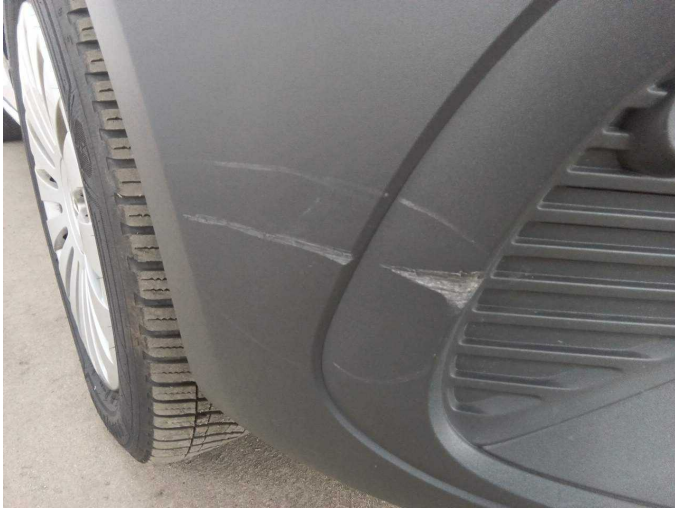
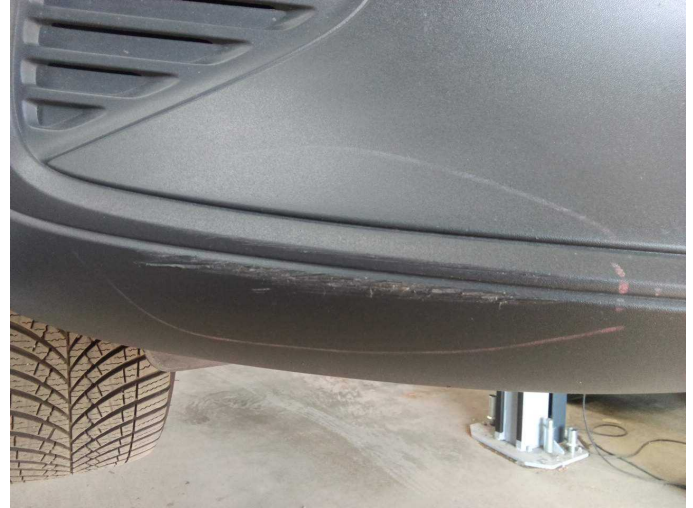
**Damage 3:** Front bumper: Front bumper - Scratch(es) - Replace

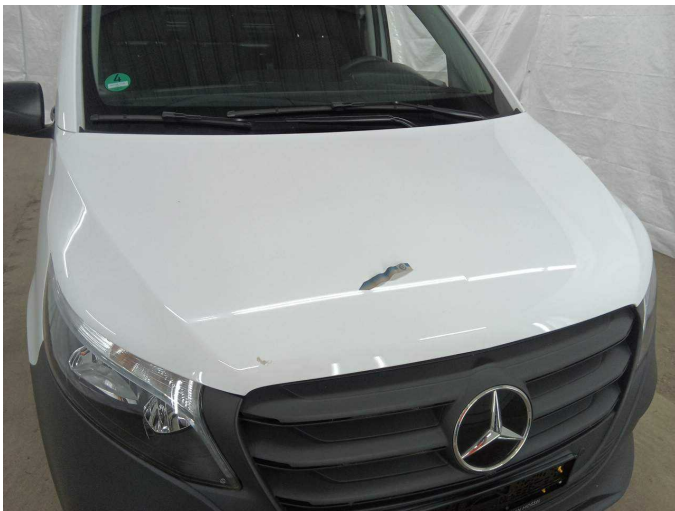
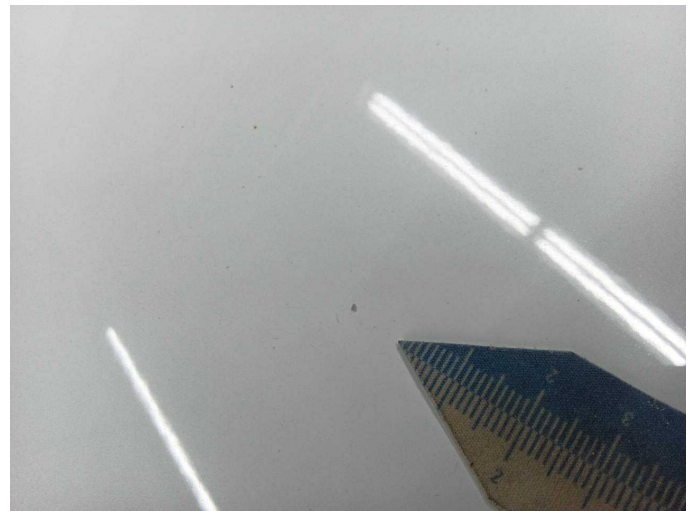
**Wear and tear 1:** Bonnet: Bonnet - Stone chips - No deduction

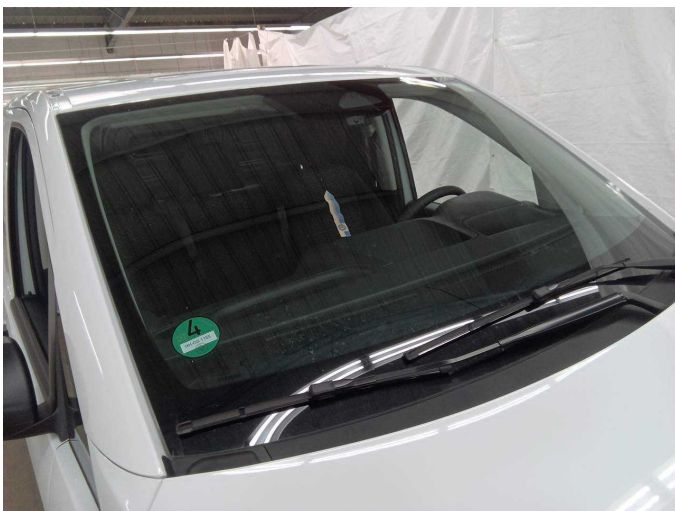
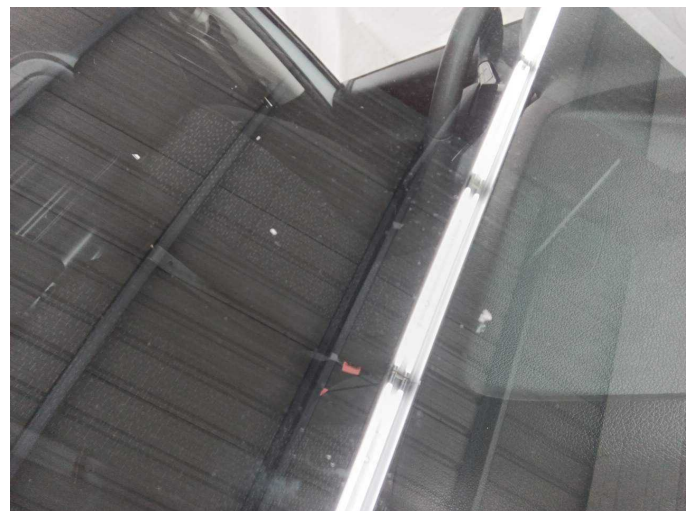
**Wear and tear 2:** Vehicle glazing: Windscreen - Stone chips - No deduction
