## Expertise

Protocol number: 46193881  
Order No. / Reference: 26153174  
Inspection date: 1 Jun 2026

Model: 317 CDI Sprinter Lang HA 9G-TRONIC PRO

VIN: W1V3KCFZ3TP845170

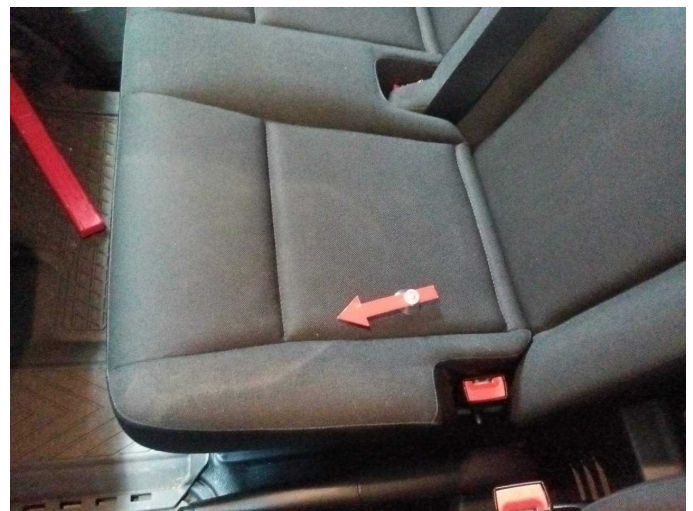
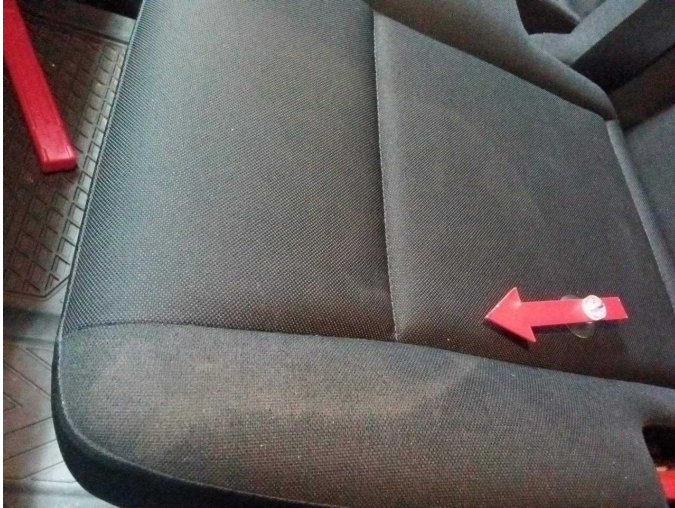
Damage 1: Seat - front: Seat cover - right side - Soiled - Clean

**Damage 1:** Seat - front: Seat cover - right side - Soiled - Clean

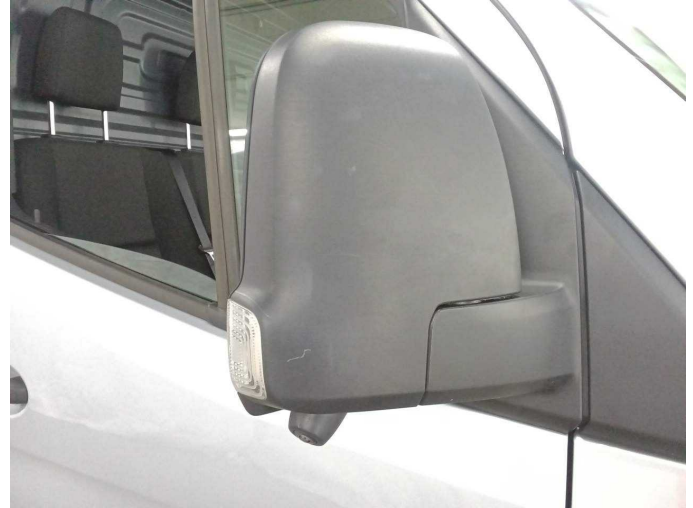
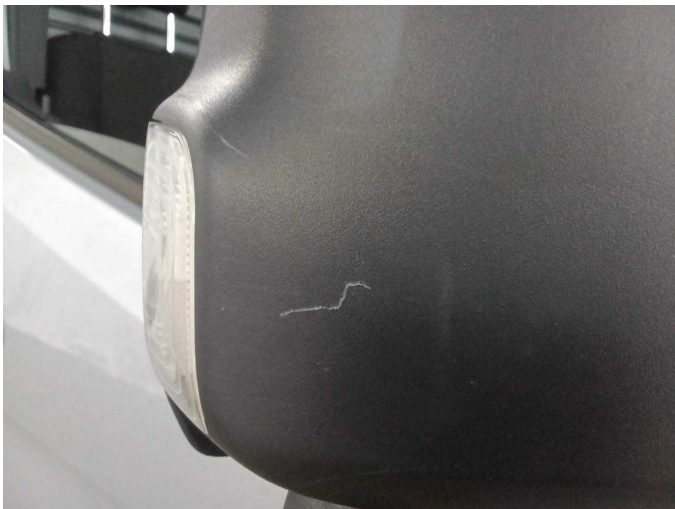
**Damage 2:** Wing mirror - right side: Mirror housing - Scratch(es) - Loss in value

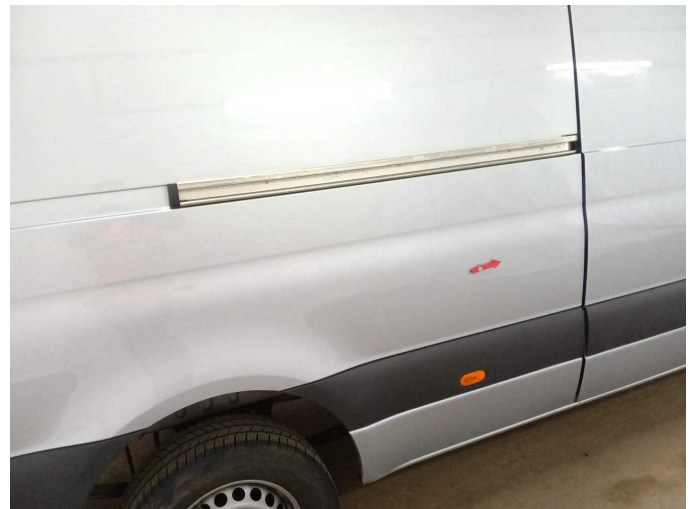
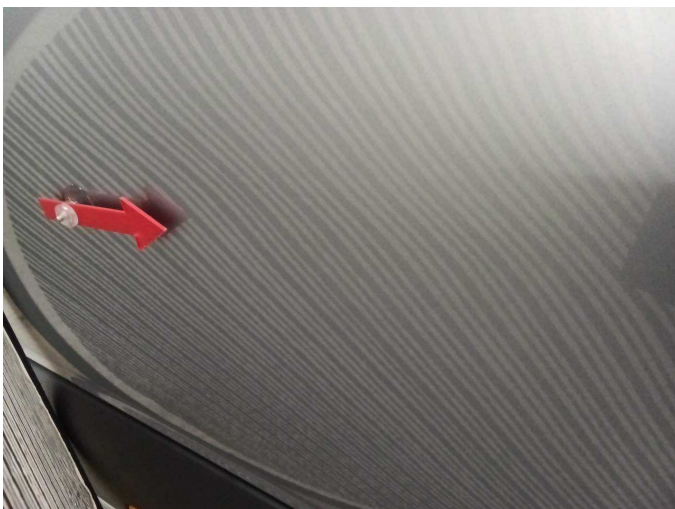
**Damage 3:** Side panel - rear right side: Side panel - dent(s) - Smooth repair work

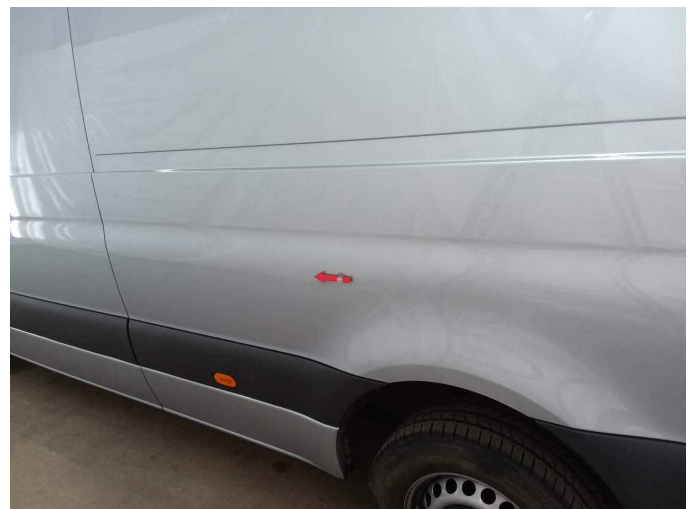
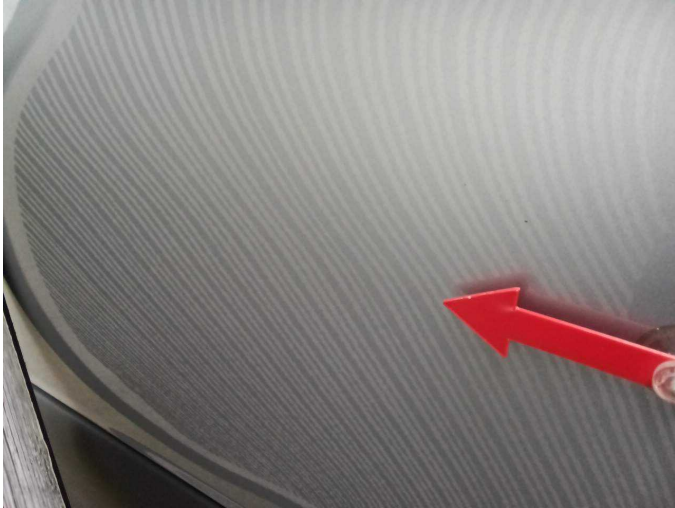
**Damage 4:** Side panel - rear left side: Side panel - dent(s) - Smooth repair work

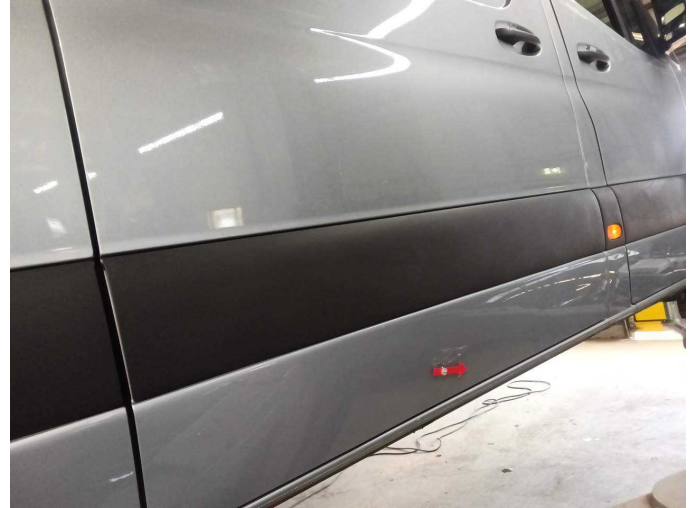
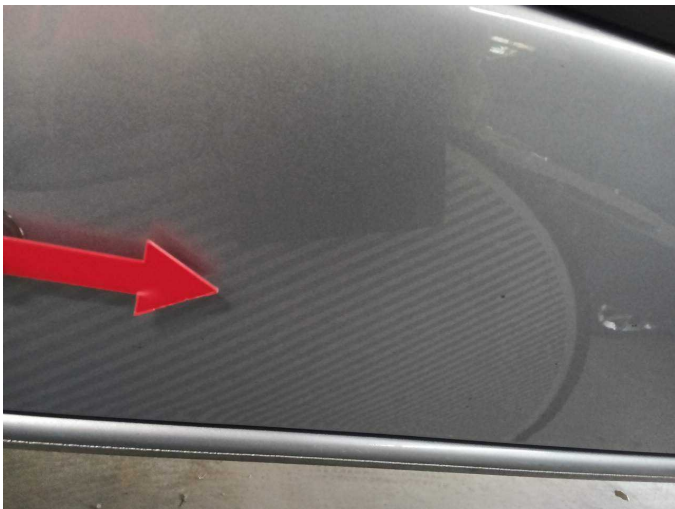
**Damage 5:** Sliding door, right: Sliding door - dent(s) - Smooth repair work

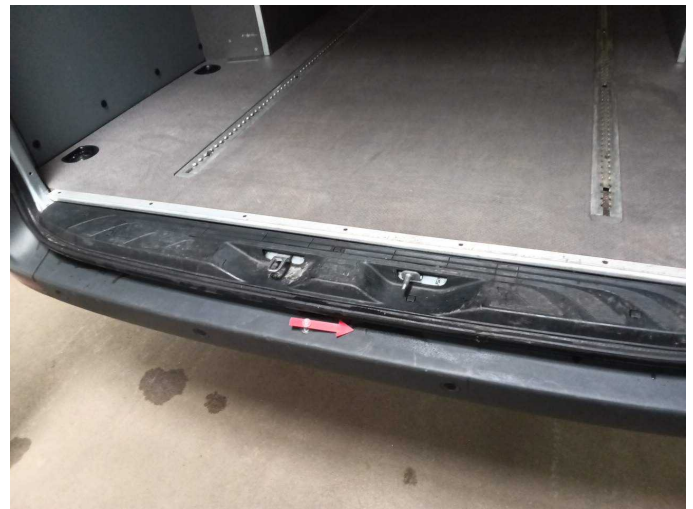
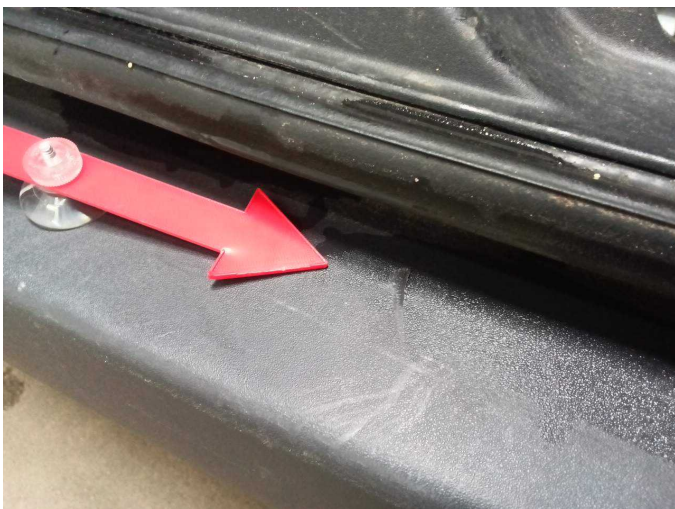
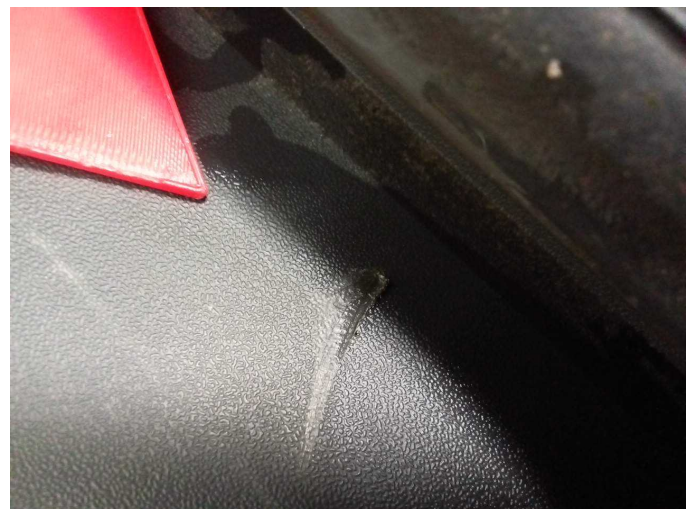
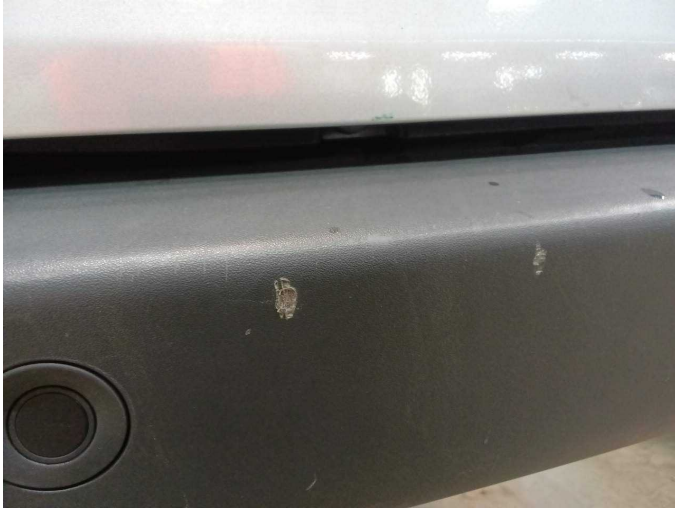
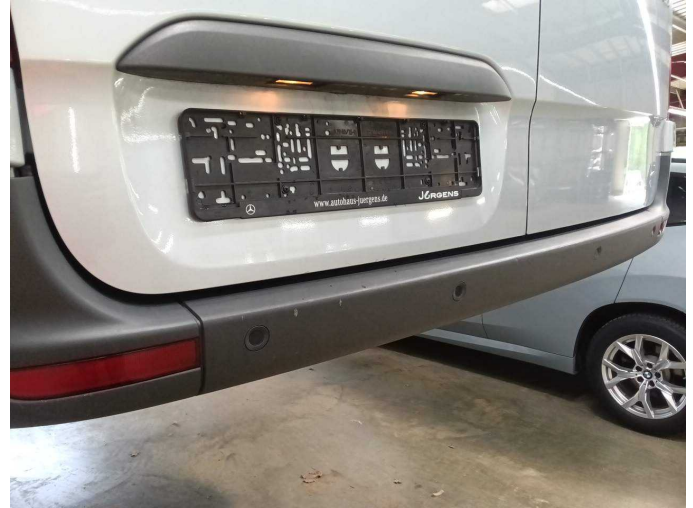
**Damage 6:** Rear bumper: Rear bumper - Scratched - Replace

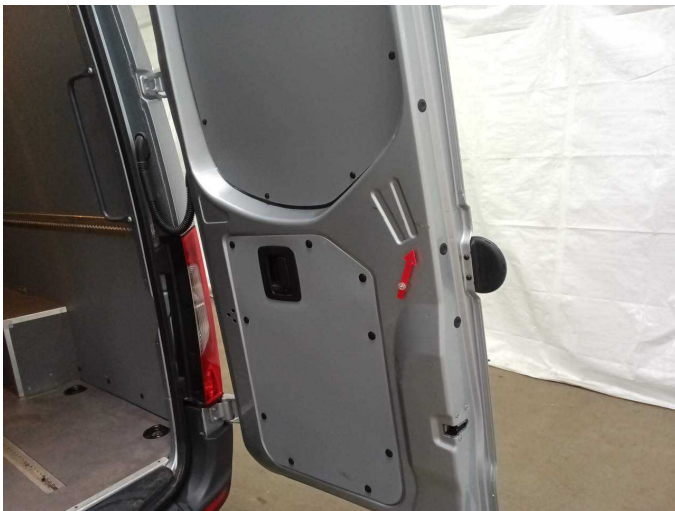
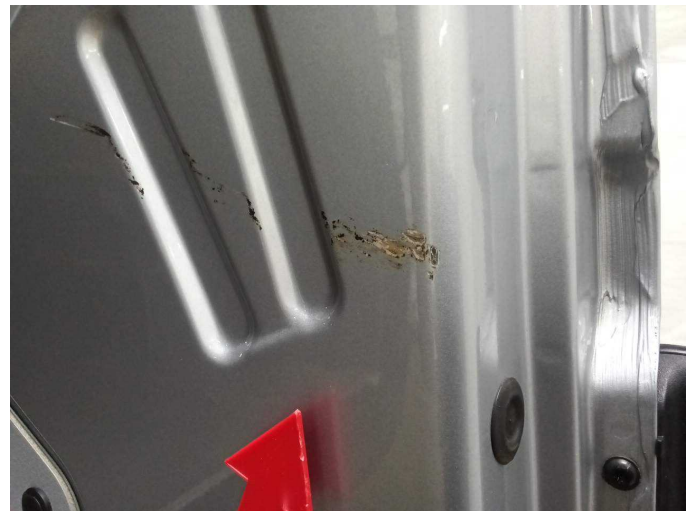
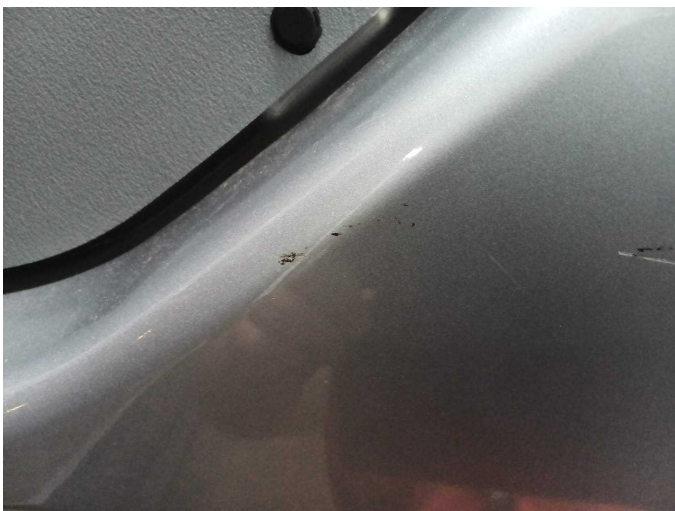
**Damage 7:** Boot lid / rear door: Boot lid - Scratched - Paint

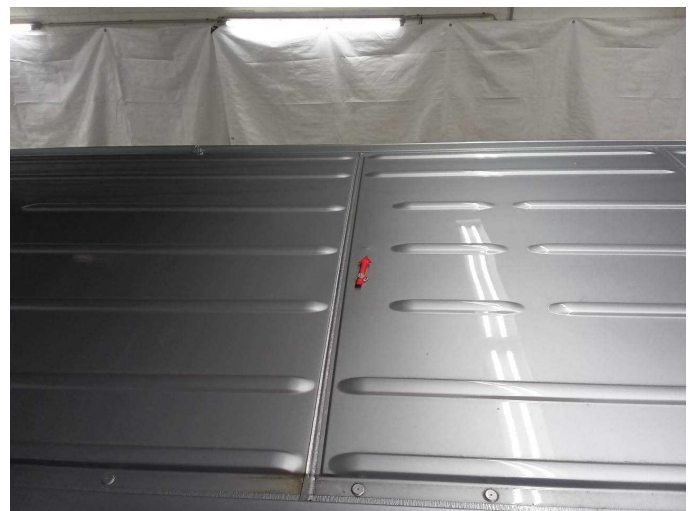
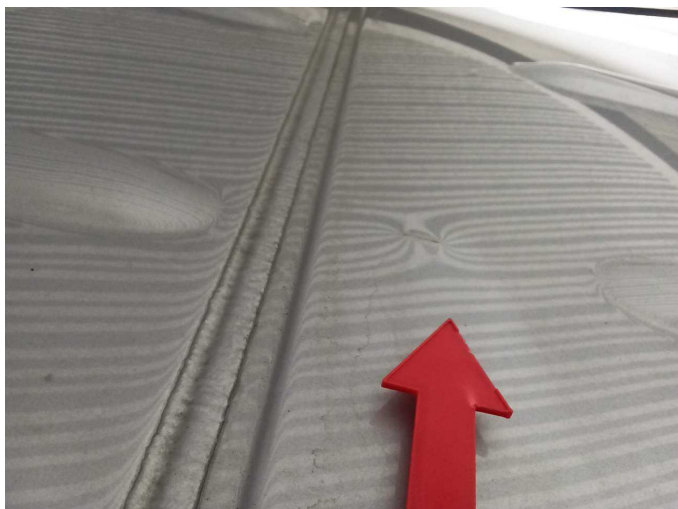
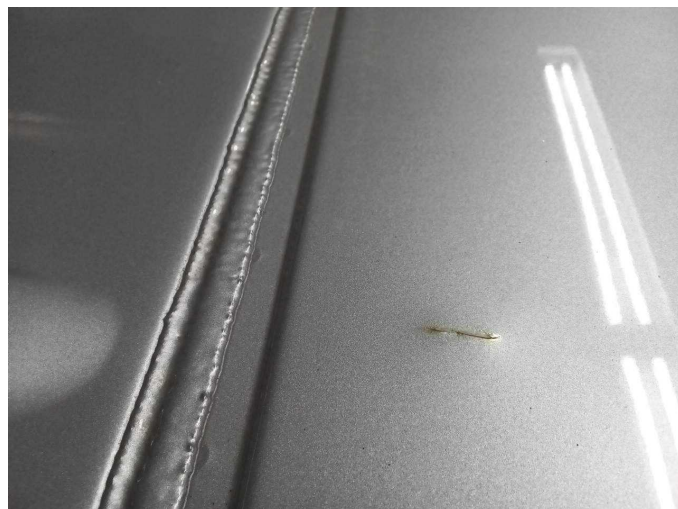
**Damage 8:** Roof: Roof - Dent / paintcoat damage - Repair and paint
