## Expertise

Protocol number: 46145159  
Order No. / Reference: 26496971  
Inspection date: 18 Jun 2026

Model: IONIQ 5 77,4 kWh Techniq

VIN: KMHKN81EFPU201419

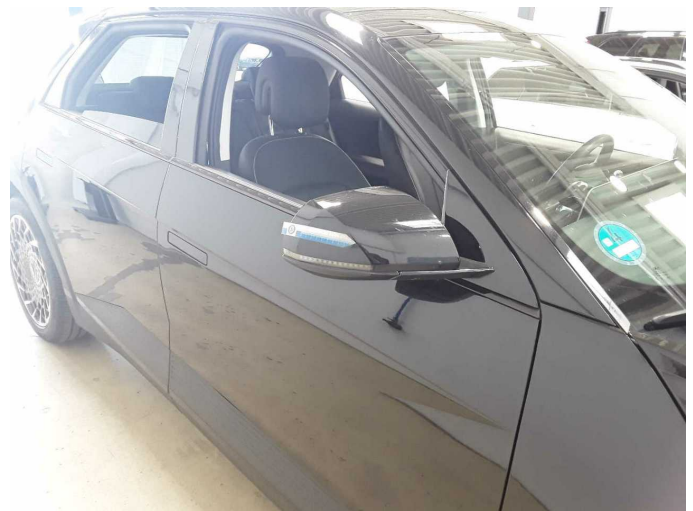
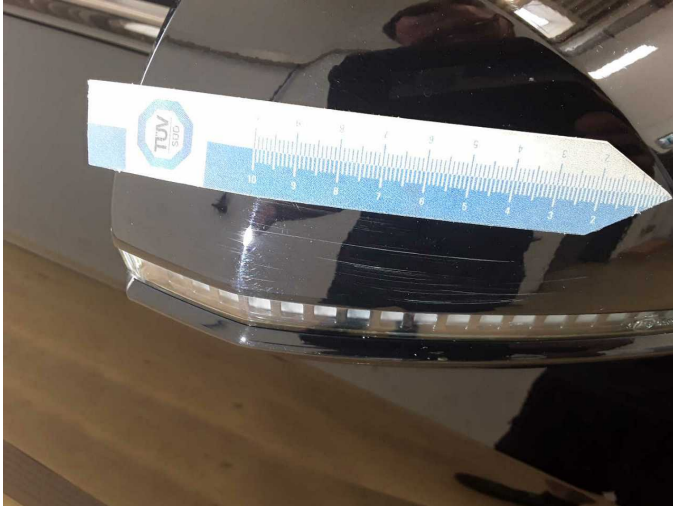
Damage 1: Wing mirror - right side: Cap - Scratch(es) - Smart repair

**Damage 1:** Wing mirror - right side: Cap - Scratch(es) - Smart repair

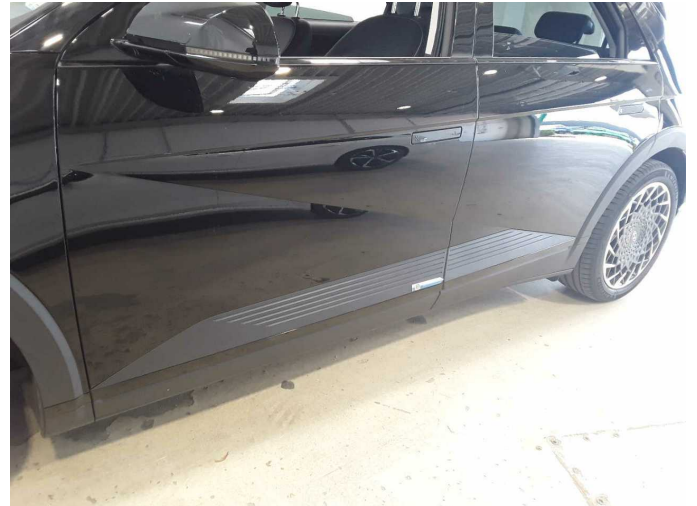
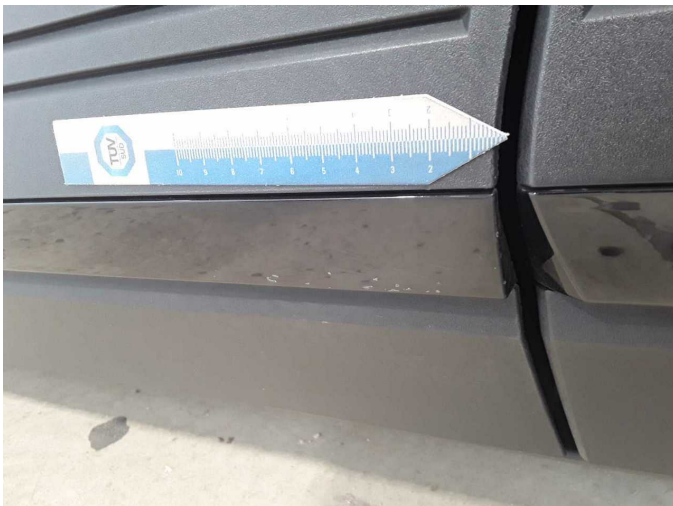
**Damage 2:** Door - front left side: Brightware - lower - Scratch(es) - Smart repair

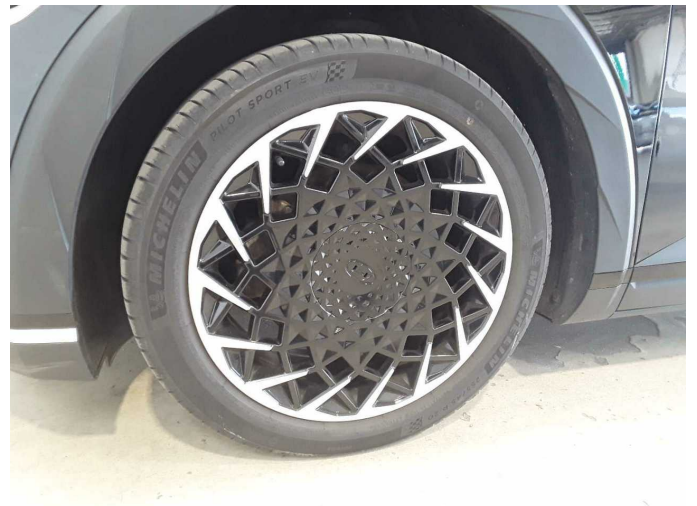
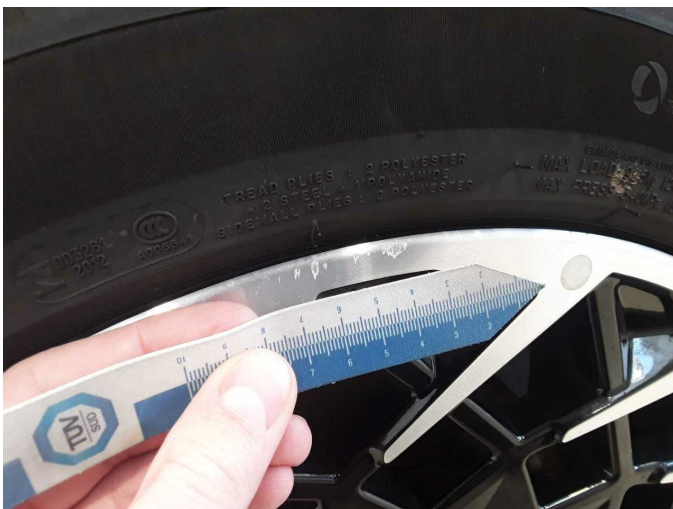
**Damage 3:** Wheel / tyres: Alloy rim - front left side - Scratch(es) - Loss in value

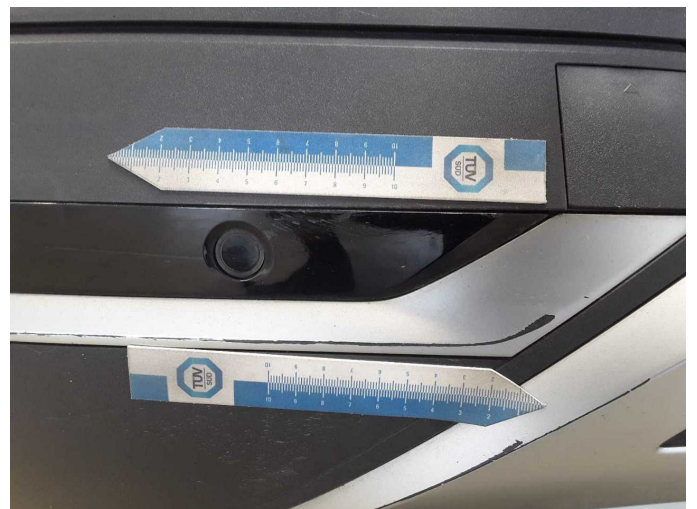
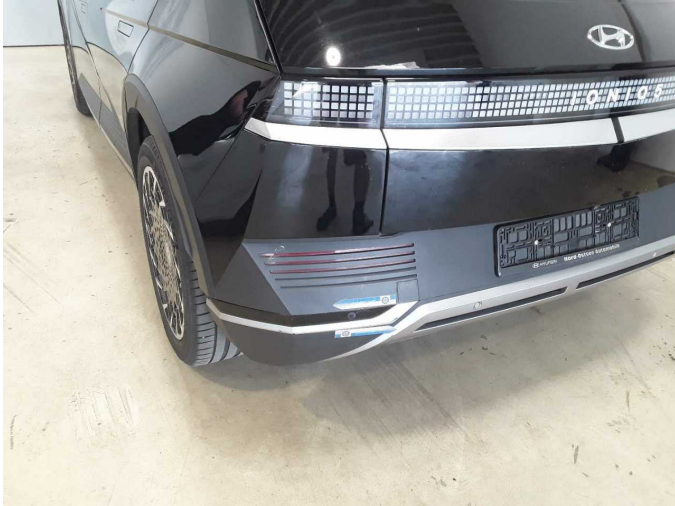
**Damage 4:** Rear bumper: Protection strip - left side - Scratch(es) - Smart repair

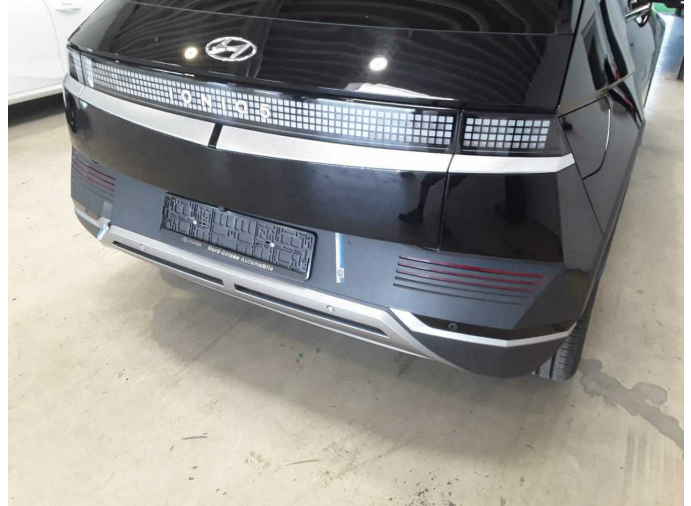
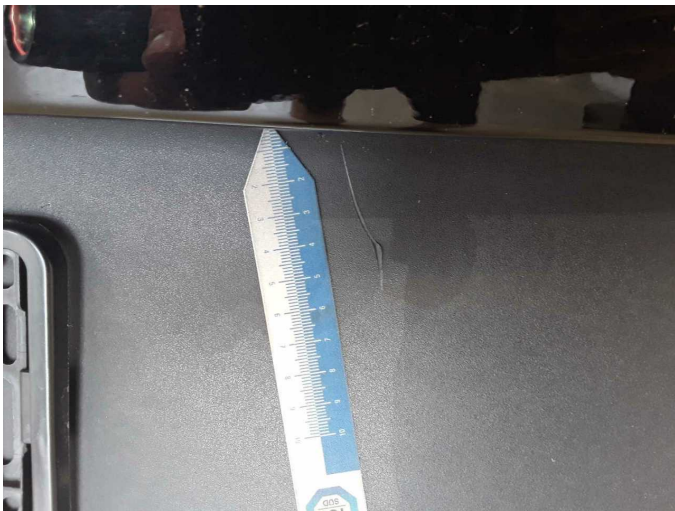
**Damage 5:** Rear bumper: Protection strip - centre - Scratch(es) - Smart repair

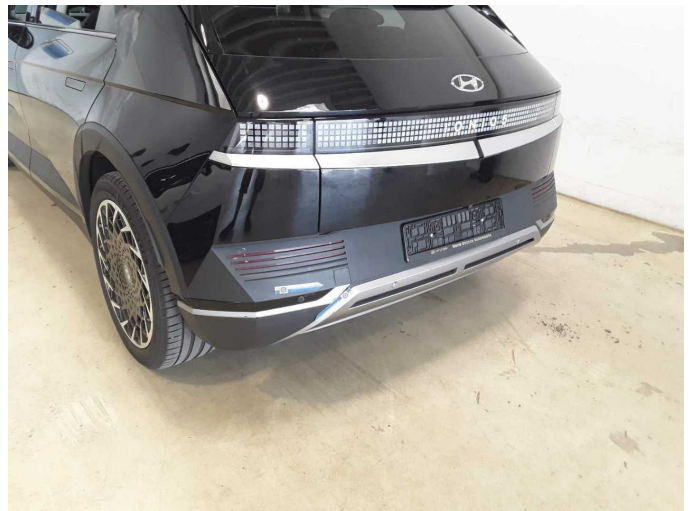
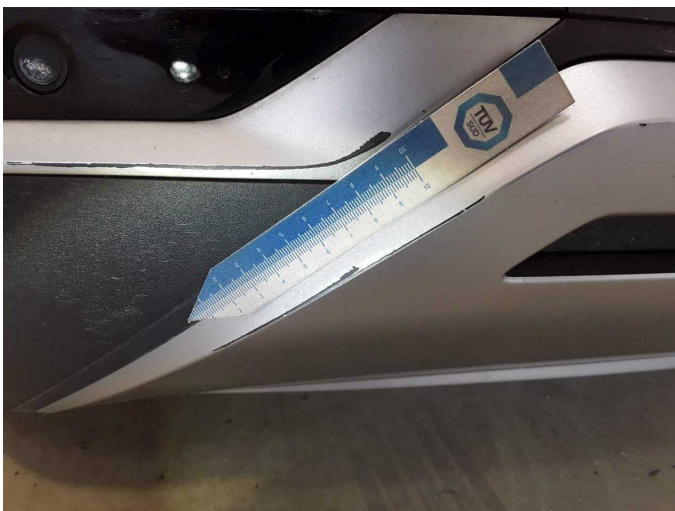
**Damage 6:** Rear bumper: Spoiler - Scratch(es) - Smart repair

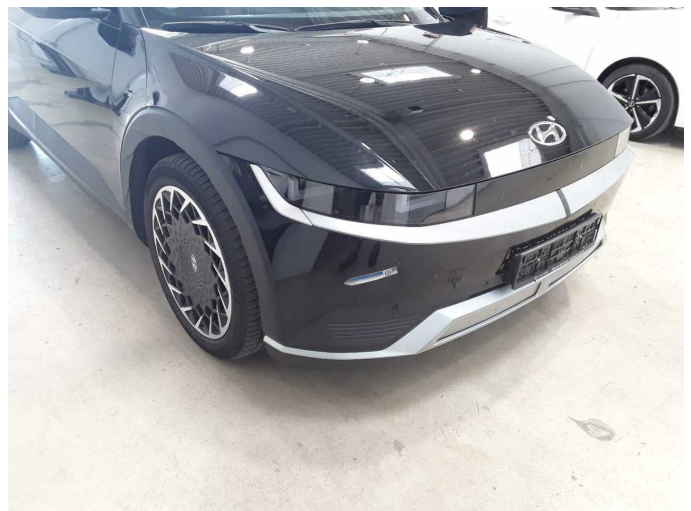
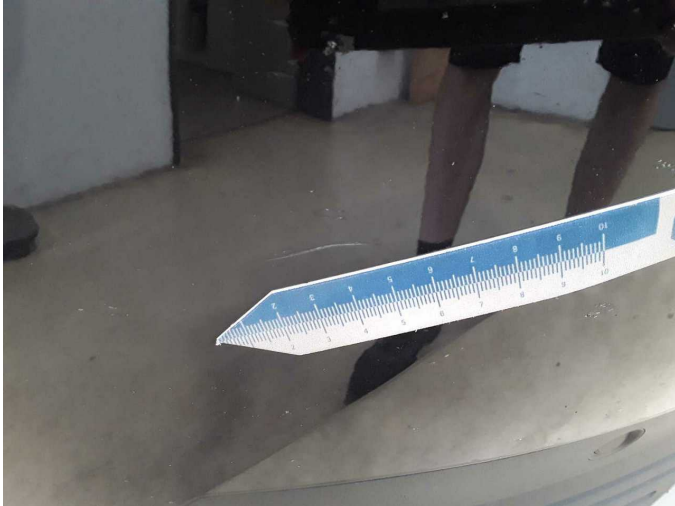
**Damage 8:** Front bumper: Front bumper - Scratch(es) - Smart repair

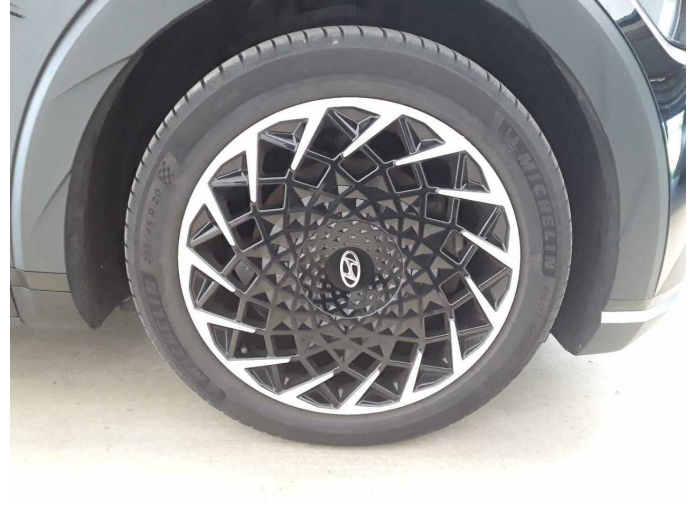
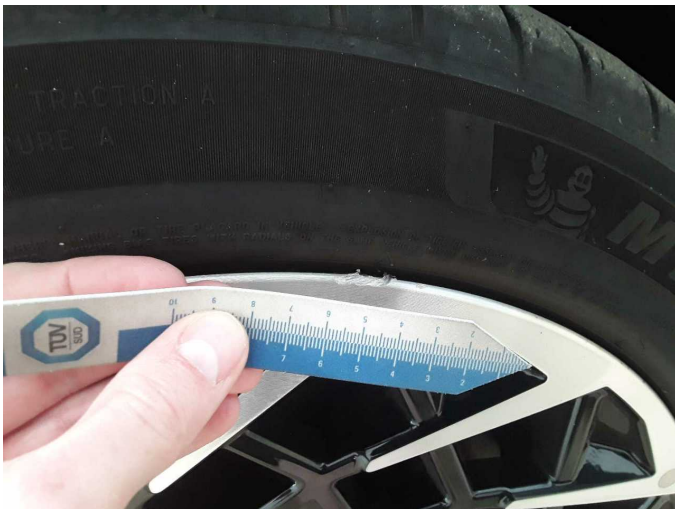
**Damage 9:** Wheel / tyres: Alloy rim - front right side - Scratch(es) - Loss in value

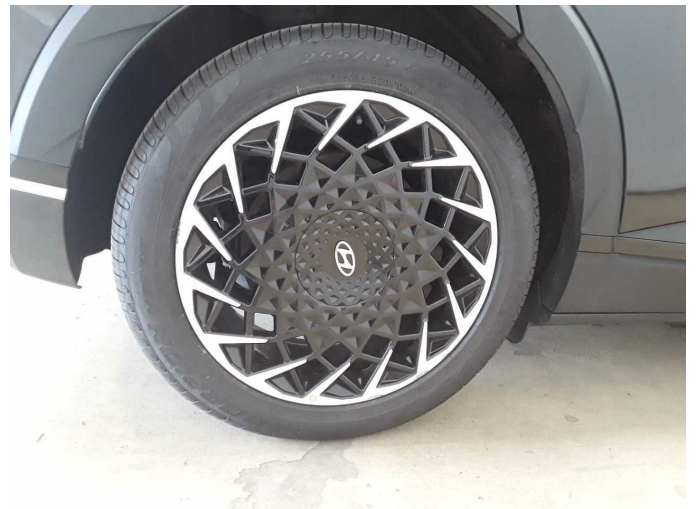
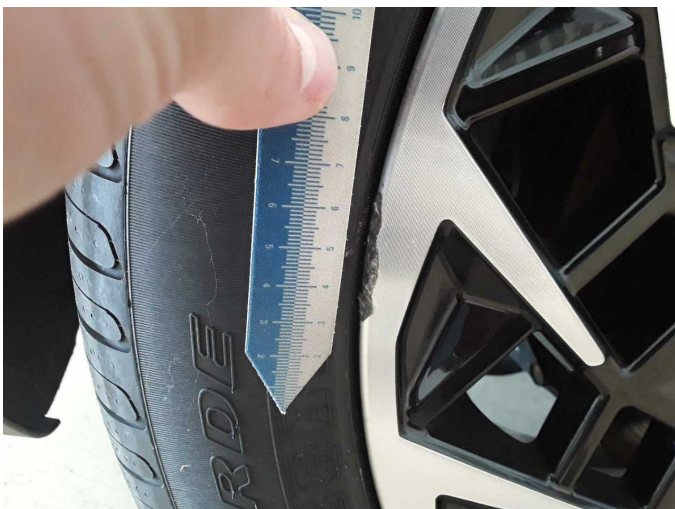
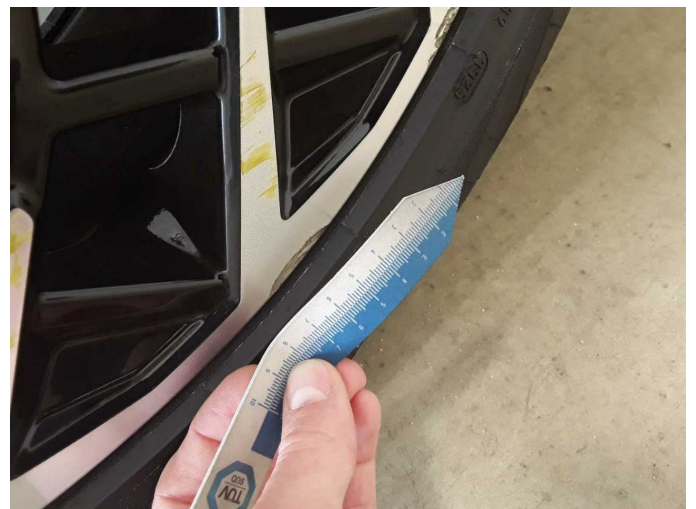
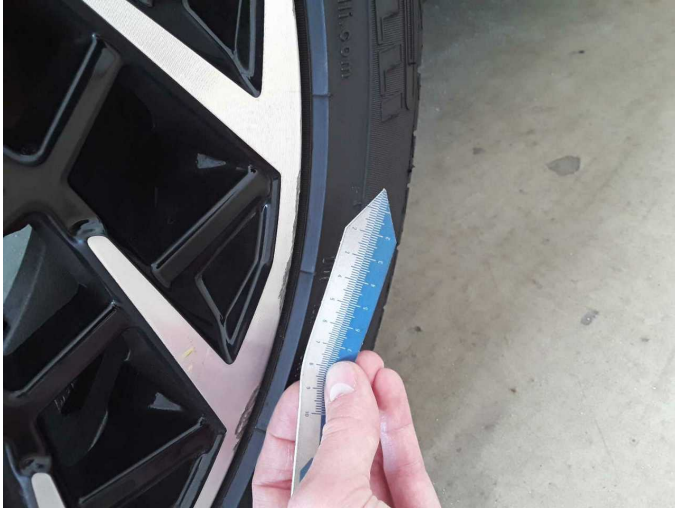
**Damage 10:** Wheel / tyres: Alloy rim - rear right side - Scratched - Replace
