## Expertise

Protocol number: 46227573  
Order No. / Reference: 26489364  
Inspection date: 29 Jun 2026

Model: Tarraco 1.4 e-Hybrid DSG Xperience

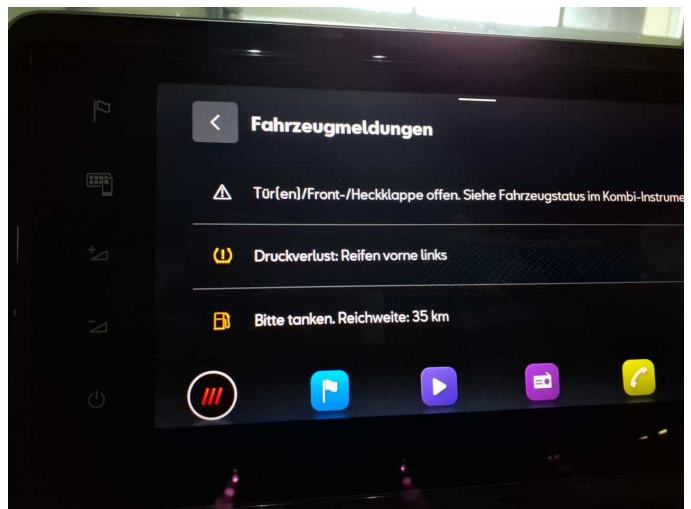
Damage 1: Wheel / tyres: Pressure sensor - Functional / admissibility - Perform diagnosis

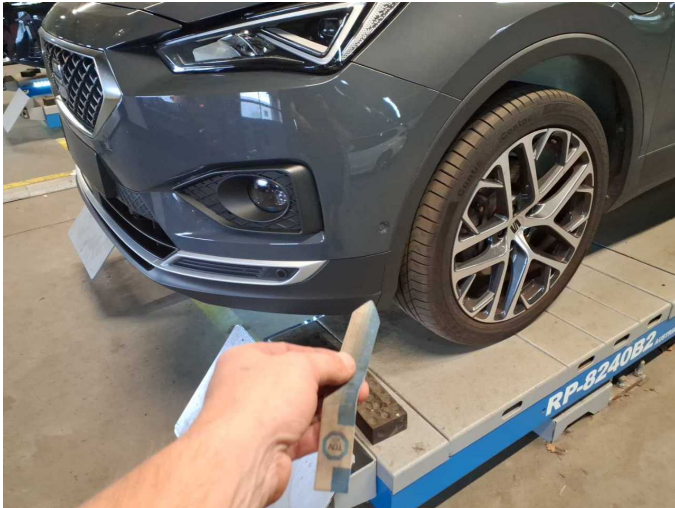
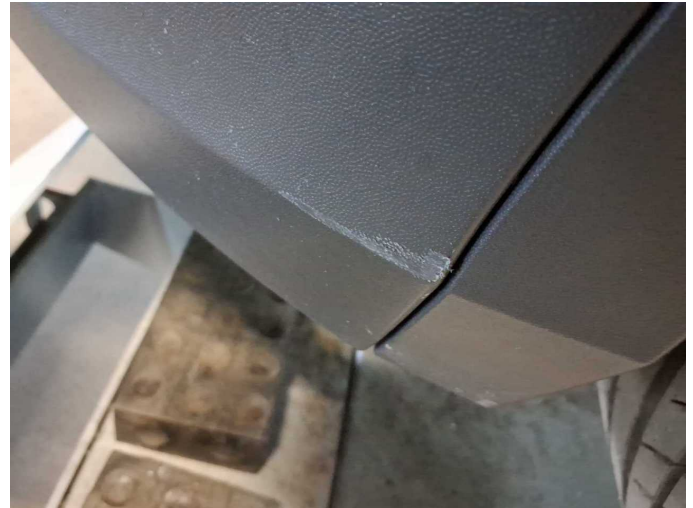
| No. | Component group | Description |
|---|---|--|
| 2 | Front bumper | Spoiler - Scratch(es) - Smart repair |

**Damage 2:** Front bumper: Spoiler - Scratch(es) - Smart repair

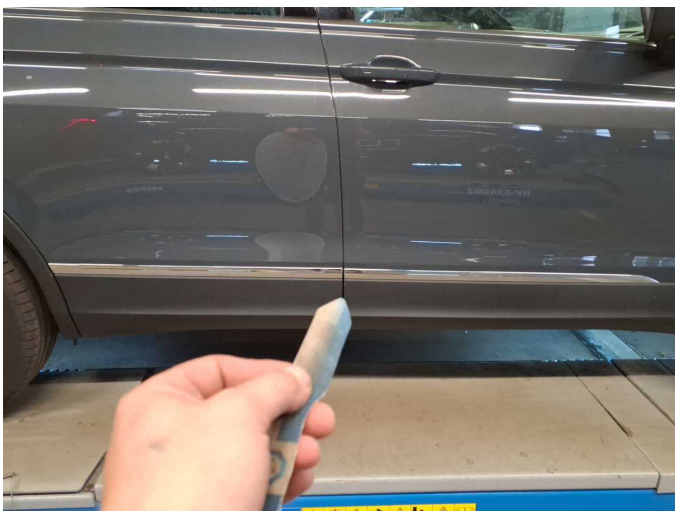
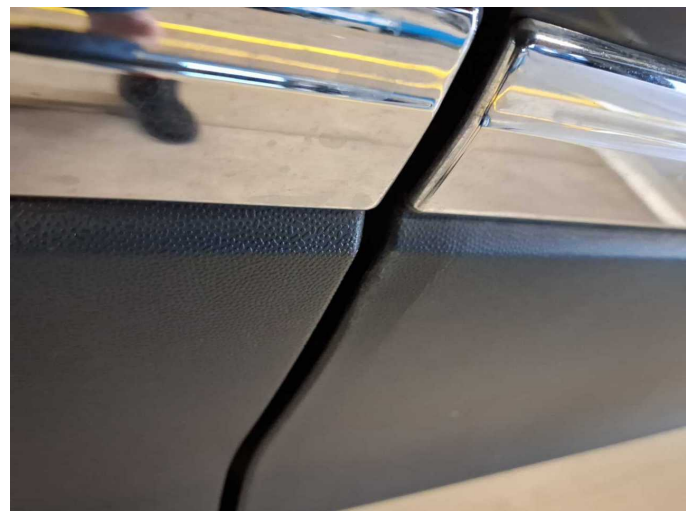
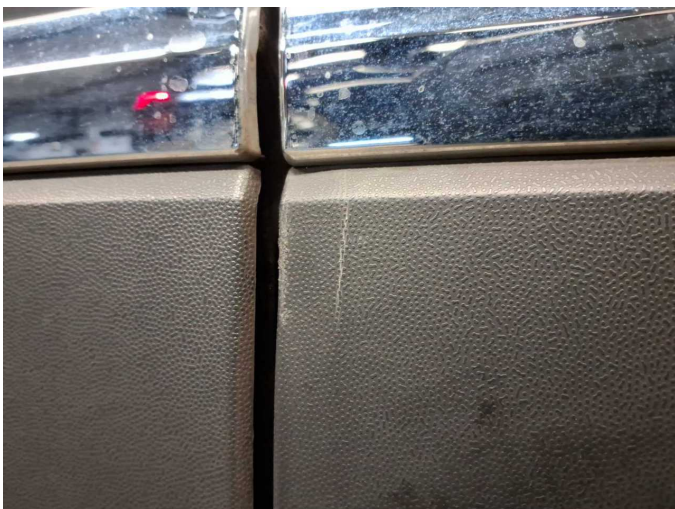
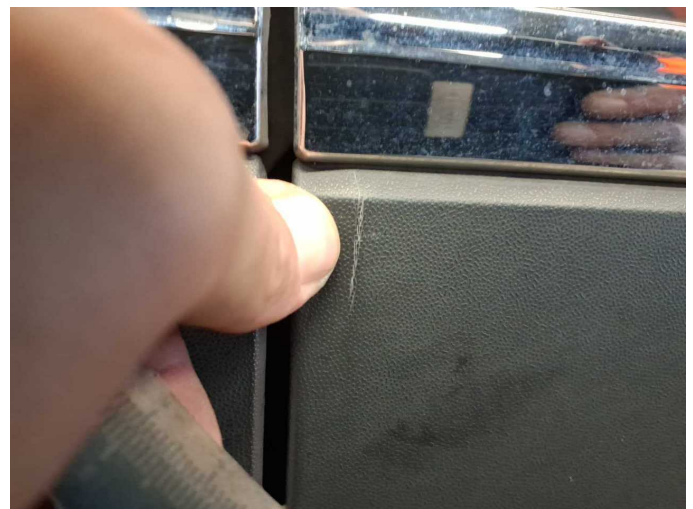
| No. | Component group | Description |
|---|---|--|
| 3 | Door - front right side | Brightware - lower - Broken / torn - Replace |

**Damage 3:** Door - front right side: Brightware - lower - Broken / torn - Replace

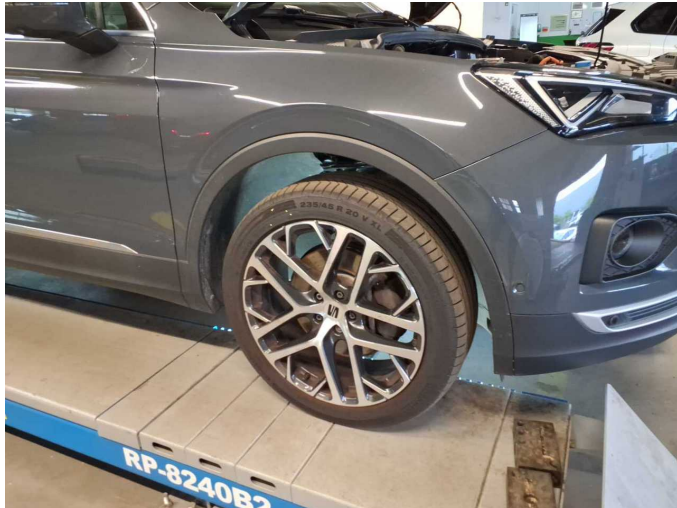
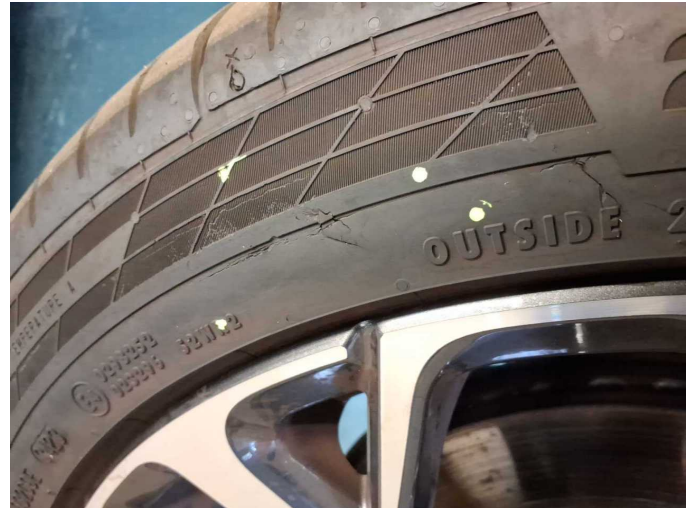
| No. | Component group | Description |
|---|---|--|
| 4 | Wheel / tyres | Tyre - front right side (Flanke) - Damaged - Replace |

**Damage 4:** Wheel / tyres: Tyre - front right side (Flanke) - Damaged - Replace

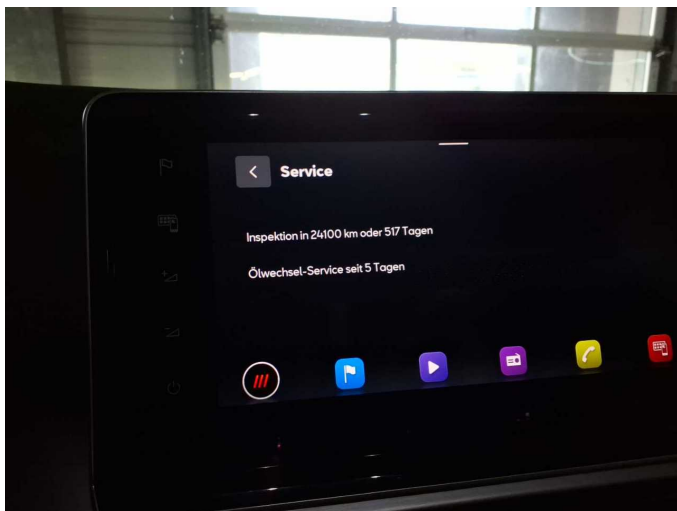
| No. | Component group | Description |
|---|---|--|
| 5 | Misc. | Inspection / maintenance - Due - Perform |

**Damage 5:** Misc.: Inspection / maintenance - Due - Perform

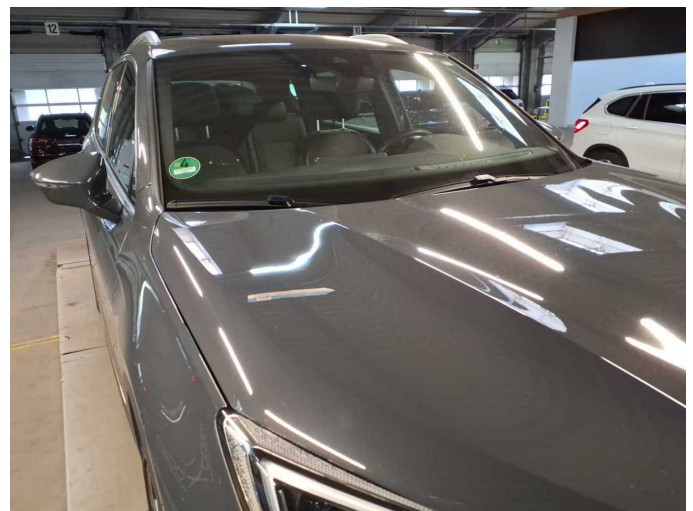
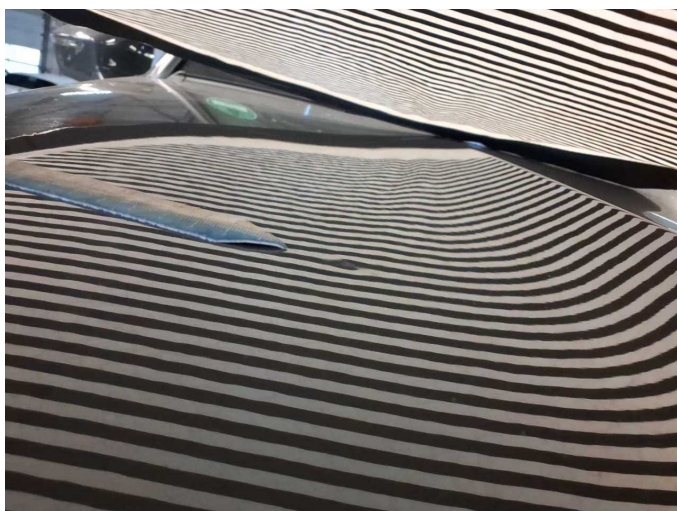
| No. | Component group | Description |
|---|---|--|
| 4 | Bonnet | Bonnet - dent(s) - No deduction |

**Wear and tear 4:** Bonnet: Bonnet - dent(s) - No deduction

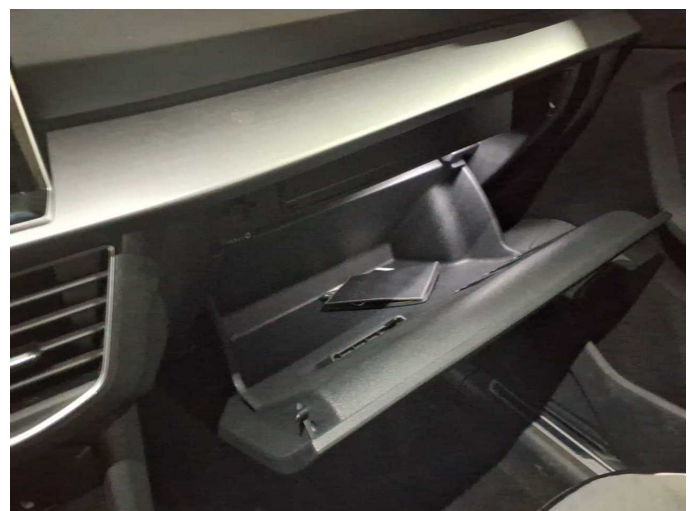
Documents - Log book

**Missing part 1:** Documents: Log book - Missing - Replace

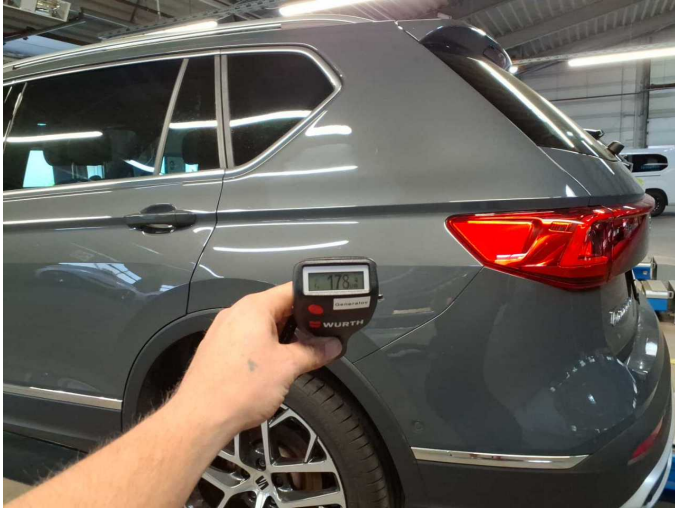
| Side panel - rear left side | 178 µm | Door - rear left side | 143 µm |

**Repainting 1:** Side panel - rear left side

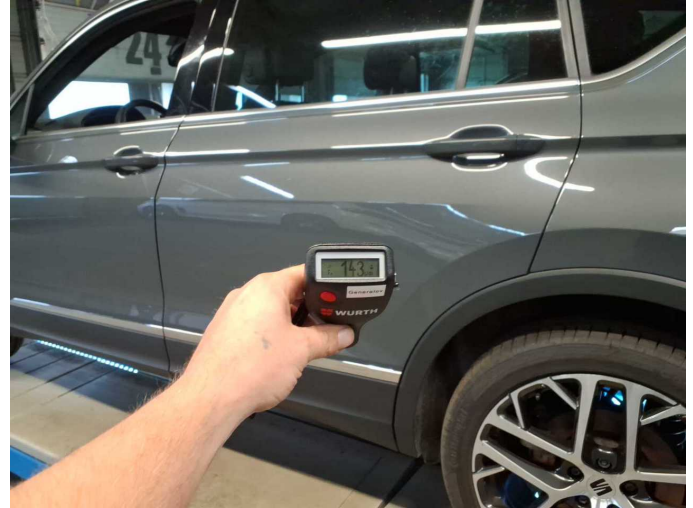
**Repainting 2:** Door - rear left side

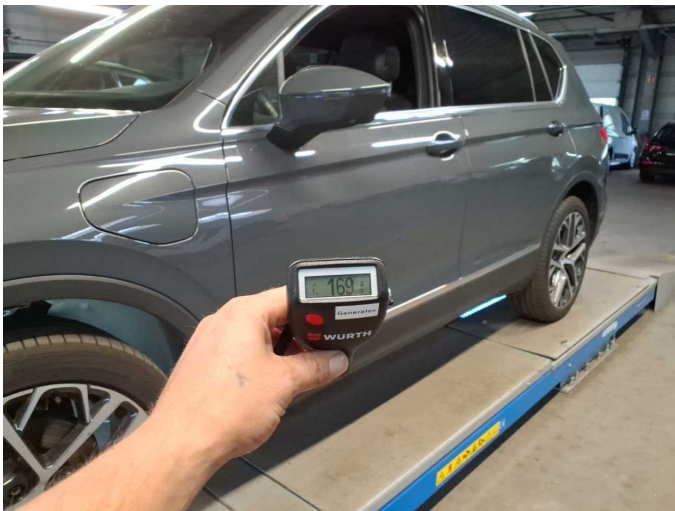
| Door - front left side | 169 µm | | |

**Repainting 3:** Door - front left side
