Expertise

Protocol number: 46874050  
Order No. / Reference: 26779987  
Inspection date: 4 Aug 2026

Manufacturer: Opel

Model: Insignia Grand Sport 1.5 Diesel Business

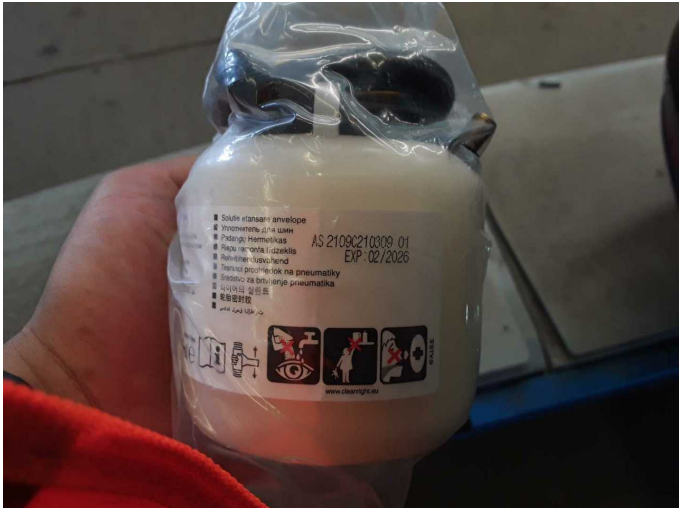
| No. | Component group | Description |
|---|---|---|
| 1 | Equipment | Tirefit filler - Expired - Replace |

Damage 1: Equipment: Tirefit filler - Expired - Replace

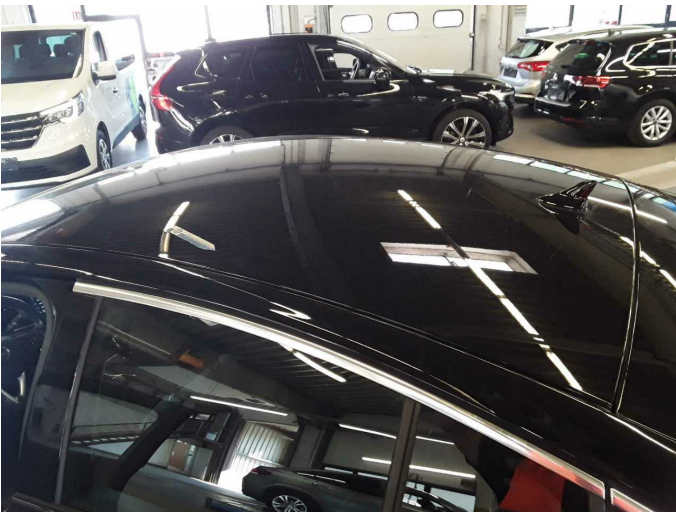
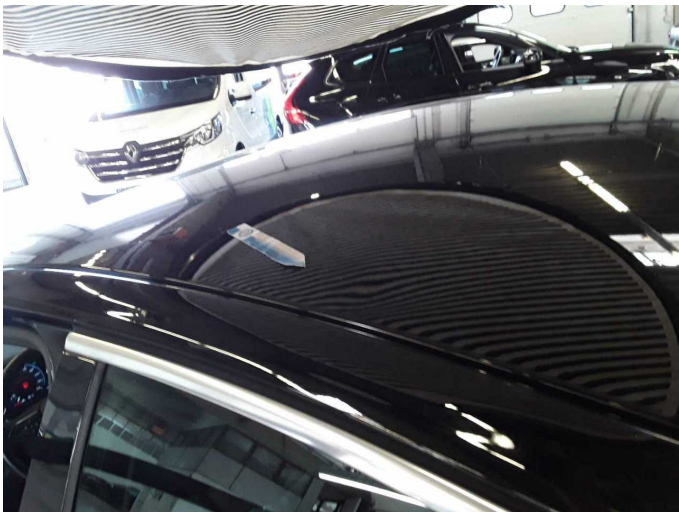
| No. | Component group | Description |
|---|---|---|
| 2 | Roof | Roof - dent(s) - Smooth repair work |

Damage 2: Roof: Roof - dent(s) - Smooth repair work

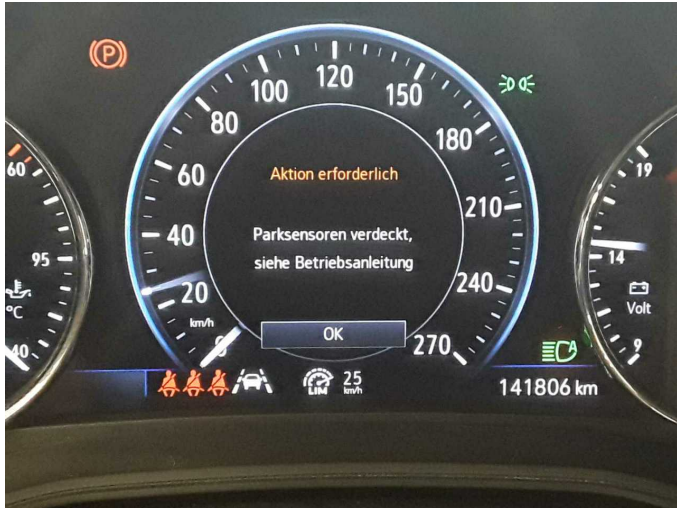
| No. | Component group | Description |
|---|---|---|
| 3 | Front bumper | Parking sensors - centre - Electrical fault - Perform diagnosis |

**Damage 3:** Front bumper: Parking sensors - centre - Electrical fault - Perform diagnosis

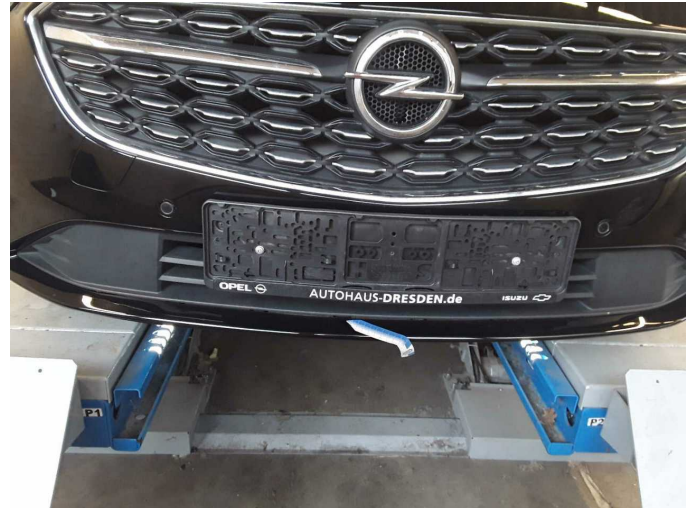
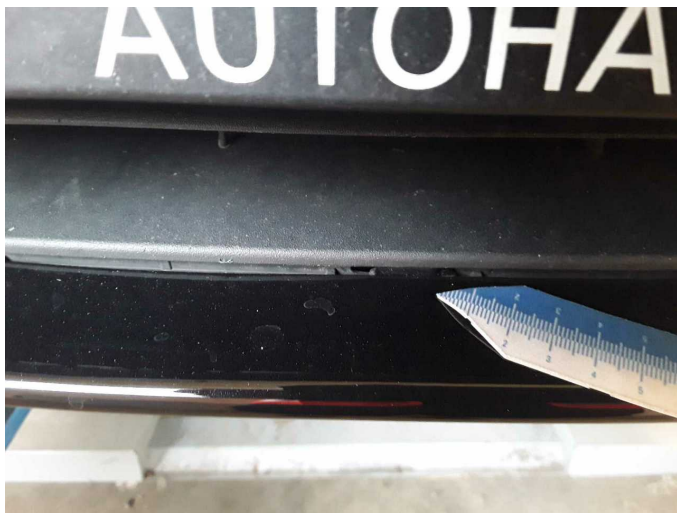
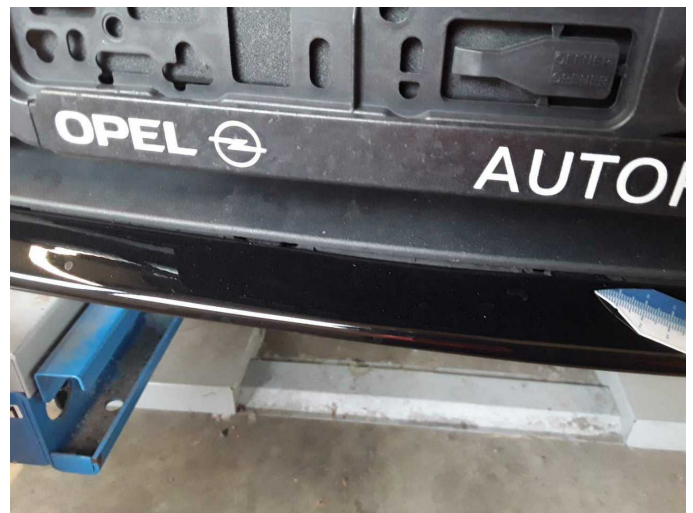
| No. | Component group | Description |
|---|---|---|
| 4 | Front bumper | Air-inlet grille - Malposition - Set / adjust |

**Damage 4:** Front bumper: Air-inlet grille - Malposition - Set / adjust

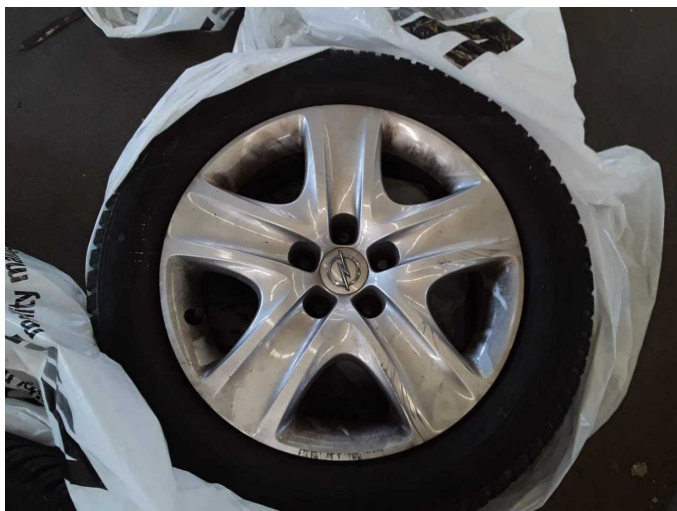
| No. | Component group | Description |
|---|---|---|
| 1 | 2nd wheel set | 1 wheel cover - Scratched - No deduction |

**Wear and tear 1:** 2nd wheel set: 1 wheel cover - Scratched - No deduction

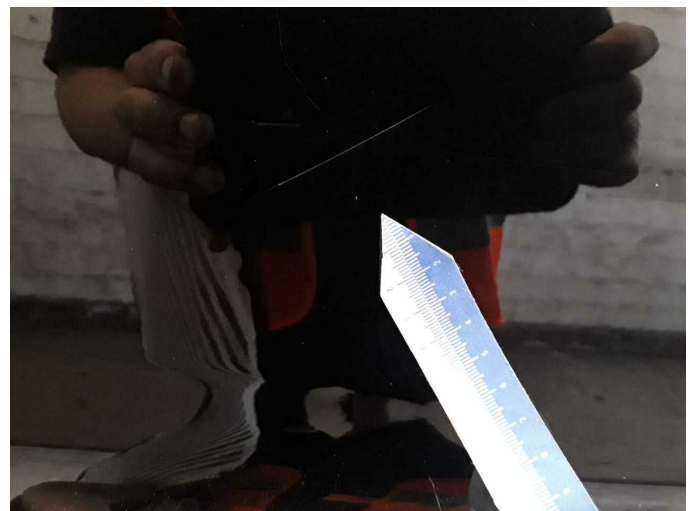
| No. | Component group | Description |
|---|---|---|
| 2 | Door - front right side | Door - Scratch(es) - No deduction |

**Wear and tear 2:** Door - front right side: Door - Scratch(es) - No deduction

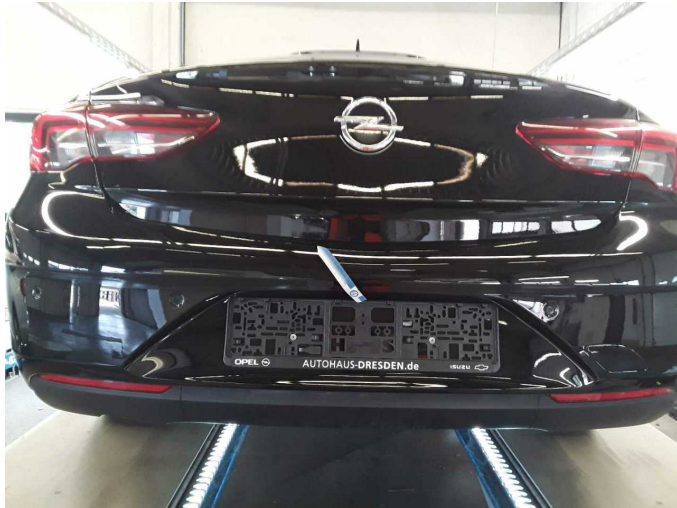
| No. | Component group | Description |
|---|---|---|
| 3 | Rear bumper | Rear bumper - Scratch(es) - No deduction |

**Wear and tear 3:** Rear bumper: Rear bumper - Scratch(es) - No deduction

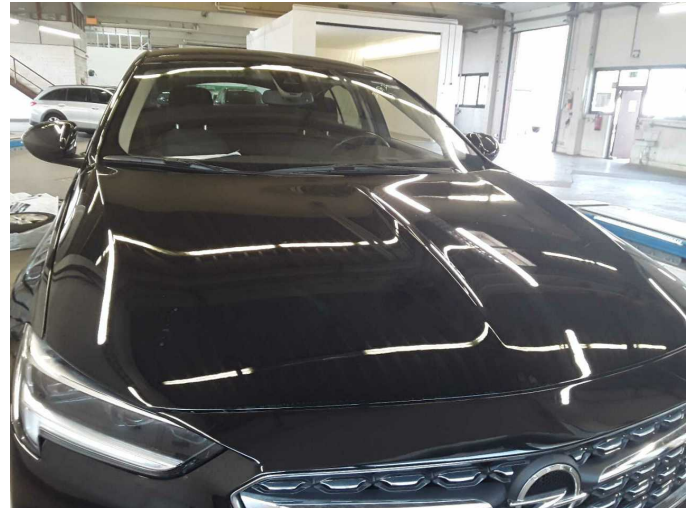
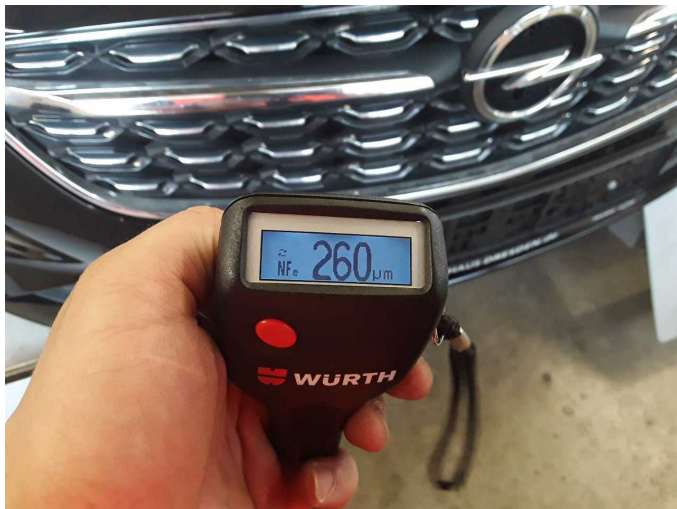
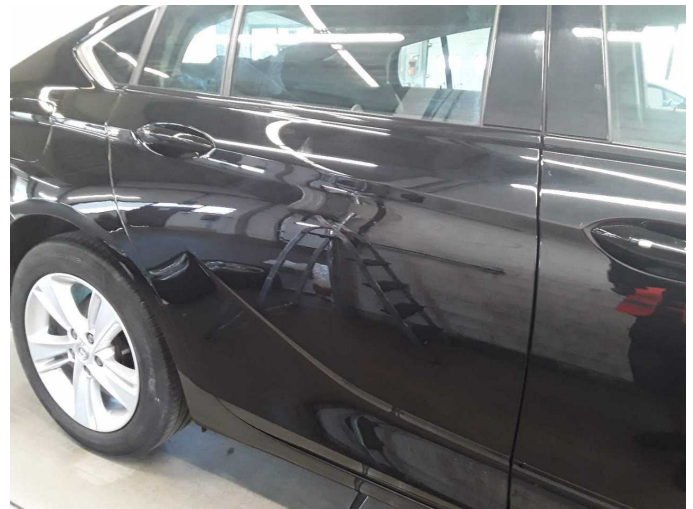
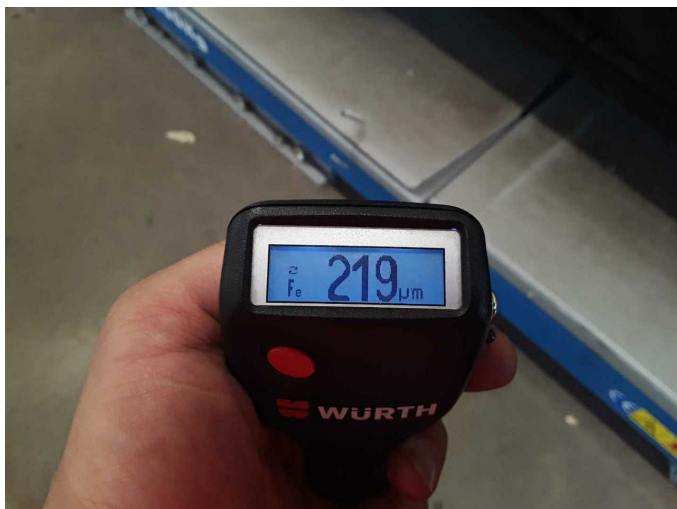
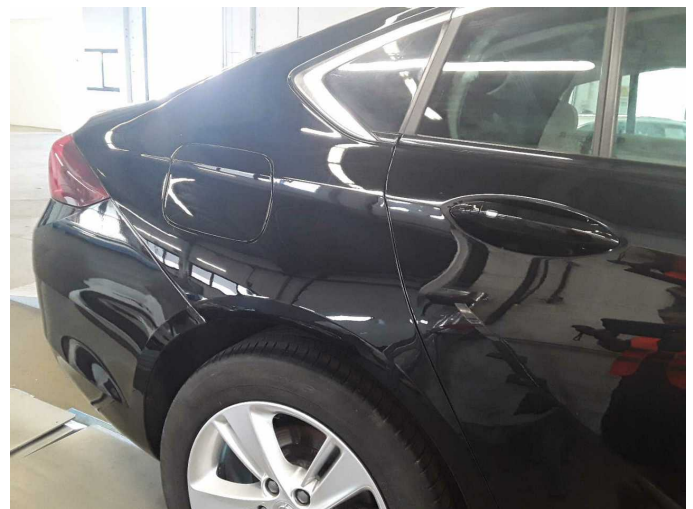
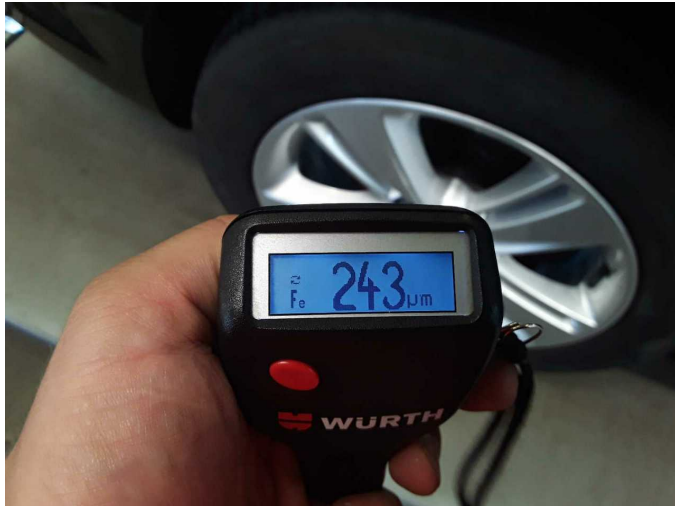
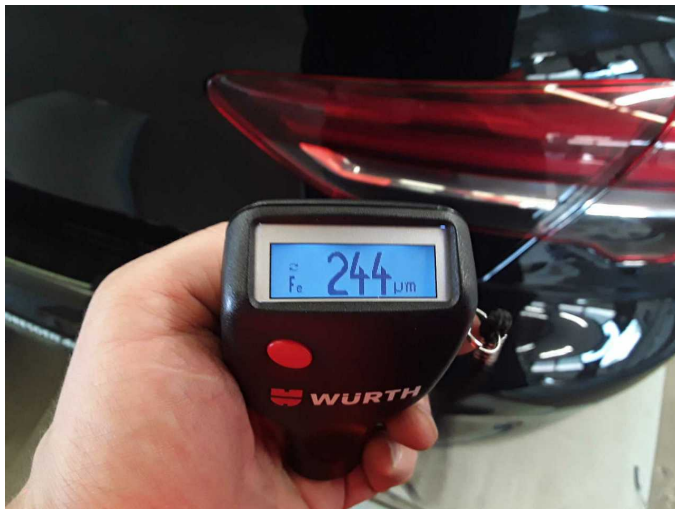
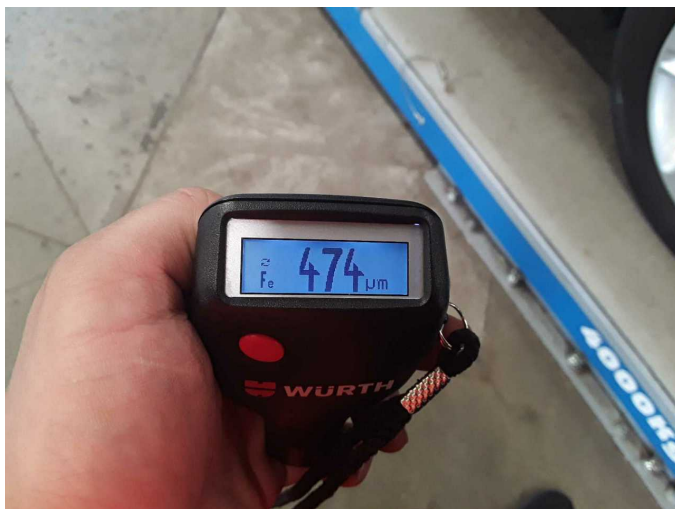
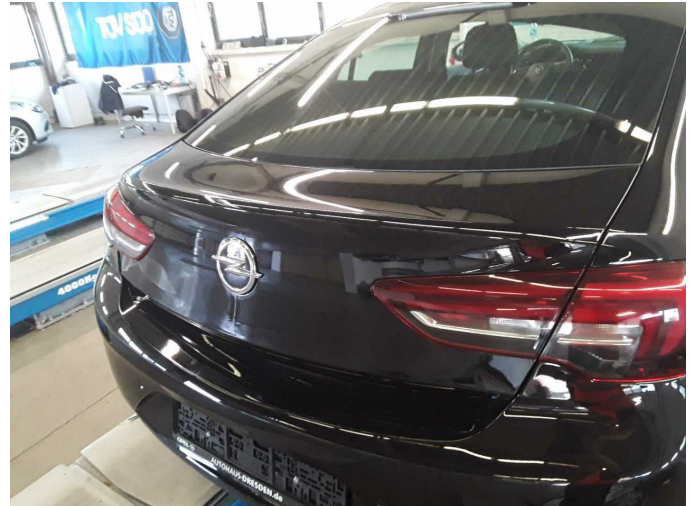
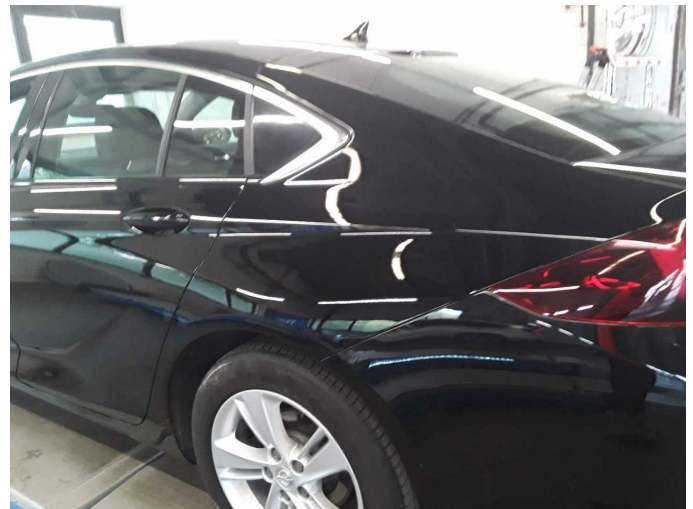
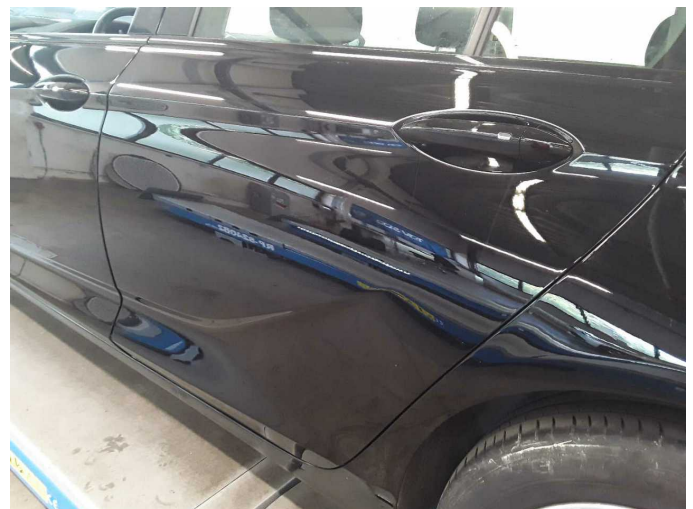
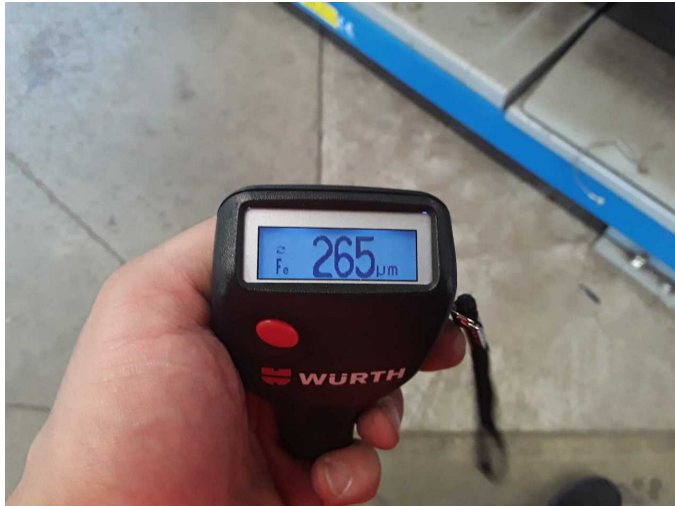
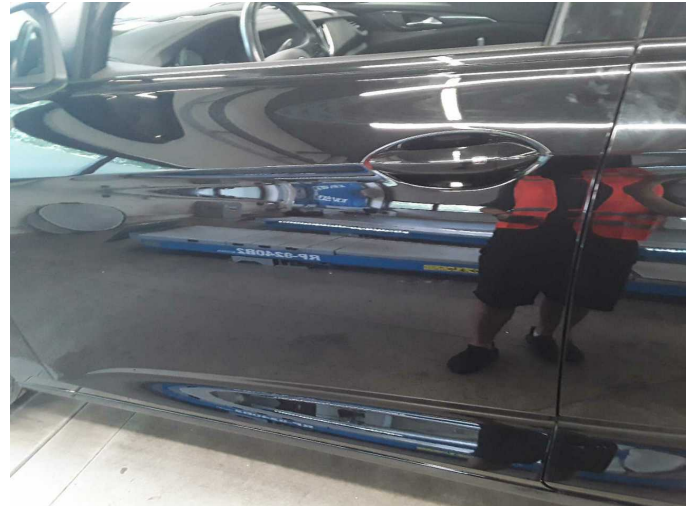
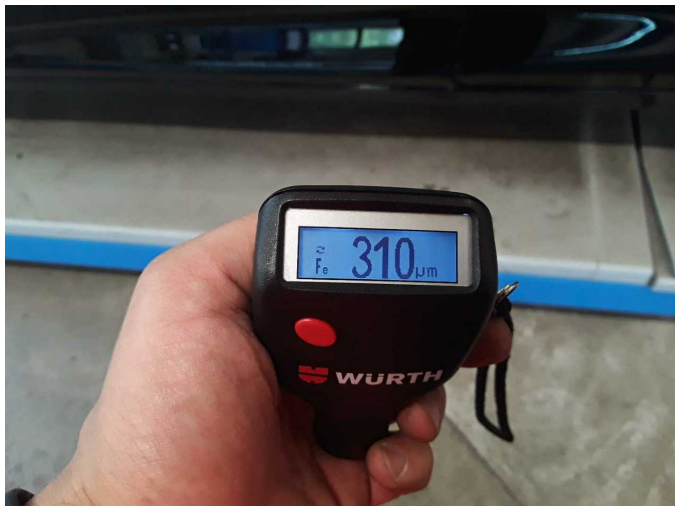
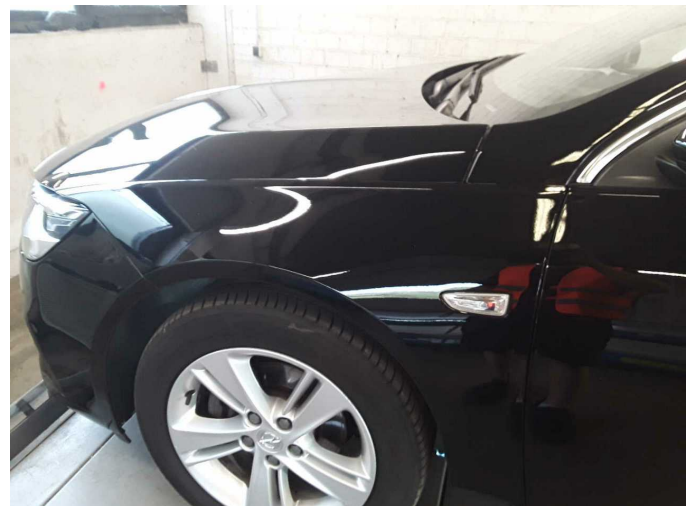
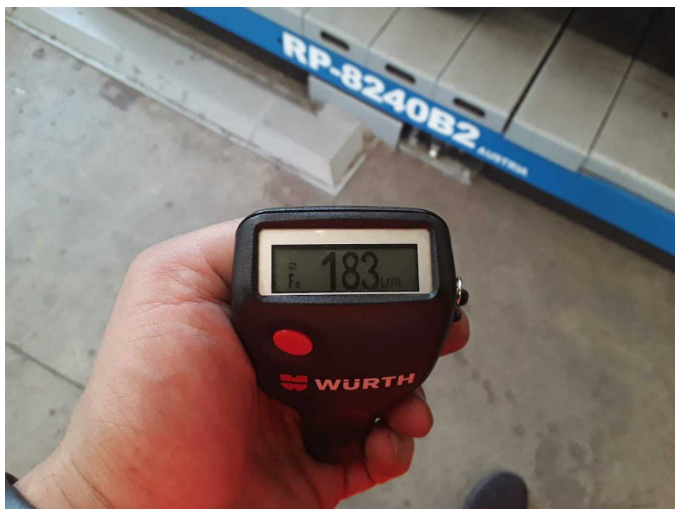
| No. | Repainting |
|---|---|
| 1 | Boot lid / rear door, Mudguard - left side, Bonnet, Side panel - rear left side, Side panel - rear right side, Door - rear left side, Door - rear right side, Door - front left side |

| Boot lid / rear door | 255 µm | Mudguard - left side | 258 µm |
| Bonnet | 282 µm | Side panel - rear left side | 459 µm |
| Side panel - rear right side | 238 µm | Door - rear left side | 298 µm |
| Door - rear right side | 203 µm | Door - front left side | 291 µm |

**Repainting 1:** Boot lid / rear door, Mudguard - left side, Bonnet, Side panel - rear left side, Side panel - rear right side, Door - rear left side, Door - rear right side, Door - front left side
