Expertise

Protocol number: 45840997
Order No. / Reference: 26435716
Inspection date: 9 Jun 2026

Model: Focus Turnier 2.0 EcoBlue Start-Stopp-System Aut.
COOL&CONNECT

VIN: WF0PXXGCHPLS78311

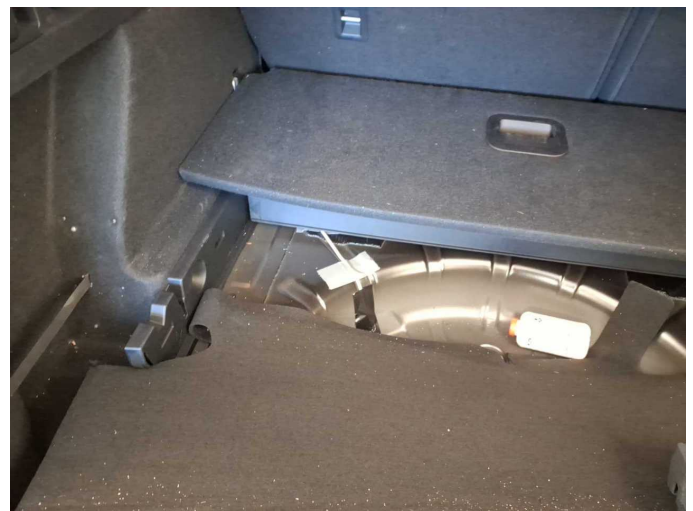
| No. | Component group | Description |
|---|---|--|
| 2 | Electrical system | Cable strand (Kabelführung von Frontbereich in Laderaum) - Differs from the original configuration - Un- / install |

Damage 2: Electrical system: Cable strand (Kabelführung von Frontbereich in Laderaum) - Differs from the original configuration - Un-/install

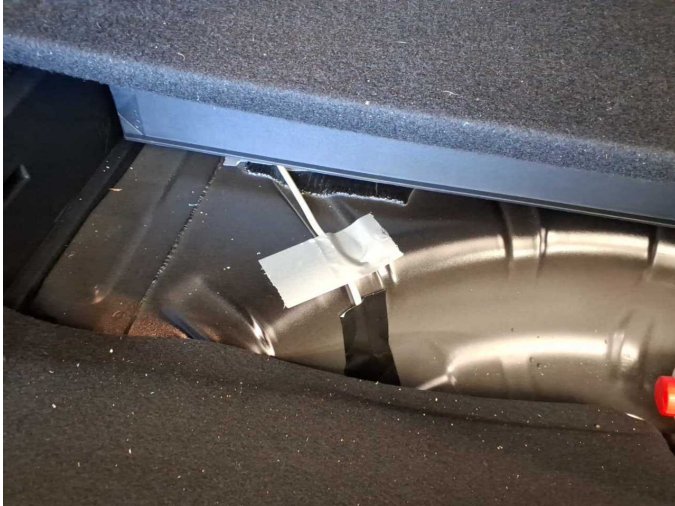
Damage 2: Electrical system: Cable strand (Kabelführung von Frontbereich in Laderaum) - Differs from the original configuration - Un-/install

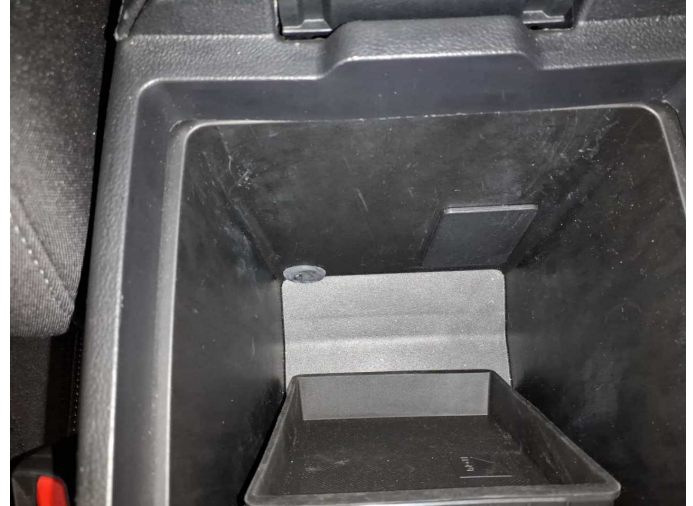
| No. | Component group | Description |
|---|---|--|
| 3 | Interior | Arm rest, front (Deckel hinten, Fehlbohrungen) - Differs from the original configuration - Replace |

Damage 3: Interior: Arm rest, front (Deckel hinten, Fehlbohrungen) - Differs from the original configuration - Replace

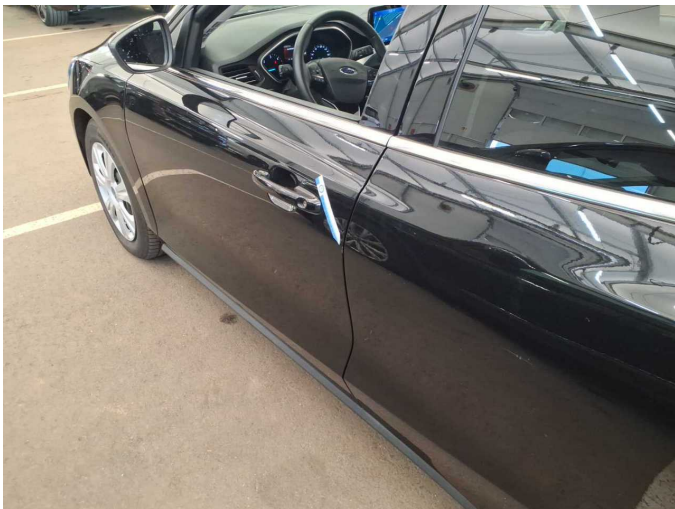
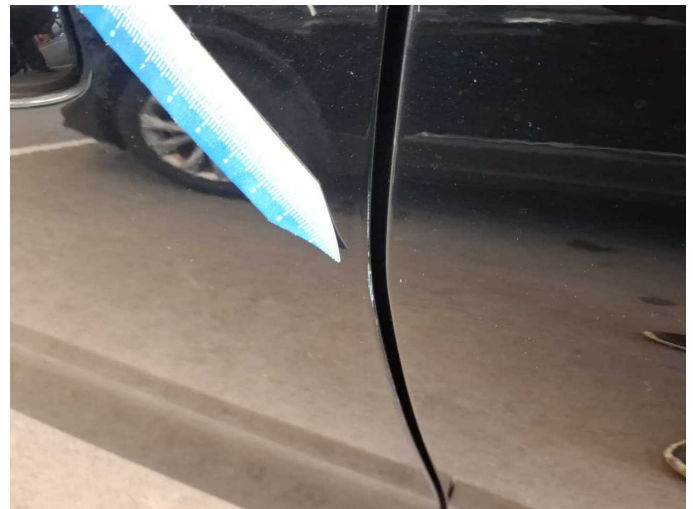
| No. | Component group | Description |
|---|---|--|
| 4 | Door - front left side | Door edge - Scratched - Smart repair |

Damage 4: Door - front left side: Door edge - Scratched - Smart repair

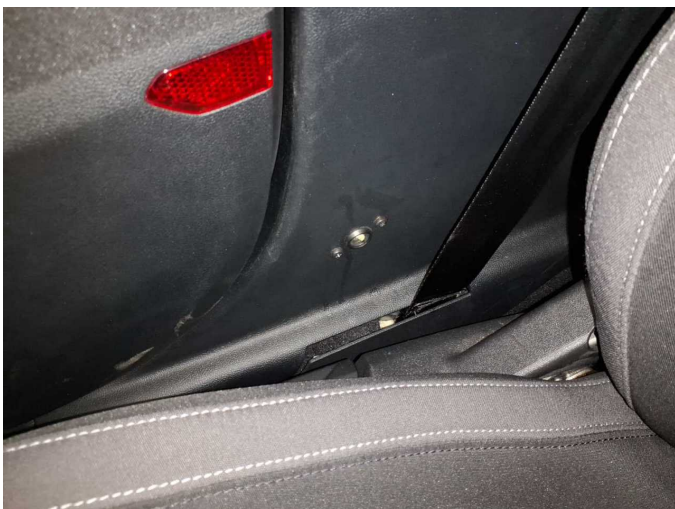
| No. | Component group | Description |
|---|---|--|
| 5 | Trim / covers | B-pillar - trim - interior, right side (Fehlbohrungen) - Differs from the original configuration - Replace |

Damage 5: Trim / covers: B-pillar - trim - interior, right side (Fehlbohrungen) - Differs from the original configuration - Replace

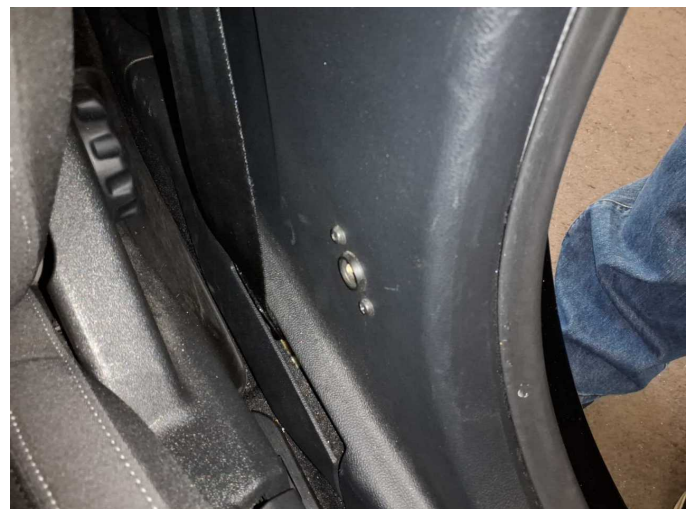
| No. | Component group | Description |
|---|---|--|
| 6 | Body | B-pillar - left side (Fehlbohrungen) - Differs from the original configuration - Replace |

Damage 6: Body: B-pillar - left side (Fehlbohrungen) - Differs from the original configuration - Replace

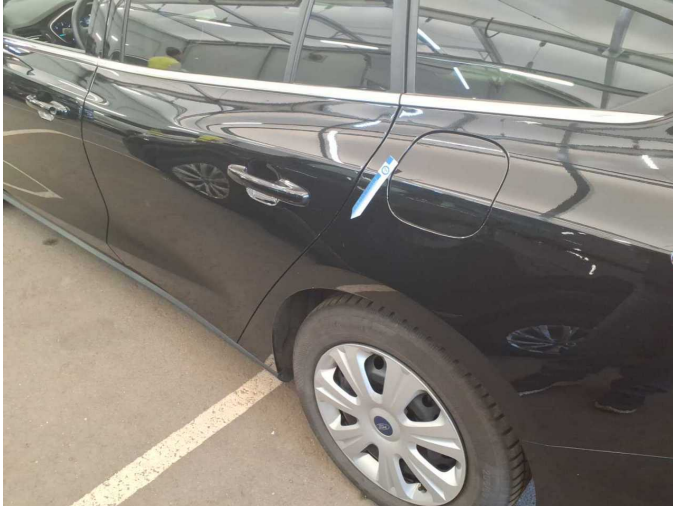
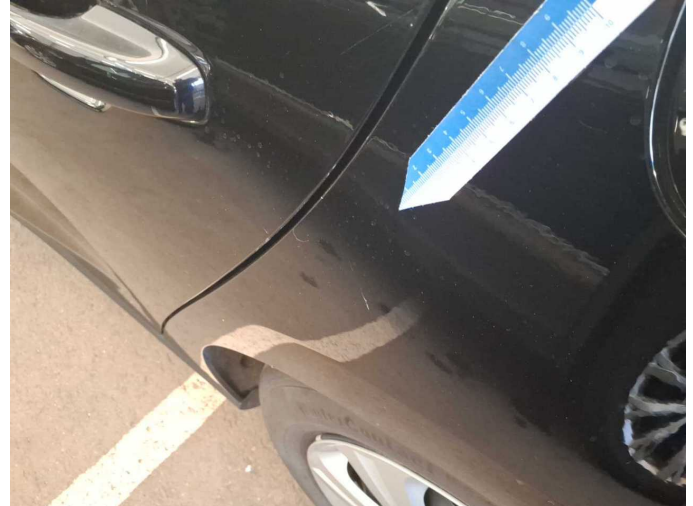
| No. | Component group | Description |
|---|---|--|
| 7 | Side panel - rear left side | Side panel - Scratched - Smart repair |

Damage 7: Side panel - rear left side: Side panel - Scratched - Smart repair

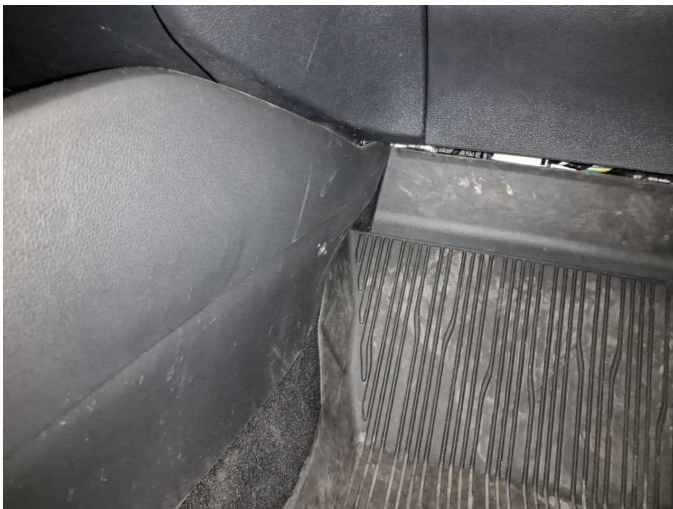
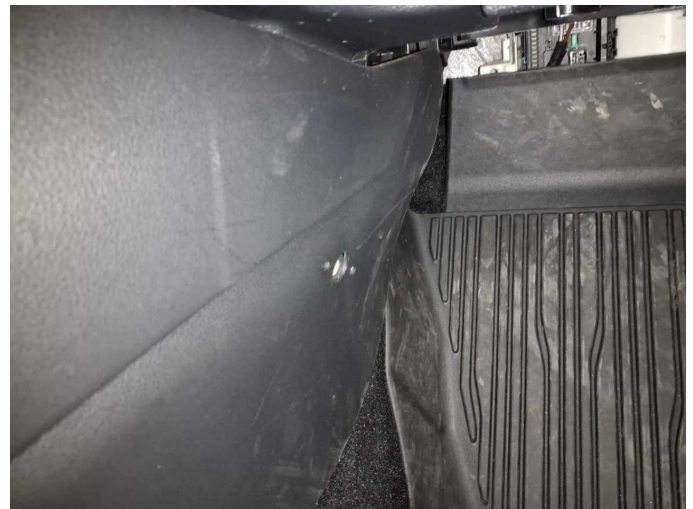
| No. | Component group | Description |
|---|---|--|
| 8 | Instrument panel | Centre console - front (Verkleidung rechts, Fehlbohrungen) - Differs from the original configuration - Replace |

Damage 8: Instrument panel: Centre console - front (Verkleidung rechts, Fehlbohrungen) - Differs from the original configuration - Replace

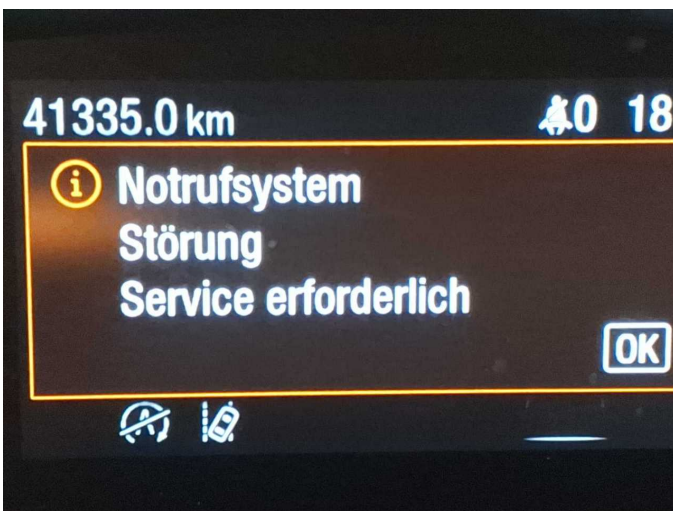
| Engine function test | An engine test run was performed, problem has been detected This is due to the following reason.: Bordnetzbatterie Spannung gering, Motorstart ohne ext. Stromquelle nicht möglich, Notrufsystem ohne Funktion |

| No. | Component group | Description |
|---|---|--|
| 9 | Electronic systems | Electronic systems (Notrufsystem) - Specify findings - Perform diagnosis |

Damage 9: Electronic systems: Electronic systems (Notrufsystem) - Specify findings - Perform diagnosis

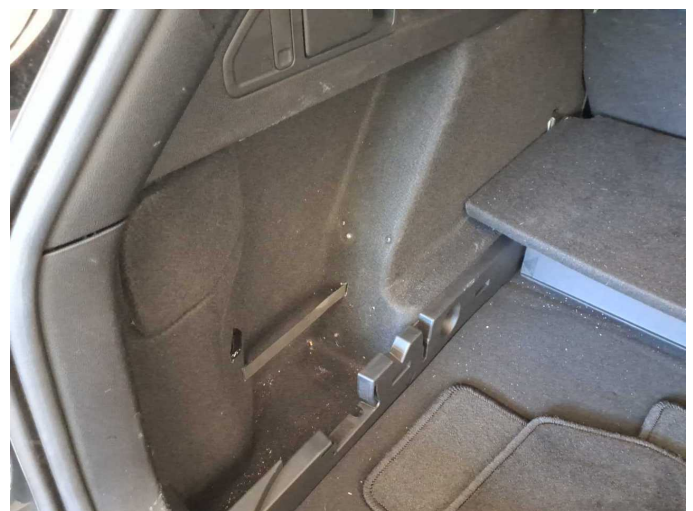
| No. | Component group | Description |
|---|---|--|
| 10 | Trim / covers | Cargo area - lining -left side (Fehlbohrungen) - Differs from the original configuration - Replace |

Damage 10: Trim / covers: Cargo area - lining -left side (Fehlbohrungen) - Differs from the original configuration - Replace

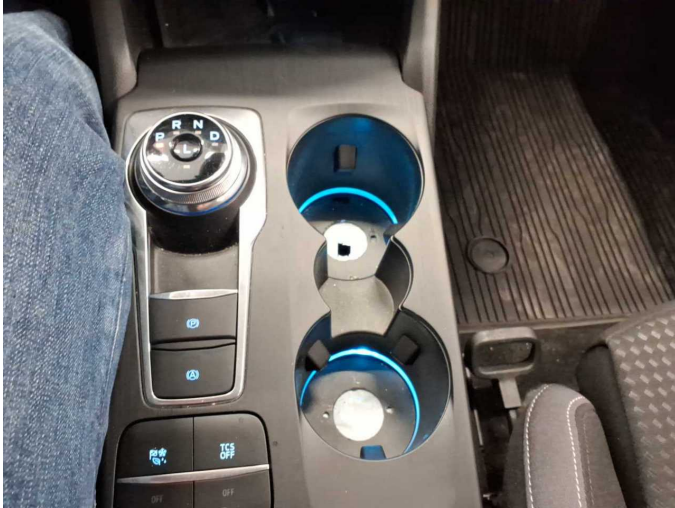
| No. | Component group | Description |
|---|---|--|
| 11 | Instrument panel | Centre console - front (Getränkehalter, Fehlbohrungen) - Differs from the original configuration - Replace |

Damage 11: Instrument panel: Centre console - front (Getränkehalter, Fehlbohrungen) - Differs from the original configuration - Replace

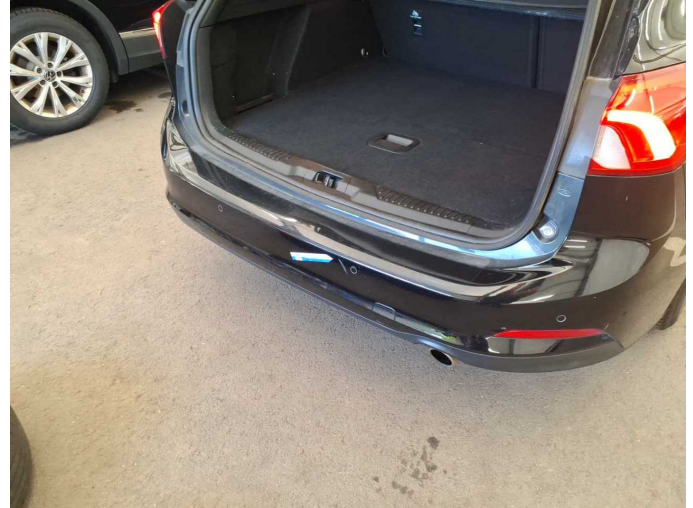
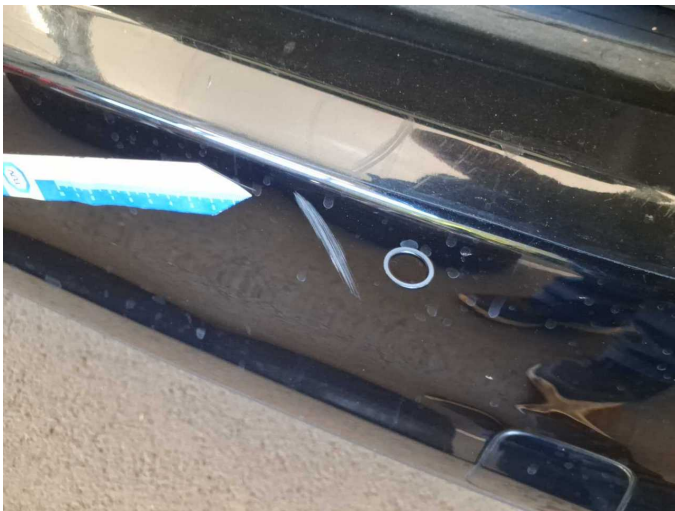
| No. | Component group | Description |
|---|---|--|
| 12 | Rear bumper | Rear bumper - Scratched - Paint |

Damage 12: Rear bumper: Rear bumper - Scratched - Paint

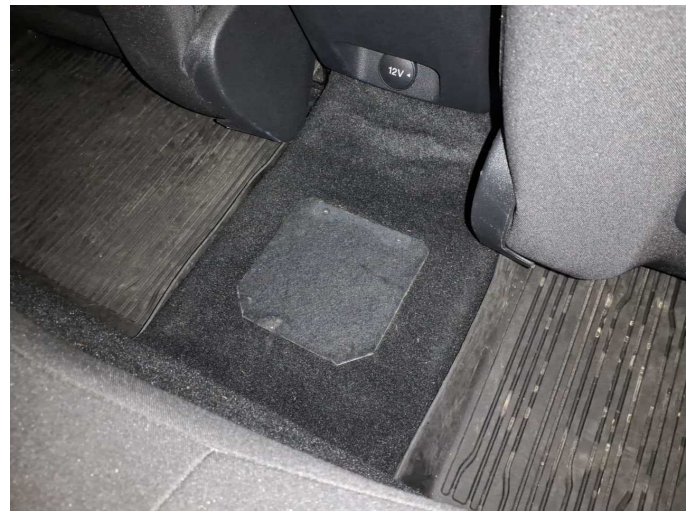
| No. | Component group | Description |
|---|---|--|
| 13 | Trim / covers | Carpet - Differs from the original configuration - Replace |

Damage 13: Trim / covers: Carpet - Differs from the original configuration - Replace

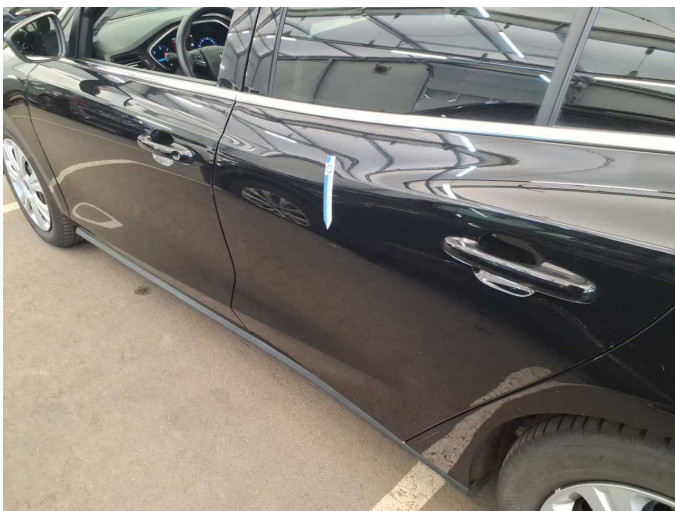
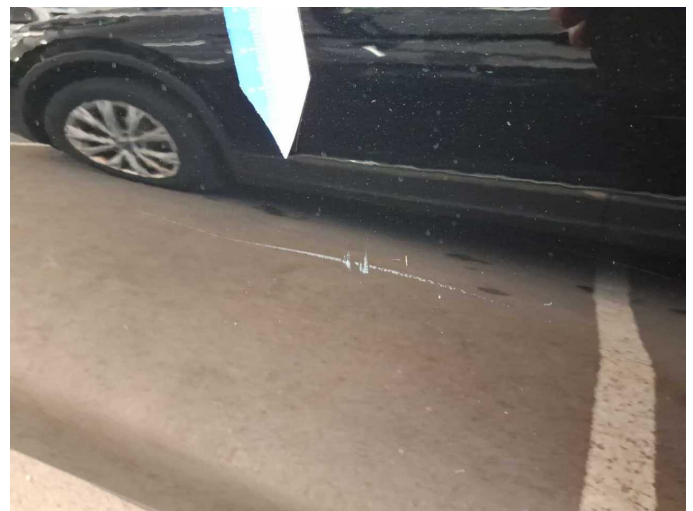
| No. | Component group | Description |
|---|---|--|
| 14 | Door - rear left side | Door - Scratched - Paint |

Damage 14: Door - rear left side: Door - Scratched - Paint
