Expertise

Protocol number: 46226910  
Order No. / Reference: 26562219  
Inspection date: 30 Jun 2026

Manufacturer: Skoda  
VIN: TMBJJ7NS7P8040317

Model: Kodiaq 2.0 TDI DSG L&K

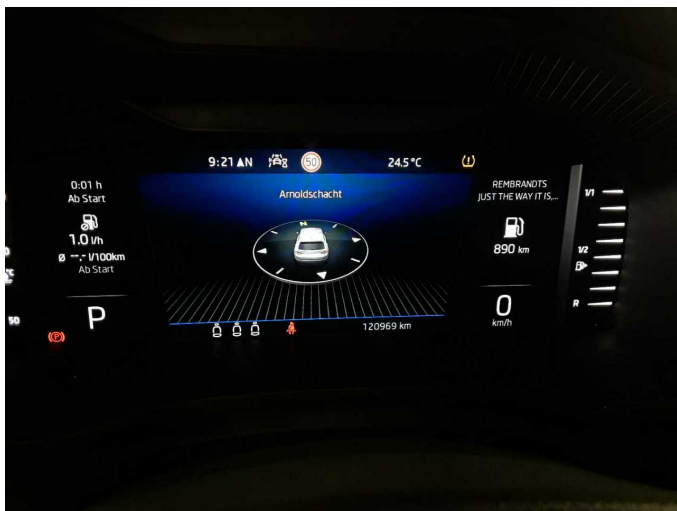
| No. | Component group | Description |
|---|---|---|
| 2 | Wheel / tyres | Pressure sensor (Reifendruck) - on - Perform diagnosis |

Damage 2: Wheel / tyres: Pressure sensor (Reifendruck) - on - Perform diagnosis

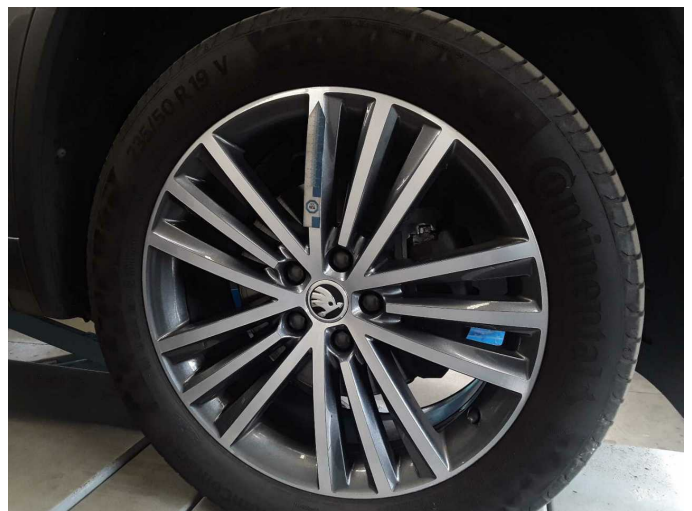
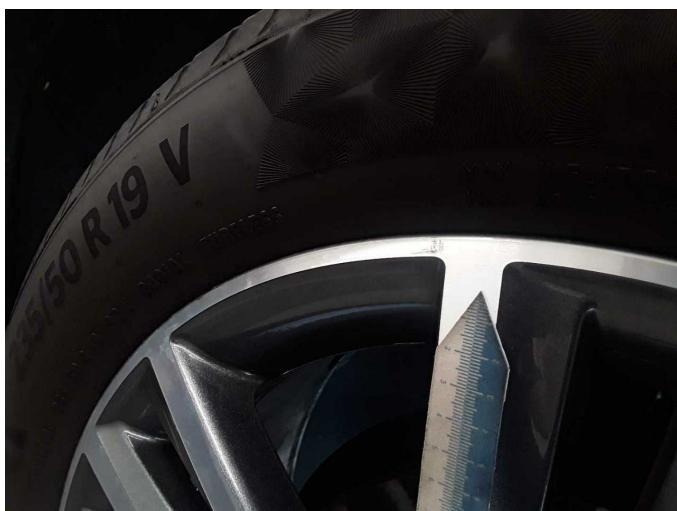
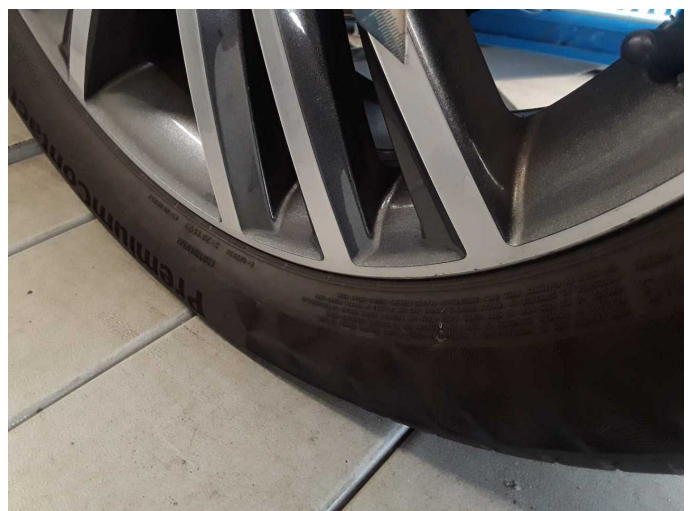
| No. | Component group | Description |
|---|---|---|
| 3 | Wheel / tyres | Alloy rim - front right side - Scratch(es) - Loss in value |

Damage 3: Wheel / tyres: Alloy rim - front right side - Scratch(es) - Loss in value

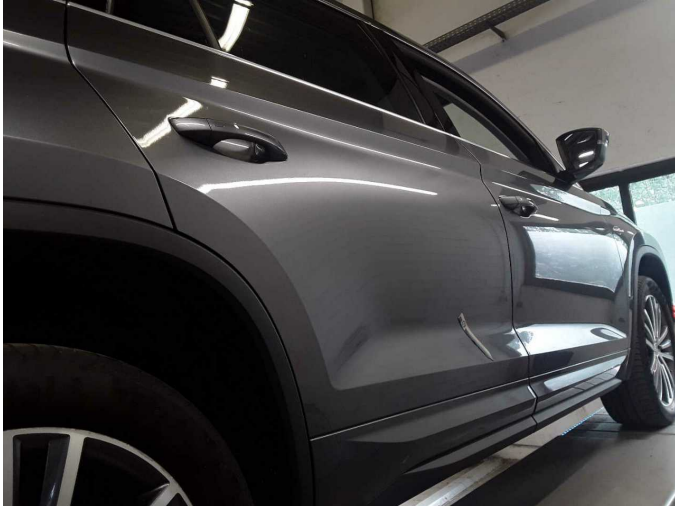
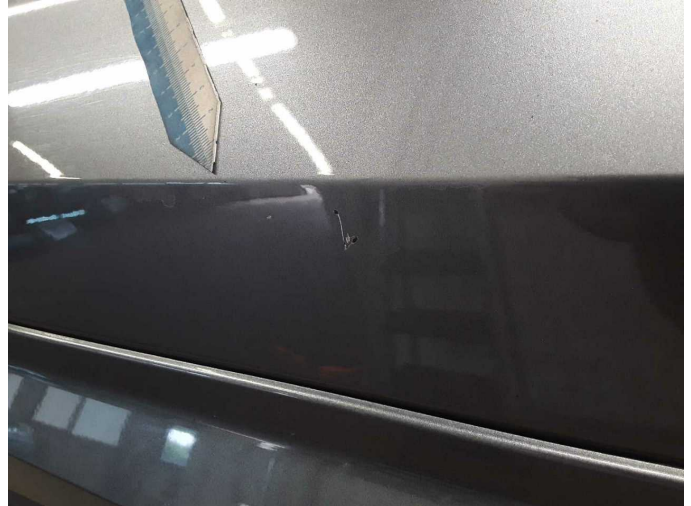
| No. | Component group | Description |
|---|---|---|
| 4 | Door - rear right side | Door - Scratch(es) - Smart repair |

**Damage 4:** Door - rear right side: Door - Scratch(es) - Smart repair

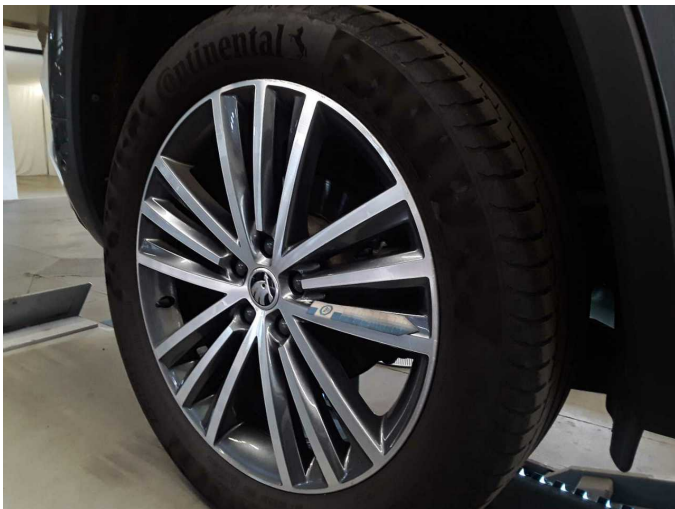
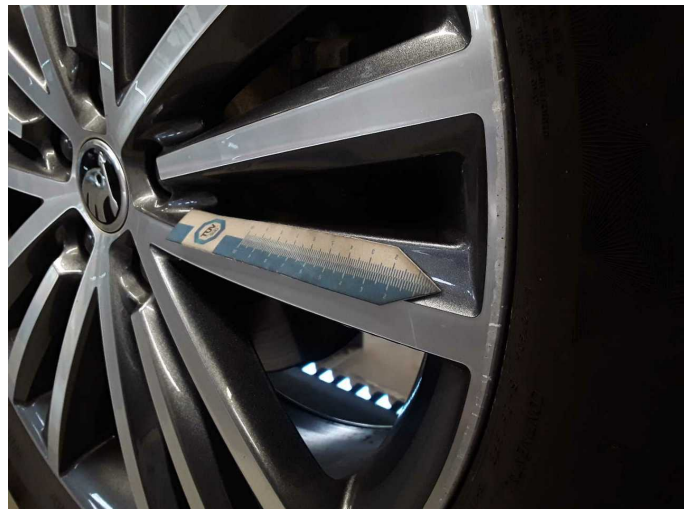
| No. | Component group | Description |
|---|---|---|
| 5 | Wheel / tyres | Alloy rim - rear right side - Scratch(es) - Loss in value |

**Damage 5:** Wheel / tyres: Alloy rim - rear right side - Scratch(es) - Loss in value

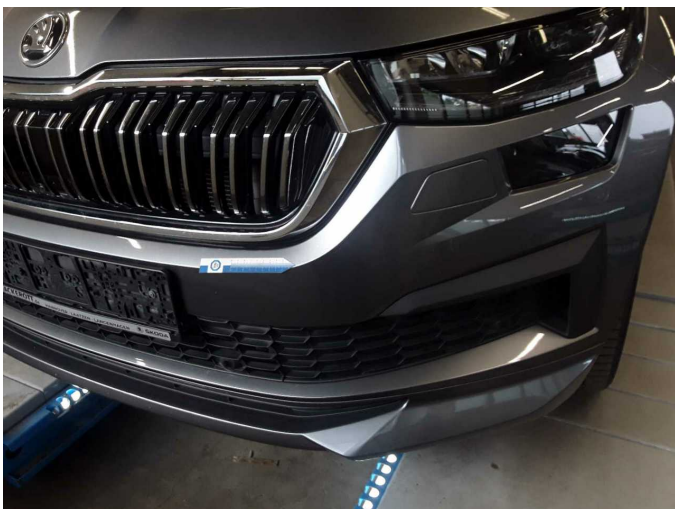
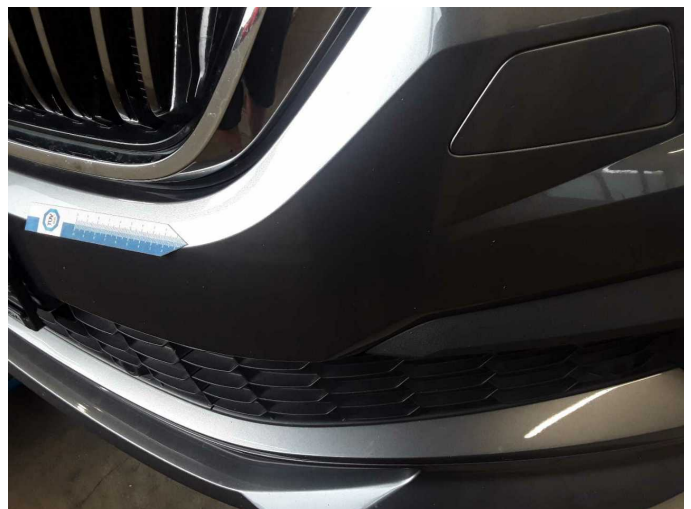
| No. | Component group | Description |
|---|---|---|
| 1 | Front bumper | Front bumper - Stone chips - No deduction |

**Wear and tear 1:** Front bumper: Front bumper - Stone chips - No deduction

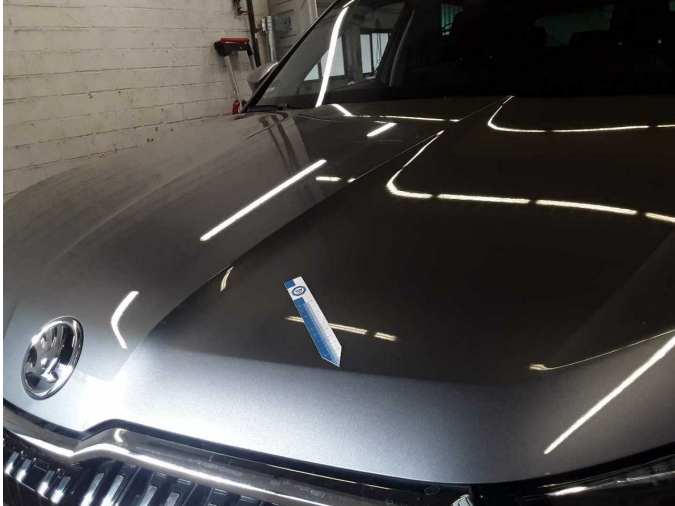
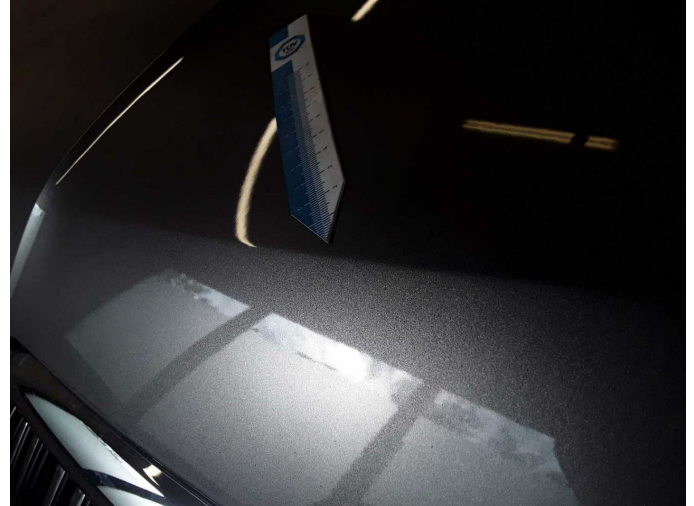
| No. | Component group | Description |
|---|---|---|
| 2 | Bonnet | Bonnet - Stone chips - No deduction |

**Wear and tear 2:** Bonnet: Bonnet - Stone chips - No deduction

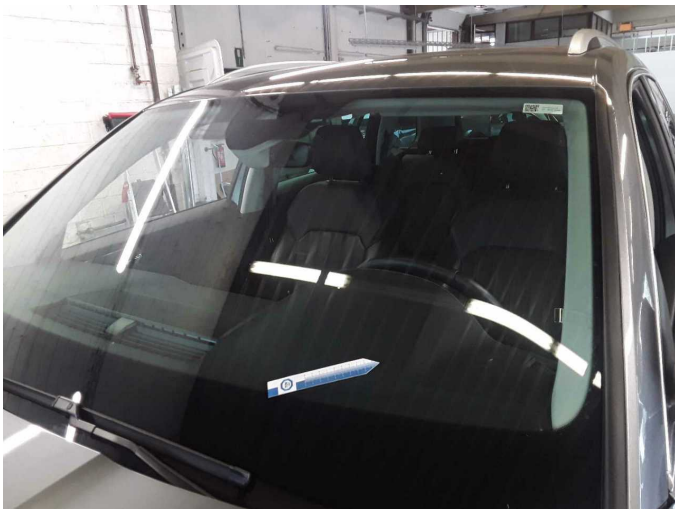
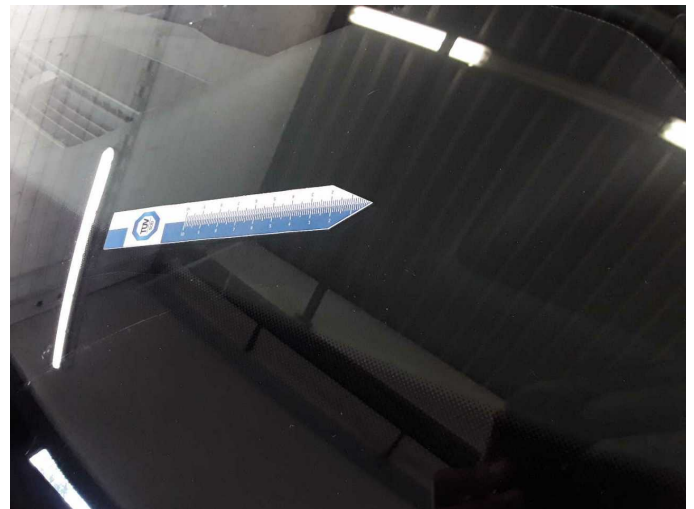
| No. | Component group | Description |
|---|---|---|
| 3 | Vehicle glazing | Windscreen - Stone chips - No deduction |

**Wear and tear 3:** Vehicle glazing: Windscreen - Stone chips - No deduction
