## Expertise

Protocol number: 46358019  
Order No. / Reference: 26616856  
Inspection date: 30 Jun 2026

Manufacturer: Volkswagen

Model: Touran 2.0 TDI SCR DSG ACTIVE

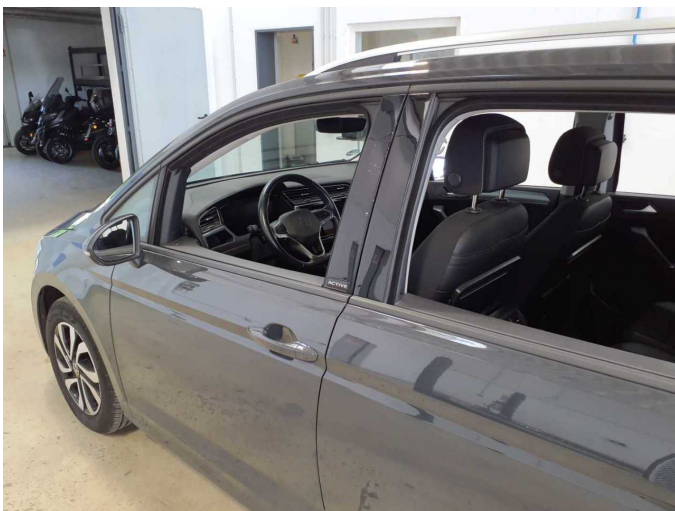
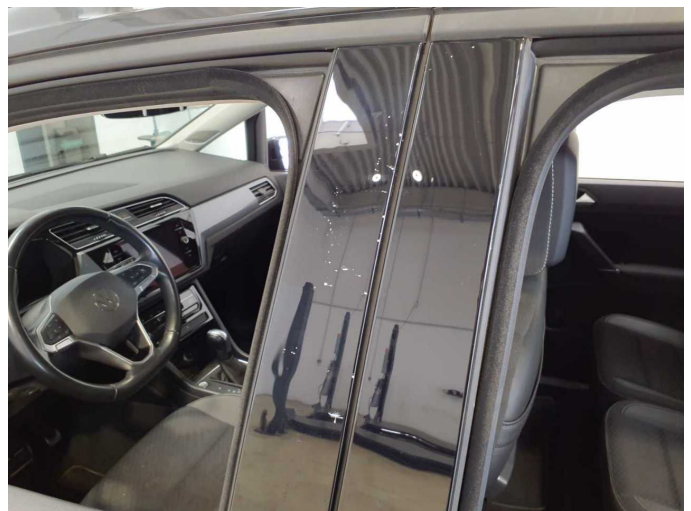
Damage 2: Door - front left side: Door (Verkleidung oben) - Soiled - Clean

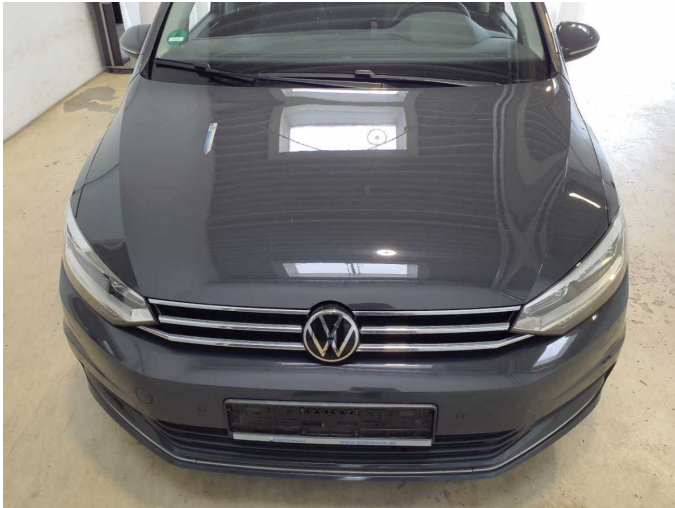
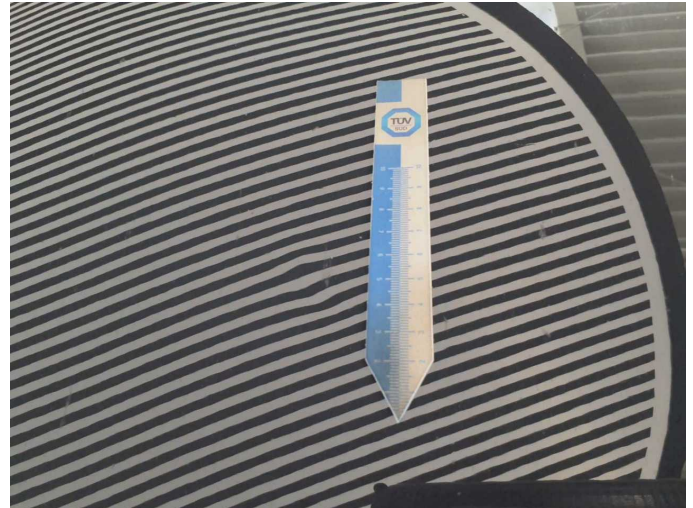
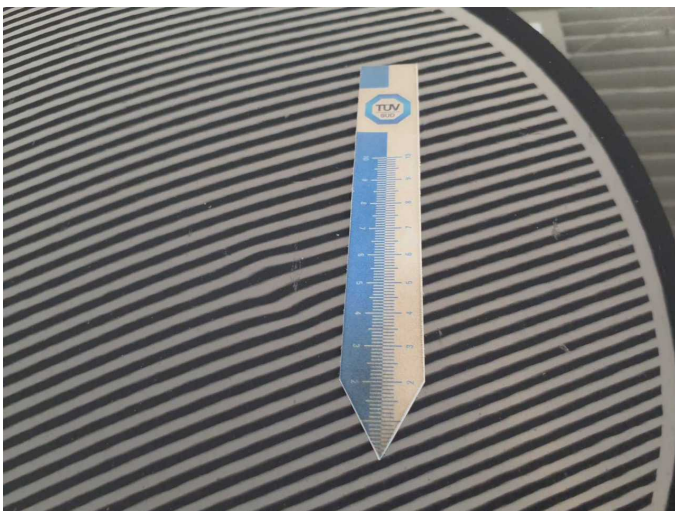
**Damage 3:** Bonnet: Bonnet (Zusätzlich Steinschläge) - dent(s) - Smooth repair work

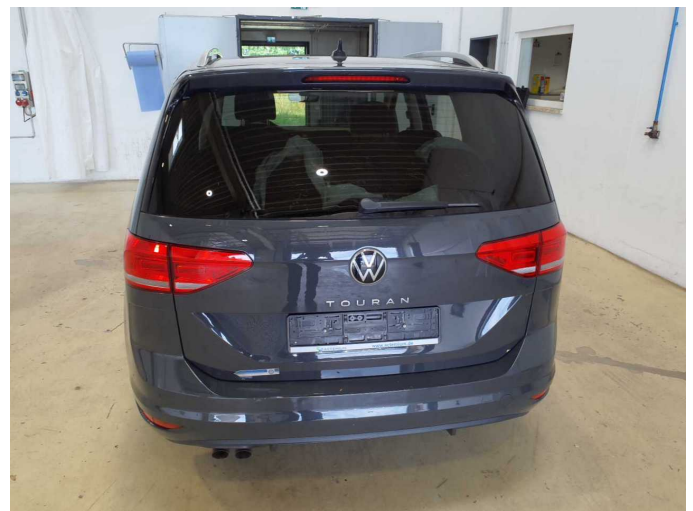
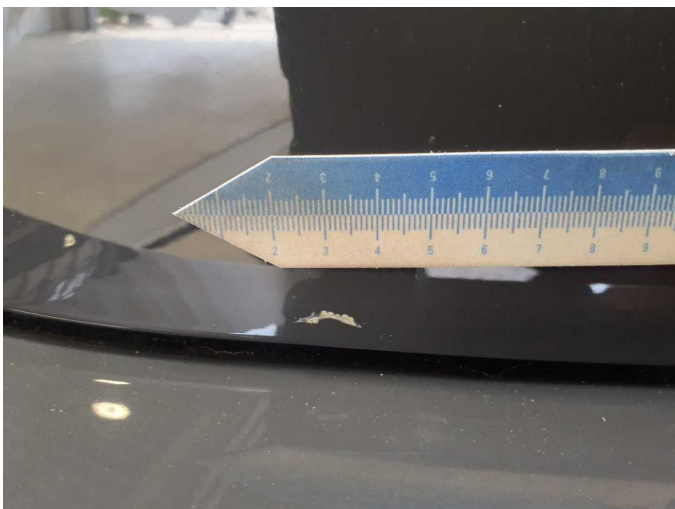
**Damage 4:** Boot lid / rear door: Boot lid - Scratch(es) - Smart repair

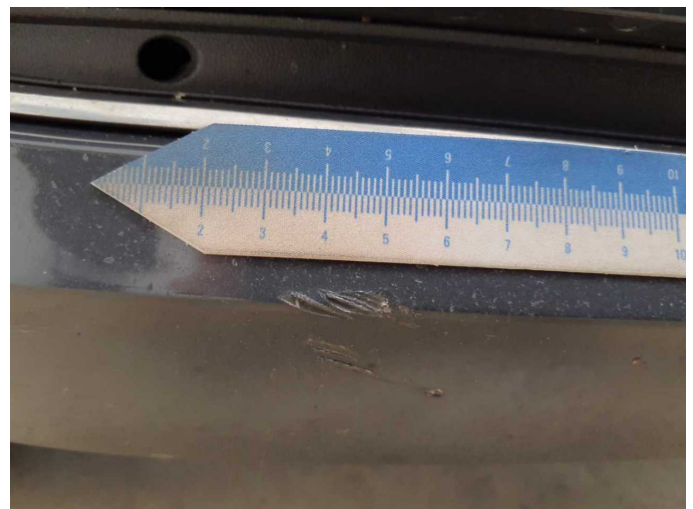
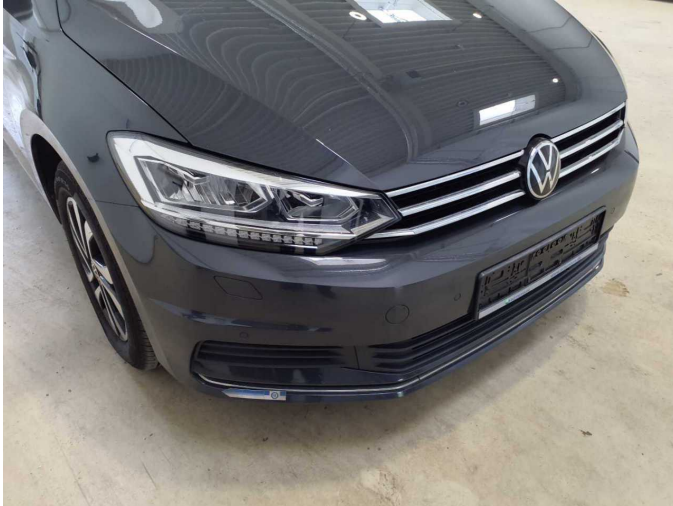
**Damage 5:** Front bumper: Front bumper - Scratch(es) - Smart repair

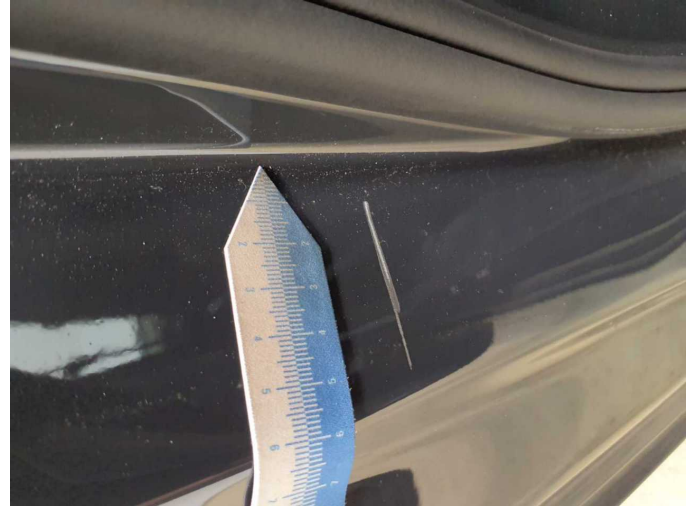
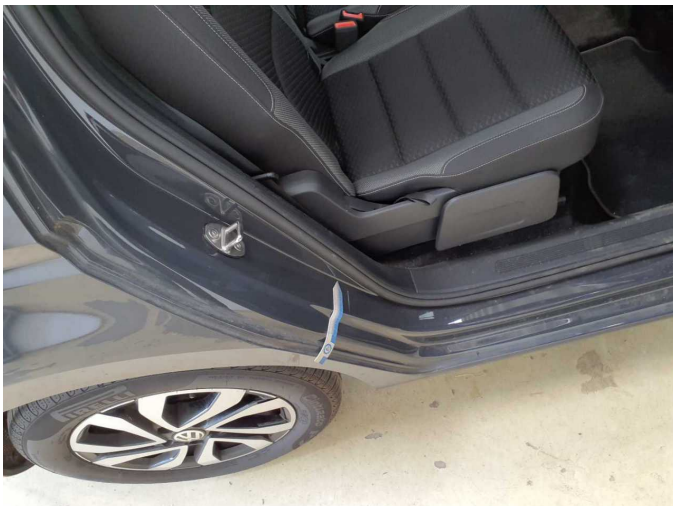
**Damage 6:** Side panel - rear right side: Sill - Scratch(es) - Smart repair

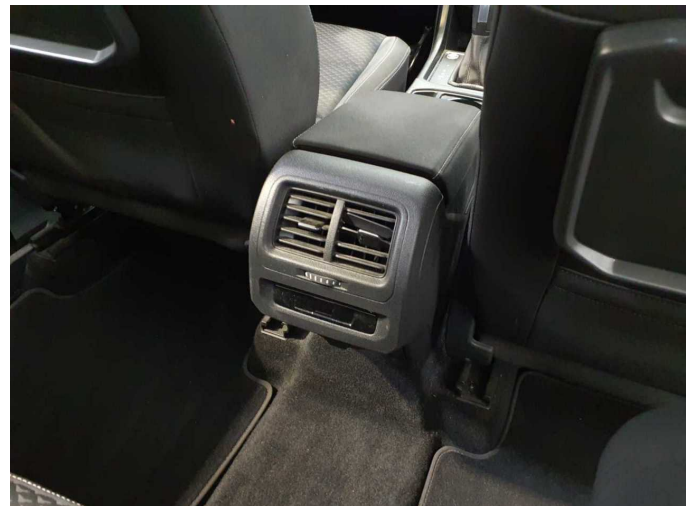
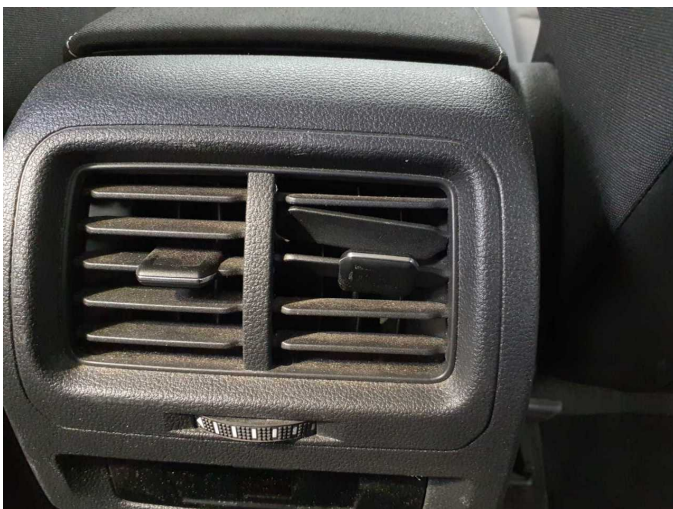
**Damage 7:** Instrument panel: Air nozzle - centre (Hinten) - Broken / torn - Replace

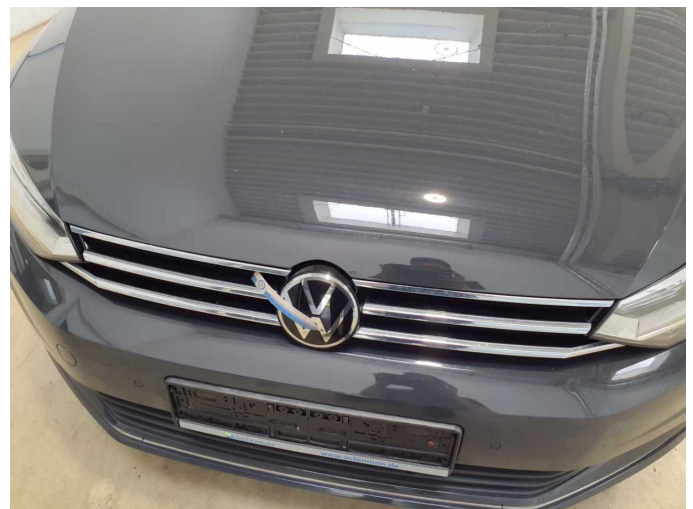
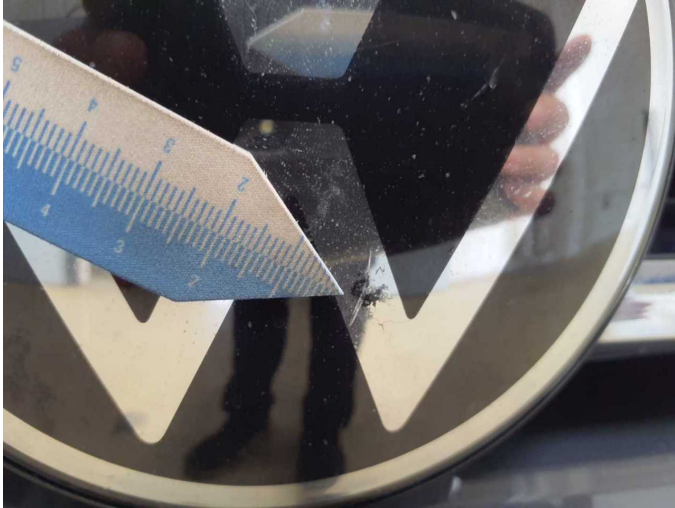
**Damage 8:** Bonnet: Emblem - Broken / torn - Replace

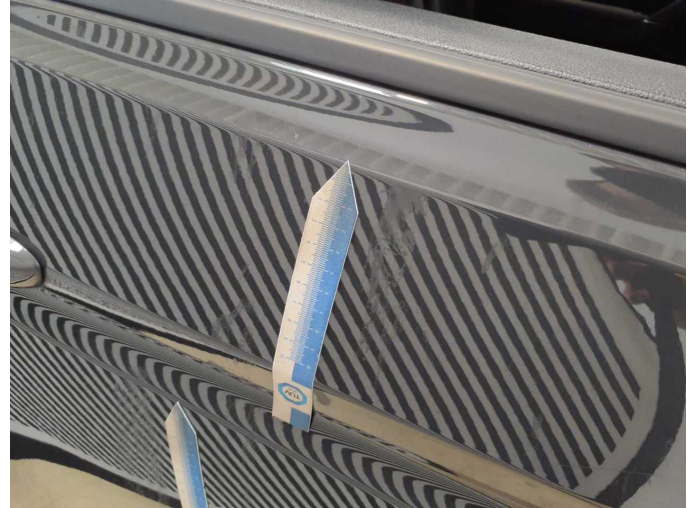
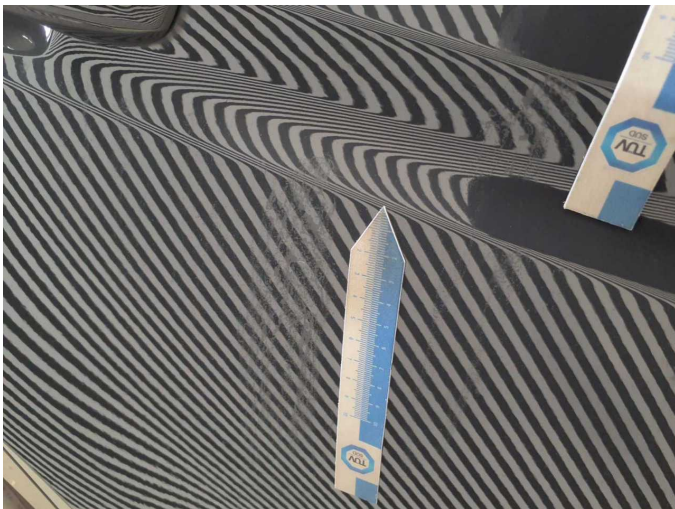
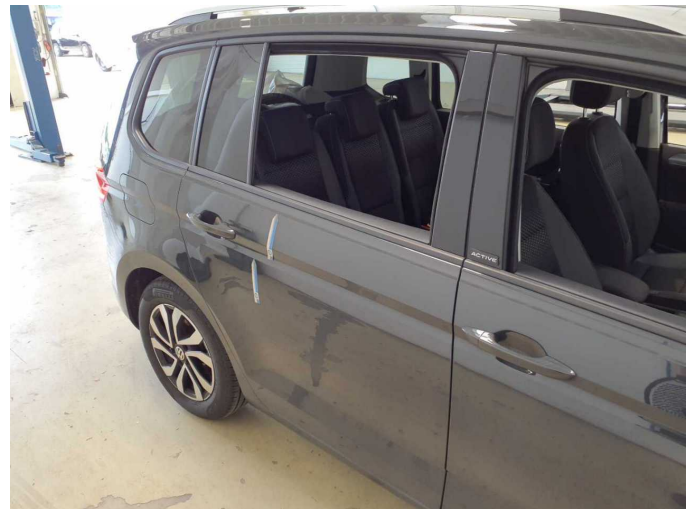
**Damage 9:** Door - rear right side: Door (Anätzung) - Paint defect - Repair and paint

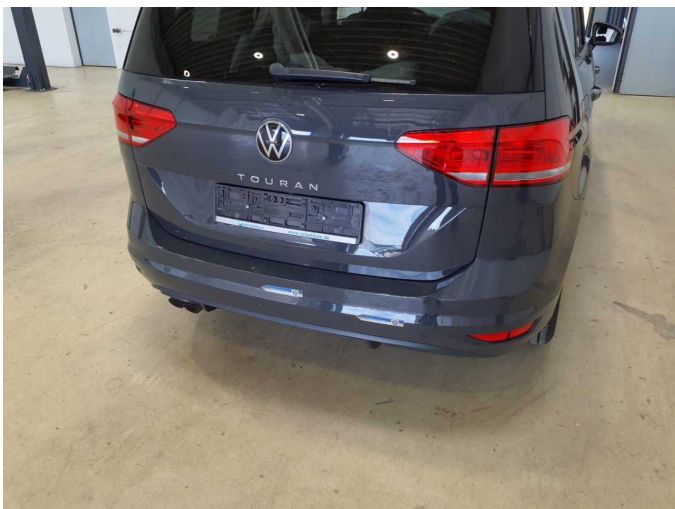
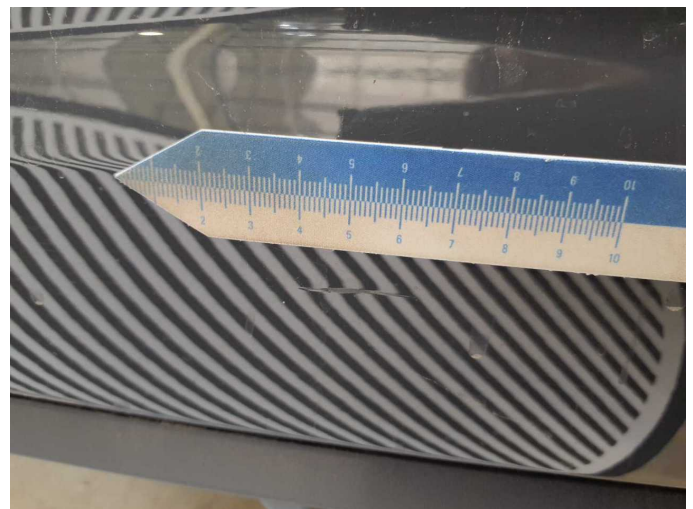
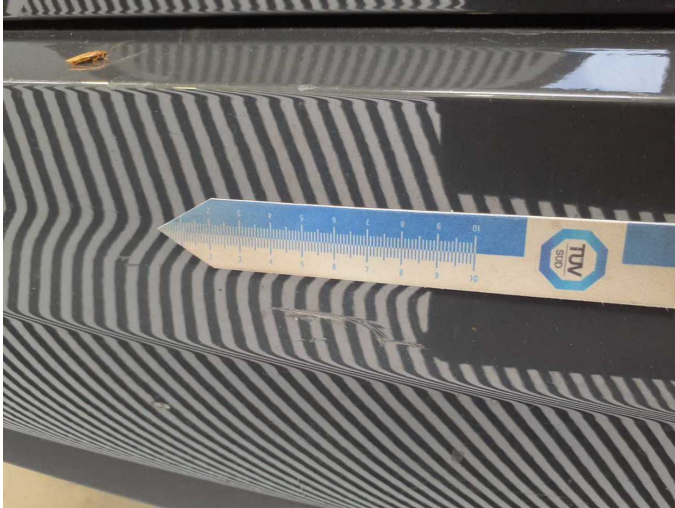
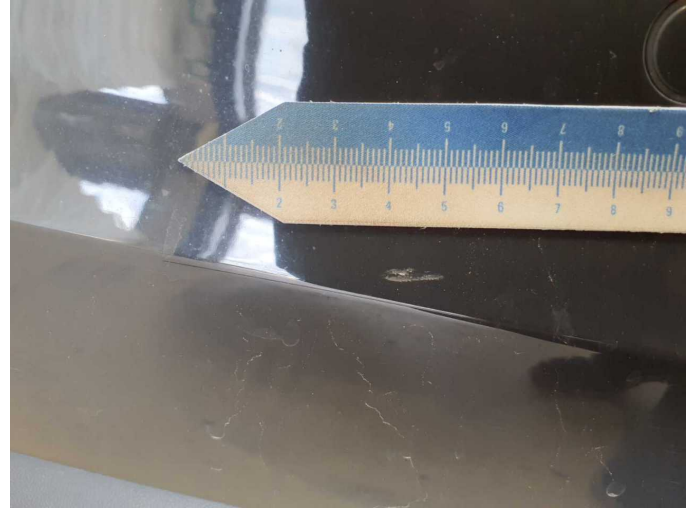
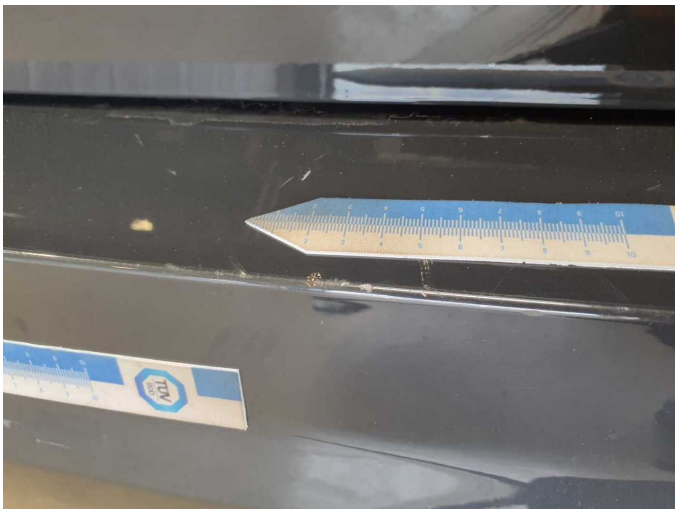
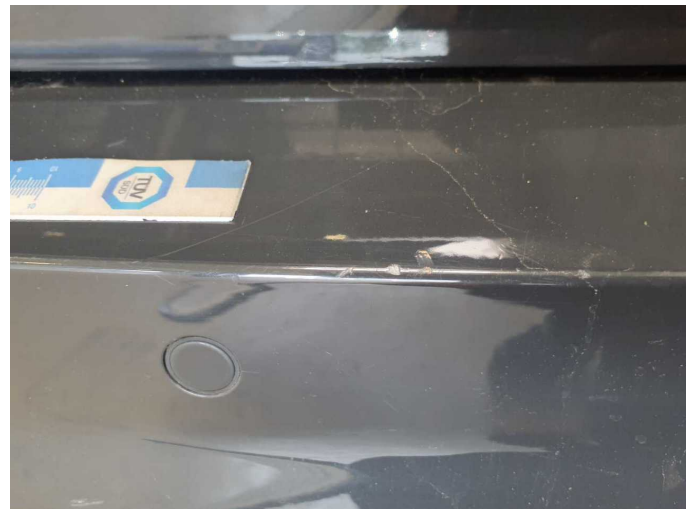
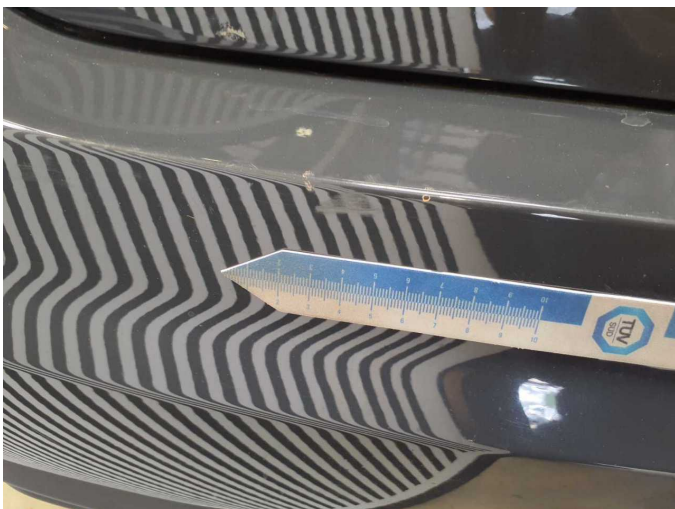
**Damage 10:** Rear bumper: Rear bumper - Dent / paintcoat damage - Repair and paint

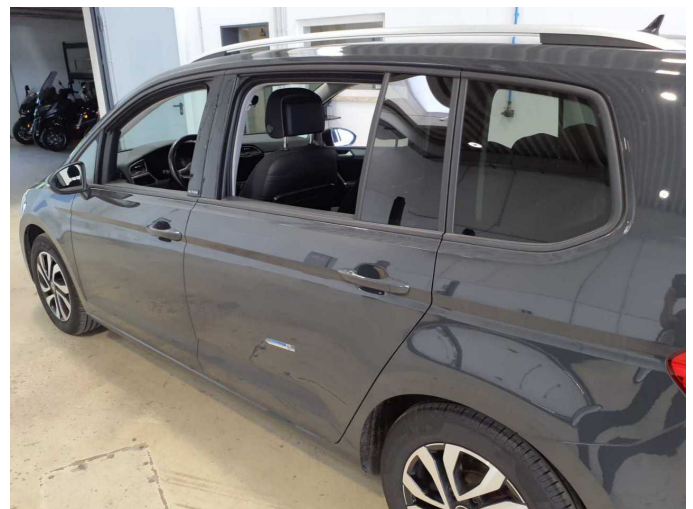
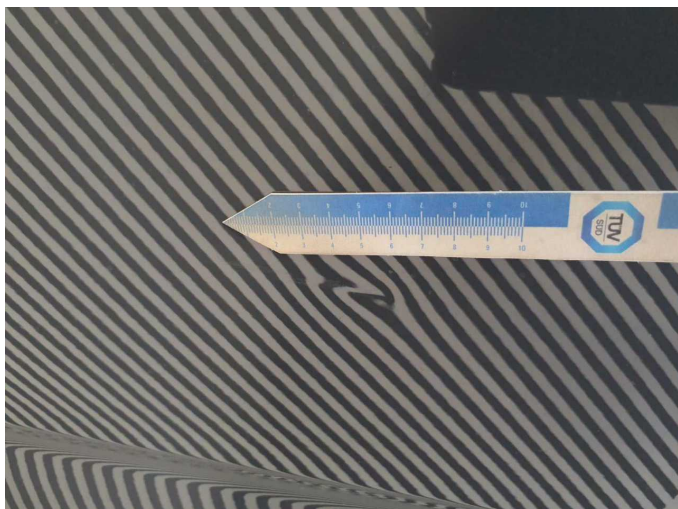
**Damage 11:** Door - rear left side: Door - Deformed - Repair and paint
