Expertise

Protocol number: 46095203
Order No. / Reference: 26490256
Inspection date: 22 Jun 2026

Manufacturer: Volvo

Model: XC90 T8 AWD Recharge Geartronic R-Design Edition

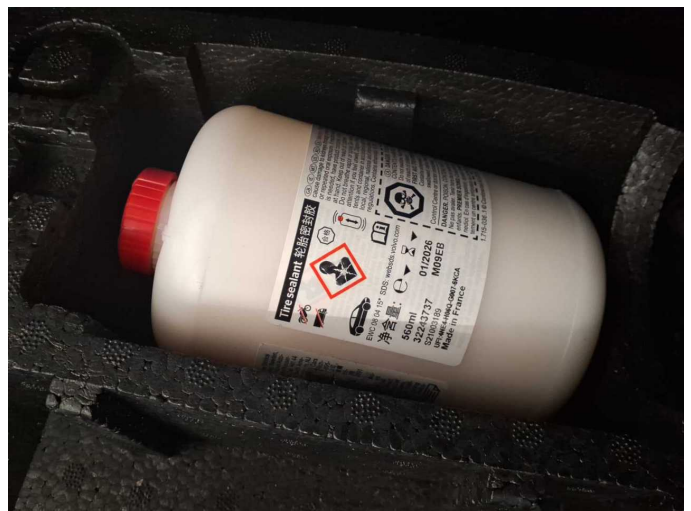
Damage 1: Equipment: Tirefit filler - Expired - Replace

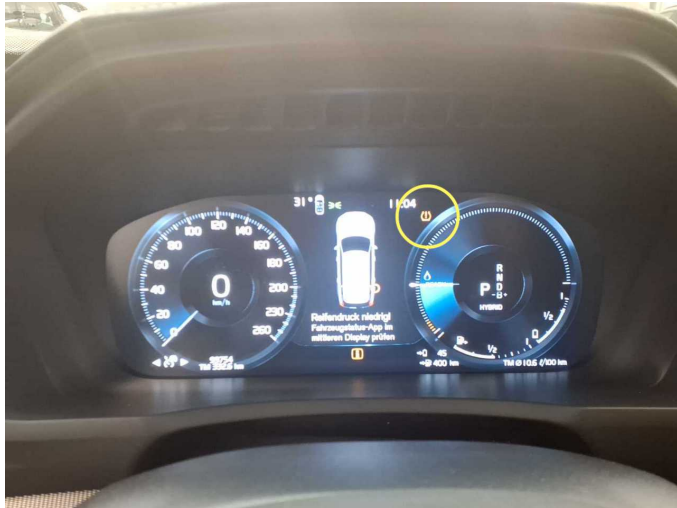
Damage 2: Instrument panel: Indicator light (Reifendruck) - on - Perform diagnosis

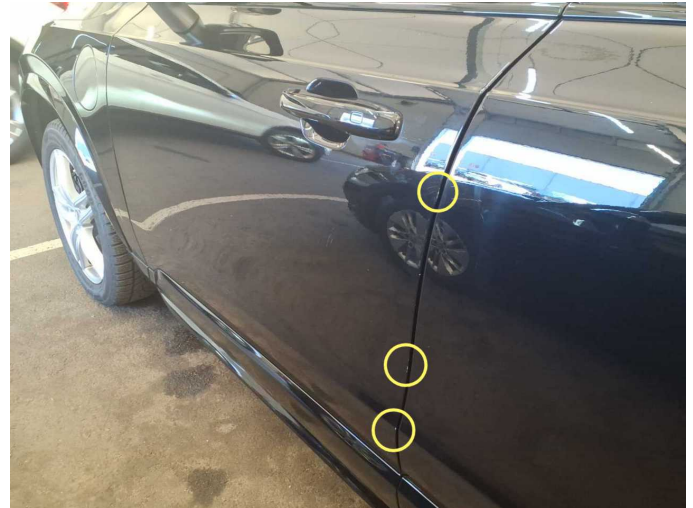
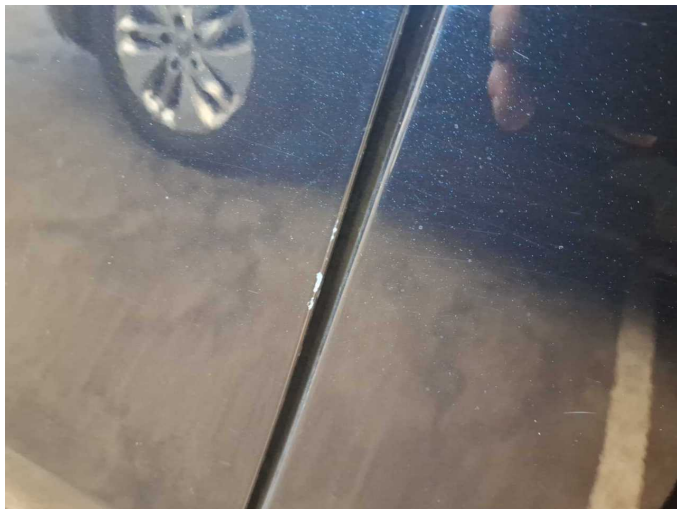
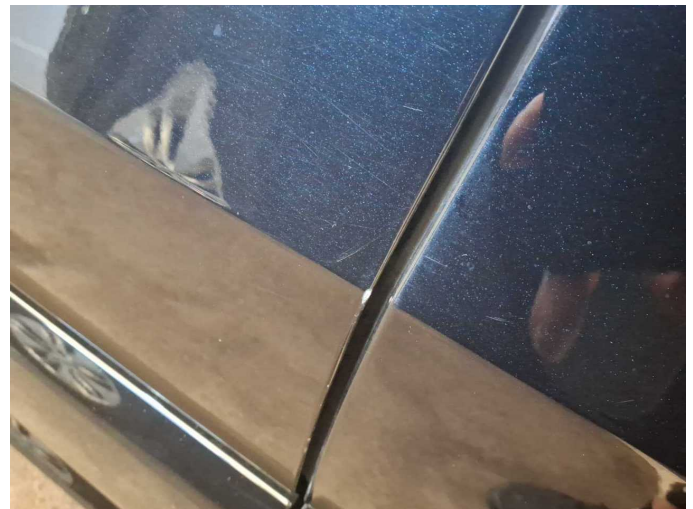
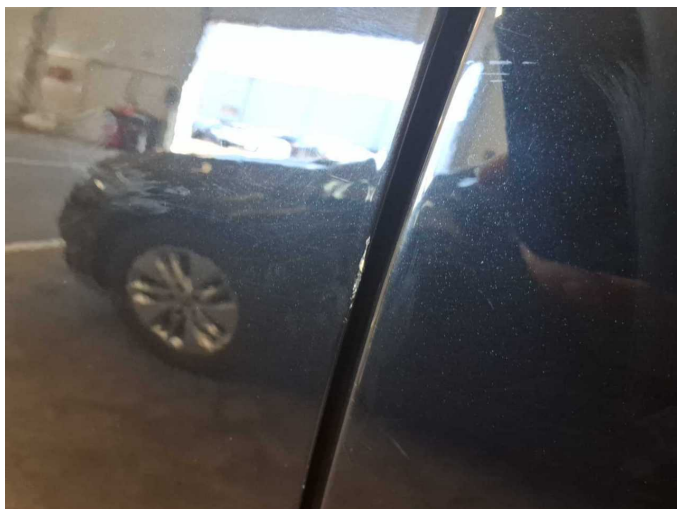
Damage 3: Door - front left side: Door edge - Scratch(es) - Smart repair

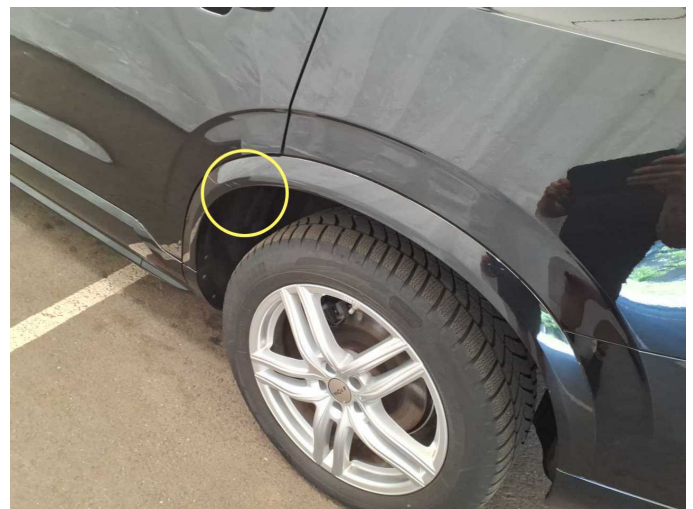
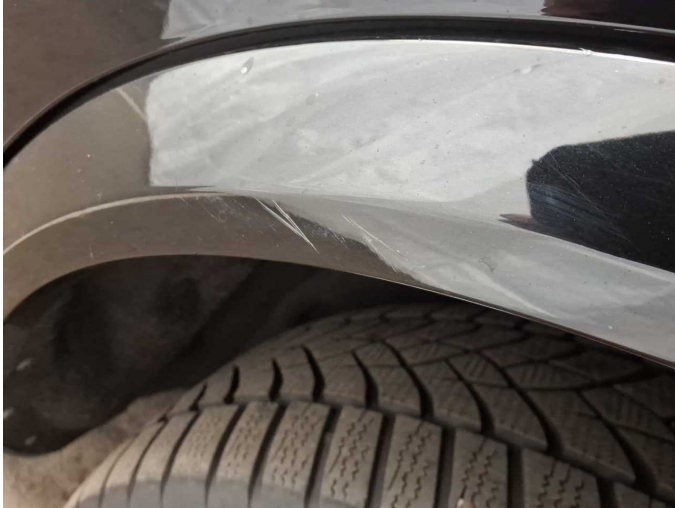
Damage 4: Side panel - rear left side: Wheel well extension - Scratch(es) - Smart repair

Damage 4: Side panel - rear left side: Wheel well extension - Scratch(es)
- Smart repair

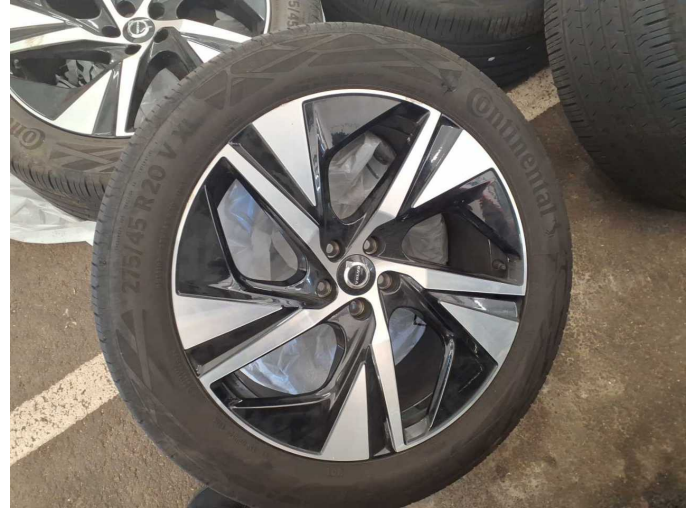
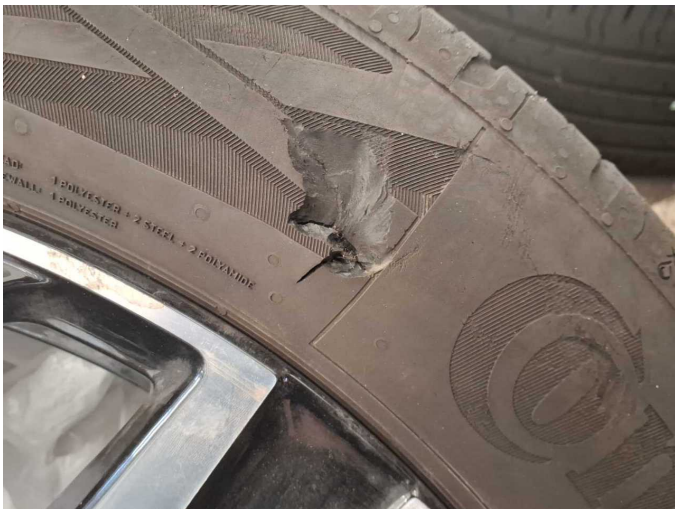
Damage 5: 2nd wheel set: 1 tyre (Sommerreifen) - Damaged - Replace

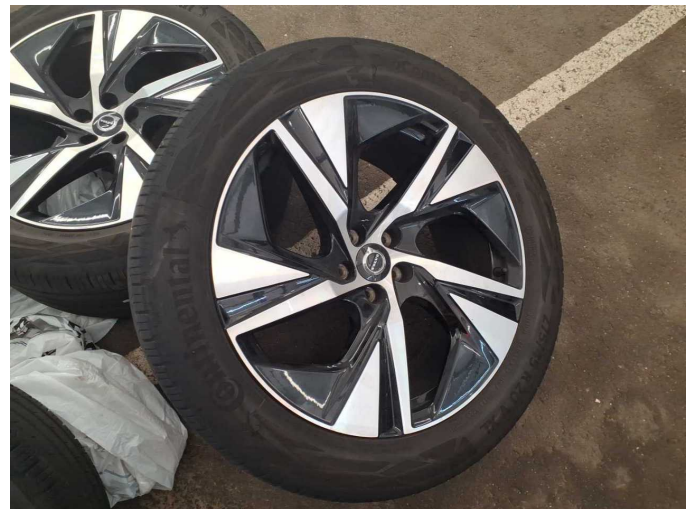
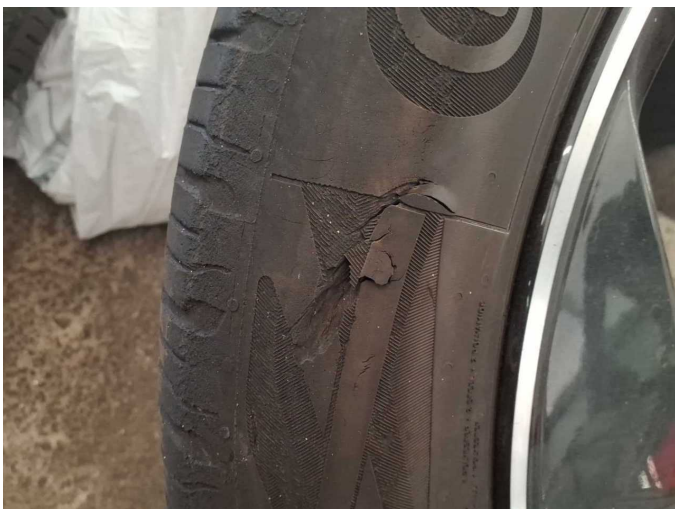
Damage 6: 2nd wheel set: 1 tyre (Sommerreifen) - Damaged - Replace

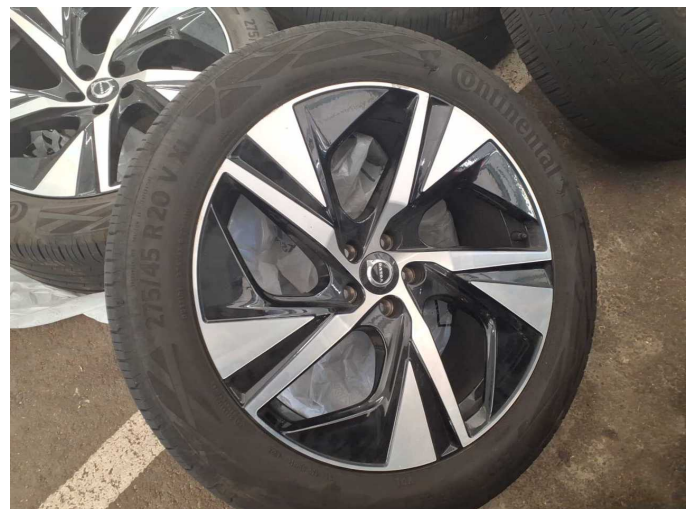
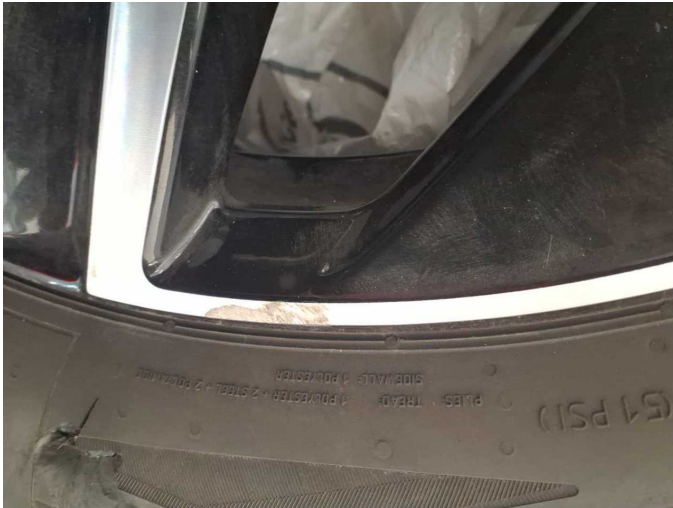
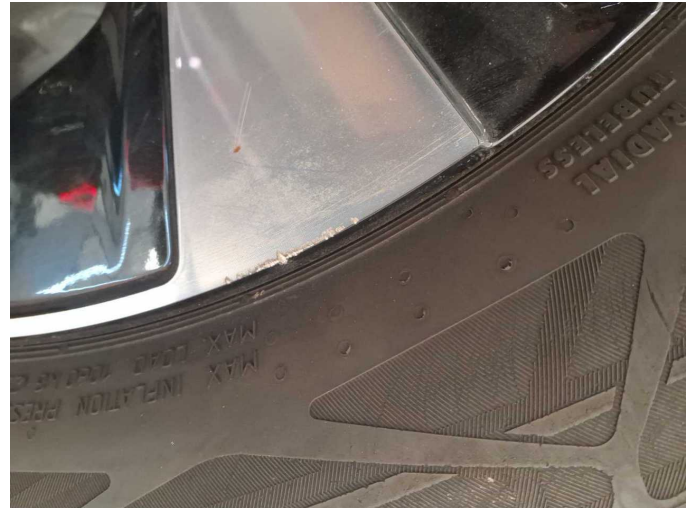
Damage 7: 2nd wheel set: 1 alloy rim - Scratched - Loss in value

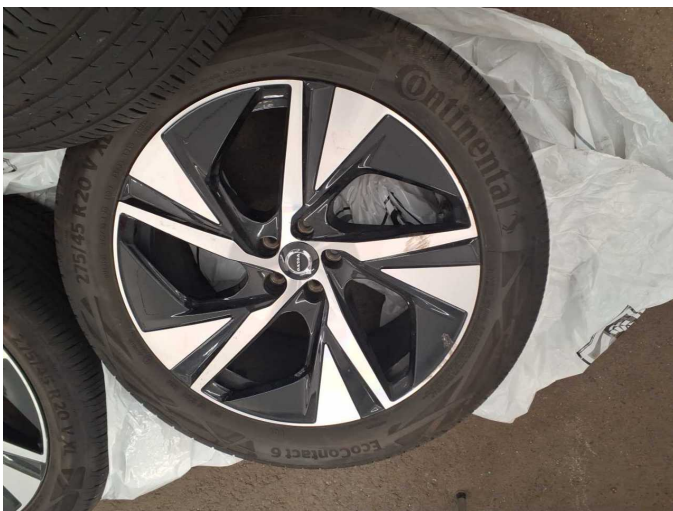
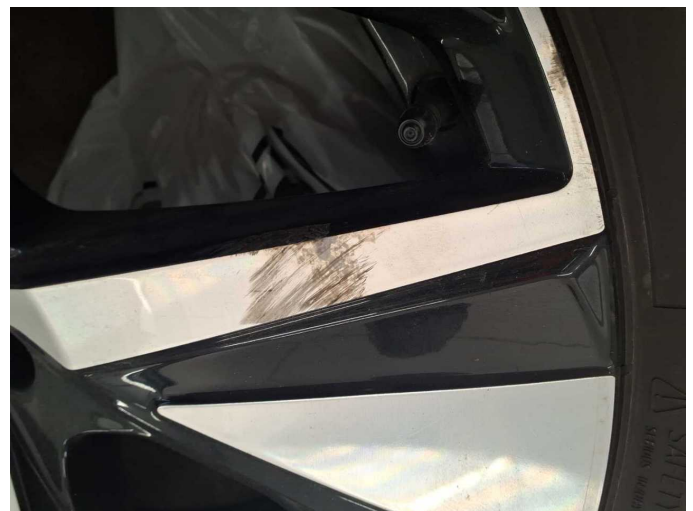
Damage 8: 2nd wheel set: 1 alloy rim - Scratched - Loss in value

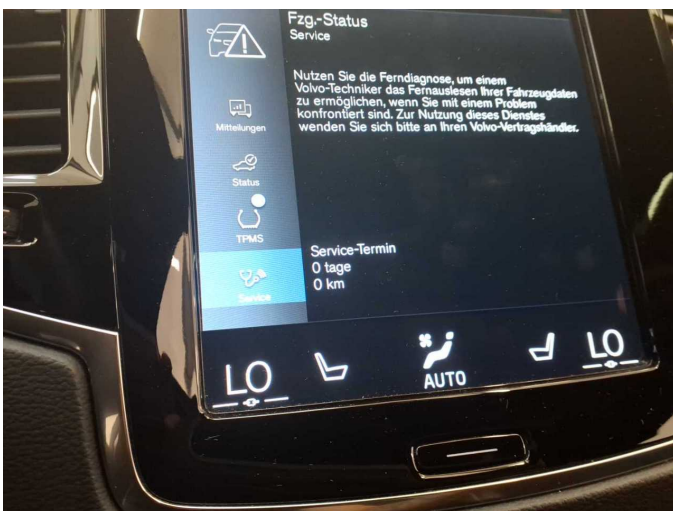
Damage 9: Misc.: Inspection / maintenance - Due - Perform

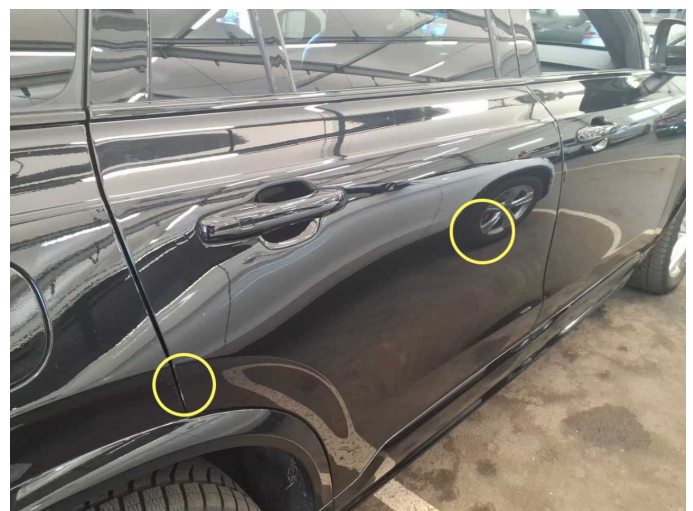
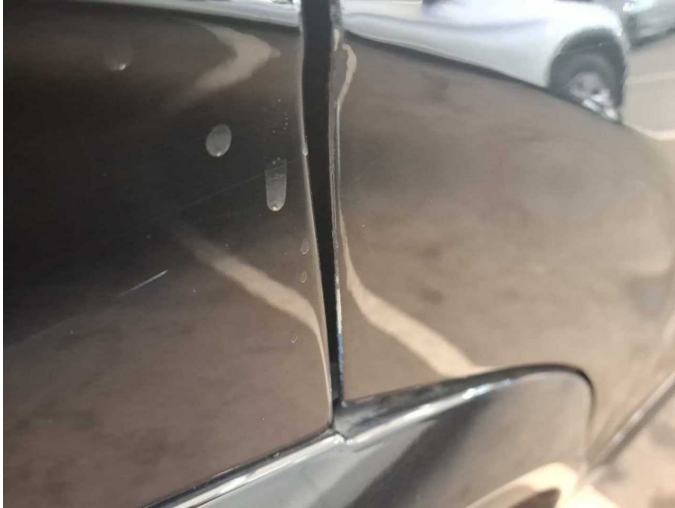
Damage 10: Door - rear right side: Door - Dent / paintcoat damage - Paint

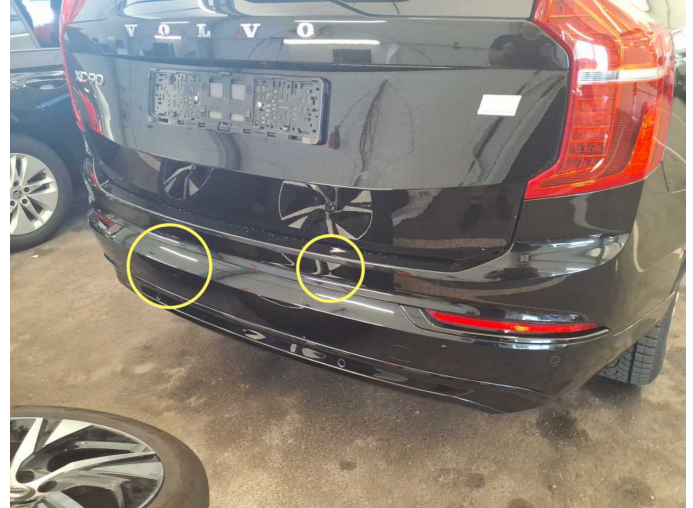
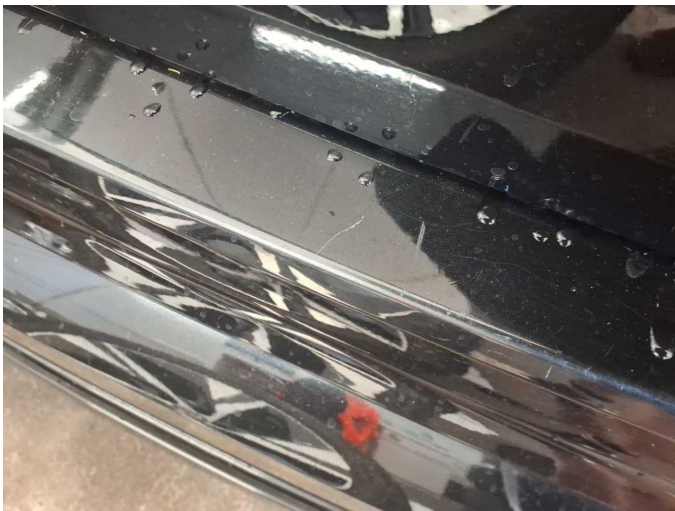
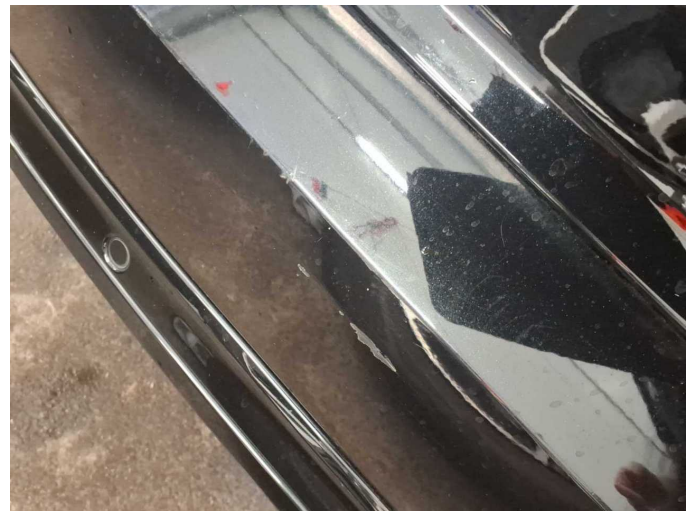
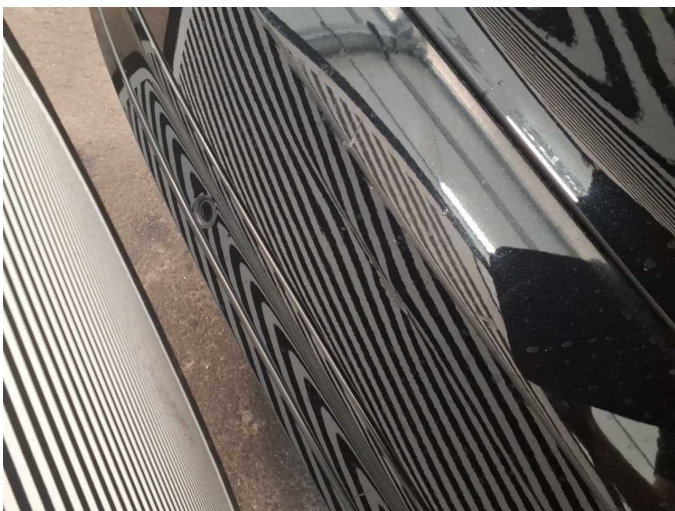
Damage 11: Rear bumper: Rear bumper - Scratch(es) - Paint

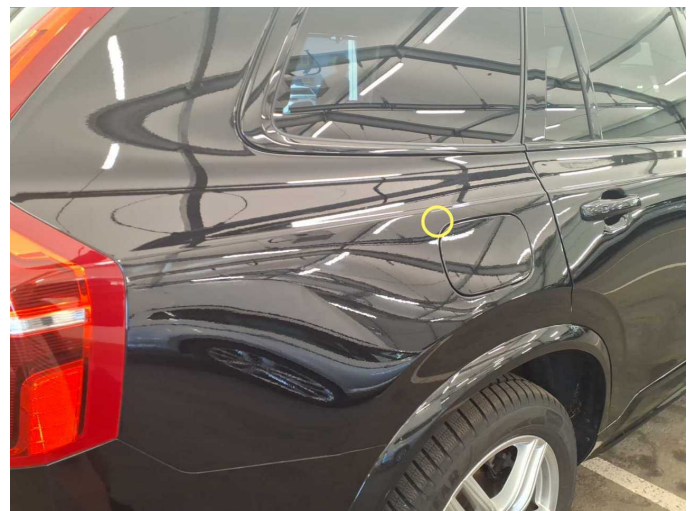
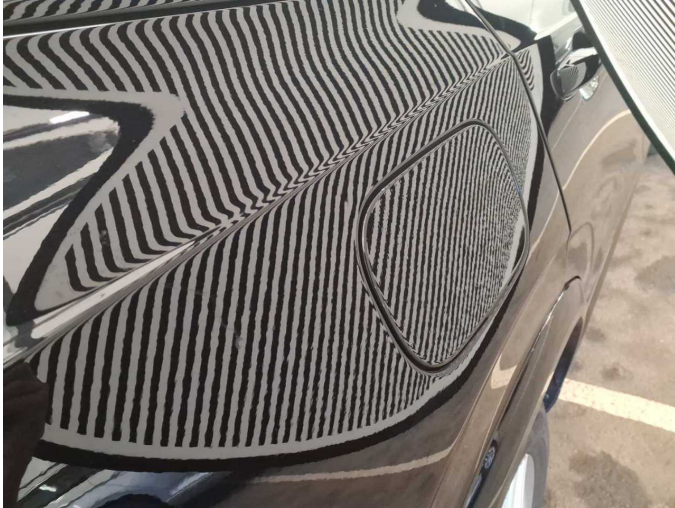
Wear and tear 6: Side panel - rear left side: Side panel - dent(s) - No deduction

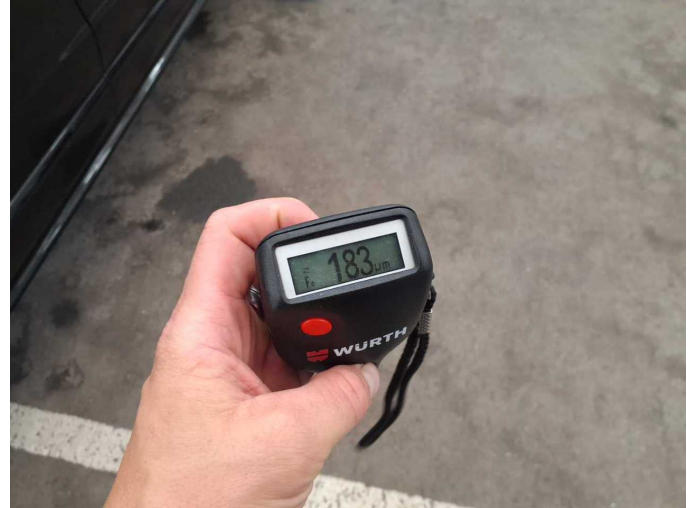
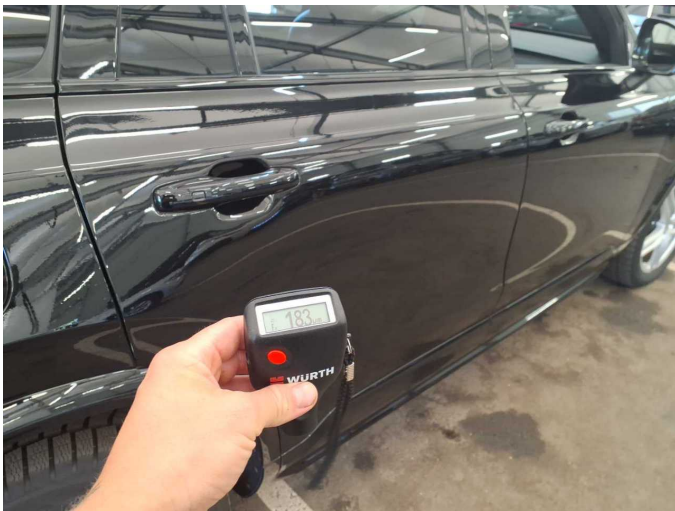
No.	Repainting
1	Door - rear right side, Professionally carried out, Invoice of repair done Non-existent

Door - rear right side	183 µm
------------------------	--------

Repainting 1: Door - rear right side
