Expertise

Protocol number: 46557849  
Order No. / Reference: 26536668  
Inspection date: 16 Jul 2026

Manufacturer: Peugeot

Model: 308 SW BlueHDi 130 EAT8 Allure Pack

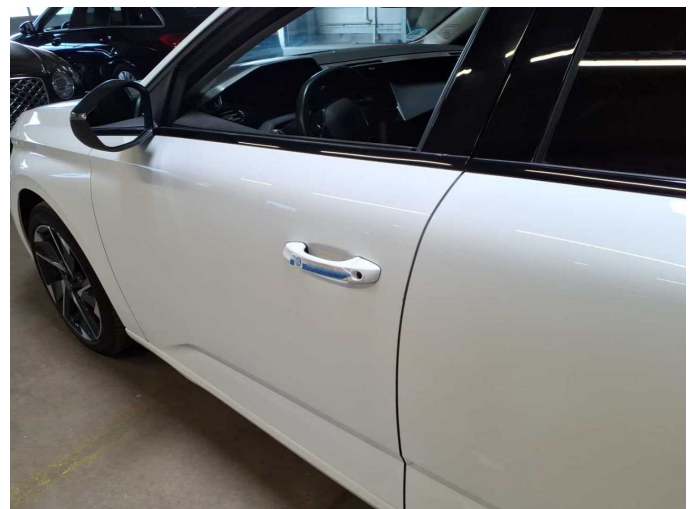
| No. | Component group | Description |
|---|---|---|
| 2 | Door - front left side | Door handle - outside (Schlossabdeckung) - Scratch(es) - Smart repair |

**Damage 2:** Door - front left side: Door handle - outside (Schlossabdeckung) - Scratch(es) - Smart repair

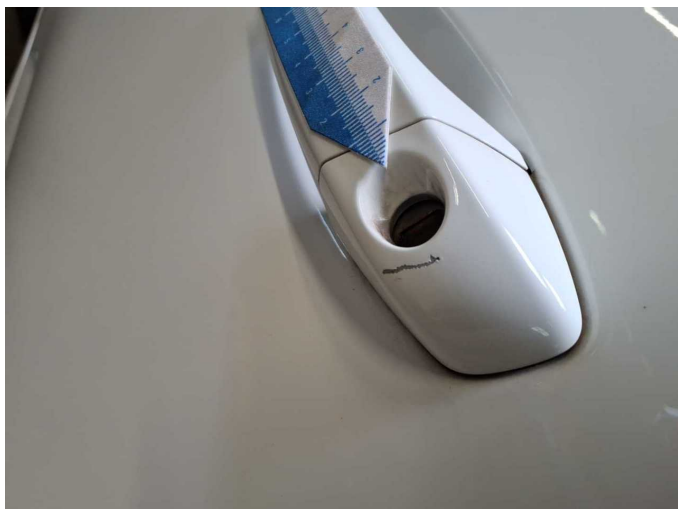
**Damage 2:** Door - front left side: Door handle - outside (Schlossabdeckung) - Scratch(es) - Smart repair

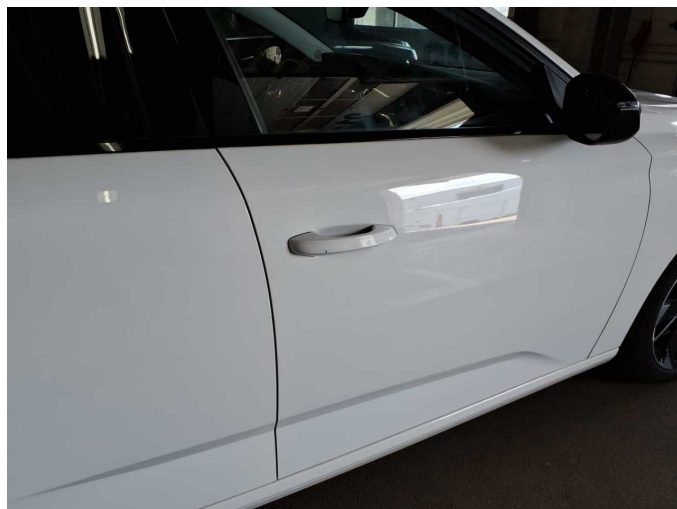
| No. | Component group | Description |
|---|---|---|
| 3 | Door - front right side | Door handle - outside - Scratch(es) - Smart repair |

**Damage 3:** Door - front right side: Door handle - outside - Scratch(es) - Smart repair

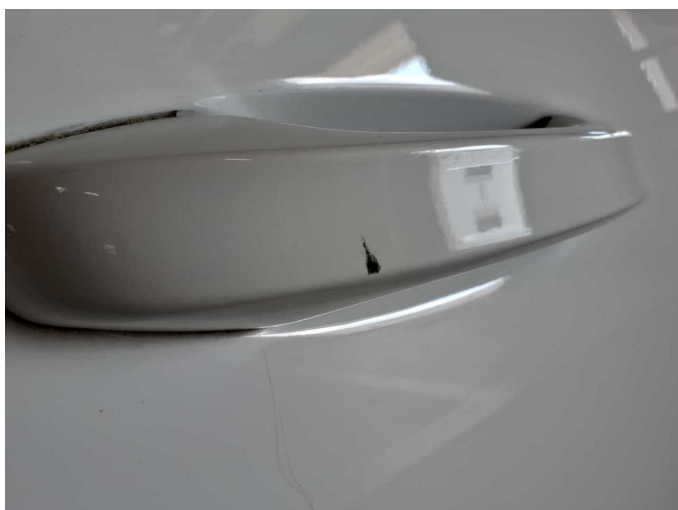
**Damage 3:** Door - front right side: Door handle - outside - Scratch(es) - Smart repair

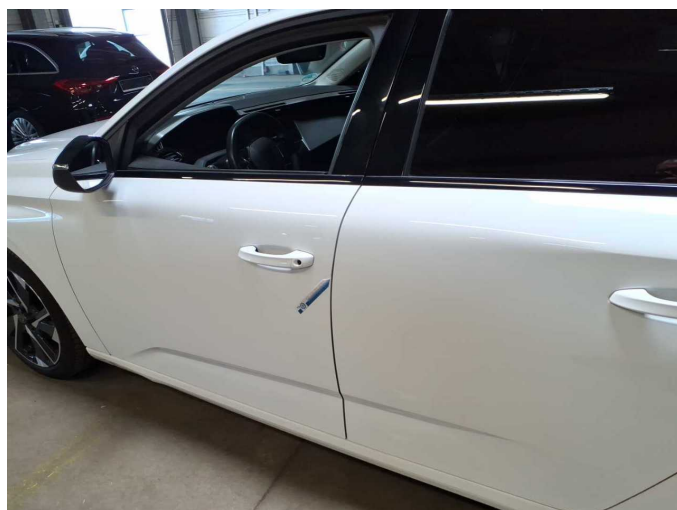
| No. | Component group | Description |
|---|---|---|
| 4 | Door - front left side | Door edge - Scratch(es) - Smart repair |

**Damage 4:** Door - front left side: Door edge - Scratch(es) - Smart repair

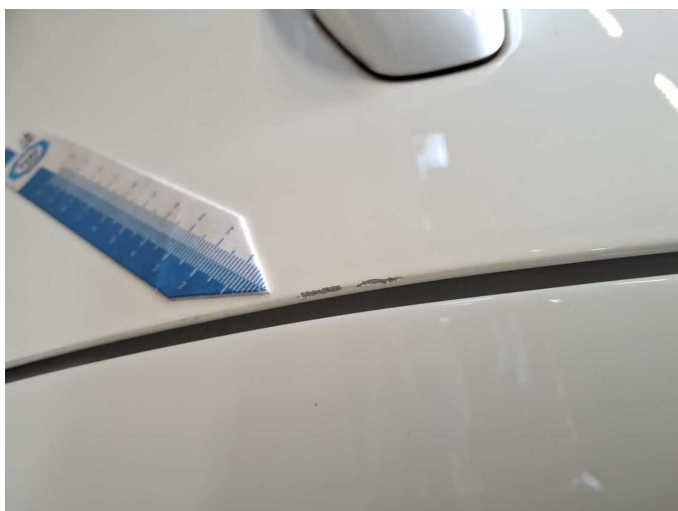
**Damage 4:** Door - front left side: Door edge - Scratch(es) - Smart repair

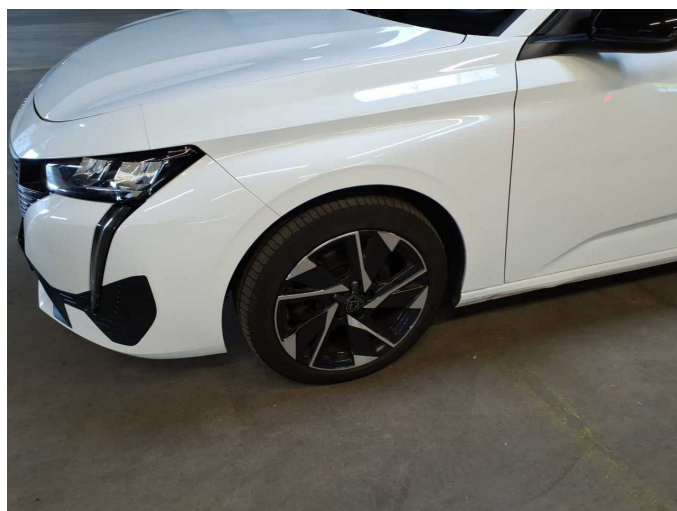
| No. | Component group | Description |
|---|---|---|
| 5 | Wheel / tyres | Tyre - front left side (Flanke) - Damaged - Replace |

**Damage 5:** Wheel / tyres: Tyre - front left side (Flanke) - Damaged - Replace

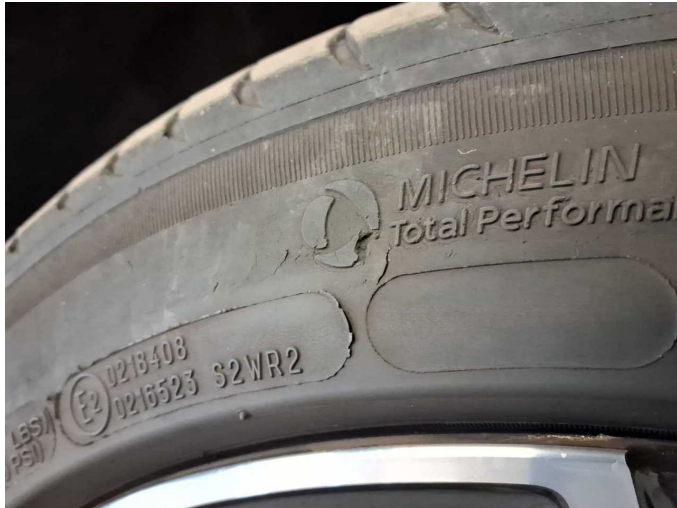
**Damage 5:** Wheel / tyres: Tyre - front left side (Flanke) - Damaged - Replace

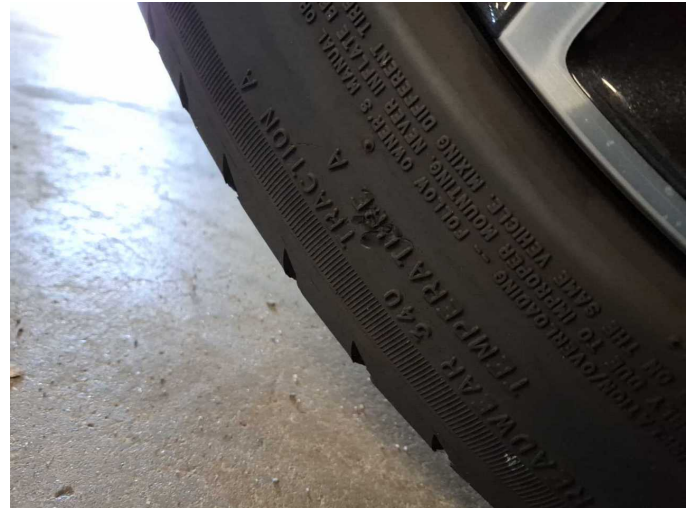
**Damage 5:** Wheel / tyres: Tyre - front left side (Flanke) - Damaged - Replace

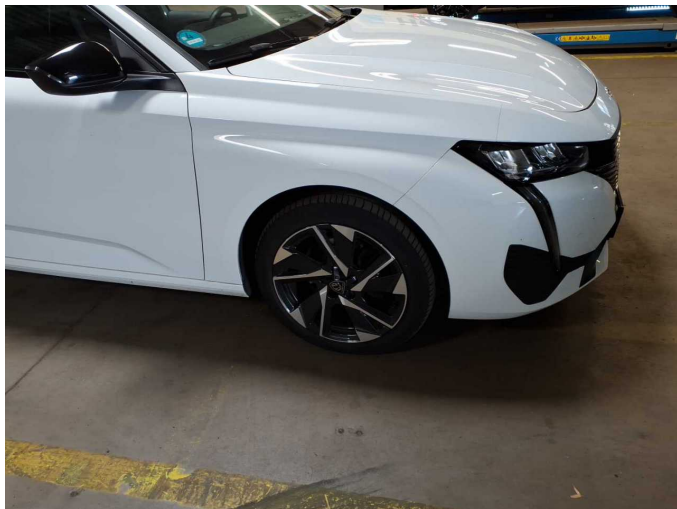
| No. | Component group | Description |
|---|---|---|
| 6 | Wheel / tyres | Tyre - front right side (Flanke) - Damaged - Replace |

**Damage 6:** Wheel / tyres: Tyre - front right side (Flanke) - Damaged - Replace

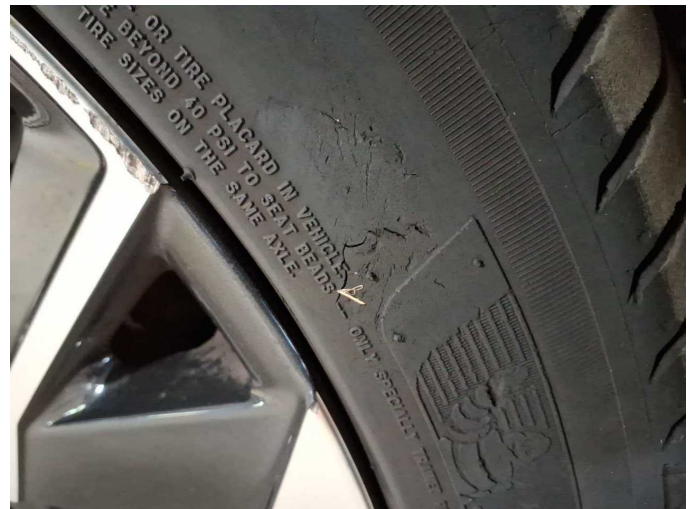
**Damage 6:** Wheel / tyres: Tyre - front right side (Flanke) - Damaged - Replace

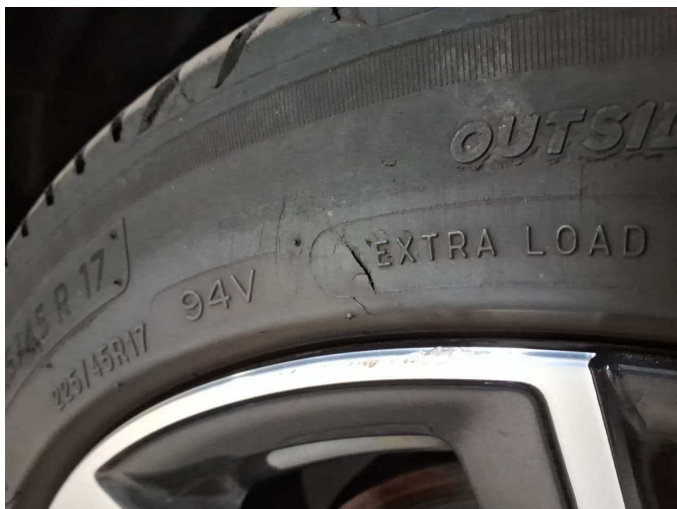
**Damage 6:** Wheel / tyres: Tyre - front right side (Flanke) - Damaged - Replace

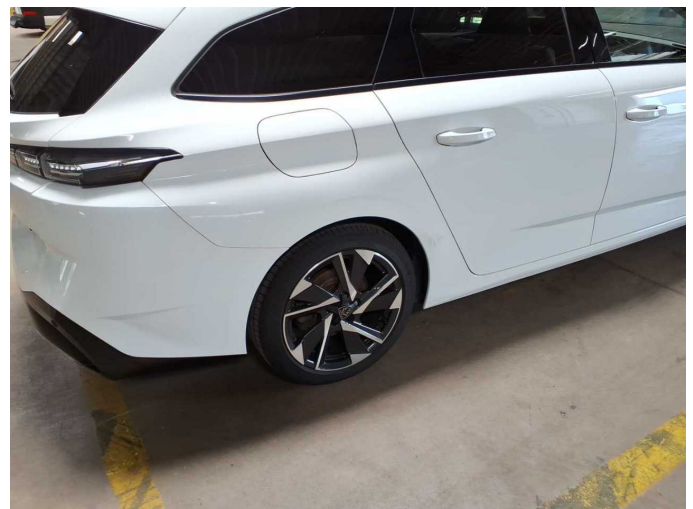
| No. | Component group | Description |
|---|---|---|
| 7 | Wheel / tyres | Tyre - rear right side (Flanke, nicht fahrbereit) - Damaged - Replace |

**Damage 7:** Wheel / tyres: Tyre - rear right side (Flanke, nicht fahrbereit) - Damaged - Replace

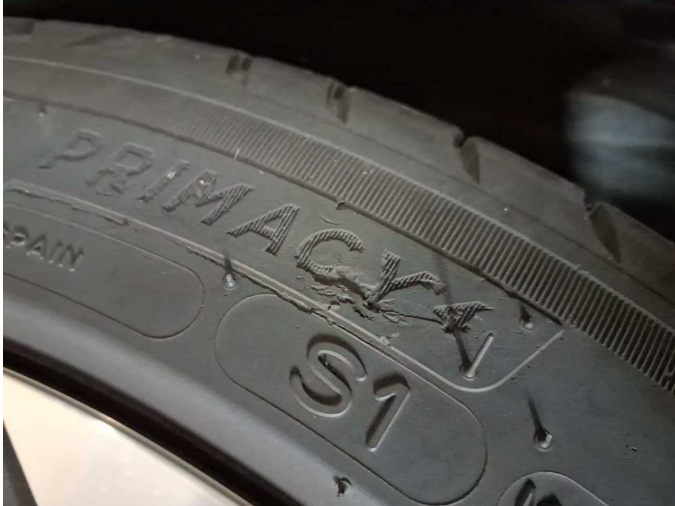
**Damage 7:** Wheel / tyres: Tyre - rear right side (Flanke, nicht fahrbereit) - Damaged - Replace

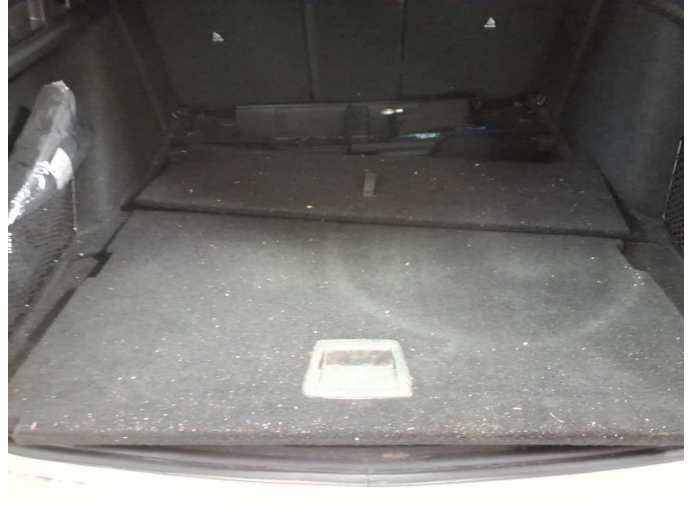
| No. | Component group | Description |
|---|---|---|
| 9 | Interior | Interior - Soiled - Clean |

**Damage 9:** Interior: Interior - Soiled - Clean

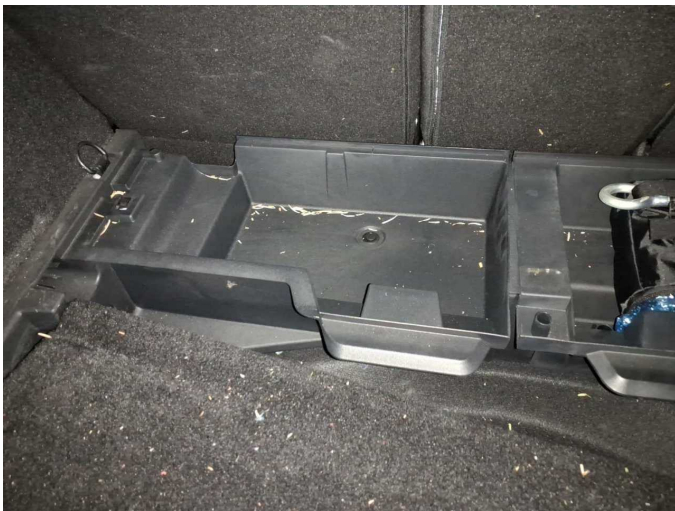
**Damage 9:** Interior: Interior - Soiled - Clean

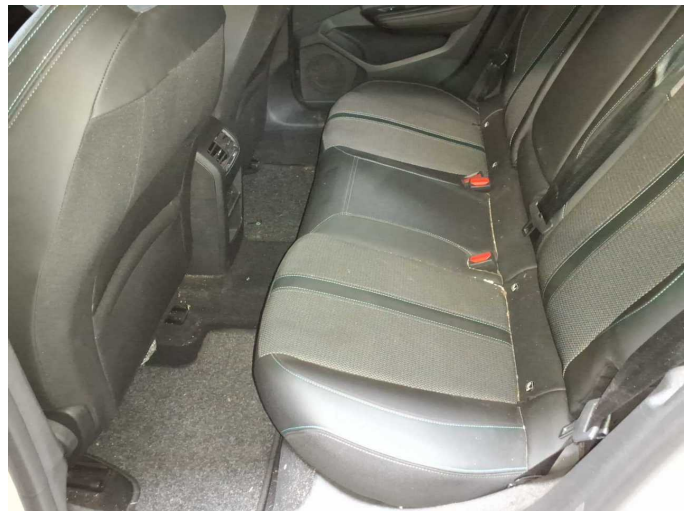
**Damage 9:** Interior: Interior - Soiled - Clean

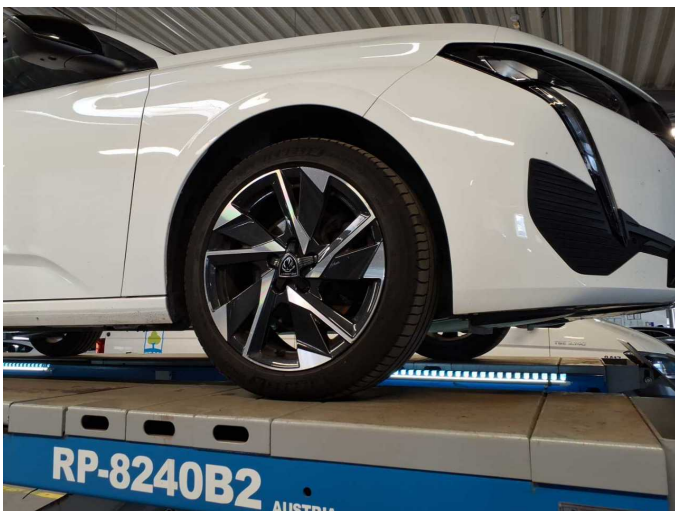
| No. | Component group | Description |
|---|---|---|
| 10 | Wheel / tyres | Alloy rim - front right side - Scratch(es) - Loss in value |

**Damage 10:** Wheel / tyres: Alloy rim - front right side - Scratch(es) - Loss in value

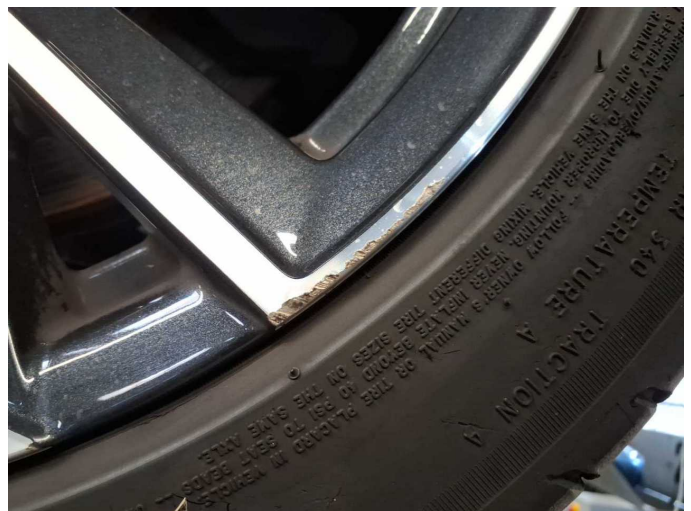
**Damage 10:** Wheel / tyres: Alloy rim - front right side - Scratch(es) - Loss in value

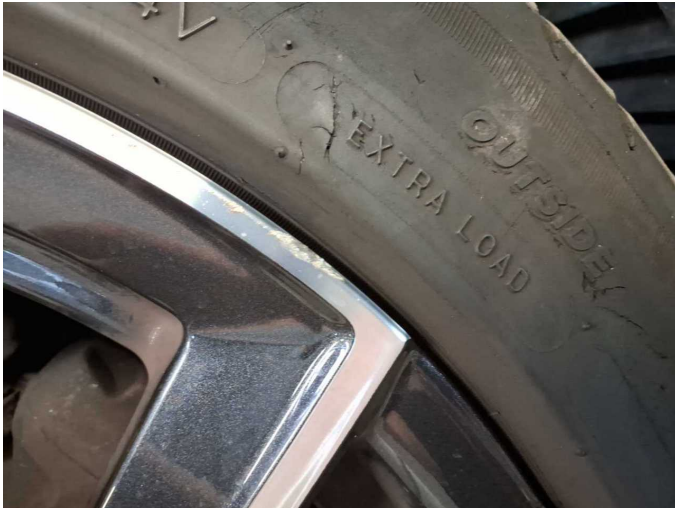
**Damage 10:** Wheel / tyres: Alloy rim - front right side - Scratch(es) - Loss in value

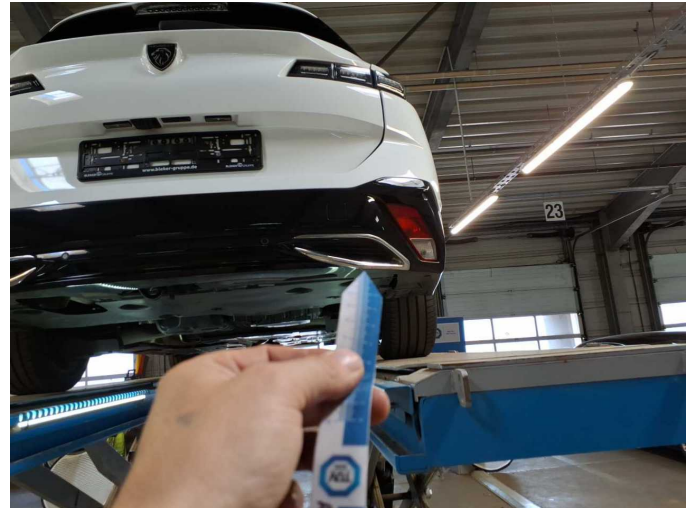
| No. | Component group | Description |
|---|---|---|
| 11 | Exhaust system | Exhaust system (Blende rechts) - Scratched - Replace |

**Damage 11:** Exhaust system: Exhaust system (Blende rechts) - Scratched - Replace

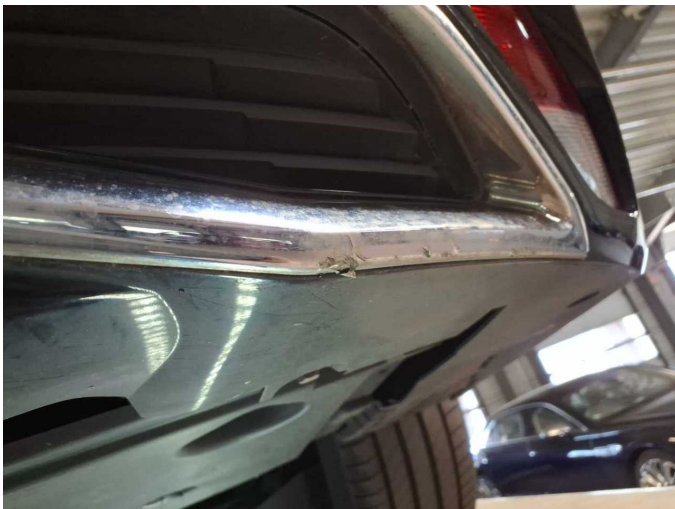
**Damage 11:** Exhaust system: Exhaust system (Blende rechts) - Scratched - Replace

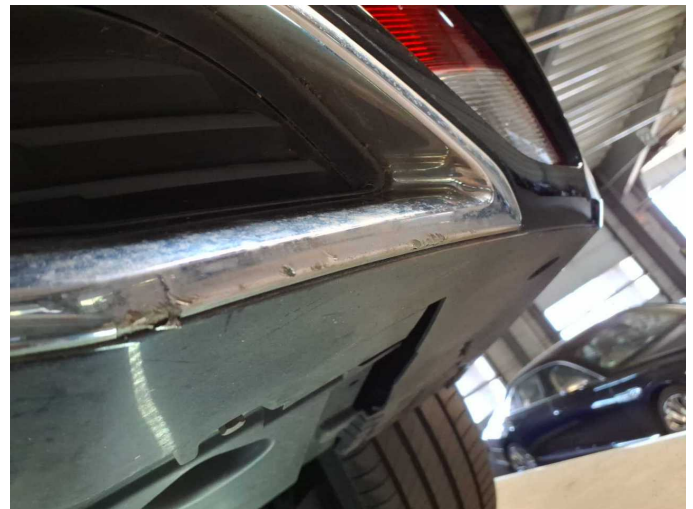
**Damage 11:** Exhaust system: Exhaust system (Blende rechts) - Scratched - Replace

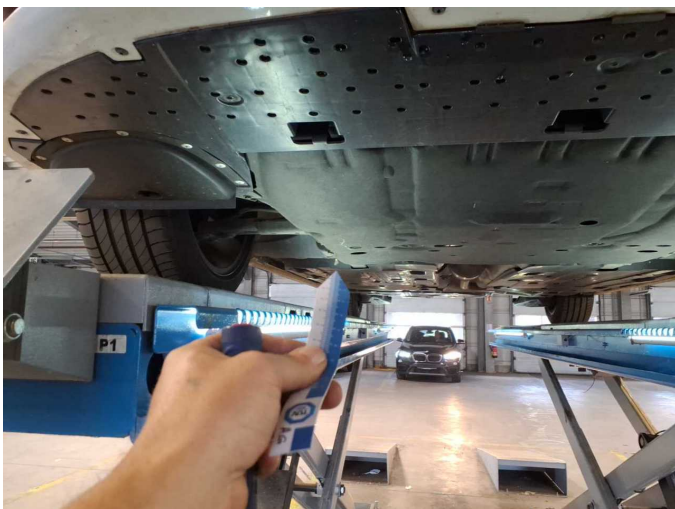
| No. | Component group | Description |
|---|---|---|
| 12 | Engine | Engine cowling - lower - Broken / torn - Replace |

**Damage 12:** Engine: Engine cowling - lower - Broken / torn - Replace

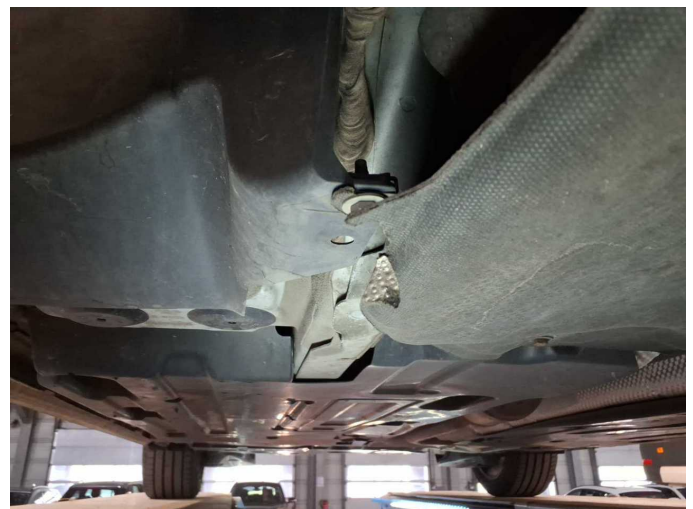
**Damage 12:** Engine: Engine cowling - lower - Broken / torn - Replace

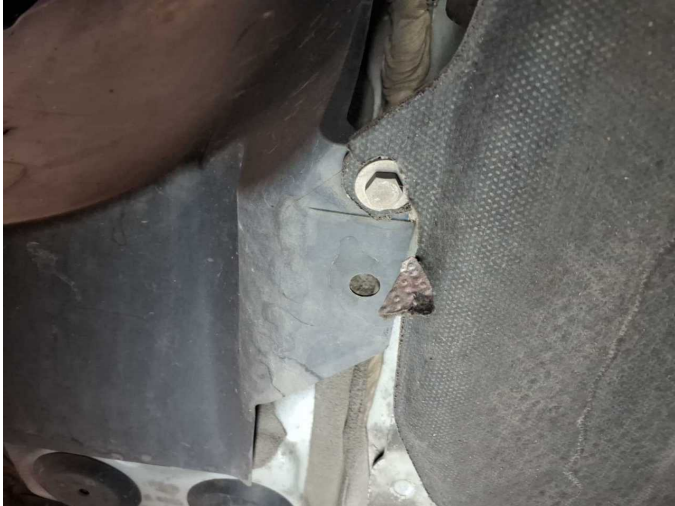
**Damage 12:** Engine: Engine cowling - lower - Broken / torn - Replace

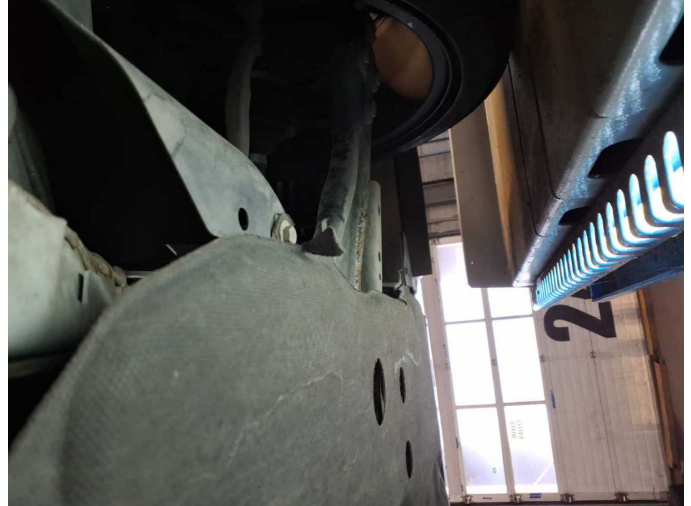
**Damage 12:** Engine: Engine cowling - lower - Broken / torn - Replace

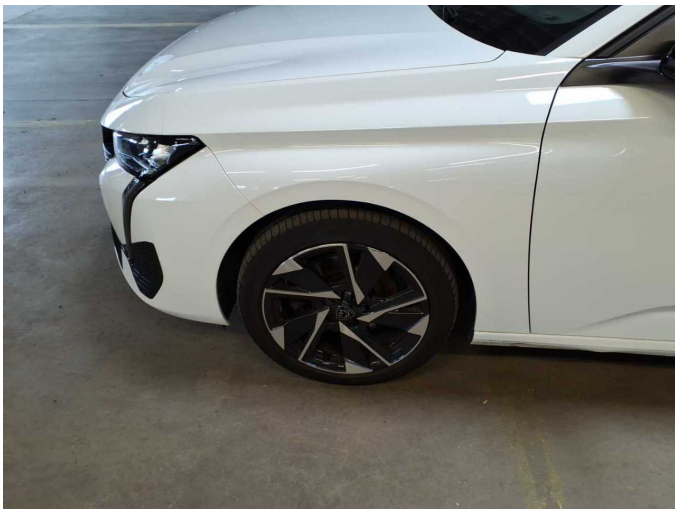
| No. | Component group | Description |
|---|---|---|
| 13 | Wheel / tyres | Alloy rim - front left side (Materialabtrag) - Scratched - Replace |

**Damage 13:** Wheel / tyres: Alloy rim - front left side (Materialabtrag) - Scratched - Replace

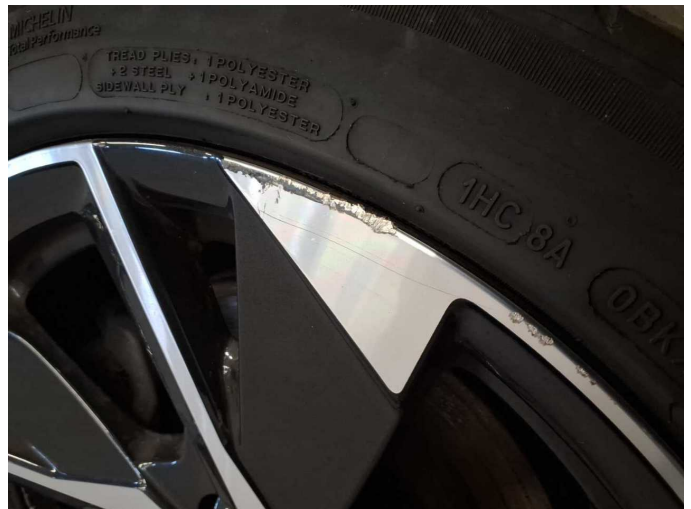
**Damage 13:** Wheel / tyres: Alloy rim - front left side (Materialabtrag) - Scratched - Replace

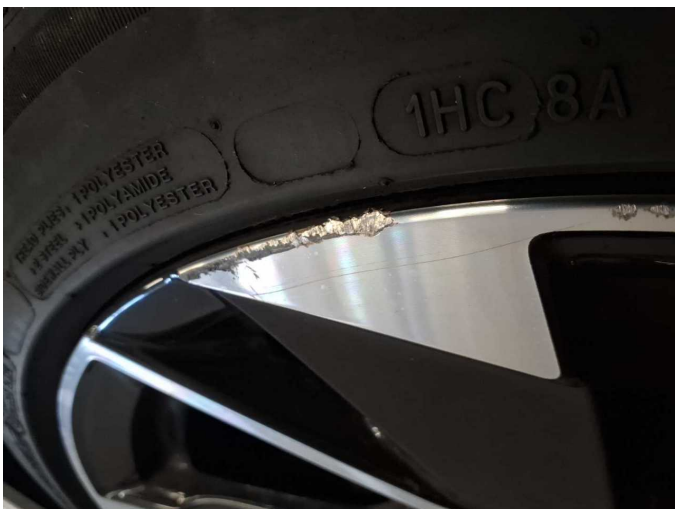
**Damage 13:** Wheel / tyres: Alloy rim - front left side (Materialabtrag) - Scratched - Replace

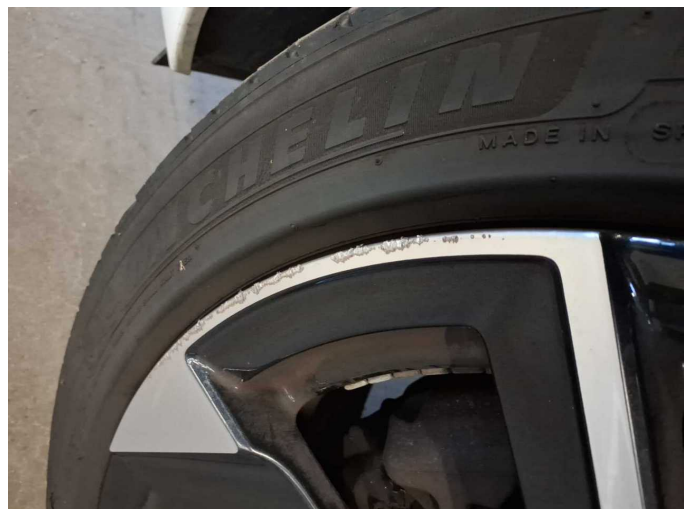
**Damage 13:** Wheel / tyres: Alloy rim - front left side (Materialabtrag) - Scratched - Replace

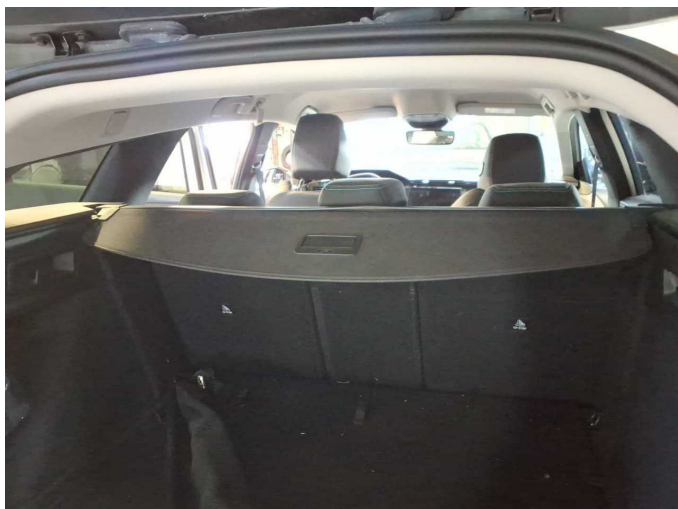
| No. | Component group | Description |
|---|---|---|
| 14 | Interior | Boot cover / roller cover - Deformed - Replace |

**Damage 14:** Interior: Boot cover / roller cover - Deformed - Replace

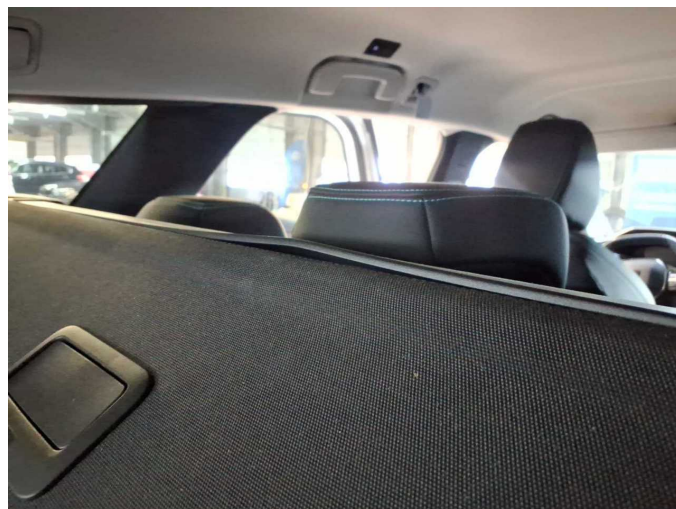
**Damage 14:** Interior: Boot cover / roller cover - Deformed - Replace

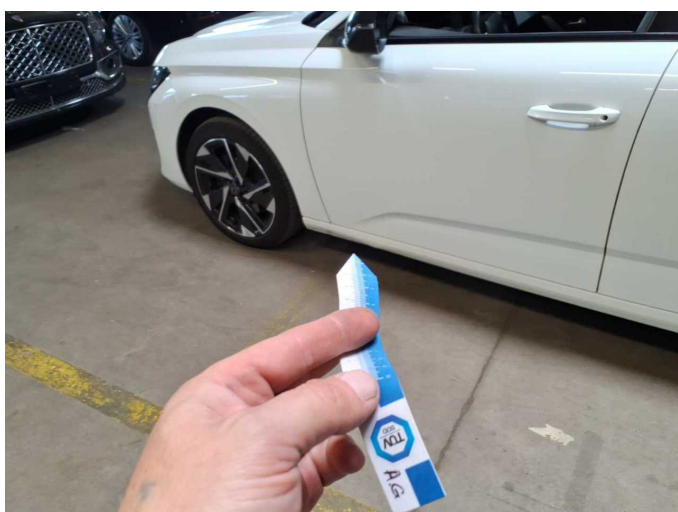
| No. | Component group | Description |
|---|---|---|
| 15 | Sill - left side | Sill - Deformed - Repair and paint |

**Damage 15:** Sill - left side: Sill - Deformed - Repair and paint

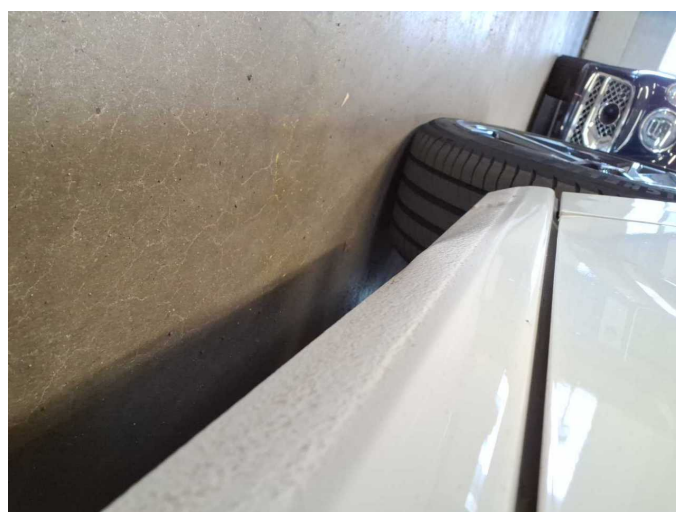
**Damage 15:** Sill - left side: Sill - Deformed - Repair and paint

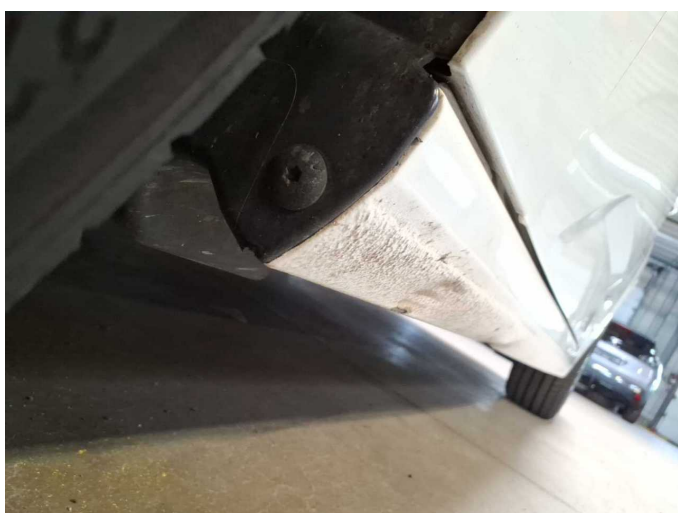
**Damage 15:** Sill - left side: Sill - Deformed - Repair and paint

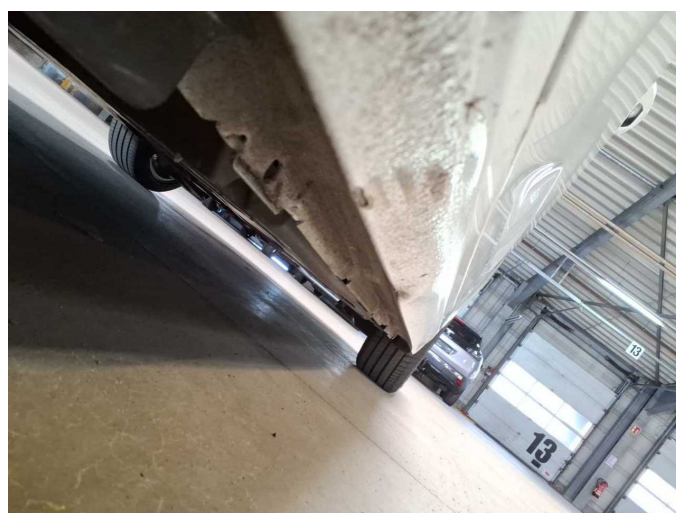
**Damage 15:** Sill - left side: Sill - Deformed - Repair and paint

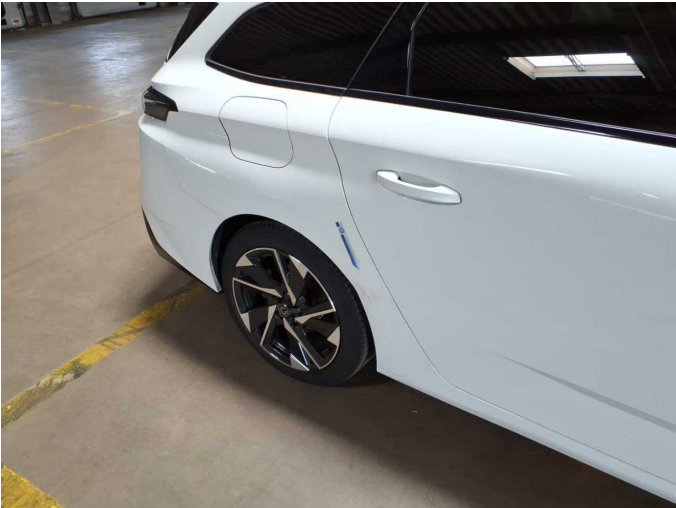
| No. | Component group | Description |
|---|---|---|
| 16 | Side panel - rear right side | Side panel - Deformed - Repair and paint |

**Damage 16:** Side panel - rear right side: Side panel - Deformed - Repair and paint

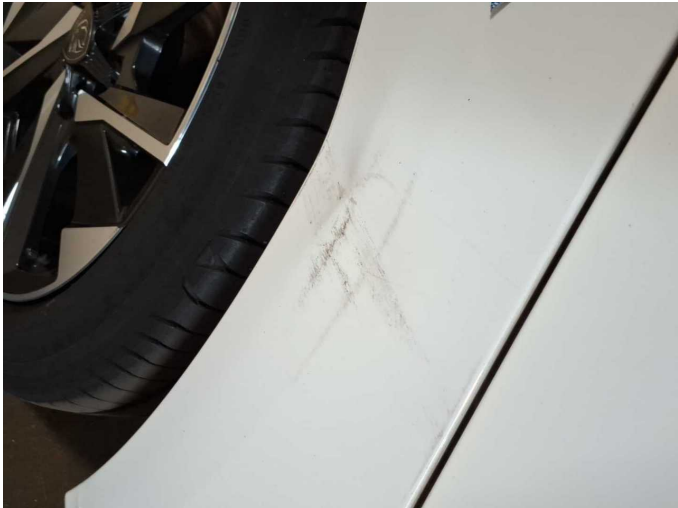
**Damage 16:** Side panel - rear right side: Side panel - Deformed - Repair and paint

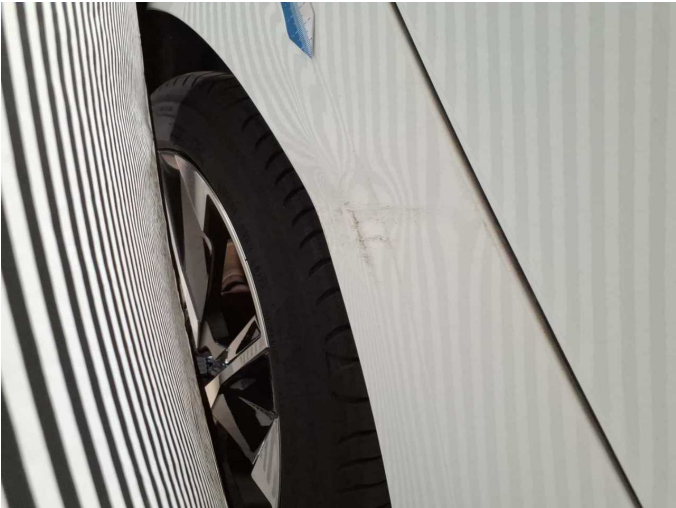
**Damage 16:** Side panel - rear right side: Side panel - Deformed - Repair and paint

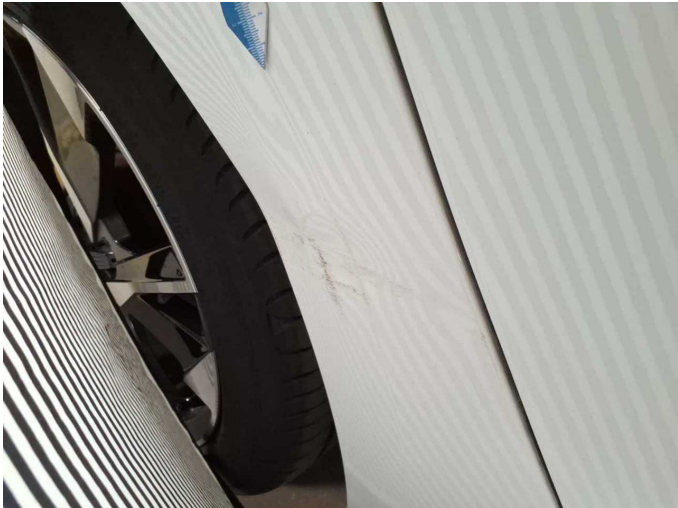
**Damage 16:** Side panel - rear right side: Side panel - Deformed - Repair and paint

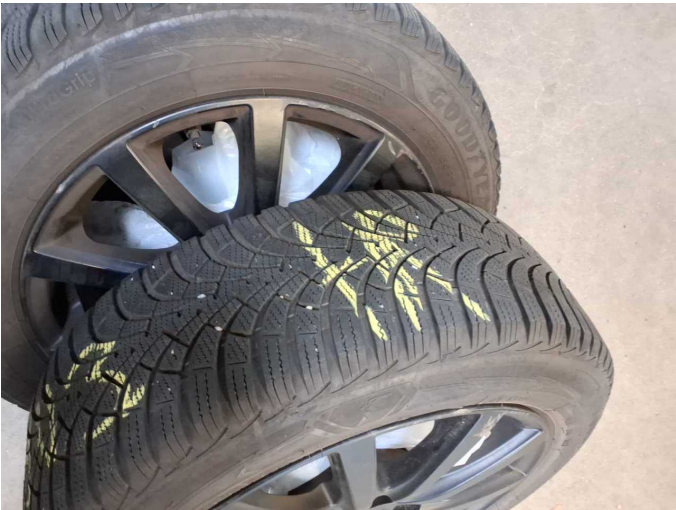
| No. | Component group | Description |
|---|---|---|
| 2 | 2nd wheel set | 1 tyre - Damaged - No deduction |

**Wear and tear 2:** 2nd wheel set: 1 tyre - Damaged - No deduction

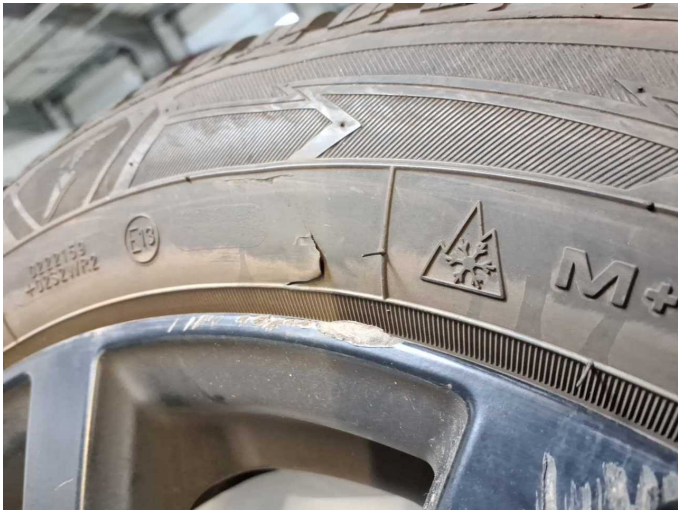
**Wear and tear 2:** 2nd wheel set: 1 tyre - Damaged - No deduction

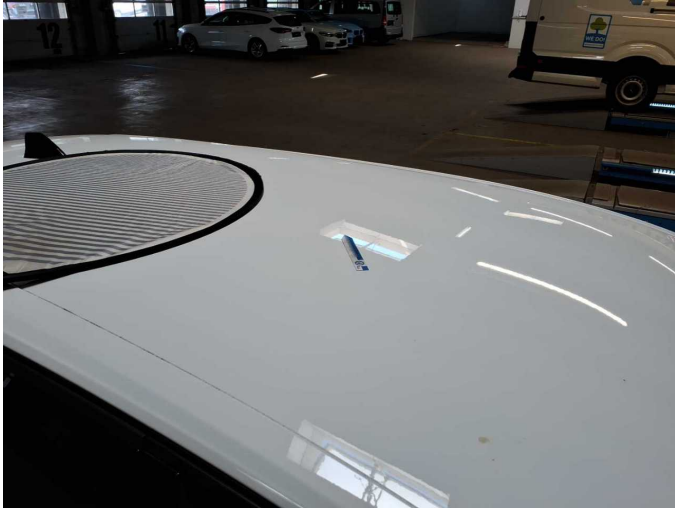
| No. | Component group | Description |
|---|---|---|
| 5 | Roof | Roof - dent(s) - Smooth repair work |

**Wear and tear 5:** Roof: Roof - dent(s) - Smooth repair work

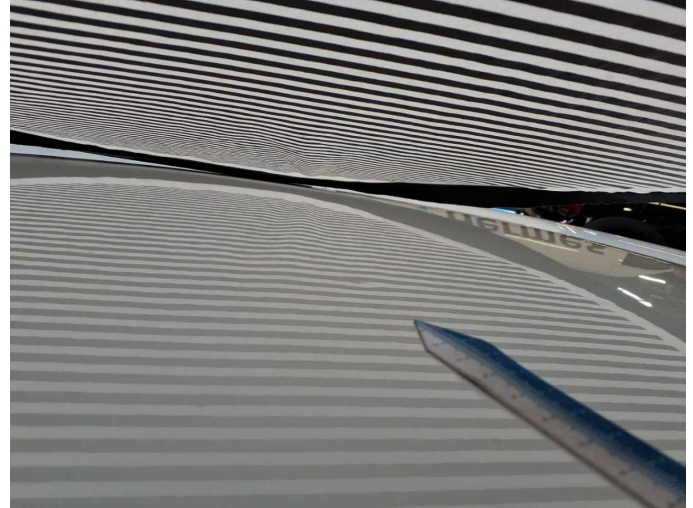
**Wear and tear 5:** Roof: Roof - dent(s) - Smooth repair work

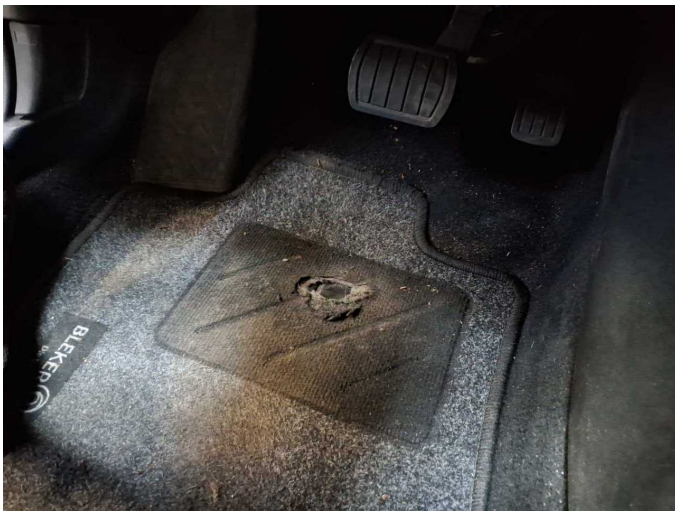
| No. | Component group | Description |
|---|---|---|
| 6 | Trim / covers | Floor mats - Broken / torn - No deduction |

**Wear and tear 6:** Trim / covers: Floor mats - Broken / torn - No deduction
