Expertise

Protocol number: 46277879  
Order No. / Reference: 26611694  
Inspection date: 29 Jun 2026

Manufacturer: Volkswagen

Model: Caddy Cargo 2.0 TDI BMT

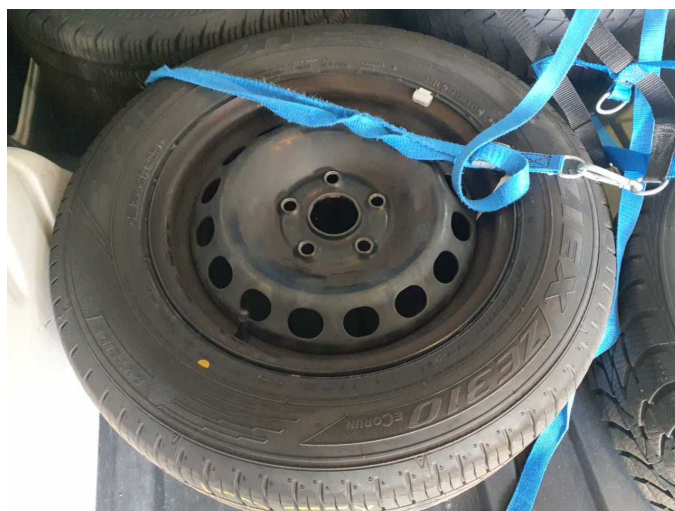
| No. | Component group | Description |
|---|---|---|
| 1 | 2nd wheel set | 1 tyre (Bereifung vermischt, umziehen) - Differs from the original configuration - Un- / install |

**Damage 1:** 2nd wheel set: 1 tyre (Bereifung vermischt, umziehen) - Differs from the original configuration - Un- / install

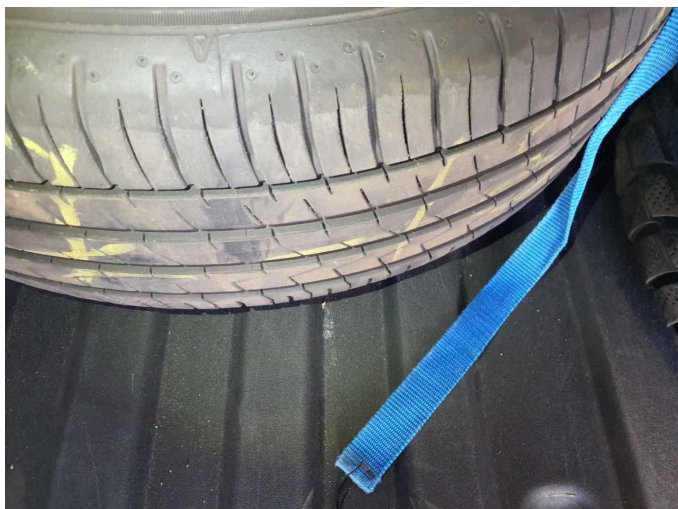
**Damage 1:** 2nd wheel set: 1 tyre (Bereifung vermischt, umziehen) - Differs from the original configuration - Un- / install

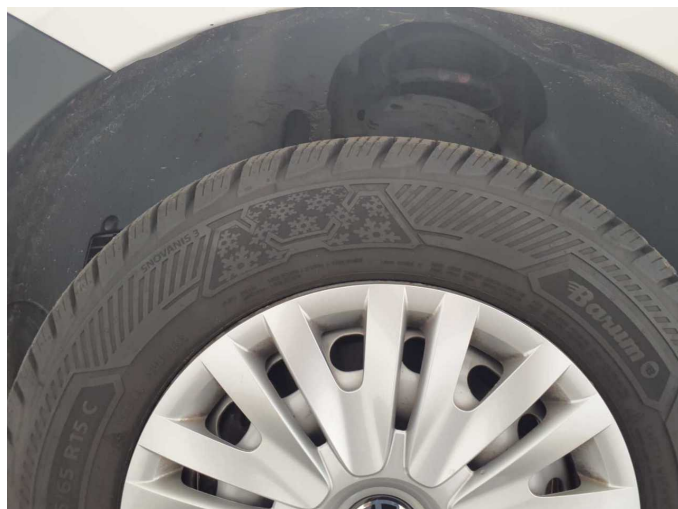
**Damage 1:** 2nd wheel set: 1 tyre (Bereifung vermischt, umziehen) - Differs from the original configuration - Un- / install

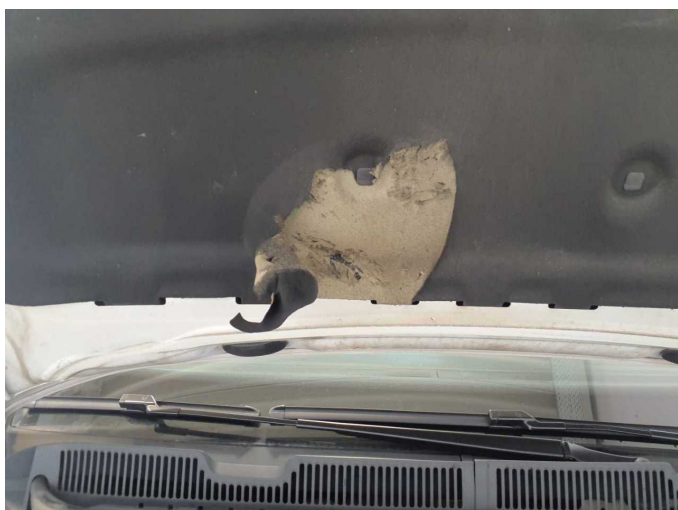
| No. | Component group | Description |
|---|---|---|
| 2 | Bonnet | Insulation lining - Damage caused by marten / rodent - Replace |

**Damage 2:** Bonnet: Insulation lining - Damage caused by marten / rodent - Replace

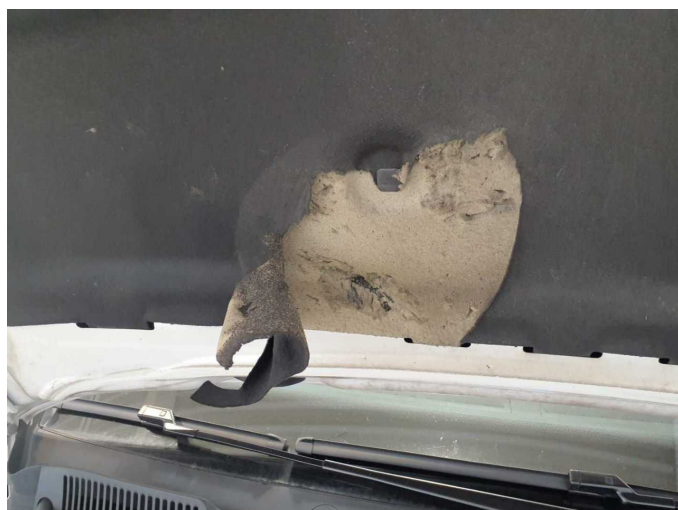
**Damage 2:** Bonnet: Insulation lining - Damage caused by marten / rodent - Replace

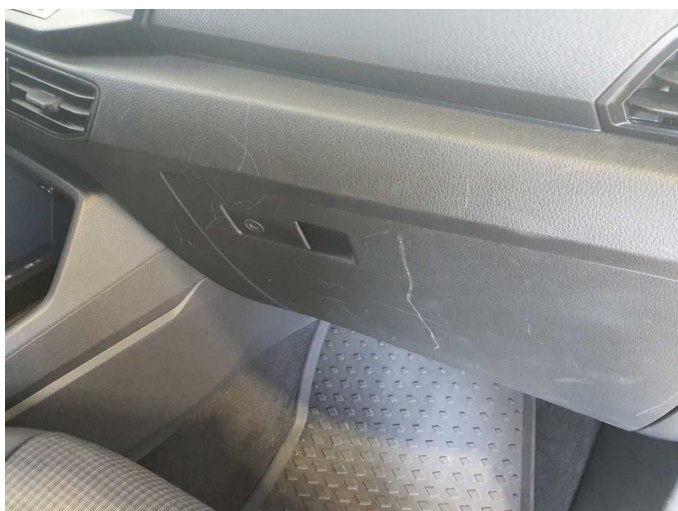
| No. | Component group | Description |
|---|---|---|
| 3 | Instrument panel | Centre console - front - Scratch(es) - Loss in value |

**Damage 3:** Instrument panel: Centre console - front - Scratch(es) - Loss in value

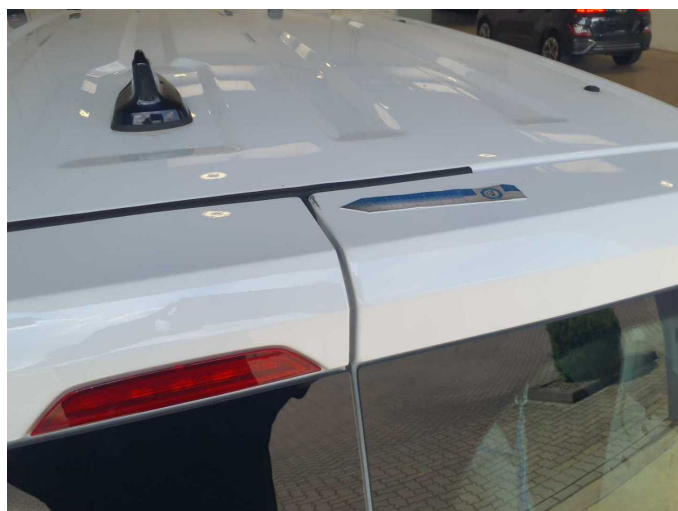
| No. | Component group | Description |
|---|---|---|
| 4 | Boot lid / rear door | Rear door - right side - Scratch(es) - Smart repair |

**Damage 4:** Boot lid / rear door: Rear door - right side - Scratch(es) - Smart repair

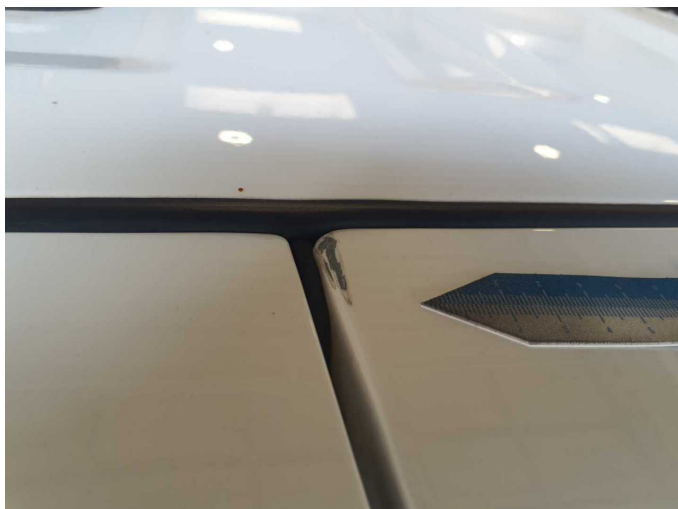
**Damage 4:** Boot lid / rear door: Rear door - right side - Scratch(es) - Smart repair

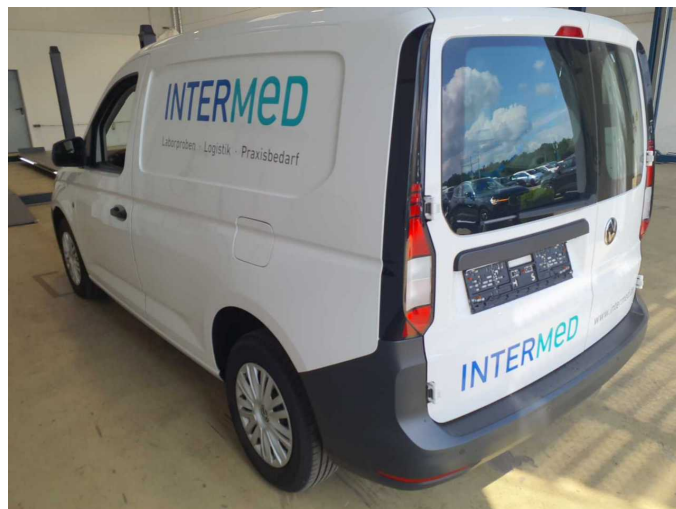
| No. | Component group | Description |
|---|---|---|
| 5 | Body | Body - Glued / labelled - De-glue / neutralise |

**Damage 5:** Body: Body - Glued / labelled - De-glue / neutralise

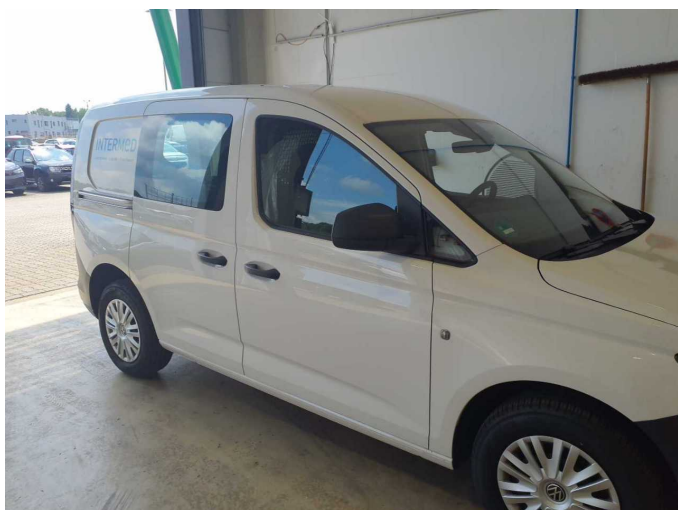
**Damage 5:** Body: Body - Glued / labelled - De-glue / neutralise

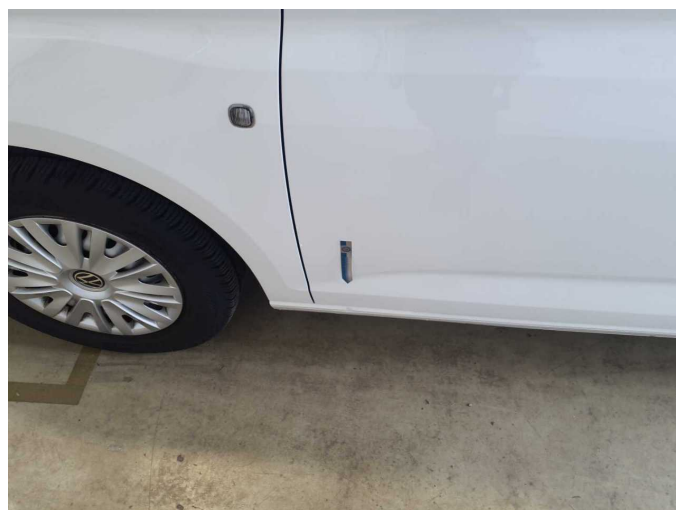
| No. | Component group | Description |
|---|---|---|
| 6 | Door - front left side | Door - Dent / paintcoat damage - Repair and paint |

**Damage 6:** Door - front left side: Door - Dent / paintcoat damage - Repair and paint

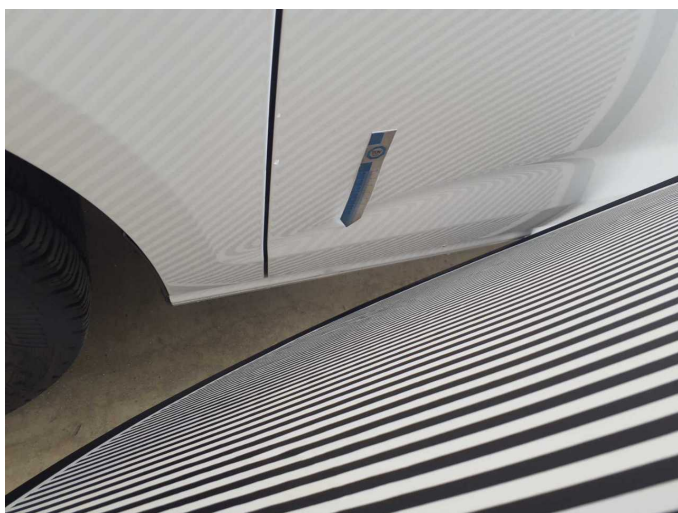
**Damage 6:** Door - front left side: Door - Dent / paintcoat damage - Repair and paint

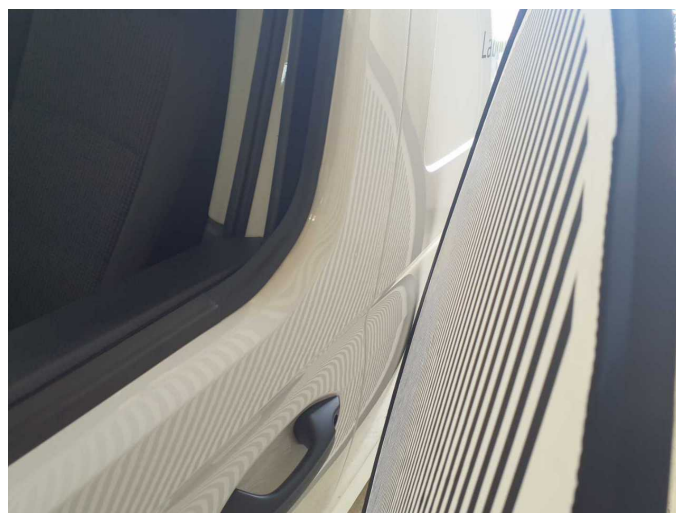
**Damage 6:** Door - front left side: Door - Dent / paintcoat damage - Repair and paint

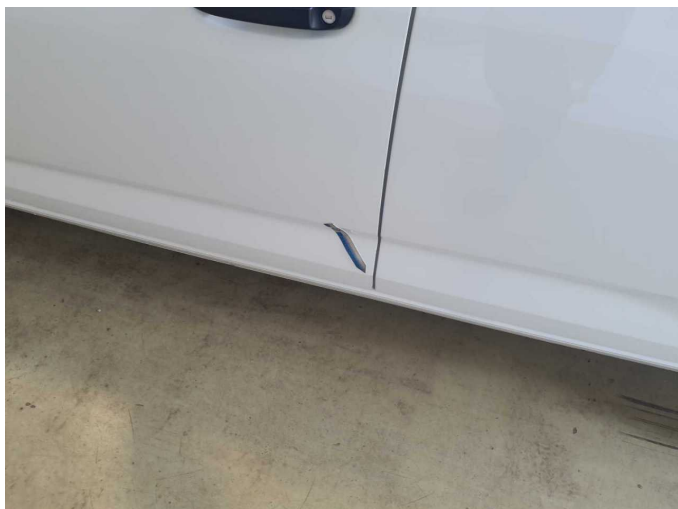
**Damage 6:** Door - front left side: Door - Dent / paintcoat damage - Repair and paint

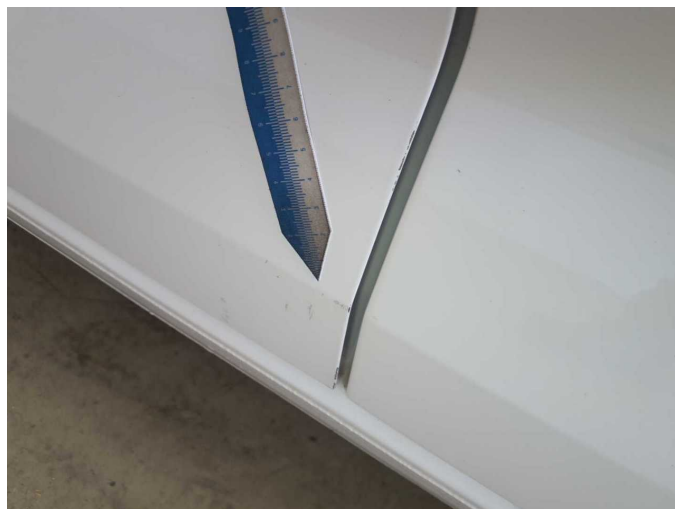
**Damage 6:** Door - front left side: Door - Dent / paintcoat damage - Repair and paint

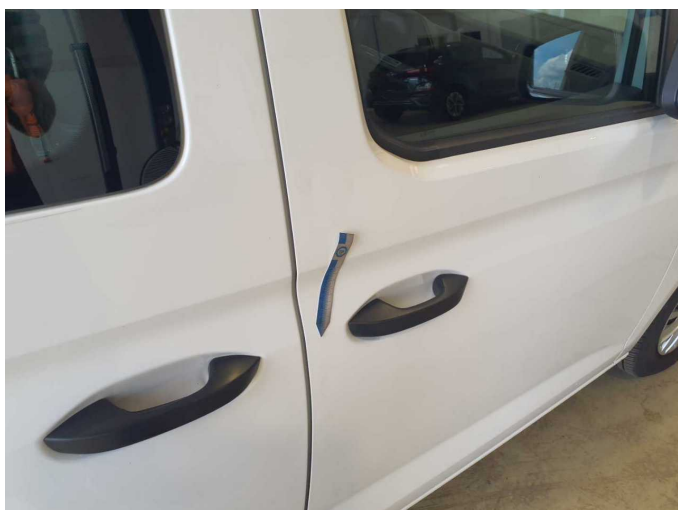
| No. | Component group | Description |
|---|---|---|
| 7 | Door - front right side | Door - Dent / paintcoat damage - Repair and paint |

**Damage 7:** Door - front right side: Door - Dent / paintcoat damage - Repair and paint

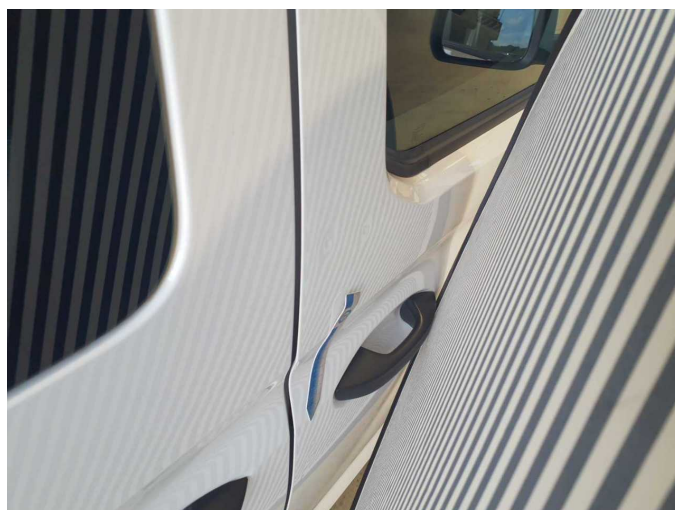
**Damage 7:** Door - front right side: Door - Dent / paintcoat damage - Repair and paint

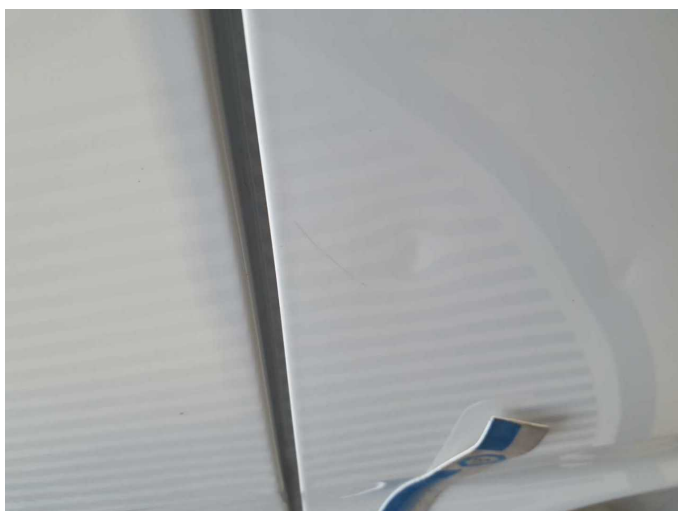
**Damage 7:** Door - front right side: Door - Dent / paintcoat damage - Repair and paint

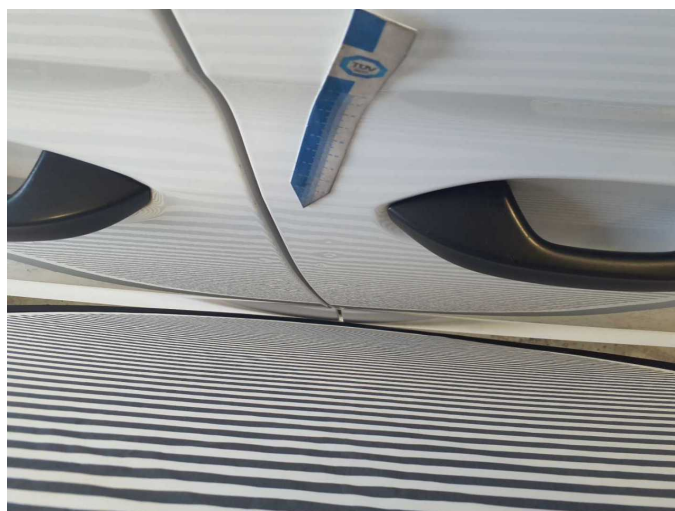
**Damage 7:** Door - front right side: Door - Dent / paintcoat damage - Repair and paint

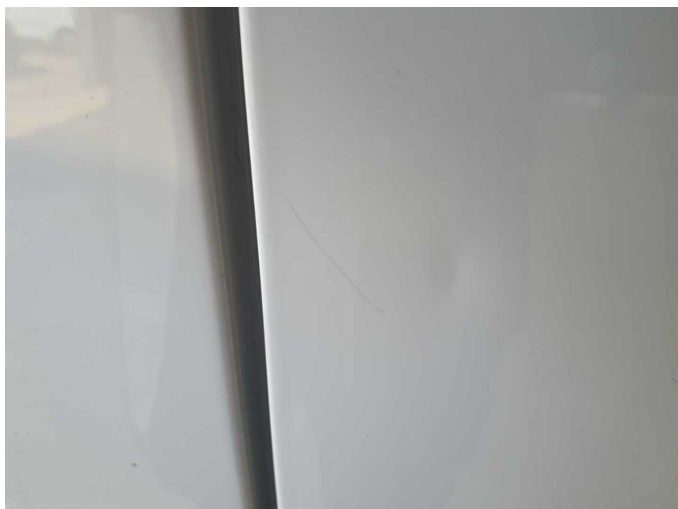
**Damage 7:** Door - front right side: Door - Dent / paintcoat damage - Repair and paint

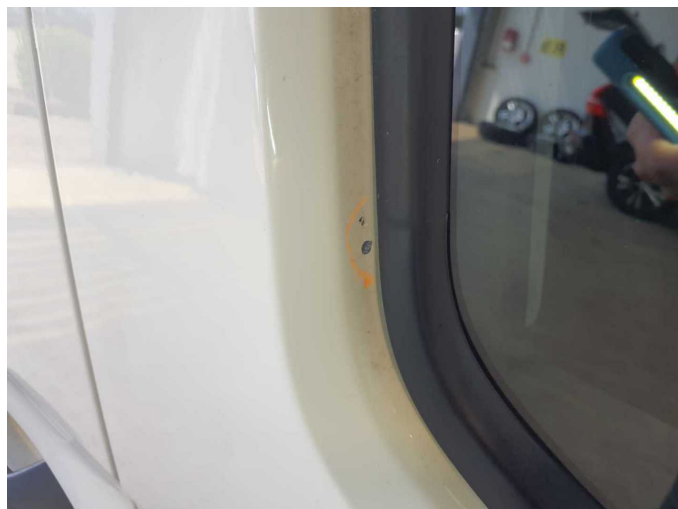
**Damage 7:** Door - front right side: Door - Dent / paintcoat damage - Repair and paint

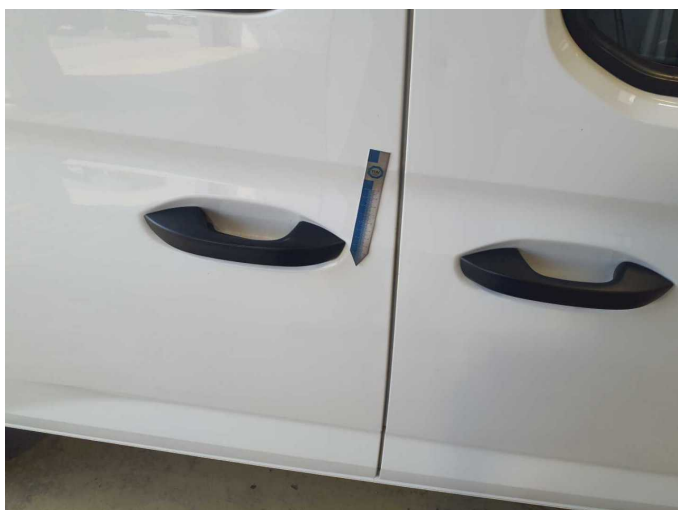
| No. | Component group | Description |
|---|---|---|
| 8 | Sliding door, right | Sliding door - Dent / paintcoat damage - Repair and paint |

**Damage 8:** Sliding door, right: Sliding door - Dent / paintcoat damage - Repair and paint

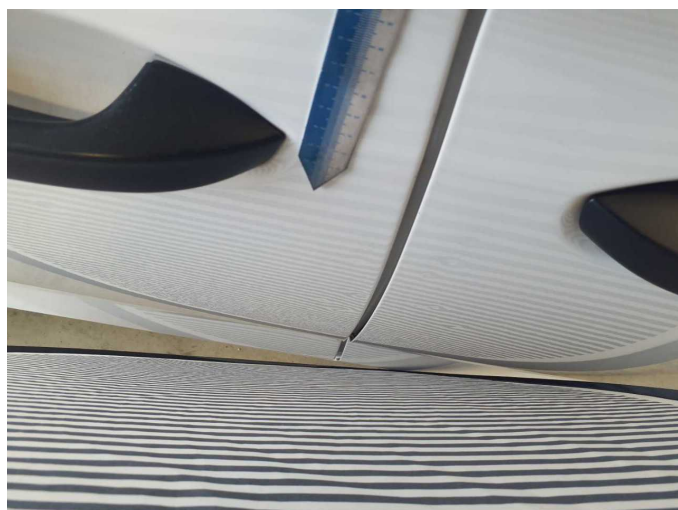
**Damage 8:** Sliding door, right: Sliding door - Dent / paintcoat damage - Repair and paint

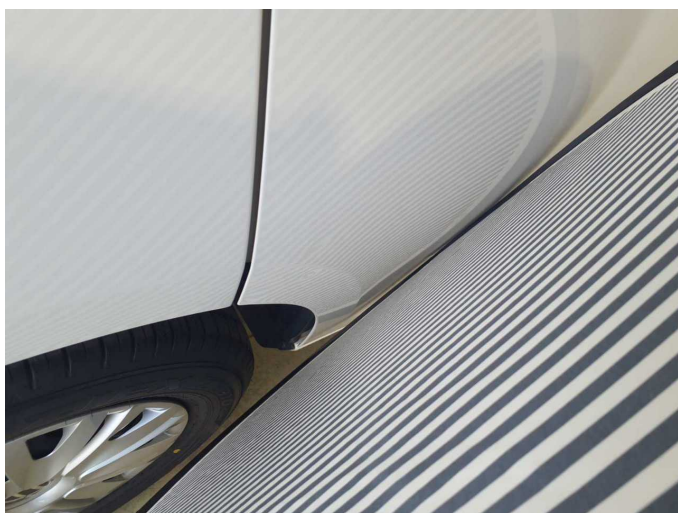
**Damage 8:** Sliding door, right: Sliding door - Dent / paintcoat damage - Repair and paint

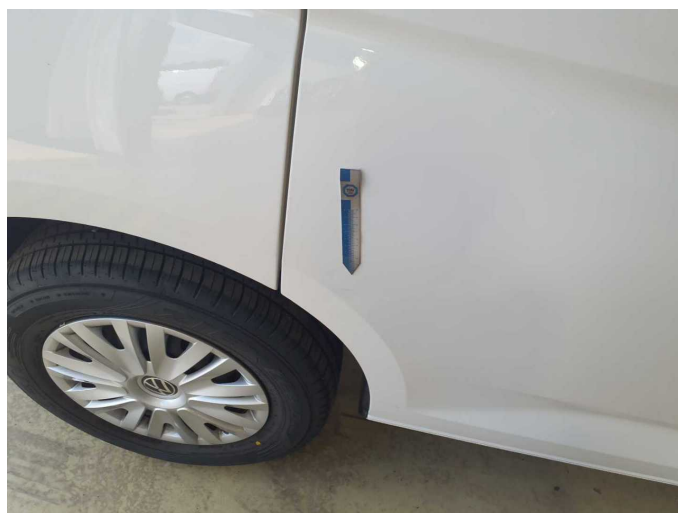
**Damage 8:** Sliding door, right: Sliding door - Dent / paintcoat damage - Repair and paint

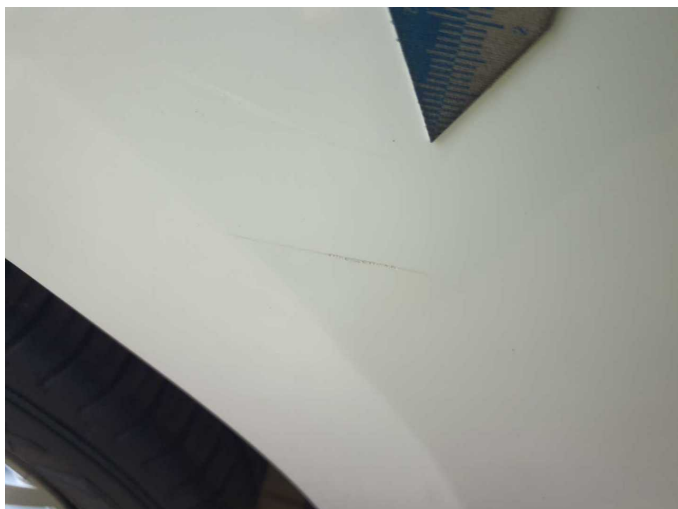
**Damage 8:** Sliding door, right: Sliding door - Dent / paintcoat damage - Repair and paint

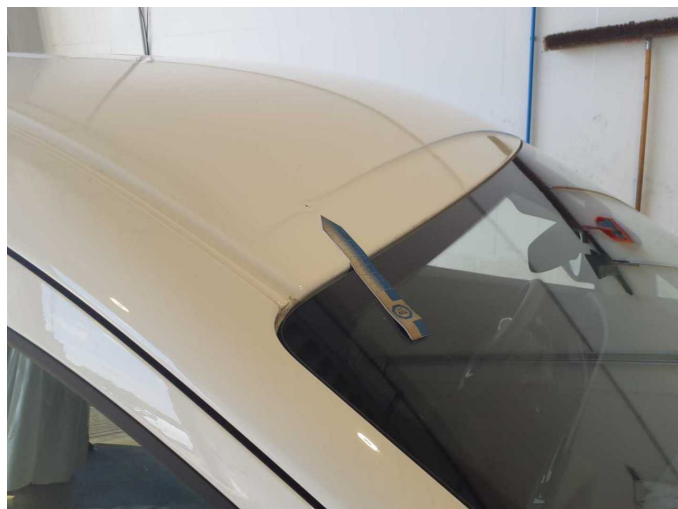
| No. | Component group | Description |
|---|---|---|
| 9 | Roof | Roof - Dent / paintcoat damage - Repair and paint |

**Damage 9:** Roof: Roof - Dent / paintcoat damage - Repair and paint

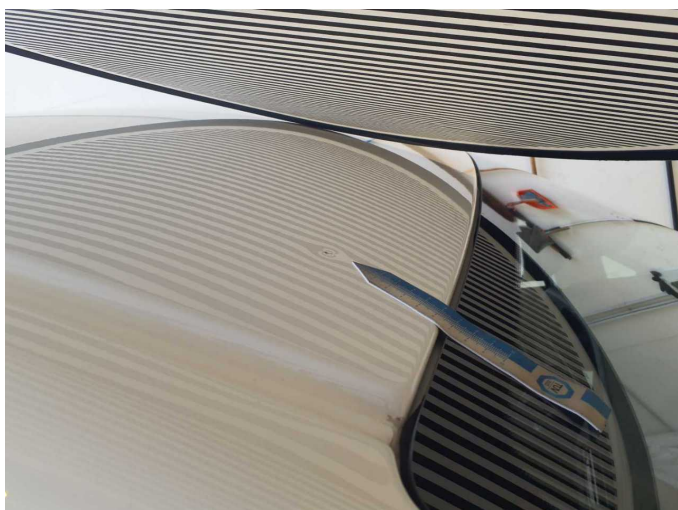
**Damage 9:** Roof: Roof - Dent / paintcoat damage - Repair and paint

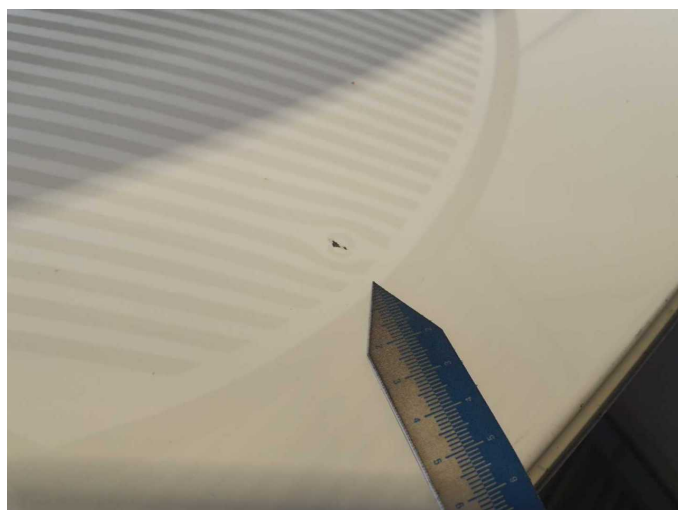
**Damage 9:** Roof: Roof - Dent / paintcoat damage - Repair and paint

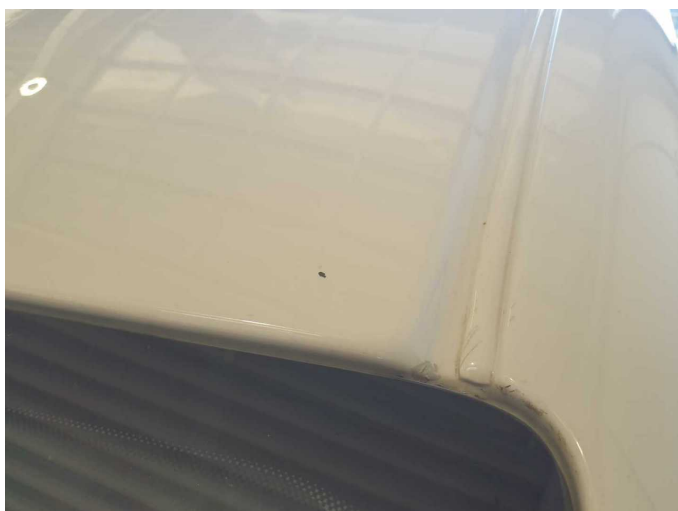
**Damage 9:** Roof: Roof - Dent / paintcoat damage - Repair and paint

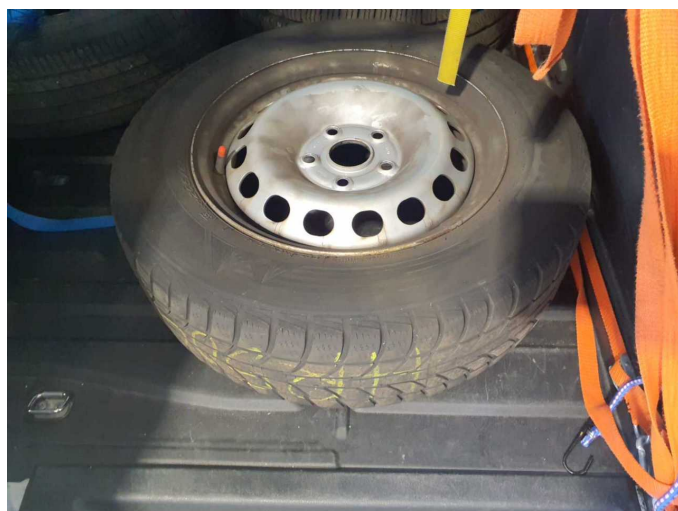
| No. | Component group | Description |
|---|---|---|
| 4 | 2nd wheel set | 1 tyre - does not meet manufacturer specifications - No deduction |

**Wear and tear 4:** 2nd wheel set: 1 tyre - does not meet manufacturer specifications - No deduction

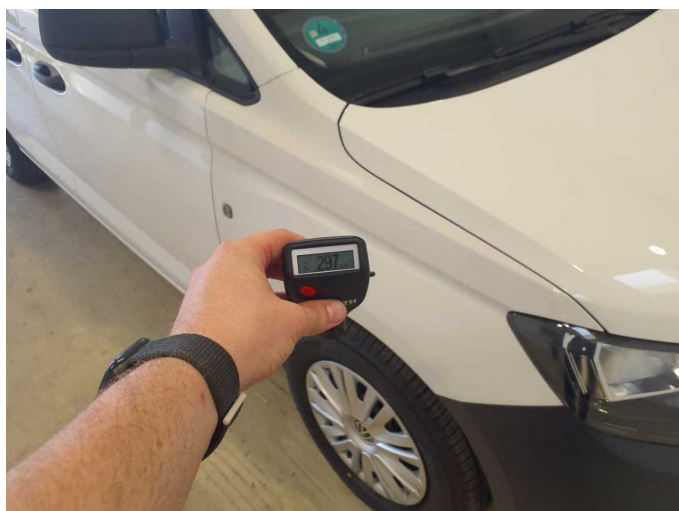
1 Mudguard - right side, Professionally carried out, Invoice of repair done Non-existent

297 µm

**Repainting 1:** Mudguard - right side

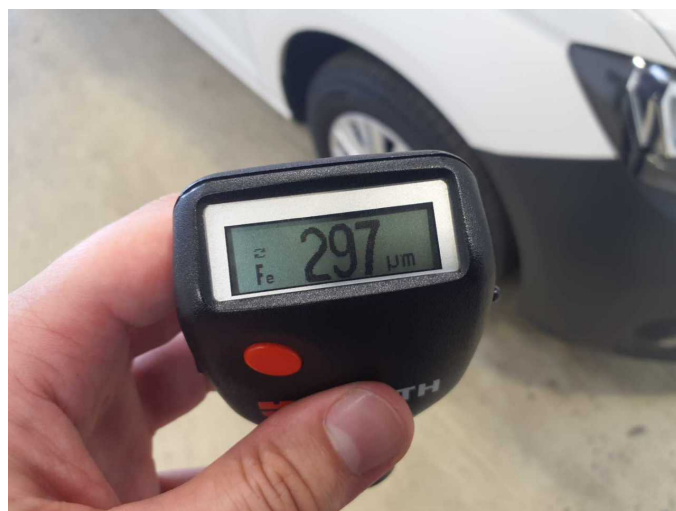
**Repainting 1:** Mudguard - right side
