Expertise

Protocol number: 46518147  
Order No. / Reference: 26639794  
Inspection date: 1 Jul 2026

Manufacturer: Skoda  
VIN: TMBJC9NY0PF041296

Model: Enyaq iV 80

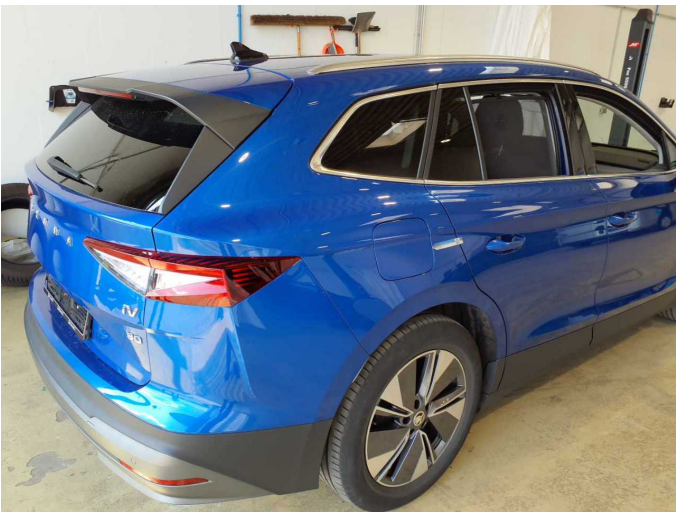
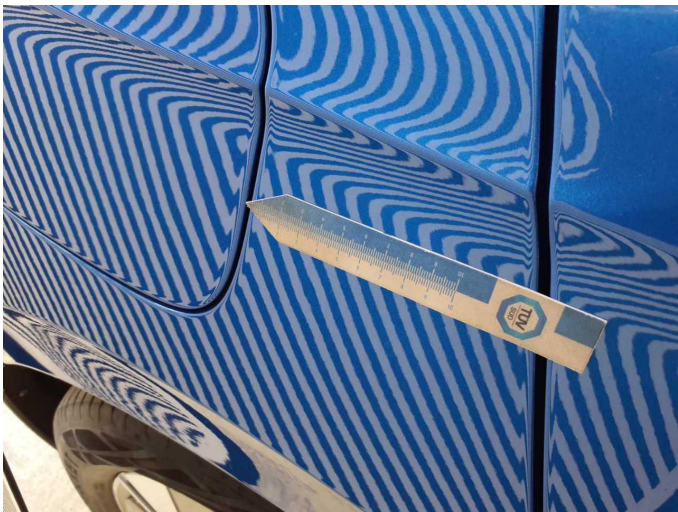
| No. | Component group | Description |
|---|---|---|
| 1 | Side panel - rear right side | Side panel - dent(s) - Smooth repair work |

Damage 1: Side panel - rear right side: Side panel - dent(s) - Smooth repair work
