## Expertise

Protocol number: 45508069  
Order No. / Reference: 26382289  
Inspection date: 19 May 2026

Manufacturer: Mercedes-Benz

Model: 317 CDI Sprinter Kompakt HA 9G-Tronic

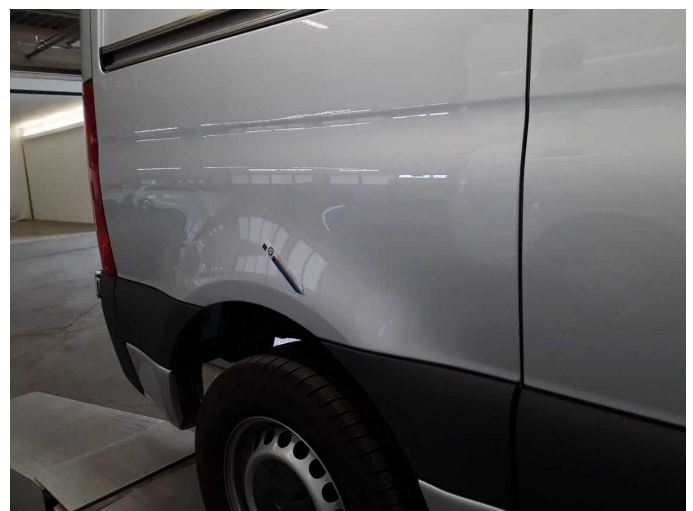
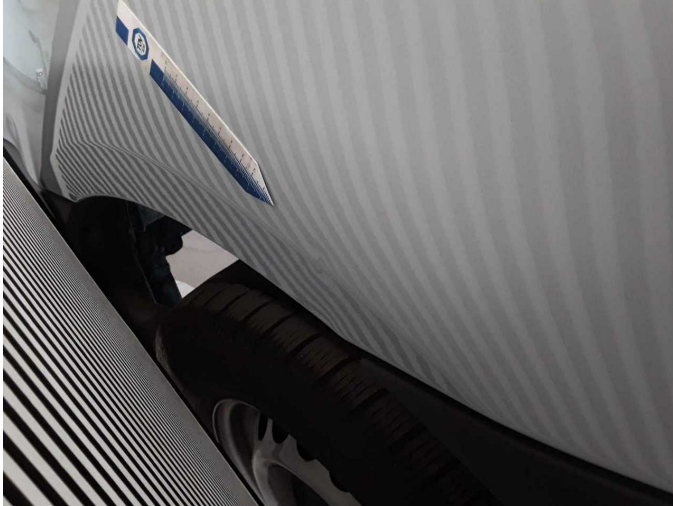
No.	Component group	Description
1	Side panel - rear right side	Side panel - dent(s) - Smooth repair work
2	Boot lid / rear door	Rear door - left side - dent(s) - Smooth repair work
3	Trim / covers	Boot lid - interior trim - Damaged - Replace
4	Bonnet	Bonnet - Dent / paintcoat damage - Repair and paint
5	Door - front left side	Door - Dent / paintcoat damage - Repair and paint
6	Door - rear right side	Door - Deformed - Repair and paint

Damage 1: Side panel - rear right side: Side panel - dent(s) - Smooth repair work

**Damage 1:** Side panel - rear right side: Side panel - dent(s) - Smooth repair work

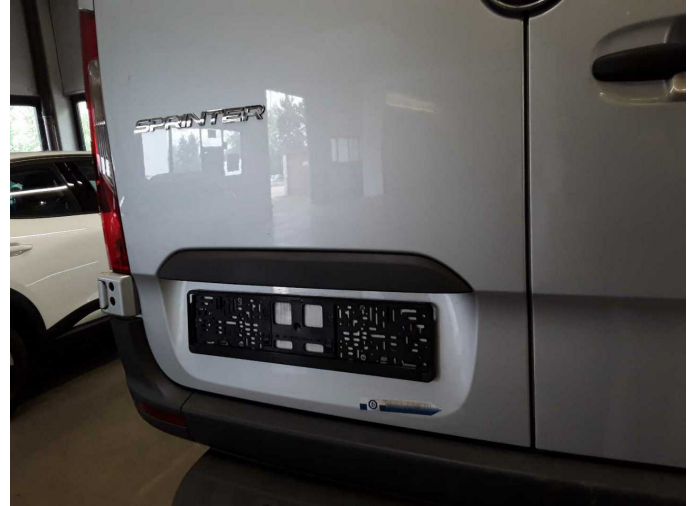
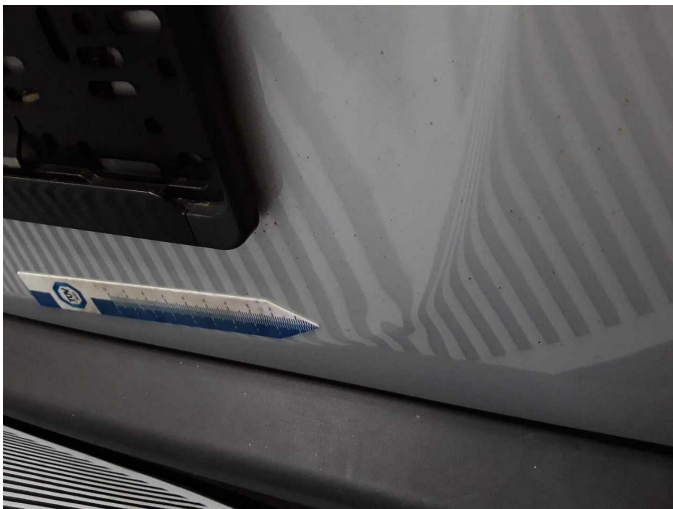
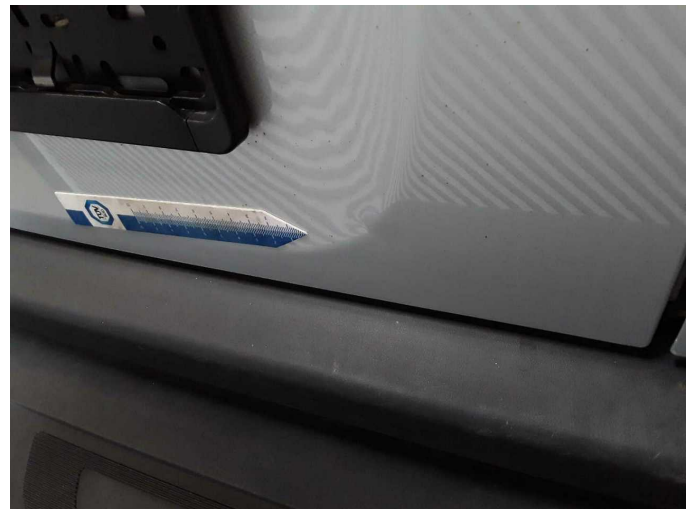
**Damage 2:** Boot lid / rear door: Rear door - left side - dent(s) - Smooth repair work

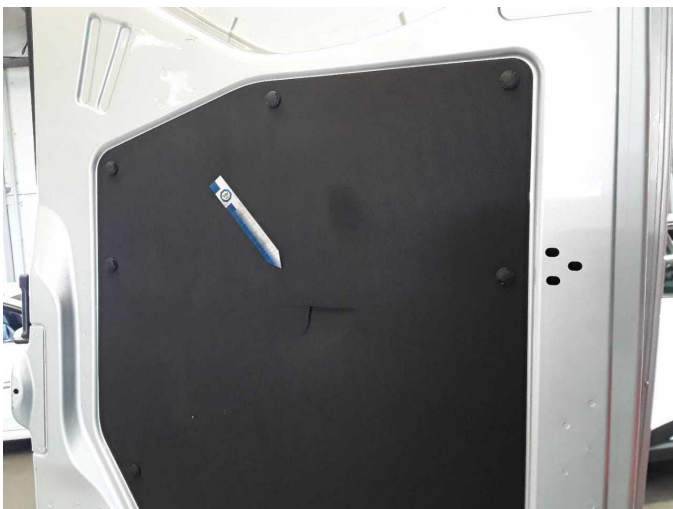
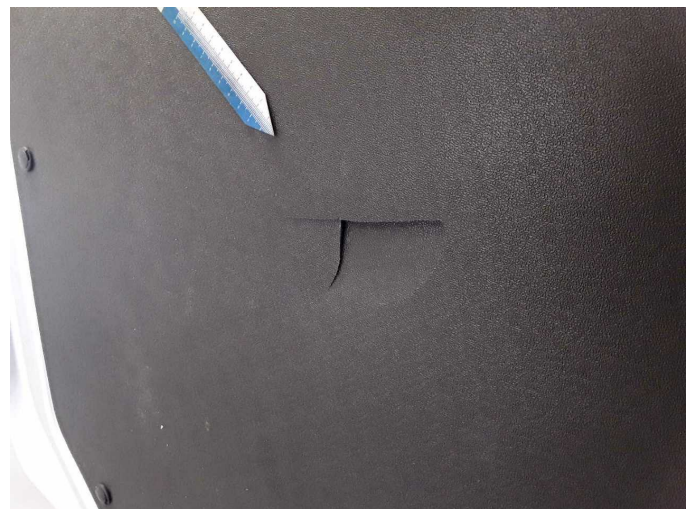
**Damage 3:** Trim / covers: Boot lid - interior trim - Damaged - Replace

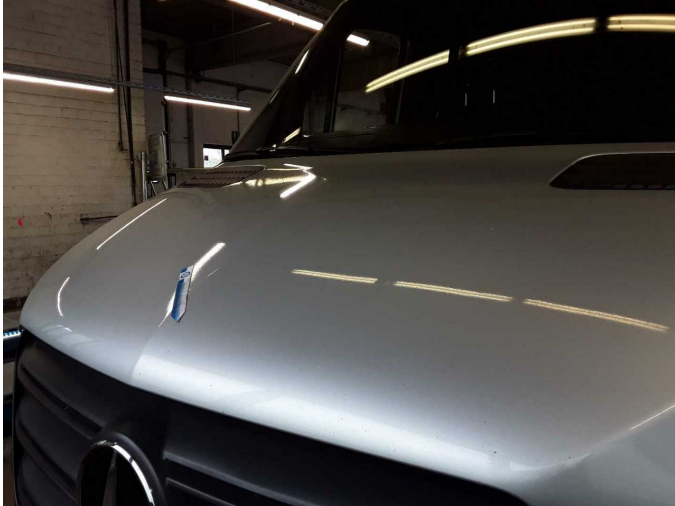
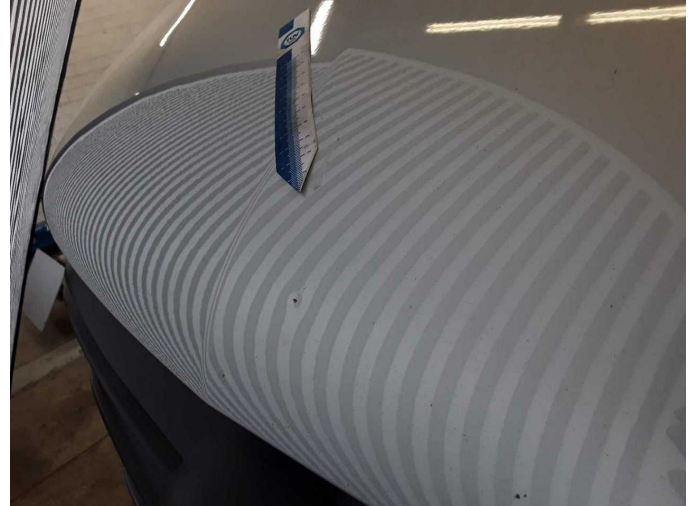
**Damage 4:** Bonnet: Bonnet - Dent / paintcoat damage - Repair and paint

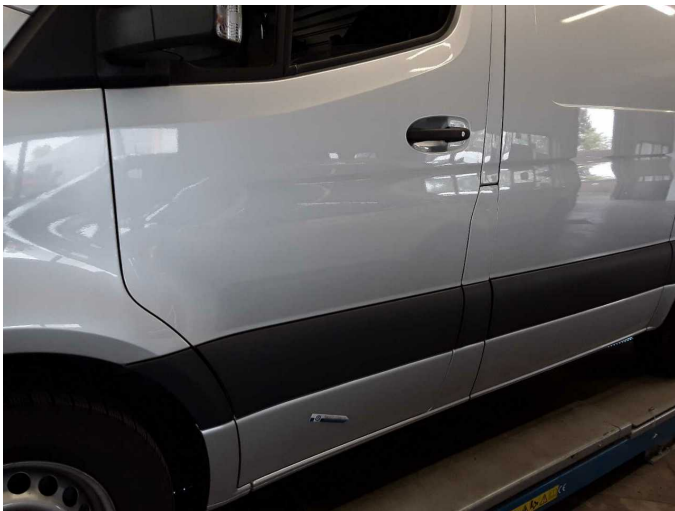
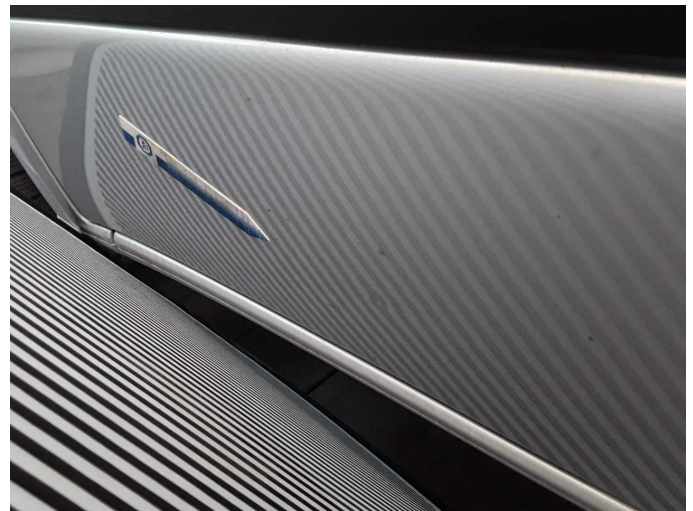
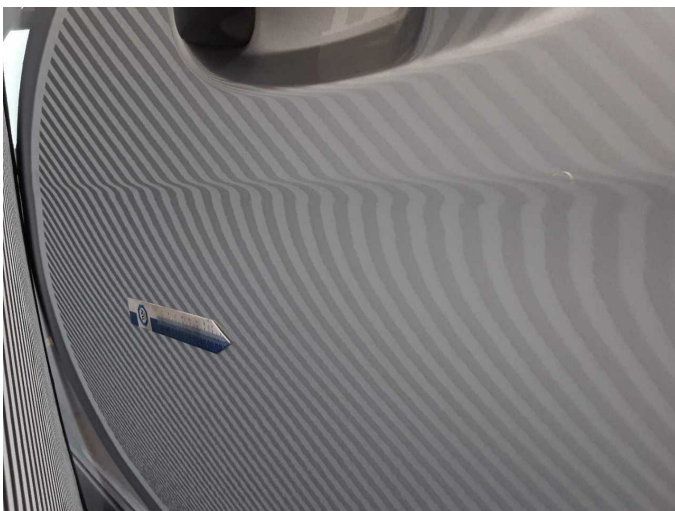
**Damage 5:** Door - front left side: Door - Dent / paintcoat damage - Repair and paint

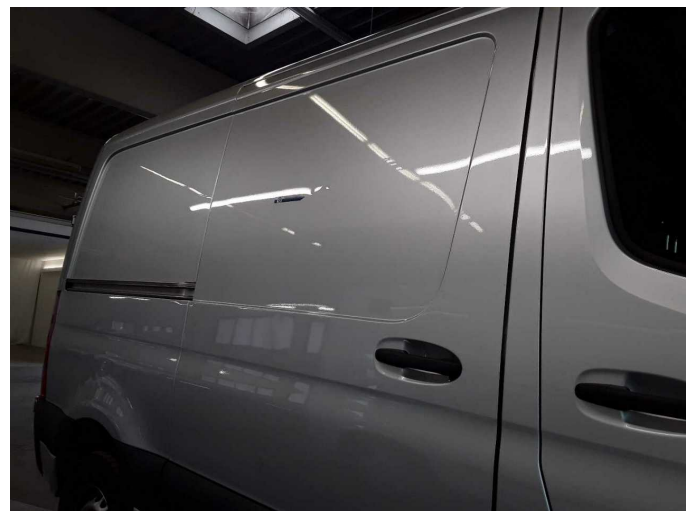
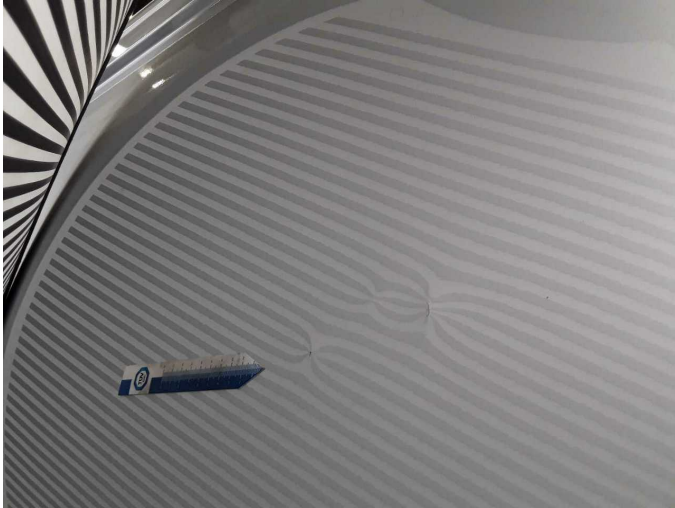
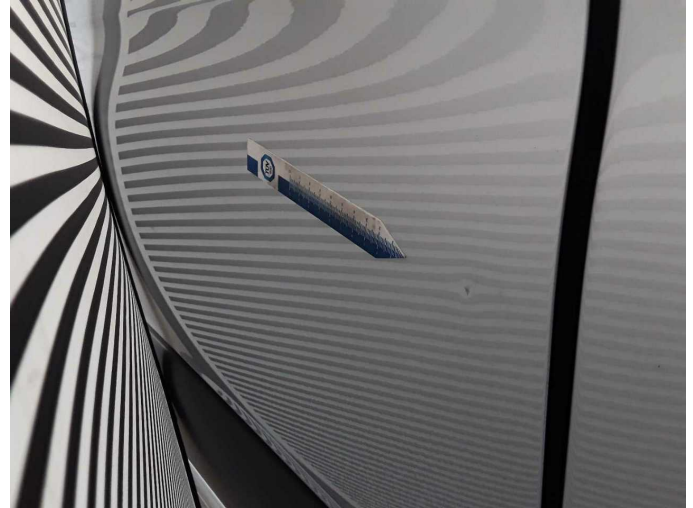
**Damage 6:** Door - rear right side: Door - Deformed - Repair and paint

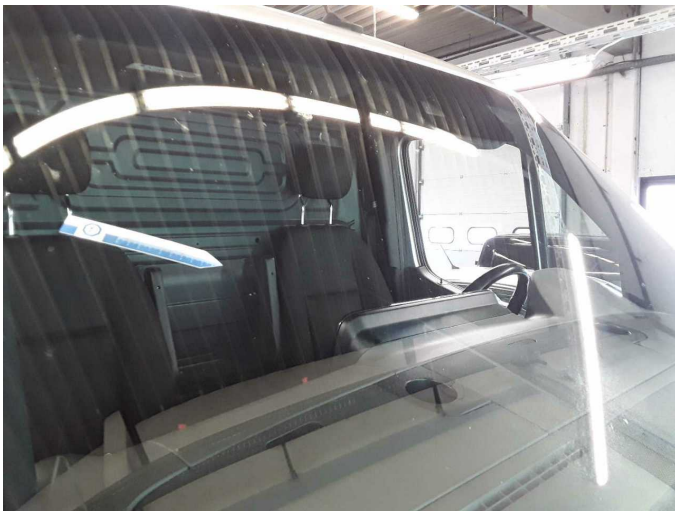
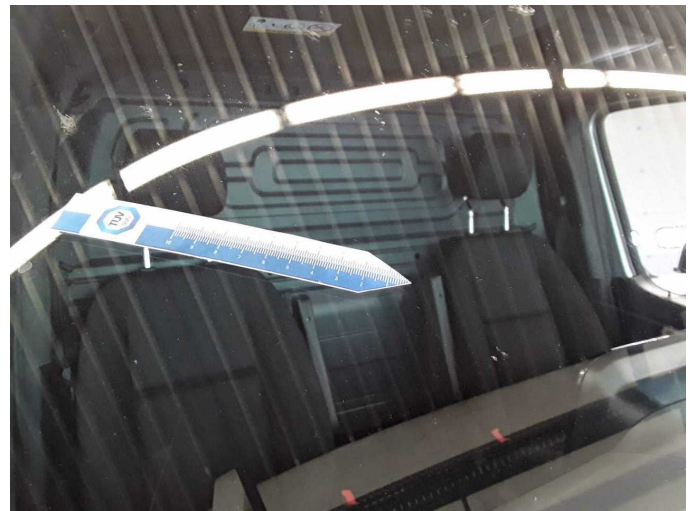
No.	Component group	Description
1	Front bumper	Front bumper (unpainted) - Stone chips - No deduction
2	Interior	Interior - Scratch(es) - No deduction
3	Vehicle glazing	Windscreen - Stone chips - No deduction

**Wear and tear 3:** Vehicle glazing: Windscreen - Stone chips - No deduction

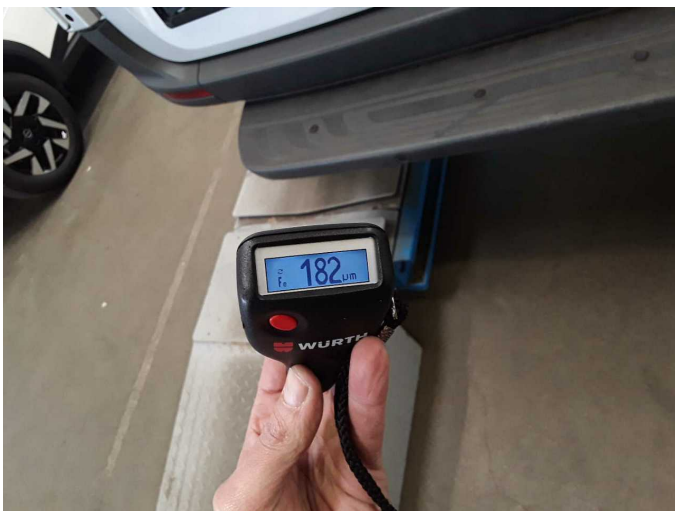
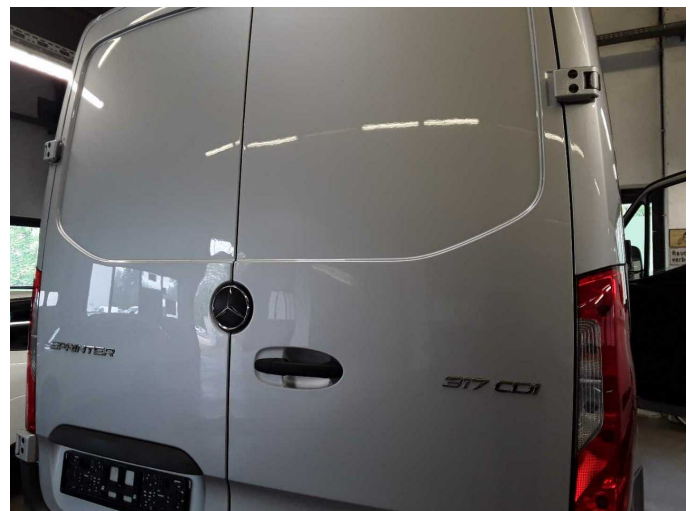
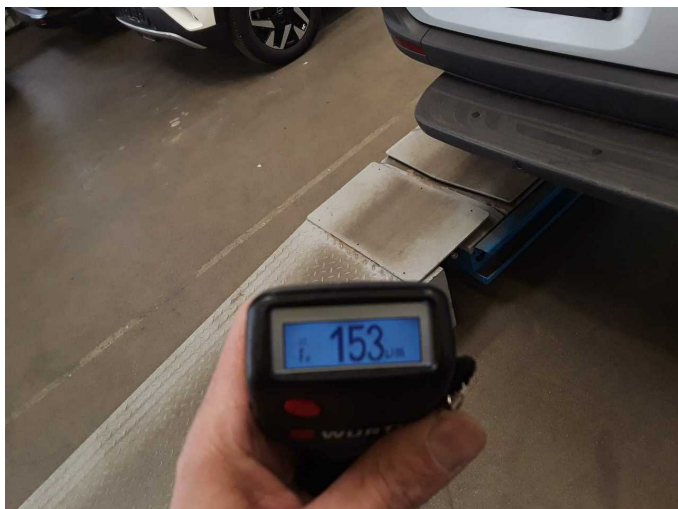
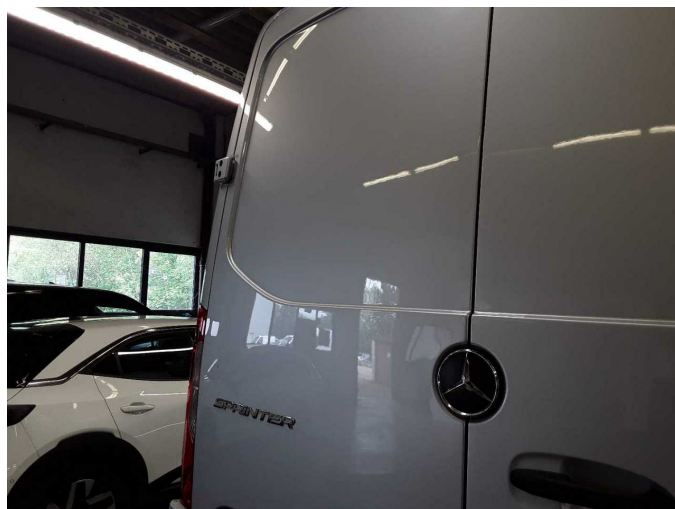
No.	Repainting
1	Boot lid / rear door

Boot lid / rear door	182 µm
----------------------	--------

**Repainting 1:** Boot lid / rear door

Repainting 1: Boot lid / rear door
