Expertise

Protocol number: 46019393
Order No. / Reference: 26412405
Inspection date: 18 Jun 2026

Model: Focus Turnier 1.5 EcoBlue Start-Stopp-System Aut. TITANIUM

VIN: WF0PXXGCHPPL83985

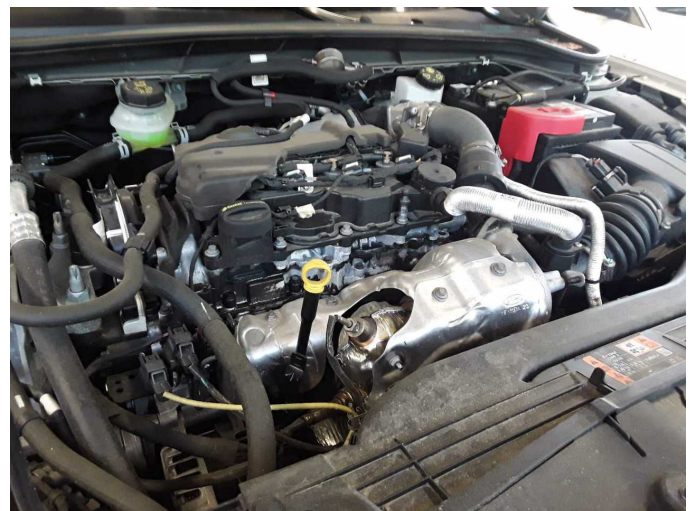
Damage 1: Engine: Engine - Leaking - Perform diagnosis

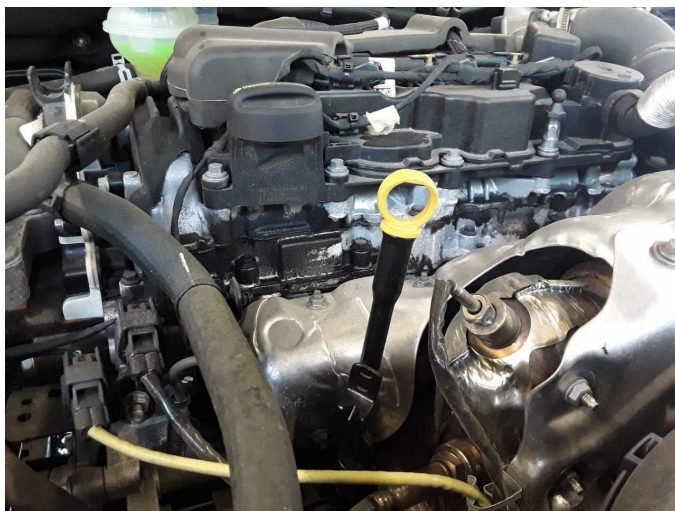
Damage 1: Engine: Engine - Leaking - Perform diagnosis

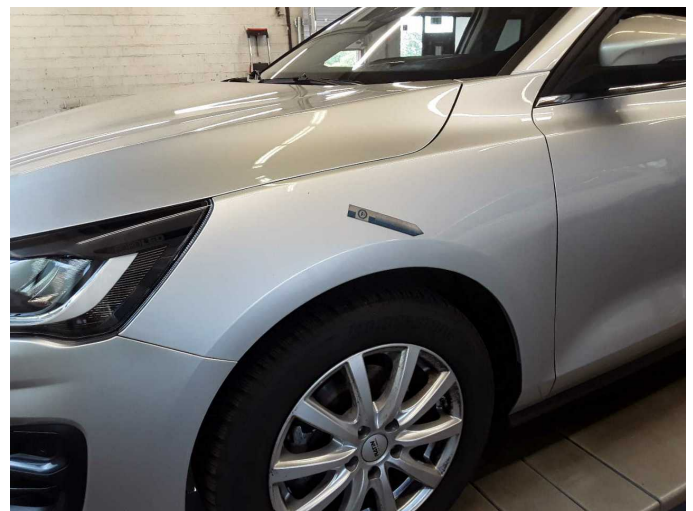
Damage 2: Mudguard - left side: Mudguard - left side - Scratch(es) - Smart repair

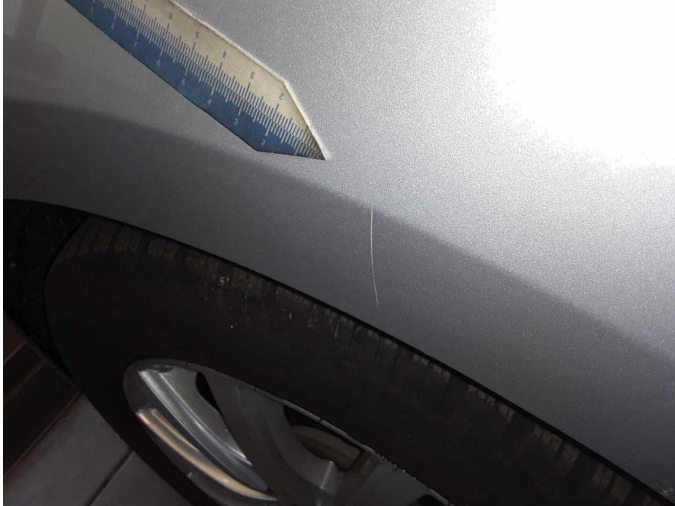
Damage 2: Mudguard - left side: Mudguard - left side - Scratch(es) - Smart repair

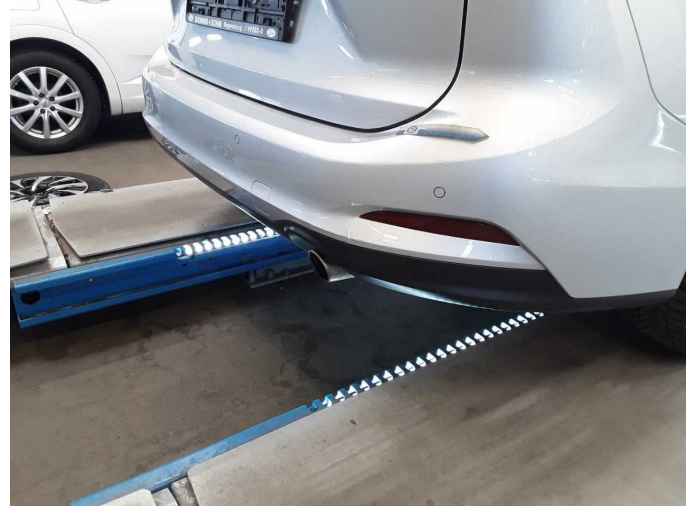
Damage 3: Rear bumper: Rear bumper - Scratch(es) - Paint

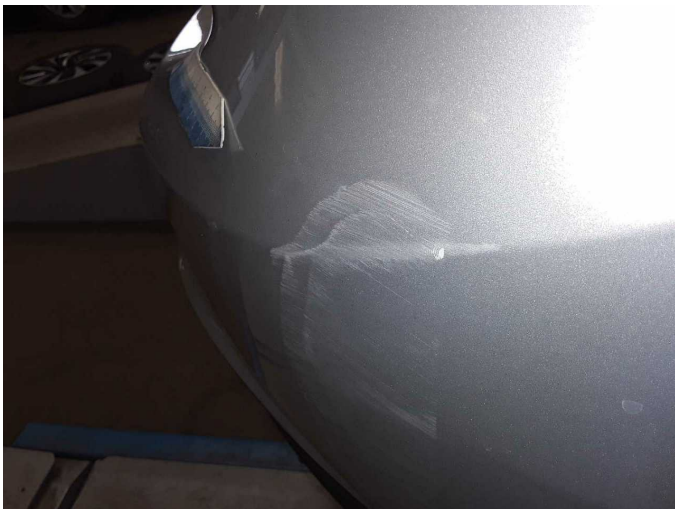
Damage 3: Rear bumper: Rear bumper - Scratch(es) - Paint

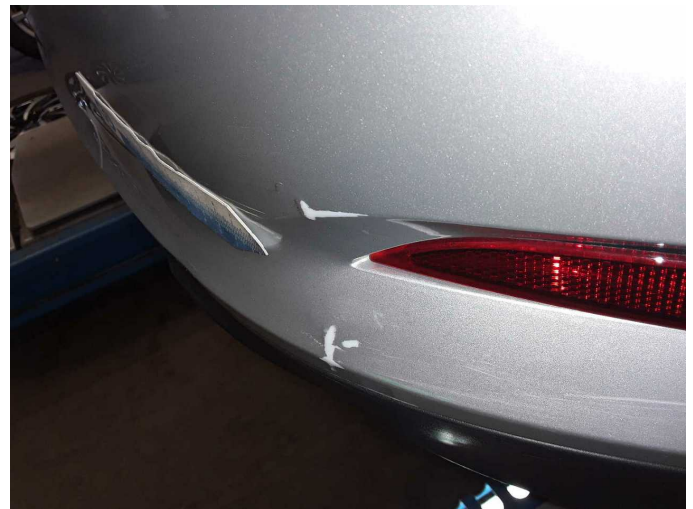
Damage 3: Rear bumper: Rear bumper - Scratch(es) - Paint

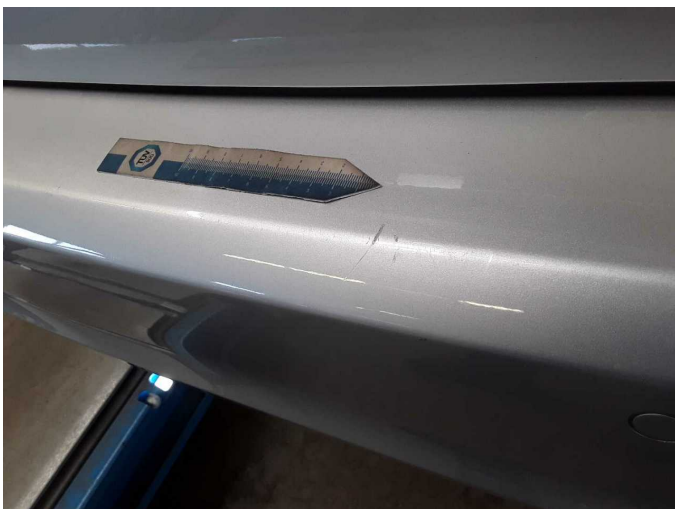
Damage 3: Rear bumper: Rear bumper - Scratch(es) - Paint

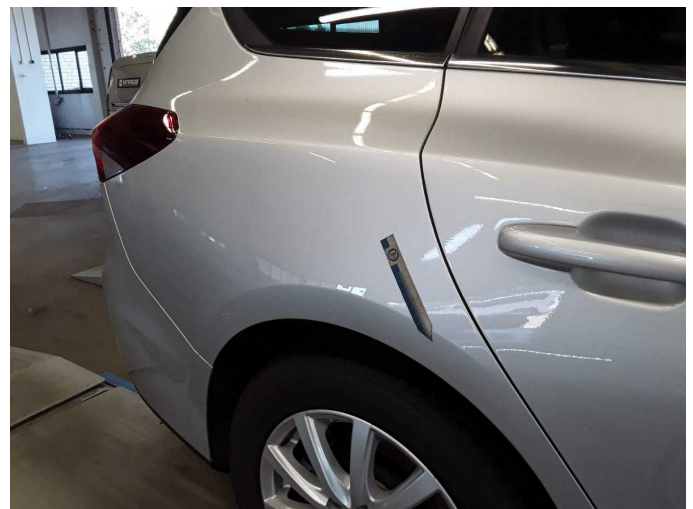
Damage 4: Side panel - rear right side: Side panel - Scratch(es) - Paint

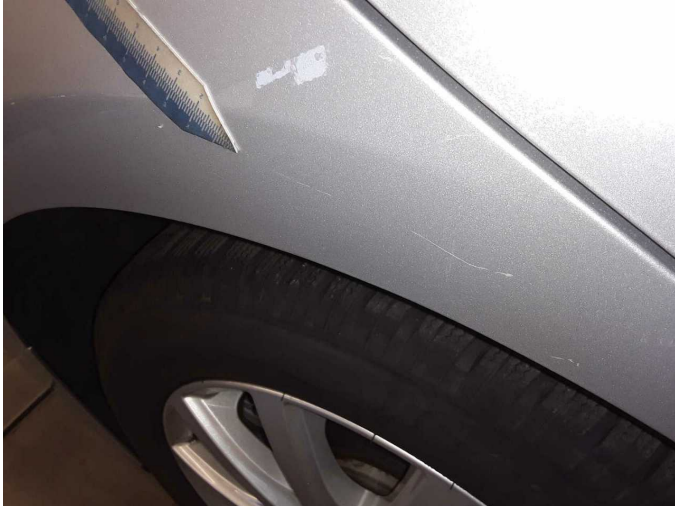
Damage 4: Side panel - rear right side: Side panel - Scratch(es) - Paint

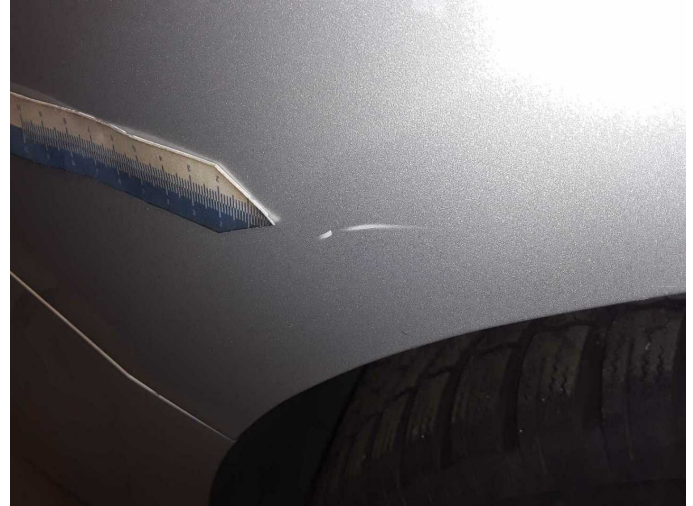
Damage 4: Side panel - rear right side: Side panel - Scratch(es) - Paint

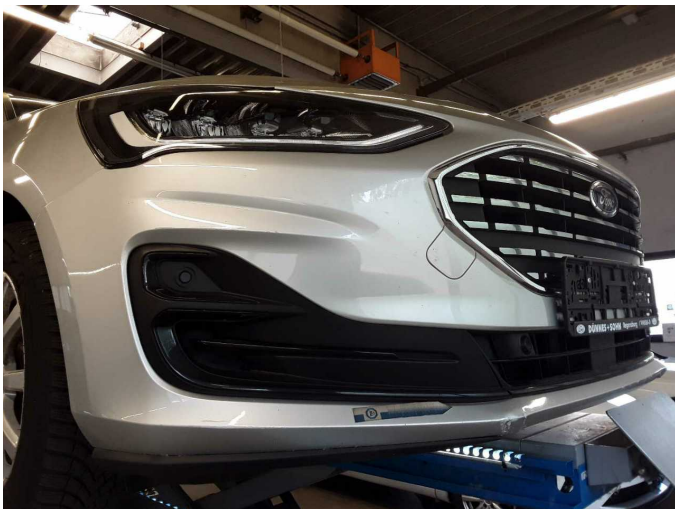
Damage 5: Front bumper: Front bumper - Deformed - Repair and paint

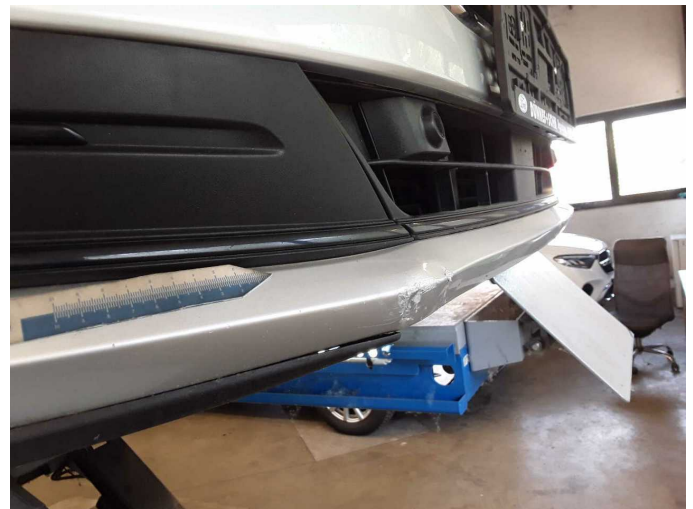
Damage 5: Front bumper: Front bumper - Deformed - Repair and paint

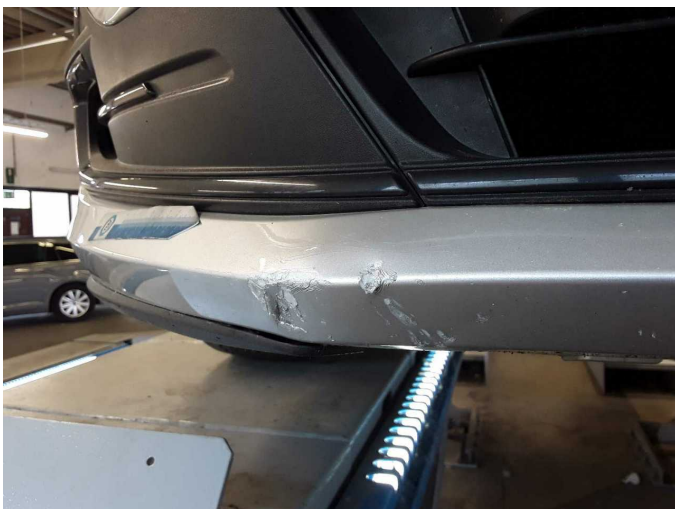
Damage 5: Front bumper: Front bumper - Deformed - Repair and paint

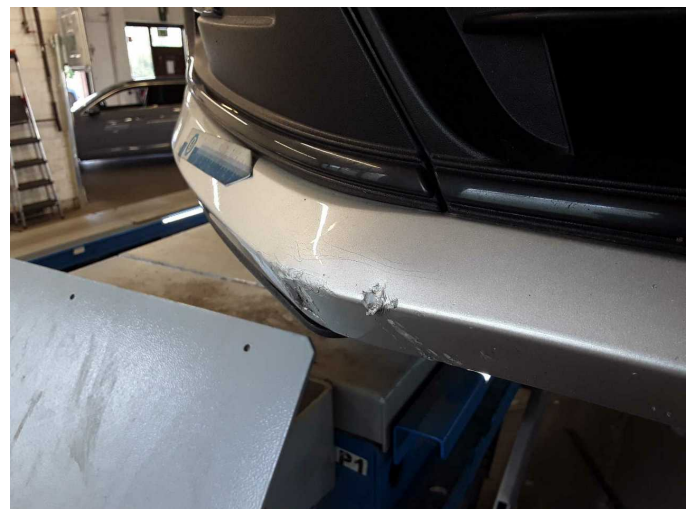
Damage 5: Front bumper: Front bumper - Deformed - Repair and paint

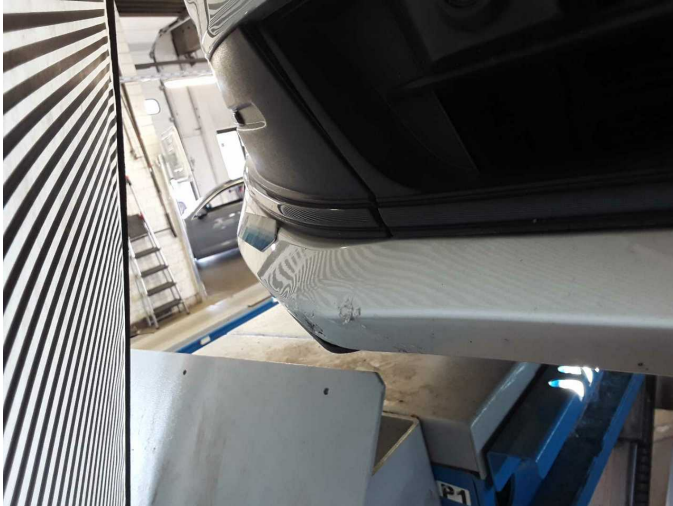
Damage 5: Front bumper: Front bumper - Deformed - Repair and paint

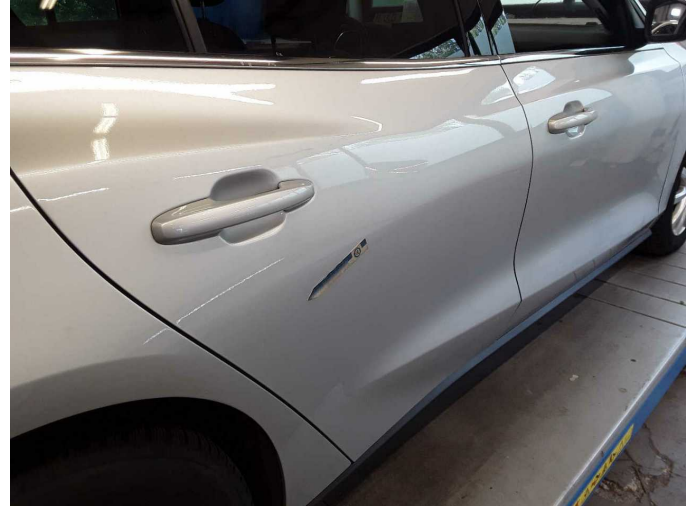
Damage 6: Door - rear right side: Door - Dent / paintcoat damage - Repair and paint

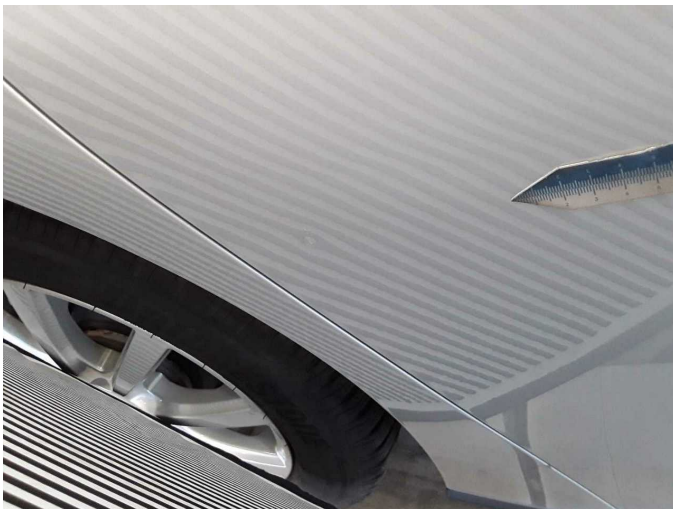
Damage 6: Door - rear right side: Door - Dent / paintcoat damage - Repair and paint

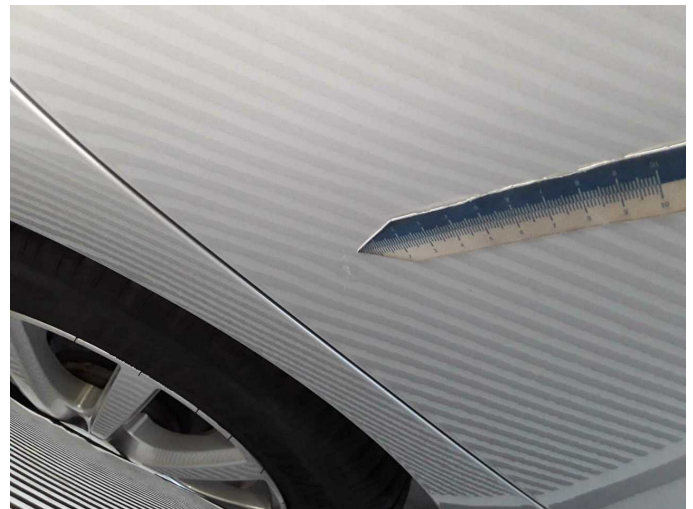
Damage 6: Door - rear right side: Door - Dent / paintcoat damage - Repair and paint

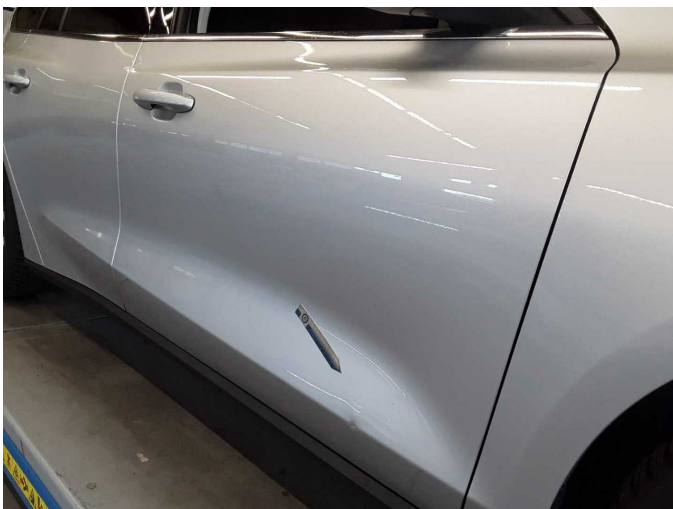
Damage 7: Door - front right side: Door - Dent / paintcoat damage - Repair and paint

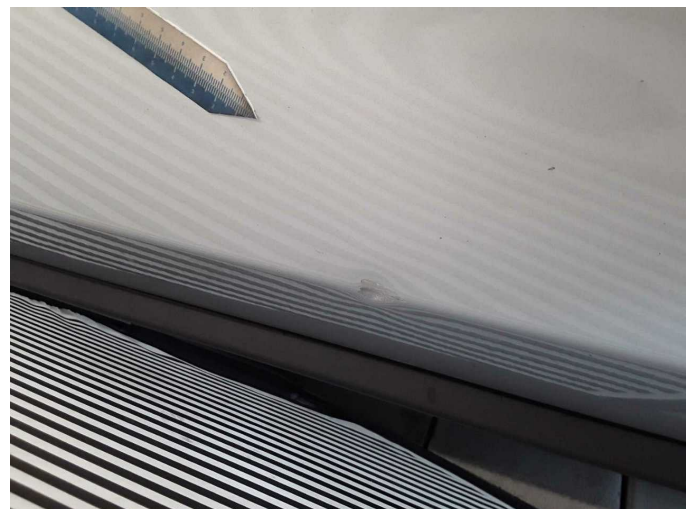
Damage 7: Door - front right side: Door - Dent / paintcoat damage - Repair and paint

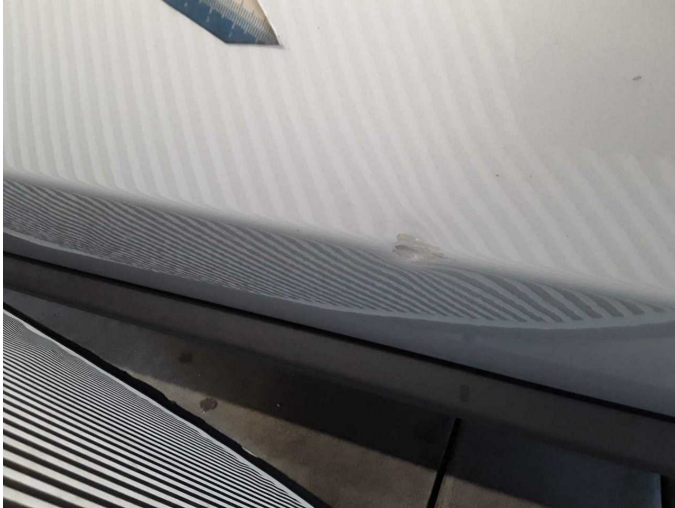
Damage 7: Door - front right side: Door - Dent / paintcoat damage - Repair and paint

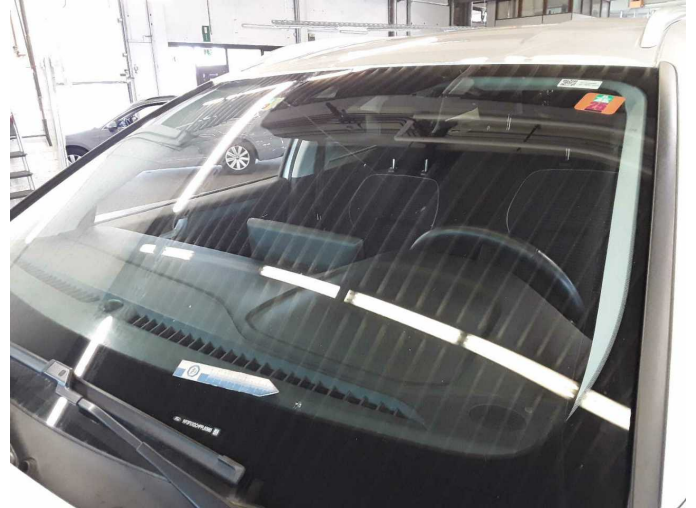
Damage 8: Vehicle glazing: Windscreen - Broken / torn - Replace

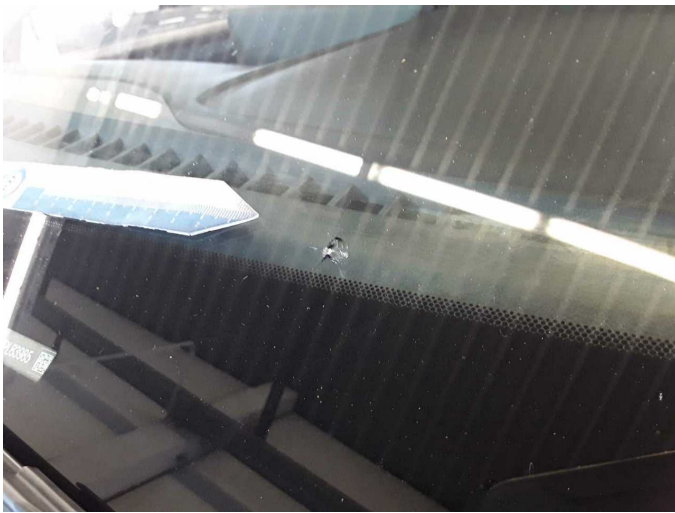
Damage 8: Vehicle glazing: Windscreen - Broken / torn - Replace

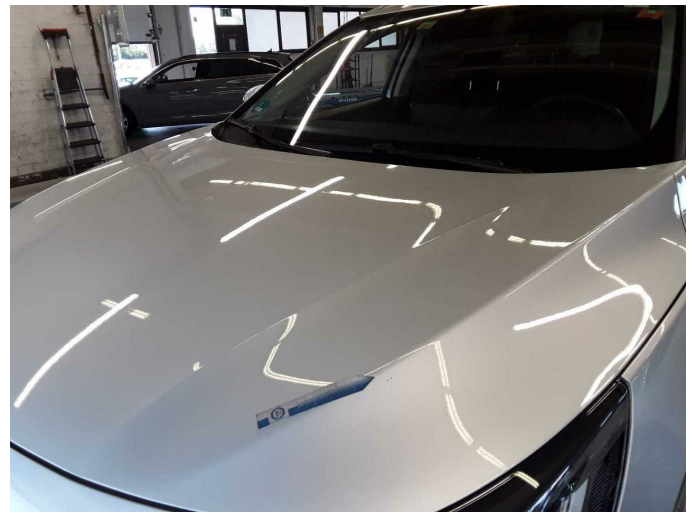
Wear and tear 3: Bonnet: Bonnet - Stone chips - No deduction

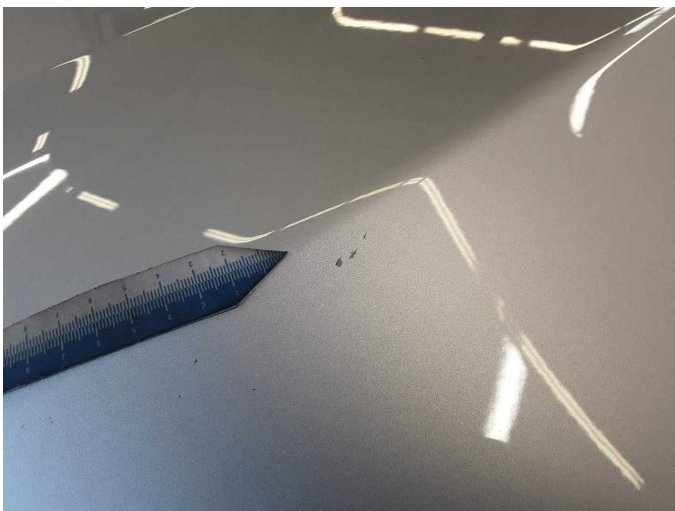
Wear and tear 3: Bonnet: Bonnet - Stone chips - No deduction
