Expertise

Protocol number: 46209499
Order No. / Reference: 26543743
Inspection date: 26 Jun 2026

Manufacturer: Peugeot

Model: 308 SW BlueHDi 130 Allure

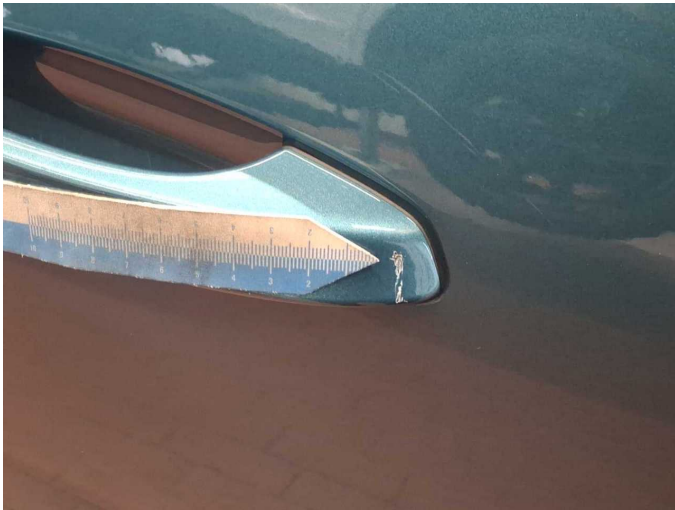
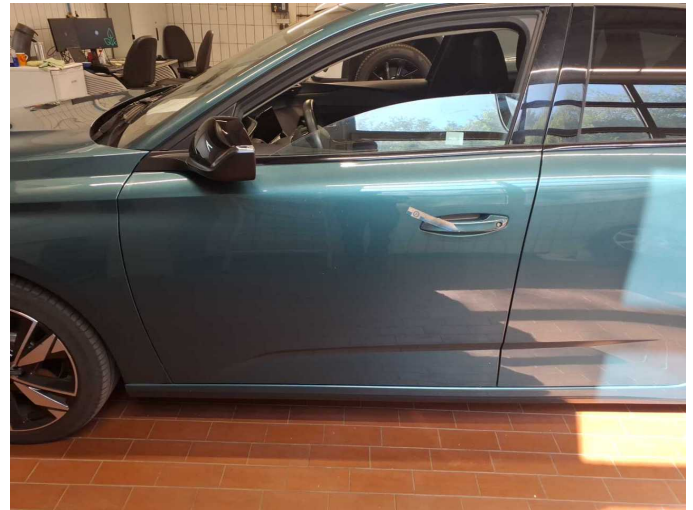
No.	Component group	Description
1	Door - front right side	Door handle - outside - Scratch(es) - Smart repair
2	Door - front left side	Door handle - outside - Scratch(es) - Smart repair
3	Side panel - rear left side	Elbow - dent(s) - Smooth repair work
4	Side panel - rear left side	Sill - Scratch(es) - Smart repair
5	Front bumper	Front bumper - Scratch(es) - Smart repair
6	Wheel / tyres	Tyre - rear right side (nicht fahrbereit) - Broken / torn - Replace
7	Wheel / tyres	Tyre - front right side (nicht fahrbereit) - Broken / torn - Replace
8	Mudguard - left side	Mudguard - left side - dent(s) - Smooth repair work
9	Wheel / tyres	Alloy rim - rear right side - Scratched - Replace
10	Wheel / tyres	Alloy rim - front right side - Scratched - Replace
11	Sill - right side	Sill (+ Unterbodenschutz anbringen) - Deformed - Repair and paint
12	Rear bumper	Spoiler - Scratch(es) - Paint
13	Rear bumper	Rear bumper - Dent / paintcoat damage - Repair and paint

Damage 1: Door - front right side: Door handle - outside - Scratch(es) - Smart repair

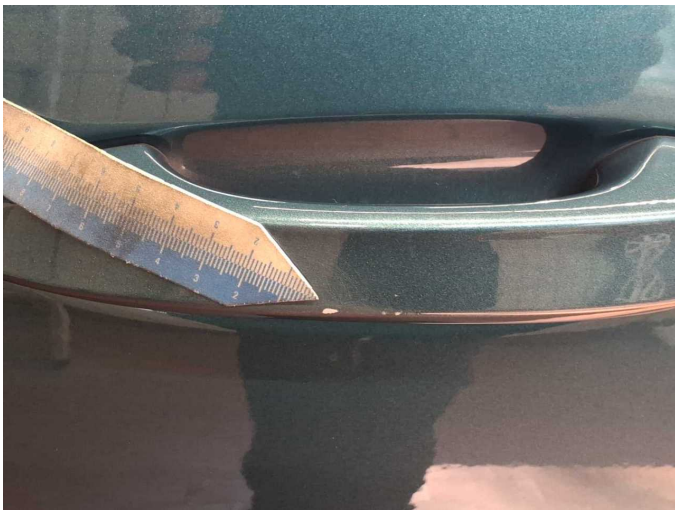
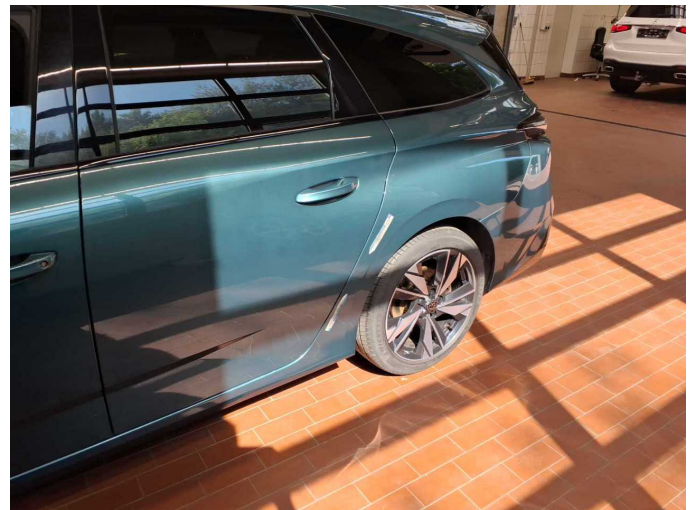
Damage 2: Door - front left side: Door handle - outside - Scratch(es) - Smart repair

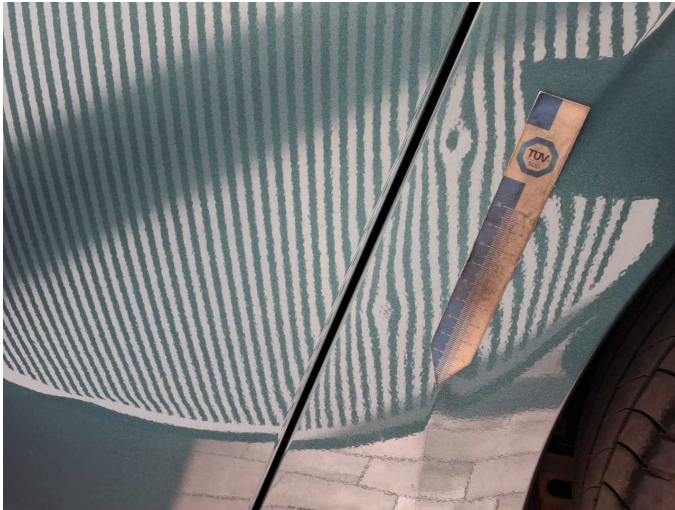
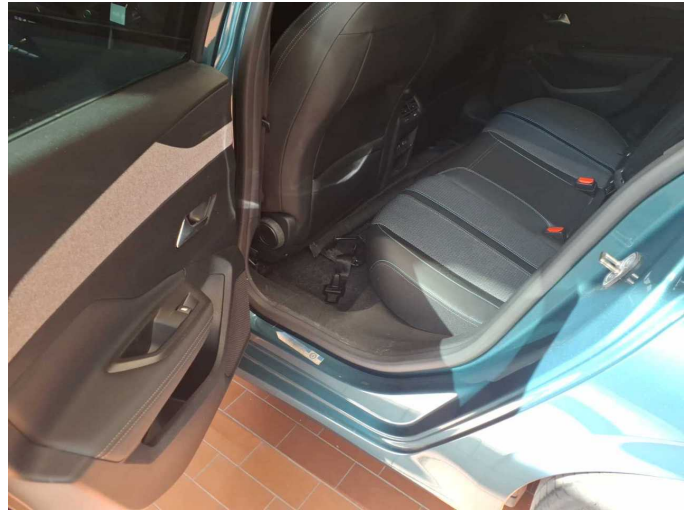
Damage 3: Side panel - rear left side: Elbow - dent(s) - Smooth repair work

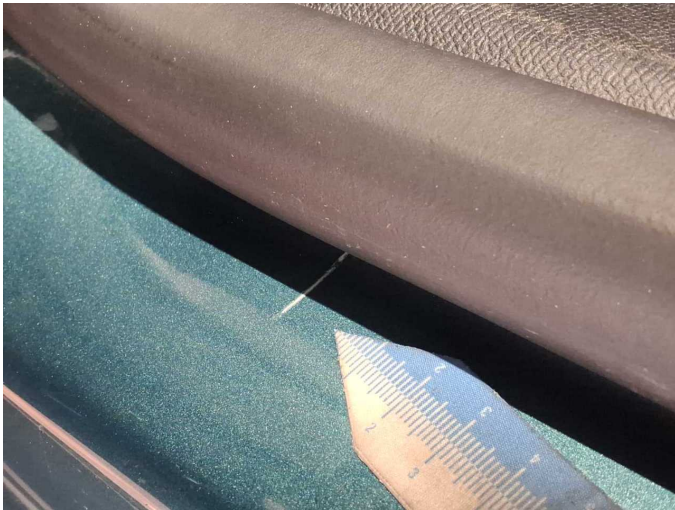
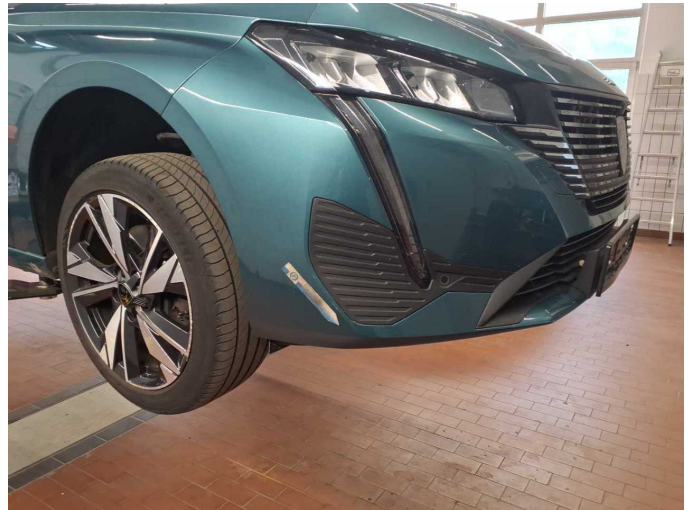
Damage 4: Side panel - rear left side: Sill - Scratch(es) - Smart repair

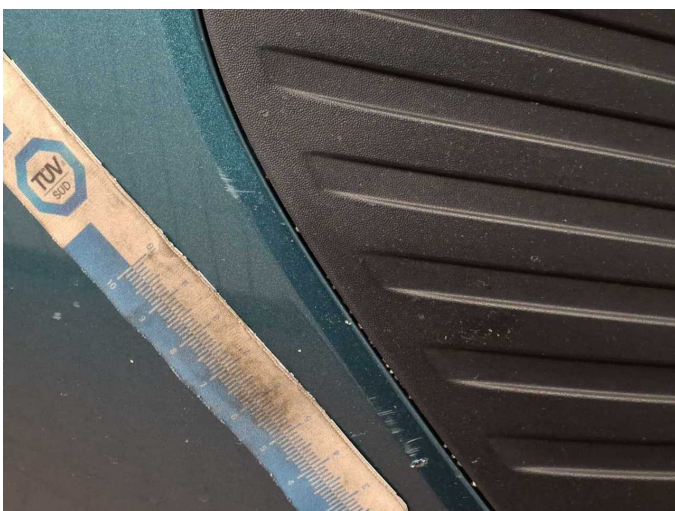
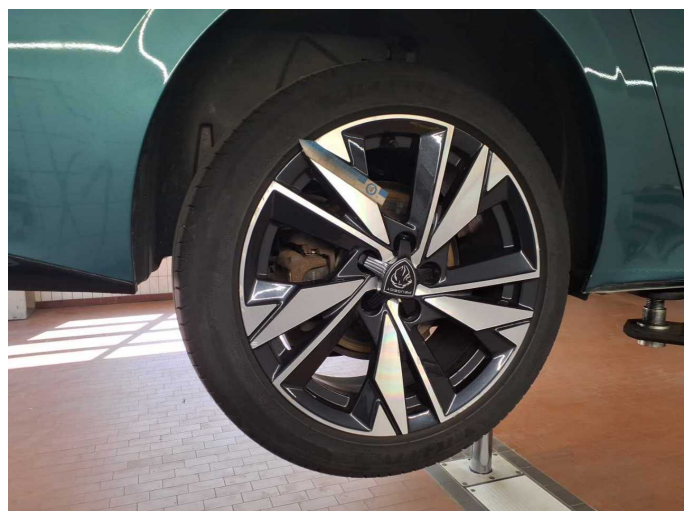
Damage 5: Front bumper: Front bumper - Scratch(es) - Smart repair

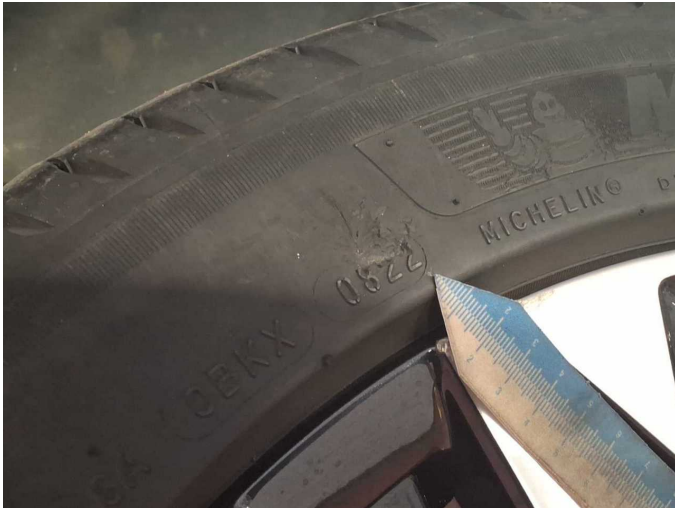
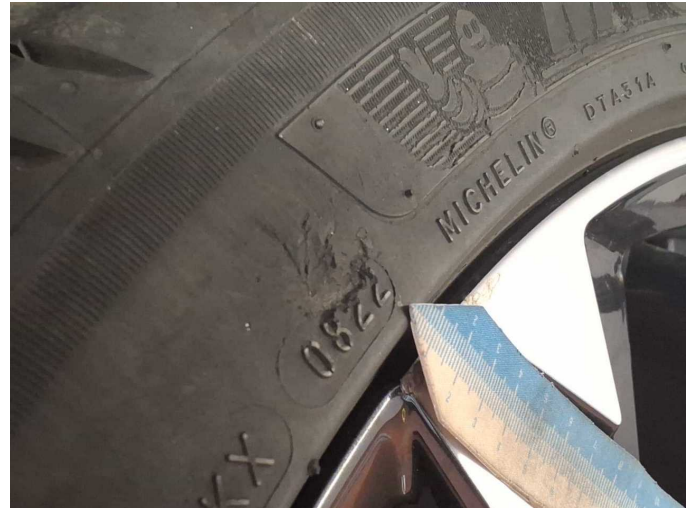
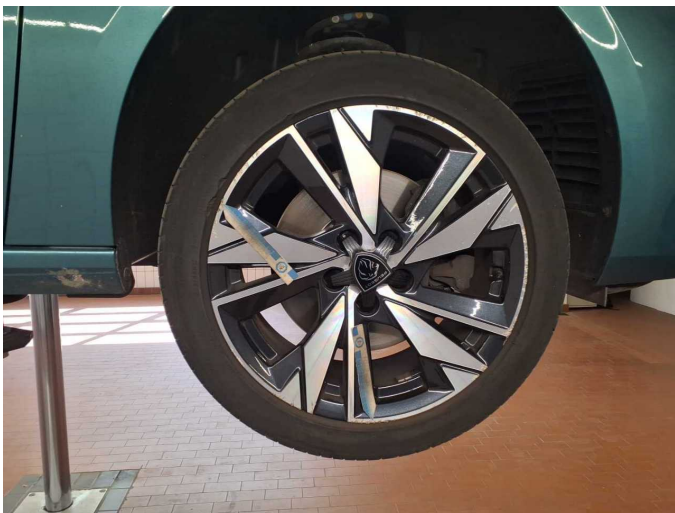
readiness to drive Not roadworthy / moveable

Damage 6: Wheel / tyres: Tyre - rear right side (nicht fahrbereit) - Broken / torn - Replace

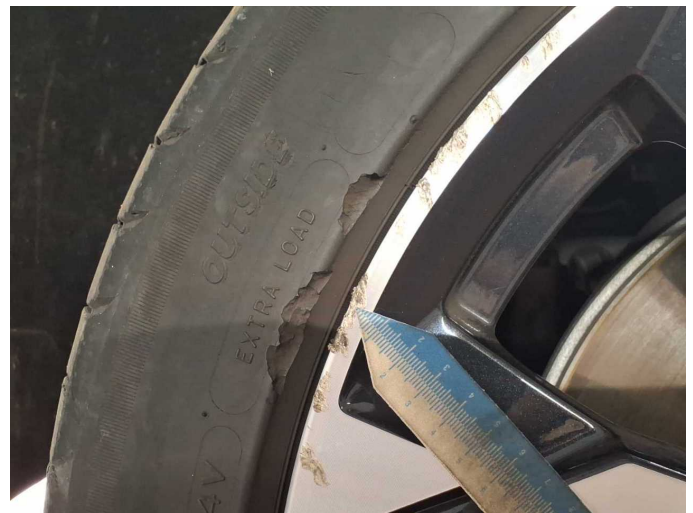
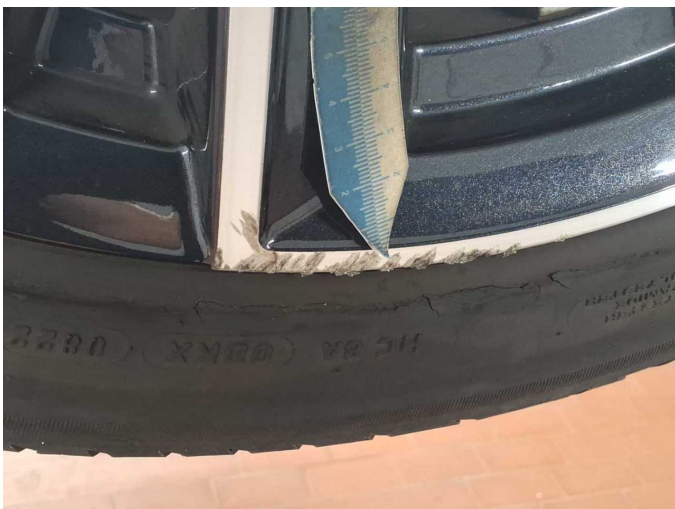
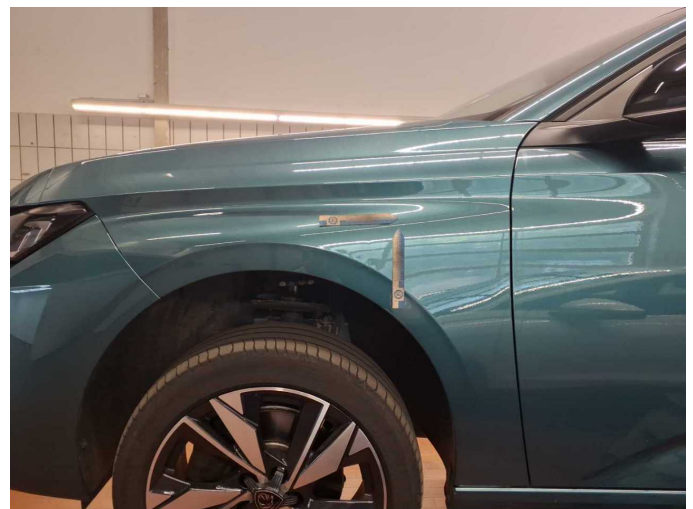
Damage 7: Wheel / tyres: Tyre - front right side (nicht fahrbereit) - Broken / torn - Replace

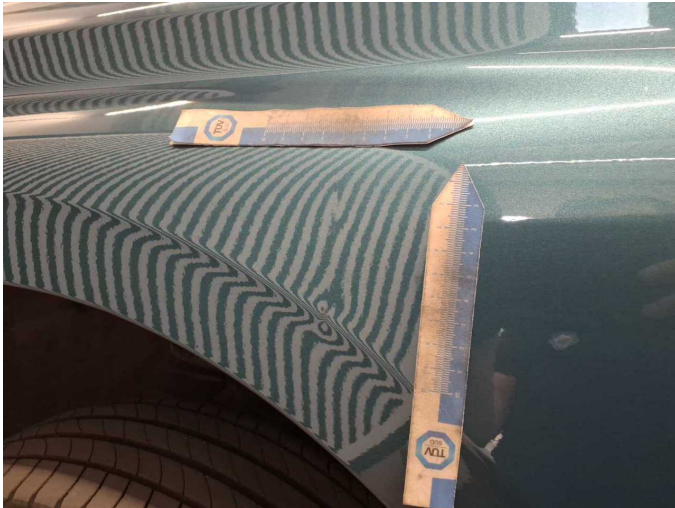
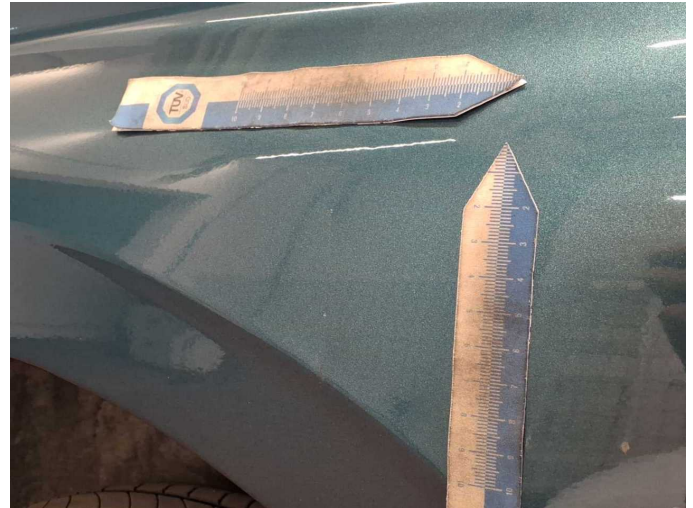
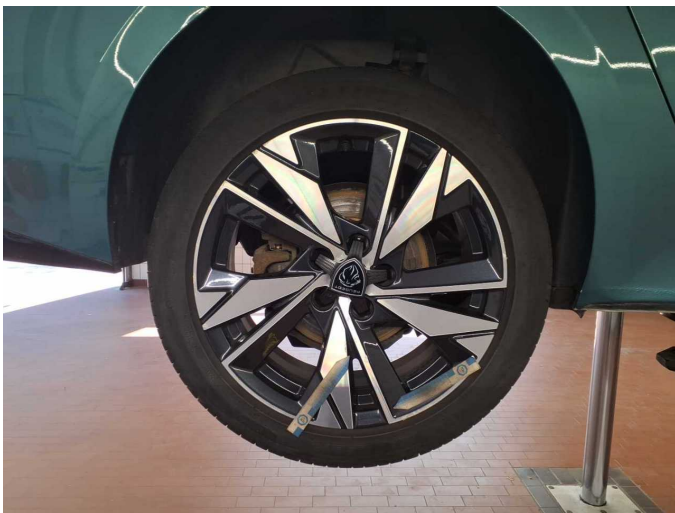
Damage 8: Mudguard - left side: Mudguard - left side - dent(s) - Smooth repair work

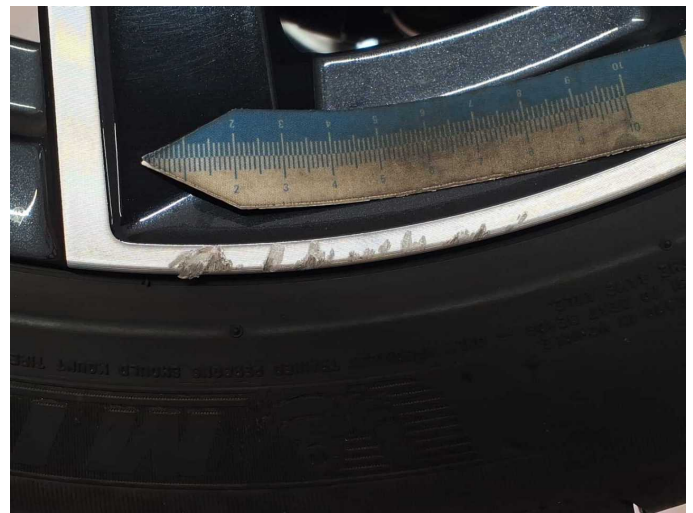
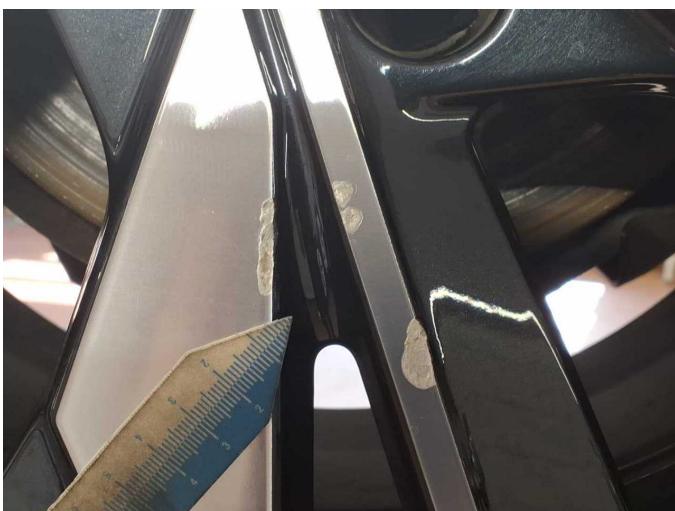
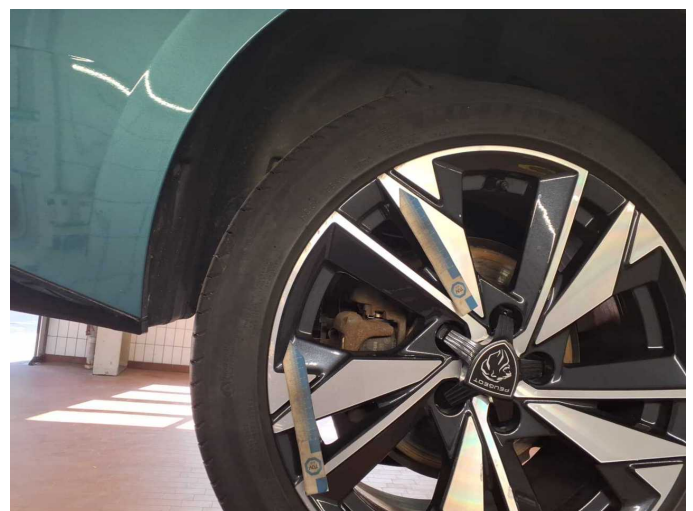
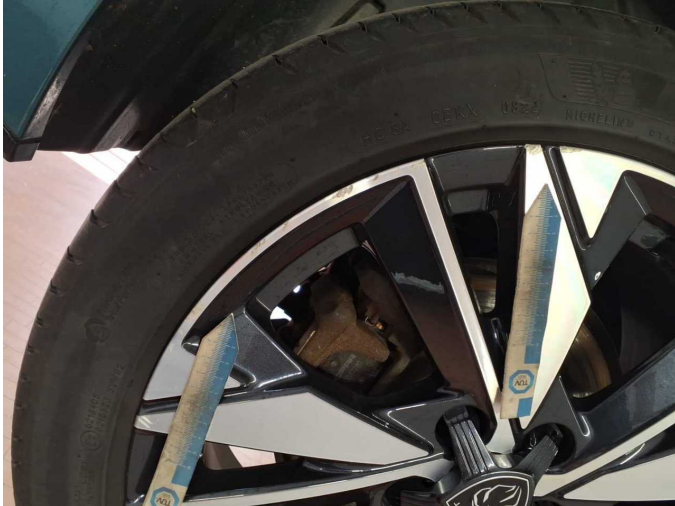
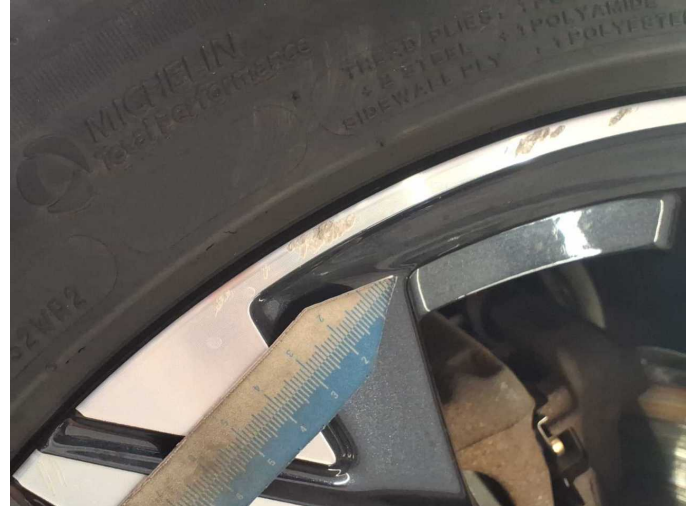
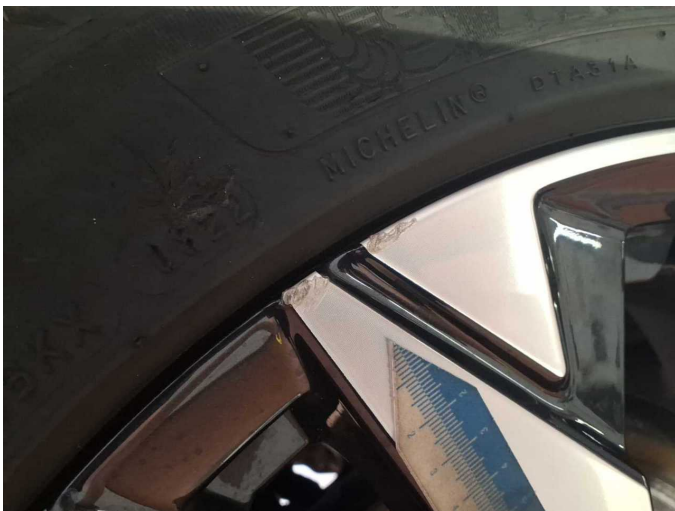
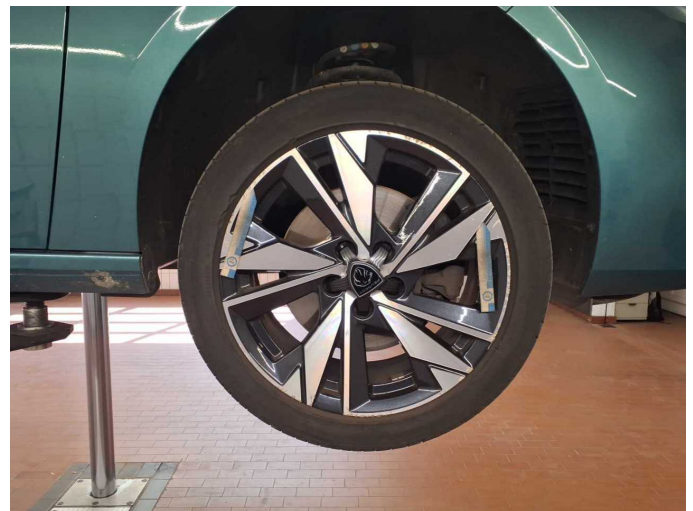
Damage 9: Wheel / tyres: Alloy rim - rear right side - Scratched - Replace

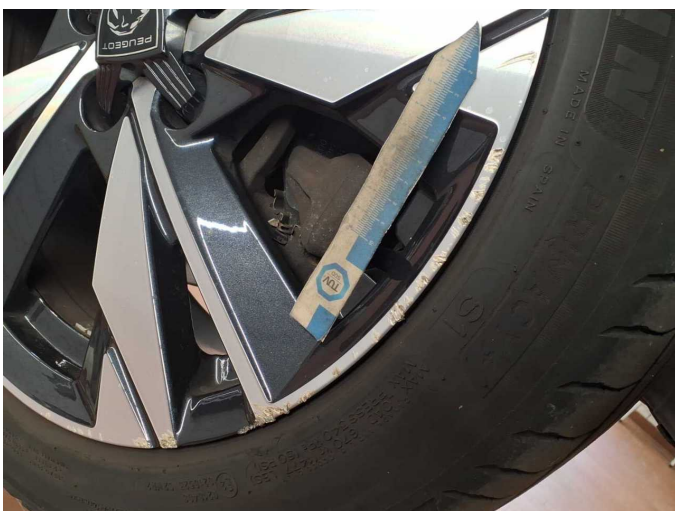
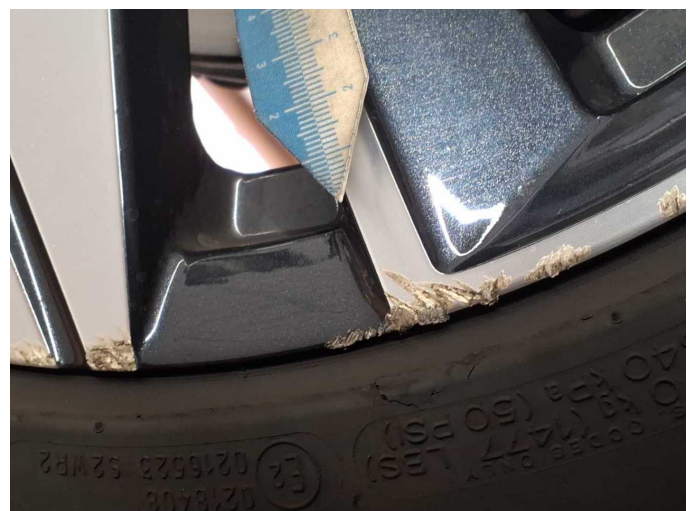
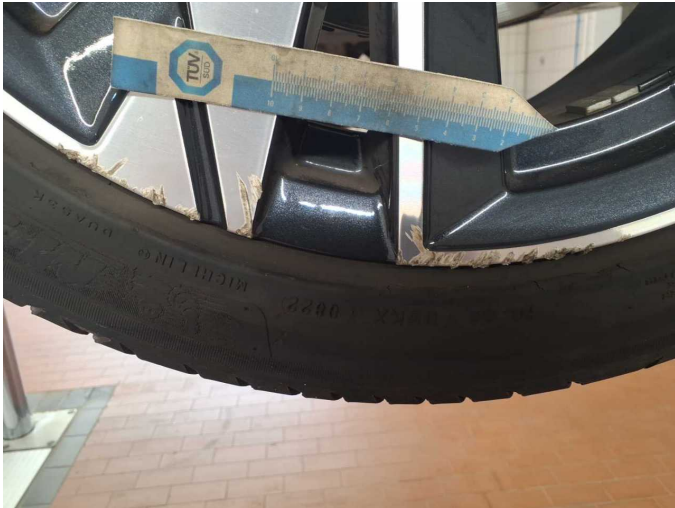
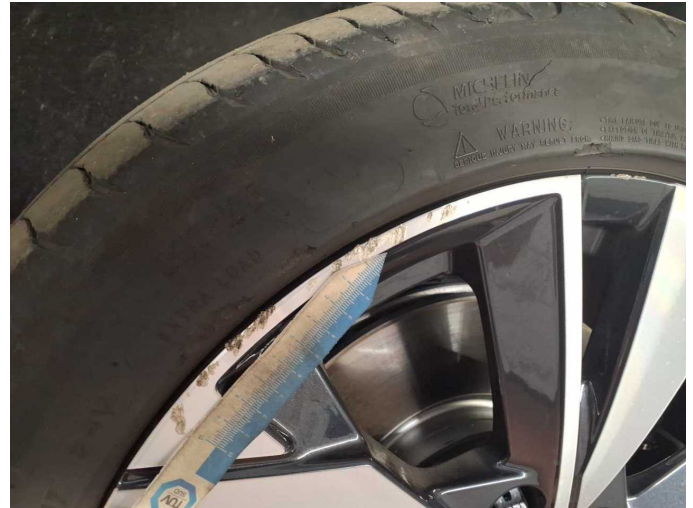
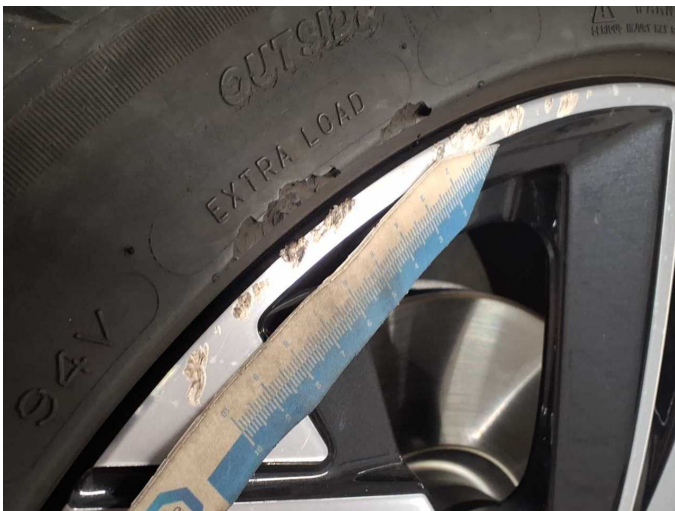
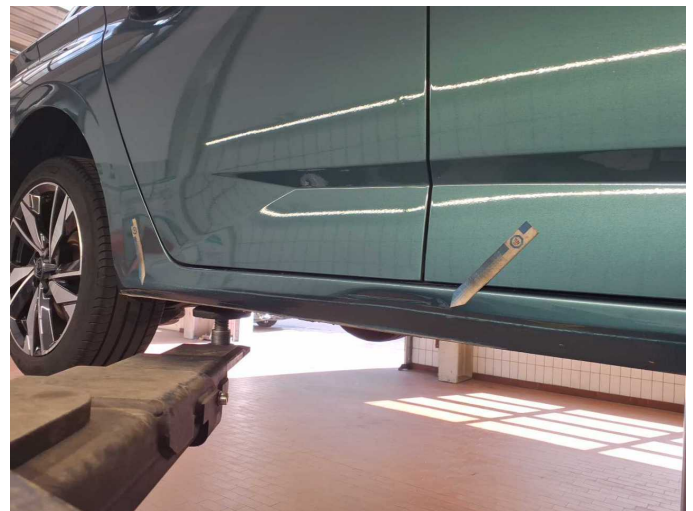
Damage 10: Wheel / tyres: Alloy rim - front right side - Scratched - Replace

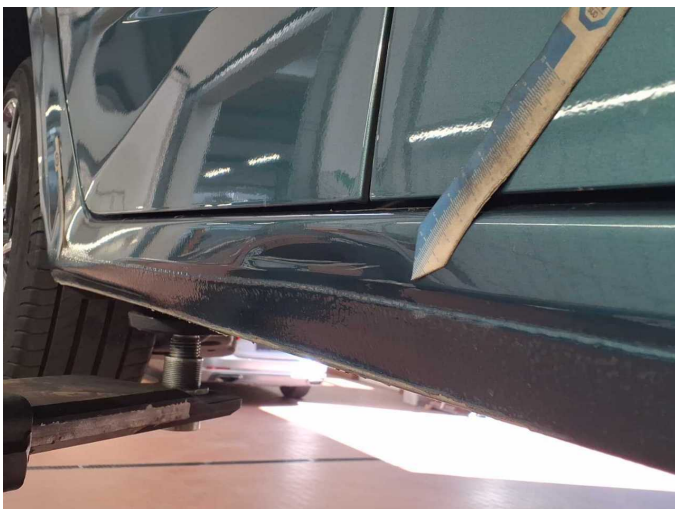
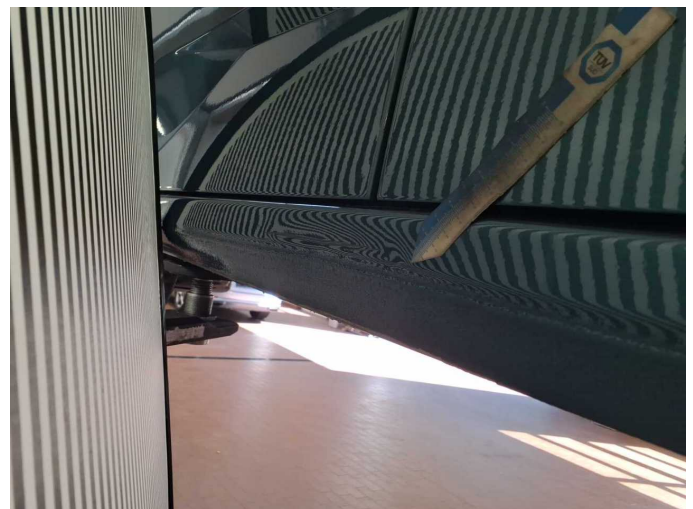
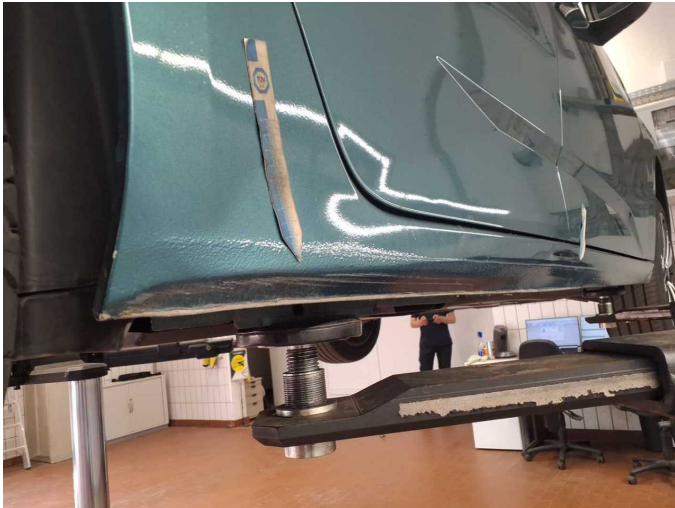
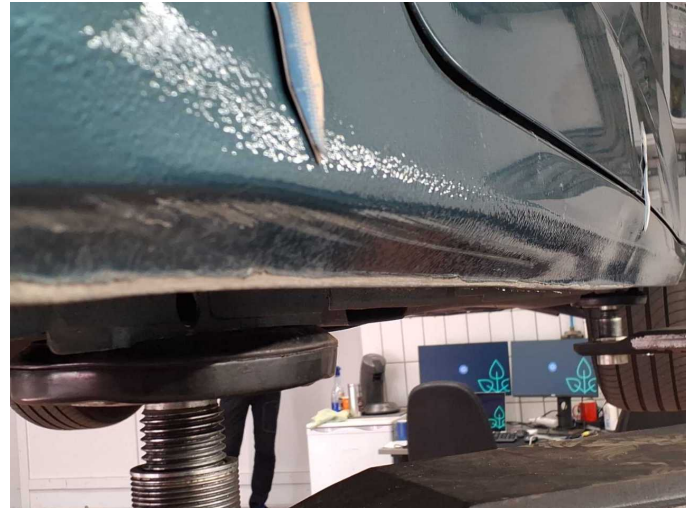
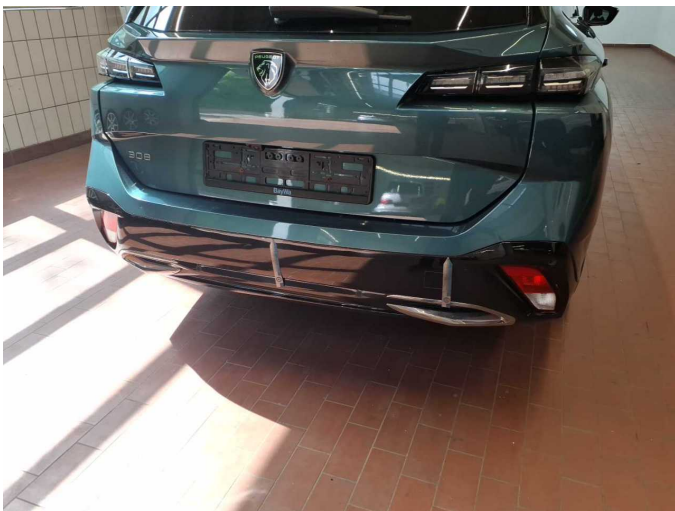
Damage 11: Sill - right side: Sill (+ Unterbodenschutz anbringen) - Deformed - Repair and paint

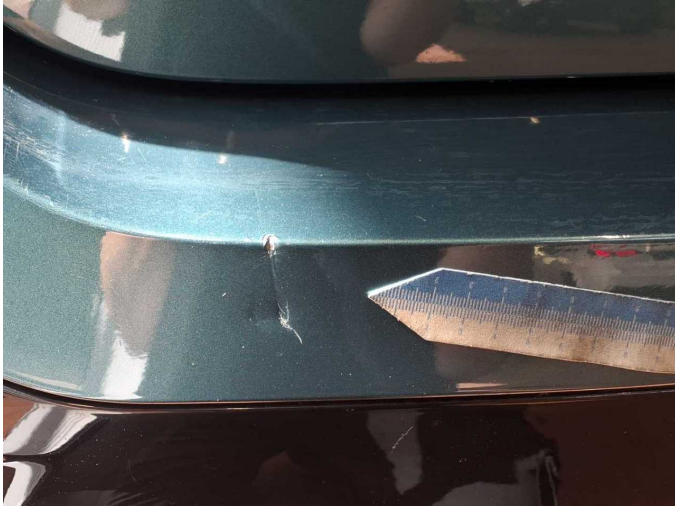
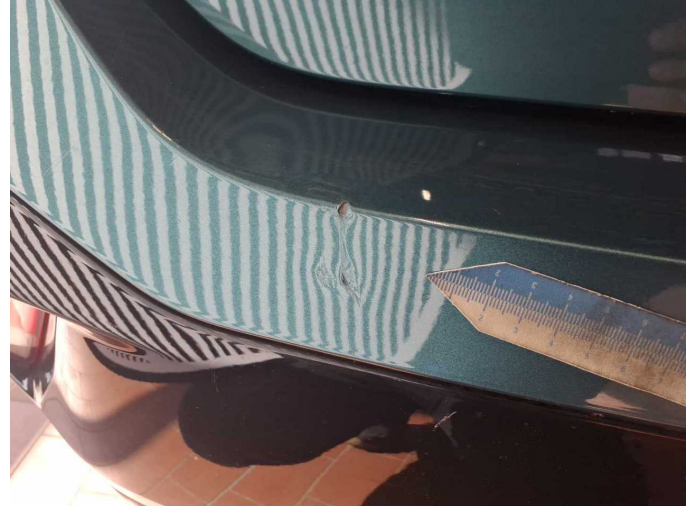
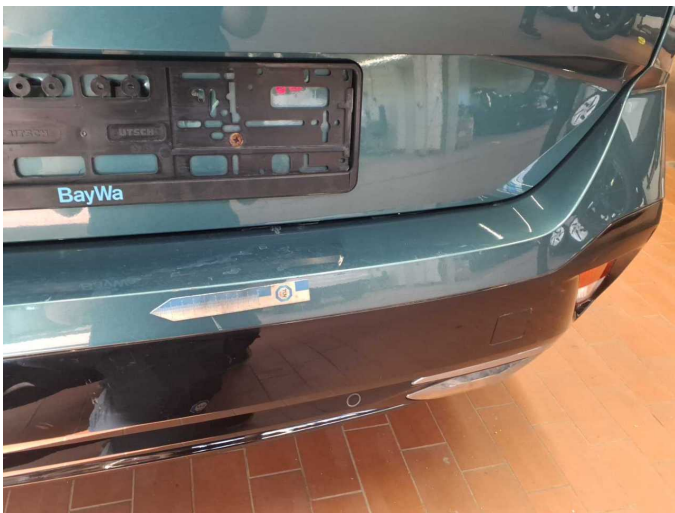
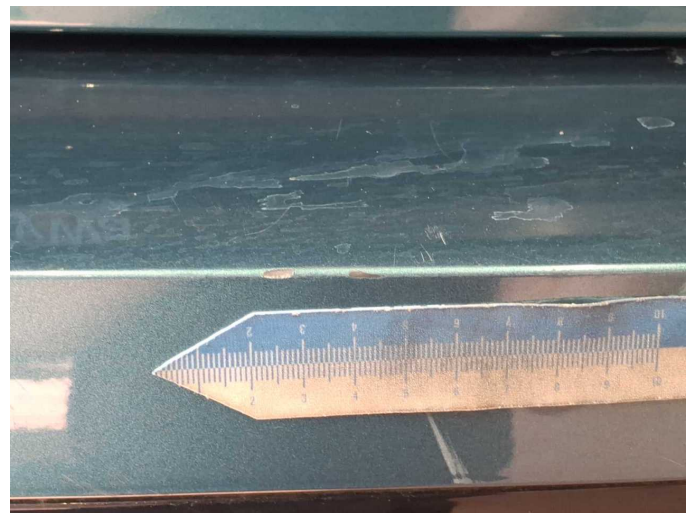
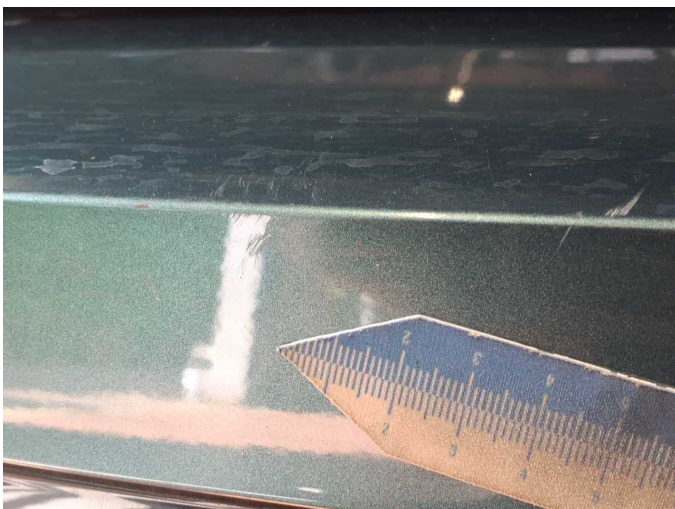
Damage 13: Rear bumper: Rear bumper - Dent / paintcoat damage - Repair and paint
