Expertise

Protocol number: 46132590
Order No. / Reference: 26501171
Inspection date: 22 Jun 2026

Manufacturer: Volkswagen

Model: ID.4 4Motion GTX

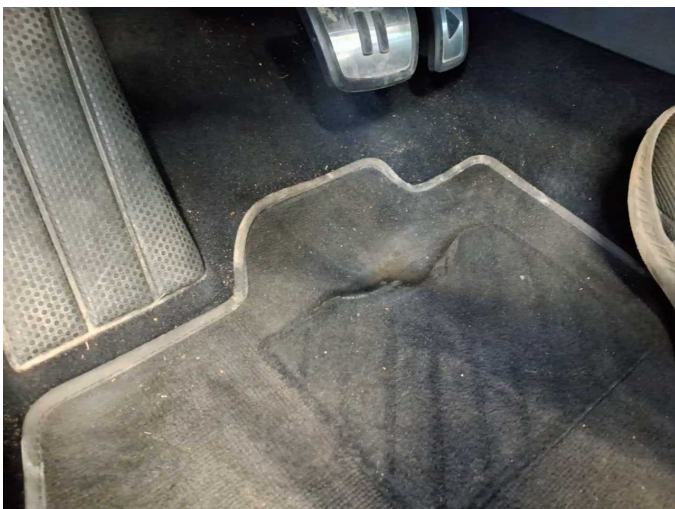
Damage 1: Trim / covers: Floor mats - Broken / torn - Replace

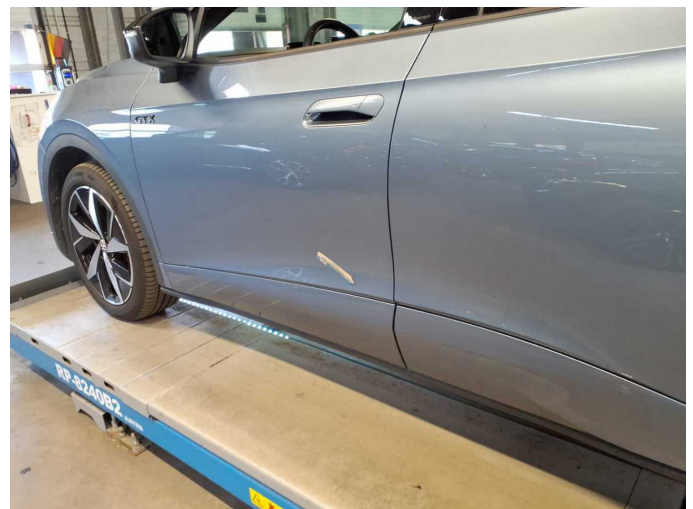
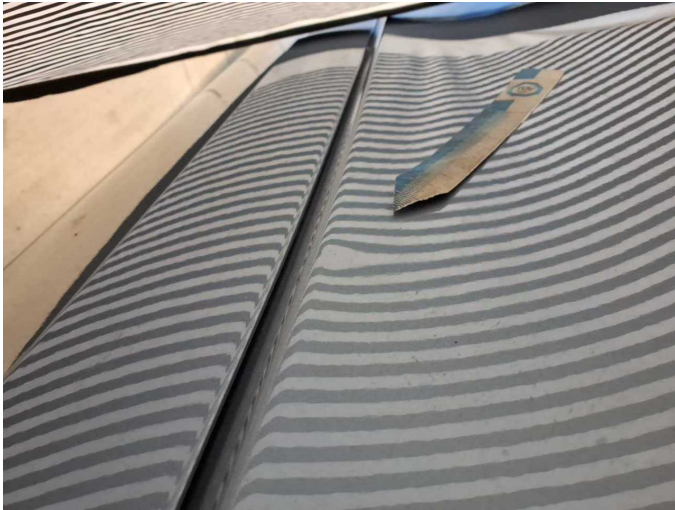
Damage 3: Door - front left side: Door - dent(s) - Smooth repair work

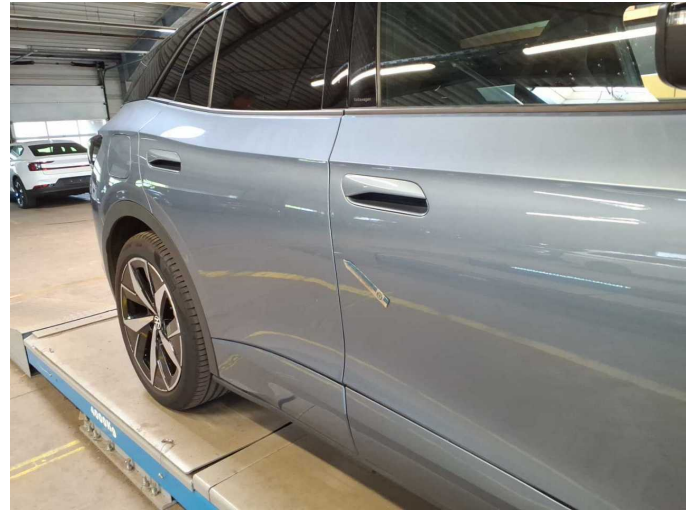
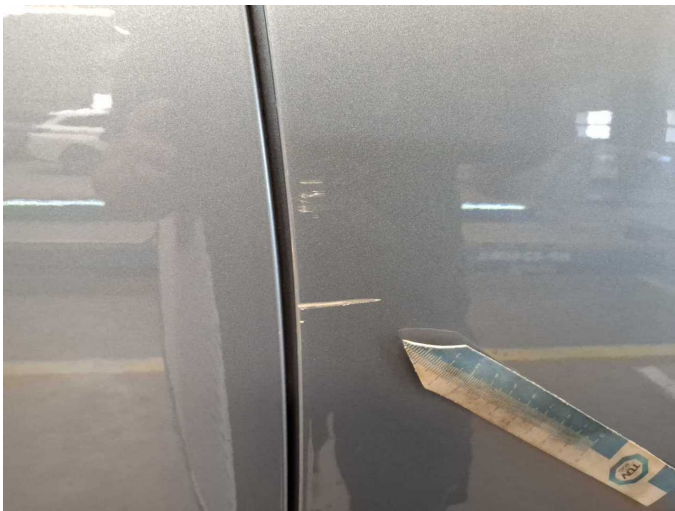
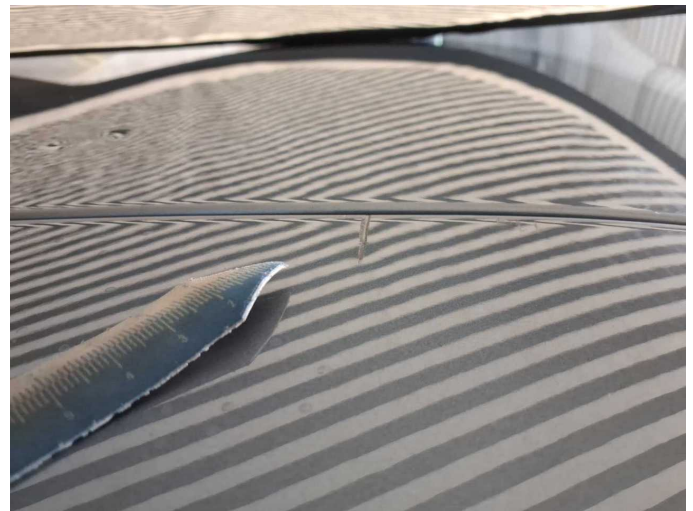
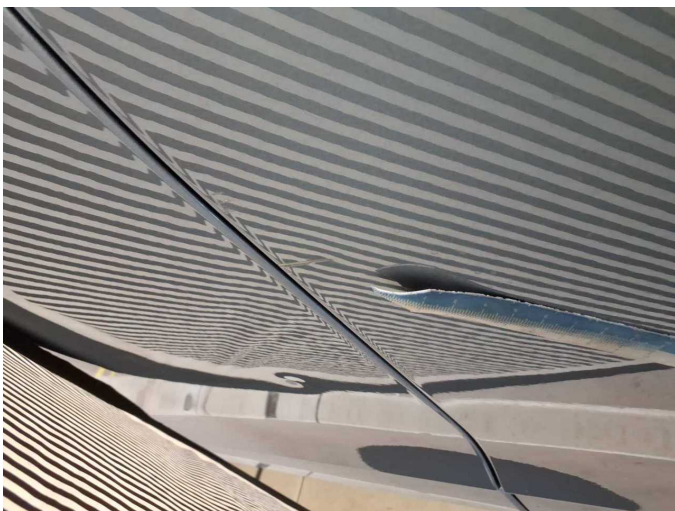
Damage 4: Door - front right side: Door - Dent / paintcoat damage - Smart repair

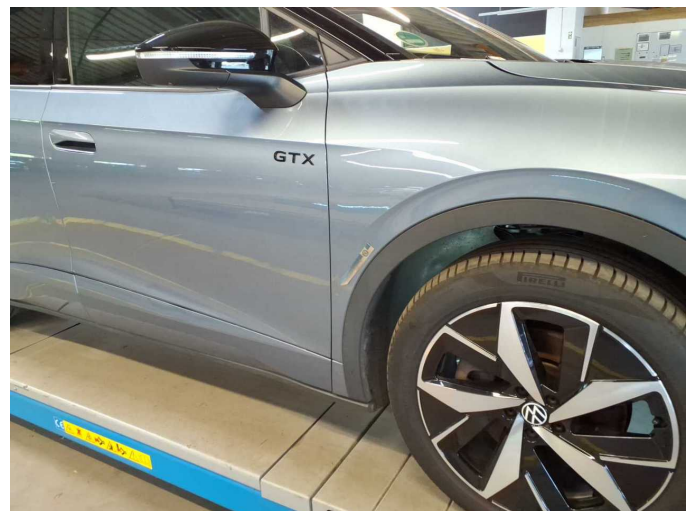
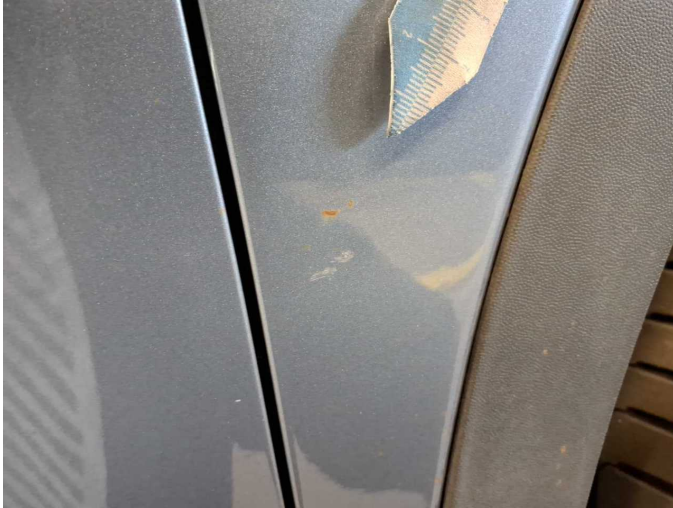
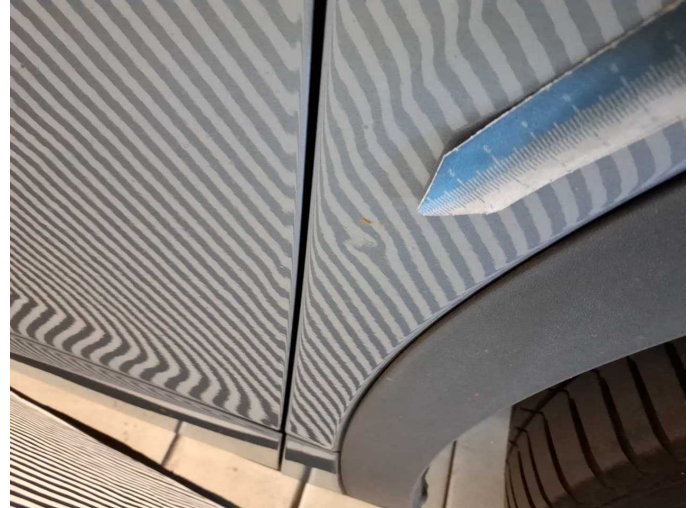
Damage 5: Mudguard - right side: Mudguard - right side - Dent / paintcoat damage - Smart repair

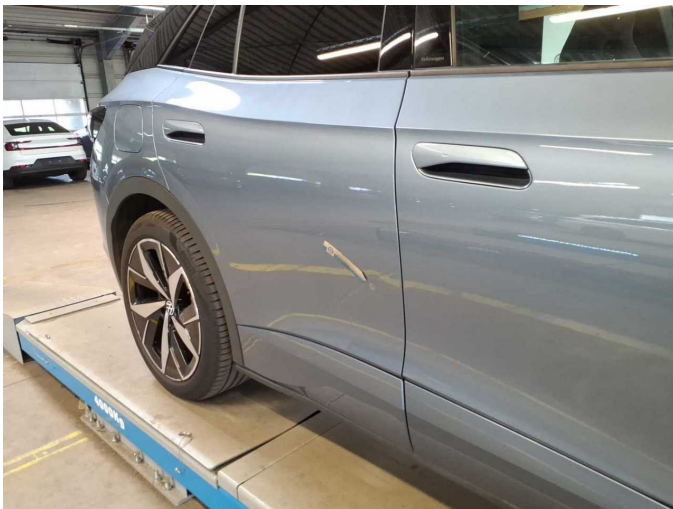
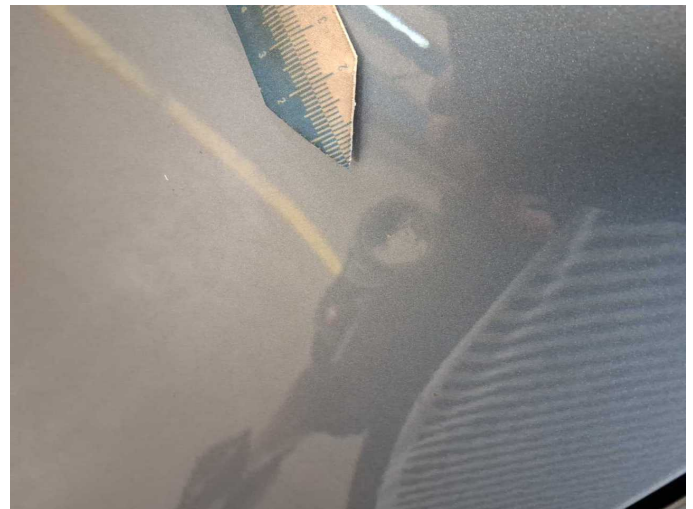
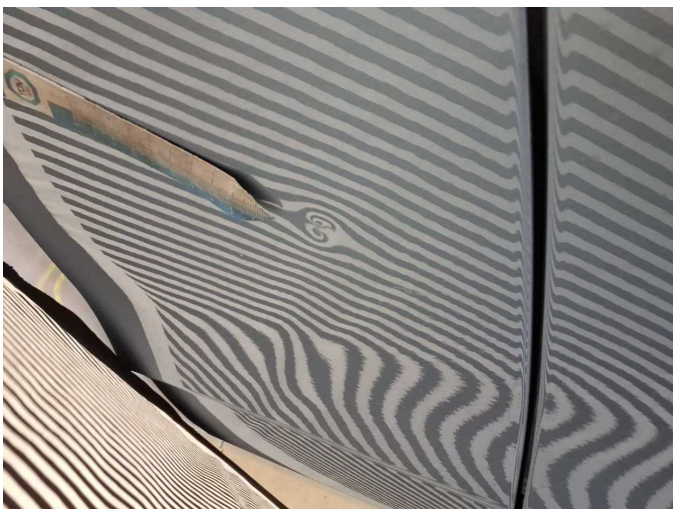
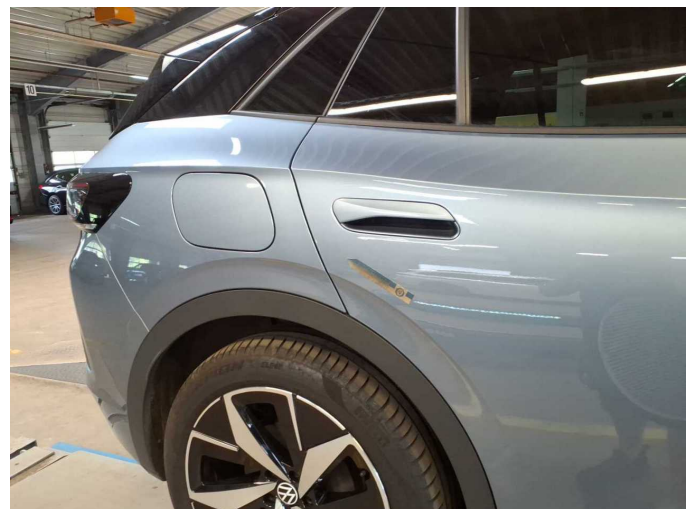
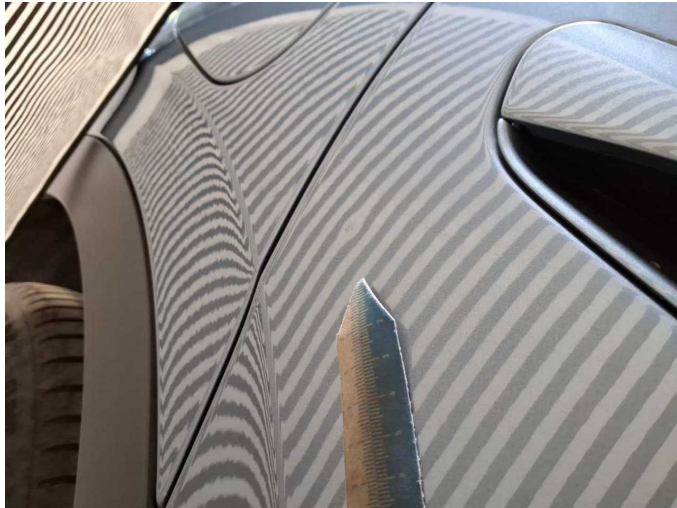
Damage 6: Door - rear right side: Door - Dent / paintcoat damage - Smart repair

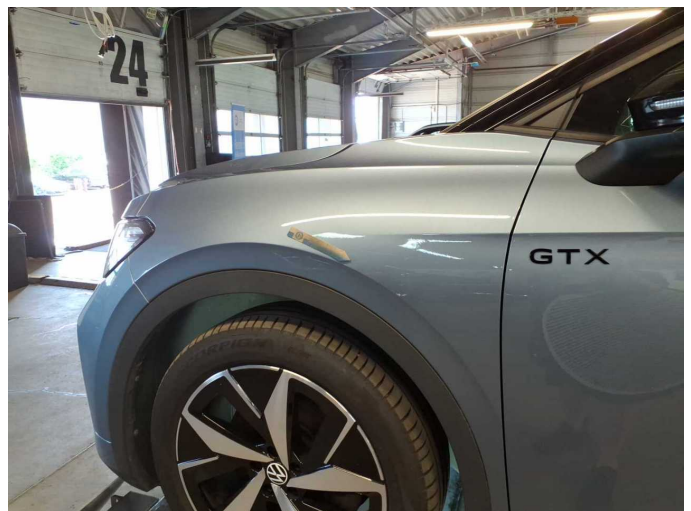
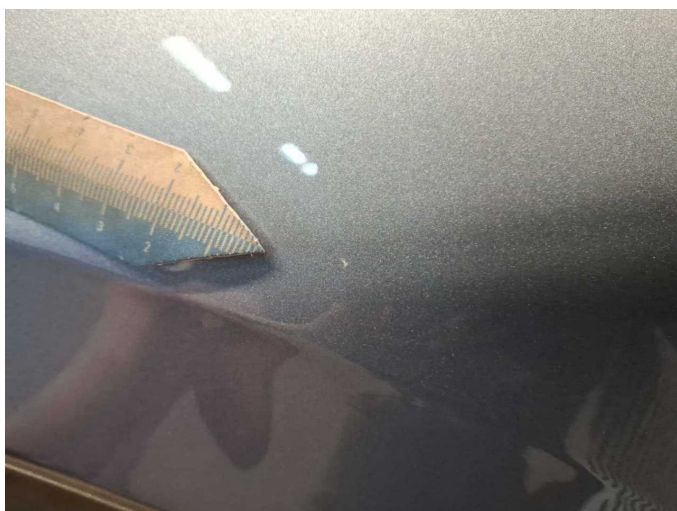
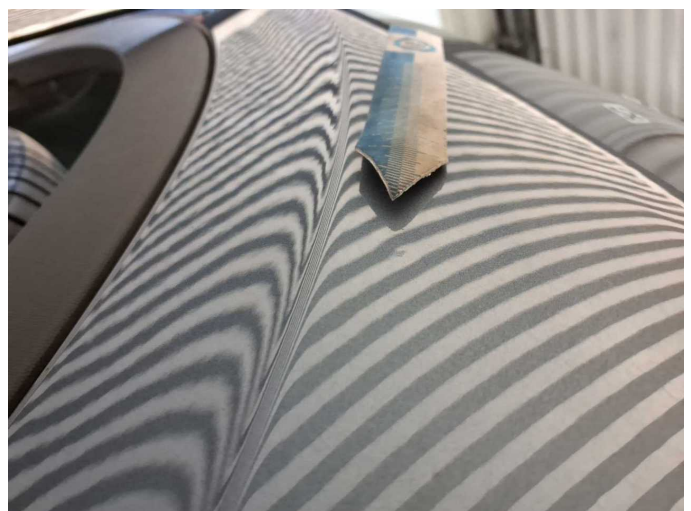
Wear and tear 2: Mudguard - left side: Mudguard - left side - Dent / paintcoat damage - No deduction

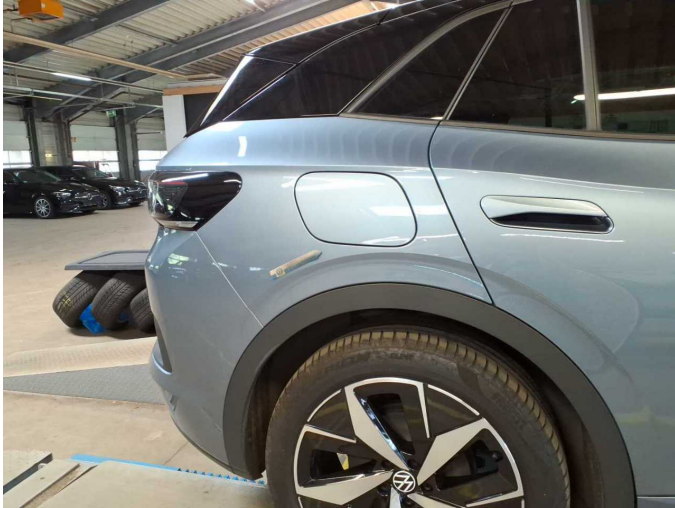
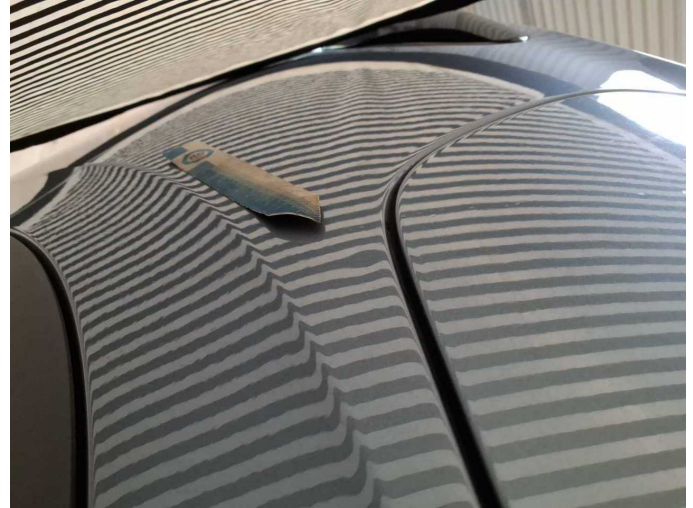
Wear and tear 3: Side panel - rear right side: Side panel - dent(s) - No deduction

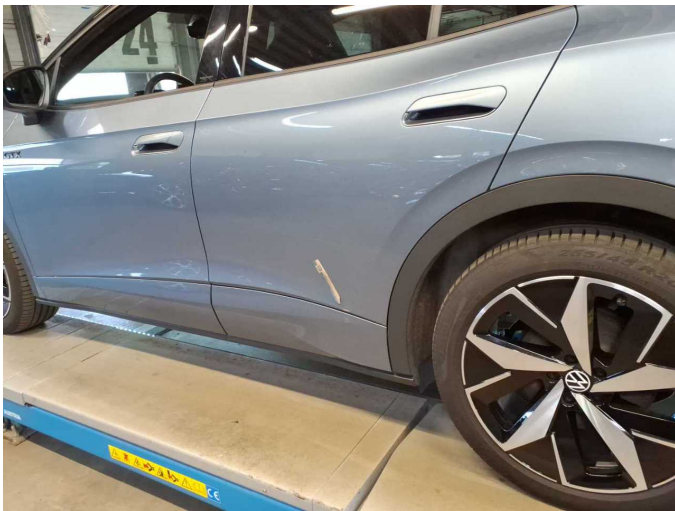
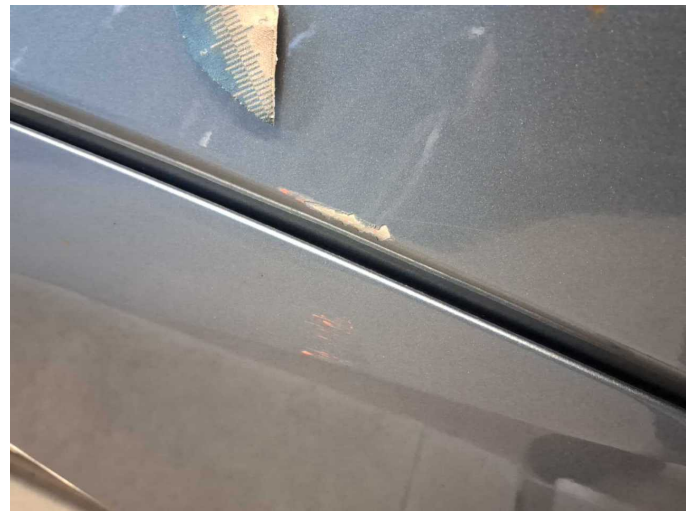
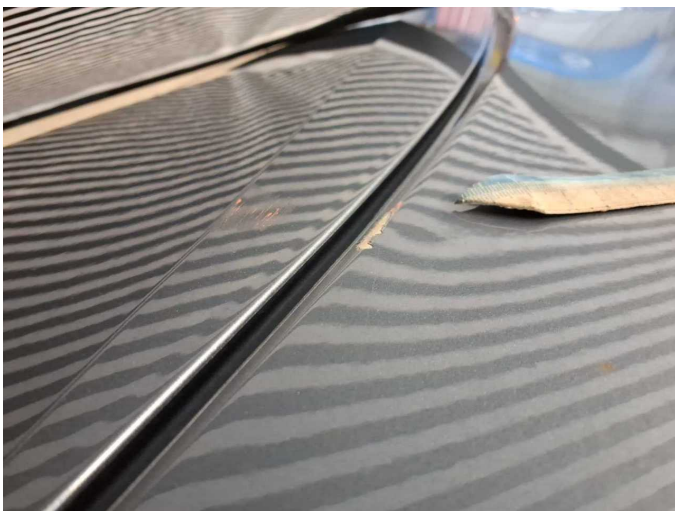
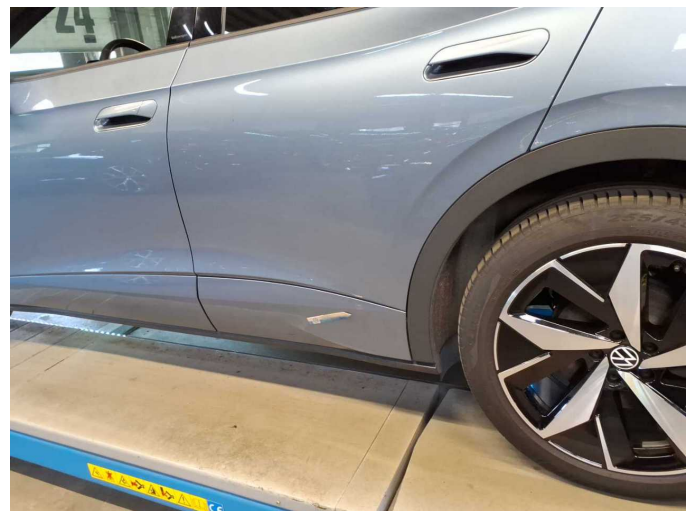
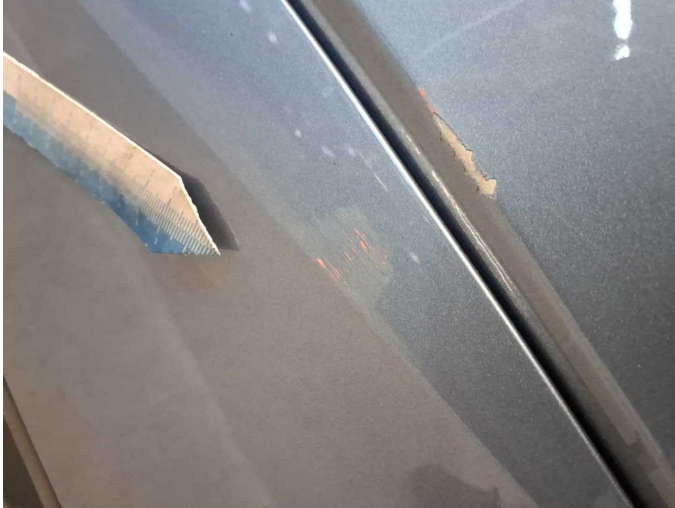
Accident 1: Side - left

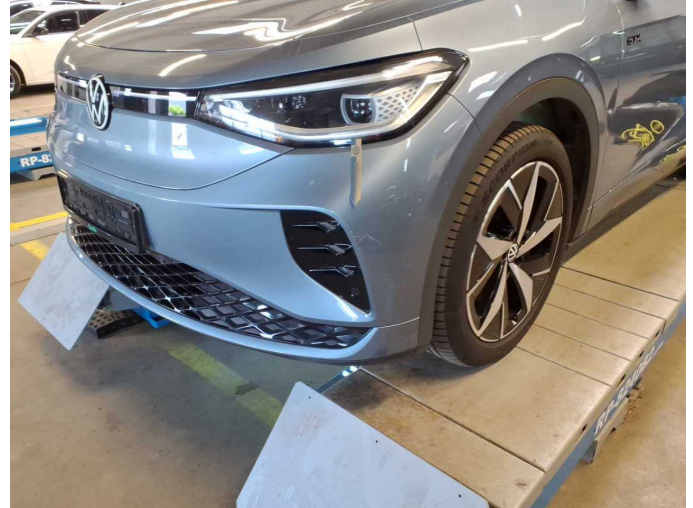
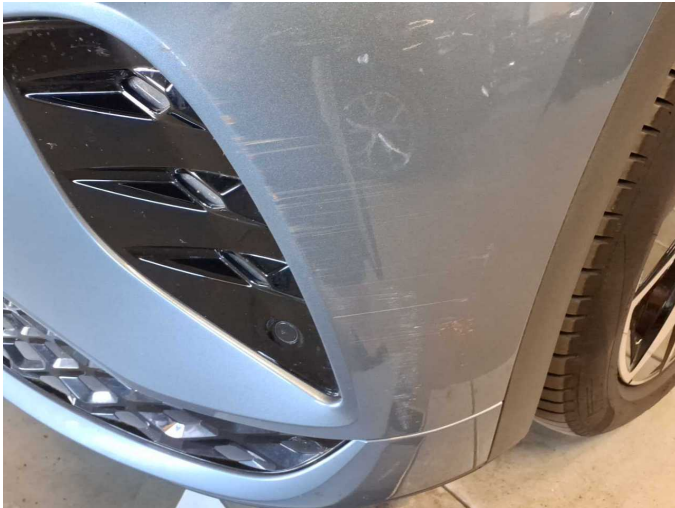
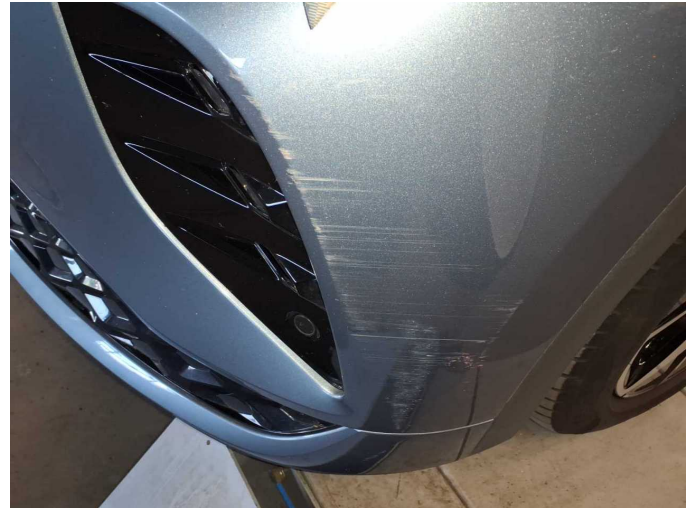
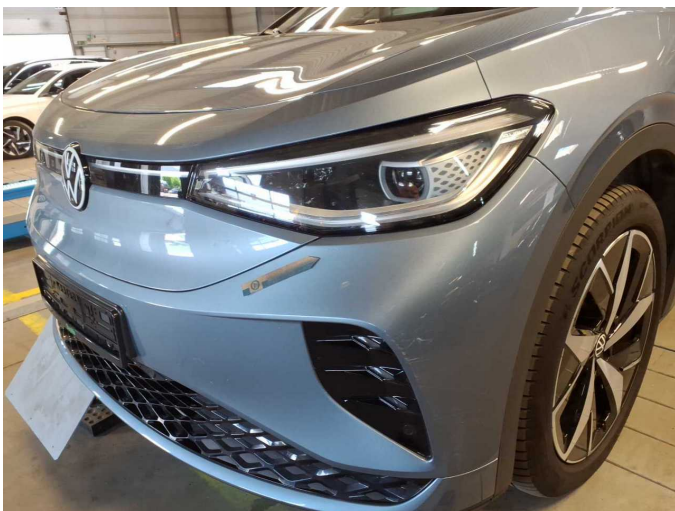
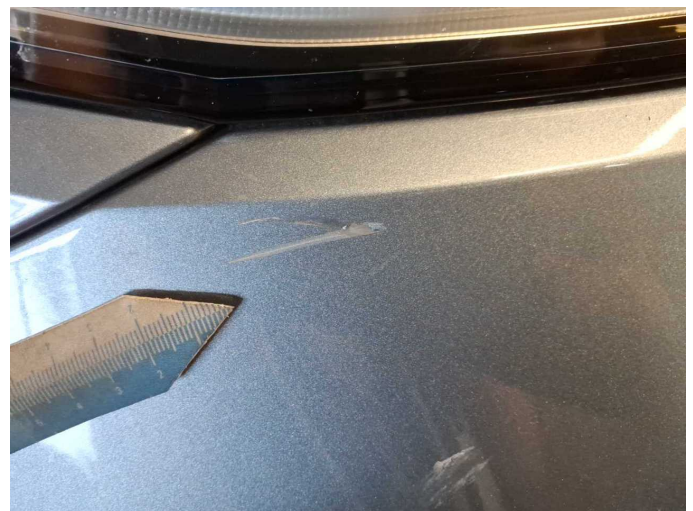
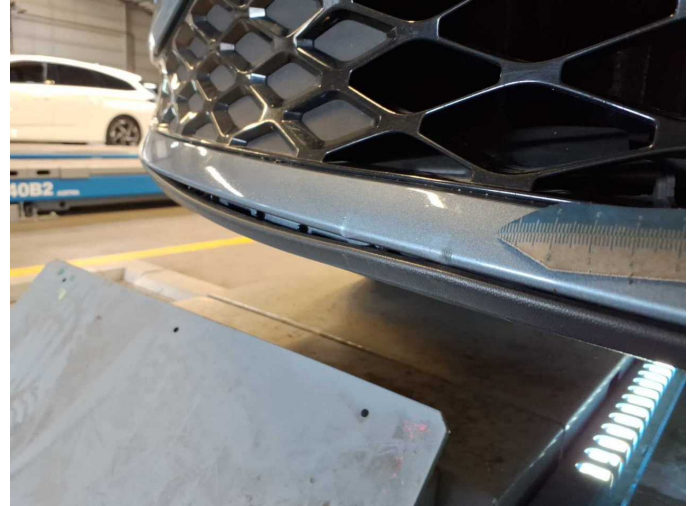
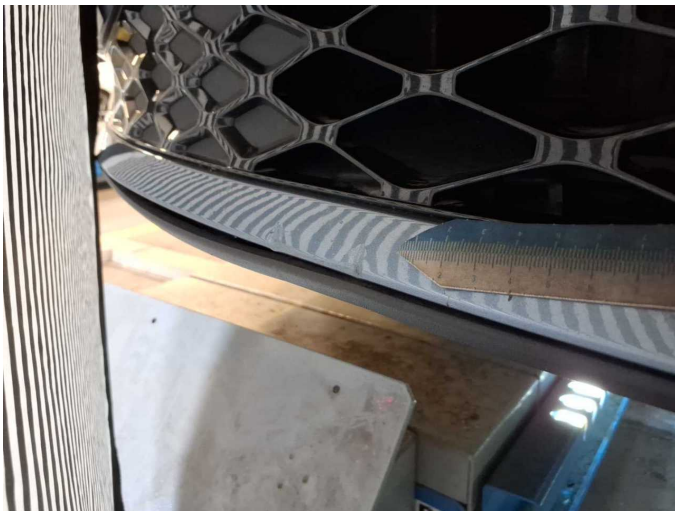
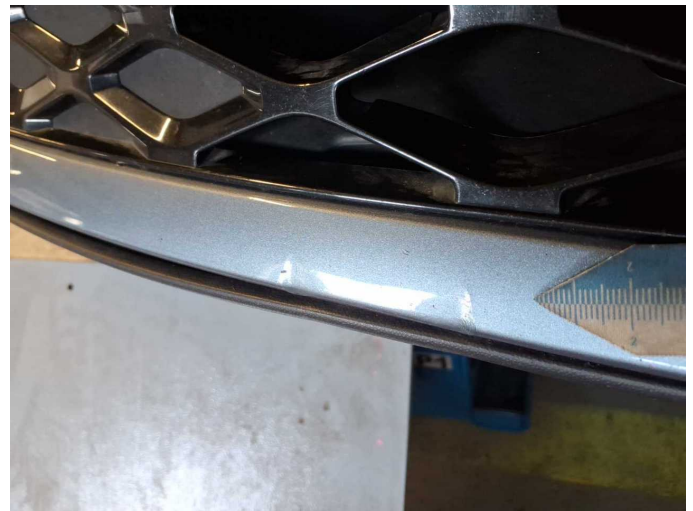
Accident 2: Front

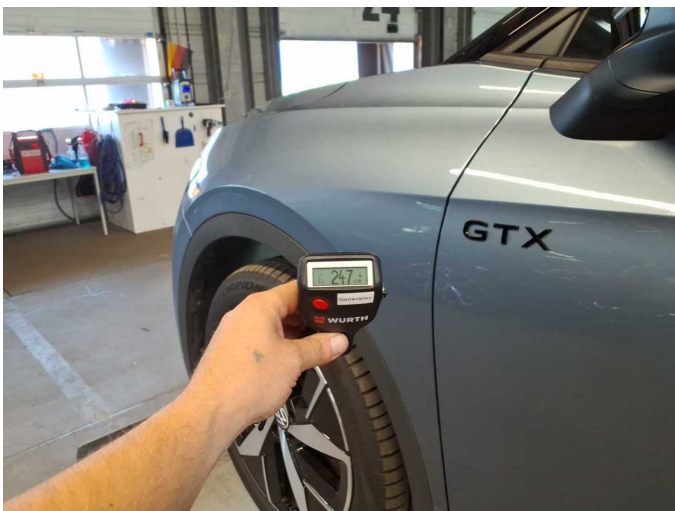
Repainting 1: Mudguard - left side

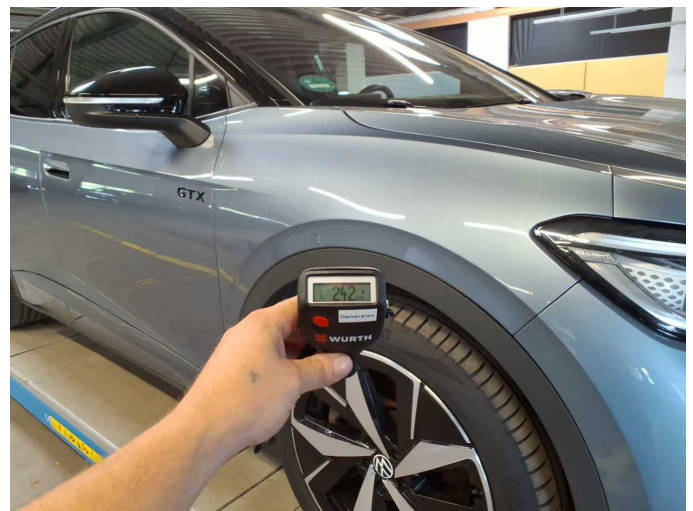
Repainting 2: Mudguard - right side

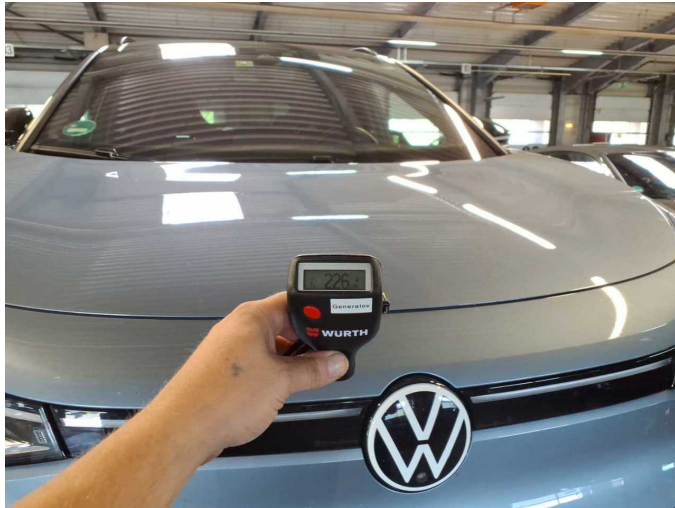
Repainting 3: Bonnet

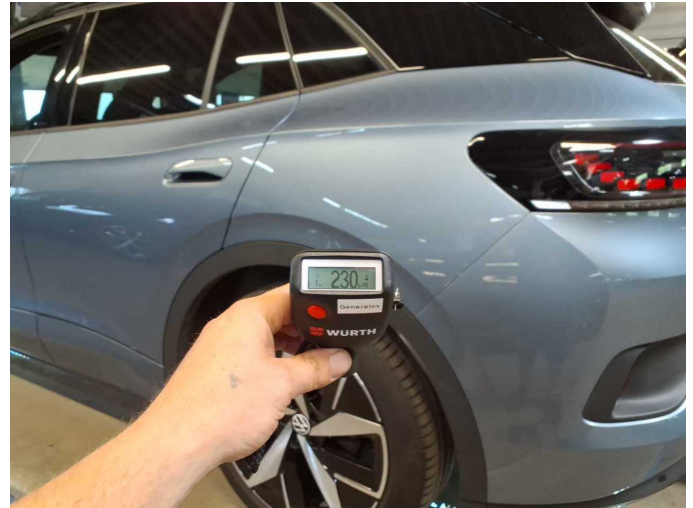
Repainting 4: Side panel - rear left side

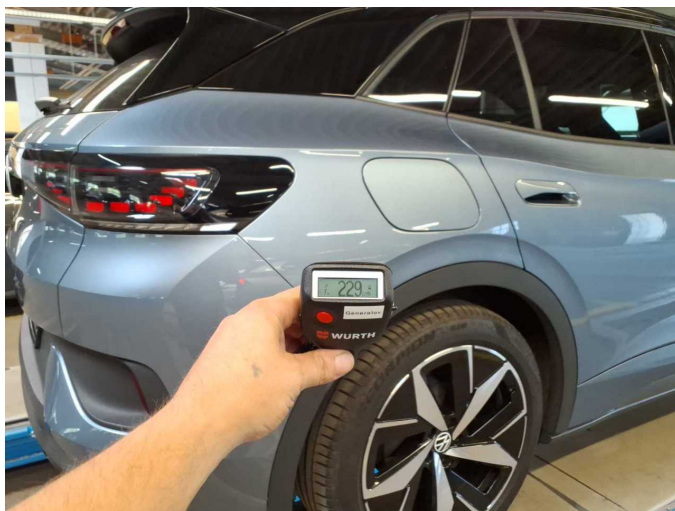
Repainting 5: Side panel - rear right side

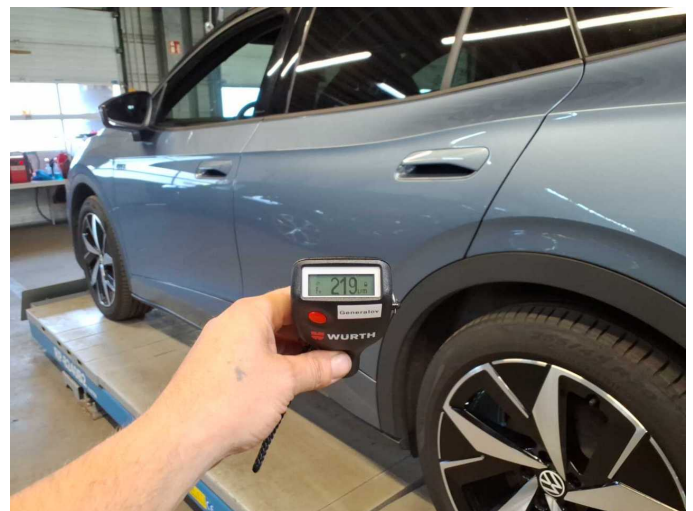
Repainting 6: Door - rear left side

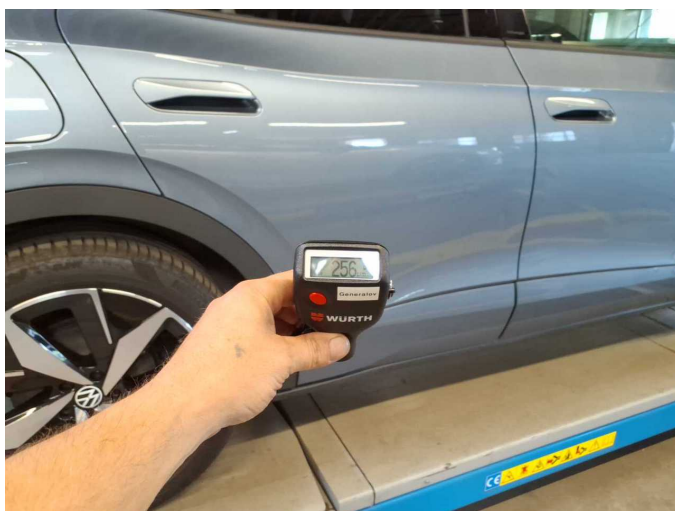
Repainting 7: Door - rear right side

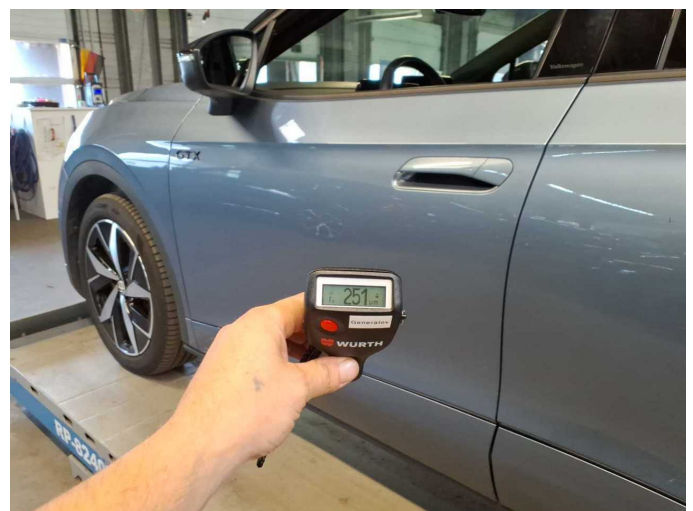
Repainting 8: Door - front left side

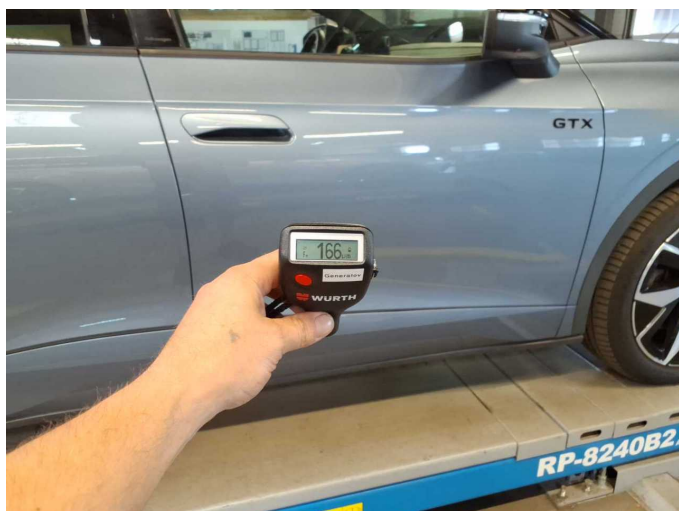
Repainting 9: Door - front right side
