Expertise

Protocol number: 46347864  
Order No. / Reference: 26420376  
Inspection date: 6 Jul 2026

Manufacturer: Peugeot

Model: 3008 BlueHDi 130 Stop & Start Allure

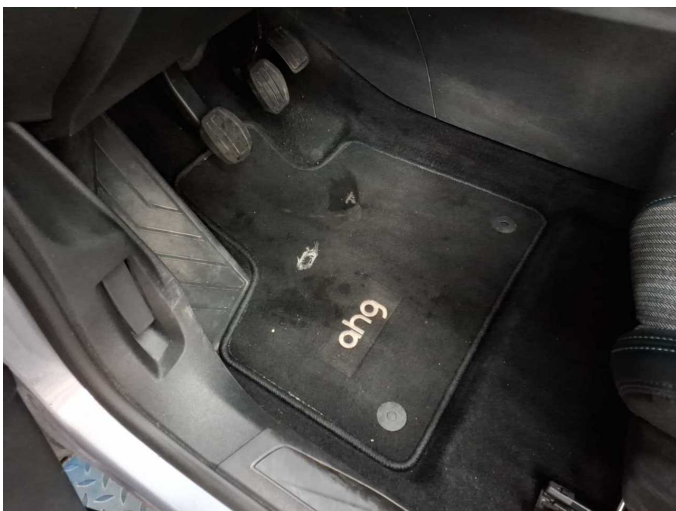
| No. | Component group | Description |
|---|---|---|
| 1 | Trim / covers | Floor mats - Holes - Replace |

Damage 1: Trim / covers: Floor mats - Holes - Replace

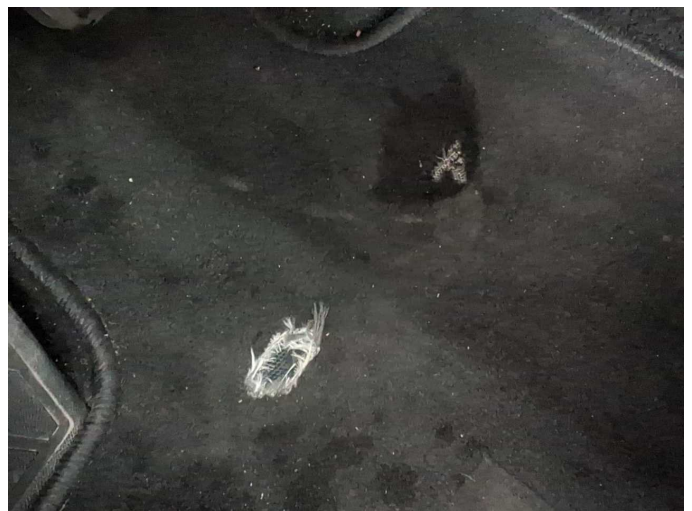
Damage 1: Trim / covers: Floor mats - Holes - Replace

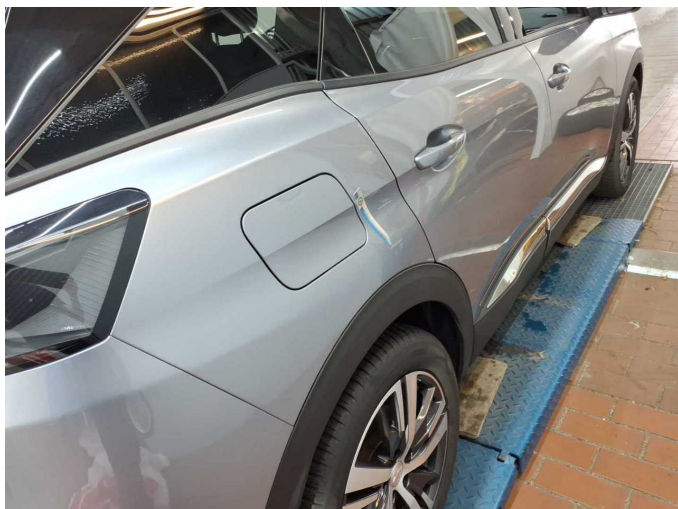
| No. | Component group | Description |
|---|---|---|
| 2 | Side panel - rear right side | Side panel - dent(s) - Smooth repair work |

**Damage 2:** Side panel - rear right side: Side panel - dent(s) - Smooth repair work

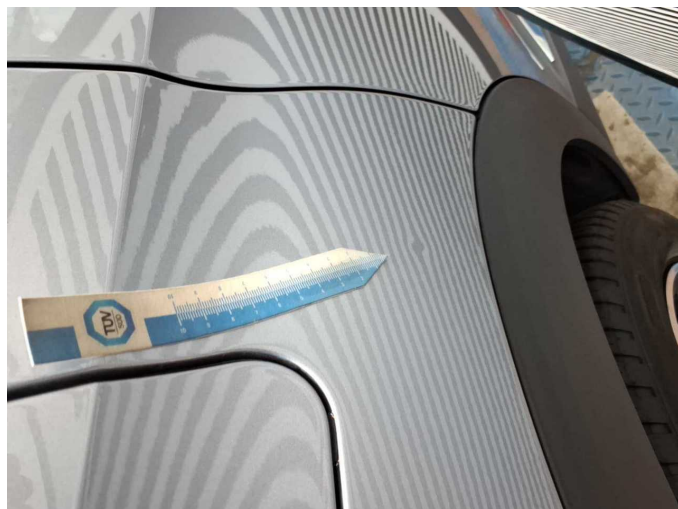
**Damage 2:** Side panel - rear right side: Side panel - dent(s) - Smooth repair work

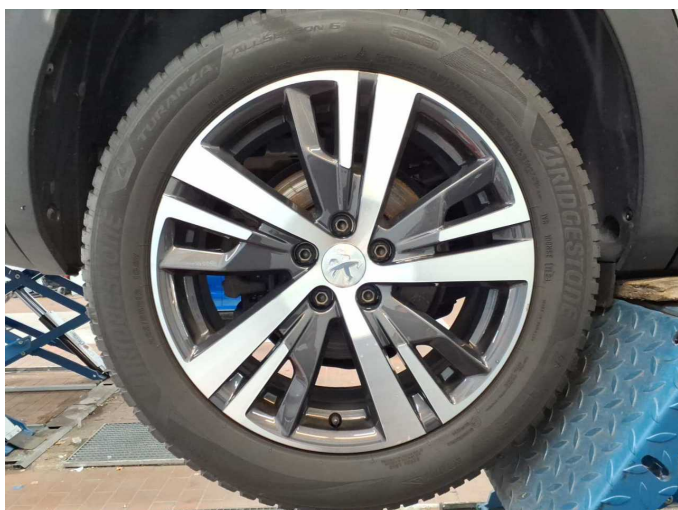
| No. | Component group | Description |
|---|---|---|
| 3 | Wheel / tyres | Alloy rim - rear right side - Scratched - Loss in value |

**Damage 3:** Wheel / tyres: Alloy rim - rear right side - Scratched - Loss in value

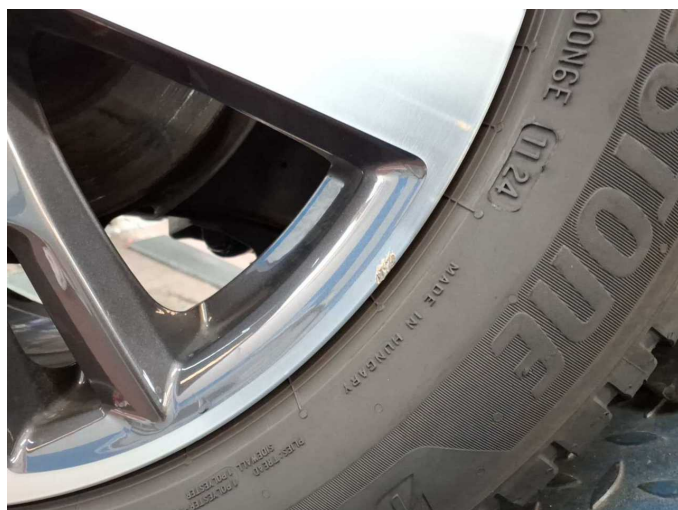
**Damage 3:** Wheel / tyres: Alloy rim - rear right side - Scratched - Loss in value
