Polestar Polestar 2 '19 BEV

Vehicle information

Make:	Polestar	License:	
Gearbox:	Automatic	Body color:	
Model:	Polestar 2 '19 BEV	VIN:	LPSVSECEKNL063135
Fuel type:	Electric	Power:	165 kW
Version:	63kWh Sing.M.St.Ra.	First registration:	28/12/2021
Mileage:	199198 km	N° of doors:

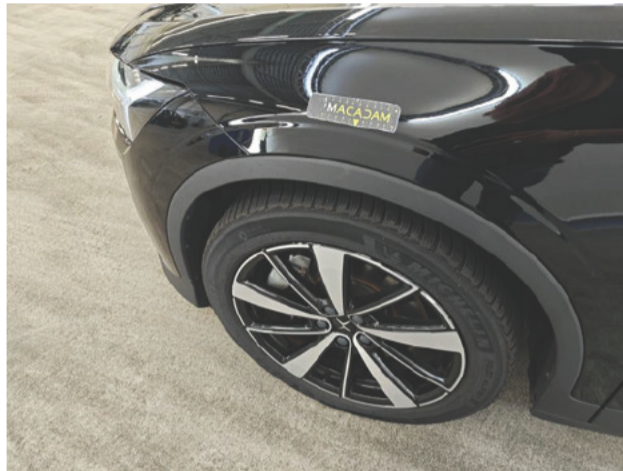
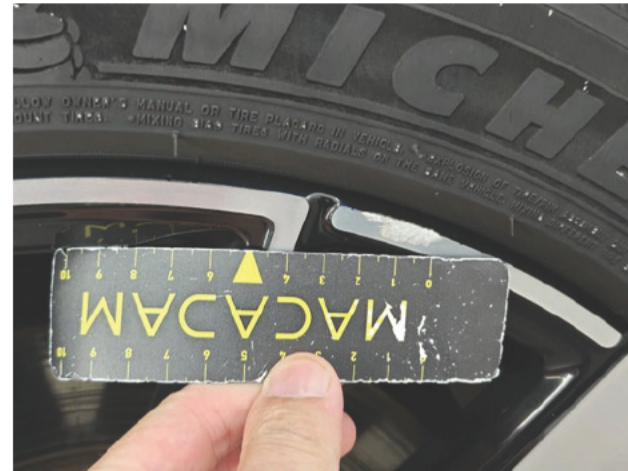
Alloy rim FL

Scratch(es)
Repair and paint (complete)
Left

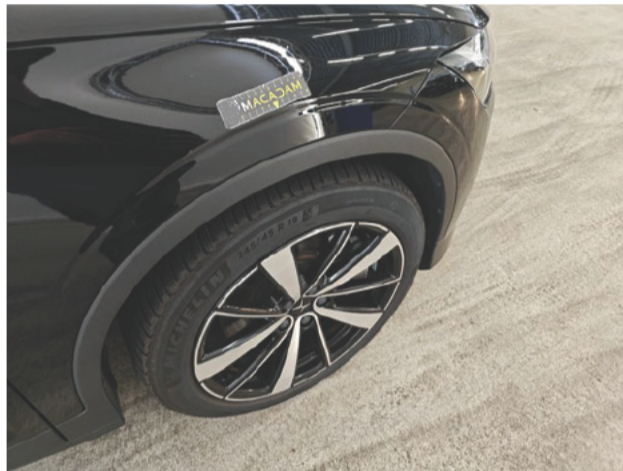
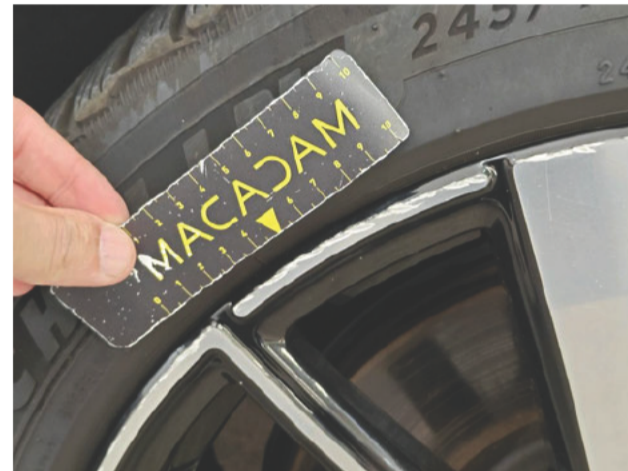
Alloy rim FR

Scratch(es)
Repair and paint (complete)
Right

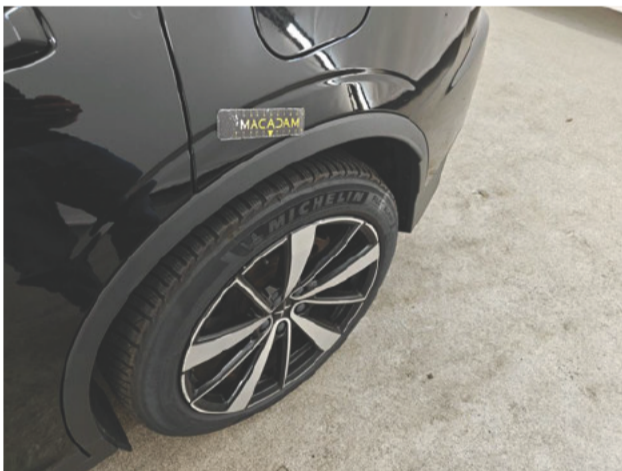
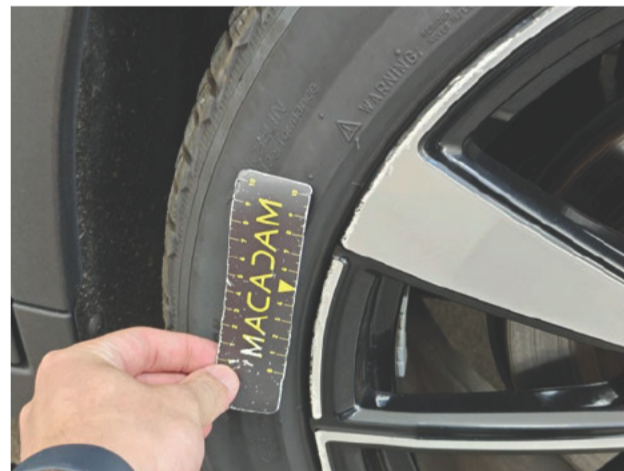
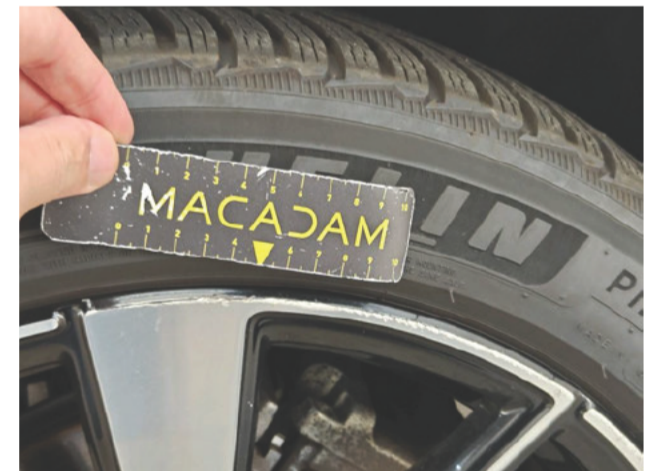
Alloy rim RL

Scratch(es)
Repair and paint (complete)
Left

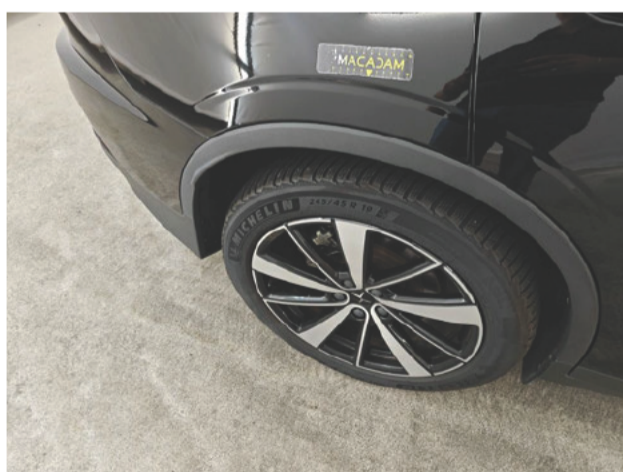
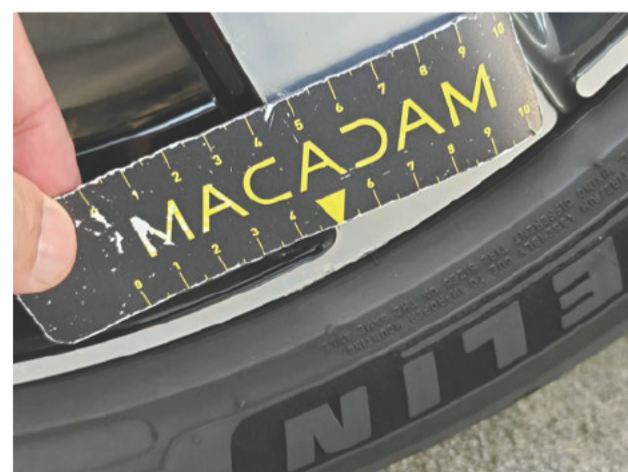
Alloy rim RR

Scratch(es)
Repair and paint (complete)
Right

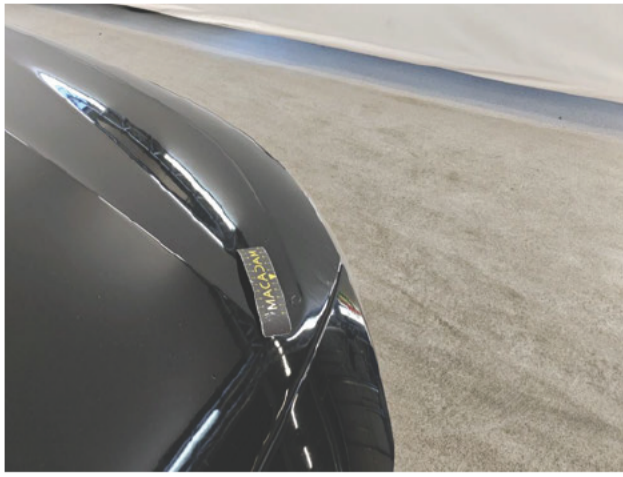
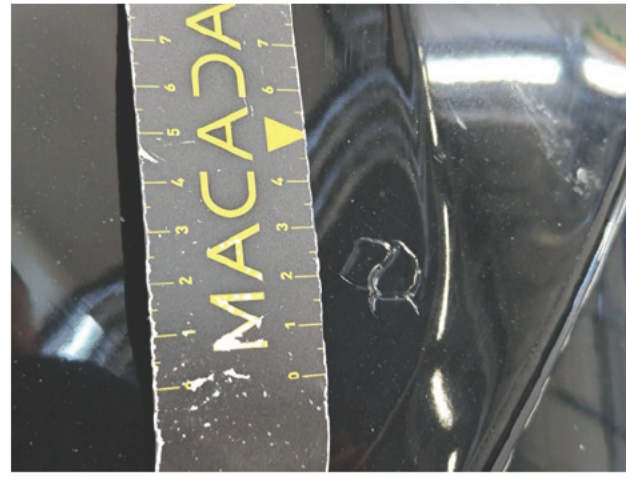
Bonnet
Chemical polution
Repair and paint (complete)
Front

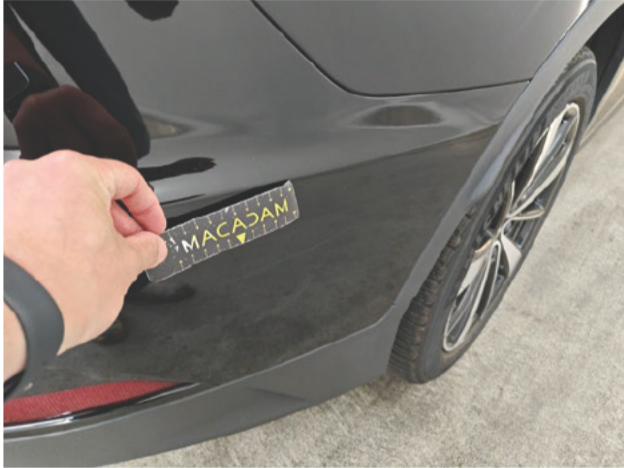
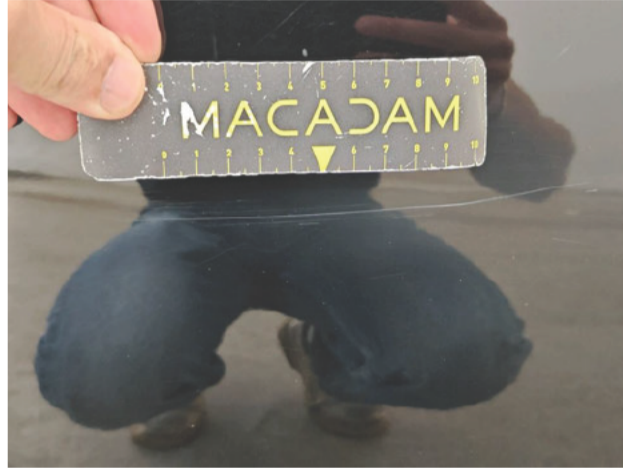
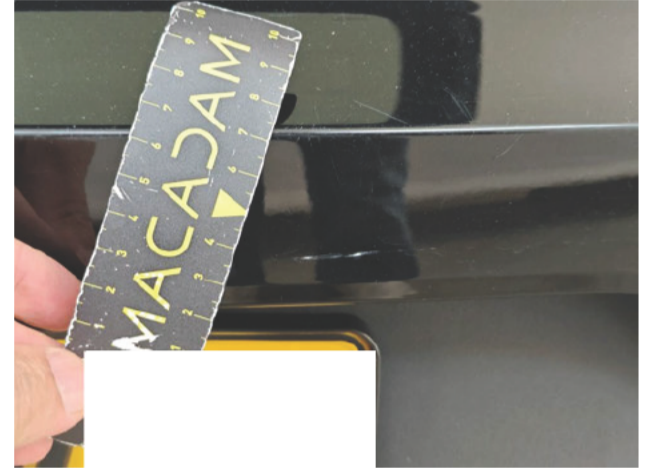
Bumper R
Scratch(es)
Repair and paint (complete)
Rear

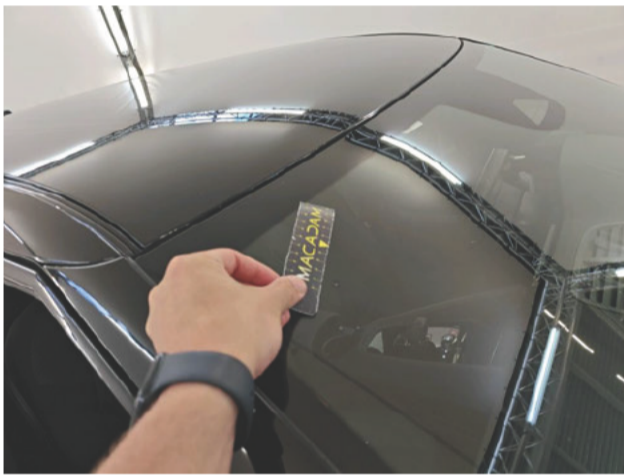
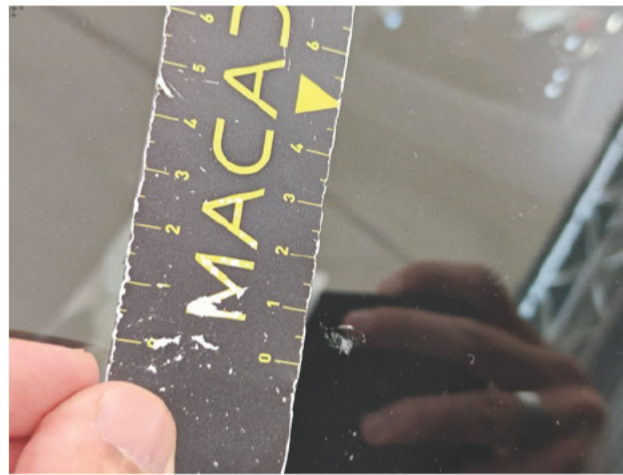
Windscreen
Stone chip(s)
Windscreen repair
Front

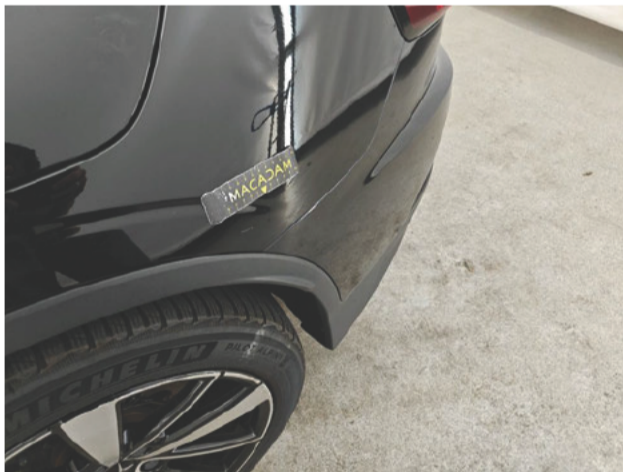
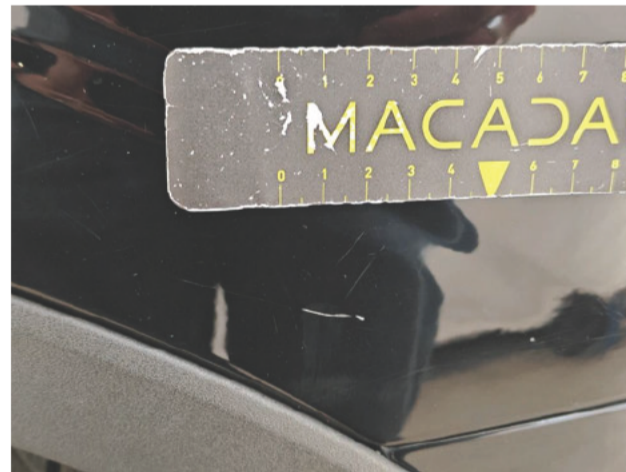
Wing RL
Scratch(es)
Repair and paint (complete)
Left
