Expertise

Protocol number: 46018380
Order No. / Reference: 26153488
Inspection date: 17 Jun 2026

Manufacturer: Mercedes-Benz

Model: 317 CDI Sprinter Standard HA PRO

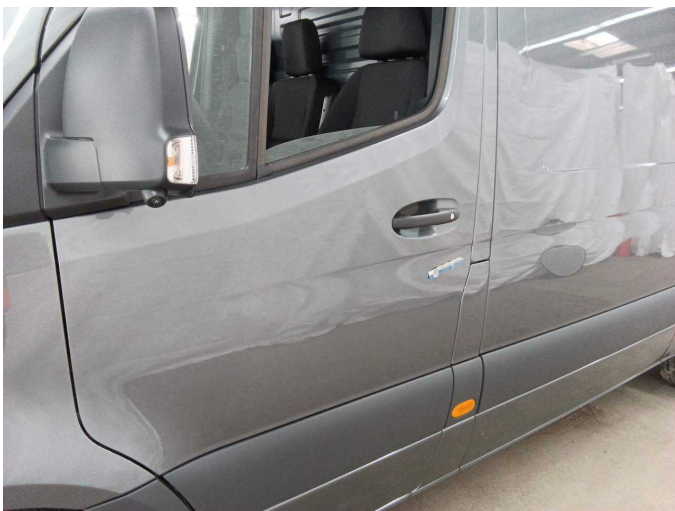
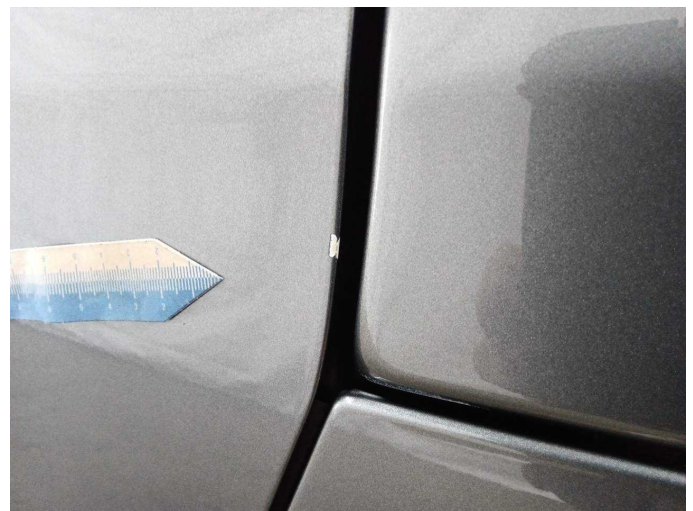
Damage 3: Door - front left side: Door edge - Scratch(es) - Smart repair

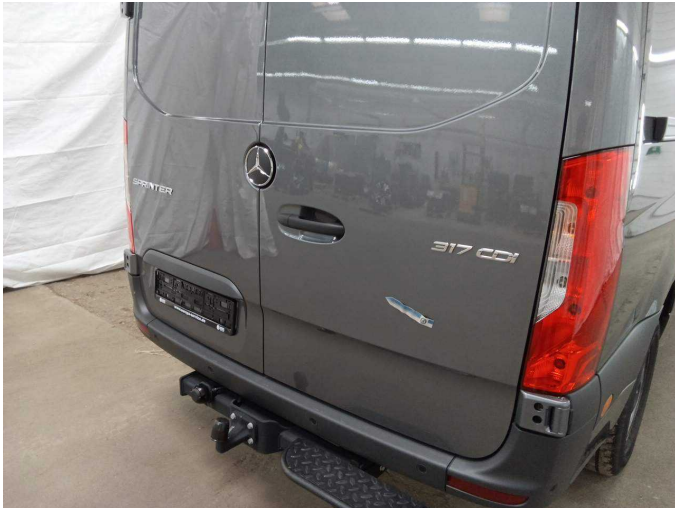
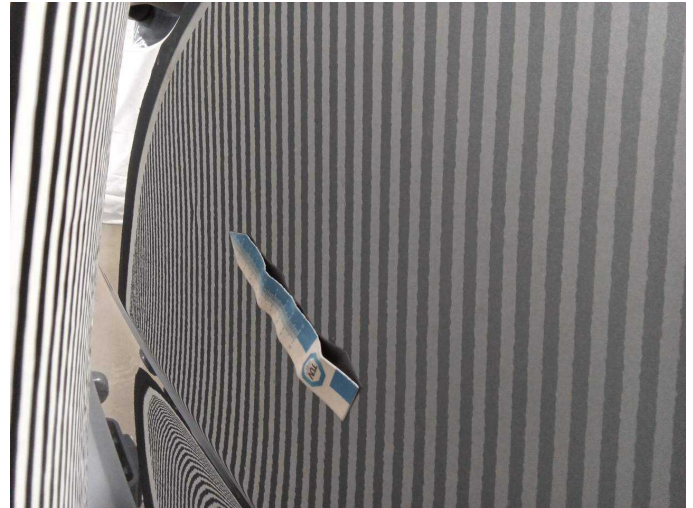
Damage 4: Boot lid / rear door: Rear door - right side - dent(s) - Smooth repair work

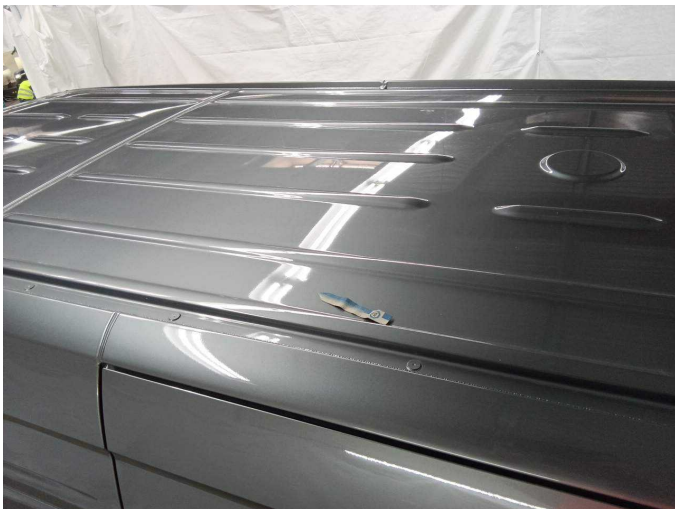
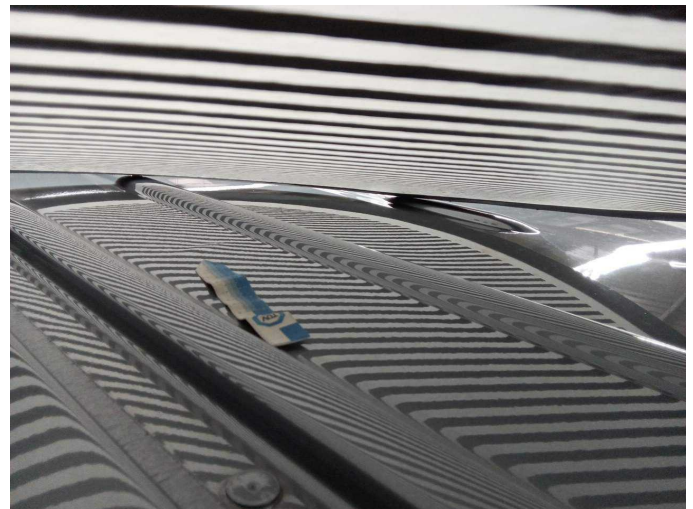
Damage 5: Roof: Roof - dent(s) - Smooth repair work

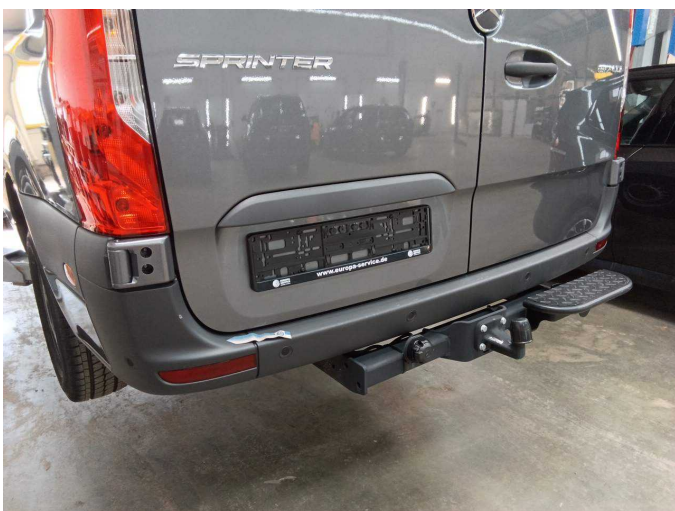
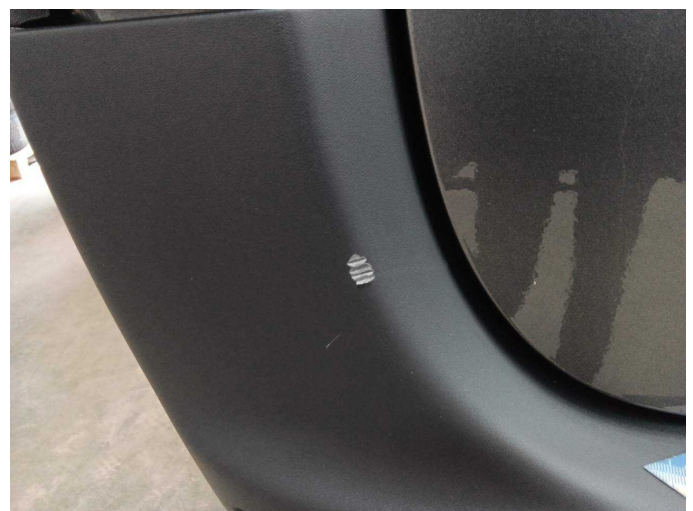
Damage 6: Rear bumper: Rear bumper - Scratch(es) - Smart repair

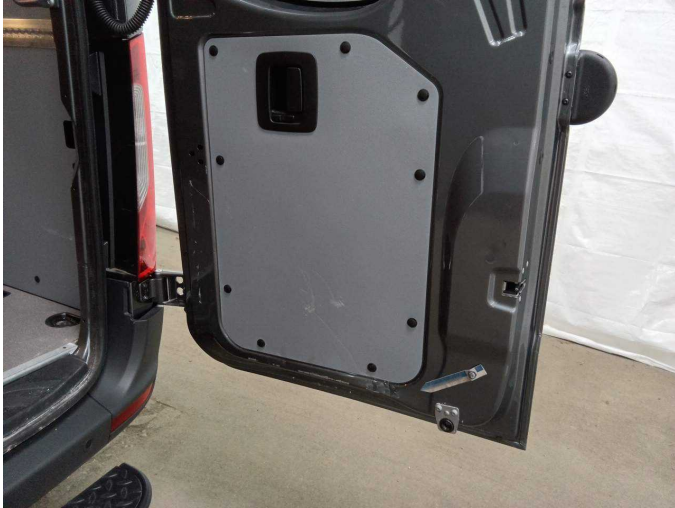
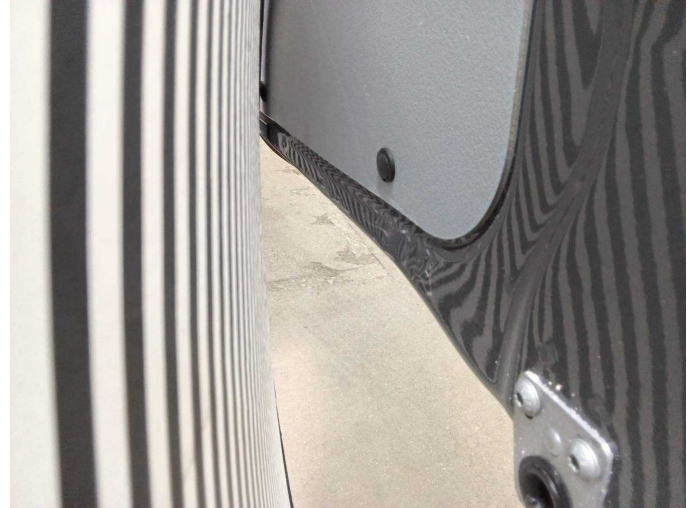
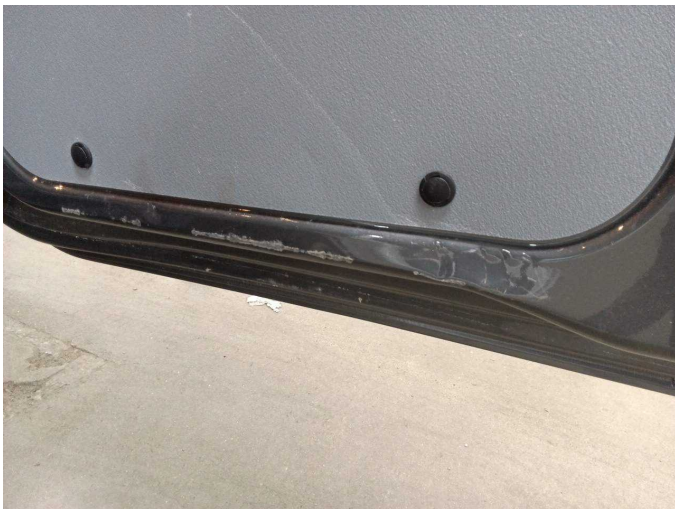
Damage 8: Boot lid / rear door: Rear door - right side (innem) - Dent / paintcoat damage - Smart repair

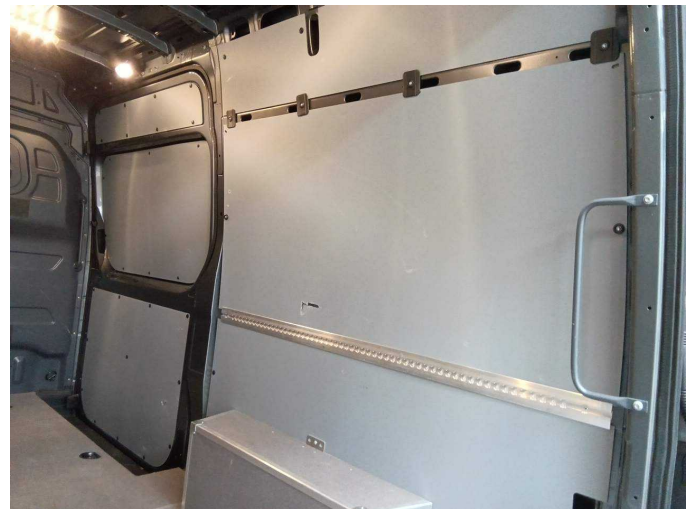
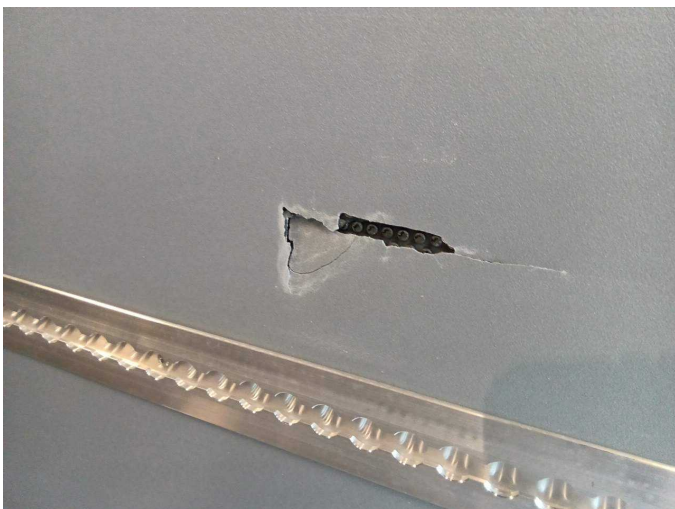
Damage 9: Trim / covers: Cargo area - lining - right side (Mitte) - Broken / torn - Replace

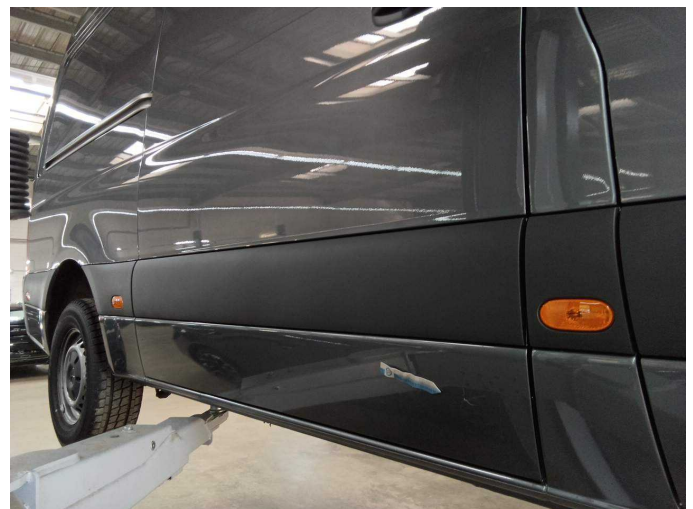
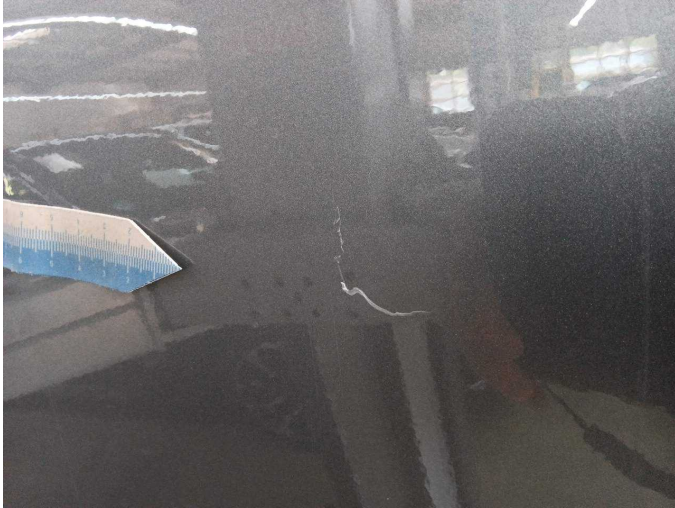
Damage 10: Sliding door, right: Sliding door (Unterhalb) - Scratch(es) - Smart repair
