Expertise

Protocol number: 46602773  
Order No. / Reference: 26719983  
Inspection date: 14 Jul 2026

Manufacturer: Skoda  
VIN: TMBLN7NSXP8052121

Model: Kodiaq 2.0 TDI 4x4 DSG Style

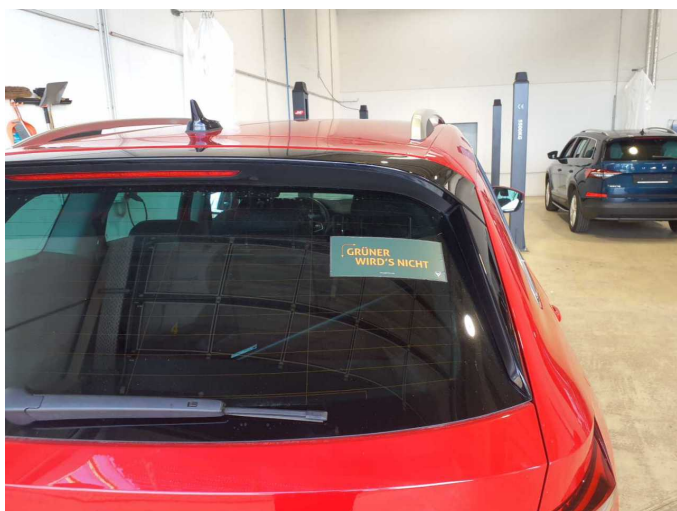
| No. | Component group | Description |
|---|---|---|
| 2 | Vehicle glazing | Rear window - Glued / labelled - De-glue / neutralise |

**Damage 2:** Vehicle glazing: Rear window - Glued / labelled - De-glue / neutralise

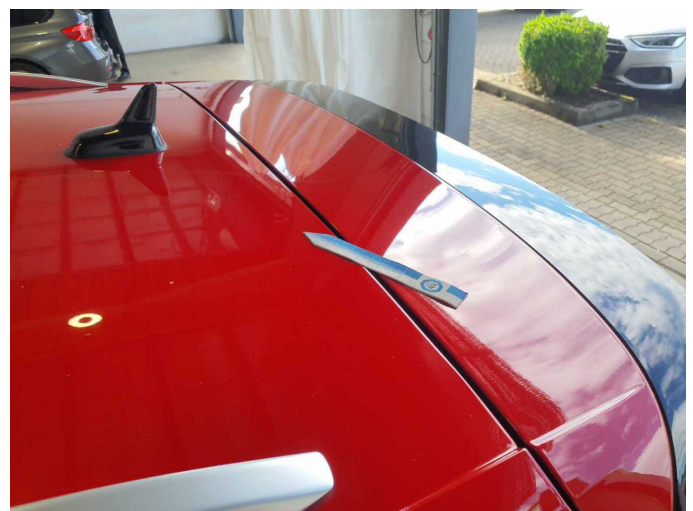
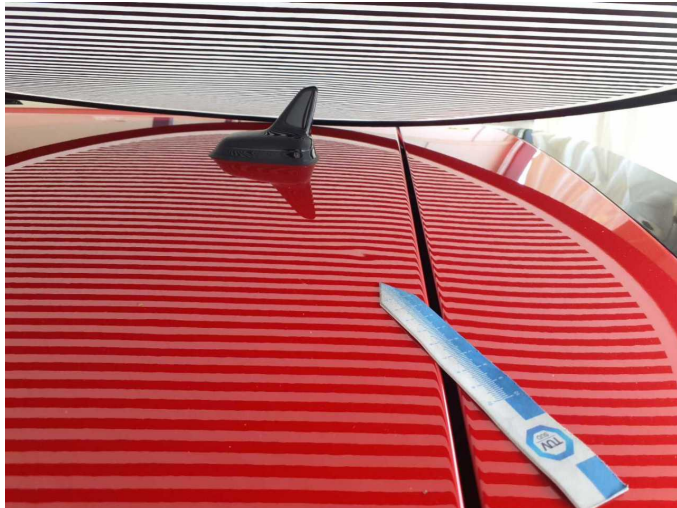
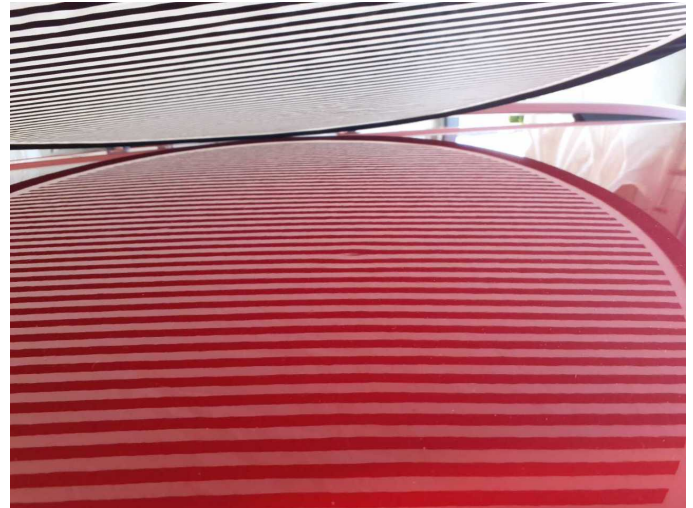
| No. | Component group | Description |
|---|---|---|
| 3 | Roof | Roof - dent(s) - Smooth repair work |

**Damage 3:** Roof: Roof - dent(s) - Smooth repair work

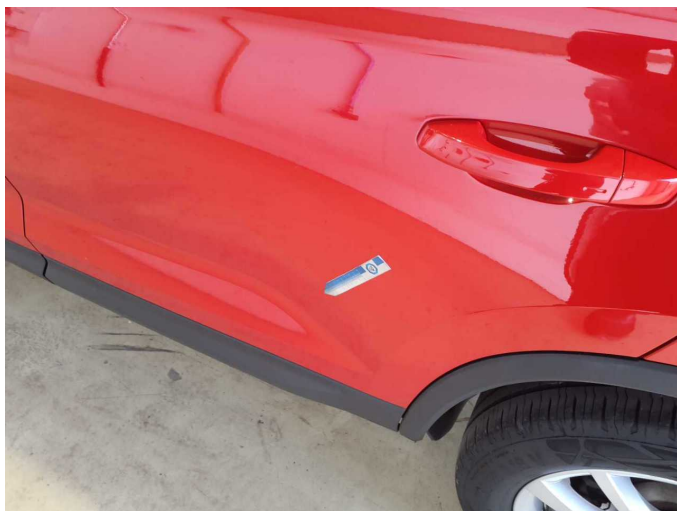
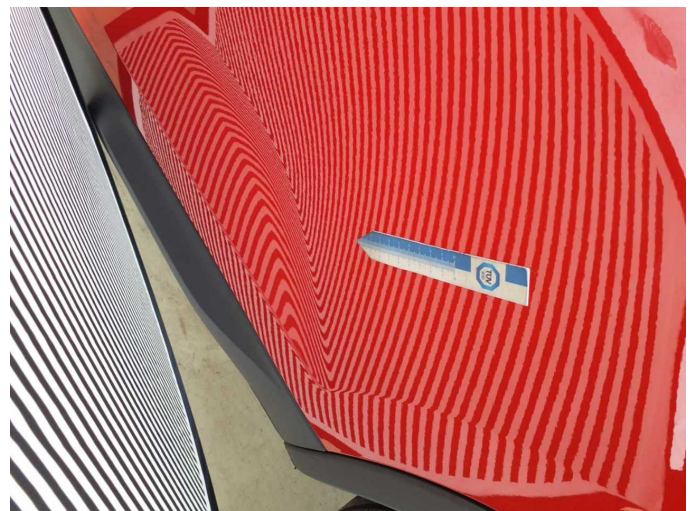
| No. | Component group | Description |
|---|---|---|
| 4 | Door - rear left side | Door - dent(s) - Smooth repair work |

**Damage 4:** Door - rear left side: Door - dent(s) - Smooth repair work

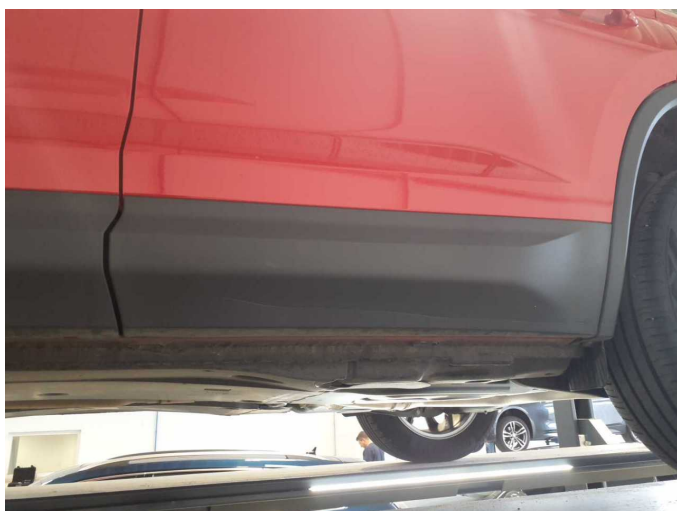
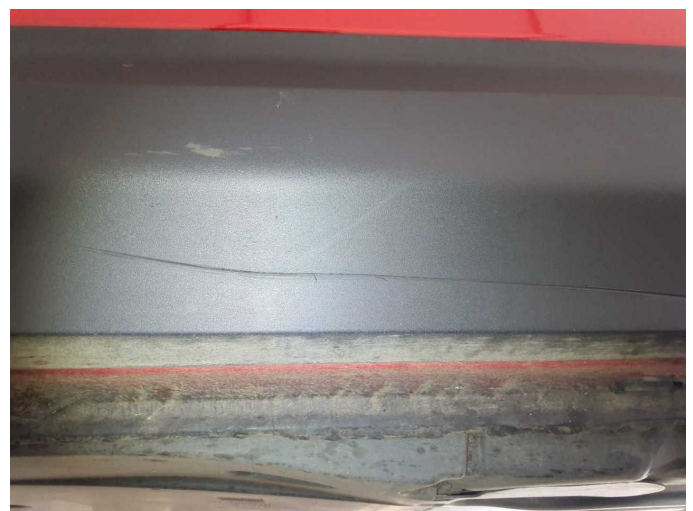
| No. | Component group | Description |
|---|---|---|
| 6 | Door - rear left side | Brightware - lower - Scratch(es) - Replace |

**Damage 6:** Door - rear left side: Brightware - lower - Scratch(es) - Replace

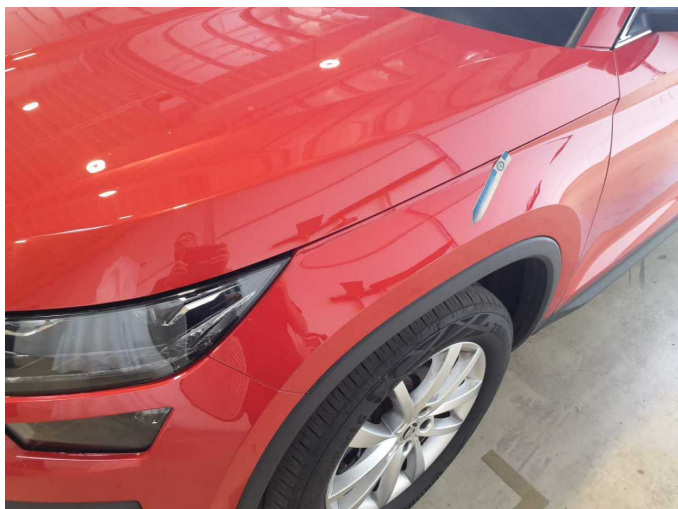
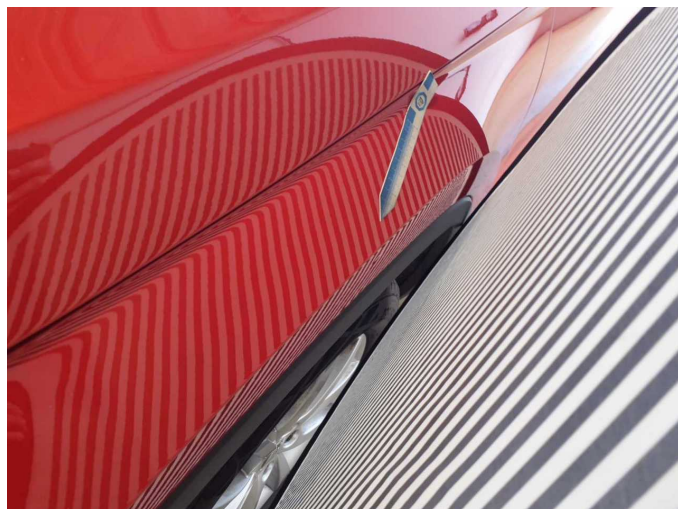
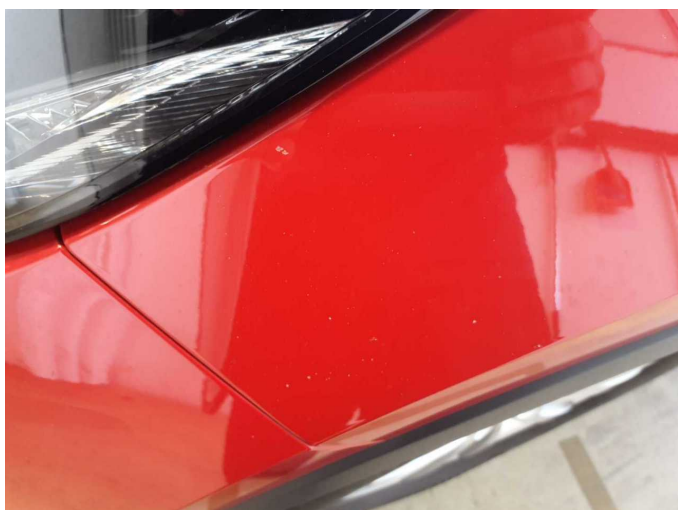
| No. | Component group | Description |
|---|---|---|
| 7 | Mudguard - left side | Mudguard - left side - Dent / paintcoat damage - Repair and paint |

**Damage 7:** Mudguard - left side: Mudguard - left side - Dent / paintcoat damage - Repair and paint

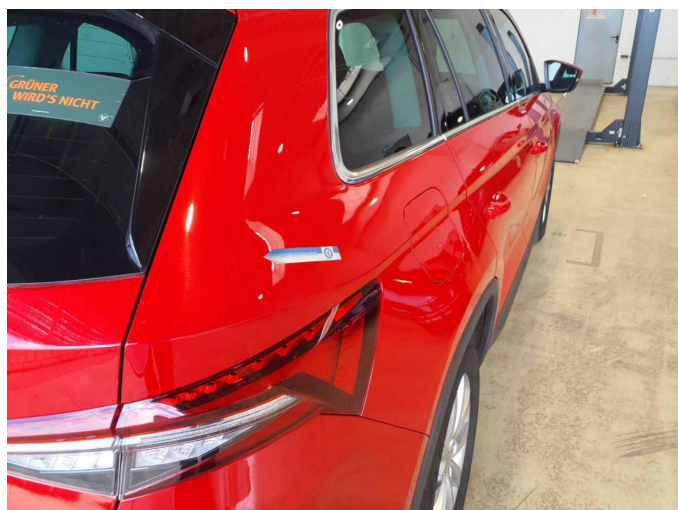
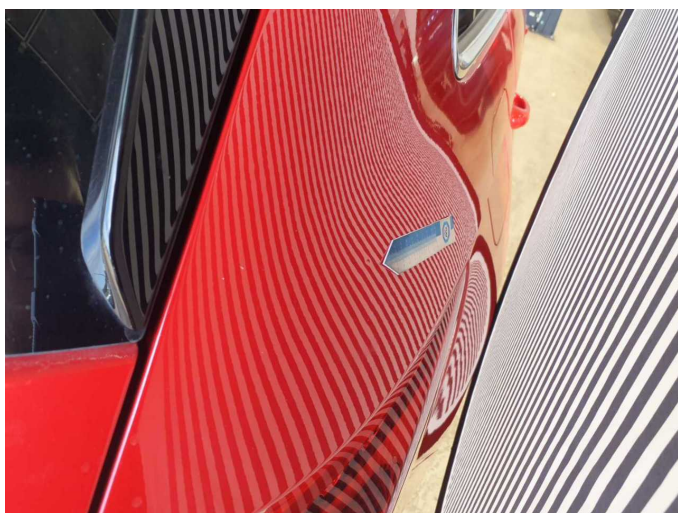
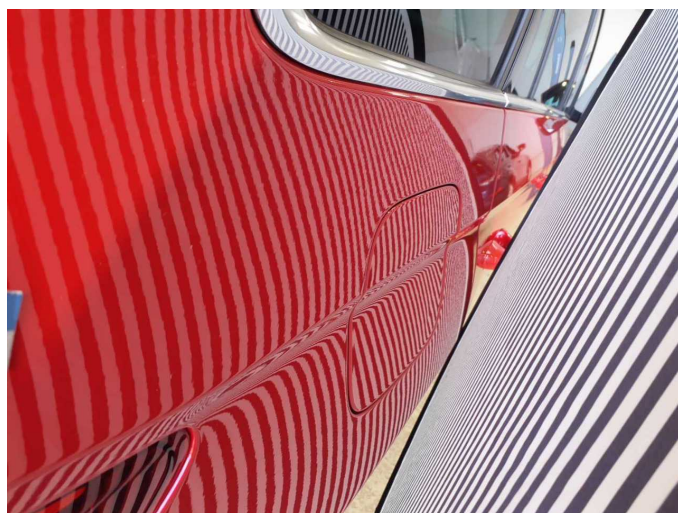
| No. | Component group | Description |
|---|---|---|
| 8 | Side panel - rear right side | Side panel (Einschlüsse) - Unprofessionally repaired - Repair and paint |

| Side panel - rear left side | 209 µm | Side panel - rear right side | 302 µm |

**Damage 8:** Side panel - rear right side: Side panel (Einschlüsse) - Unprofessionally repaired - Repair and paint

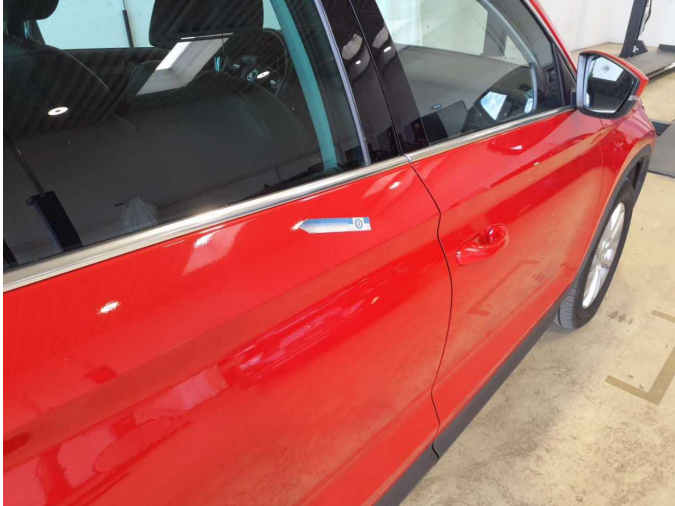
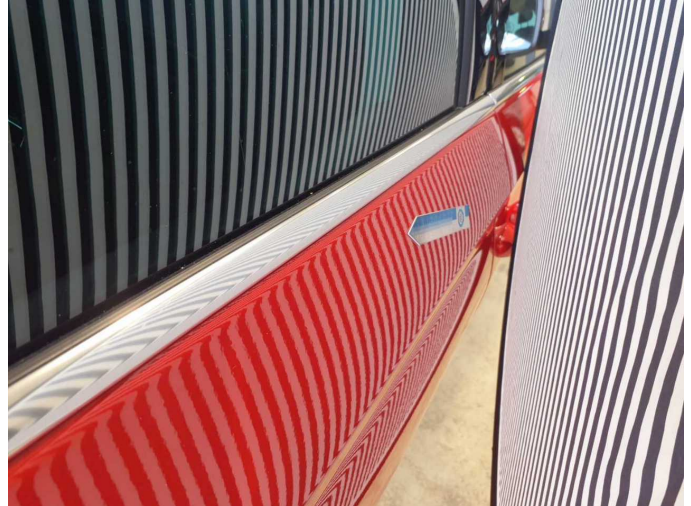
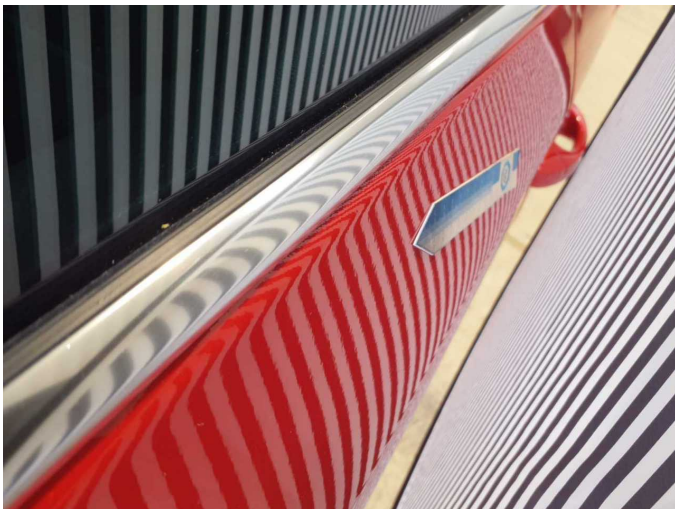
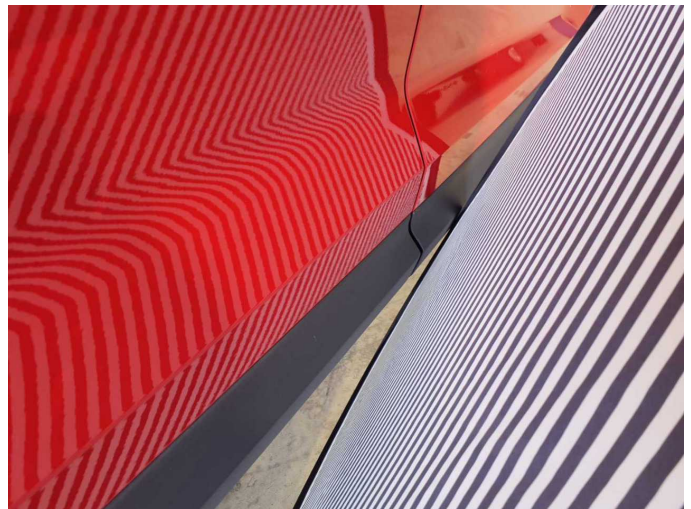
| No. | Component group | Description |
|---|---|---|
| 9 | Door - rear right side | Door (Einschlüsse) - Unprofessionally repaired - Repair and paint |

| Door - rear left side | 168 µm | Door - rear right side | 204 µm |

**Damage 9:** Door - rear right side: Door (Einschlüsse) - Unprofessionally repaired - Repair and paint

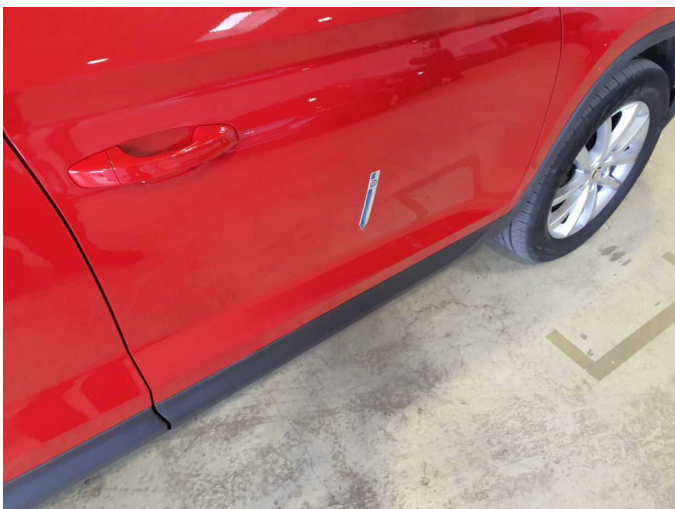
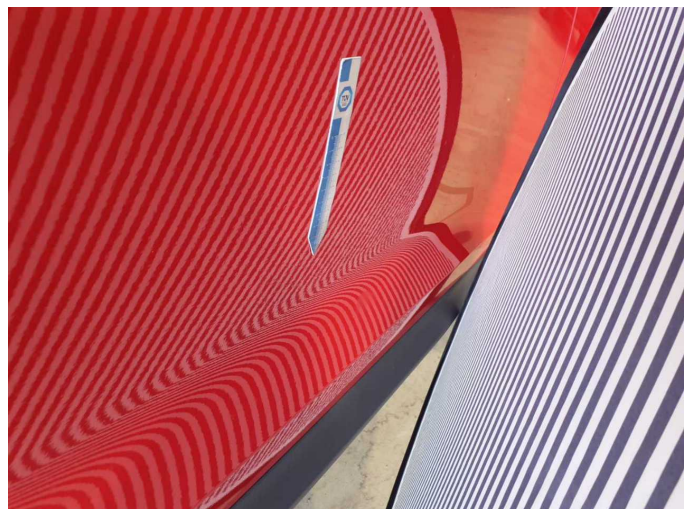
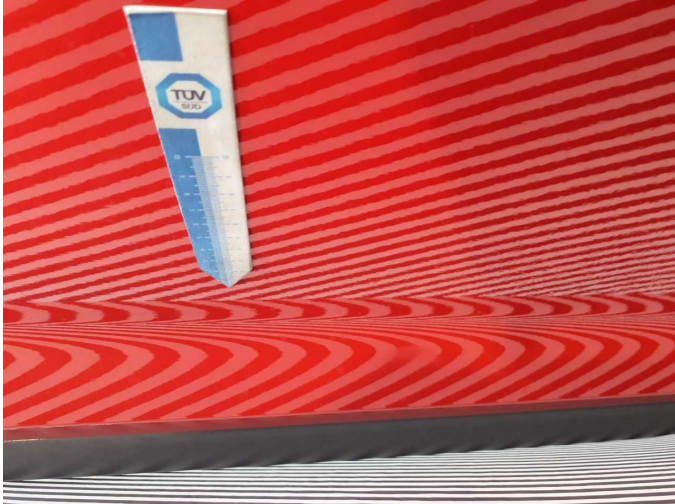
| No. | Component group | Description |
|---|---|---|
| 10 | Door - front right side | Door (Orangenhaut, Einschlüsse) - Unprofessionally repaired - Repair and paint |

| Door - front right side | 242 µm | | |

**Damage 10:** Door - front right side: Door (Orangenhaut, Einschlüsse) - Unprofessionally repaired - Repair and paint

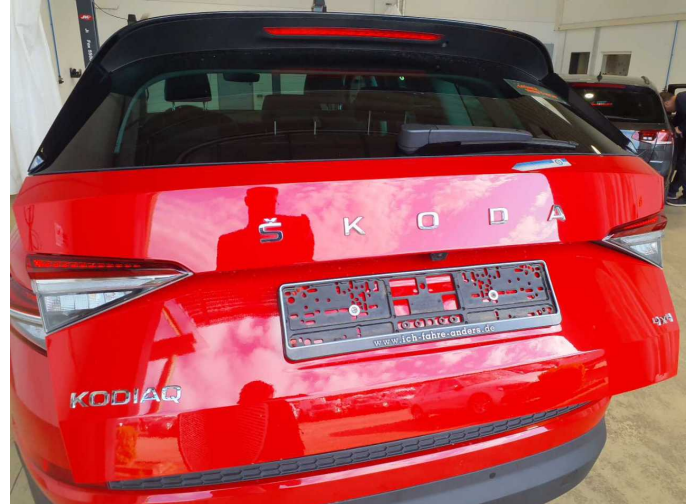
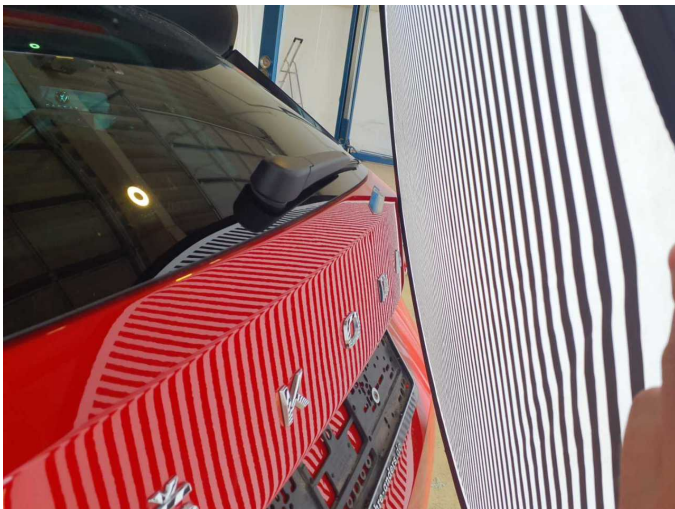
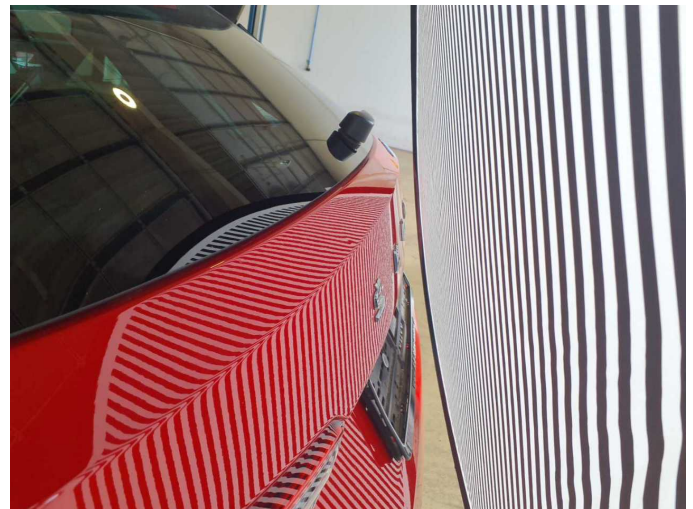
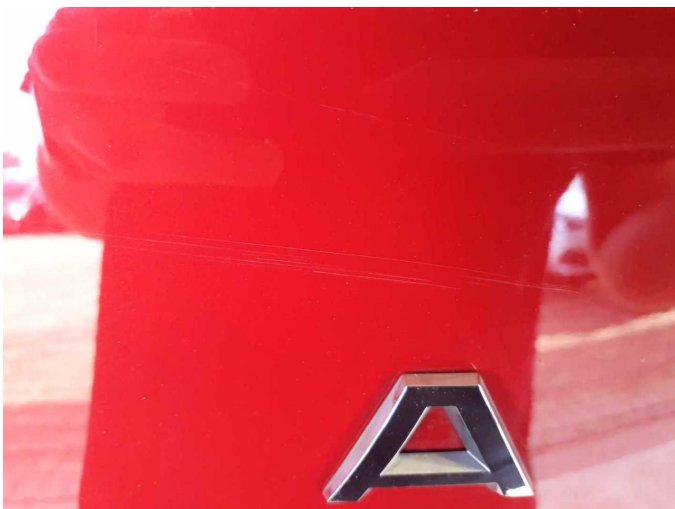
| No. | Component group | Description |
|---|---|---|
| 11 | Boot lid / rear door | Boot lid - Dent / paintcoat damage - Repair and paint |

**Damage 11:** Boot lid / rear door: Boot lid - Dent / paintcoat damage - Repair and paint

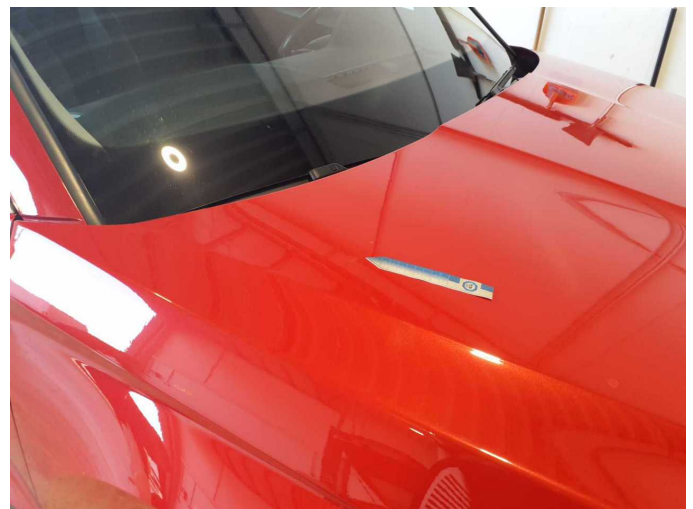
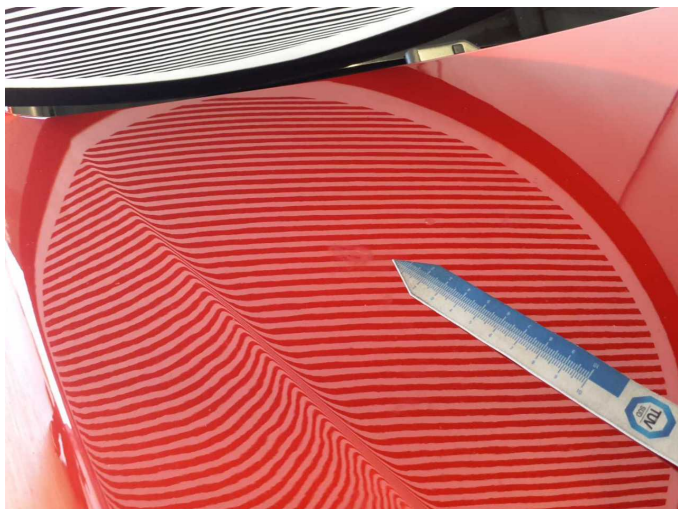
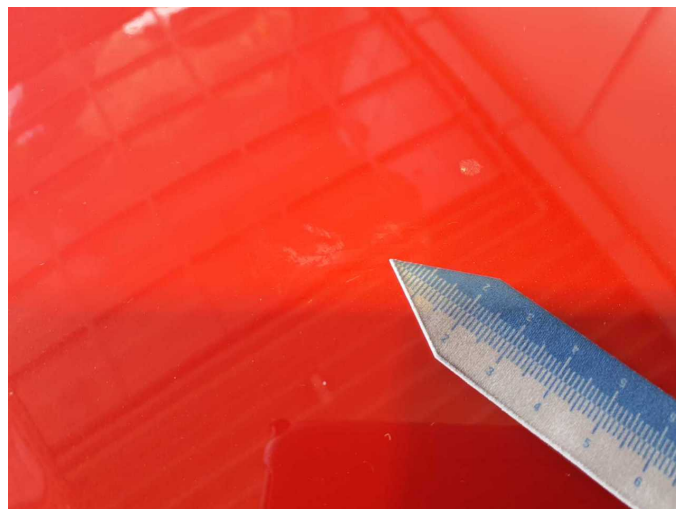
| No. | Component group | Description |
|---|---|---|
| 12 | Bonnet | Bonnet (Anätzung) - Paint defect - Repair and paint |

| Boot lid / rear door | 199 µm | Bonnet | 357 µm |

**Damage 12:** Bonnet: Bonnet (Anätzung) - Paint defect - Repair and paint

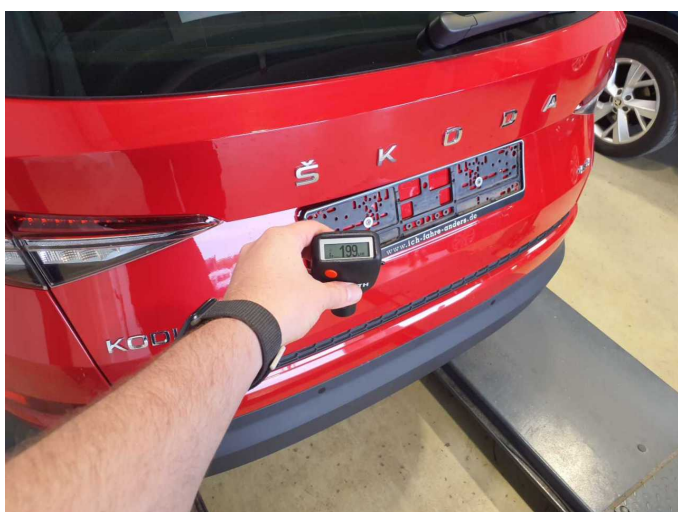
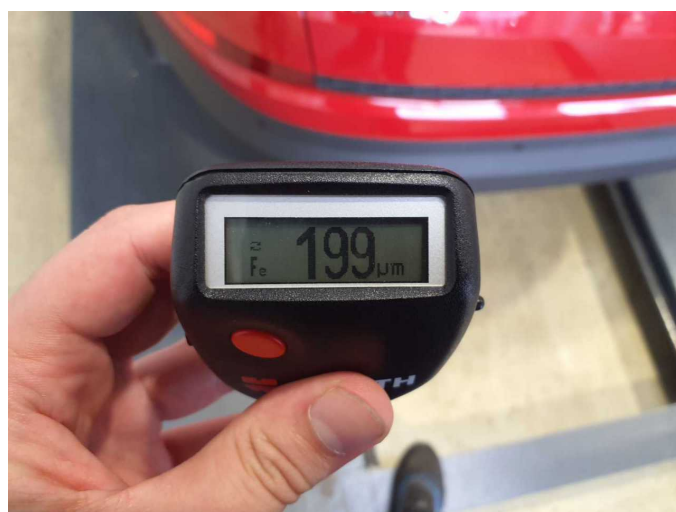
**Repainting 1:** Boot lid / rear door

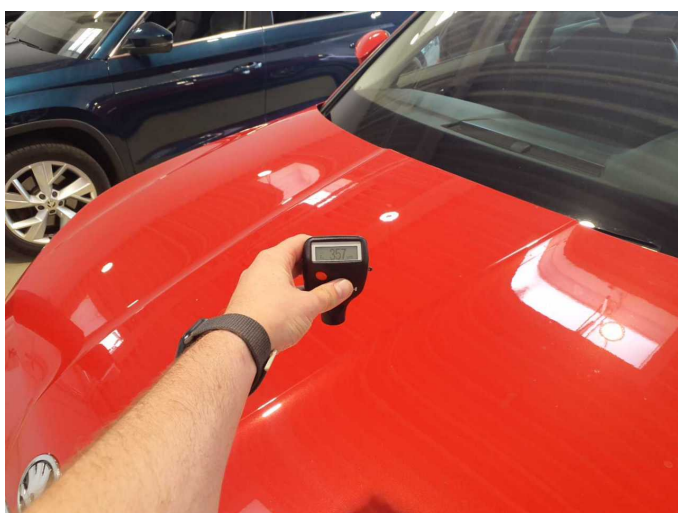
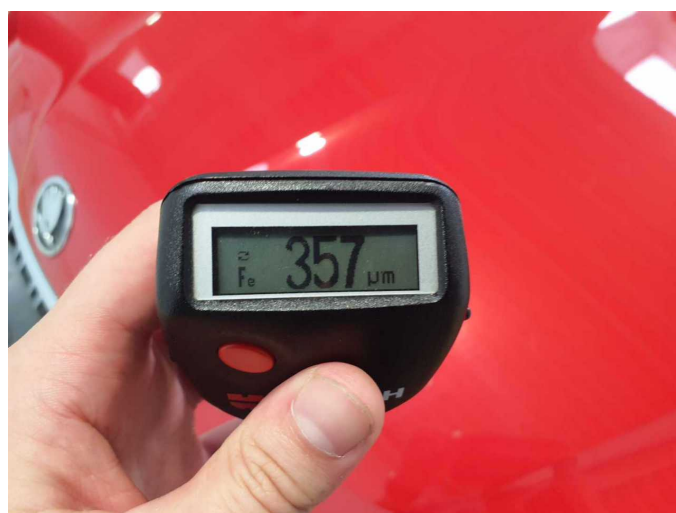
**Repainting 2:** Bonnet

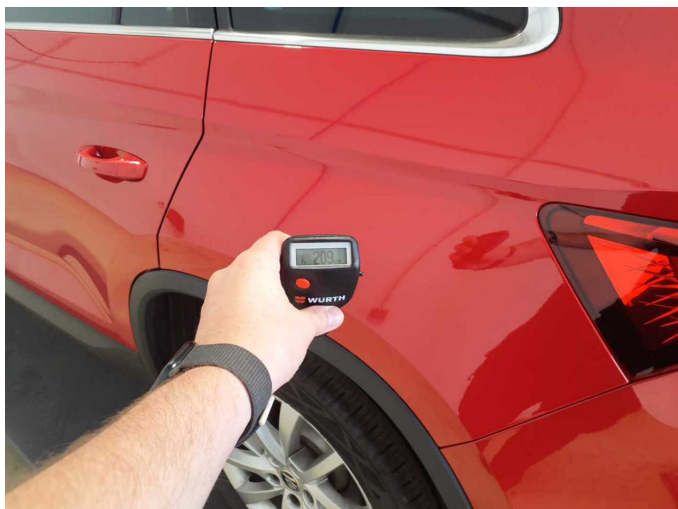
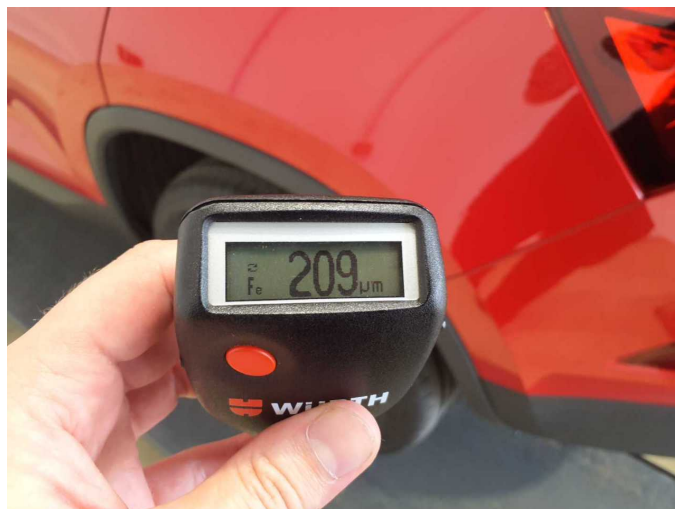
**Repainting 3:** Side panel - rear left side

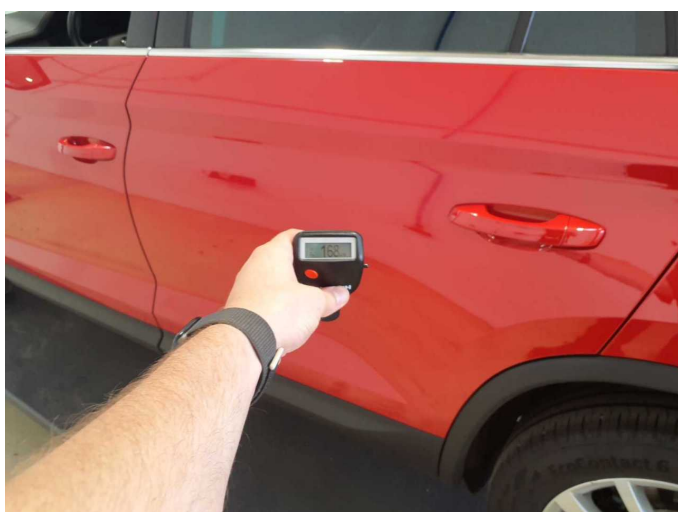
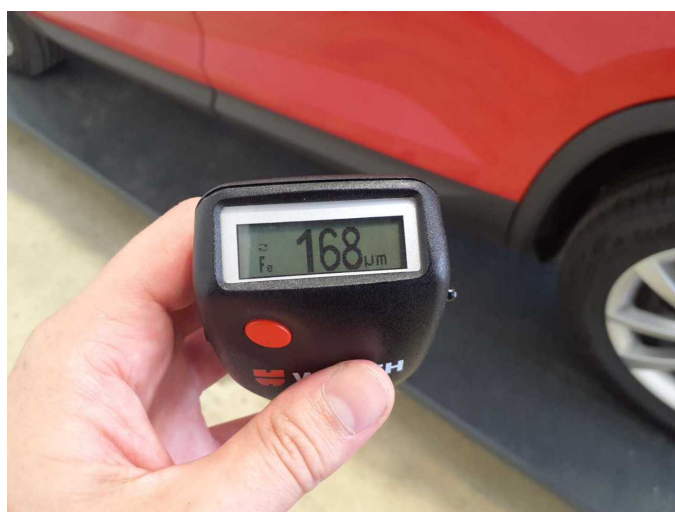
**Repainting 4:** Door - rear left side

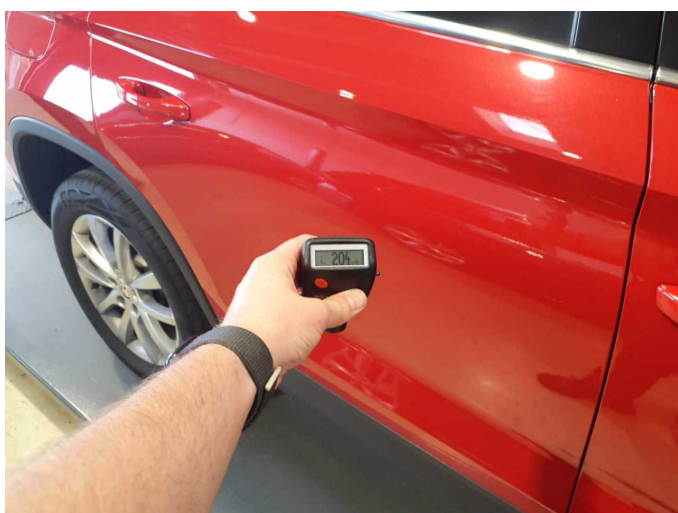
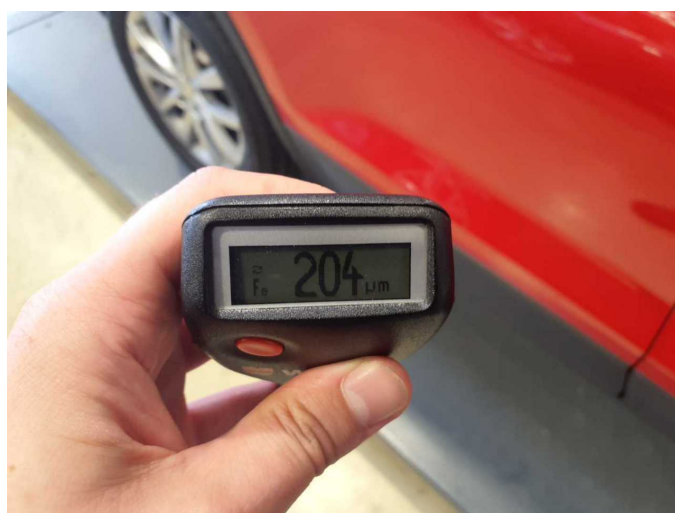
**Repainting 5:** Door - rear right side

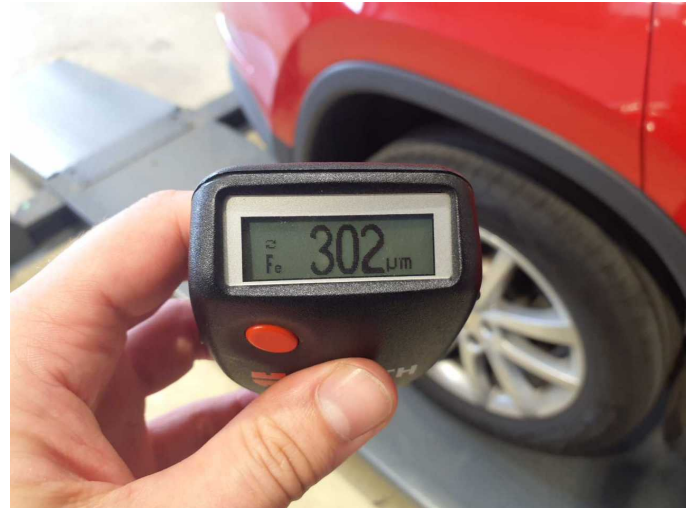
**Repainting 6:** Side panel - rear right side

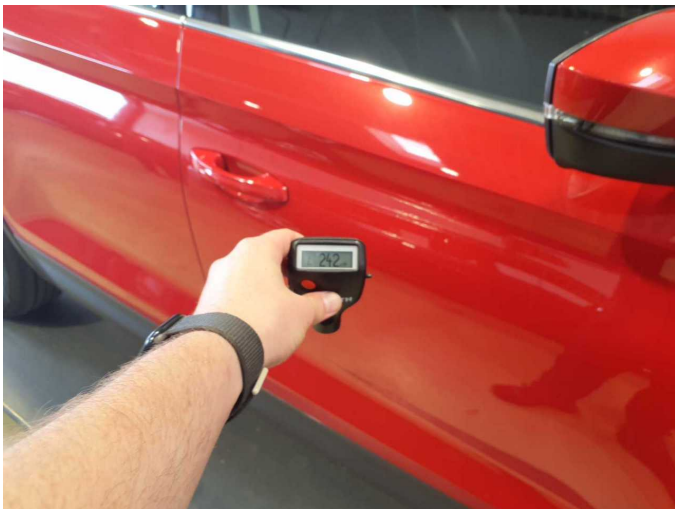
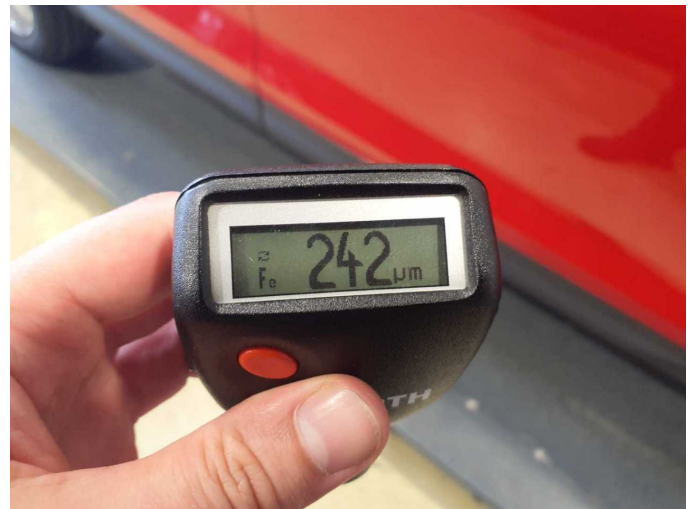
**Repainting 7:** Door - front right side
