Expertise

Protocol number: 46867776  
Order No. / Reference: 26715258  
Inspection date: 3 Aug 2026

Model: Arona 1.0 TSI OPF Style

VIN: VSSZZKJZNR043302

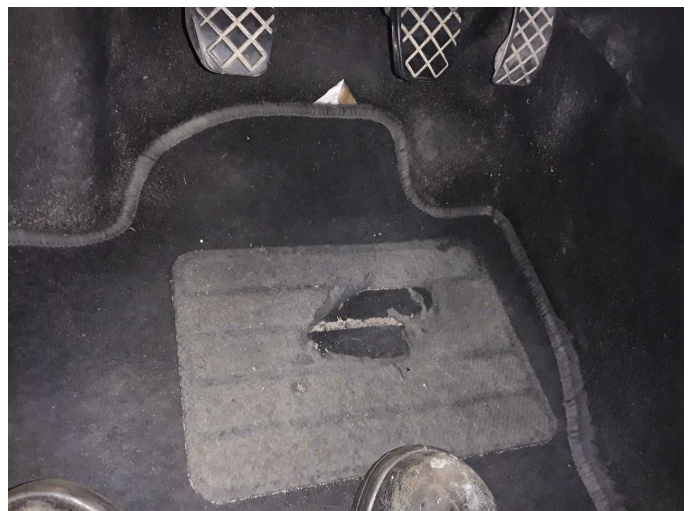
| No. | Component group | Description |
|---|---|---|
| 1 | Trim / covers | Floor mats - Damaged - Replace |

**Damage 1:** Trim / covers: Floor mats - Damaged - Replace

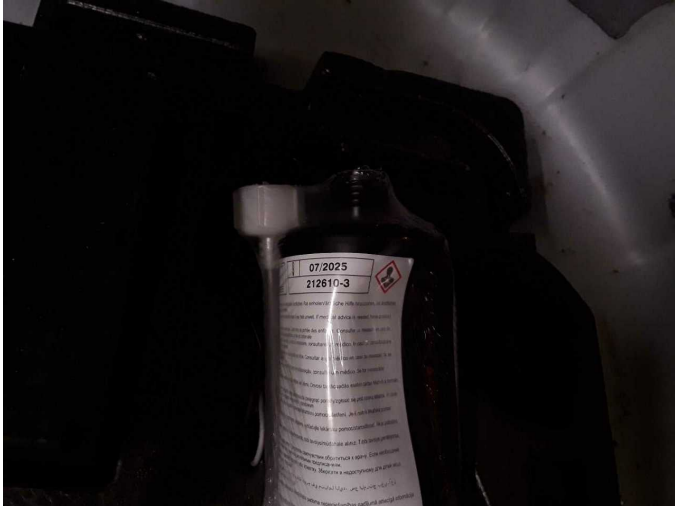
| Typ | Tyre size | Type of tyre | Manufacturer | Tread depth |
|---|---|---|---|---|
| | Tirefit | Expiration date 07/2025 | | |

| No. | Component group | Description |
|---|---|---|
| 2 | Equipment | Tirefit filler - Expired - Replace |

**Damage 2:** Equipment: Tirefit filler - Expired - Replace

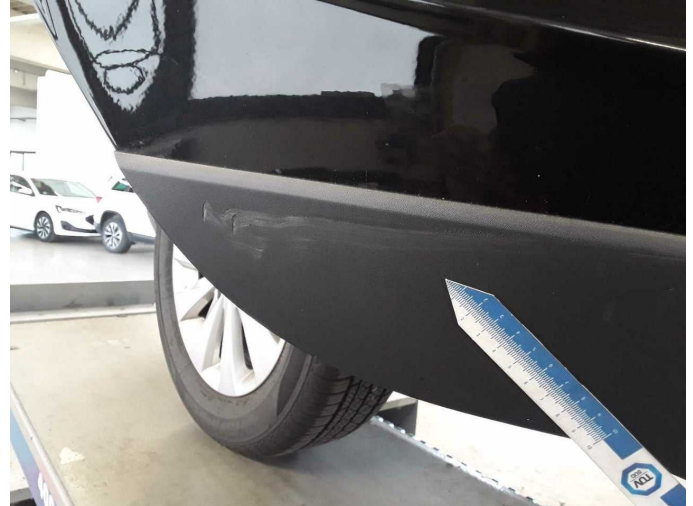
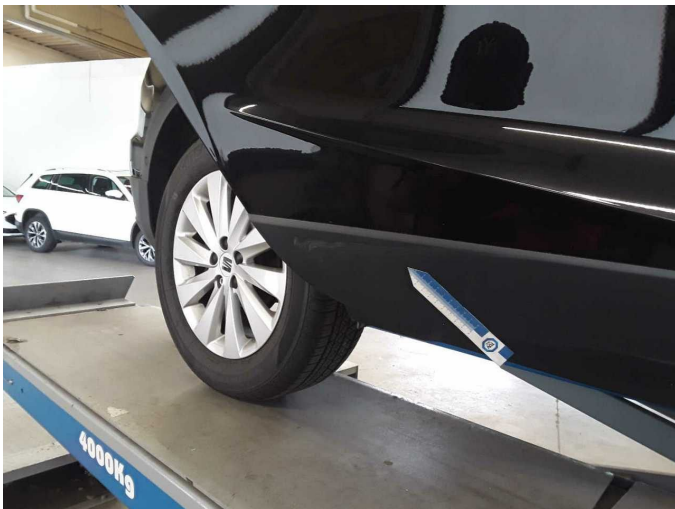
| No. | Component group | Description |
|---|---|---|
| 3 | Trim / covers | Door trim - rear right side - Scratched - Replace |

**Damage 3:** Trim / covers: Door trim - rear right side - Scratched - Replace

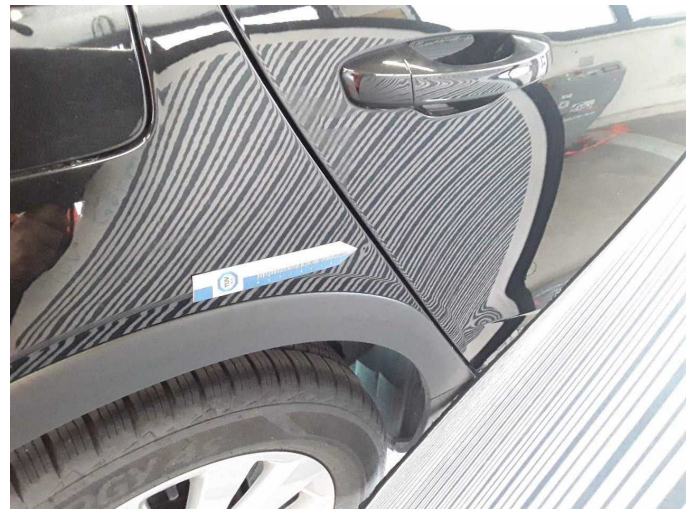
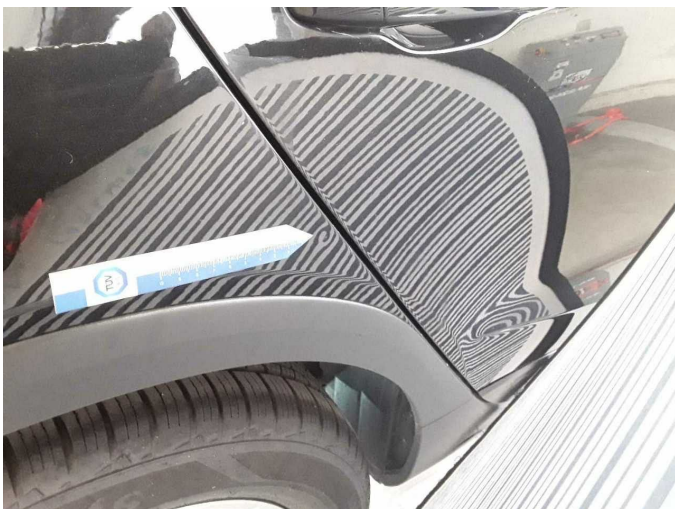
| No. | Component group | Description |
|---|---|---|
| 4 | Side panel - rear right side | Side panel - dent(s) - Smooth repair work |

**Damage 4:** Side panel - rear right side: Side panel - dent(s) - Smooth repair work

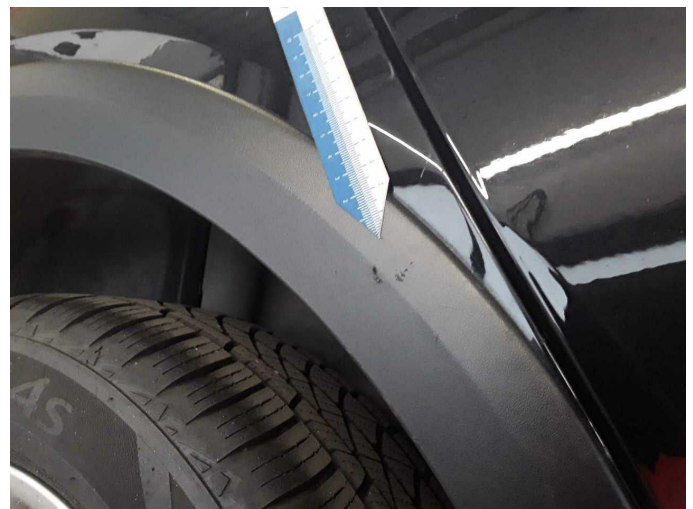
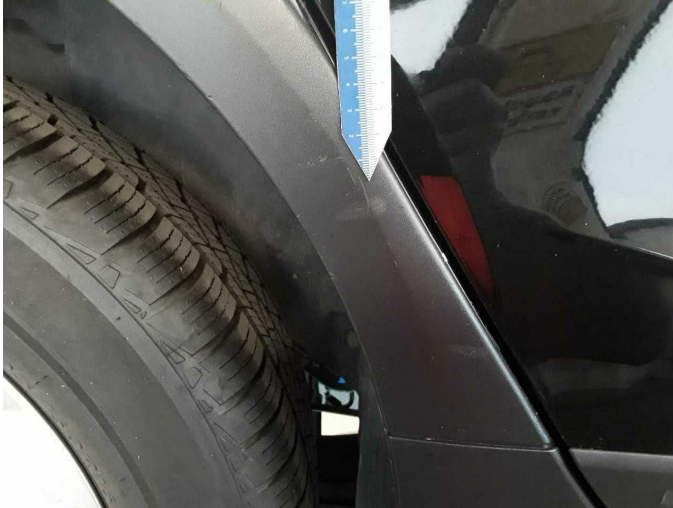
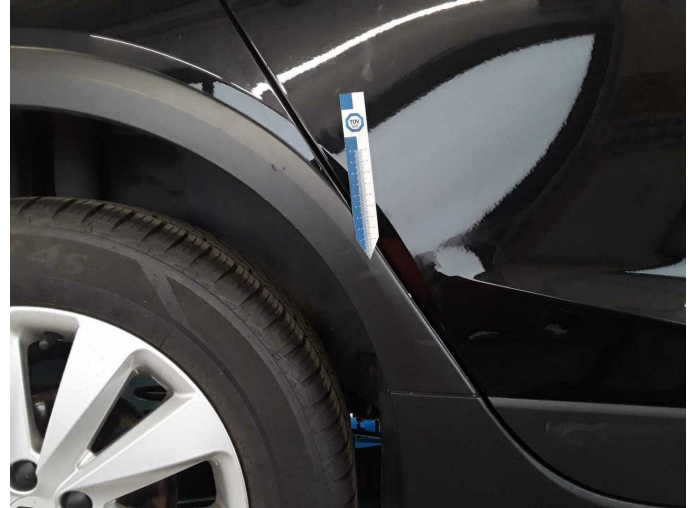
| No. | Component group | Description |
|---|---|---|
| 5 | Side panel - rear right side | Wheel arch - Scratched - Replace |

**Damage 5:** Side panel - rear right side: Wheel arch - Scratched - Replace

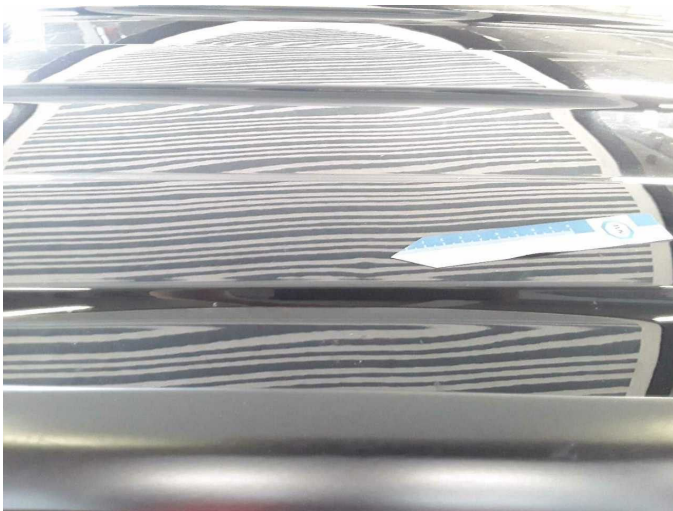
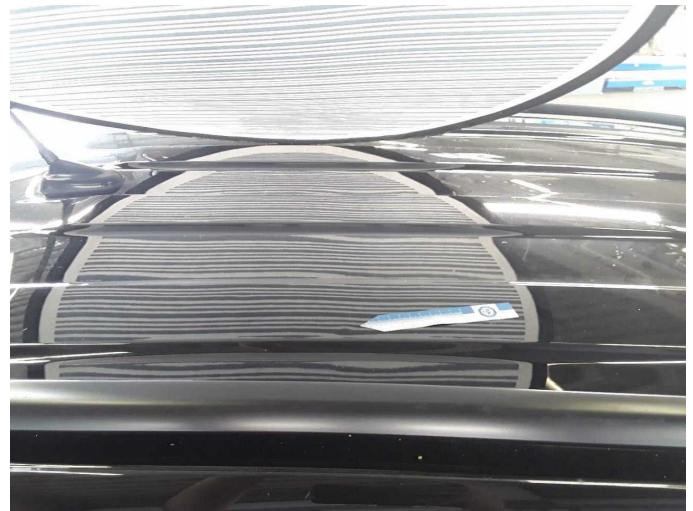
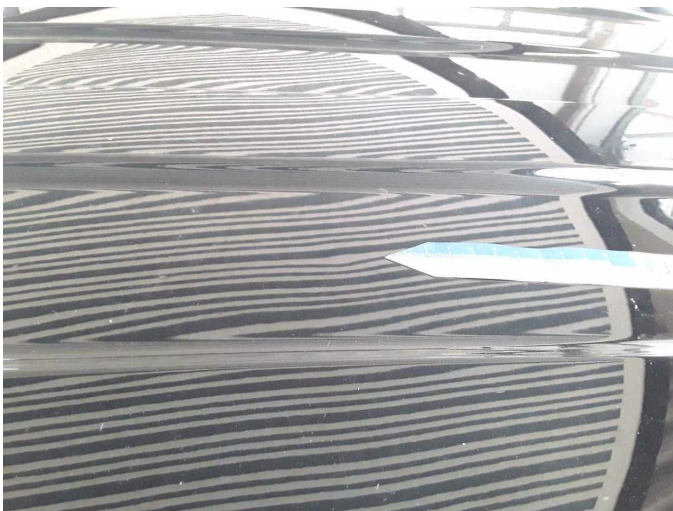
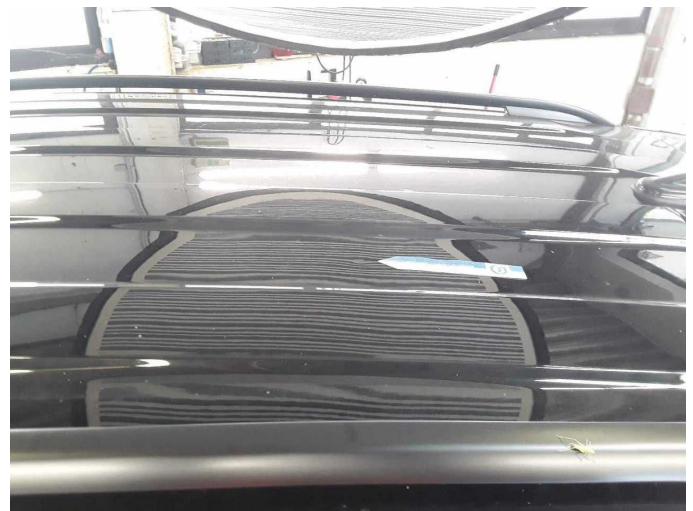
| No. | Component group | Description |
|---|---|---|
| 6 | Roof | Roof - dent(s) - Smooth repair work |

**Damage 6:** Roof: Roof - dent(s) - Smooth repair work

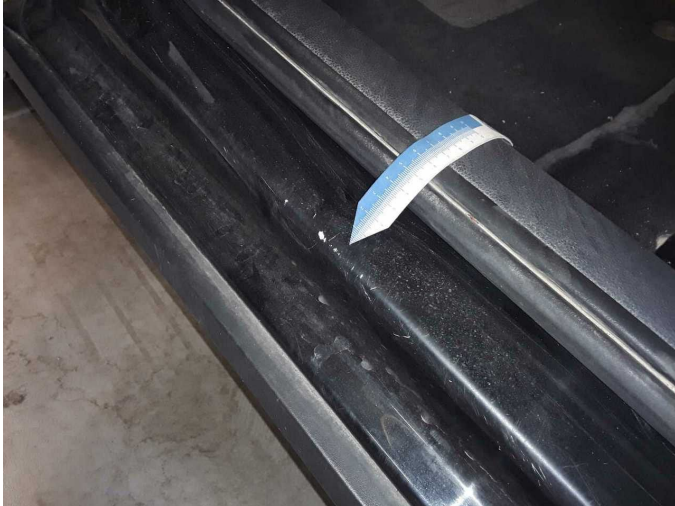
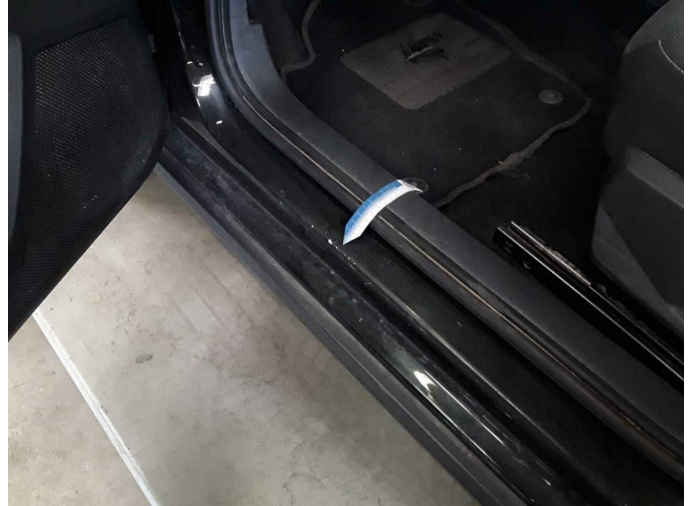
| No. | Component group | Description |
|---|---|---|
| 7 | Sill - left side | Sill - Scratch(es) - Smart repair |

**Damage 7:** Sill - left side: Sill - Scratch(es) - Smart repair

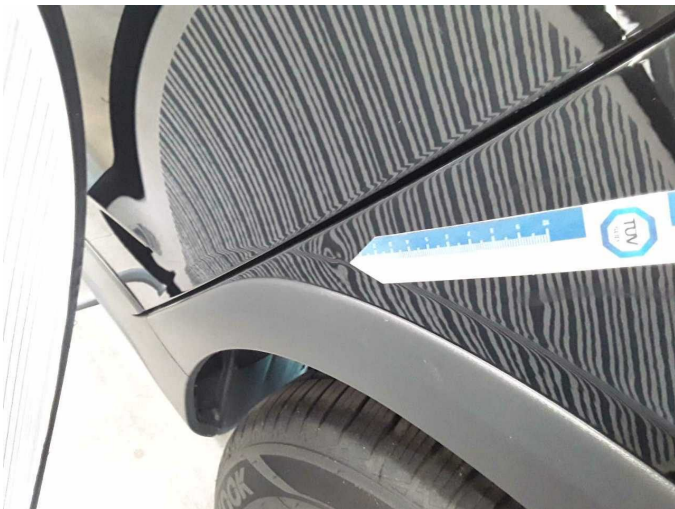
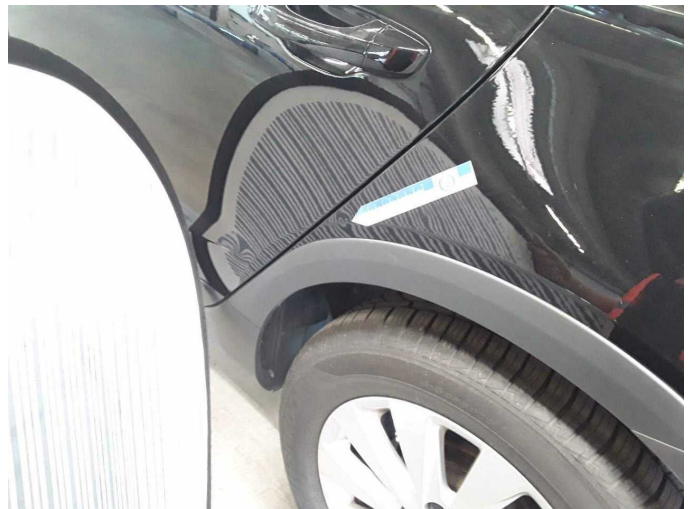
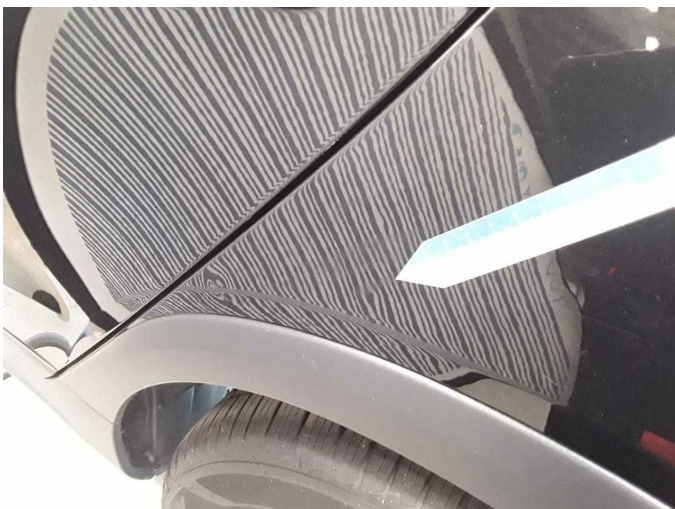
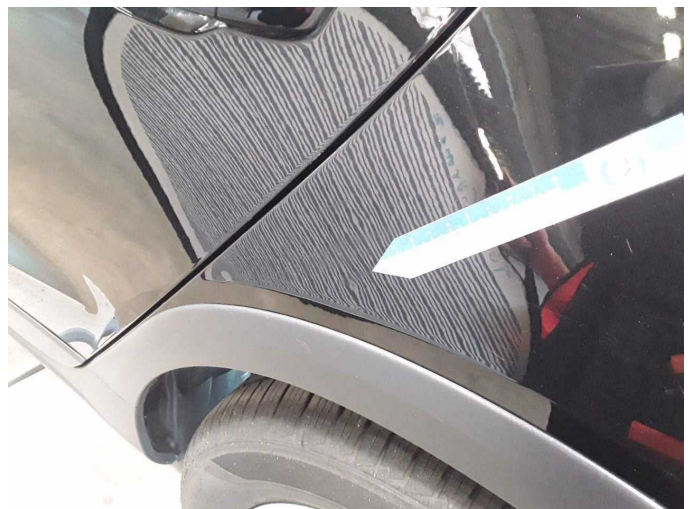
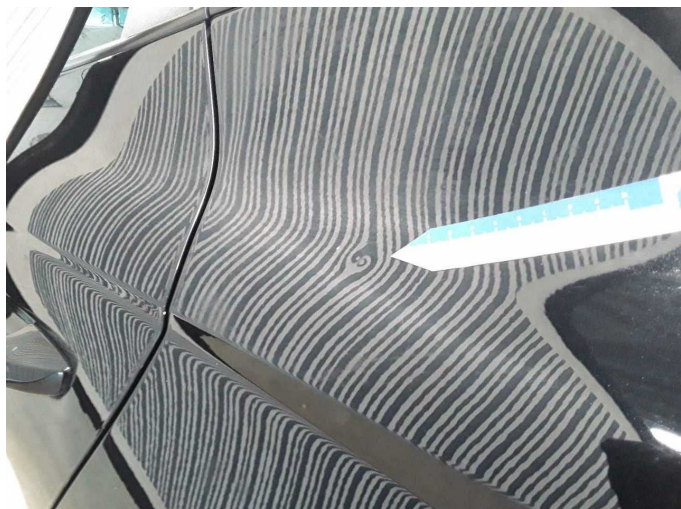
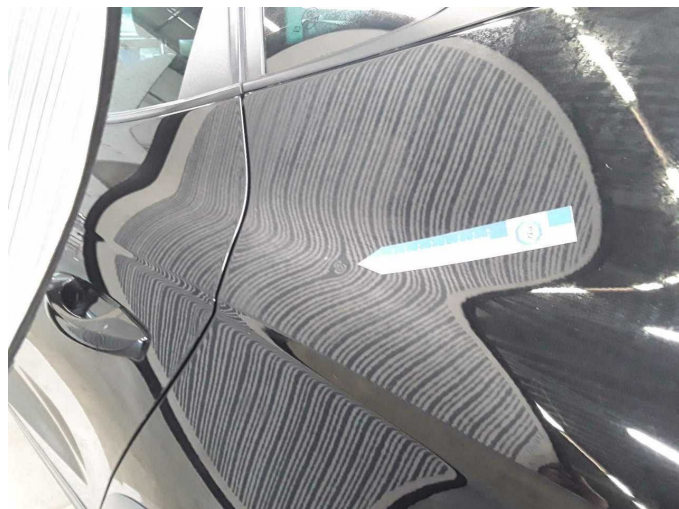
| No. | Component group | Description |
|---|---|---|
| 8 | Side panel - rear left side | Side panel - dent(s) - Smart repair |

**Damage 8:** Side panel - rear left side: Side panel - dent(s) - Smart repair

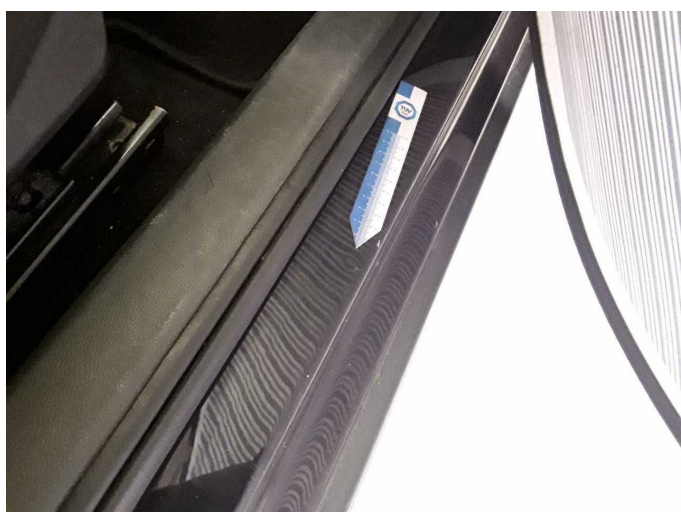
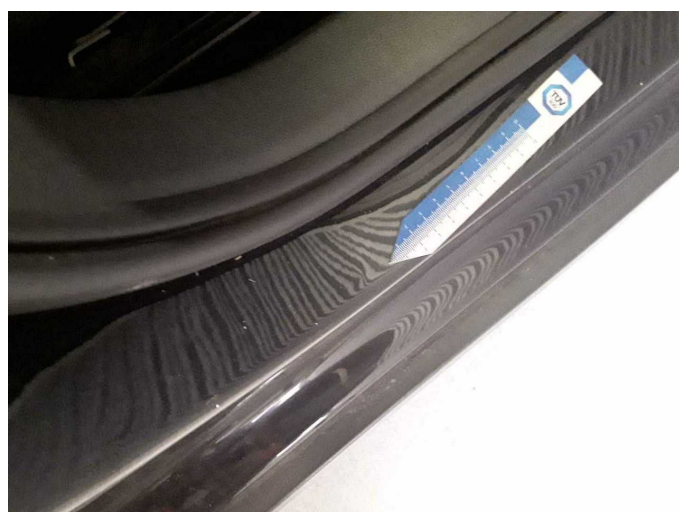
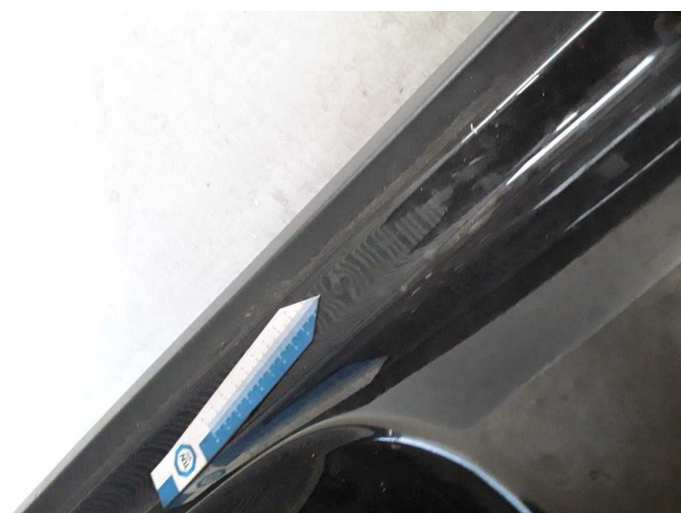
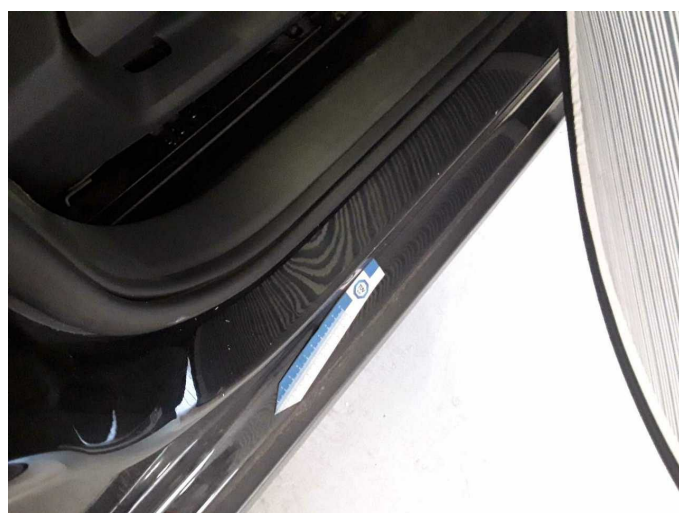
| No. | Component group | Description |
|---|---|---|
| 9 | Sill - right side | Sill - Dent / paintcoat damage - Smart repair |

**Damage 9:** Sill - right side: Sill - Dent / paintcoat damage - Smart repair

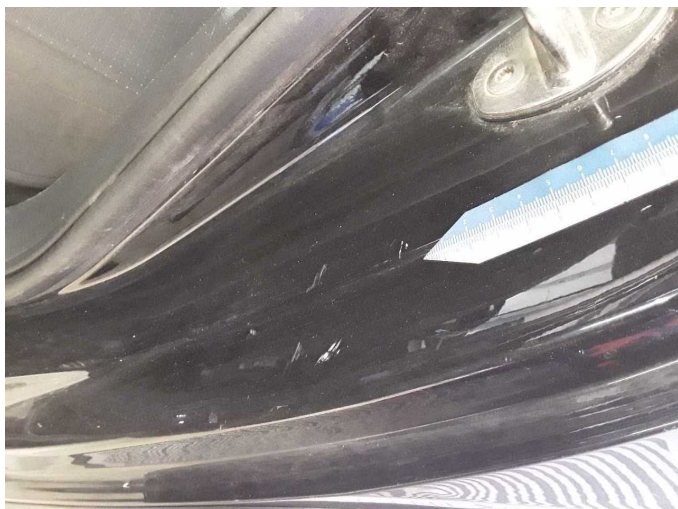
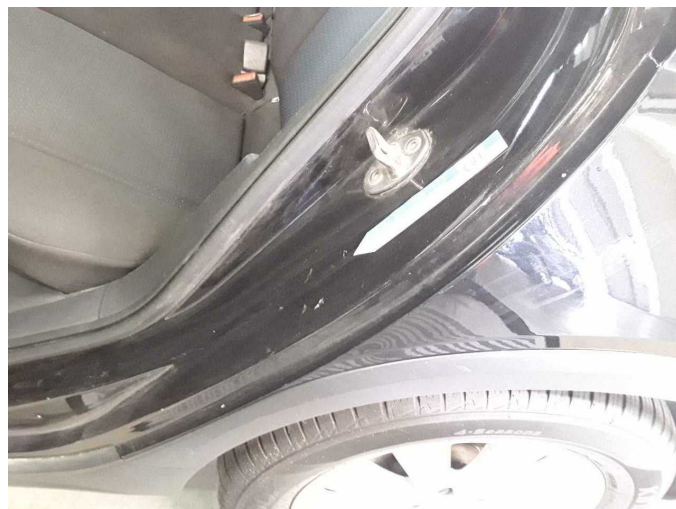
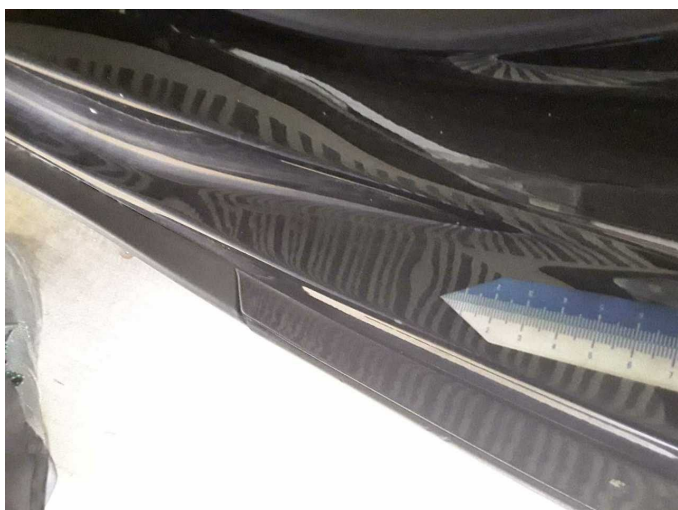
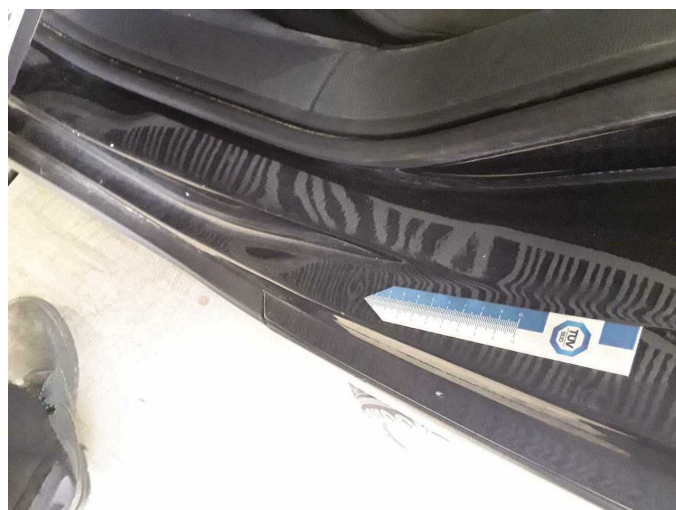
| No. | Component group | Description |
|---|---|---|
| 10 | Side panel - rear left side | Elbow (Einstieg hinten) - Scratched - Smart repair |

**Damage 10:** Side panel - rear left side: Elbow (Einstieg hinten) - Scratched - Smart repair

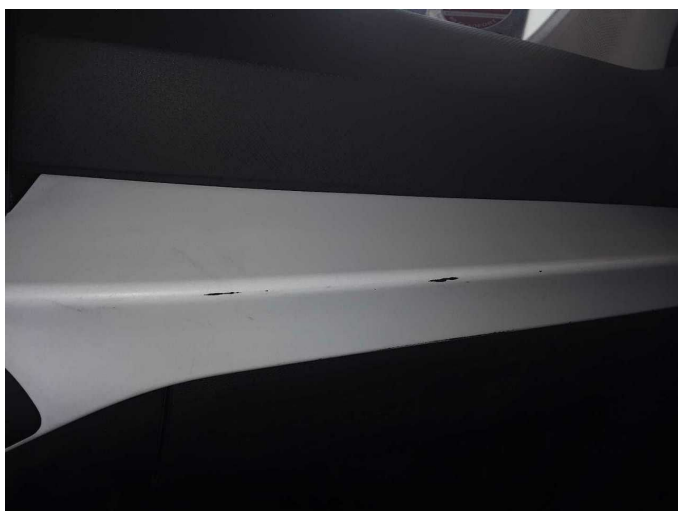
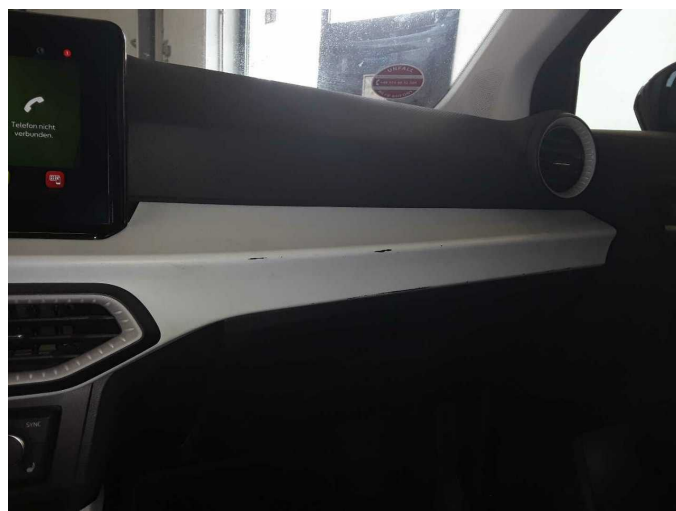
| No. | Component group | Description |
|---|---|---|
| 11 | Instrument panel | Dashboard - right side - Scratch(es) - Loss in value |

**Damage 11:** Instrument panel: Dashboard - right side - Scratch(es) - Loss in value

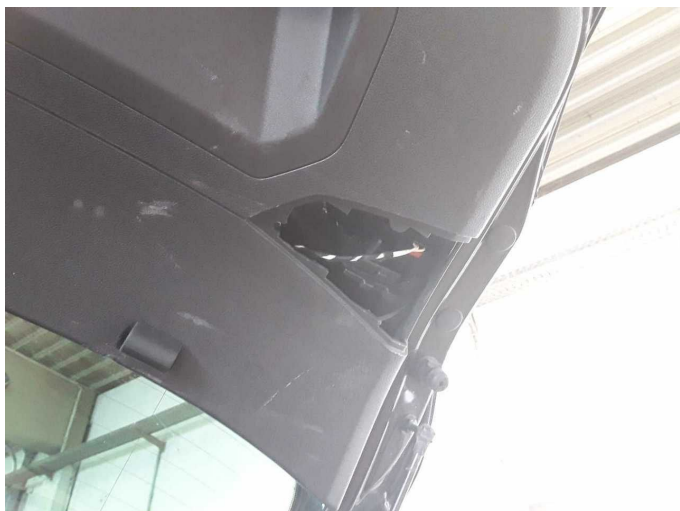
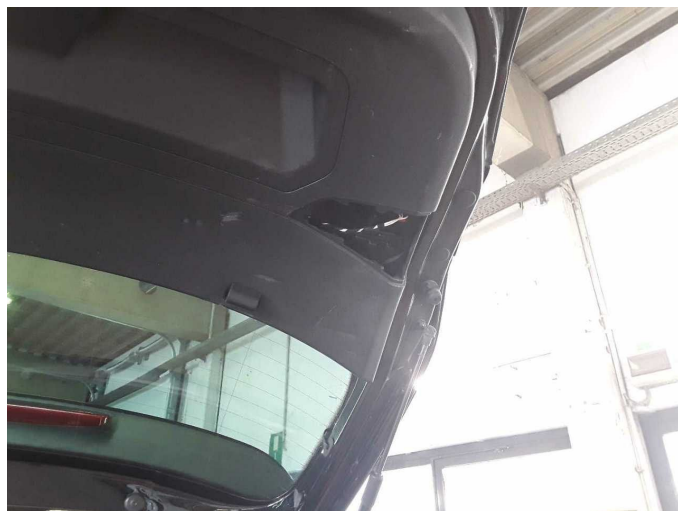
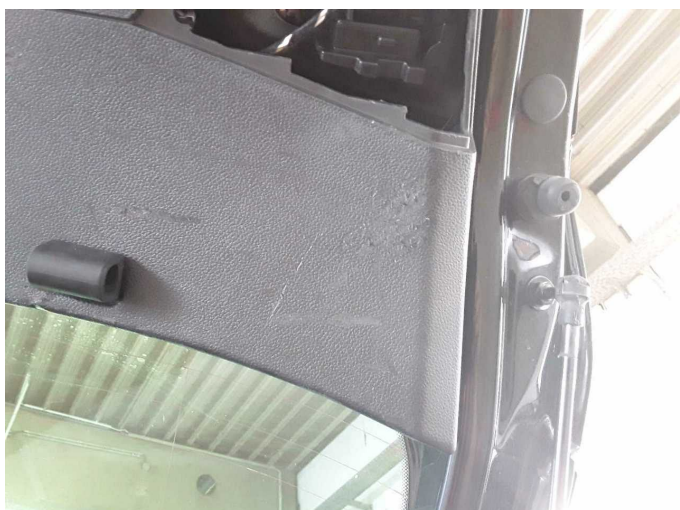
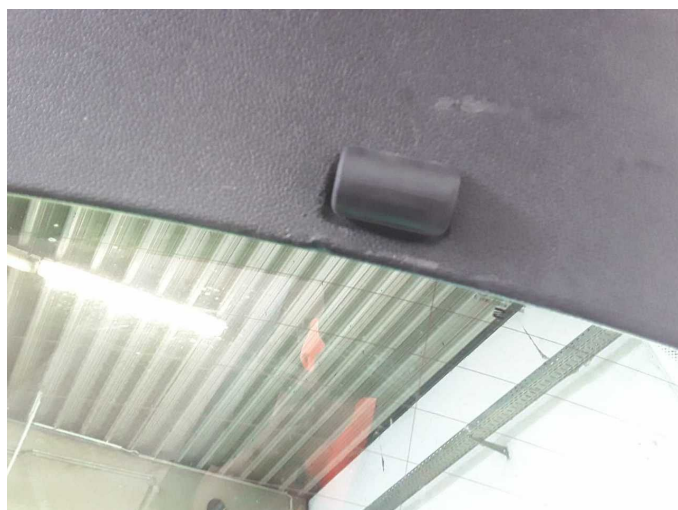
| No. | Component group | Description |
|---|---|---|
| 12 | Trim / covers | Boot lining (Beschädigungen ebenfalls vorhanden) - Missing - Replace |

**Damage 12:** Trim / covers: Boot lining (Beschädigungen ebenfalls vorhanden) - Missing - Replace

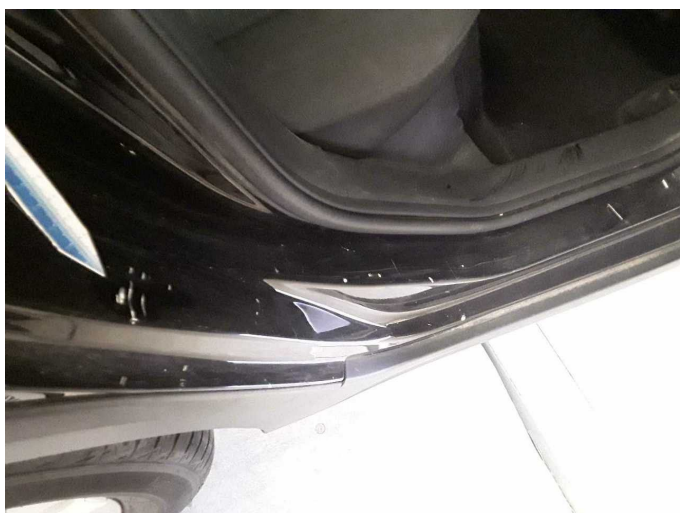
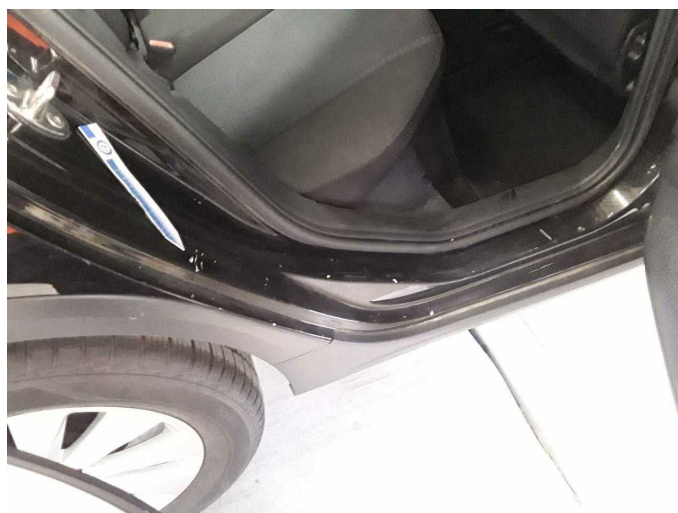
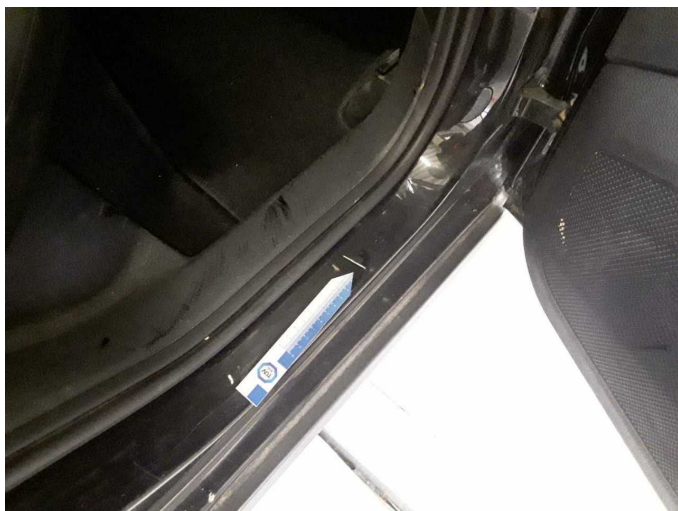
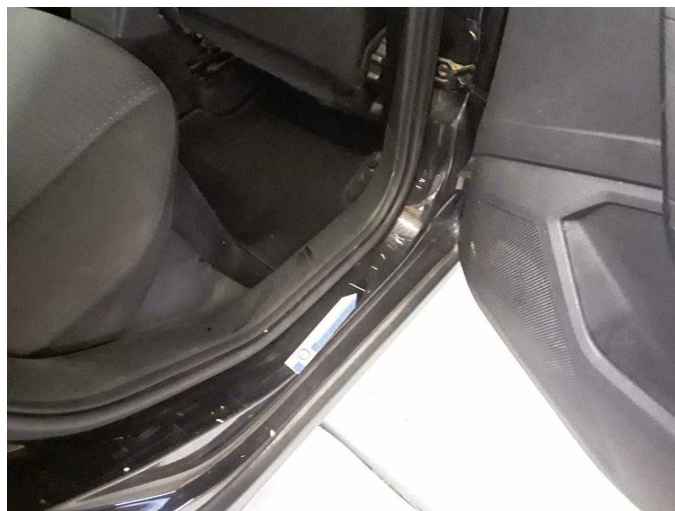
| No. | Component group | Description |
|---|---|---|
| 13 | Side panel - rear right side | Elbow (Einstieg hinten) - Scratched - Smart repair |

**Damage 13:** Side panel - rear right side: Elbow (Einstieg hinten) - Scratched - Smart repair

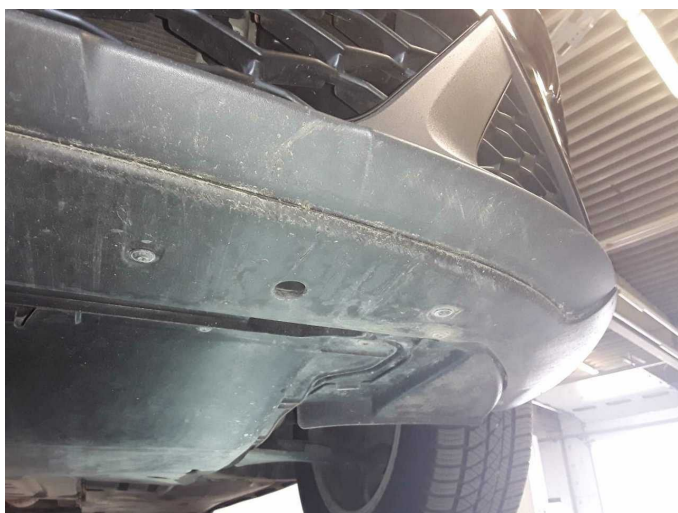
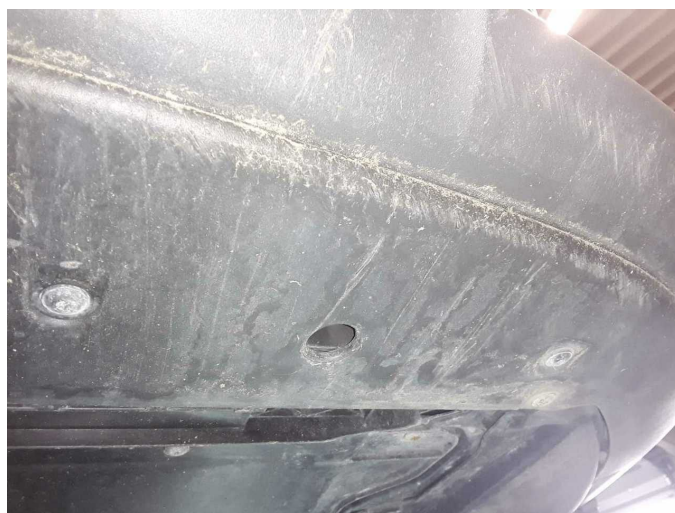
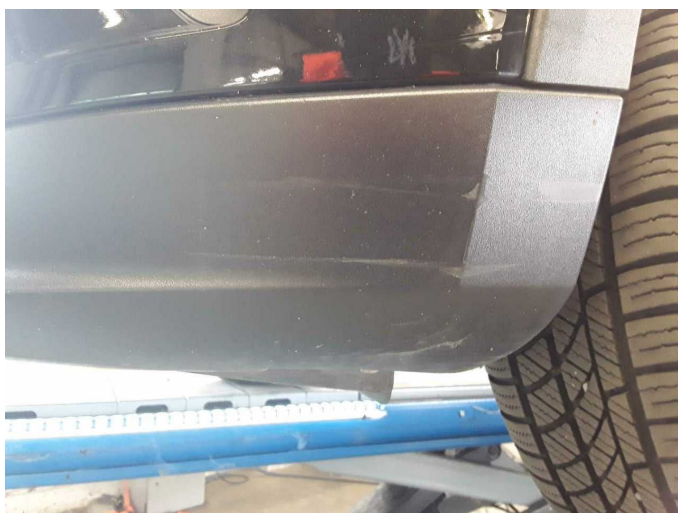
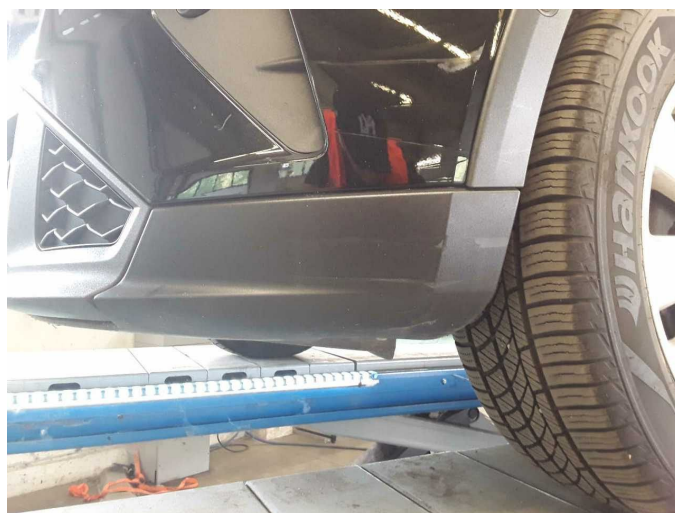
| No. | Component group | Description |
|---|---|---|
| 14 | Body | Underbody panelling - Scratched - Replace |

**Damage 14:** Body: Underbody panelling - Scratched - Replace

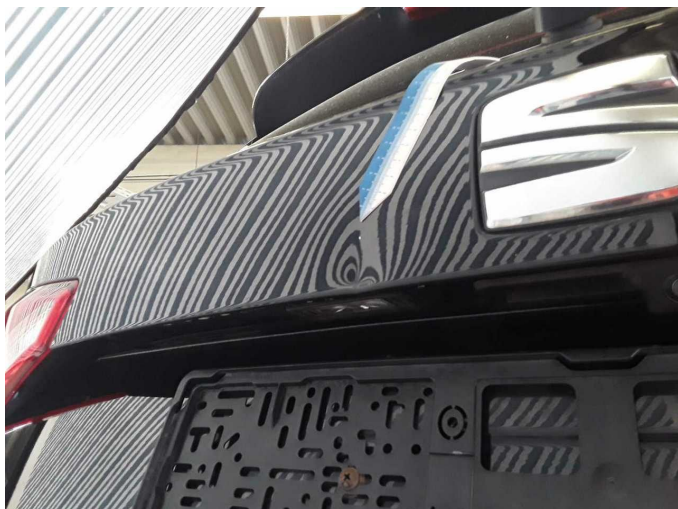
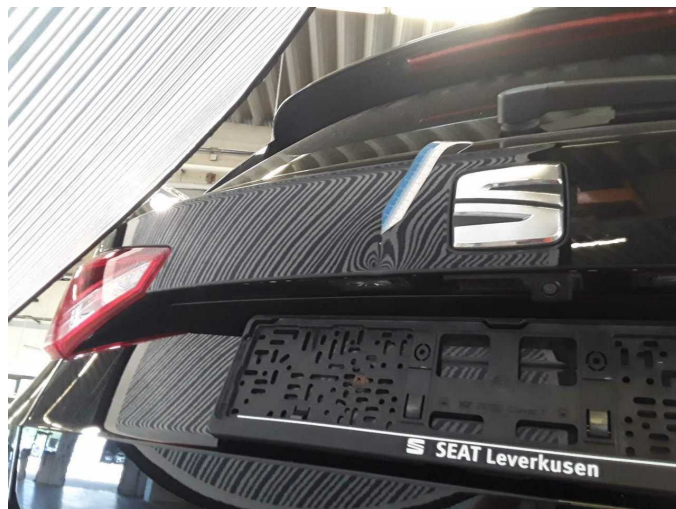
| No. | Component group | Description |
|---|---|---|
| 15 | Boot lid / rear door | Boot lid - Dent / paintcoat damage - Smart repair |

**Damage 15:** Boot lid / rear door: Boot lid - Dent / paintcoat damage - Smart repair

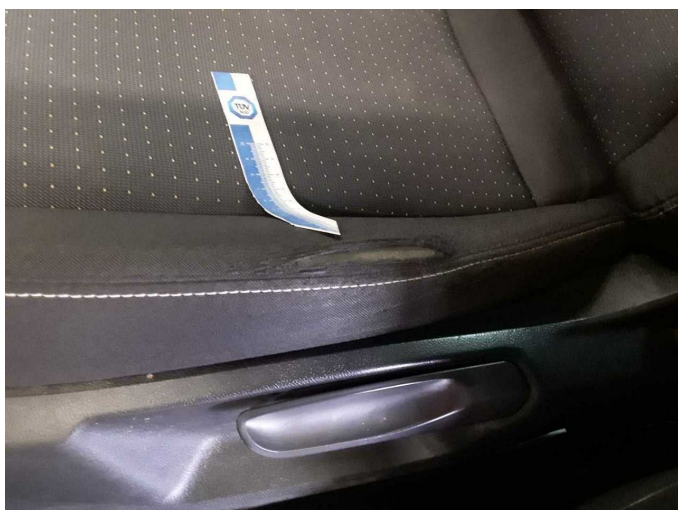
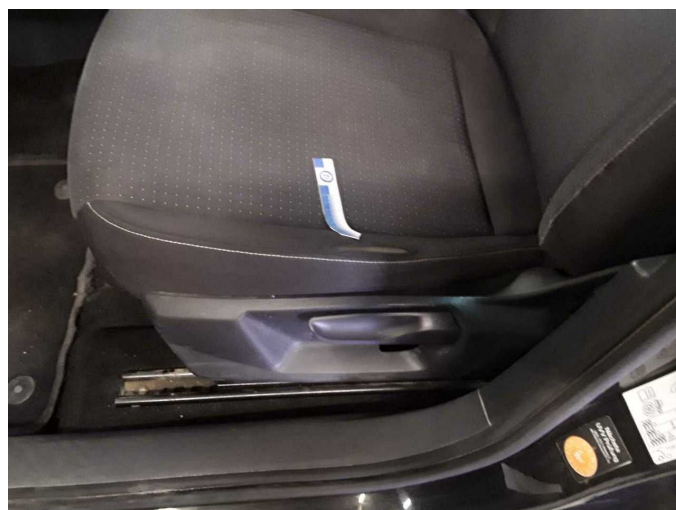
| No. | Component group | Description |
|---|---|---|
| 16 | Seat - front | Seat cover - left side - Damaged - Replace |

**Damage 16:** Seat - front: Seat cover - left side - Damaged - Replace

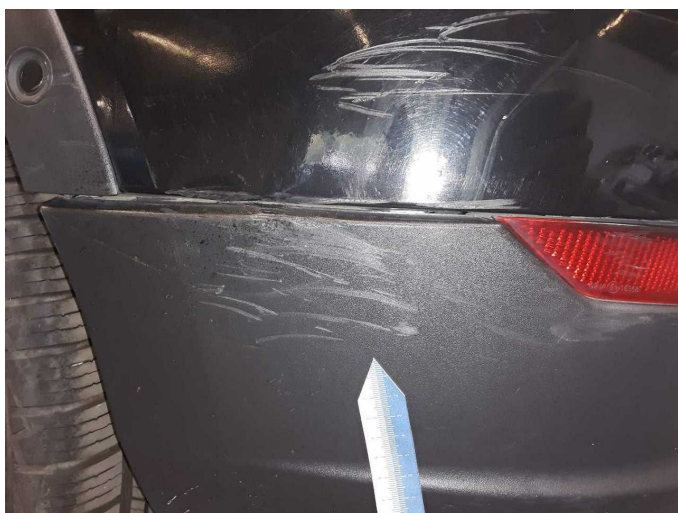
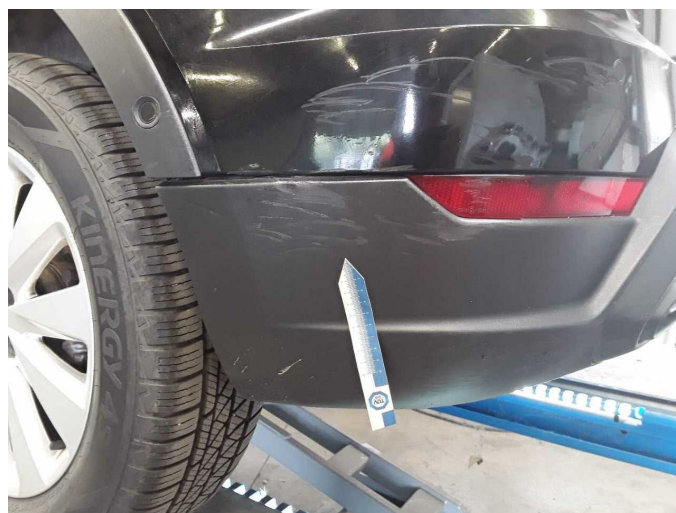
| No. | Component group | Description |
|---|---|---|
| 17 | Rear bumper | Spoiler - Scratched - Replace |

**Damage 17:** Rear bumper: Spoiler - Scratched - Replace

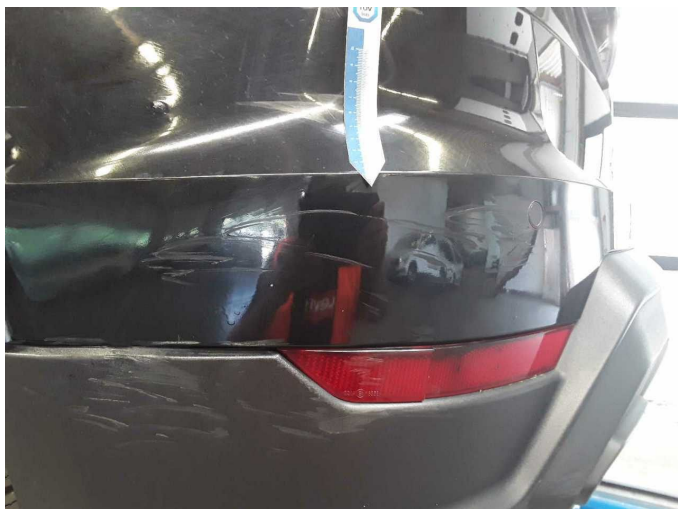
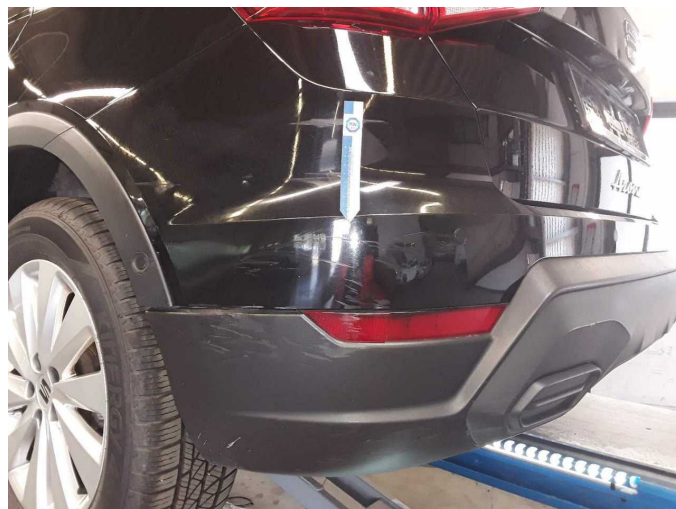
| No. | Component group | Description |
|---|---|---|
| 18 | Rear bumper | Rear bumper - Scratched - Paint |

**Damage 18:** Rear bumper: Rear bumper - Scratched - Paint

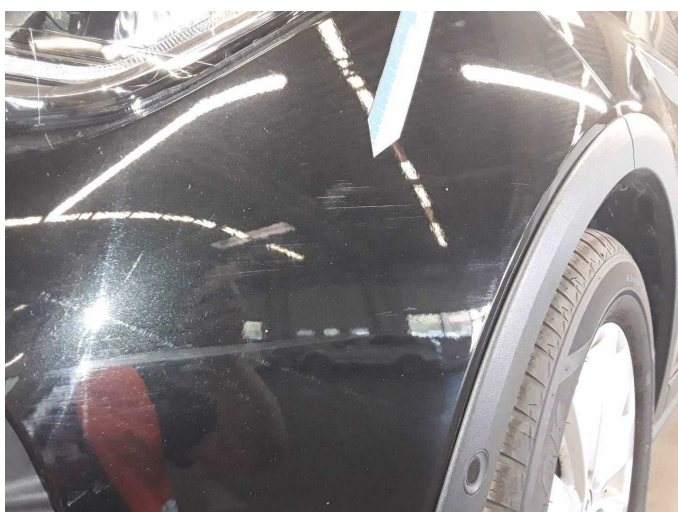
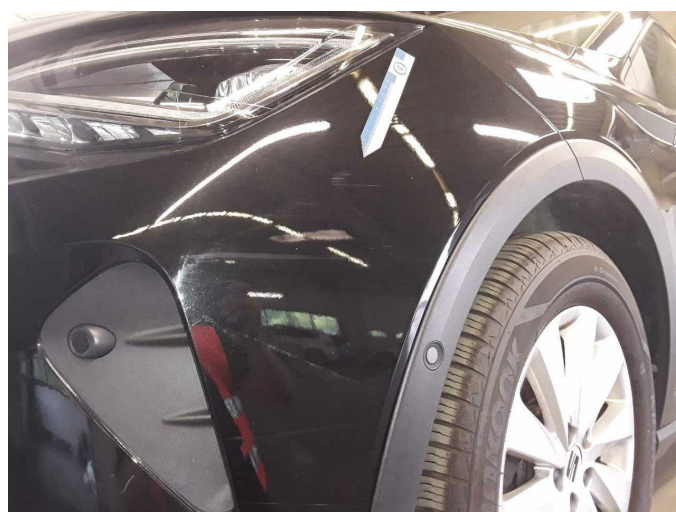
| No. | Component group | Description |
|---|---|---|
| 19 | Front bumper | Front bumper - Scratched - Paint |

**Damage 19:** Front bumper: Front bumper - Scratched - Paint

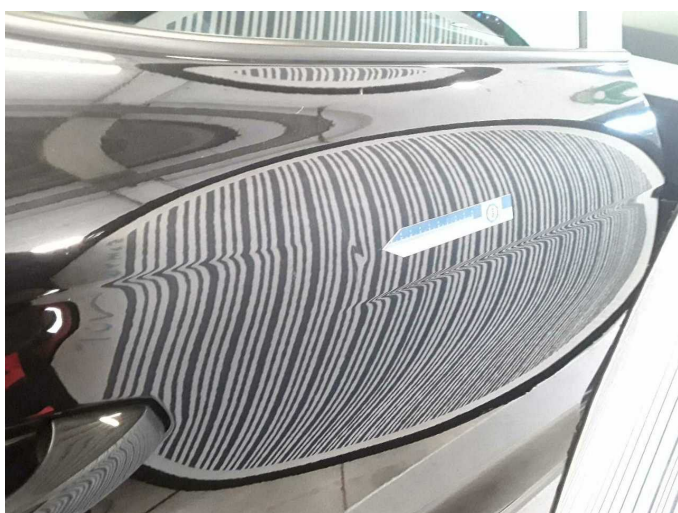
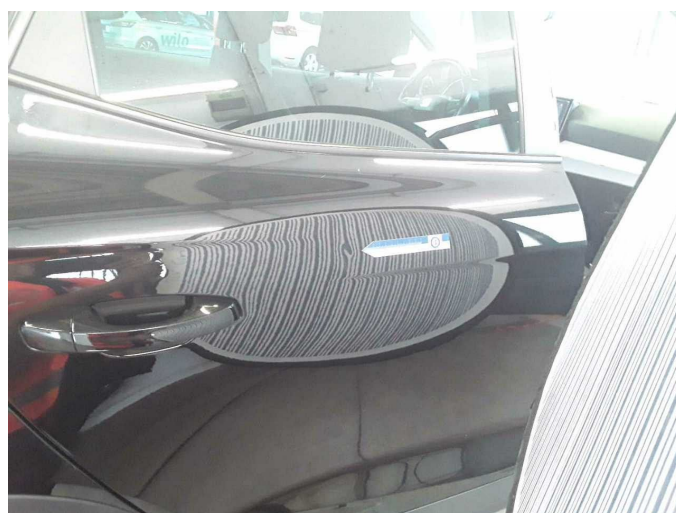
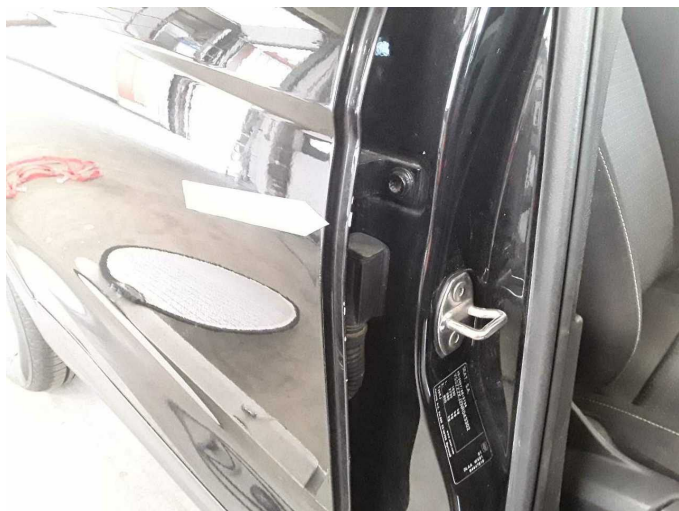
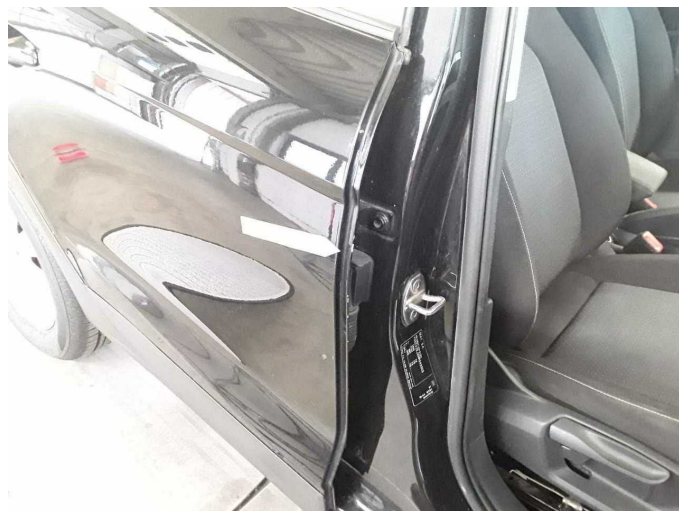
| No. | Component group | Description |
|---|---|---|
| 20 | Door - rear right side | Door - Dent / paintcoat damage - Repair and paint |

**Damage 20:** Door - rear right side: Door - Dent / paintcoat damage - Repair and paint

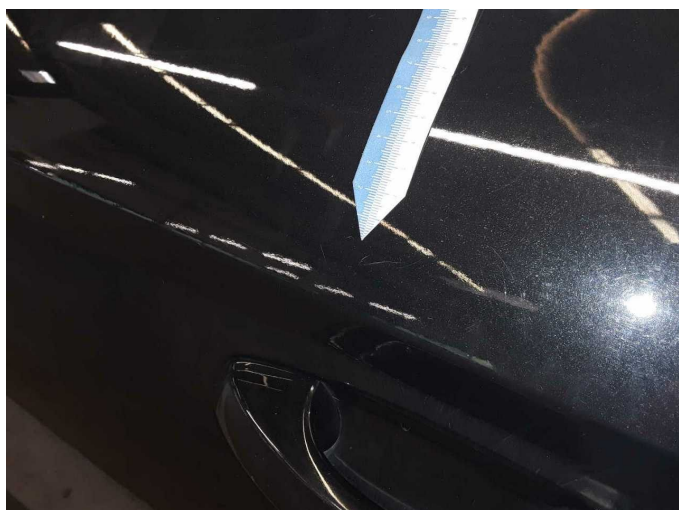
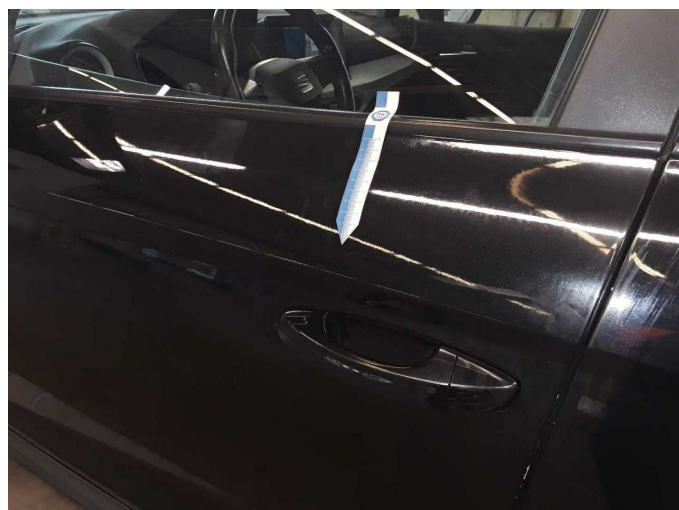
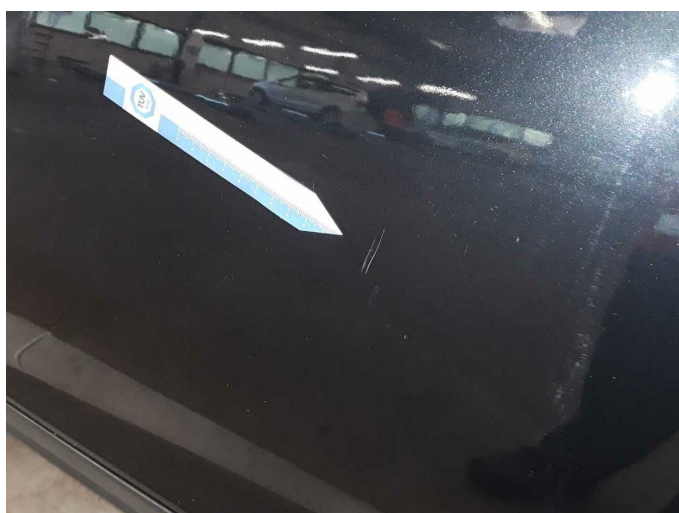
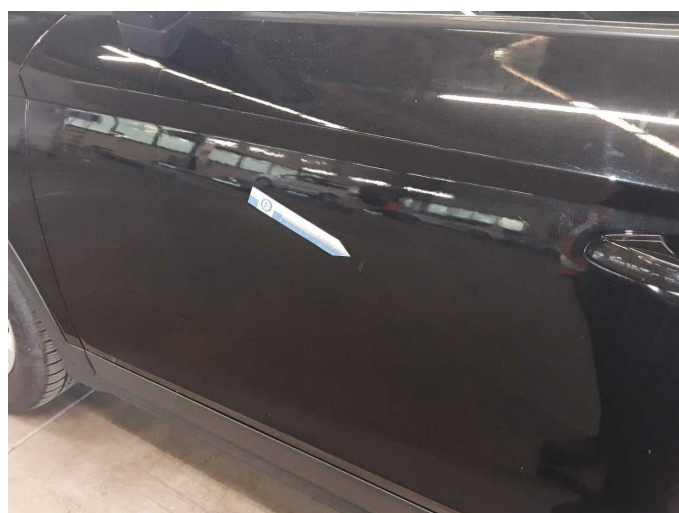
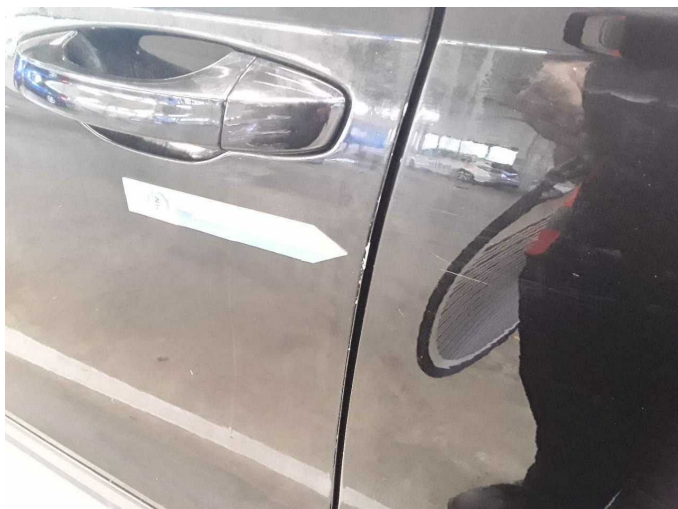
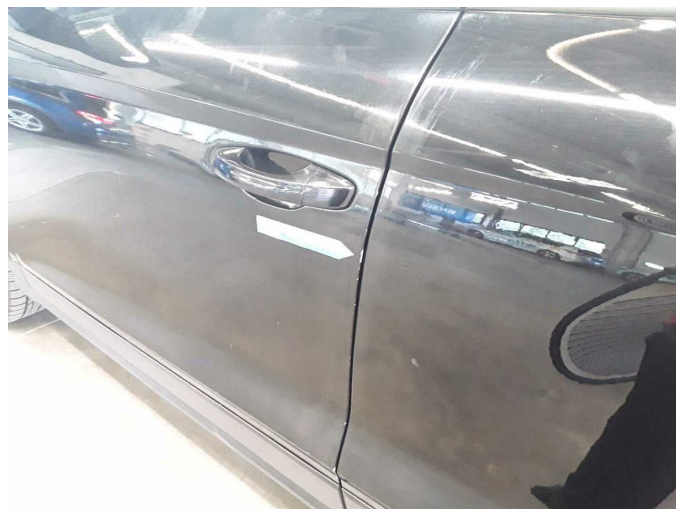
| No. | Component group | Description |
|---|---|---|
| 21 | Door - front left side | Door - Scratch(es) - Paint |

**Damage 21:** Door - front left side: Door - Scratch(es) - Paint
