Expertise

Protocol number: 46867776  
Order No. / Reference: 26715258  
Inspection date: 3 Aug 2026

Model: Arona 1.0 TSI OPF Style

VIN: VSSZZKJZNR043302

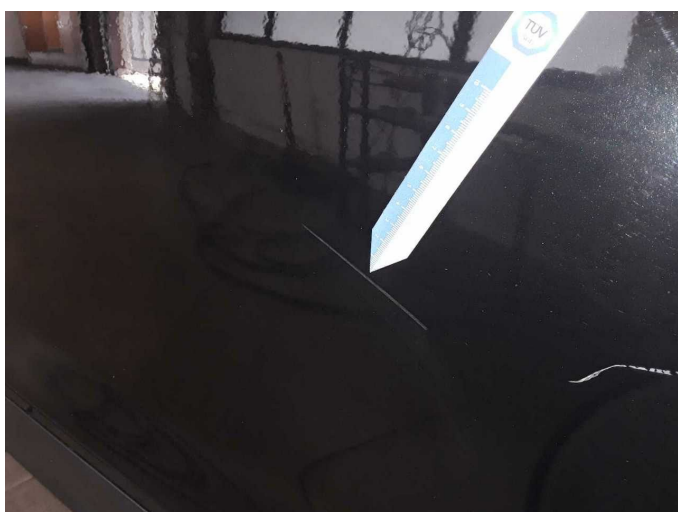
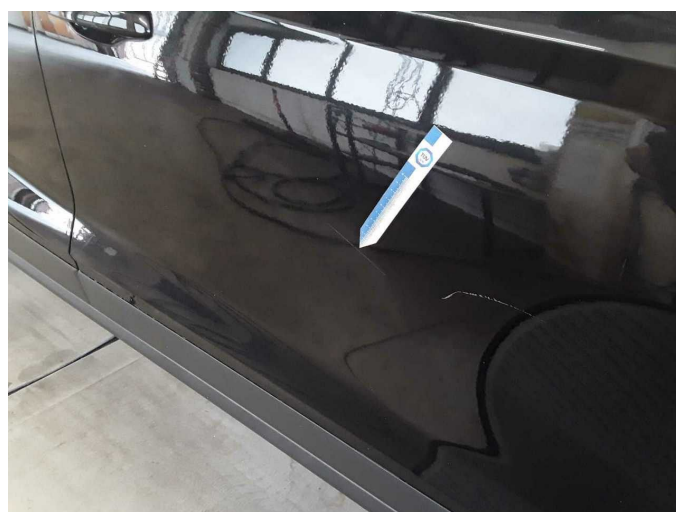
| No. | Component group | Description |
|---|---|---|
| 22 | Door - front right side | Door - Scratch(es) - Paint |

**Damage 22:** Door - front right side: Door - Scratch(es) - Paint

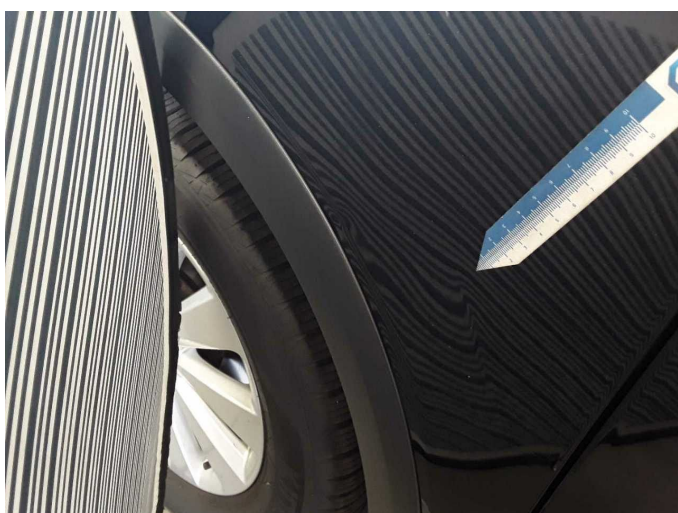
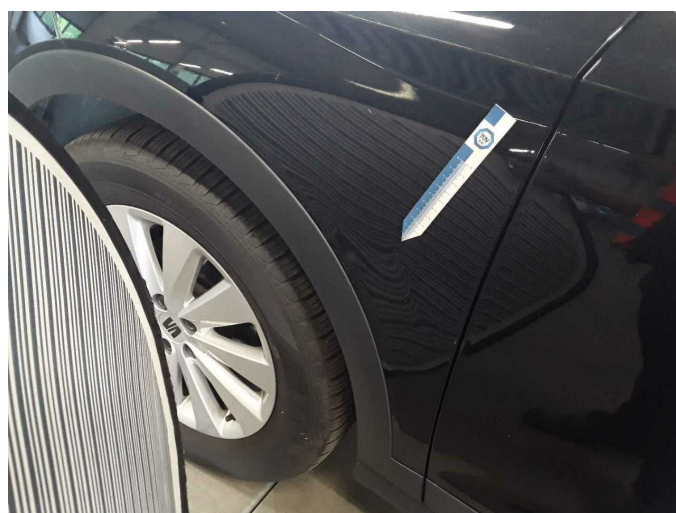
| No. | Component group | Description |
|---|---|---|
| 23 | Mudguard - left side | Mudguard - left side - Deformed - Repair and paint |

**Damage 23:** Mudguard - left side: Mudguard - left side - Deformed - Repair and paint

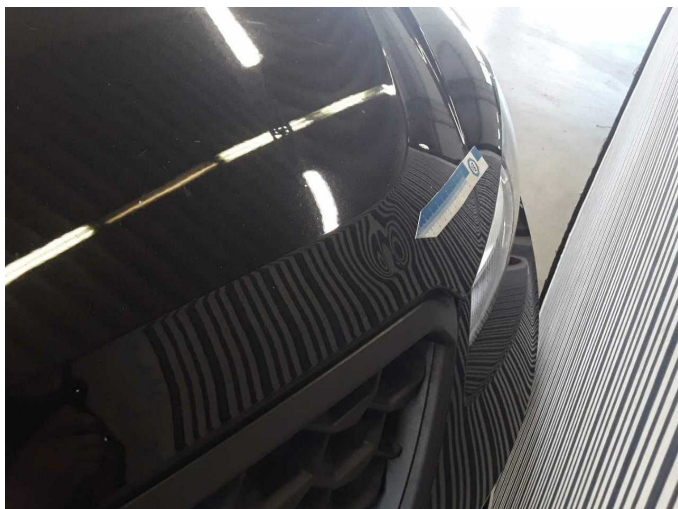
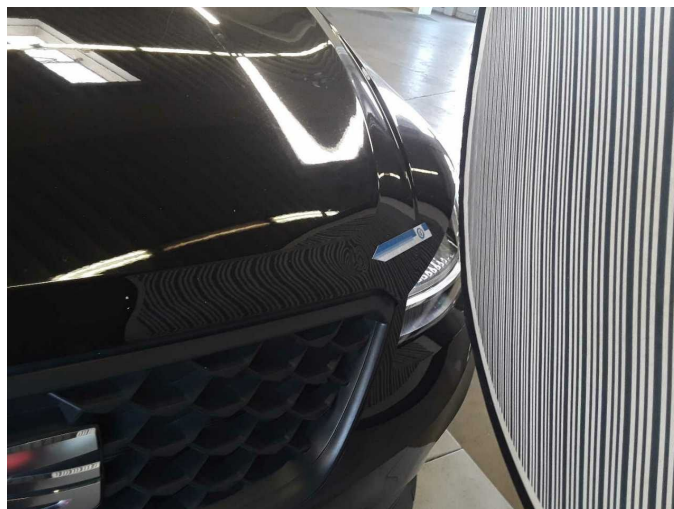
| No. | Component group | Description |
|---|---|---|
| 24 | Bonnet | Bonnet - Dent / paintcoat damage - Repair and paint |

**Damage 24:** Bonnet: Bonnet - Dent / paintcoat damage - Repair and paint
